# State Dining Room Stowe House Buckinghamshire

## Historic Building Investigation and Recording

July 2023

Document Type: Historic Building Investigation and Recording

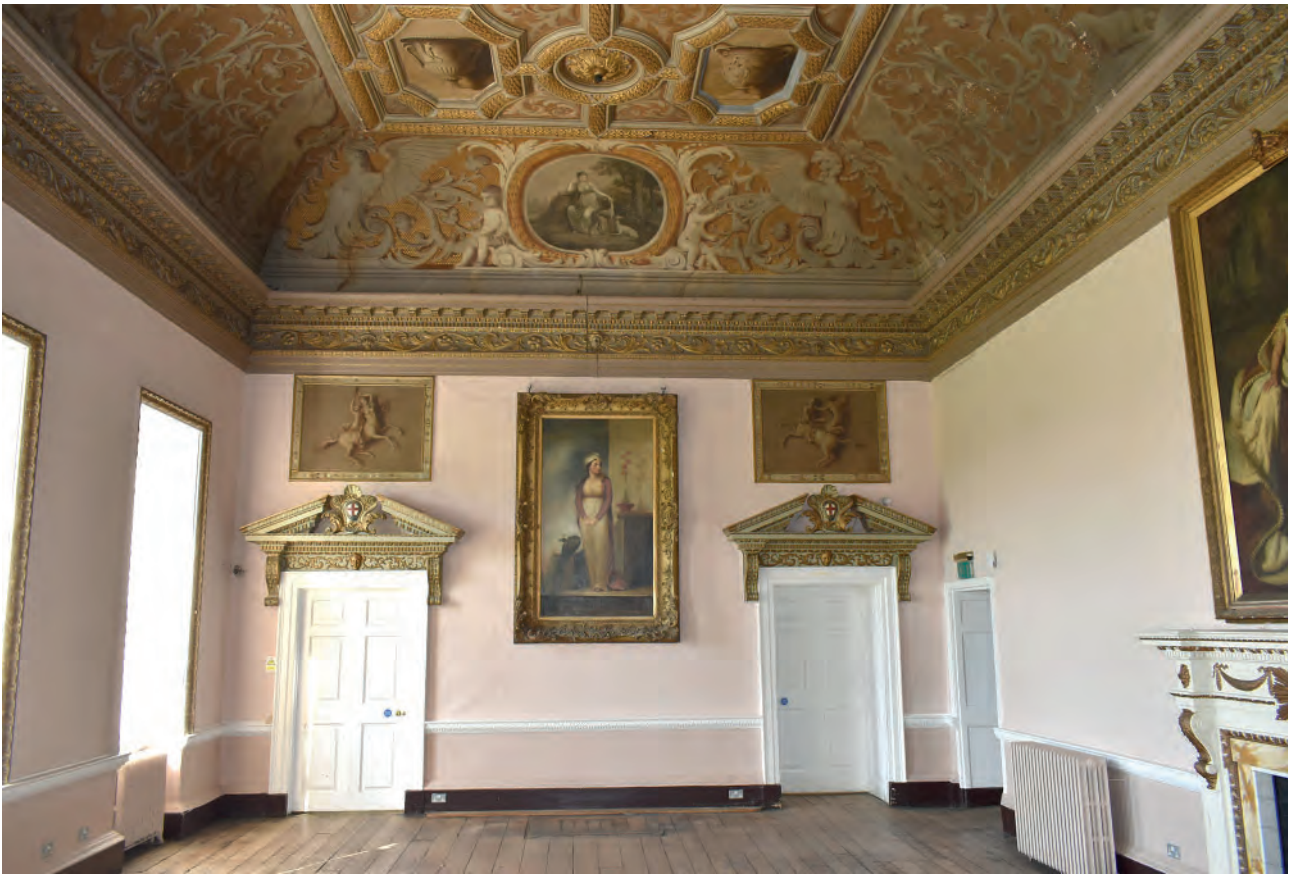
Plate 3: West wall, at the start of the project

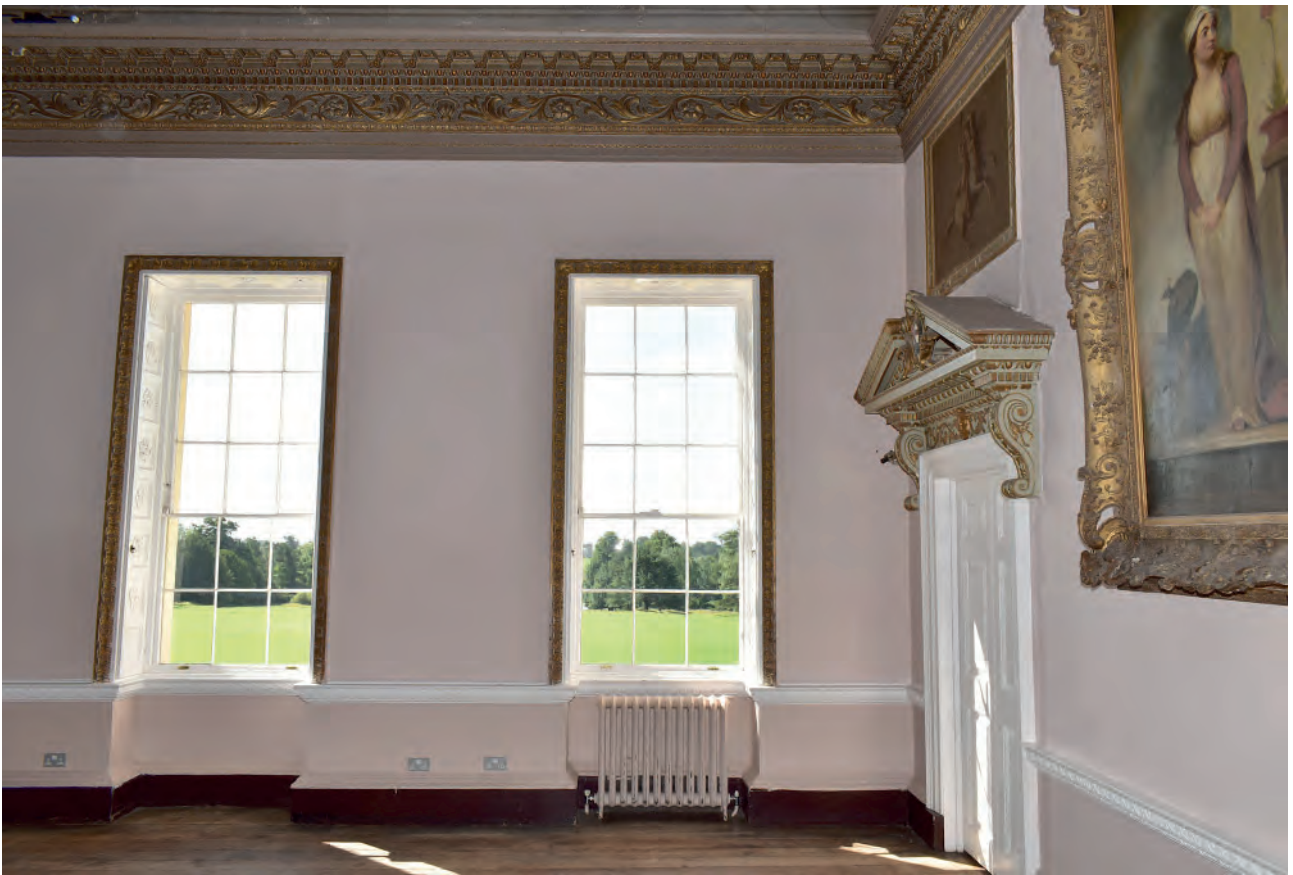
- 3.1.4 There are seven sash windows to the south wall of the room with surviving shutters (Plate 4). Radiators dating to around the time of the foundation of the school are found to alternate recesses beneath the windows (Plate 5) and there are three slightly later radiators to the north wall (Plate 6). Until the building's sale in 1922, the north, east and west walls were hung with tapestries; the fireplaces were sold at the same date and the current fireplaces date to around the opening of the school (Plates 7 and 8).

Plate 4: South wall, example of windows at the start of the project

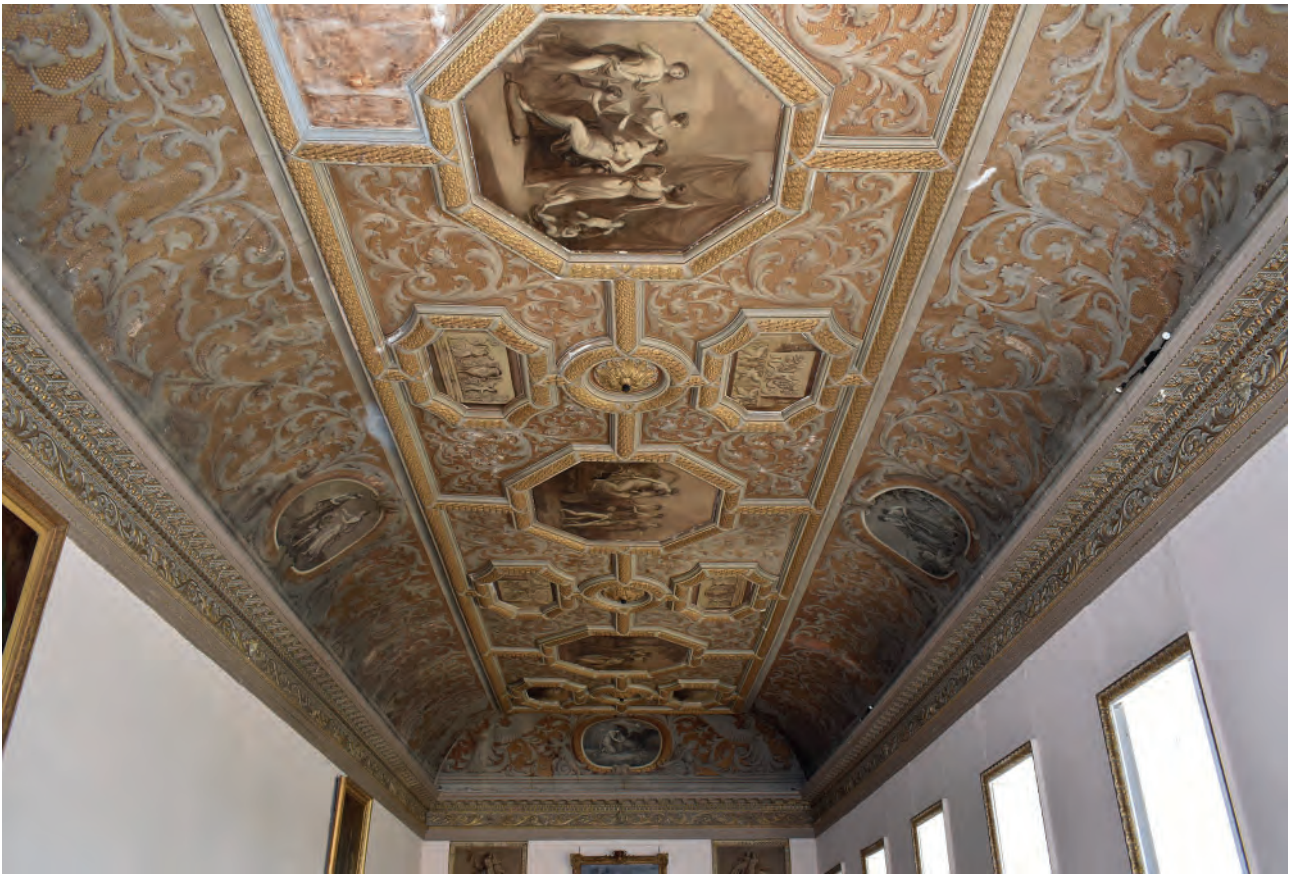
Plate 9: Ceiling, before conservation work, looking east

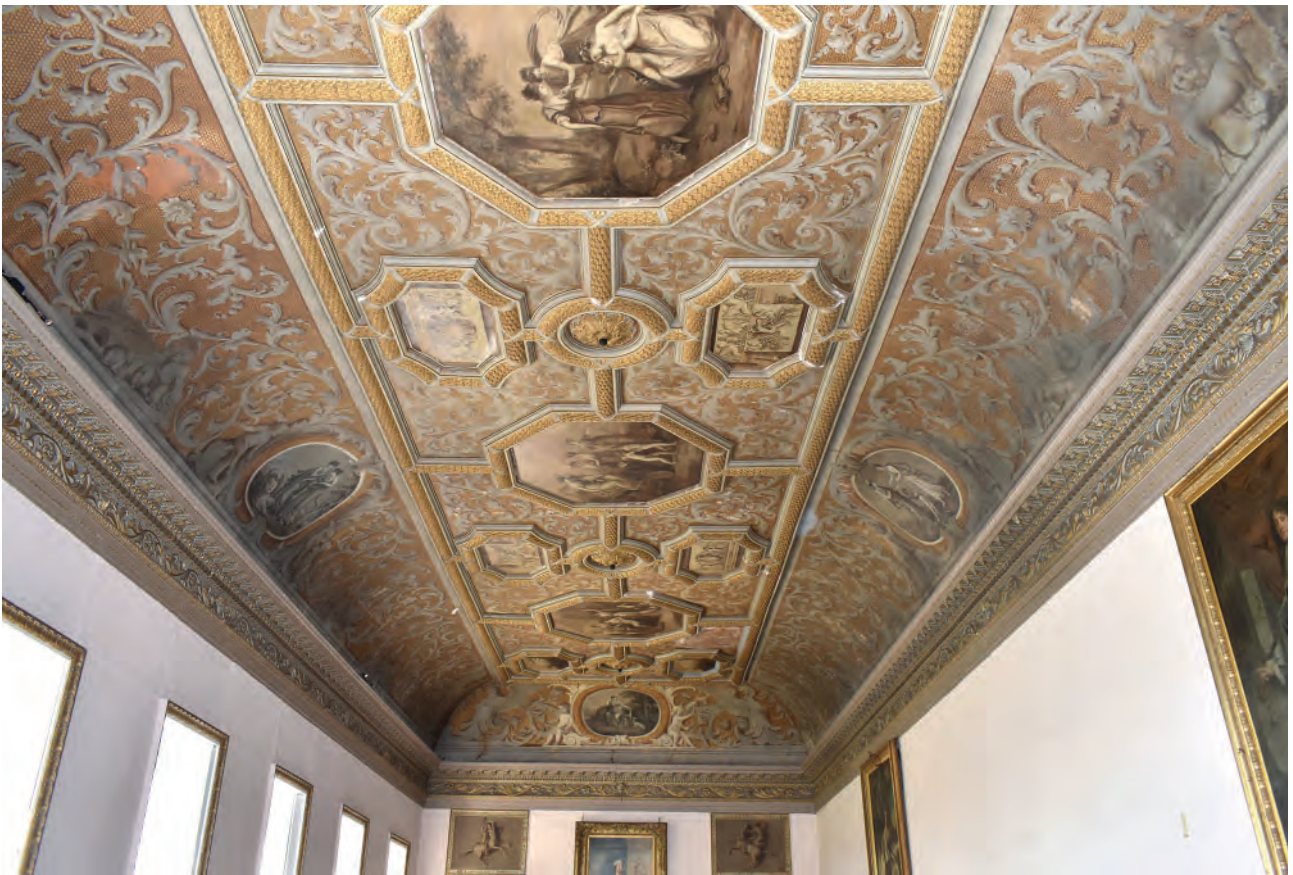
Plate 10: Ceiling, before conservation work, looking west

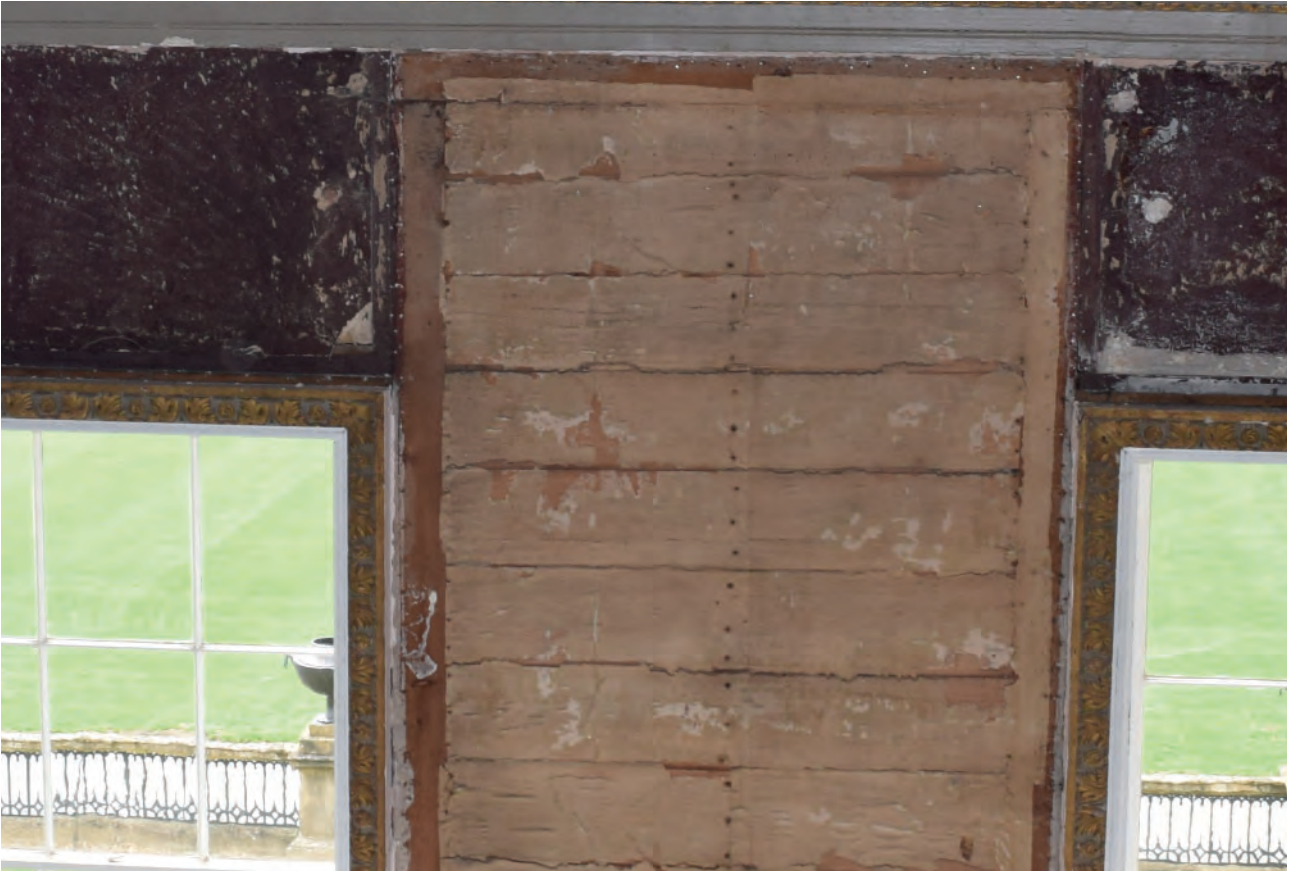
Plate 36: South wall, original plaster over windows

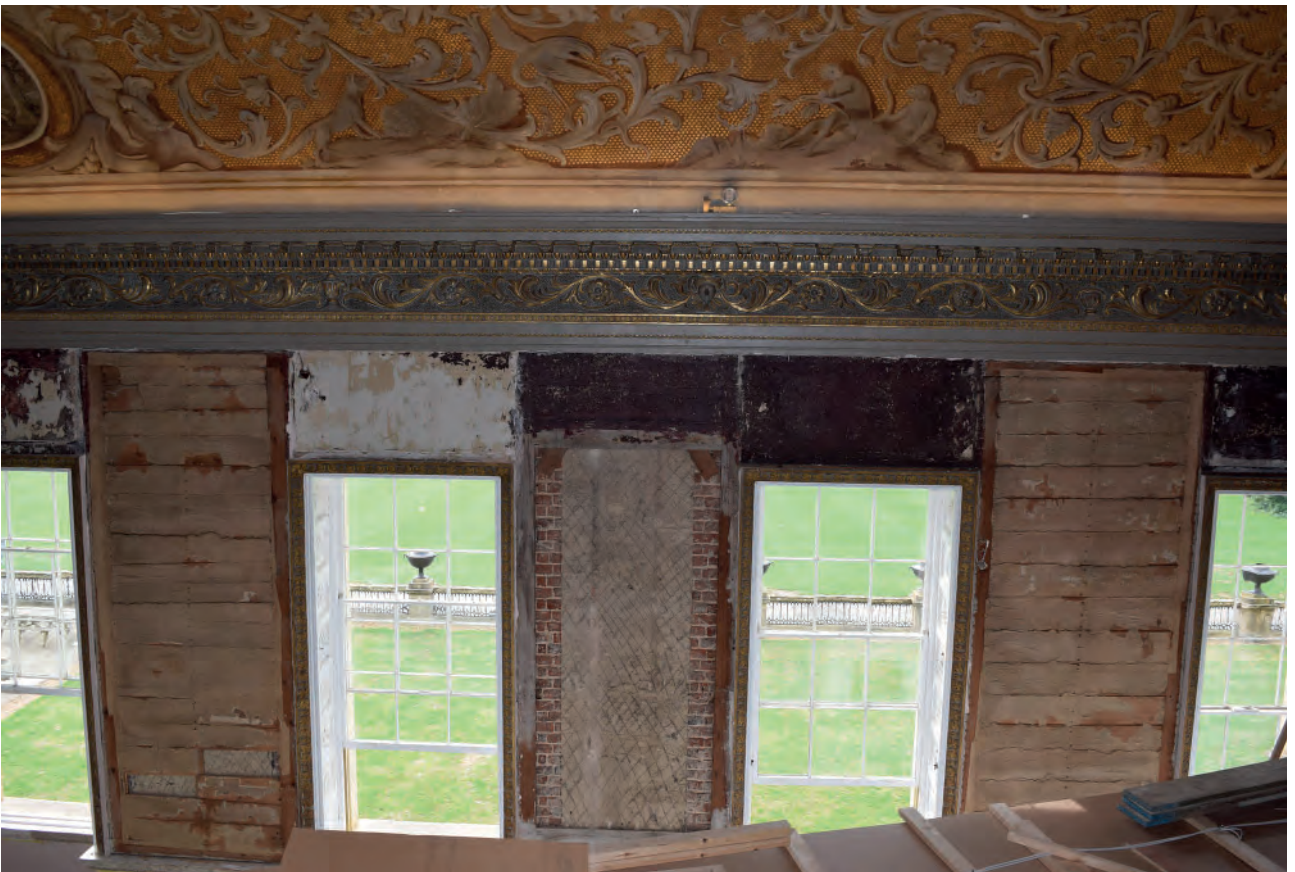
Plate 37: South wall, modern plaster between windows

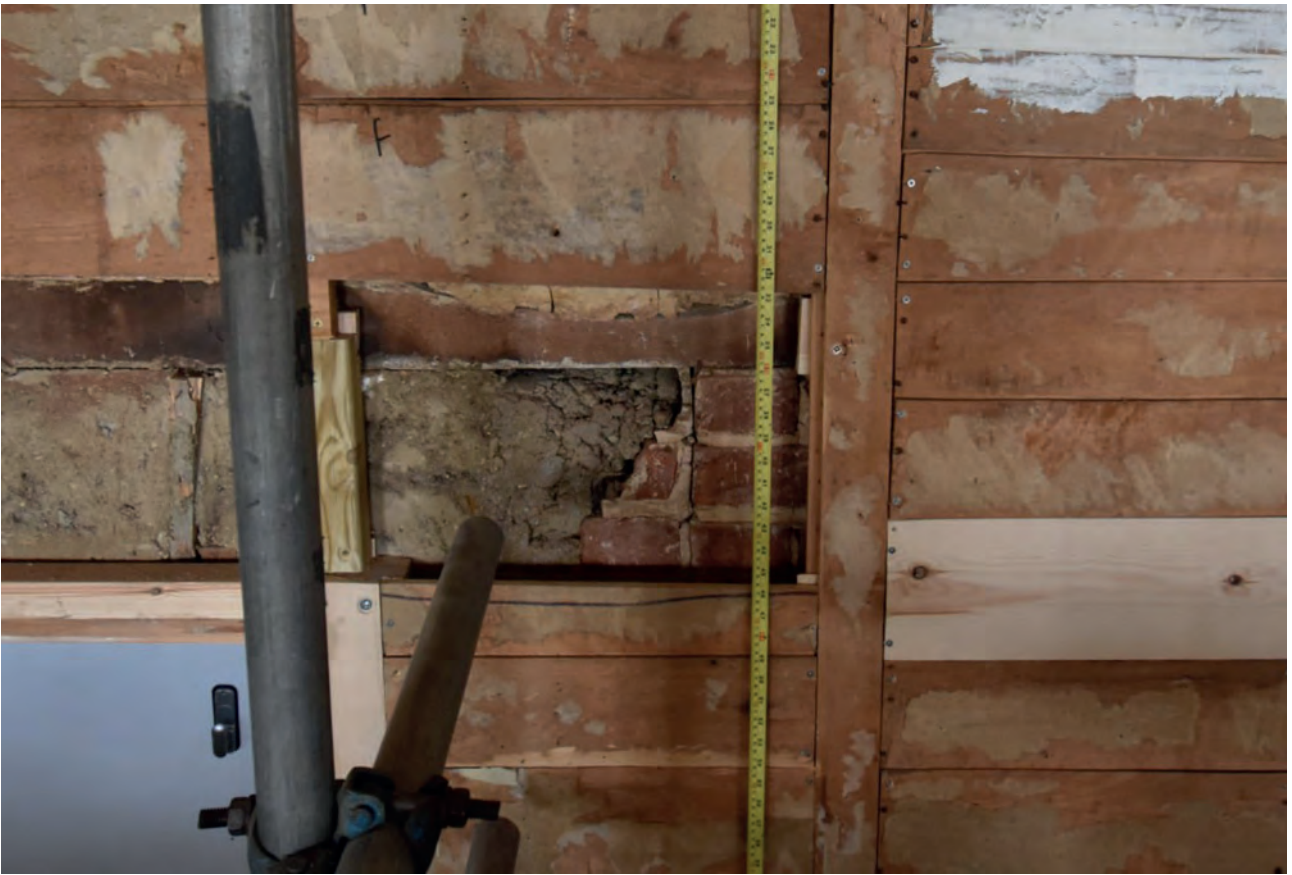
Plate 40: North wall, middle door, timber lintel

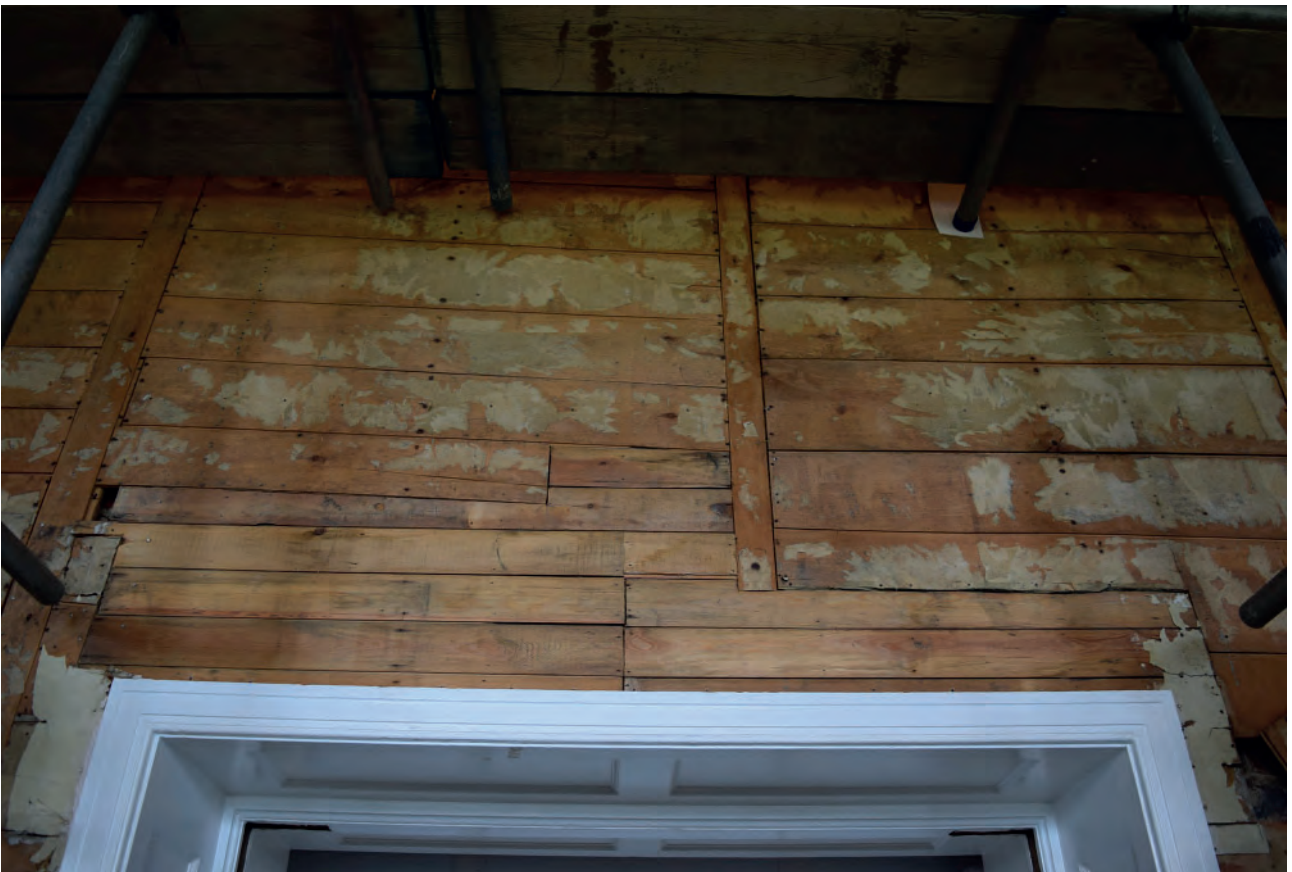
3.2.9 A similar beam, with the same concave profile on the eastern side, forms the lintel for the western entrance opening (Plates 41 and 42). This may mean that at the centre of the north wall a narrower but taller opening was first created in the wall, the remnant of which is the timber beam. Later the entrance towards the west was widened, lowering its head by 28 cm. It is possible that this rebuild of the middle door is related to the replacement of sarking boards above the door opening (Plate 43).

Plate 43: North wall, middle door, replaced sarking boards

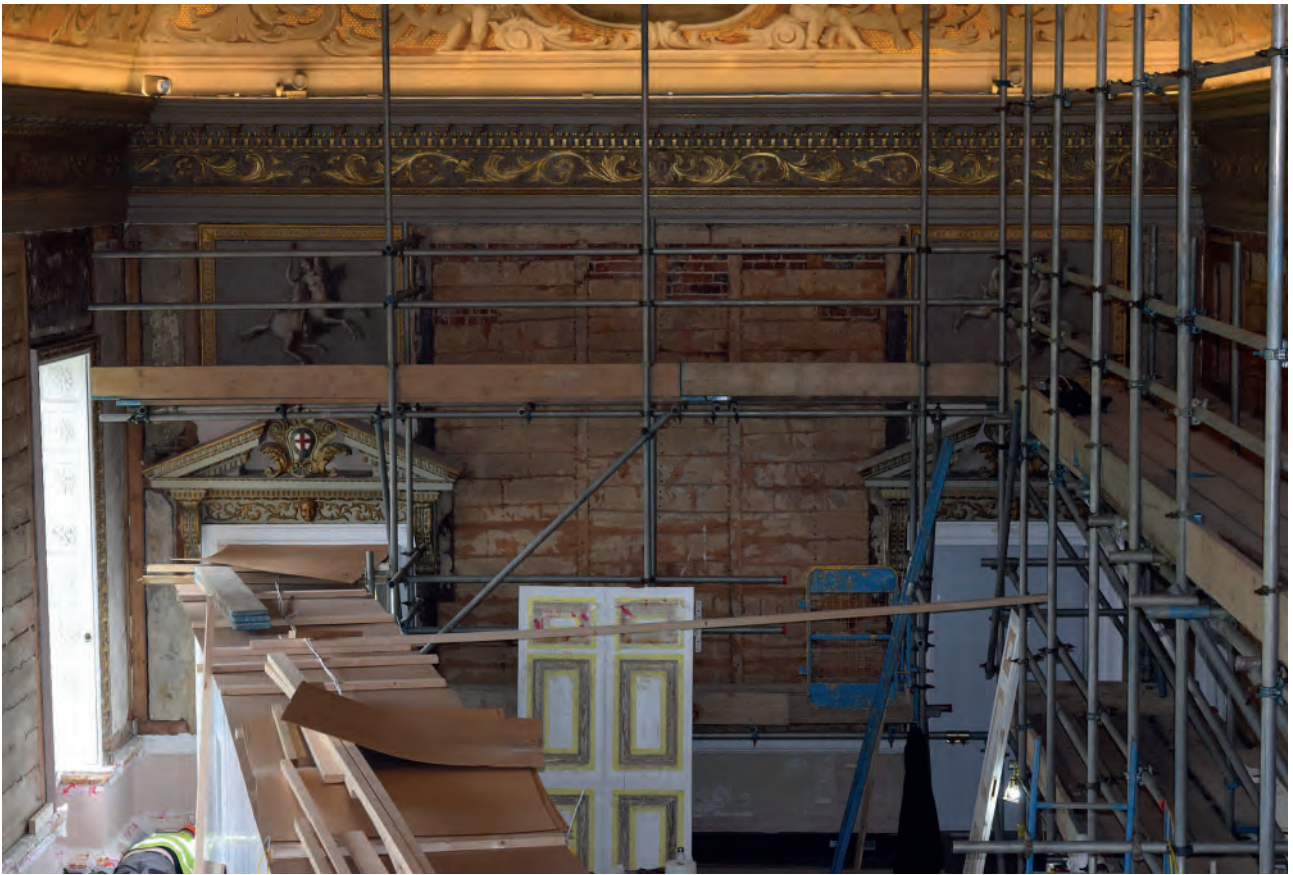
- 3.2.12 As referred to above horizontal sarking boards are found extending across most of the walls in the room, supported at each end by vertical posts within a simple timber frame. The boards are nailed into this frame. At the head of this frame is a horizontal rail which runs under the cornice and the base is set at the dado.

Plate 44: West wall, sarking boards

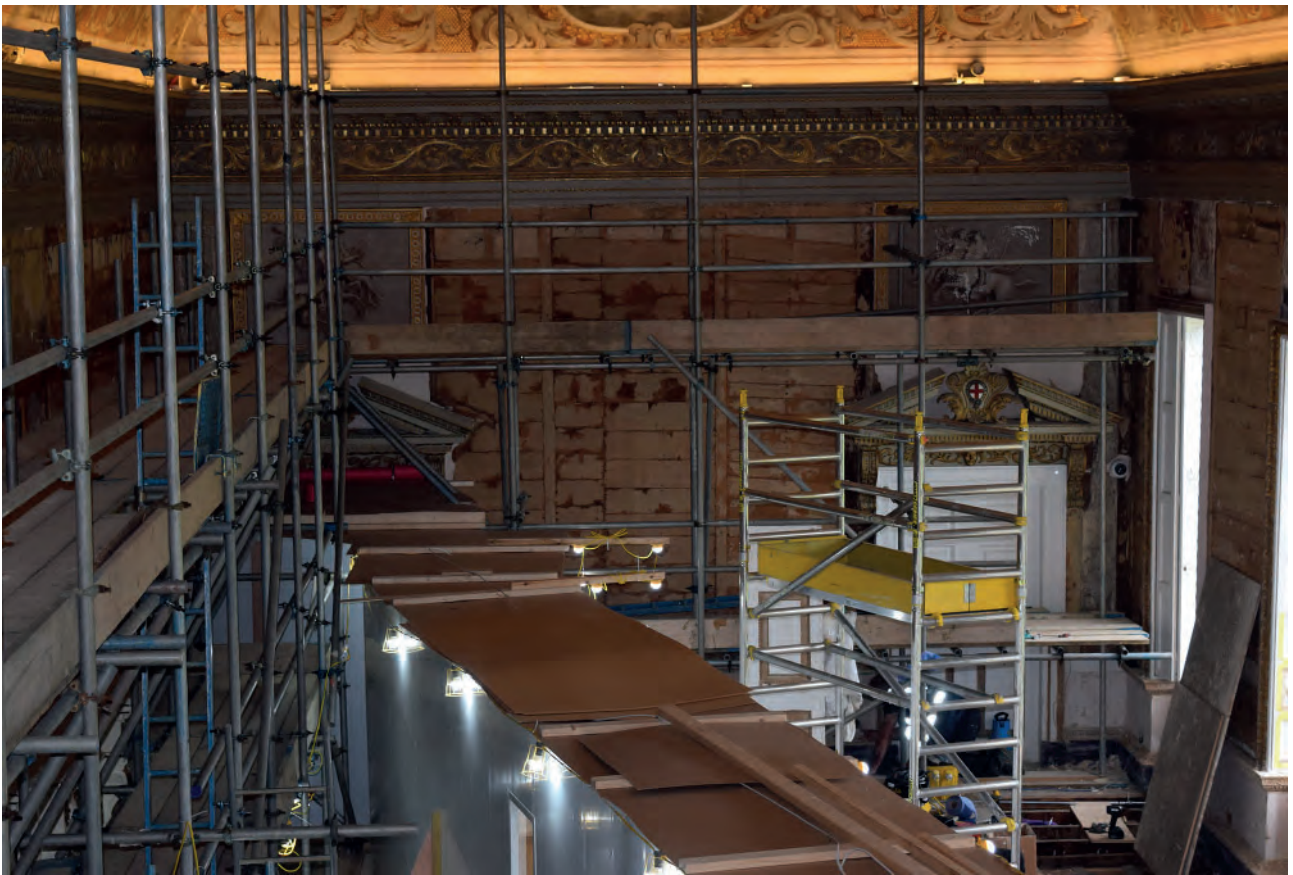
Plate 45: East wall, sarking boards

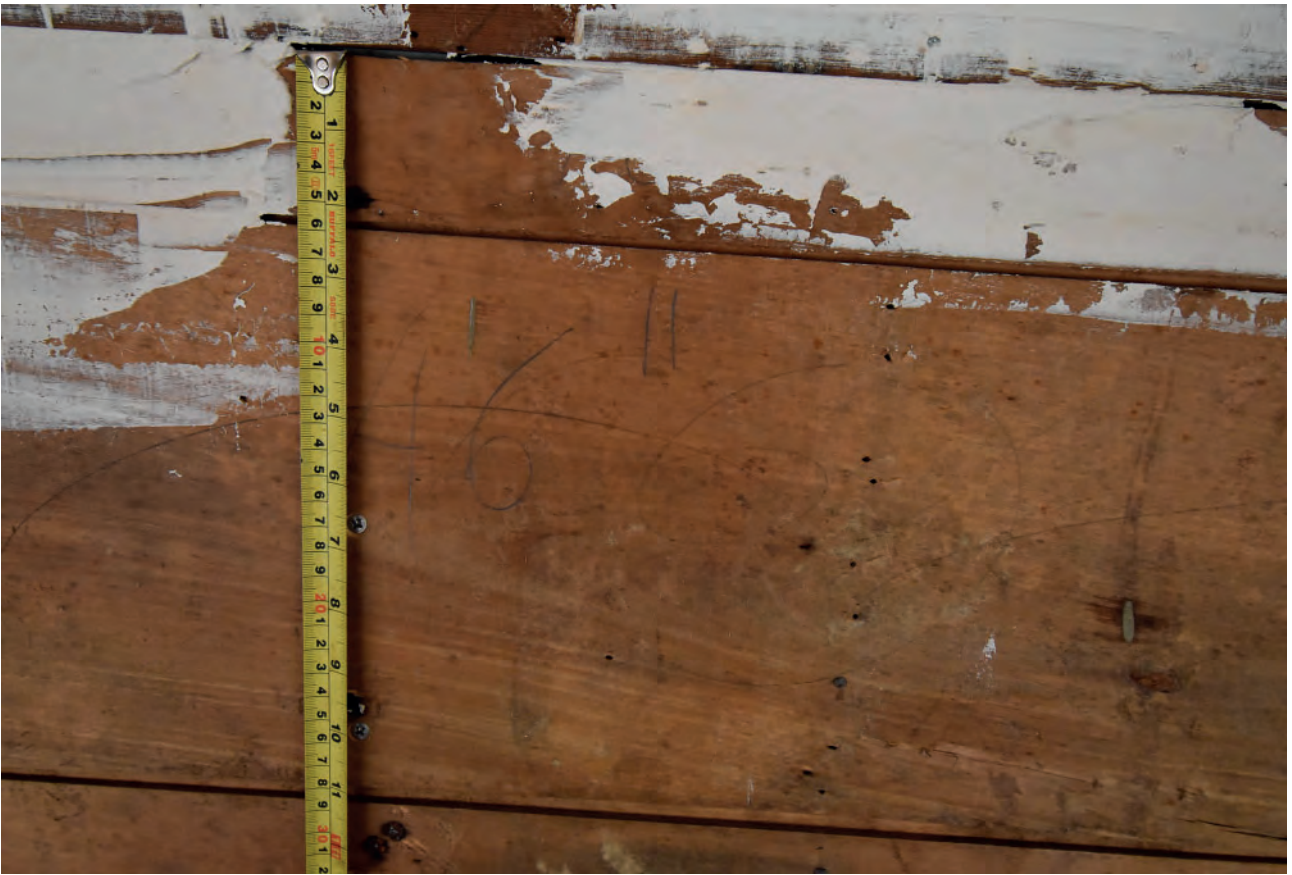
- 3.2.23 In addition to the drawings various notes and calculations of unknown origin have been found in several places. It is not known what they refer to. Some of the notes were made with a black marker and as they are evidently modern, they have not been included in this report.
- 3.2.24 On the second board from the top, on the seventh panel of the north wall, 4'6" is written, but it is not known what this refers to (Plate 58).

Plate 58: North wall, panel 7, example of graffiti

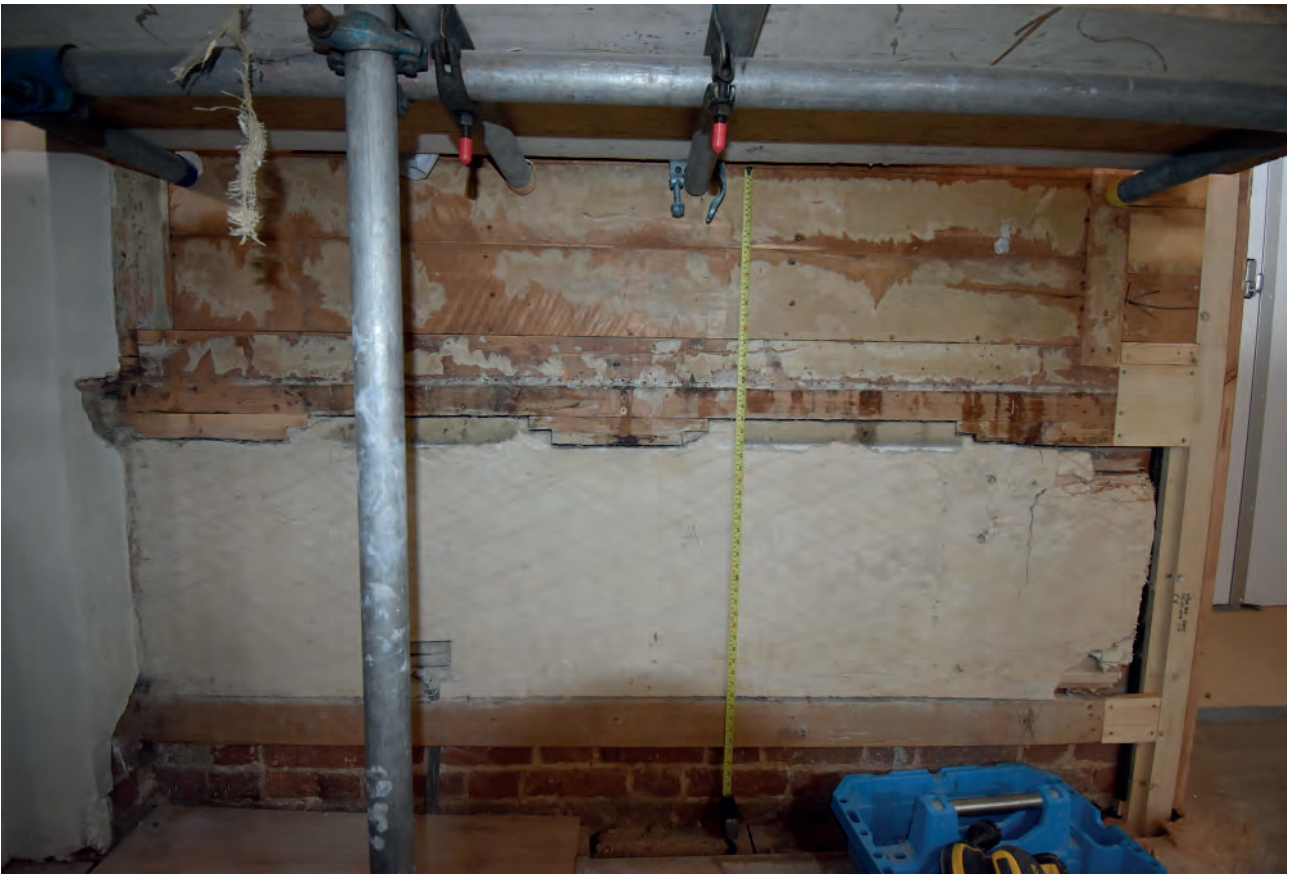
Plate 120: North wall, dado between west fireplace and middle door

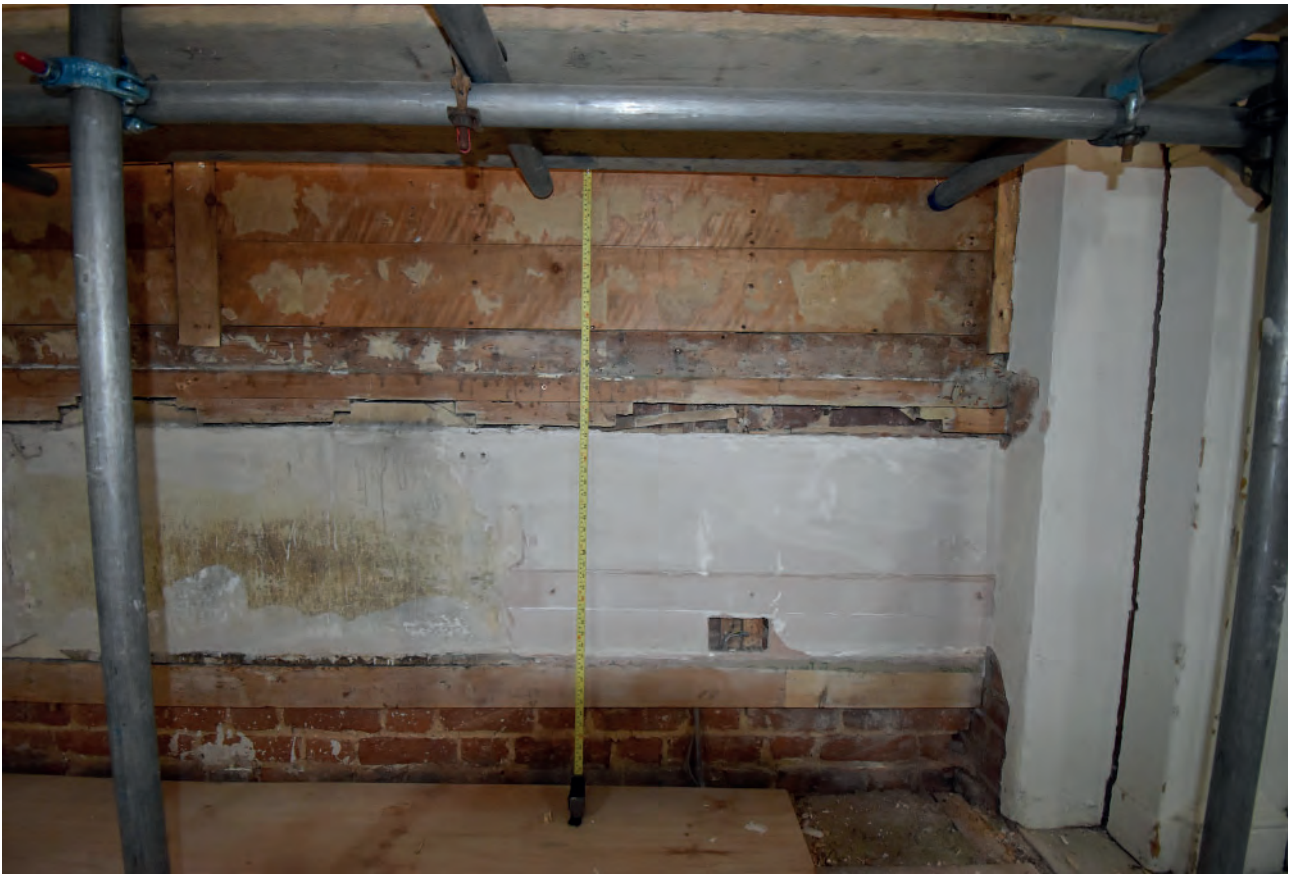
- 3.2.54 The dado on the west side of the middle door has also been remodeled. To the east of the doorway, between the wooden rails, plasterboard was placed on the wall, which was covered with cement and painted white. The plasterboard occupies space up to the middle of the second base under the top rail (Plate 121). On the eastern side of this dado there is visible damage related to the installation of the eastern fireplace and electric cables. For this reason, the last base from the east under the dado rail was damaged. The base was removed (also with lime plaster) from its original place and half of this base was fixed from the west of the eastern fireplace (Plate 122). The space between the rails in this place was additionally plastered and painted white, and in its lower part, below the damaged base for the wooden rail, a hole was cut in the wall for an electrical socket. A horizontal strip was attached to the plaster above the electrical socket (Plate 122).

Plate 122: North wall, east part of dado between middle door and east fireplace

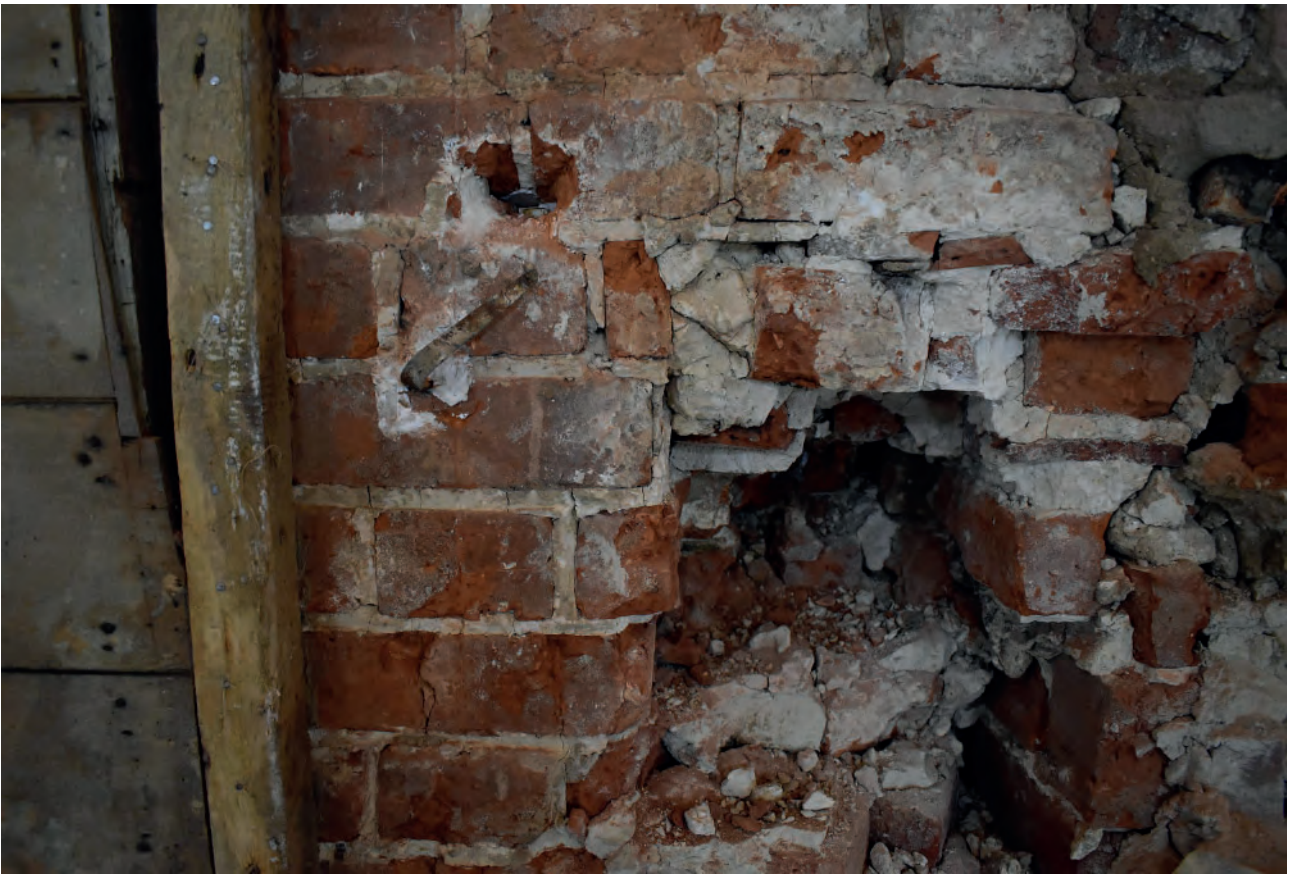
Plate 134: North wall, east part of east fireplace, development phases, Gregorian period

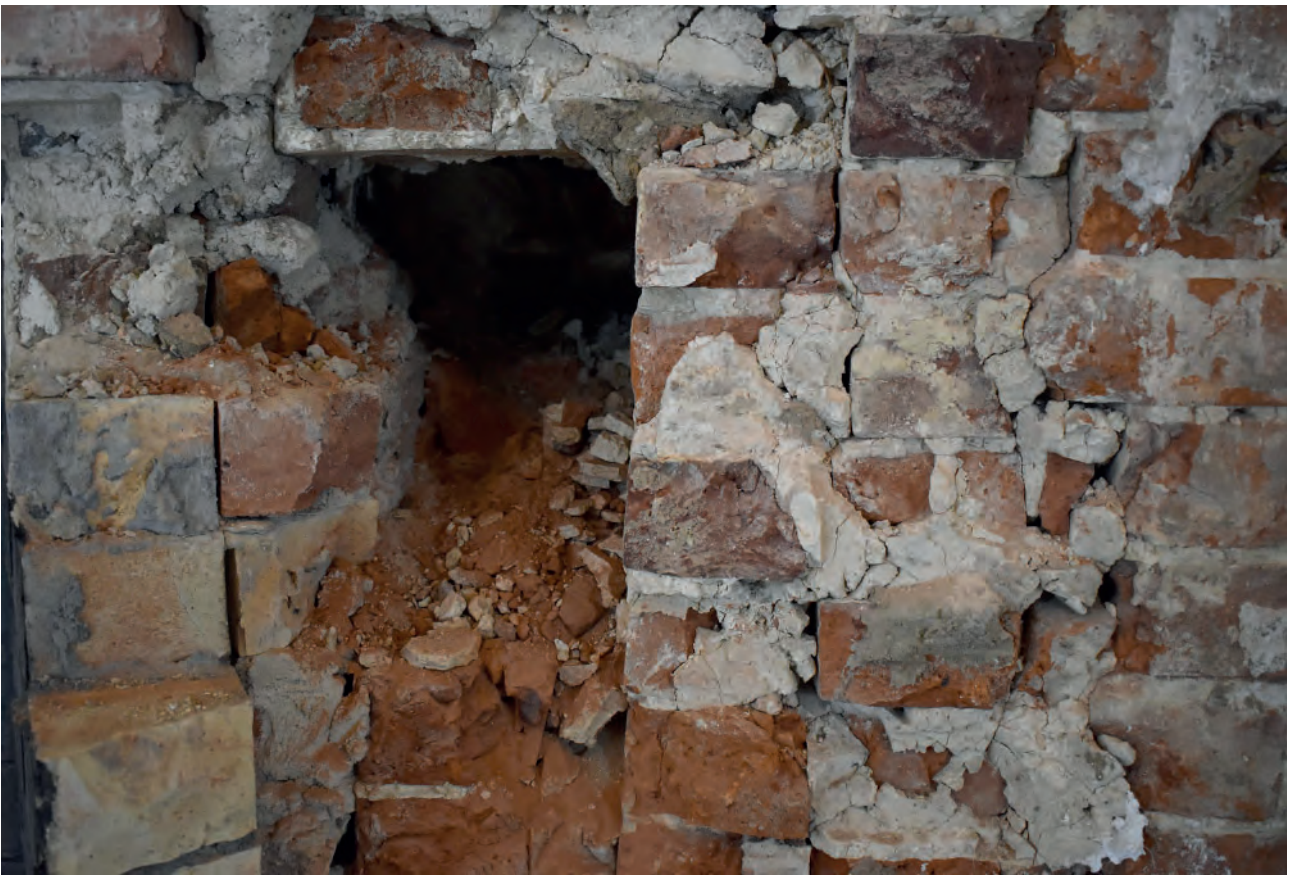
Plate 135: North wall, east part of east fireplace, development phases, Gregorian period

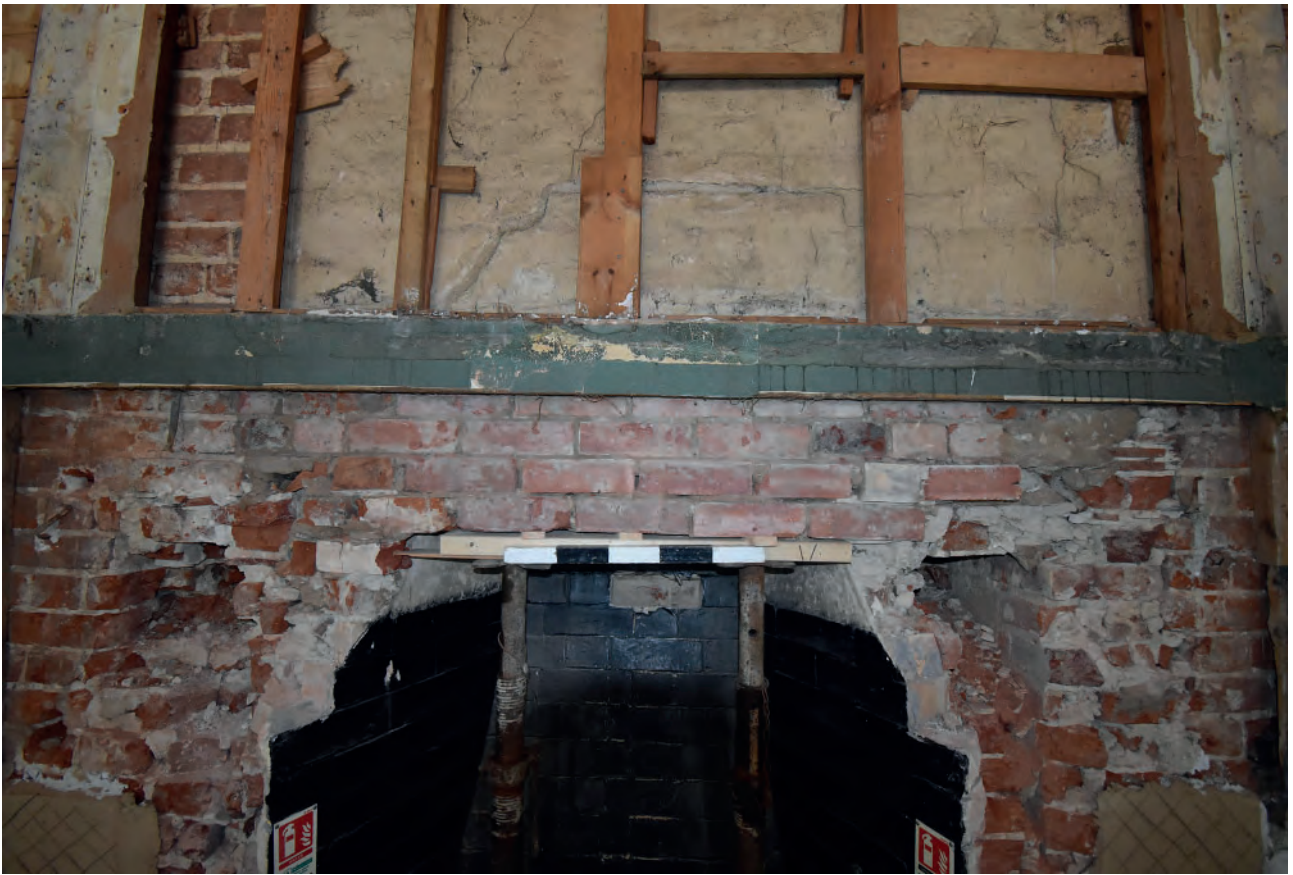
Plate 136: North wall, east fireplace, green paper over hessian

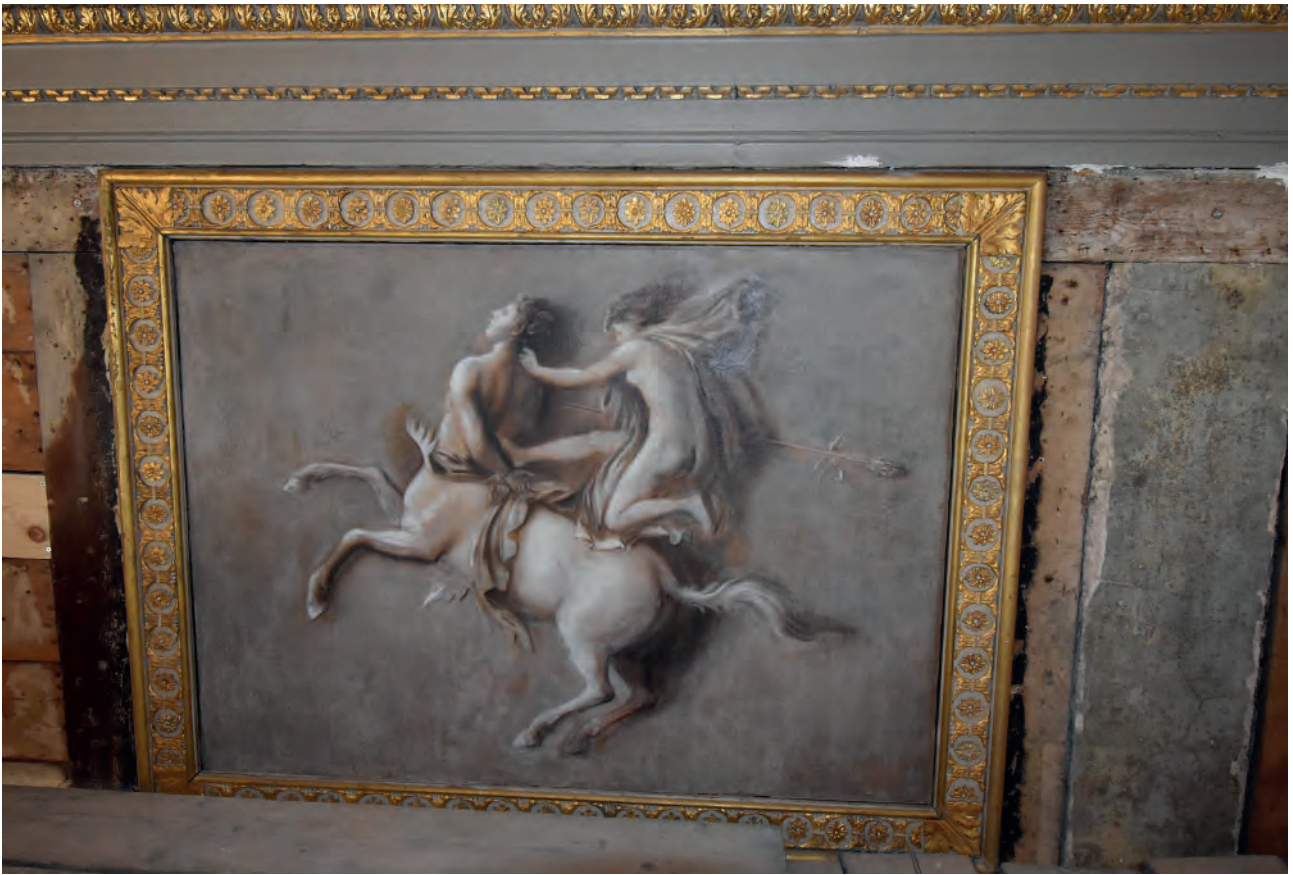
- 3.4.1 All four doors in the west and east walls in the Dining Room have open, richly decorated pediments and above each is a painting of a Centaur (Plates 44-45 and 137-140). During the conservation works to the southern pediment on the eastern wall, a fragment of red tapestry protruding from behind the Centaur painting was discovered (Plate 141). No similar or any other fabric has been found in the areas of other Centaur paintings.

Plate 138: West wall, north Centaur painting

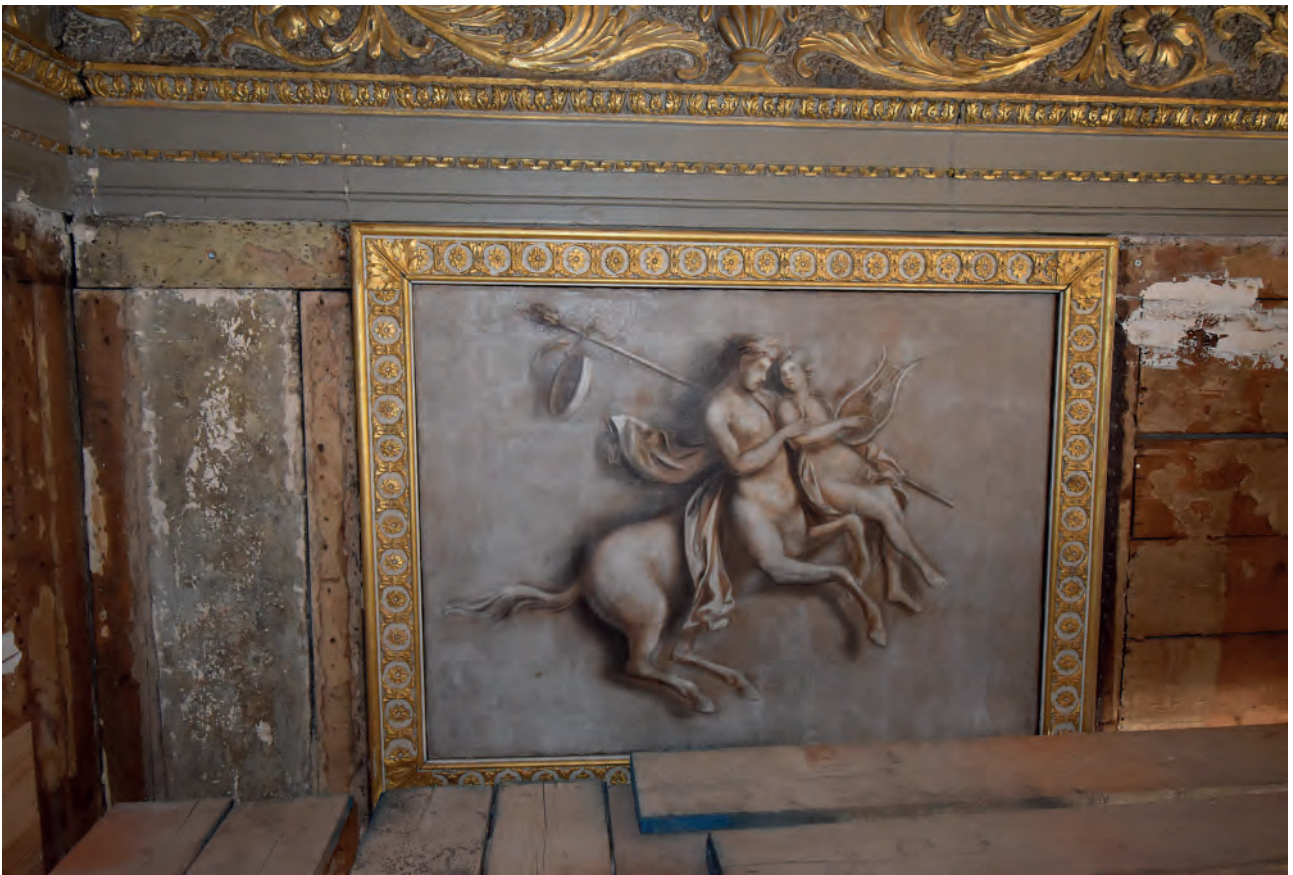
Plate 139: East wall, north Centaur painting
