AUCHINDRAIN TOWNSHIP INVERARAY ARGYLL

Interim Archaeological Report

Report no 1999-2000/053/AUA8887

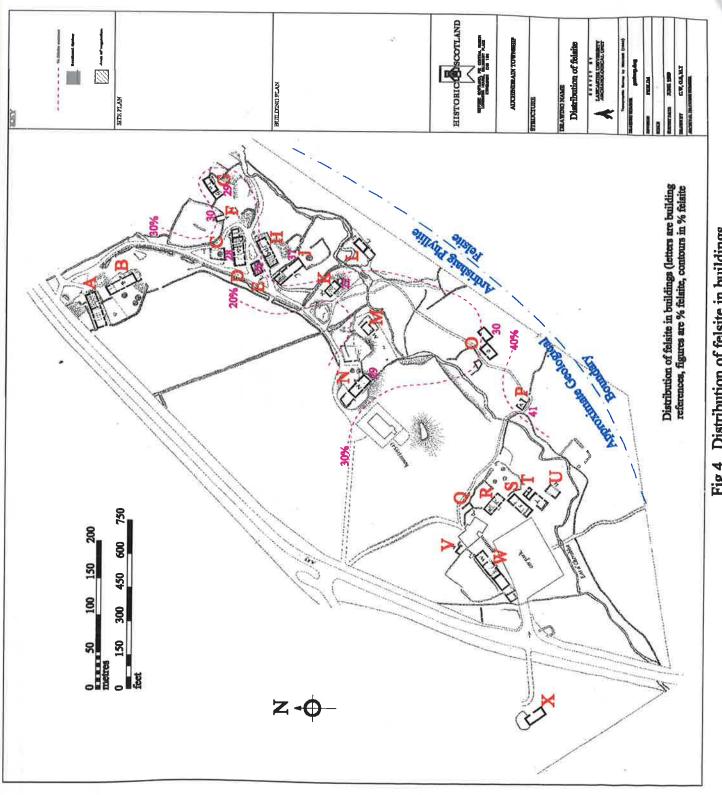
Fig 4 Distribution of felsite in buildings

- 3.5.4 Further support for a source of stones from adjacent lower slopes is provided by the variations observed in the proportions of felsite used in buildings. The percentage of felsite in each building surveyed has been plotted on a map and the data contoured (Fig 4). The map also shows the approximate position of the geological boundary between the felsite and the Ardrishaig Phyllite.

- 3.5.5 Although the data set is small, the contours very subjective, and the occurrence of felsite in buildings is confused by the apparent selection of felsite for structural use, the pattern of contours does suggest that buildings nearer to the southern site boundary contain more felsite than those further away, and across the burn. It is interesting to note that all the buildings north of the burn appear to form a coherent group. This variation in felsite content is consistent with the expected geology as the drift on the south side of the stream is likely to be richer in felsite boulders, due to derivation from the felsite outcrop on the lower slope of An Torr, than the Drift to the north of the stream, where there will be no relative enrichment in felsite. On this basis it may be possible to distinguish between a 'high felsite' Drift source of stones, on the slopes of An Torr, and a 'low felsite' Drift source of stones, on the Creag Mhor hillslope. Recognition of these two distinct sources give support for separate hushing operations on the two sides of the valley; on the north side producing 'low felsite' stone mixtures, on the south side producing 'high felsite' stone mixtures.
