# Northern Curtain Wall, Carisbrooke Castle Isle of Wight

## Historic Building Investigation and Recording

August 2019

Client: English Heritage

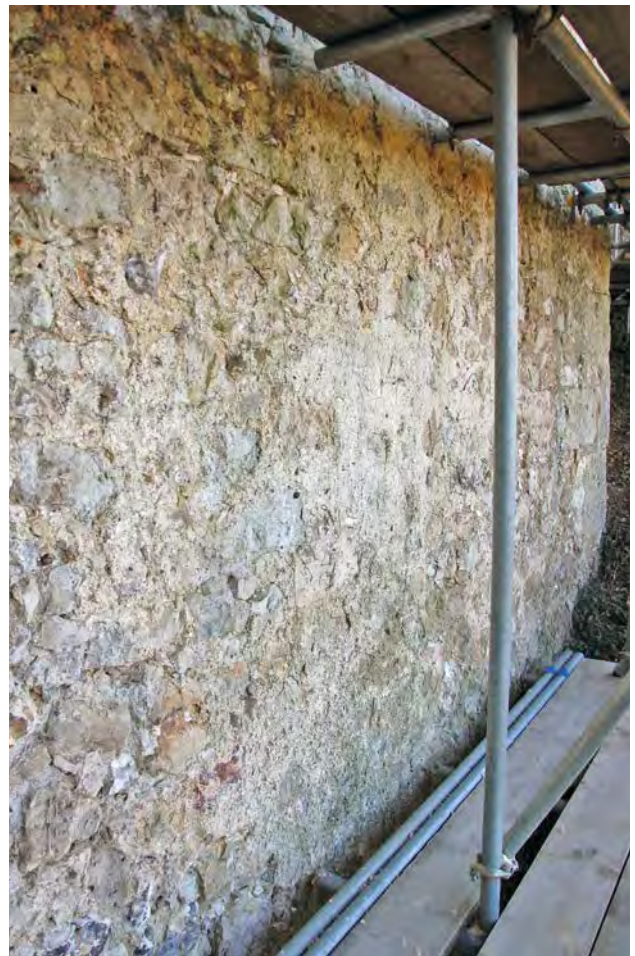
Plate 13: Traces of surviving render at level 2

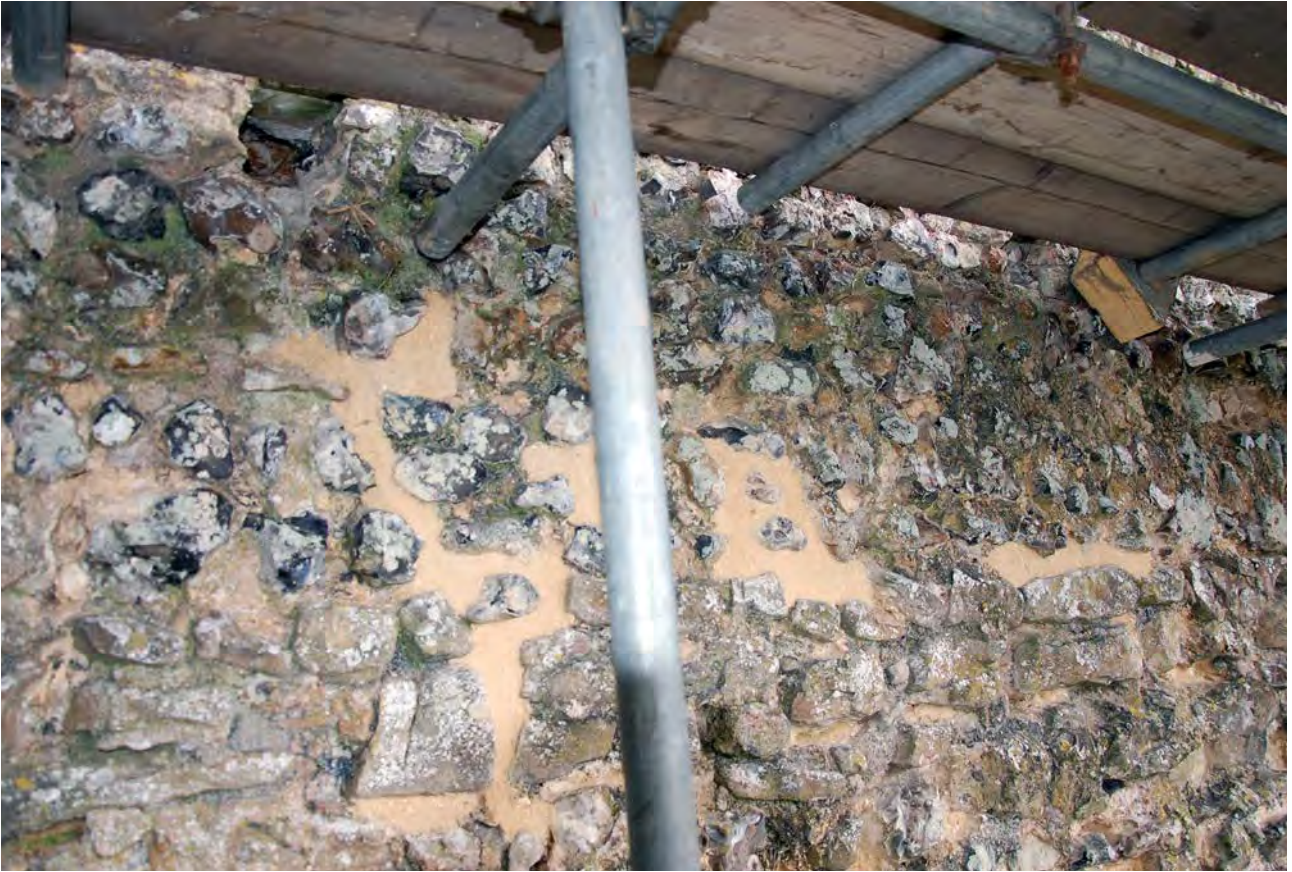
- 3.3.5 **VOID A (A1 & A2):** At the top of lift 2, directly above the postern gate, there are two small voids within the bands of largely flint facing (Pl. 14 & 15). They are c.12 cm wide by 10 cm tall and 28 cm deep, each with a stone lintel over and c.1.5 m apart. They are at the same level as each other and they must be putlogs. These coincide with lift 3 and are thus visible from both above and below. There also appears to be a possible structural horizon in the wall here suggesting there was a construction lift at this point.

Plate 14: Voids A1 & A2, level 2 curtain wall

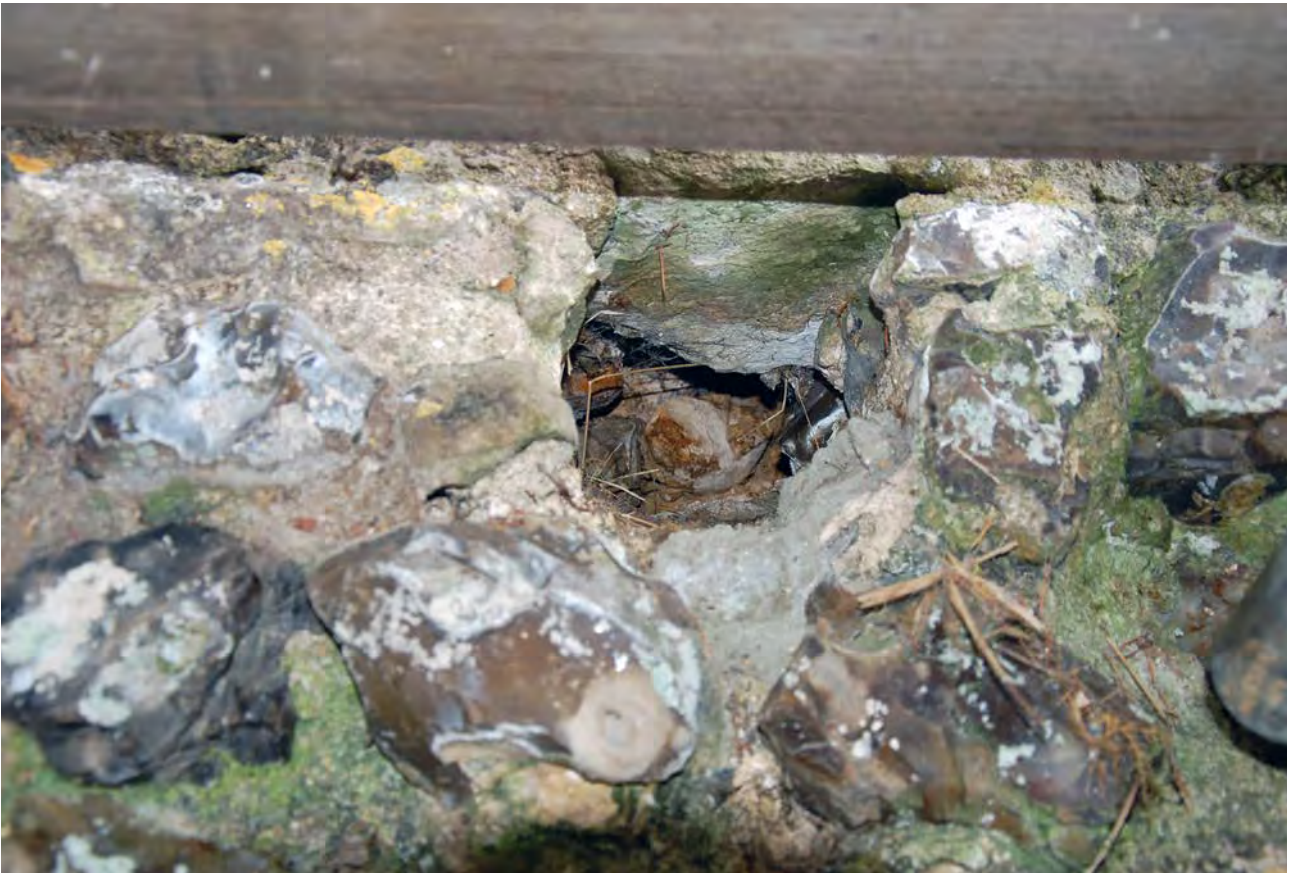
Plate 15: Void A1 at level 2

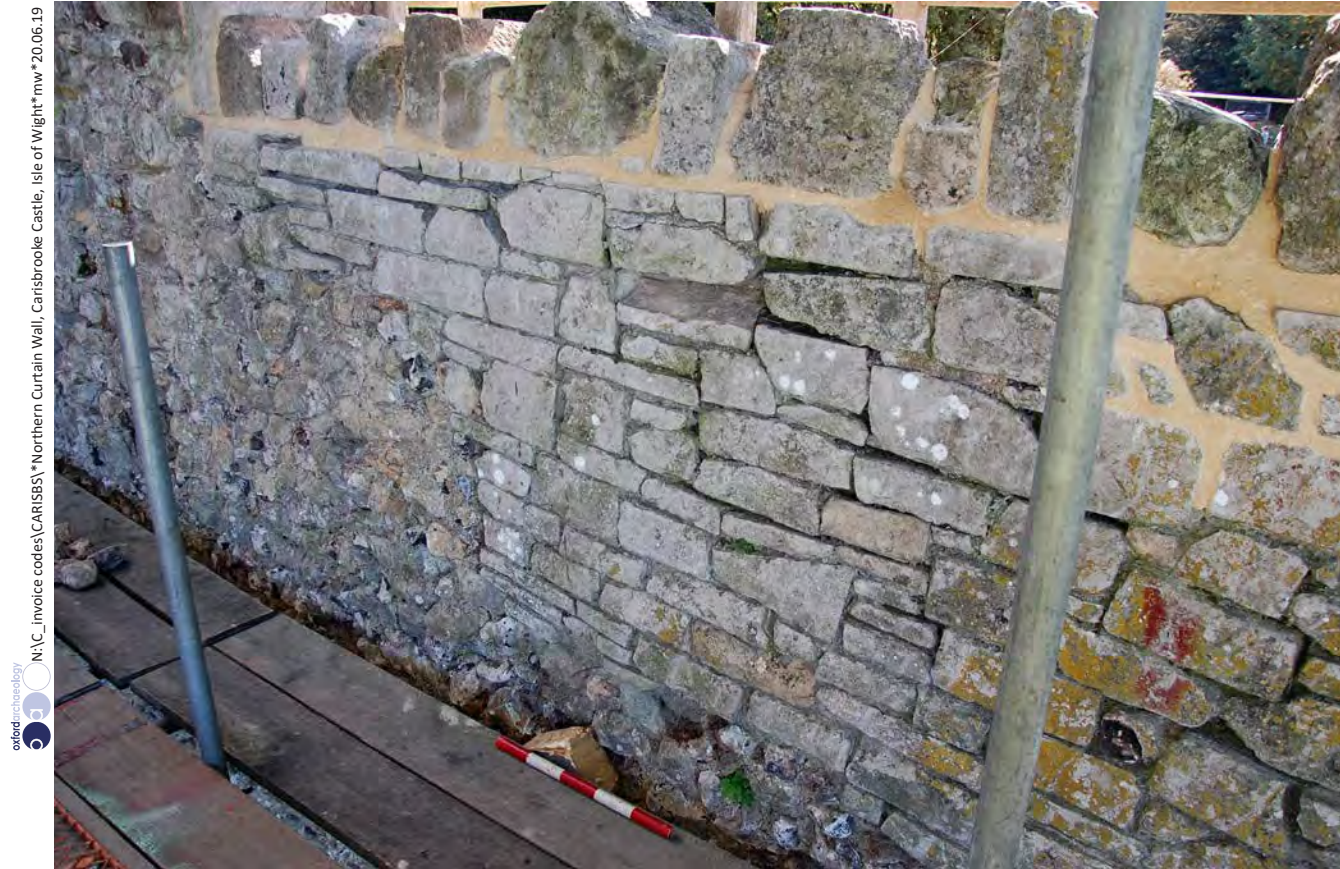
- 3.3.7 This extends westwards from a point close to the Keep as far as Kink 1, just beyond the tall buttress. There is a long section, above the Keep ditch, where this lift is adjacent to the uppermost section of wall (Pl. 16-20). At this level the wall is generally formed from small stones and with an irregular character although it is more consistent towards the top where it has been rebuilt. In some areas the wall coping has been entirely rebuilt, including a relatively modern section close to the Keep (Pl. 16).

Plate 16: Rebuilt patch at level 3

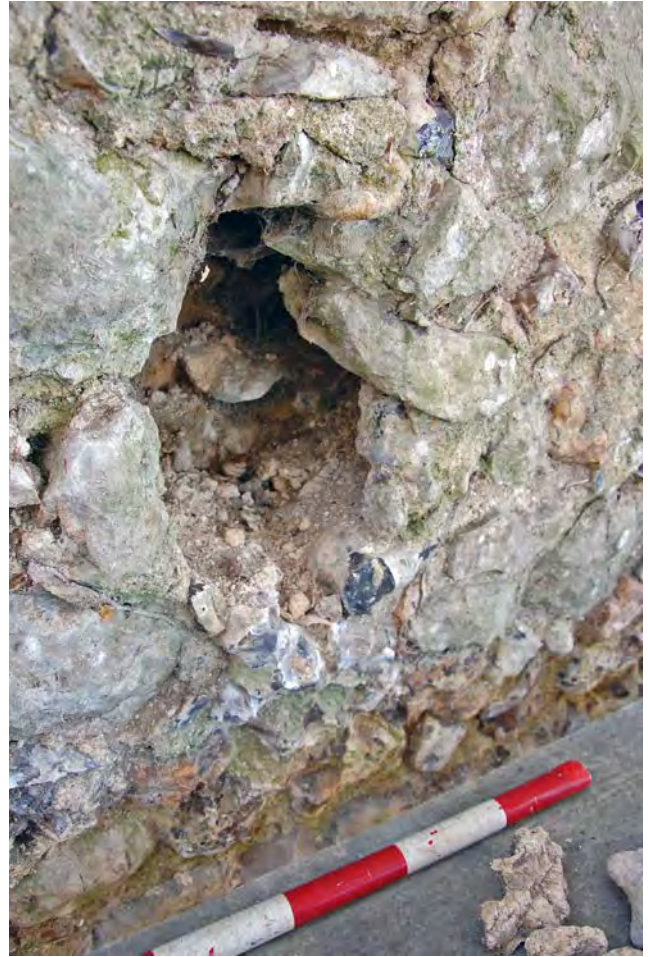
- 3.3.11 **VOID B:** Towards the east end of this section, close to steps up to the Keep and adjacent to a step in the parapet, there is a small irregular void in the wall (c.30 tall x 25 cm deep x 20 cm wide). This is in an area where there is a mix of flint and stone facing and the facing stones have been lost to expose a gap behind (Pl. 18-19). Here the deeply set mortar is an ochre colour while that closer to the face is a white colour. The white mortar extends c.15 cm in from the surface. This void strongly appears to continue laterally behind the adjacent areas where the face survives.

Plate 19: Void B at level 3

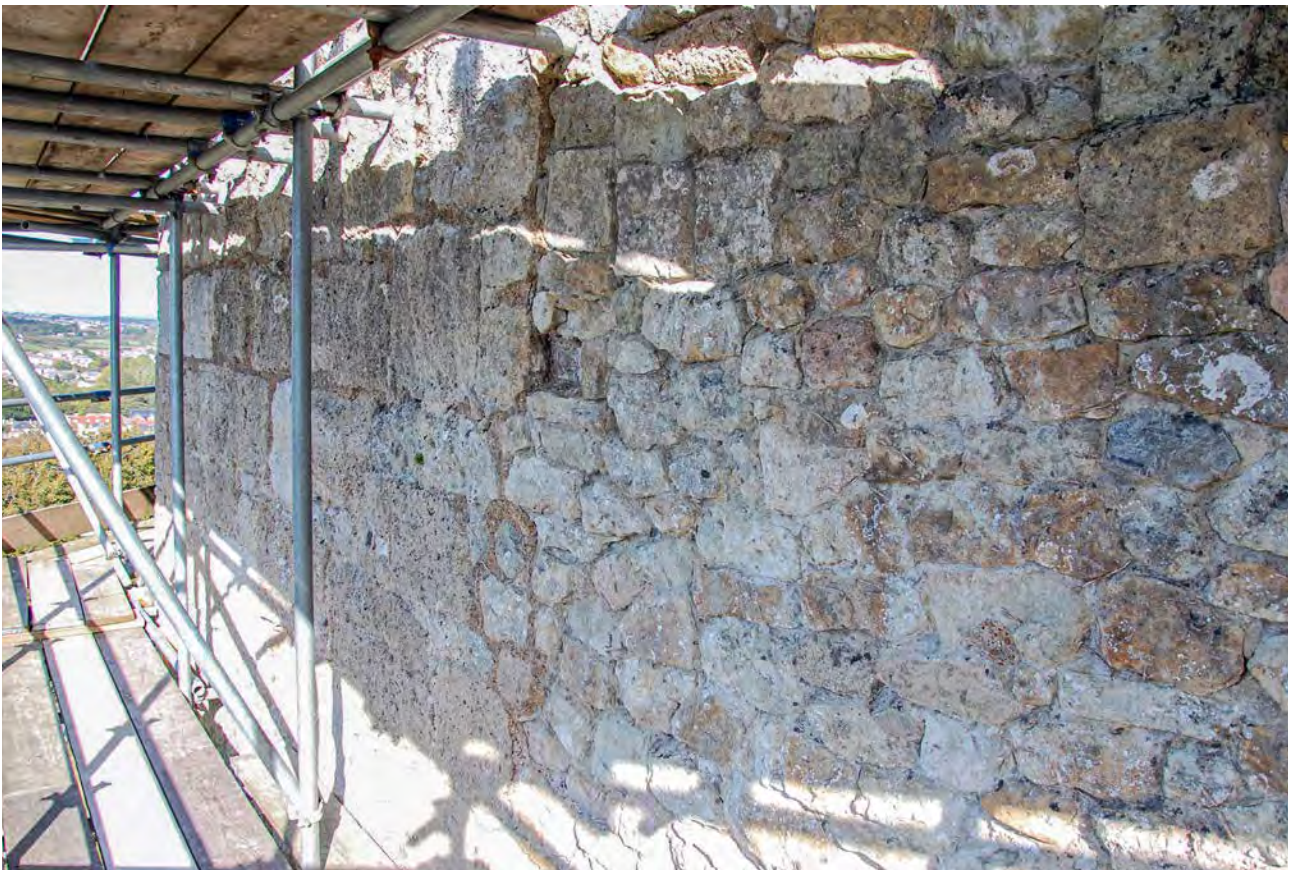
Plate 27: Construction break at level 4

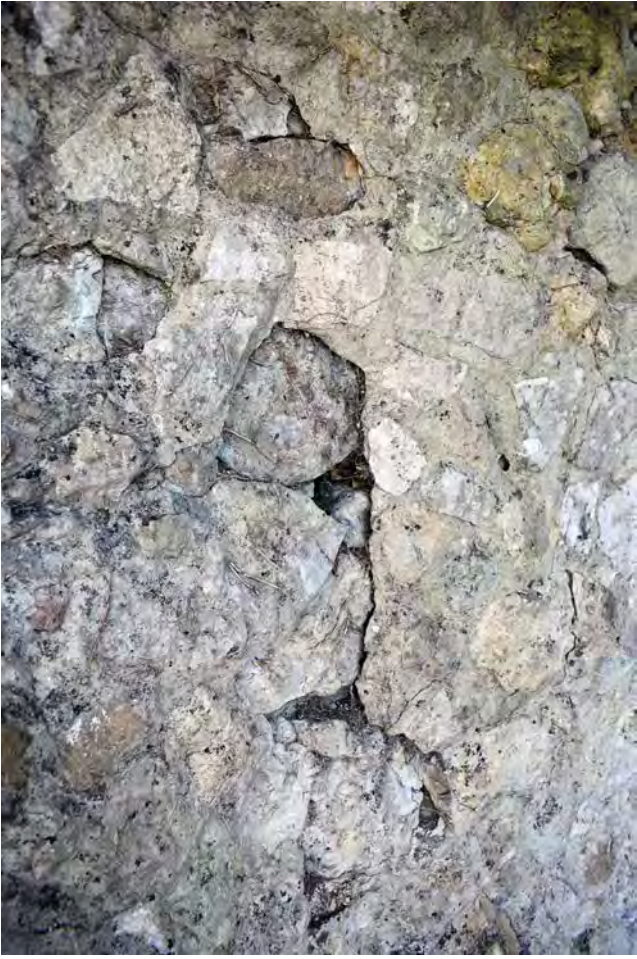
Plate 28: Skim of 20th-century render with stones embedded (level 4)

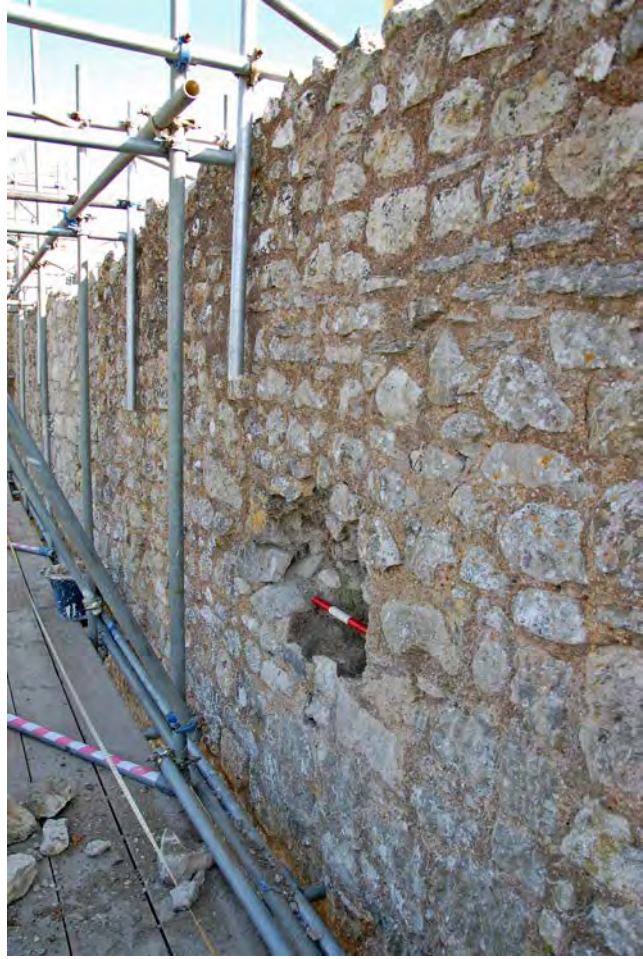
**3.3.23 VOID C:** This is located c.4.5 m to the east of Kink 2 and is in an area where the face has come away to expose a number of roots and small rubble stones bonded with soft light grey mortar with charcoal flecks (Pl. 29-30). Here there is no evidence of the ochre coloured mortar found elsewhere and it may well be that the whole patch is secondary rebuild. The void is c.60 cm wide by 45 cm tall and 15 cm deep. The top is c.1.1 m below the top of the wall. This area has a hard gravel cement-based mortar pointing and this partially survives around the edge of the void.

Plate 29: Void C at level 4

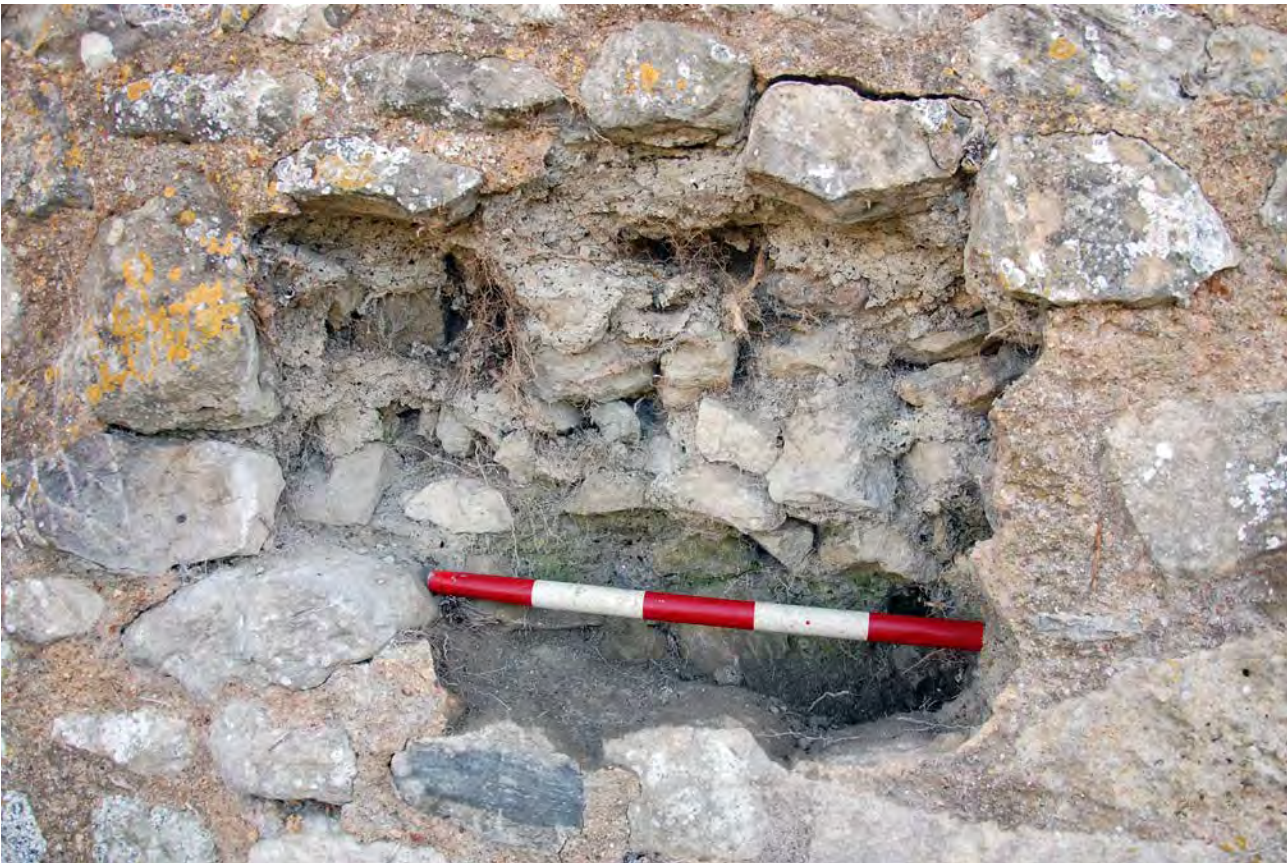
Plate 30: Void C at level 4

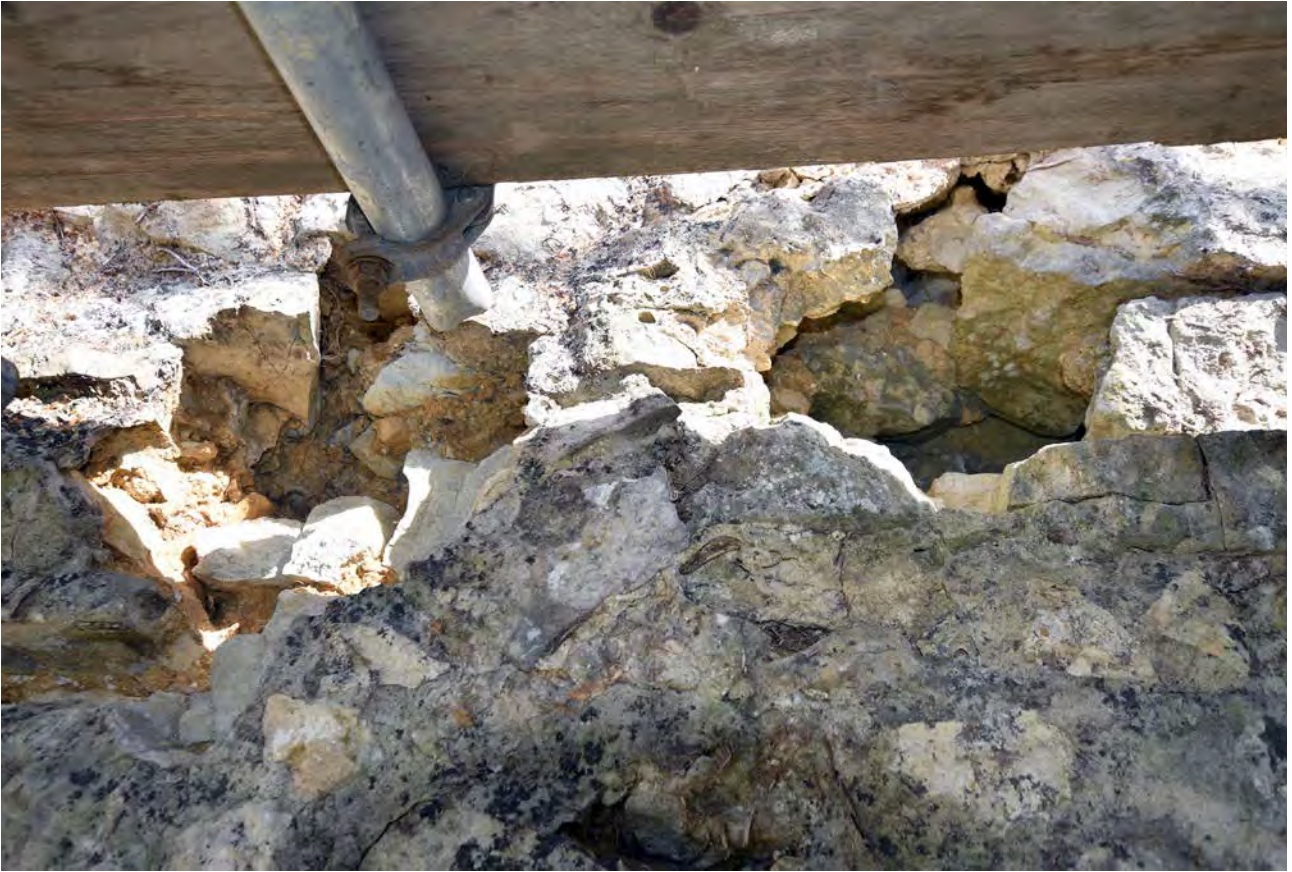
- 3.3.32 Void D3 is also shallow and there is much ochre coloured mortar exposed c.10 cm into the wall (Pl. 31). There are old light coloured stones within the void but it appears that the stones were cracked/shattered and lost their face rather than the original face being recessed to here. The cement-based gravelly mortar is visible here, as well as older ochre mortar and at the west side there is a light coloured render beneath the modern infill.

Plate 31: Voids D2 & D3

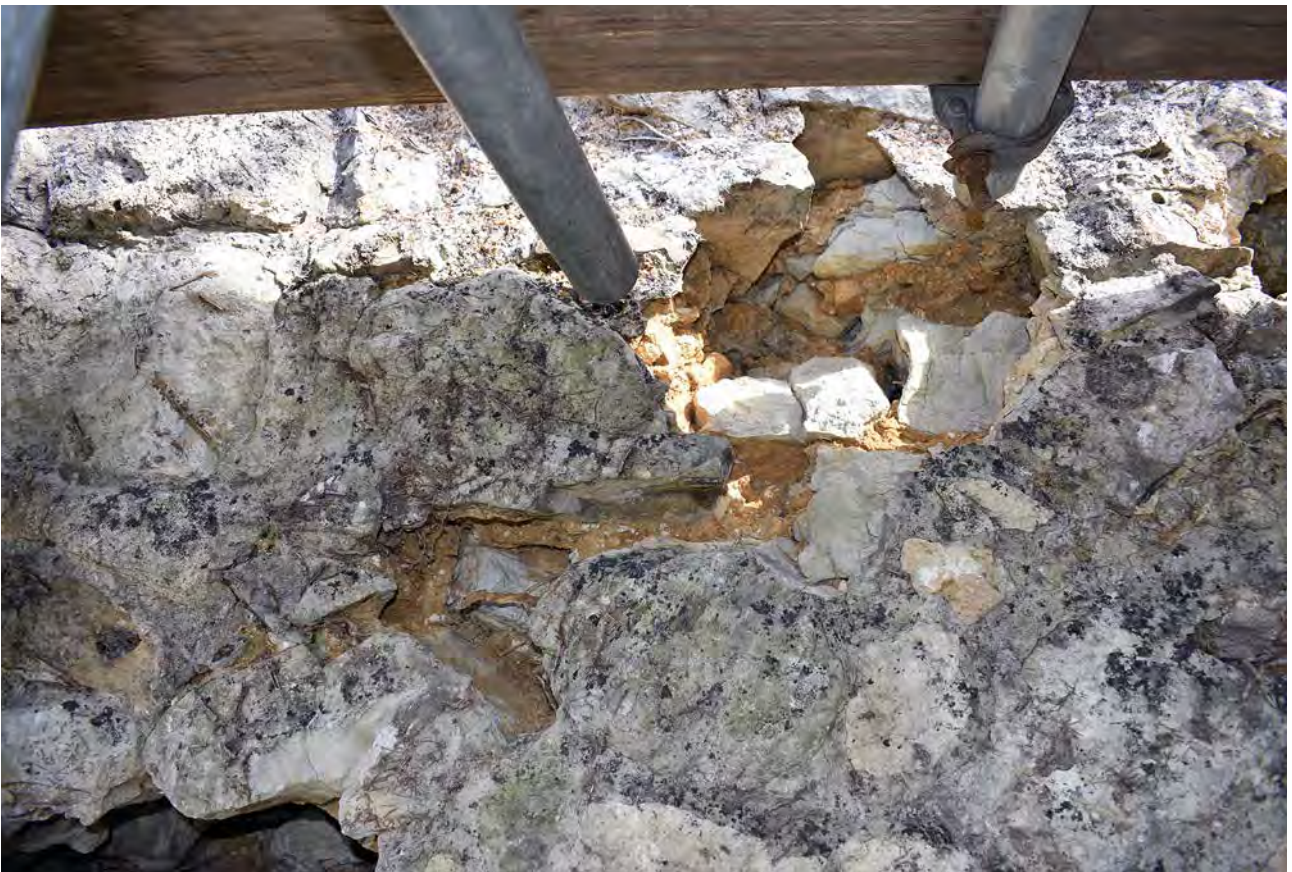
Plate 32: Void D2

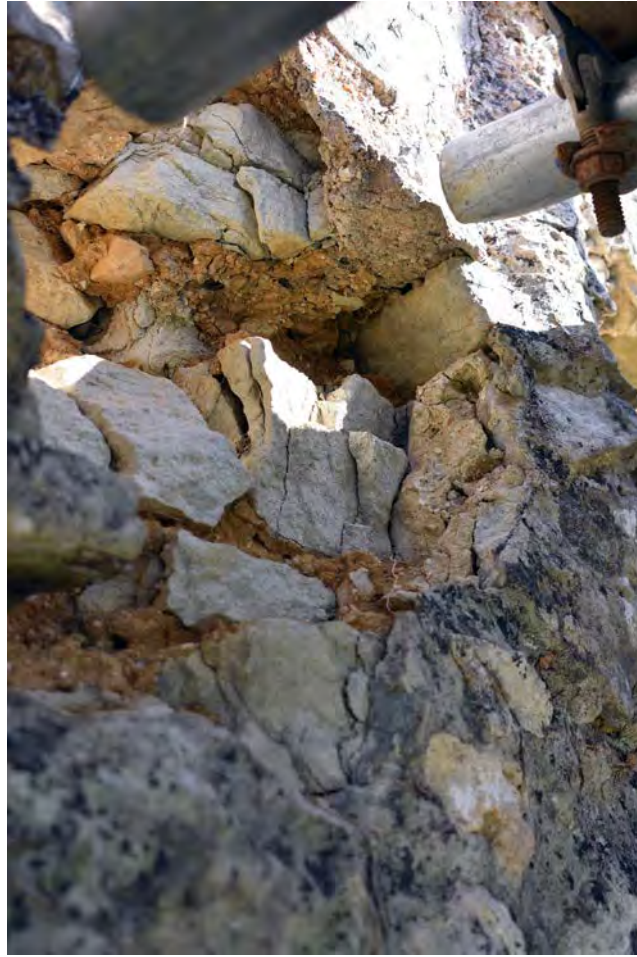
Plate 33: Void D2

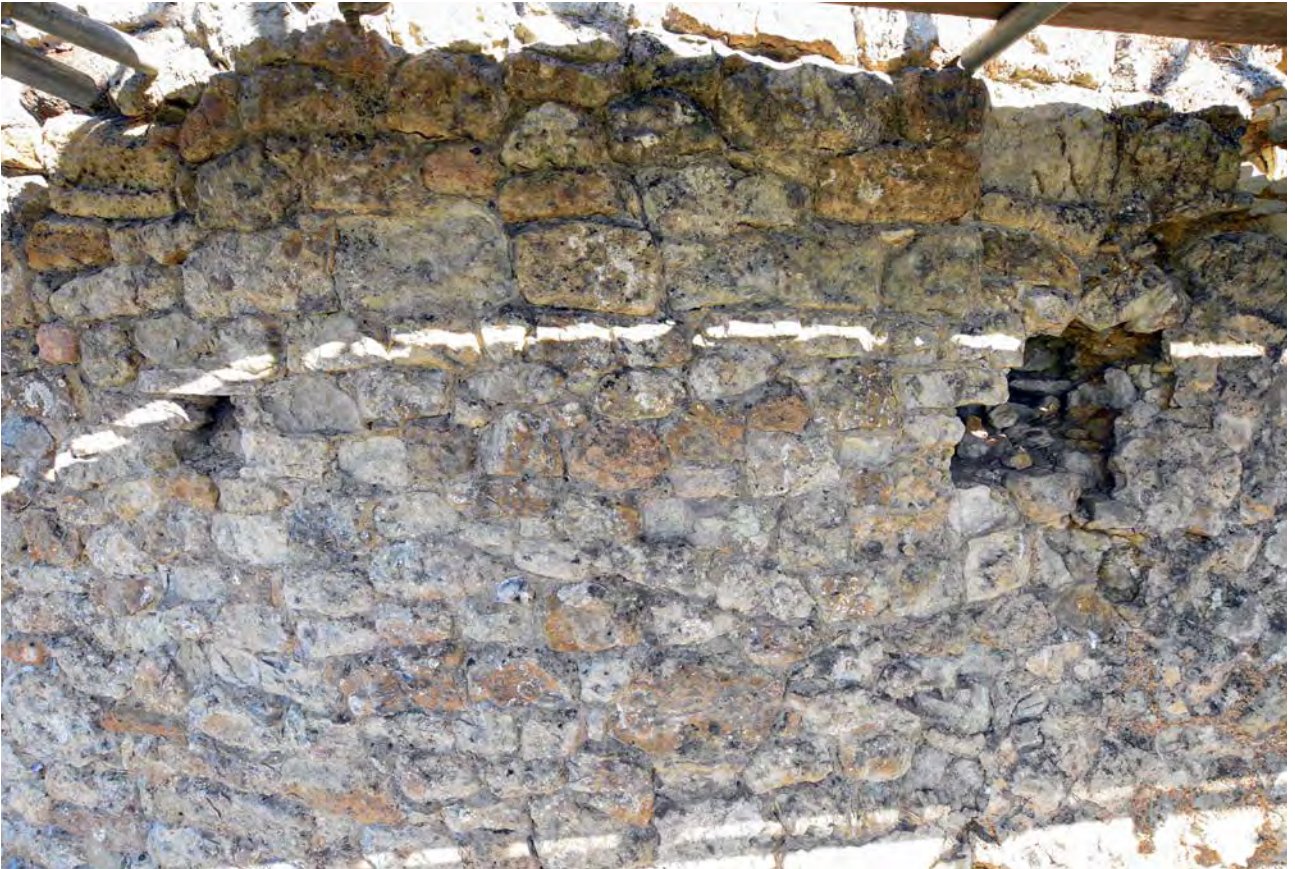
- ochre lime mortar found in the core so presumably this was a later lime coating. In D1 it is particularly noticeable that many of the stones within the wall have no mortar on them at all, almost like a dry stone wall; it may be that it has been worn away or removed by ivy.

Plate 34: Void D1 and putlog

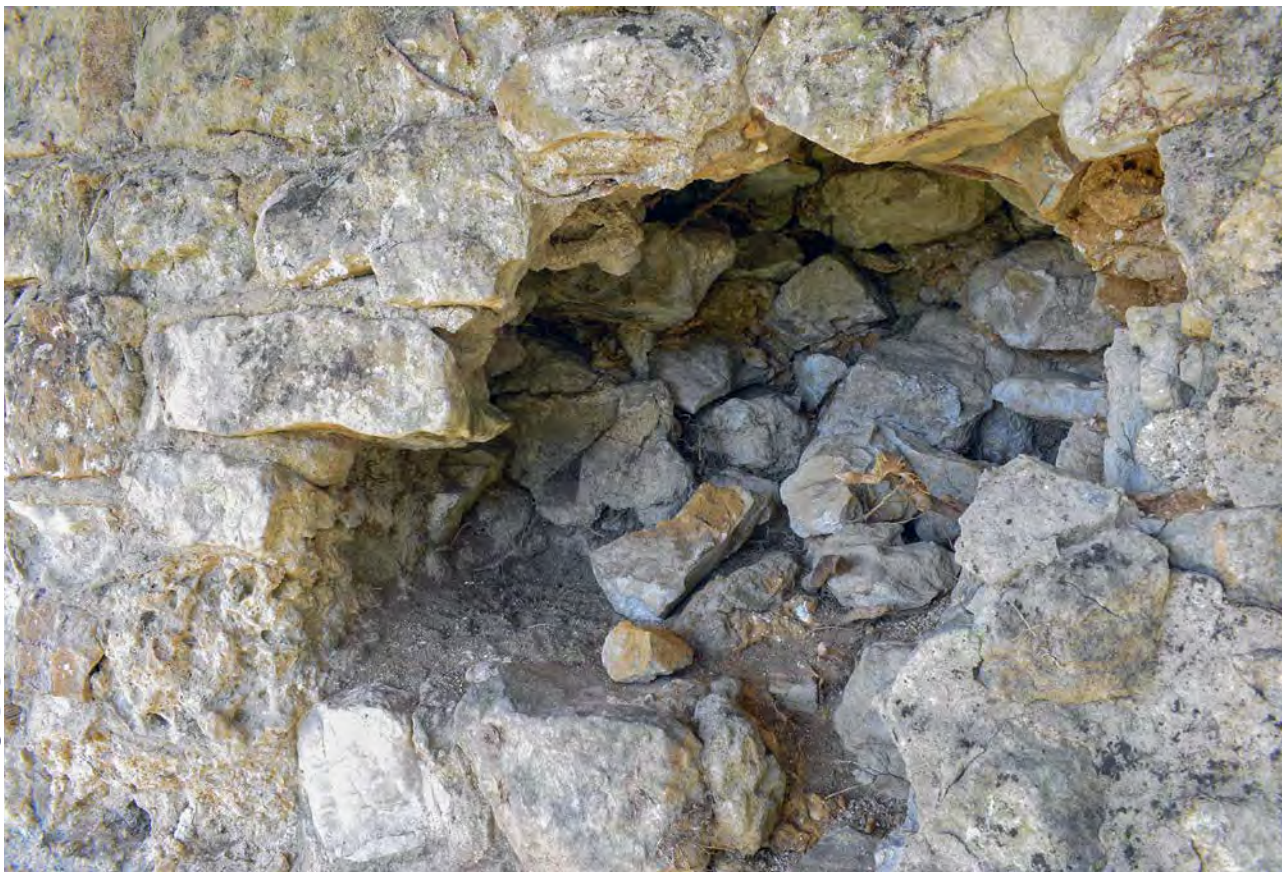
Plate 35: Void D1 (former putlog that has expanded)

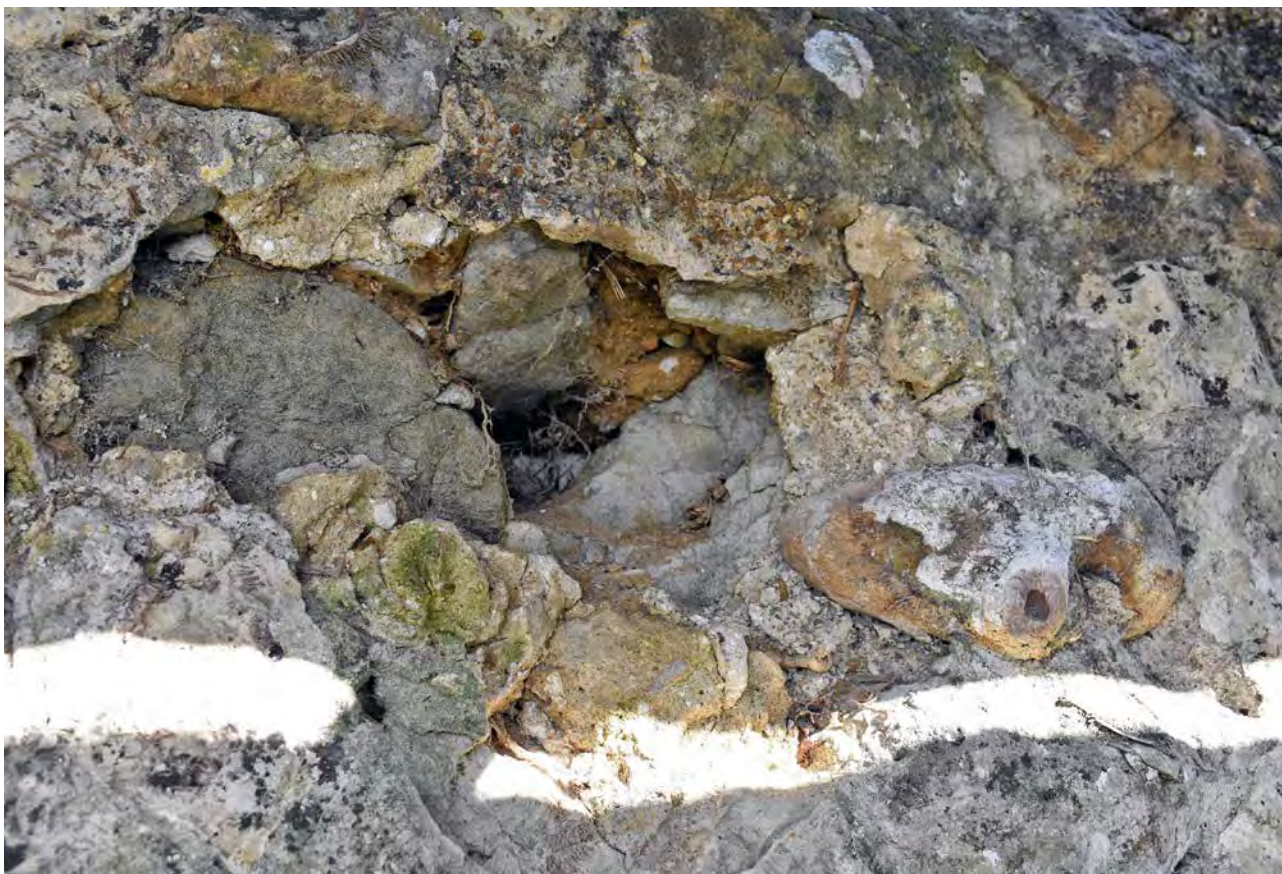
Plate 36: D6 (easternmost hole in set of voids)

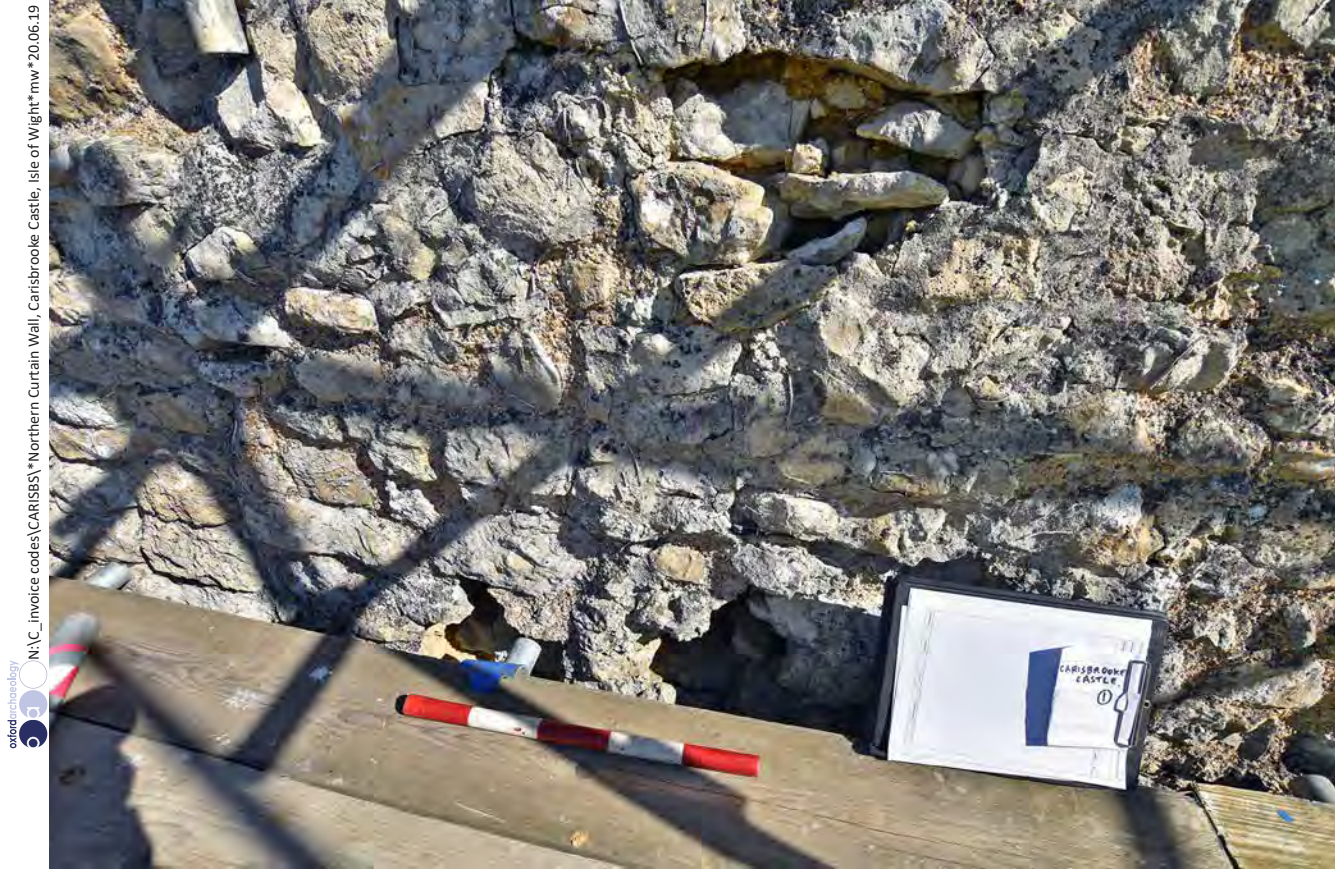
Plate 37: Void D4 at level 5

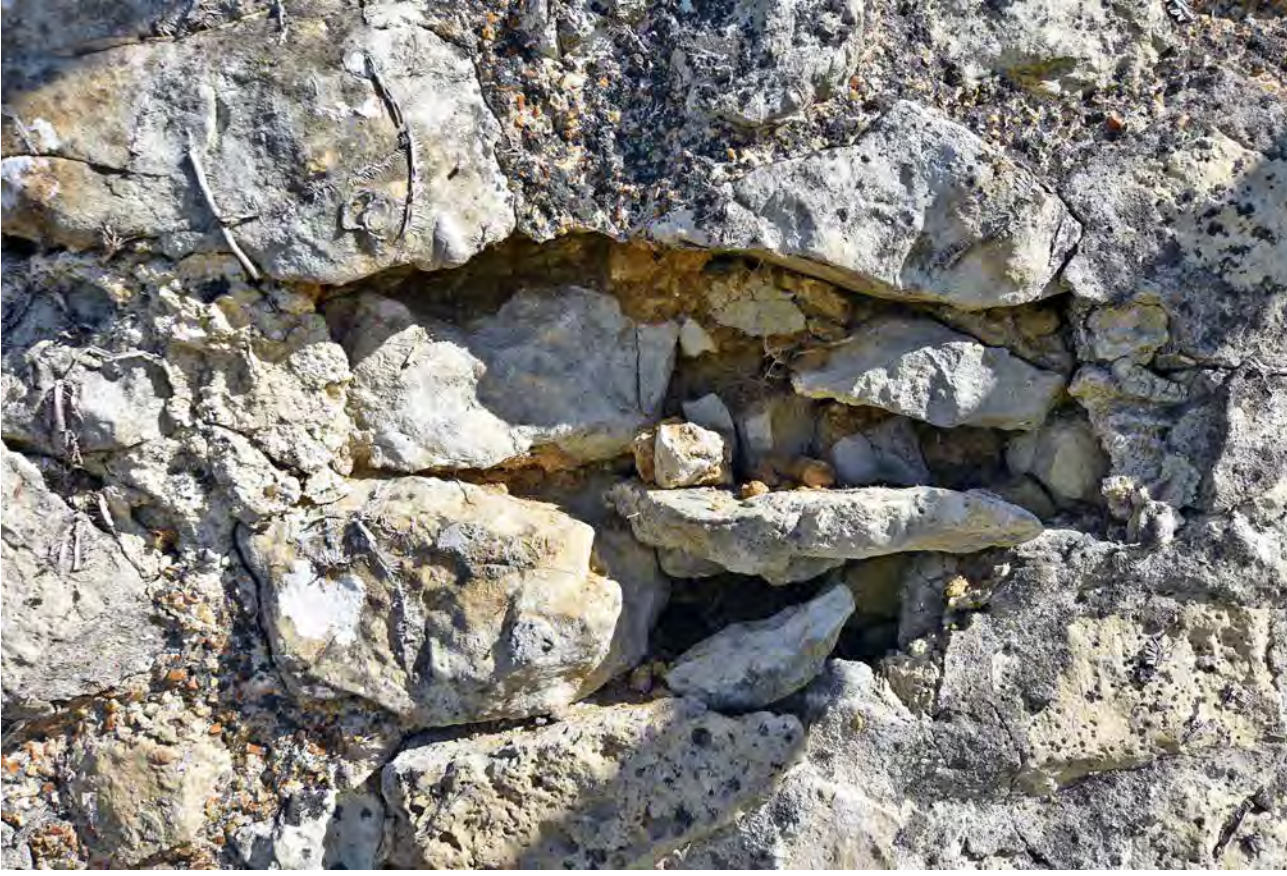
Plate 38: Void D4 (uppermost hole in this set)

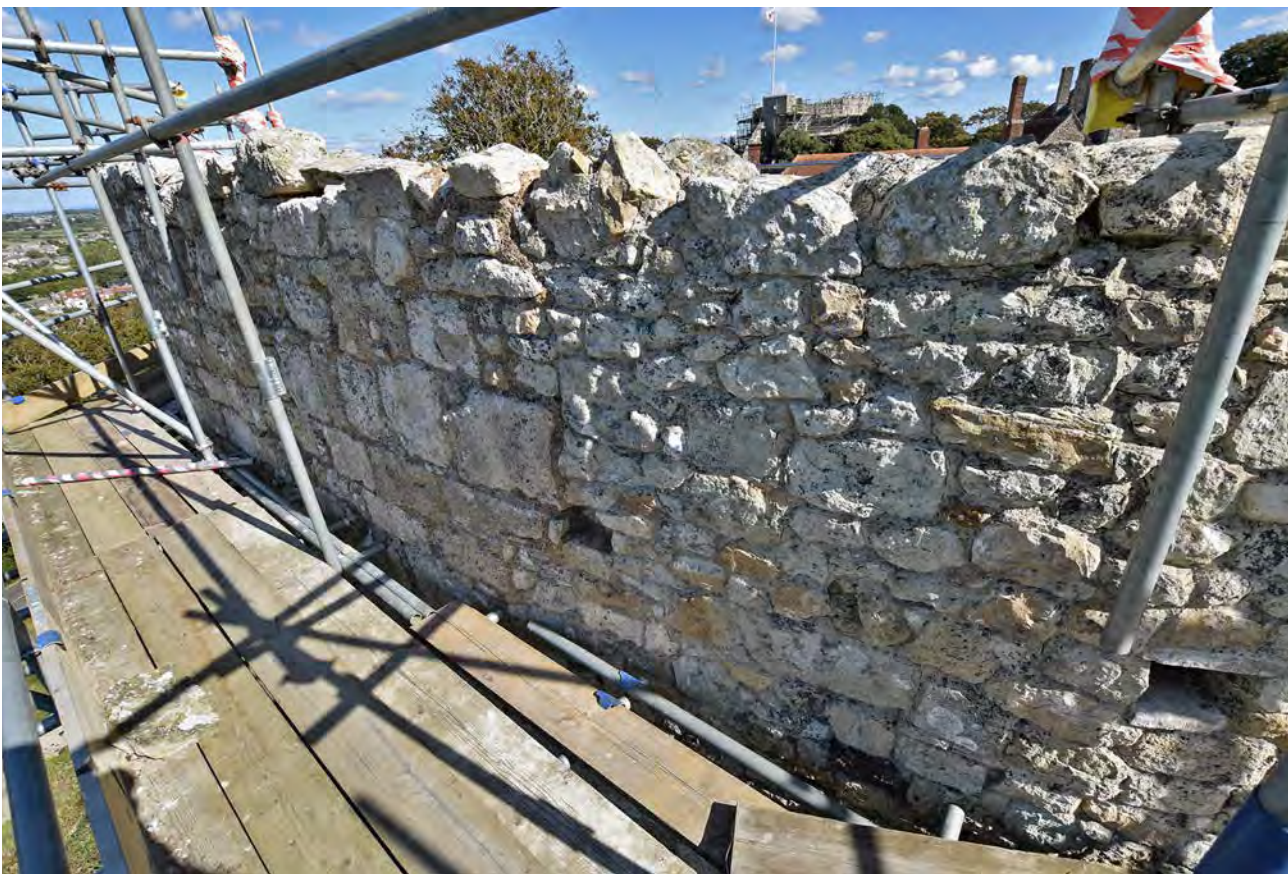
Plate 40: Construction break at level 5

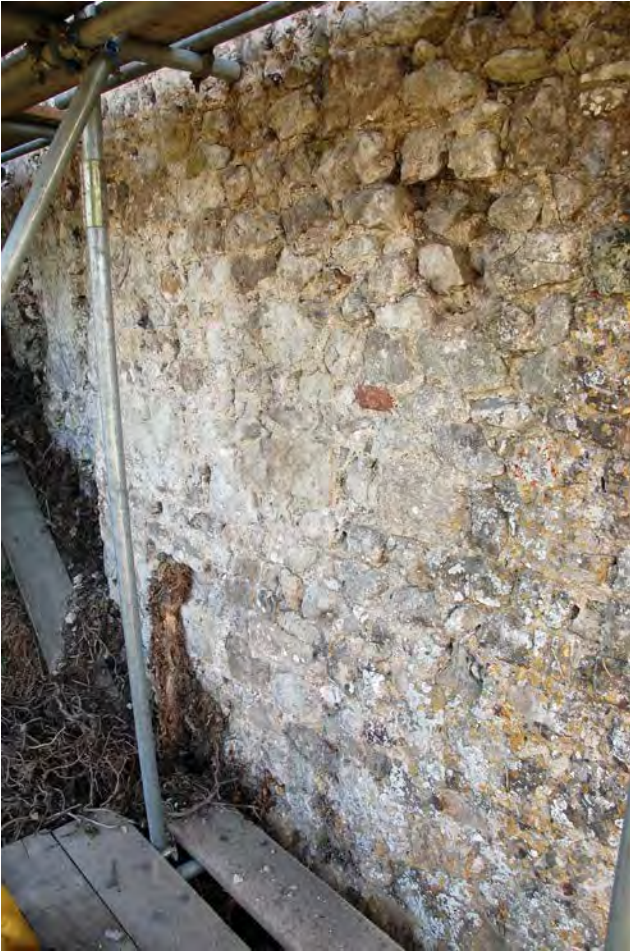
- 3.3.36 **Scaffold Level 6** is a short section by the Keep and it comprises similar uncoursed stone and a rebuilt coping (Pl. 41). There is a shallow, irregular void (c.25 cm wide x 30 cm tall x 15 cm deep) with white lime mortar. No ochre coloured mortar was noted but the void may not have been deep enough to reach this.

Plate 41: Void at level 6

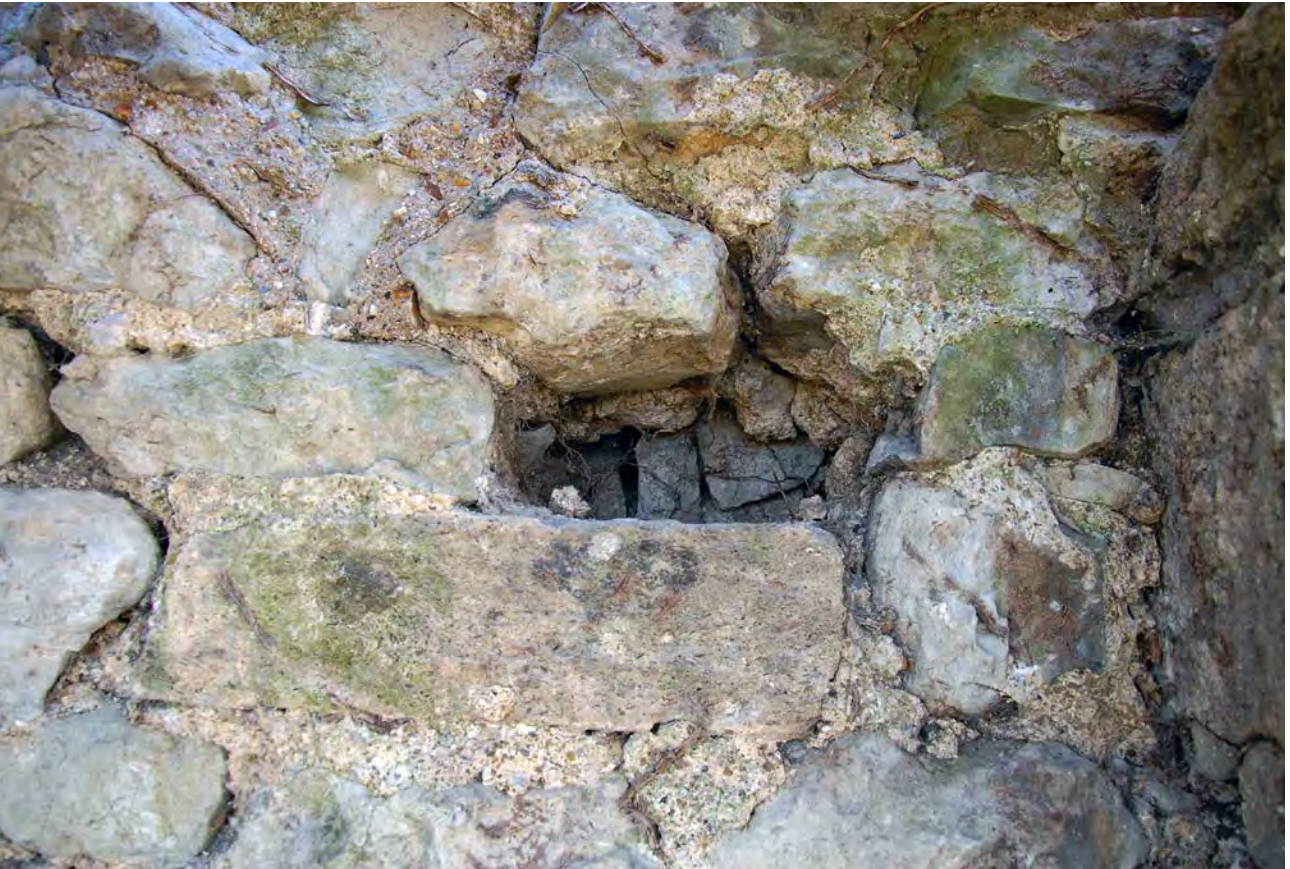
Plate 43: Small void at level 7
