British Railways Board  
Rail Link Project

# Archaeological Survey of Newlands Chapel, Charing, Kent

(Task 508/102)

Oxford Archaeological Unit  
July 1992

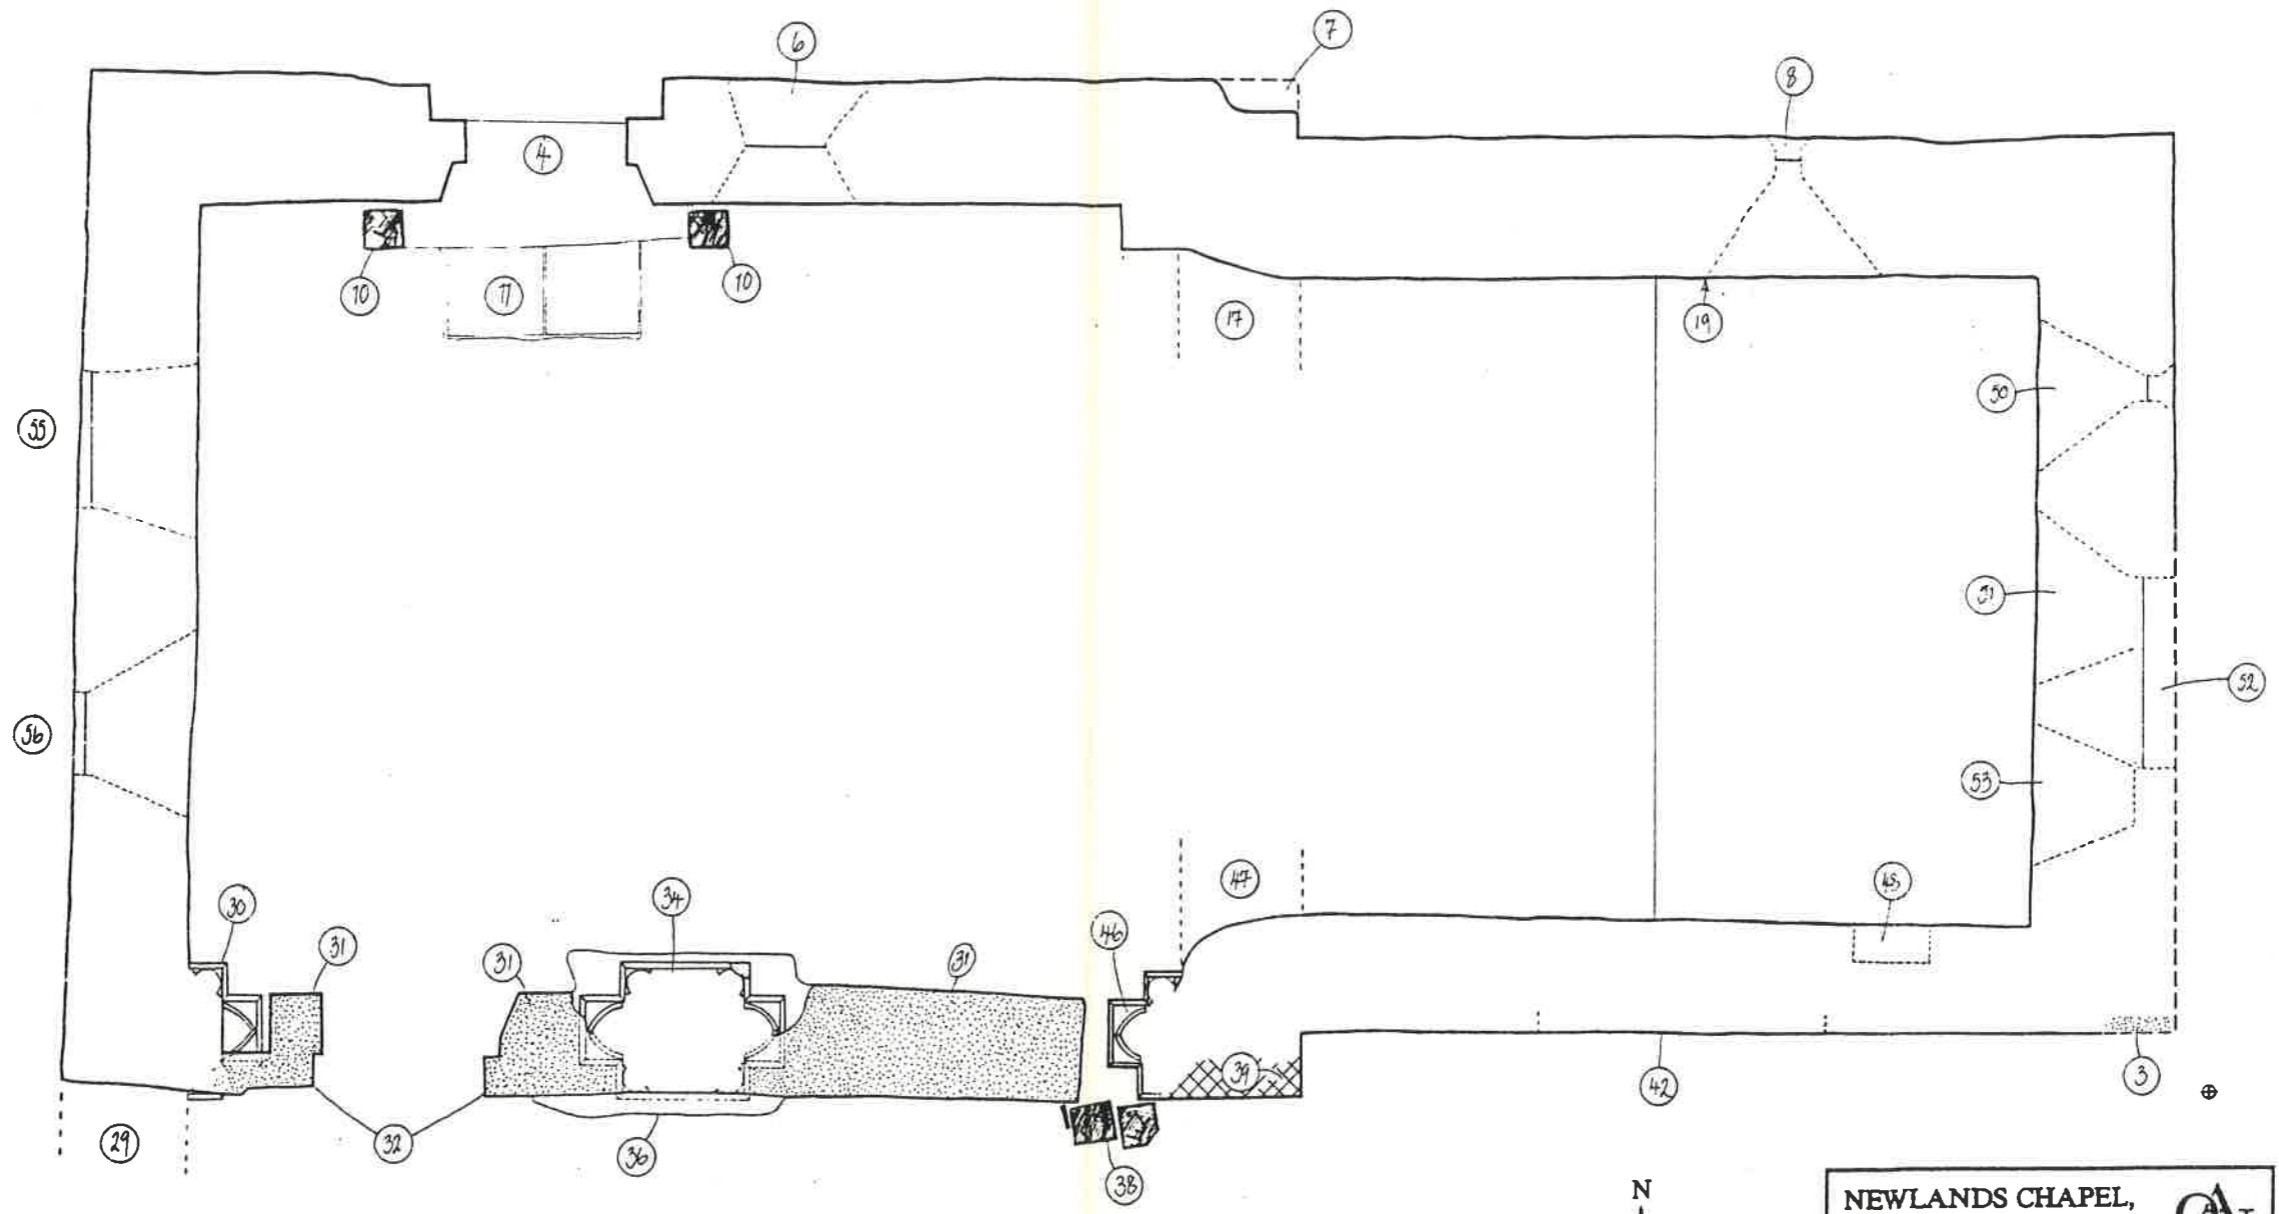
Fig. 2

5.1 **Fig. 2 Plan of chapel** (= 508/102/09)  
*Features as numbered below.*

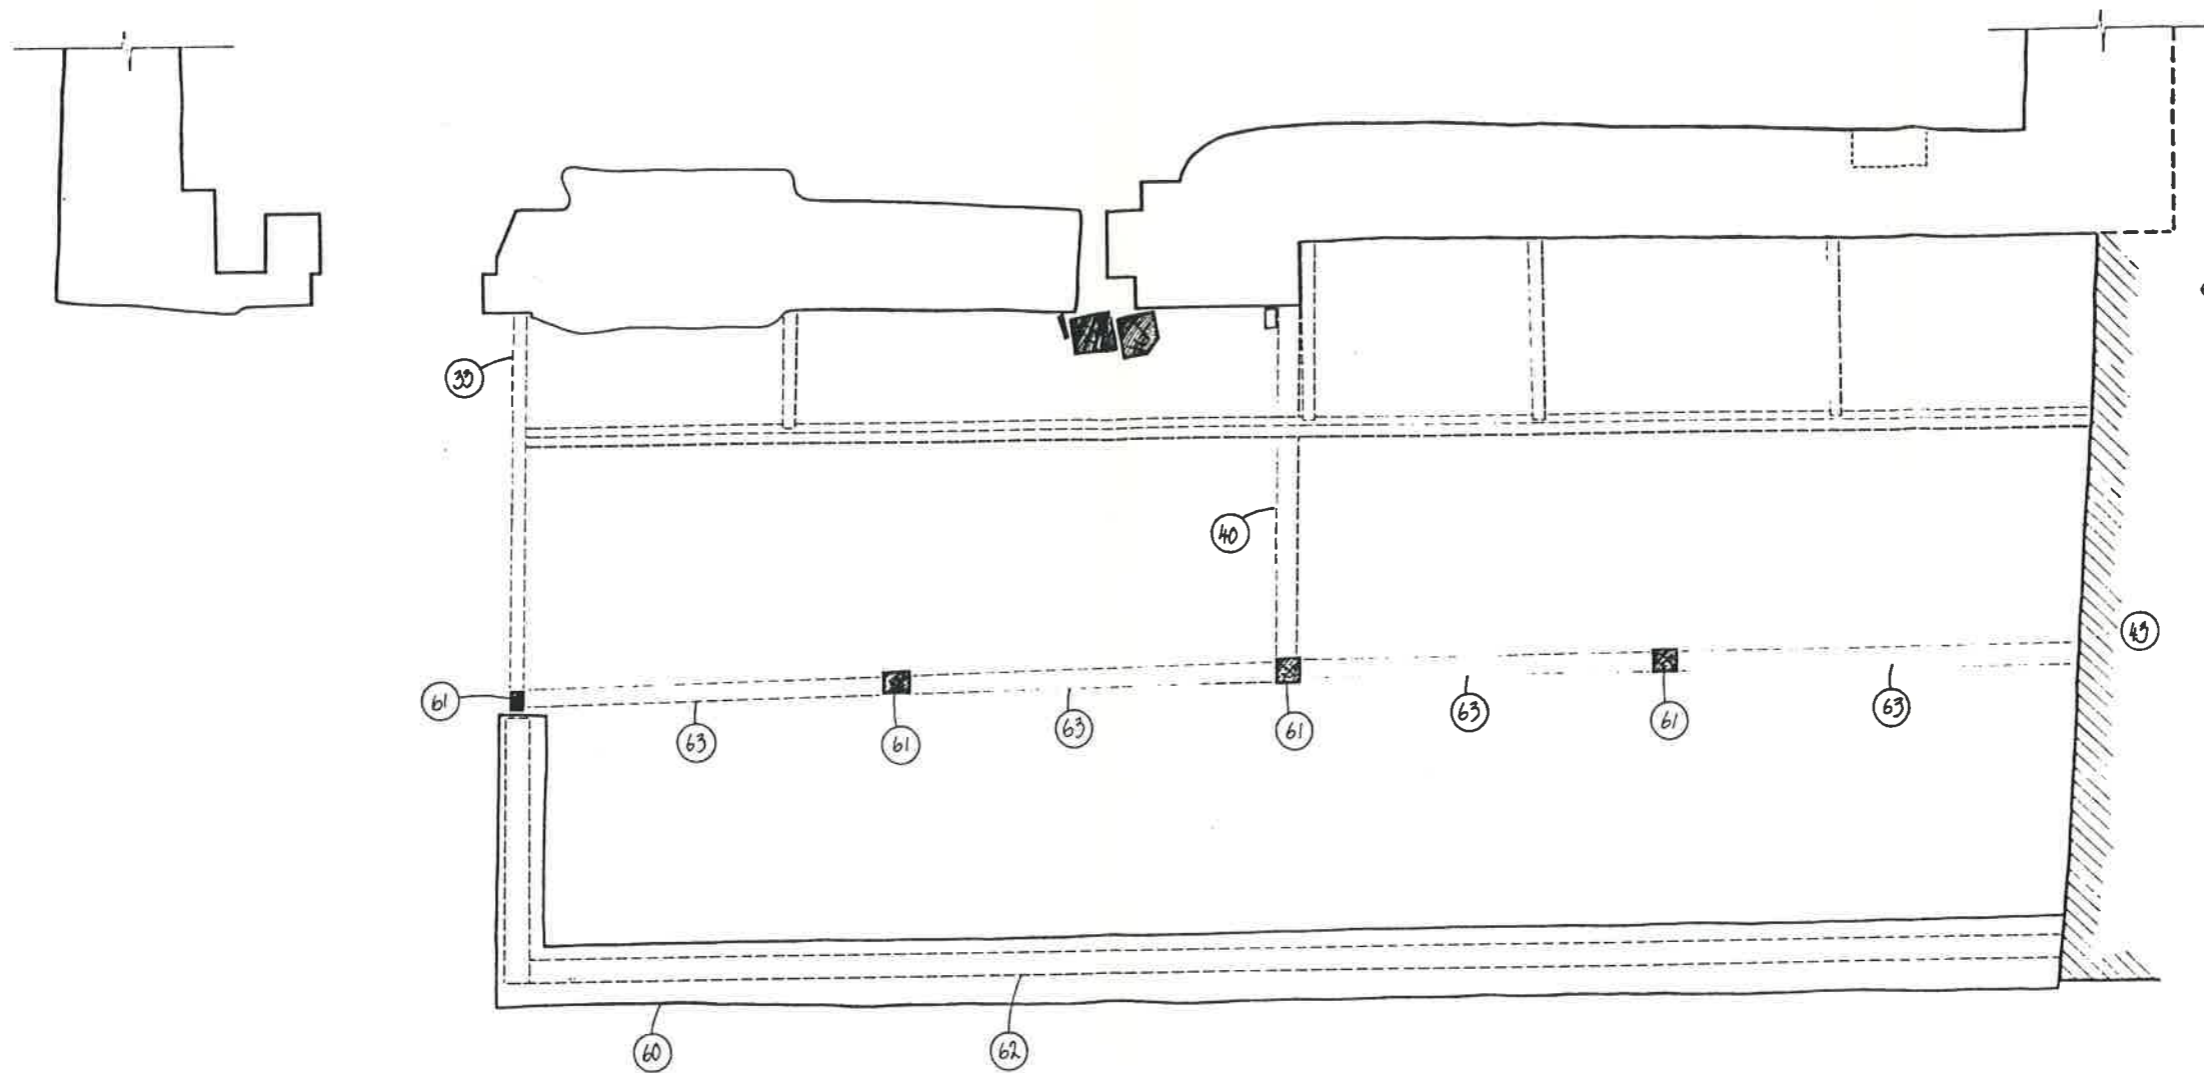
Fig. 3

5.2 **Fig. 3: Plan of outbuilding** (= 508/102/12)  
*Features as numbered below at Figs. 6 & 13.*

- [33] Tie and strut at west end of roof.
- [40] Tie at centre of roof.
- [60] Walls of south extension, in large rubble with brick quoins.
- [61] Timber posts supporting roof.
- [62] Wall-plate.
- [63] Plate on top of posts, tied to wall of chapel with two light tiebeams (shown only in plan).
- [64] Purlin supported by slender braces (not shown in section).

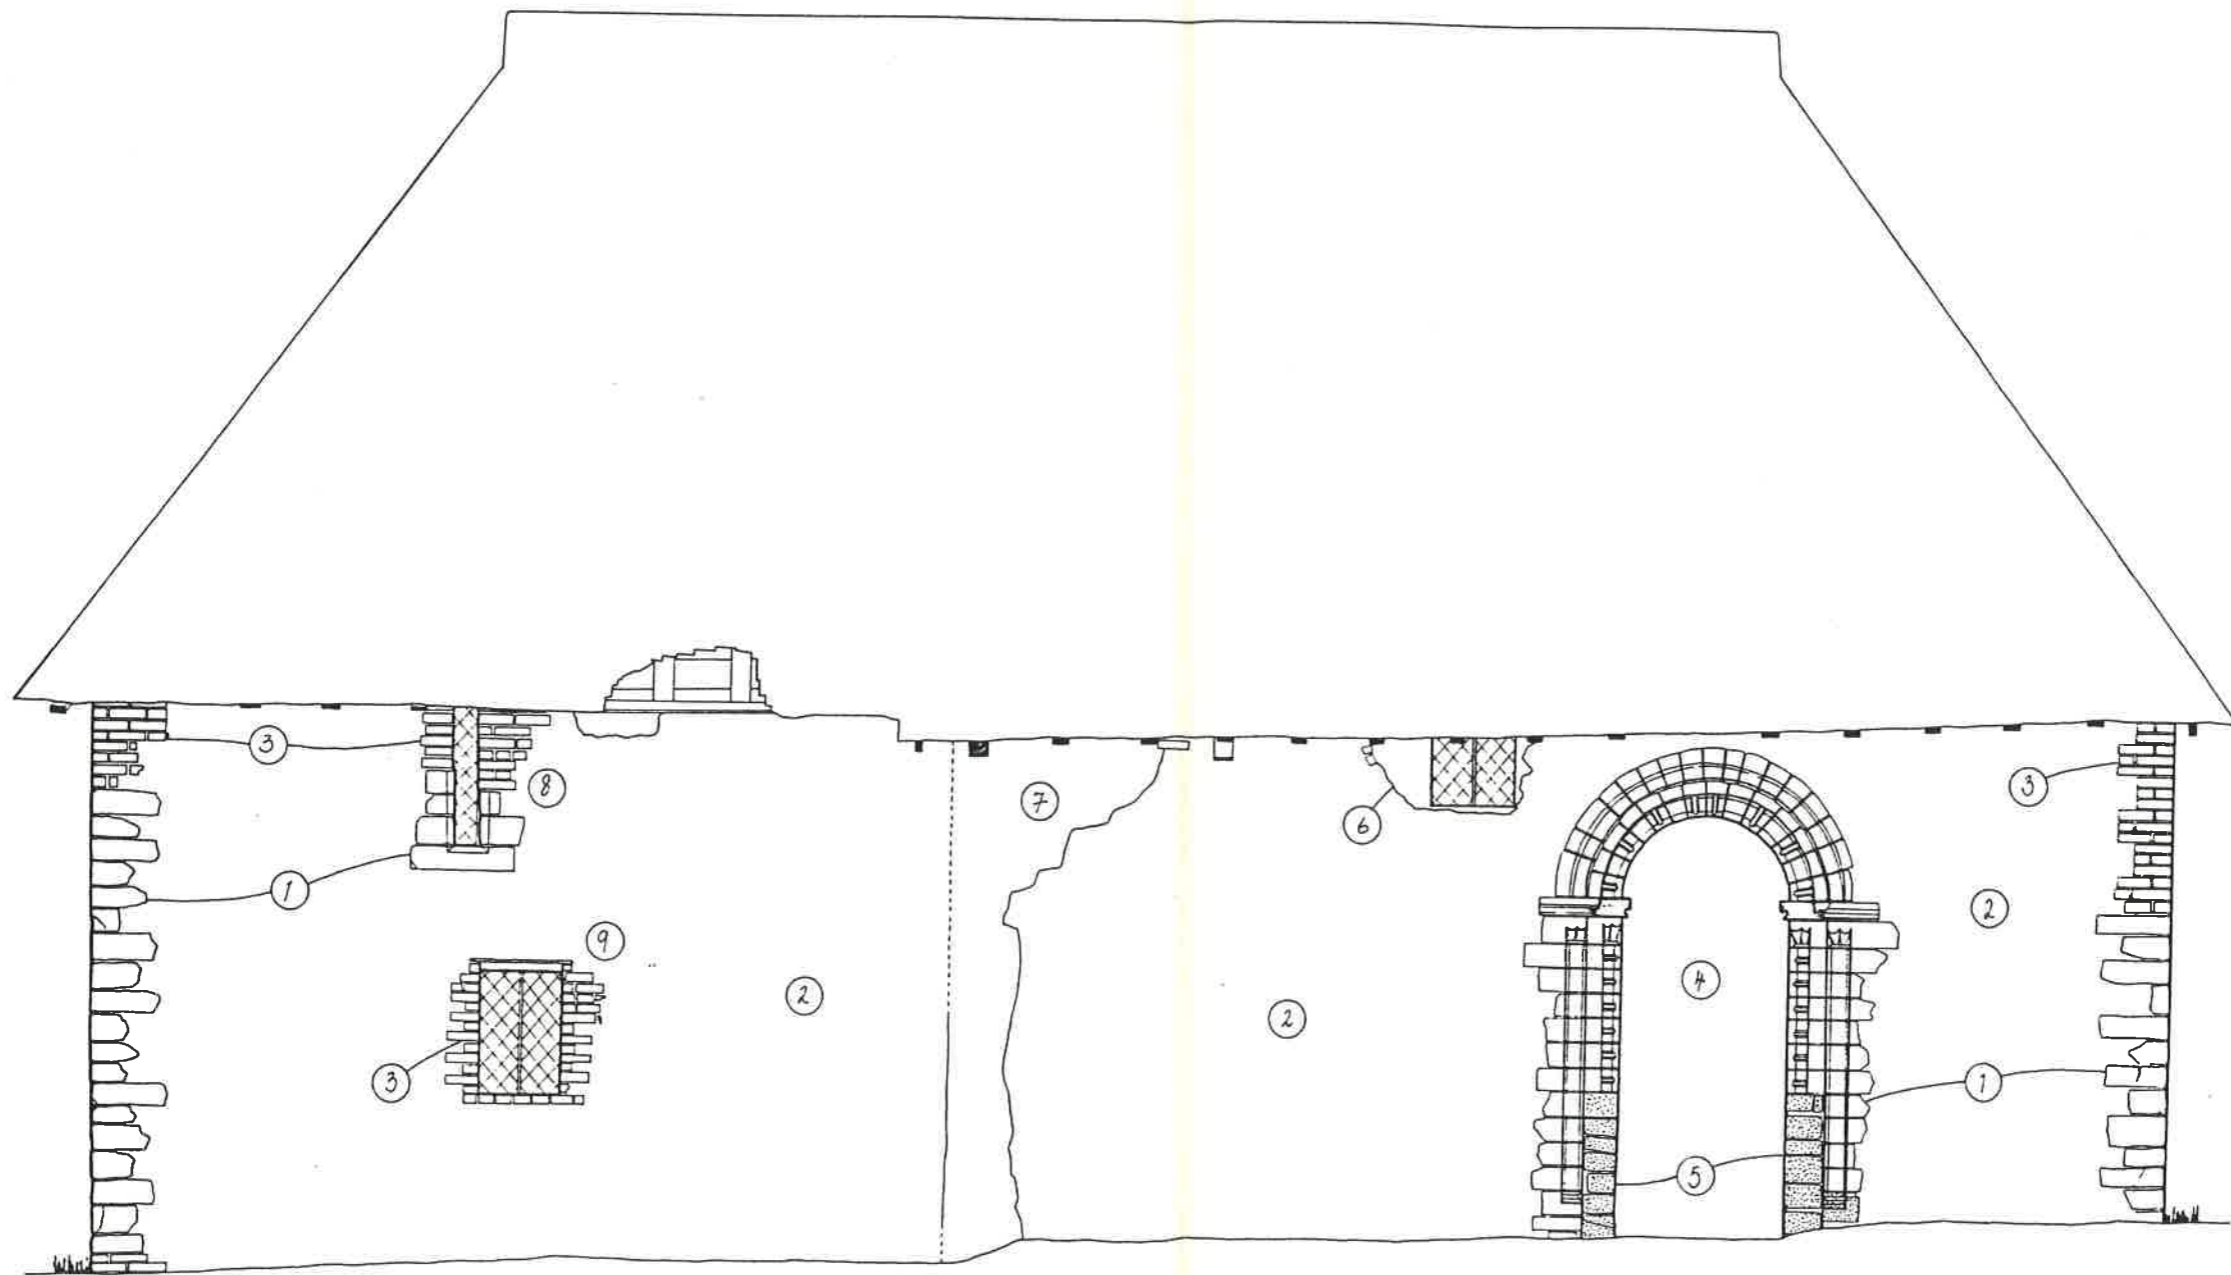
Fig. 4

5.3 **Fig. 4: North wall, exterior elevation** (= 508/102/01)

- [1] Caen stone ashlar masonry of original build.
- [2] Ragstone rubble walling of original build.
- [3] Brickwork of rebuilding phase ?18th-century.
- [4] North door of original build (see 4.4 above).
- [5] Stone repairs replacing original work in north door.
- [6] Gap in wall for nave north window, with leaded light.
- [7] Missing offset at nave/chancel corner.

- [8] North chancel window, with chamfered jambs.
- [9] Window made in rebuilding phase from medieval ambry.

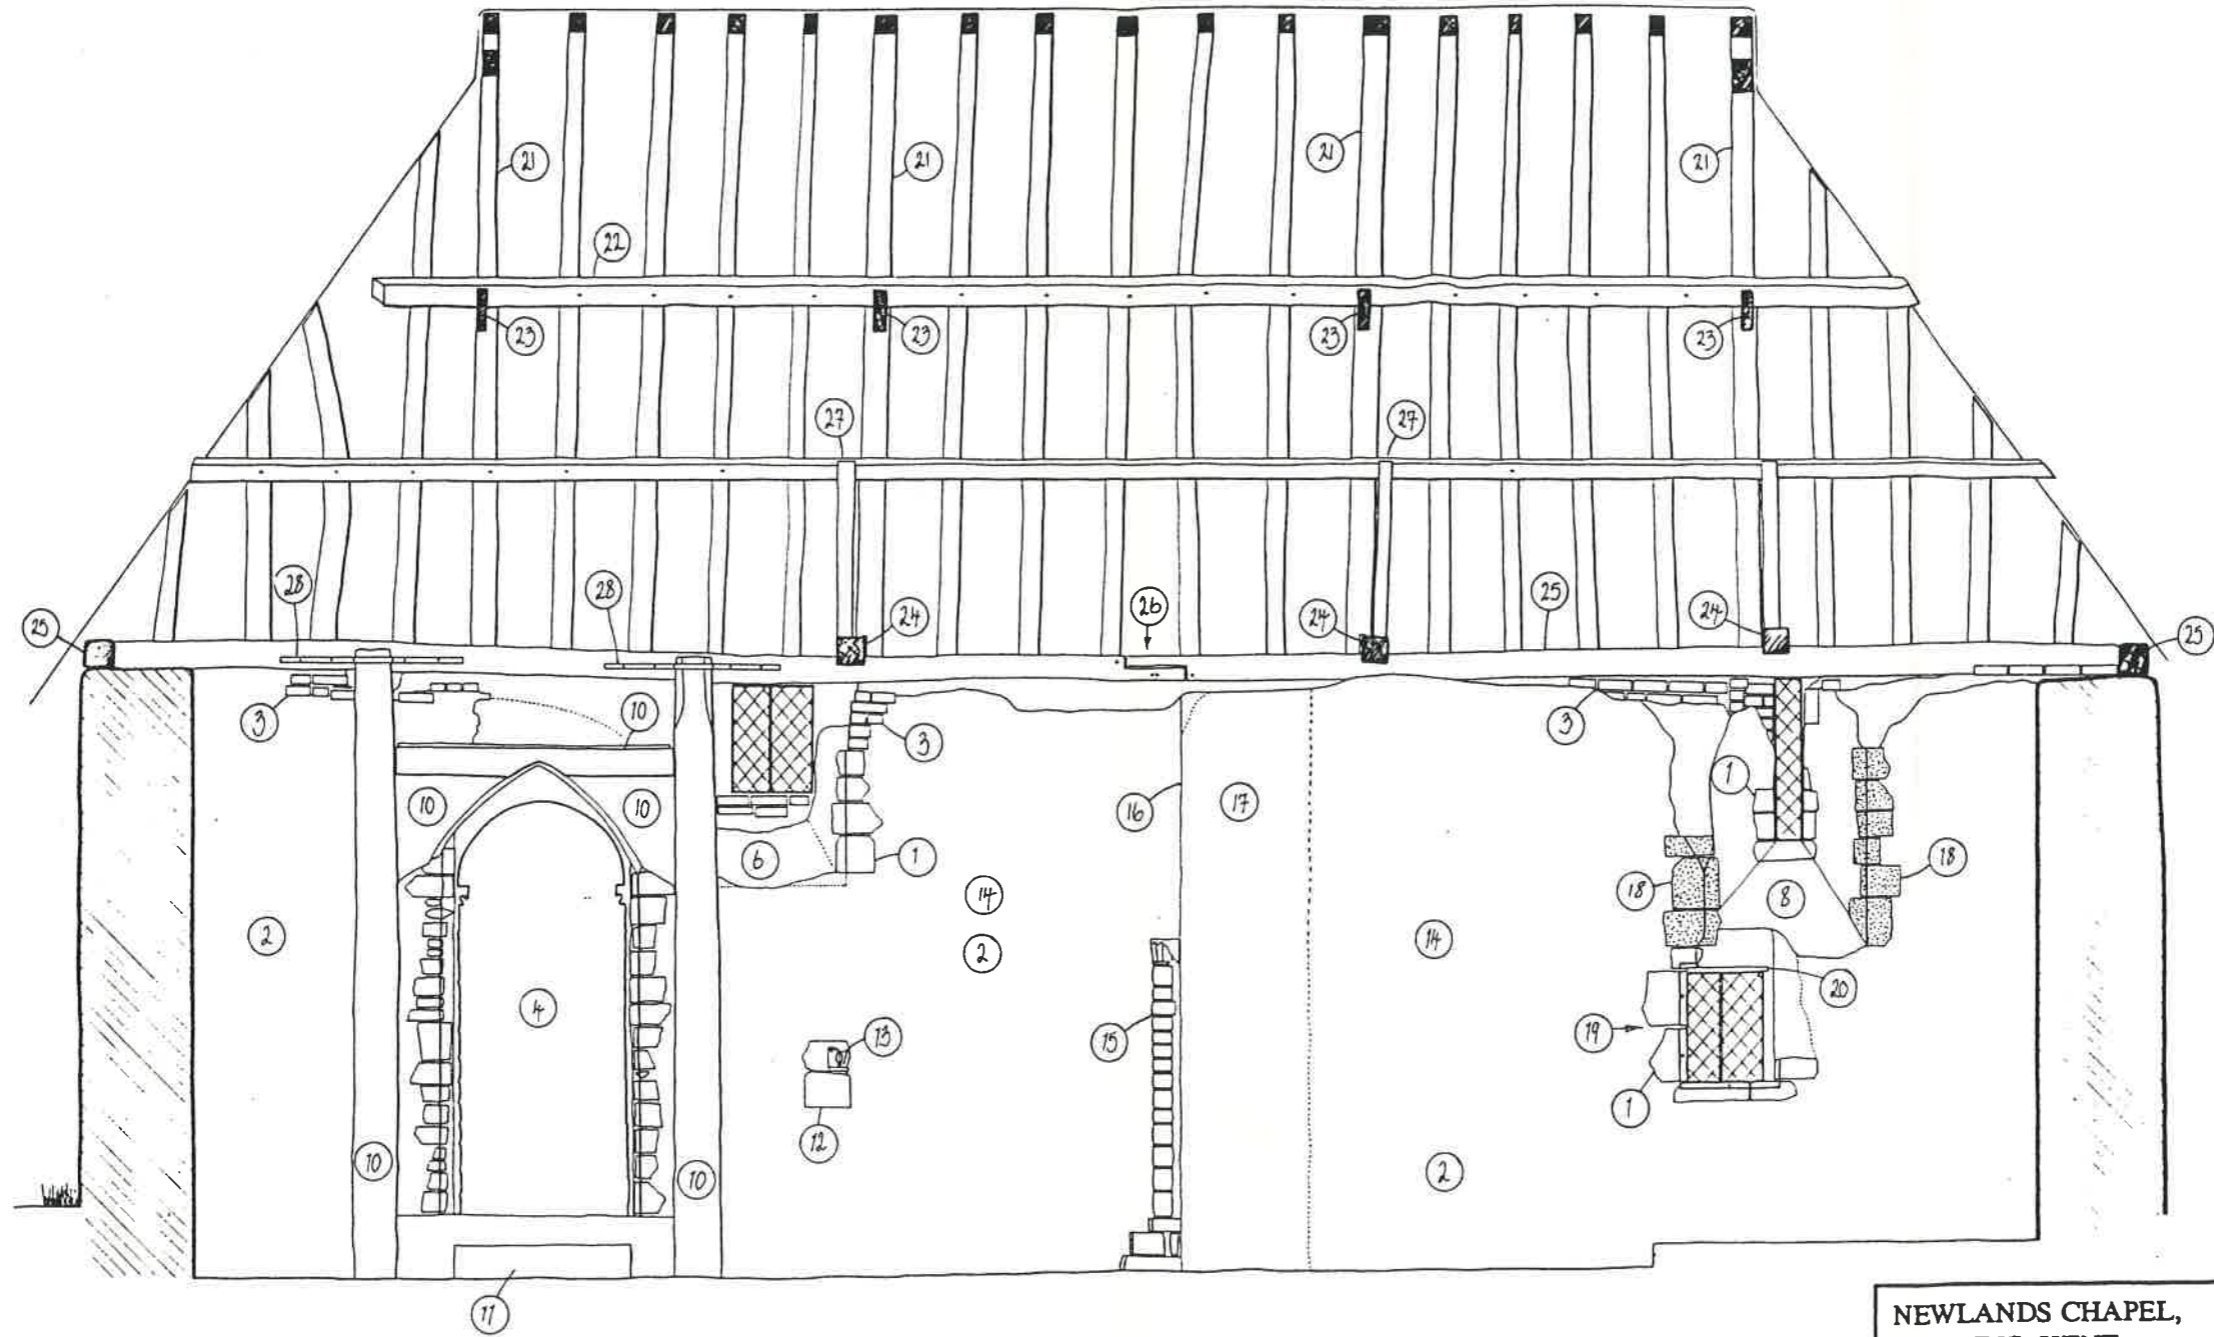
Fig. 5

**5.4 Fig. 5: North wall, interior elevation** (= 508/102/02)

- [10] Timber posts and planks supporting 19th-cent. door.
- [11] Modern step with paving slab.
- [12] Inscription recording 1963 restoration.
- [13] Romanesque cap with acanthus motif.
- [14] Area of probable original plastering.
- [15] Modern pier of recut shaft stones, scalloped cap and inverted abacus as base.
- [16] Original plastering round corner from nave to chancel arch wall.
- [17] Scar of chancel arch wall.
- [18] Chalk blocks used for internal jambs of window [8].
- [19] Ambry of Caen stone with rebate for wooden fittings, of original build.
- [20] Wooden plank forming ceiling of ambry, probably original.

*Roof:* (features [21]-[26] belong to the original period of roofing, in rebuilding phase ?18th cent.)

- [21] Principal rafters.
- [22] Purlin, pegged to common rafters.
- [23] Collars.
- [24] Tie beams.
- [25] Wall-plate
- [26] Wall-plate scarf joint.
- [27] Added purlin and struts.
- [28] Iron bands on wall-plates.

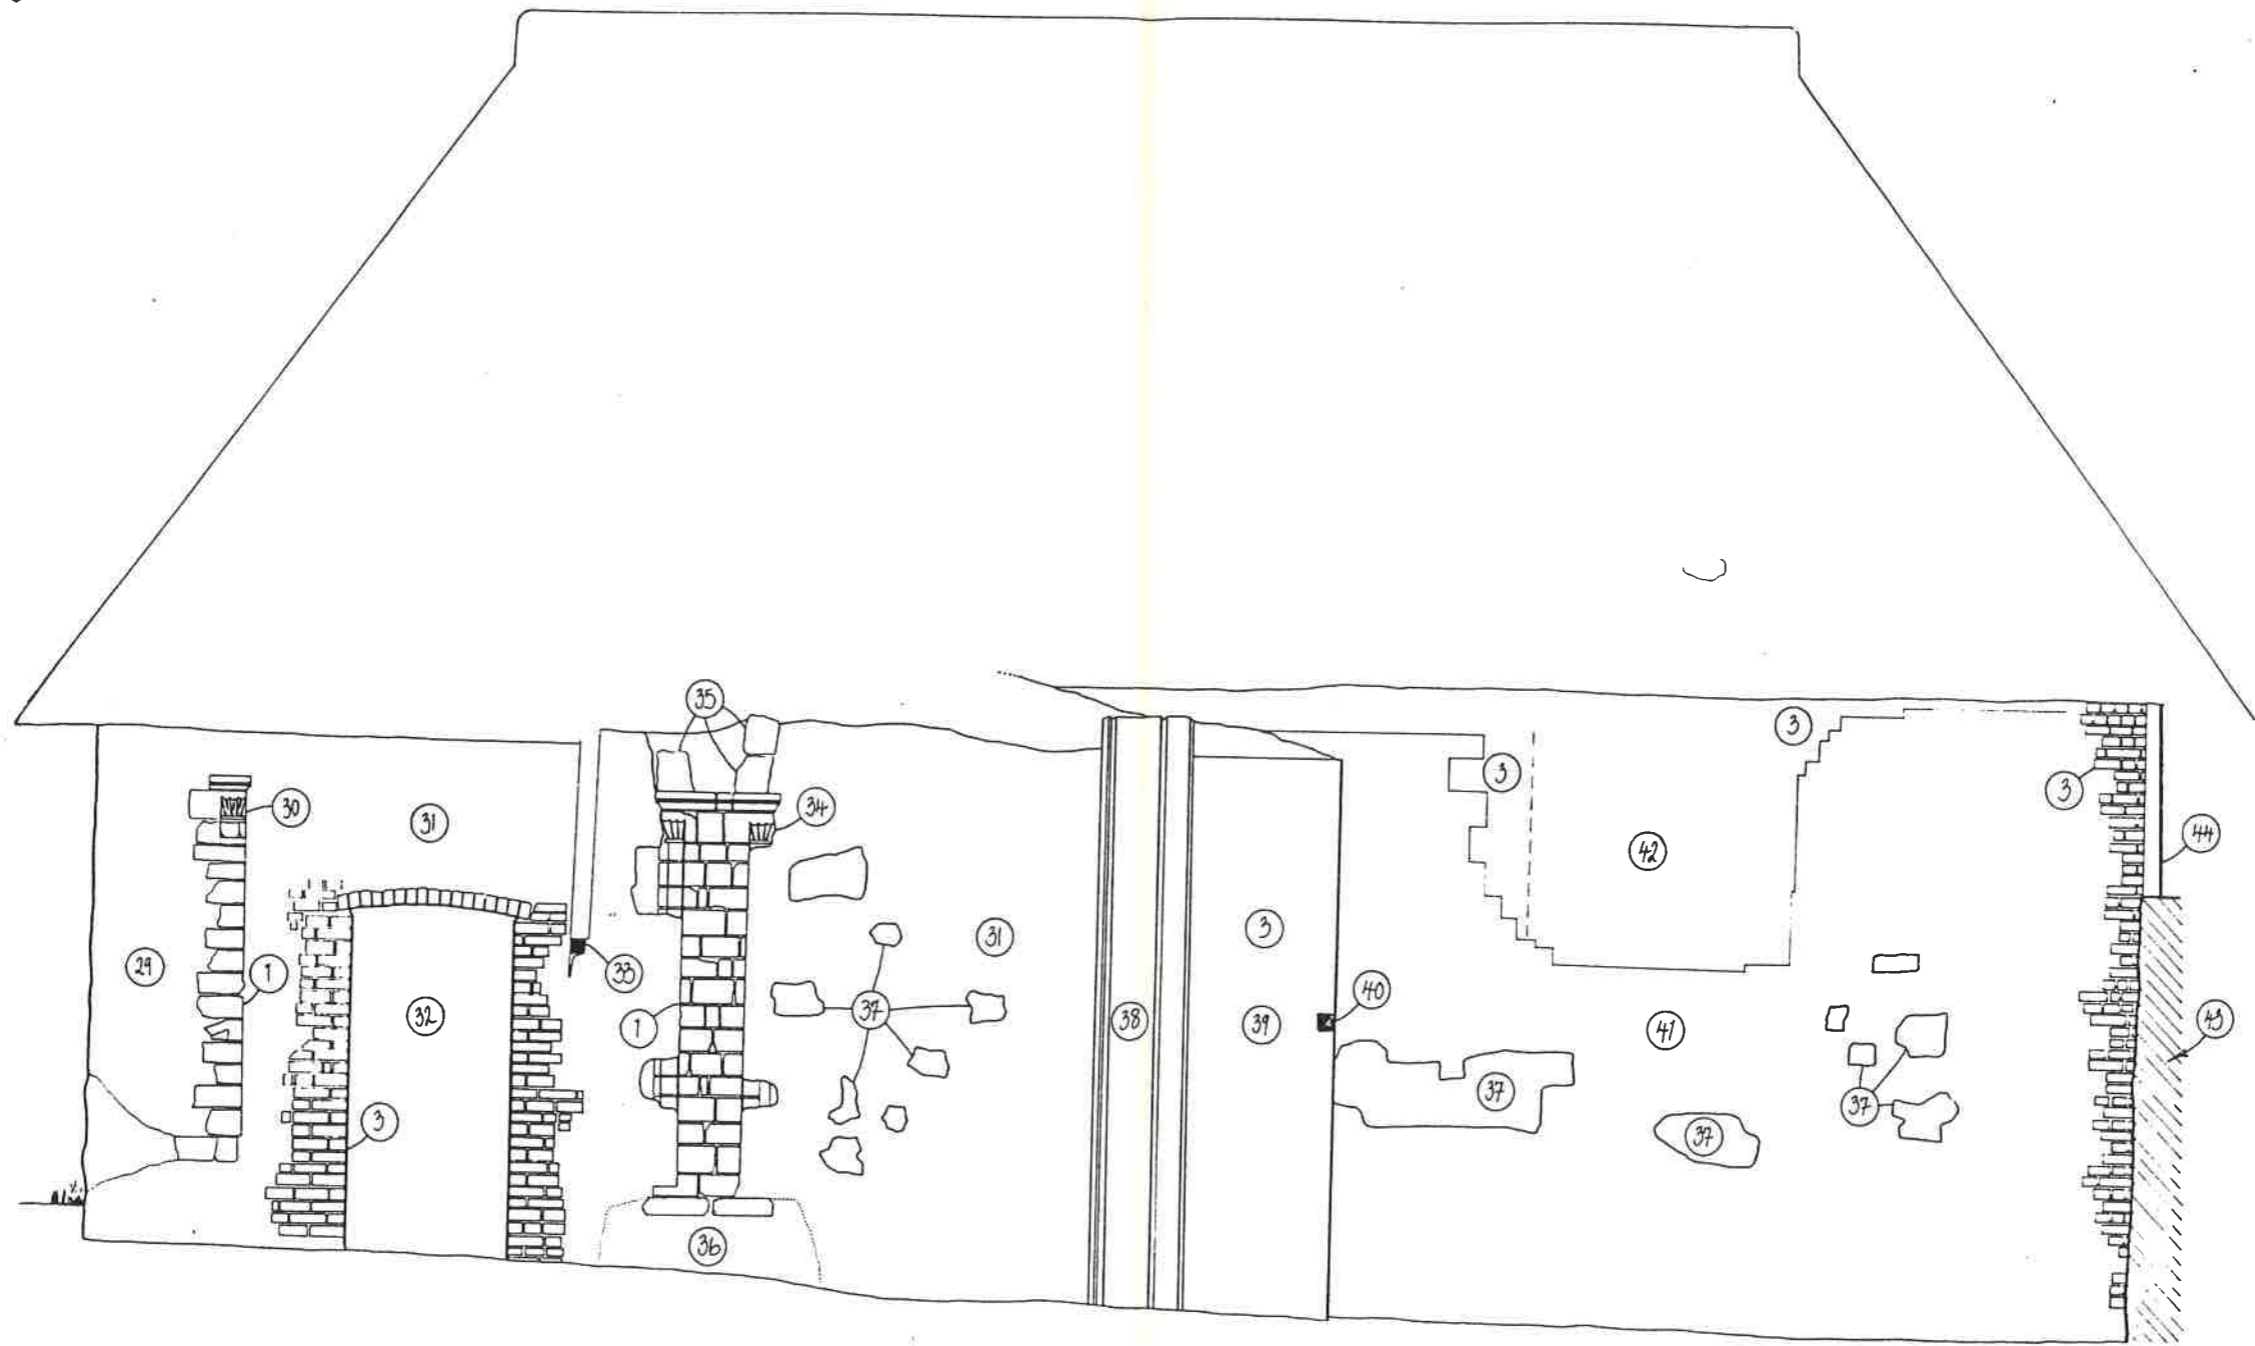
Fig. 6

**5.5 Fig. 6: South wall, exterior elevation** (= 508/102/03)

- [29] Scar of continuation of west wall to nave aisle.
- [30] West respond of nave arcade, with cap and stopped nook-shaft.
- [31] Rubble blocking of nave arcade, possibly medieval.

- [32] South door introduced in rebuilding phase.
- [33] Tie and strut at west end of roof of lean-to south extension.
- [34] Central pier of nave arcade, with nook-shafts partly exposed.

- [35] Chalk voussoirs of nave arcade arches.
- [36] Exposed foundation of pier, suggesting soil erosion.
- [37] Recent holes in face of rubble blocking.

- [38] Timber posts, probably added in 1960s to block gap in wall.
- [39] Brick buttress, probably of rebuilding phase, marking corner of nave and chancel.

- [40] Tie at centre of roof of lean-to south extension.
- [41] Rubble walling with some chalk, generally of larger stones than rubble walling of original build, and perhaps representing a later medieval rebuilding of chancel south wall.

- [42] Brick blocking (?blocking of window prior to brickwork of rebuilding phase), and perhaps representing later medieval window contemporary with [41].

- [43] Stone wall of 20th-cent. house.
- [44] Modern timber shuttering over [43].

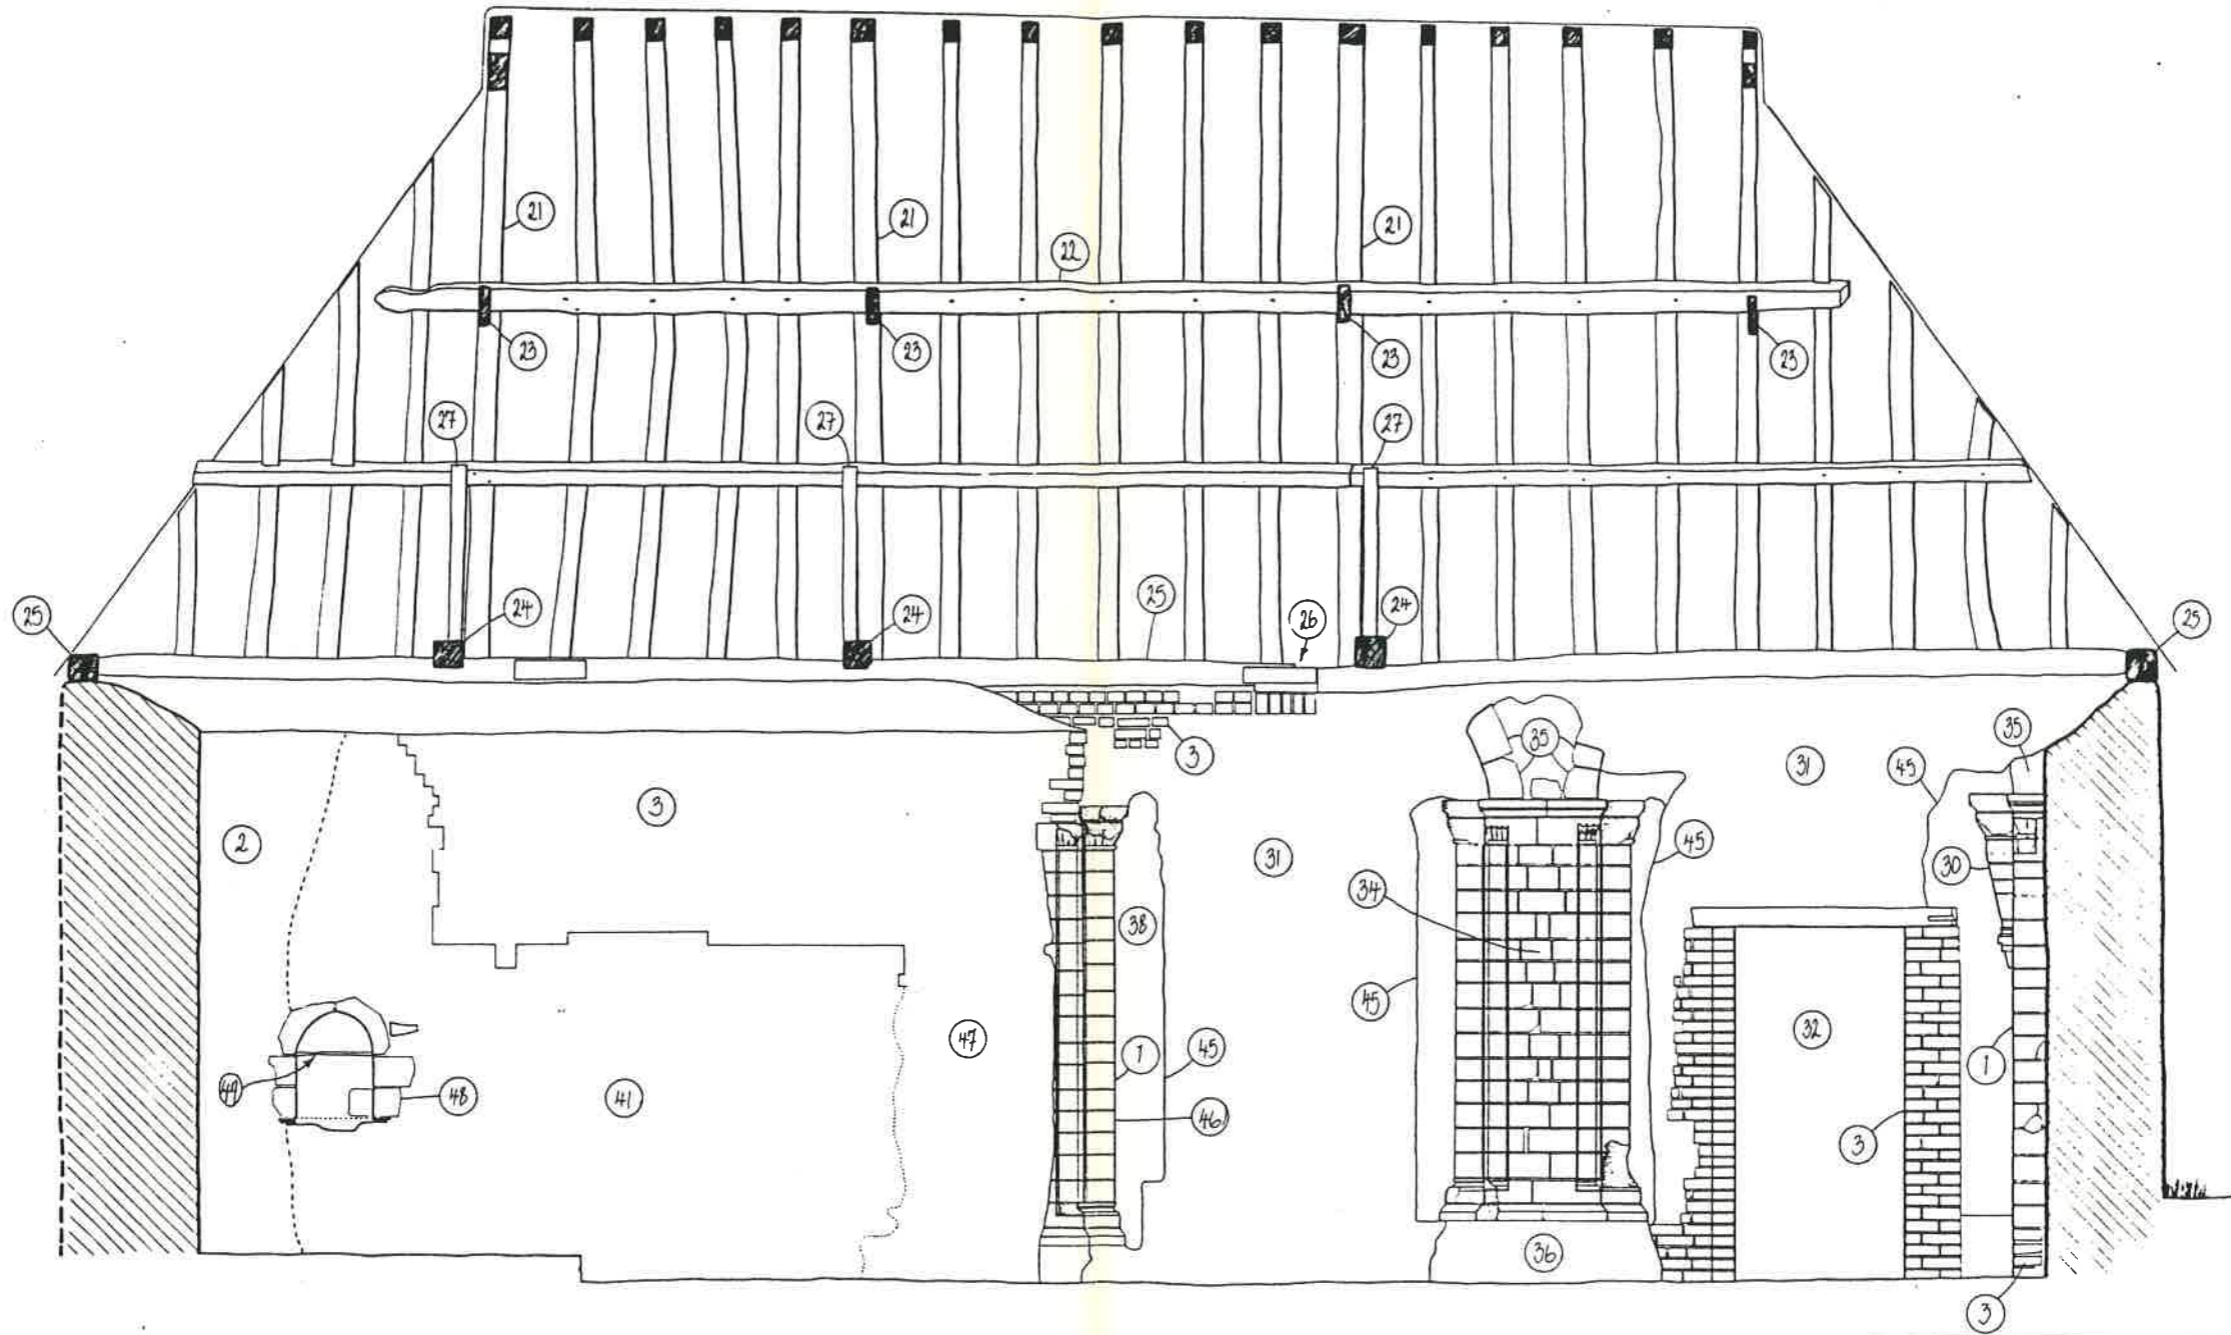
Fig. 7

**5.6 Fig. 7: South wall, interior elevation** (= 508/102/04)

- [2] Here probably surviving for short length at east end.
- [3] Here continuous over feature [42] visible externally.
- [30] Here central keeled order of respond dies back into wall.
- [45] Edge of [31] cut back to reveal ashlar masonry.
- [46] Eastern respond of nave arcade, with nook-shafts and keeled member for full height.
- [47] Curved filling of brick and rubble marking position of chancel arch wall.
- [48] Piscina, apparently of Greensand ragstone, probably of original build.
- [49] Wooden shelf in piscina, probably of original build.

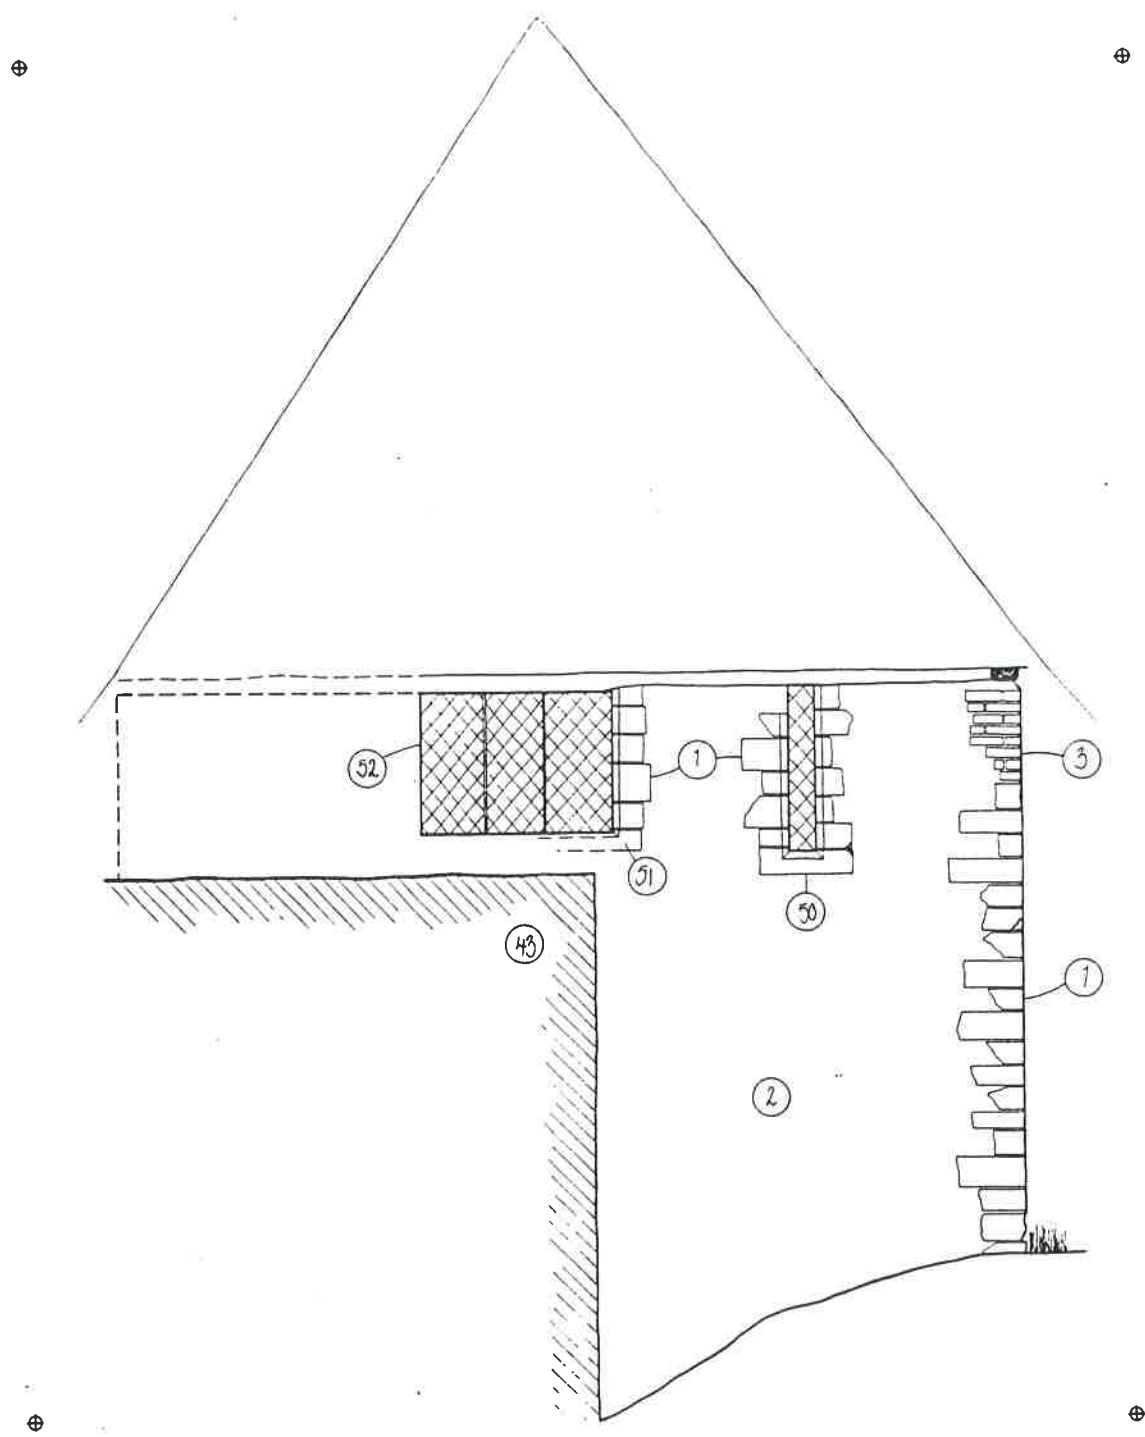
Fig. 8

**5.7 Fig. 8: East wall, exterior elevation** (= 508/102/05)

*Note falling off of ground level; upper part at south end not accessible.*

- [50] North window of east wall, with chamfered jambs.
- [51] Central window of east wall, with chamfered jamb.
- [52] Window of rebuilding phase, comprising width of central and south windows of east wall, and with leaded light.

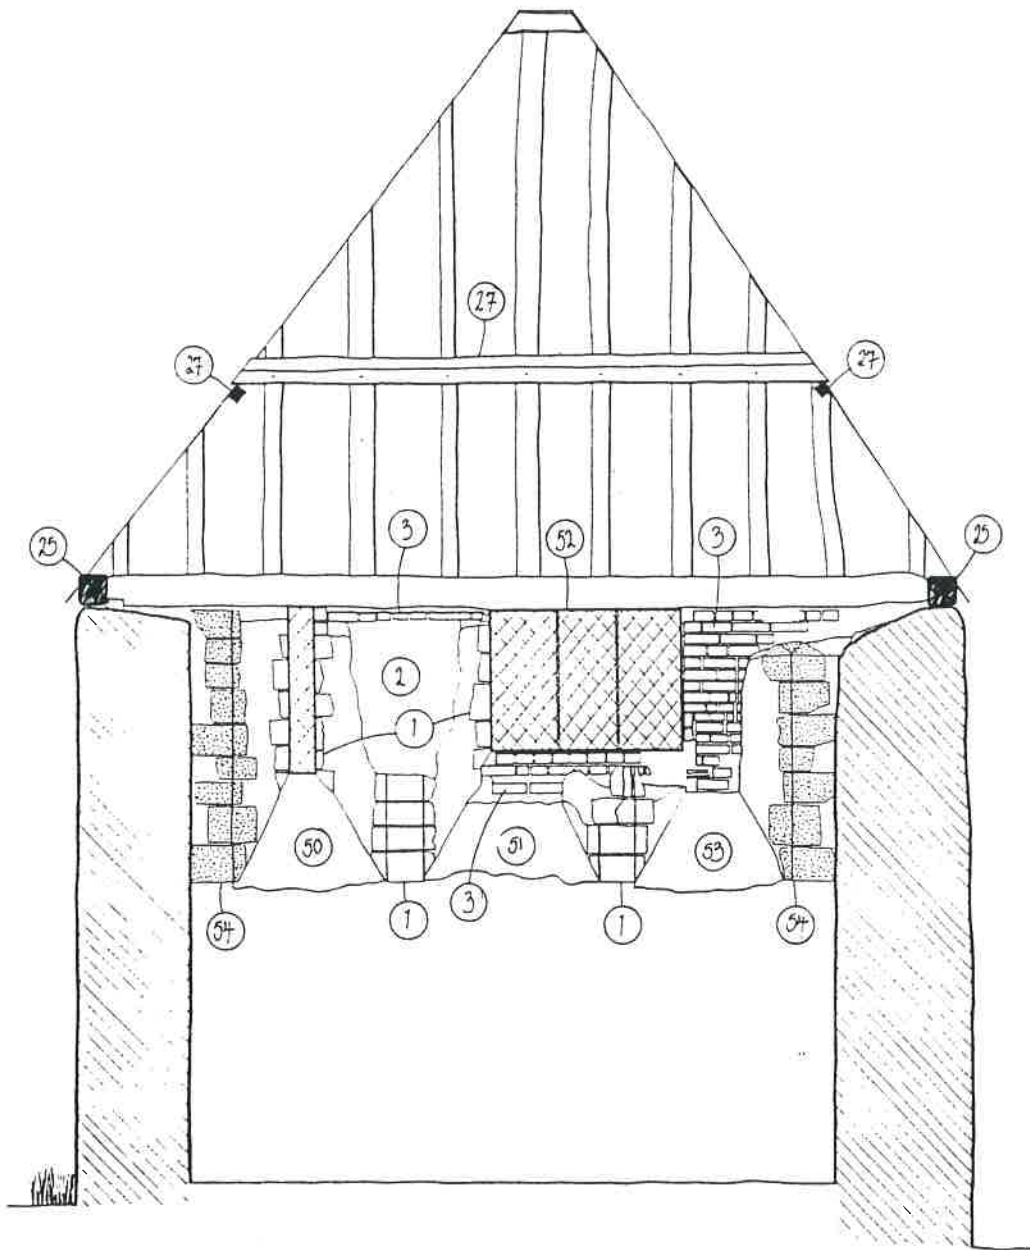
Fig. 9

**5.8 Fig. 9: East wall, interior elevation** (= 508/102/06)

*Roof is hipped, with lower purlin pegged to rafters.*

- [2] Here rubble core of wall with chalky mortar exposed by removal of jamb.
- [50] Interior of north window has rendered reveals.
- [51] Interior of central window mostly removed for [52], but wider than both the side windows, and with Caen stone jambs.
- [53] South window of east wall with rendered reveal, and blocked by brickwork of [52].
- [54] Chalk outer jambs of windows [50] and [53].

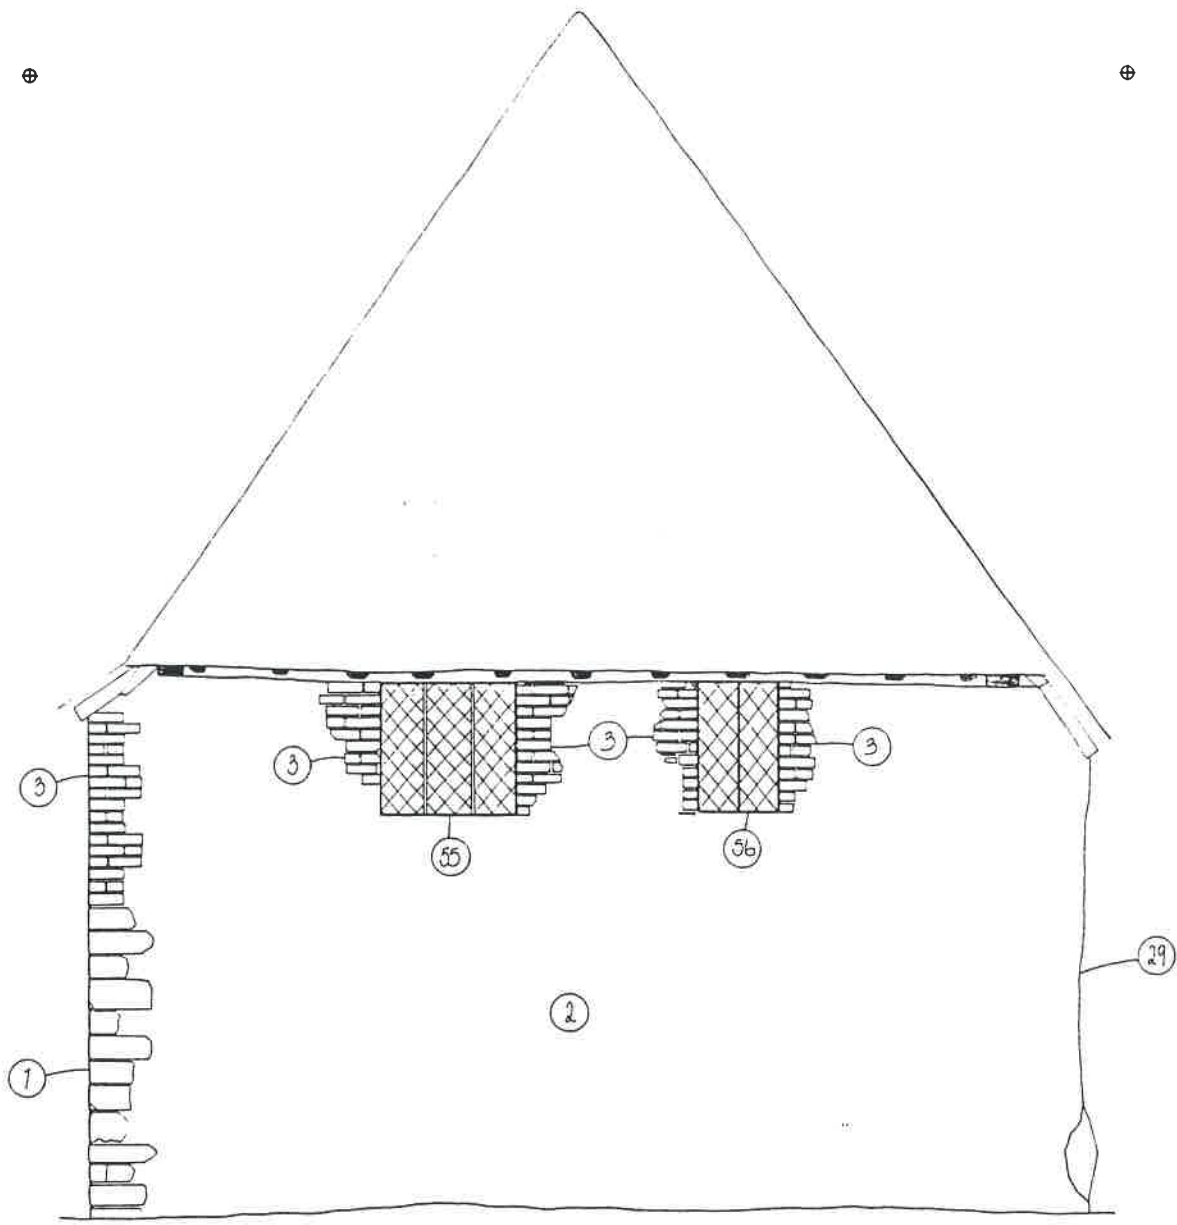
Fig. 10

**5.9 Fig. 10: West wall, exterior elevation** (= 508/102/07)

- [55] North window of west wall, enlarged in rebuilding phase.
- [56] South window of west wall, enlarged in rebuilding phase.
