British Railways Board  
Rail Link Project

# Archaeological Survey of Newlands Chapel, Charing, Kent

(Task 508/102)

Oxford Archaeological Unit  
July 1992

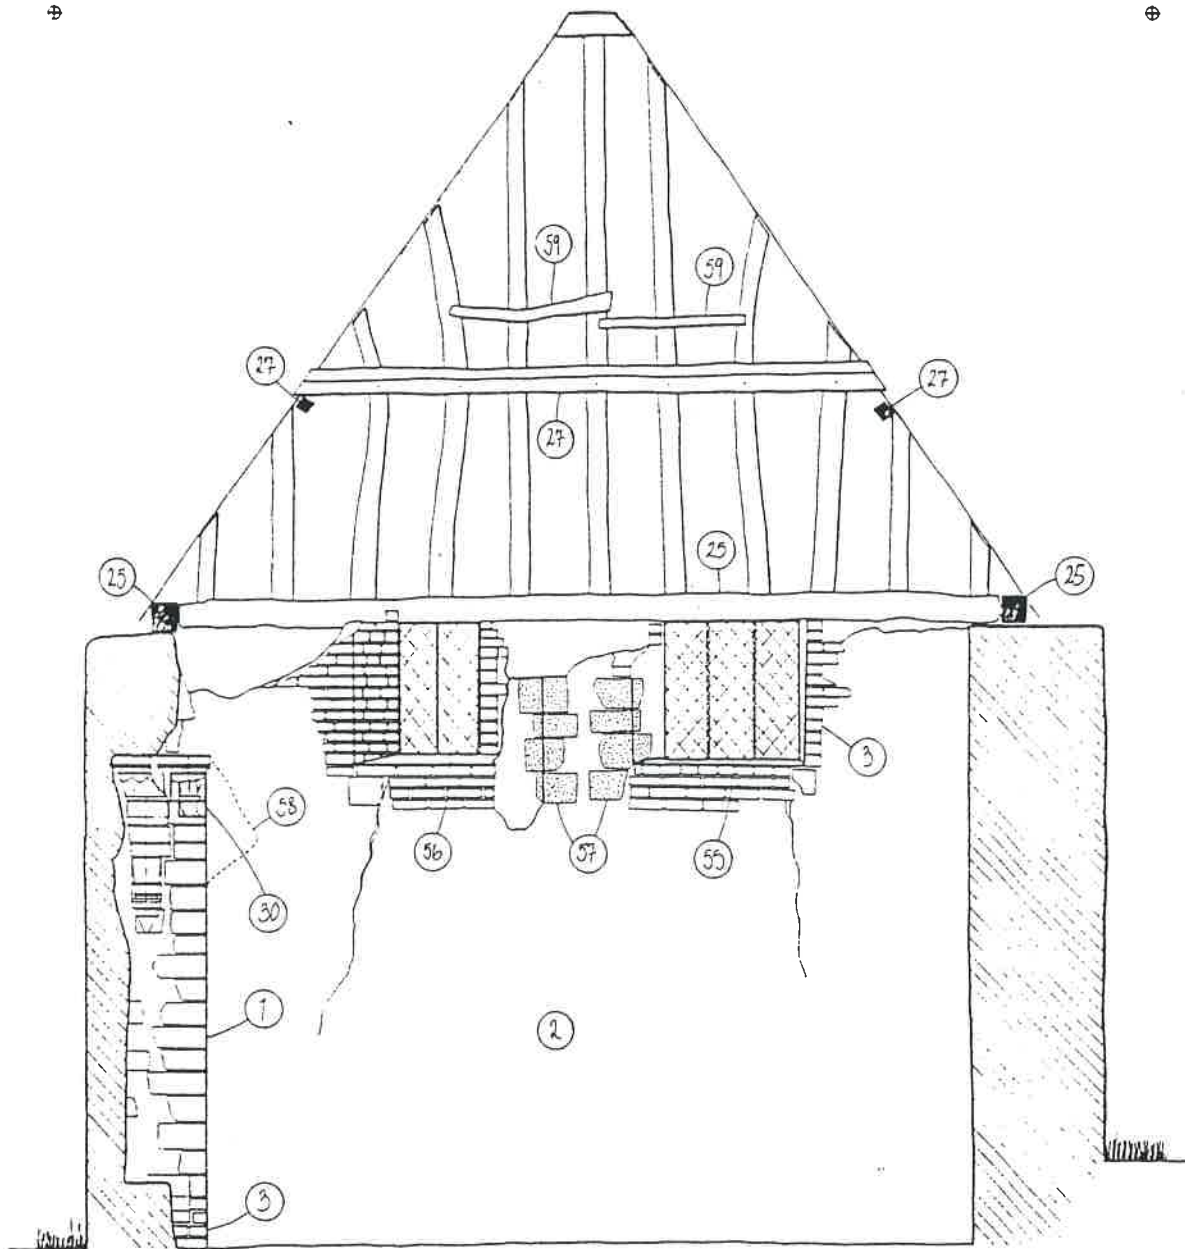
Fig. 11

**5.10 Fig. 11: West wall, interior elevation** (= 508/102/08)

- [2] Here the rubble walling is partly rendered.
- [55] Interior of north window of west wall rebuilt in brick except for central jamb.
- [56] Interior of south window of west wall rebuilt in brick except for central jamb.
- [57] Central jamb of chalk blocks.
- [58] Patch of modern repointing.
- [59] Secondary struts joining irregular rafters.

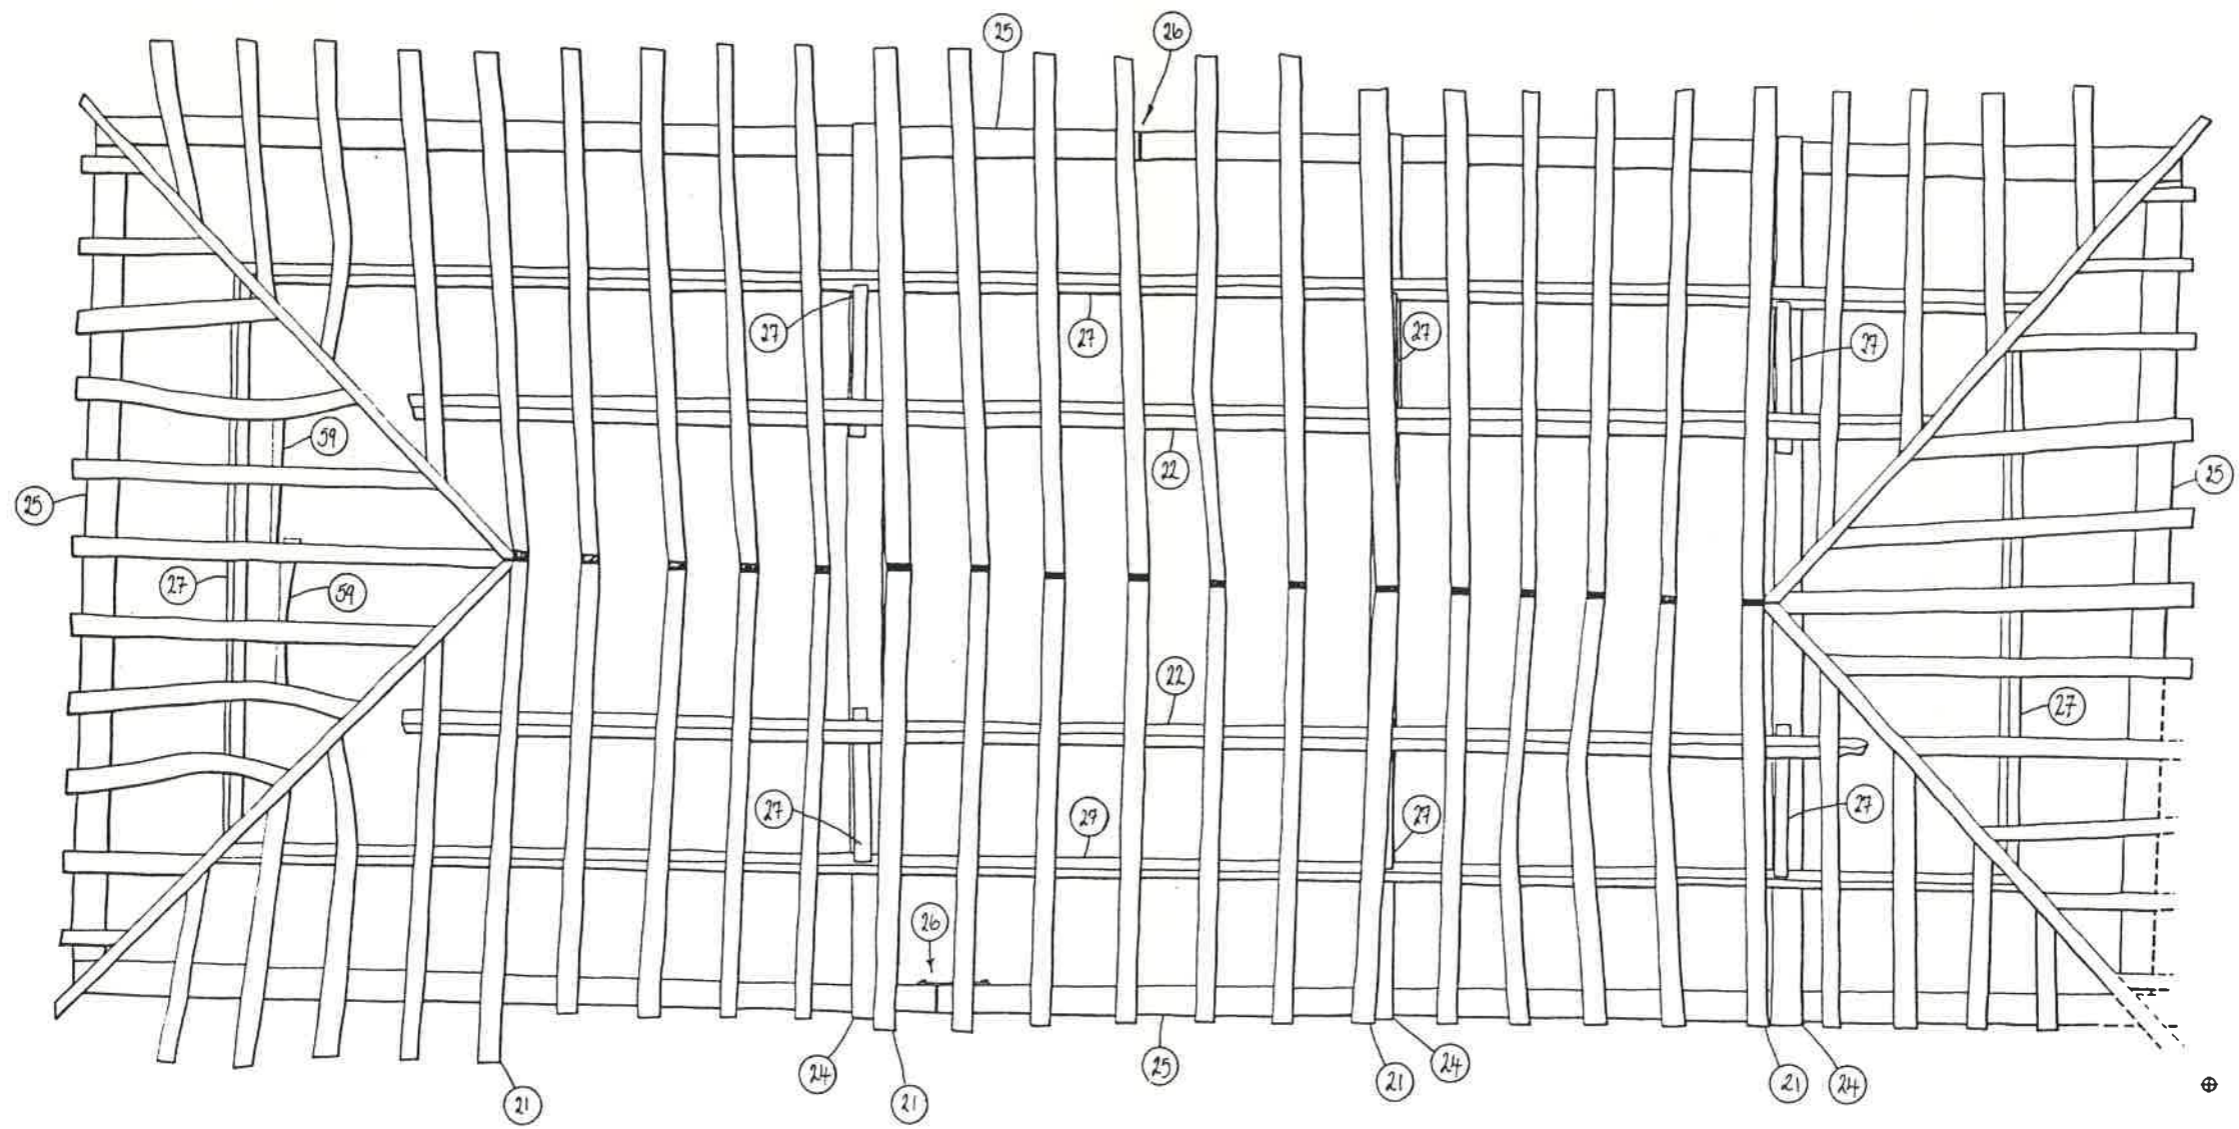
Fig. 12

**5.11 Figs. 12-3: Plan and section of roof timbers** (= 508/102/10-11)

*Roof: (features [21]-[26] belong to the original period of roofing, in rebuilding phase ?18th cent.)*

- [21] Principal rafters, diminished above collars.
- [22] Purlin, pegged to common rafters.
- [23] Collars, thin section and cambered.
- [24] Tie beams (soffit cut away on one tie only, as shown in fig. 13).
- [25] Wall-plate

- [26] Wall-plate scarf joint.
- [27] Added purlin and struts.
- [28] Iron bands on wall-plates.
- [59] Secondary struts joining irregular rafters.

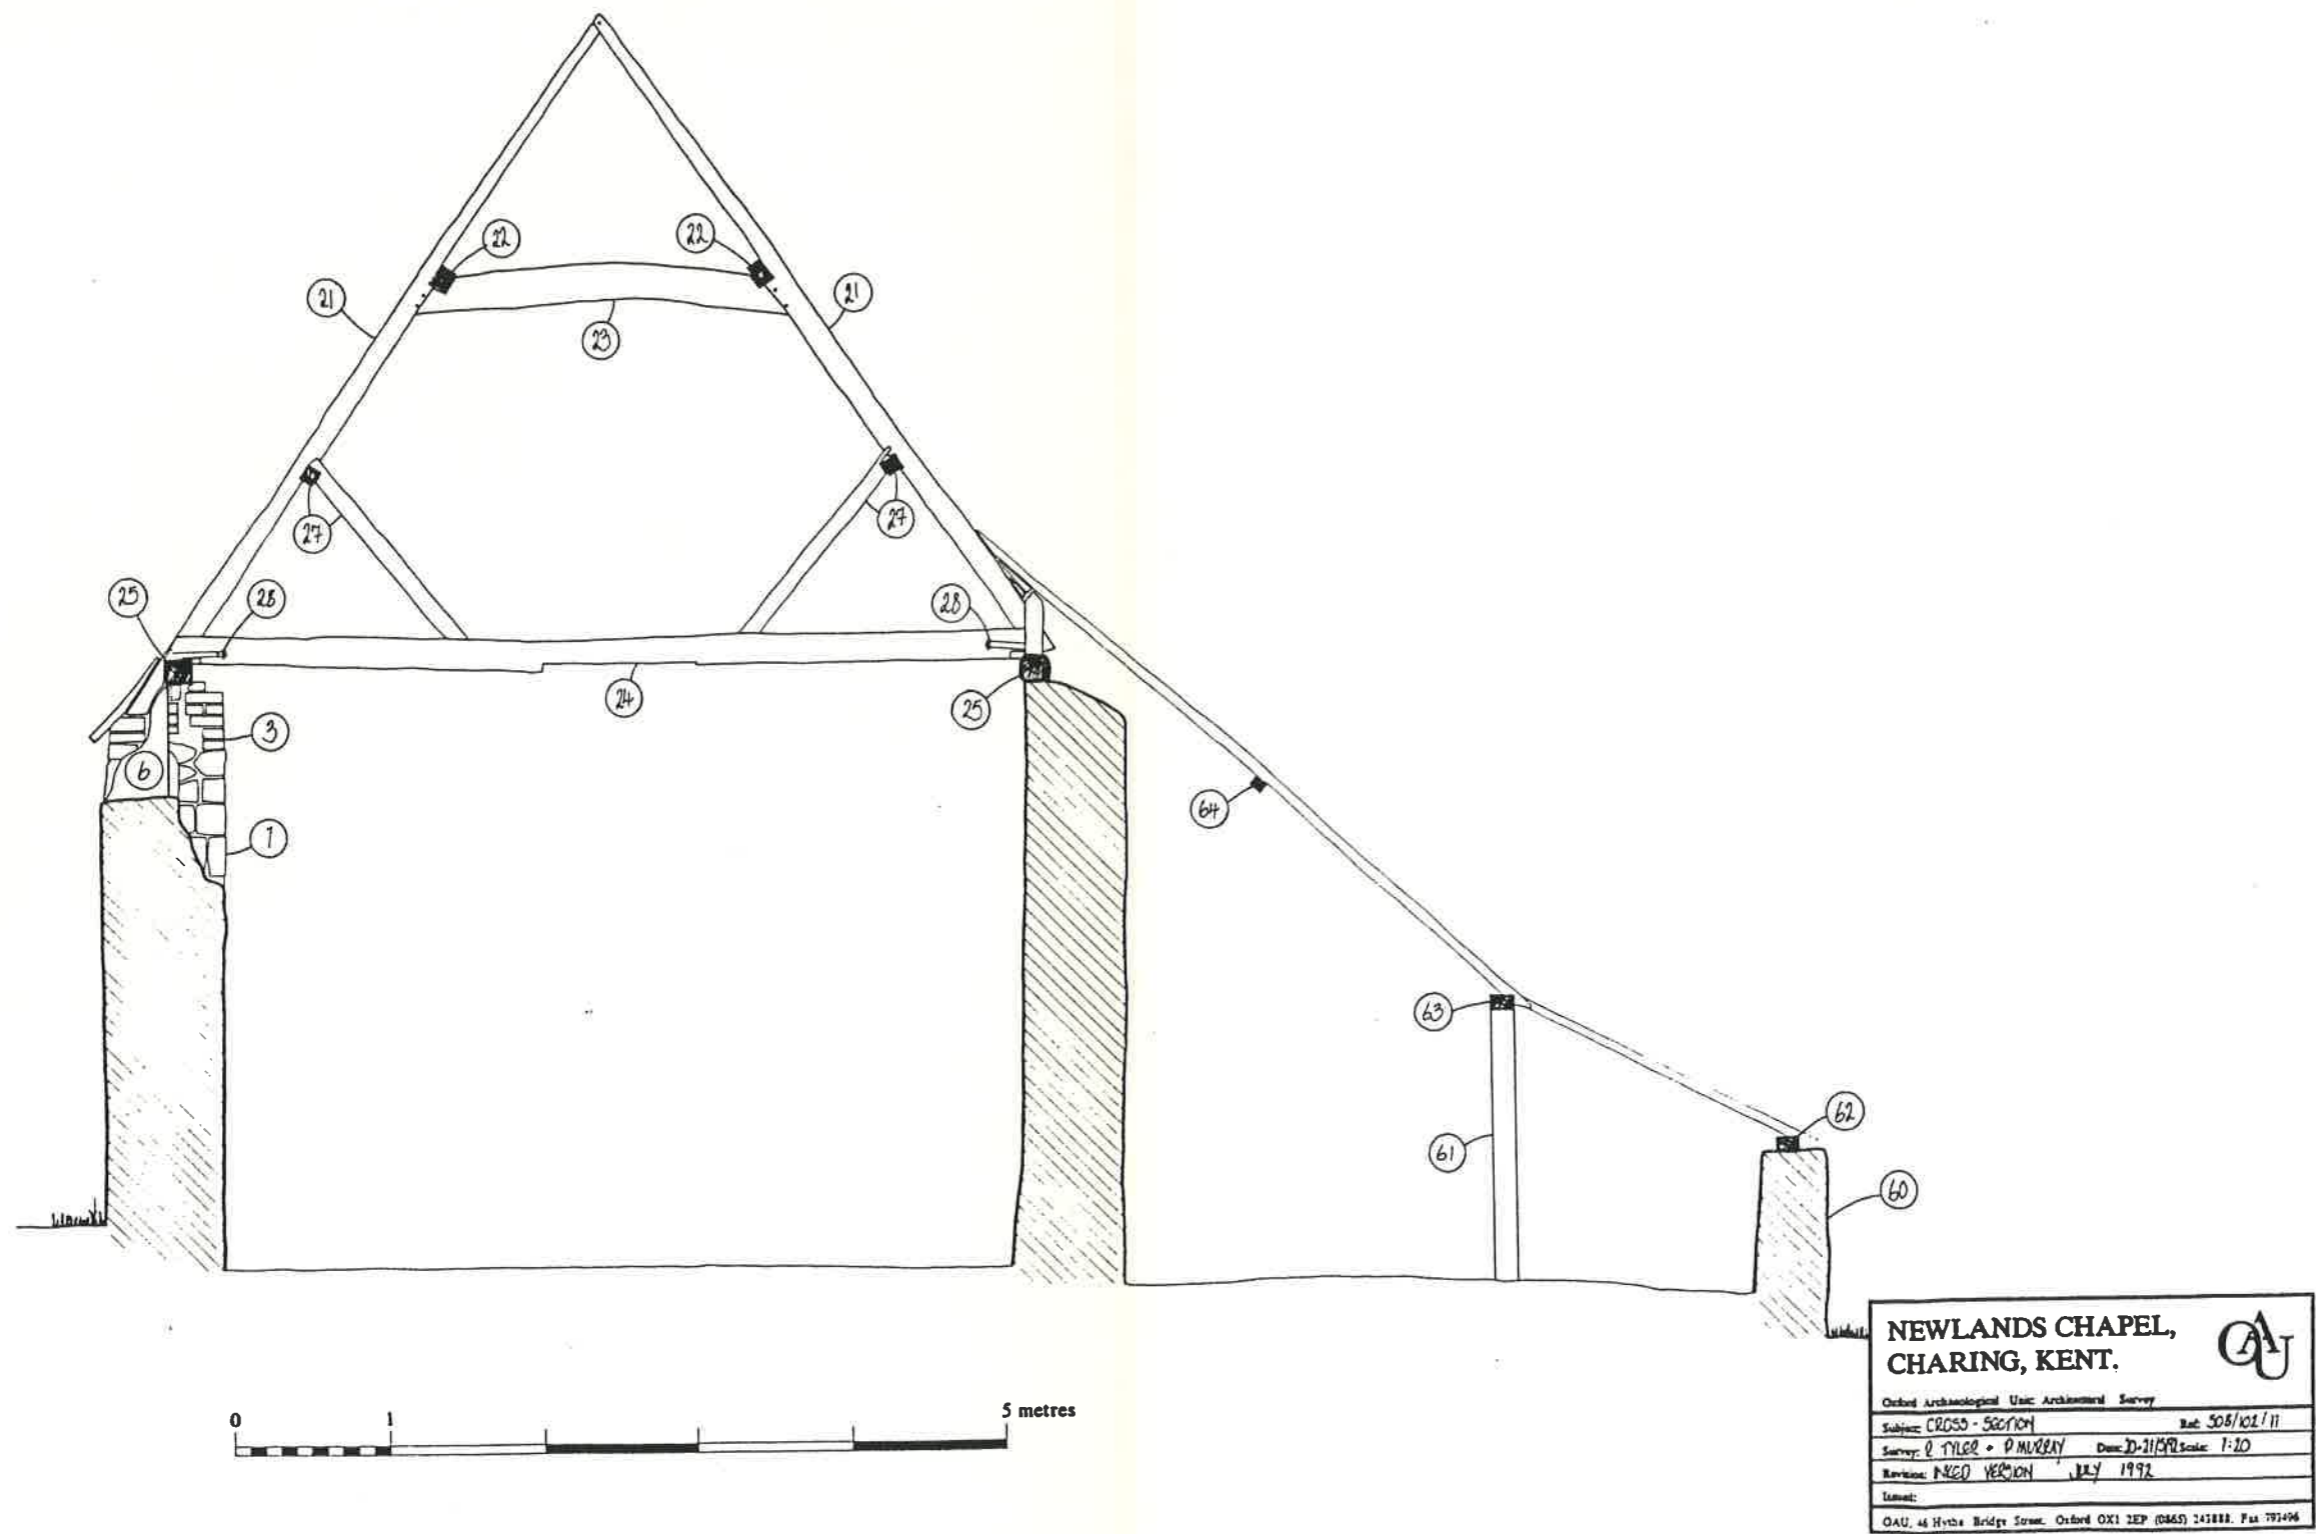
Fig. 13

5.12 **Fig. 13: Cross-section looking east** (= 508/102/11)  
*Roof of chapel as for last.*

- [60] Walls of south extension, in large rubble with brick quoins.
- [61] Timber posts supporting roof.
- [62] Wall-plate.
- [63] Plate on top of posts, tied to wall of chapel with two light tiebeams (shown only in plan).
- [64] Purlin supported by slender braces (not shown in section).
