Finsley Gate Regeneration Works, Burnley

Archaeological Watching Brief Report

November 2021

**Client: Donald Insall Associates (on behalf of
the Canal and River Trust)**

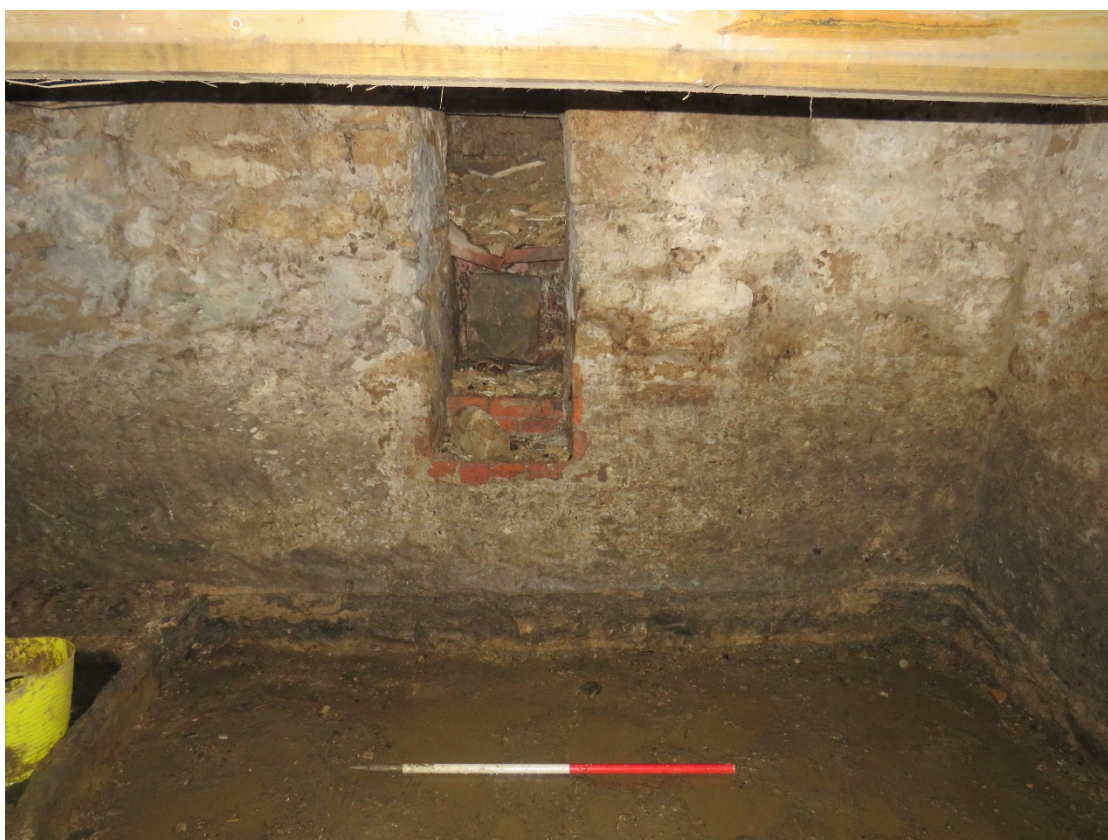
3.4.2 Excavations within Canal House Cellar (Building 1): groundworks within Building 1 (Figure 2) focused upon reduction of the floor level within the principal cellar room. This involved the excavation and reduction of ground levels by approximately 0.40m across the room (Plate 1), removing a medium grey compact sandy rubble deposit that formed the existing floor surface. This presumably had been built up post-construction of the cellar walls, potentially from the level of the original construction cut, as no further or natural deposits were observed. However, significant water ingress, requiring near constant pumping out, inhibited accurate observation. The excavations therefore only revealed a further 3-4 courses of the enclosing walls, which comprised red brick with a white lime mortar and a white lime wash over the surface. No other features or natural deposits were observed.

Plate 1. West facing cellar wall showing ground reduction within Building 1

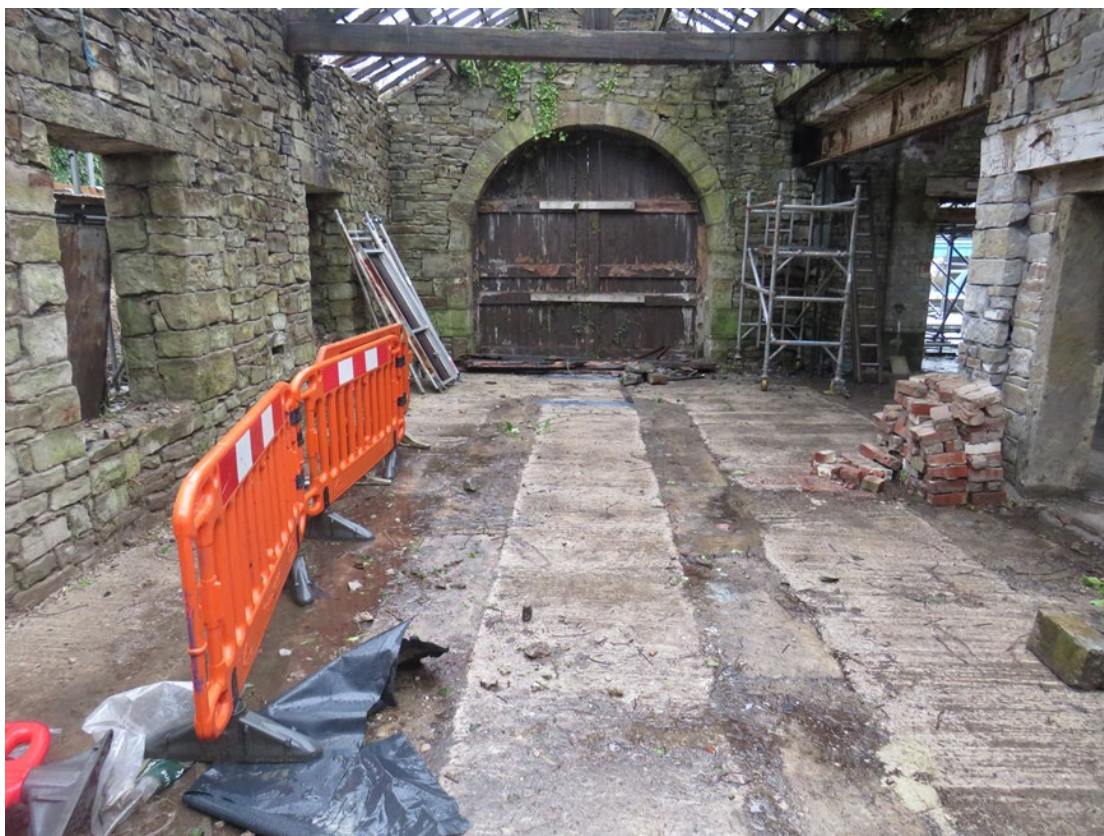
3.4.3 Excavations within the Main Warehouse (Buildings 7-9): monitored works within the main warehouse building exclusively focused upon the north/south aligned section (Building 9: Figure 2). Here a 2m wide and up to 5m long concrete deposit, extending through the center of the building, was flanked by large sandstone slabs within the floor (Plate 2).

Plate 2: The flooring within Building 9. Viewed facing north

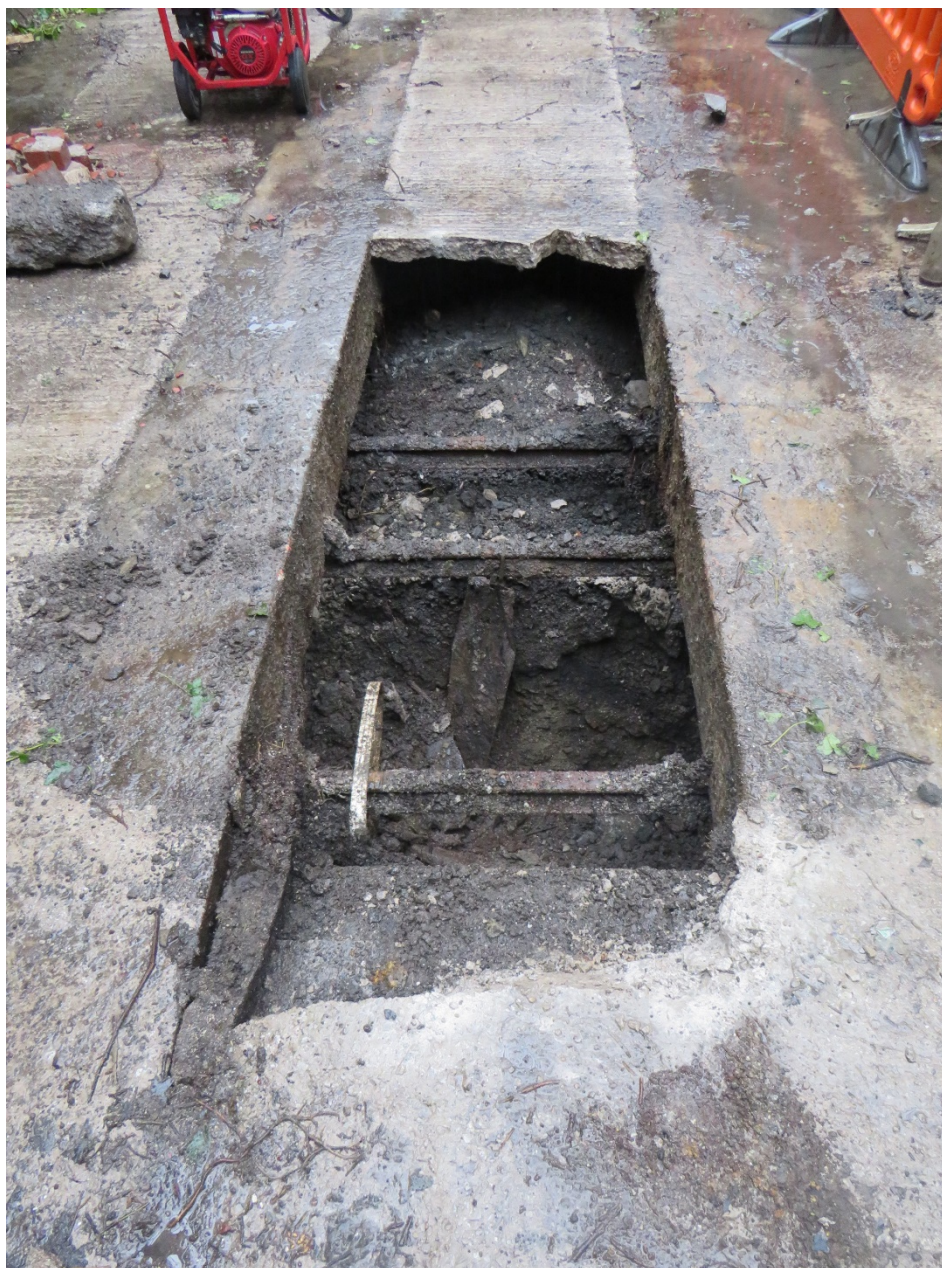
- 3.4.4 It was deemed necessary to break the concrete in this channel and explore potential depths and makeup of underlying deposits prior to and to inform development of the wider building. A slot approximately 2.5m long and 1m wide was therefore broken out, revealing a concrete layer less than 0.20m thick sealing a narrow-built channel, infilled by a loose dark grey clay soil with frequent rubble inclusions and other relatively modern detritus (Plate 3). Several iron struts also projected across the channel below the concrete capping layer and may represent a remnant of a structural feature associated with the channel. The mixed infill deposit was excavated to a depth of 1.6m, the maximum reach of the mini digger, and no base to the channel was observed, although visibility was hampered by substantial water ingress at this depth. However, the excavations did reveal a built façade to the edges of the channel, comprising large sandstone blocks. This seemed to confirm that the channel was a functional element of the building, perhaps acting as a saw pit, or some similar feature, servicing the warehouse and the wider canal hub.

Plate 3. The potential saw pit within Building 9. Viewed facing north post excavation.

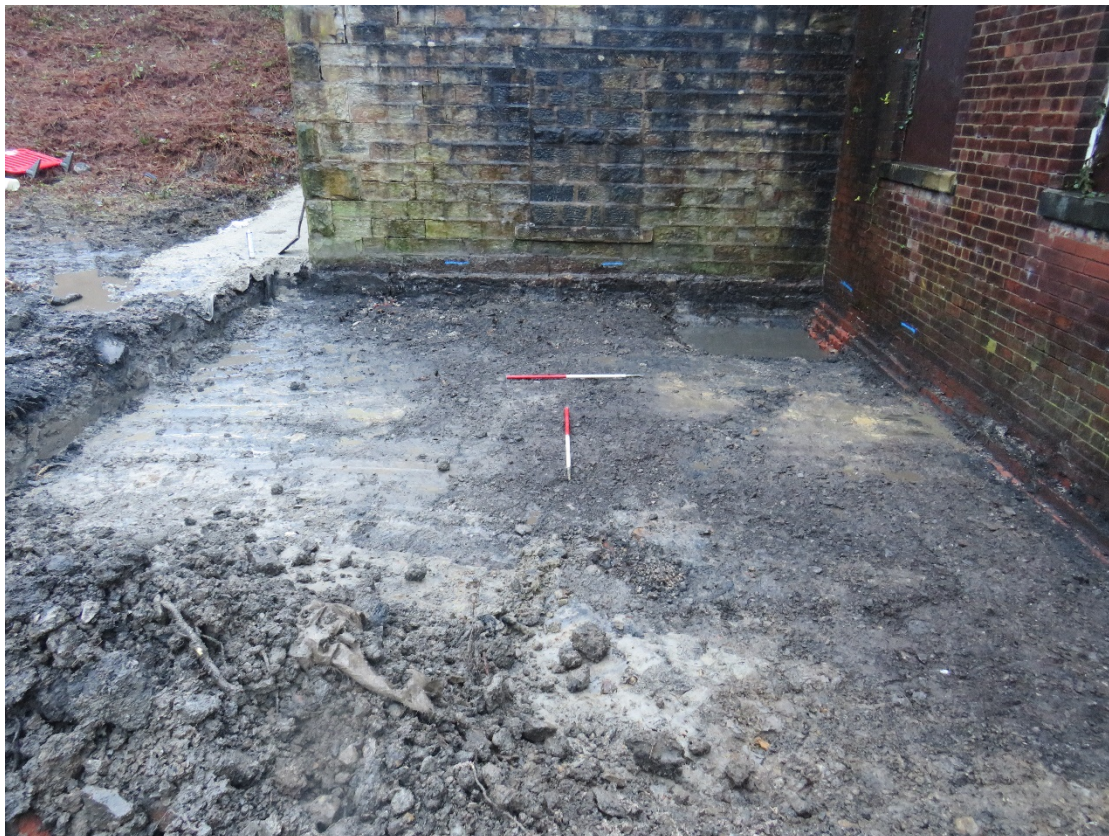
- 3.5.3 Excavations immediately to the south and rear of the warehouse removed approximately 0.30m of overburden, which consisted of a mixture of demolition materials and made ground deposits, but encountered no archaeological features save for basal courses relating to Buildings 7-9 (Plate 4).

Plate 4. Reduced ground levels to the south and rear of Buildings 7-9. Viewed facing west.

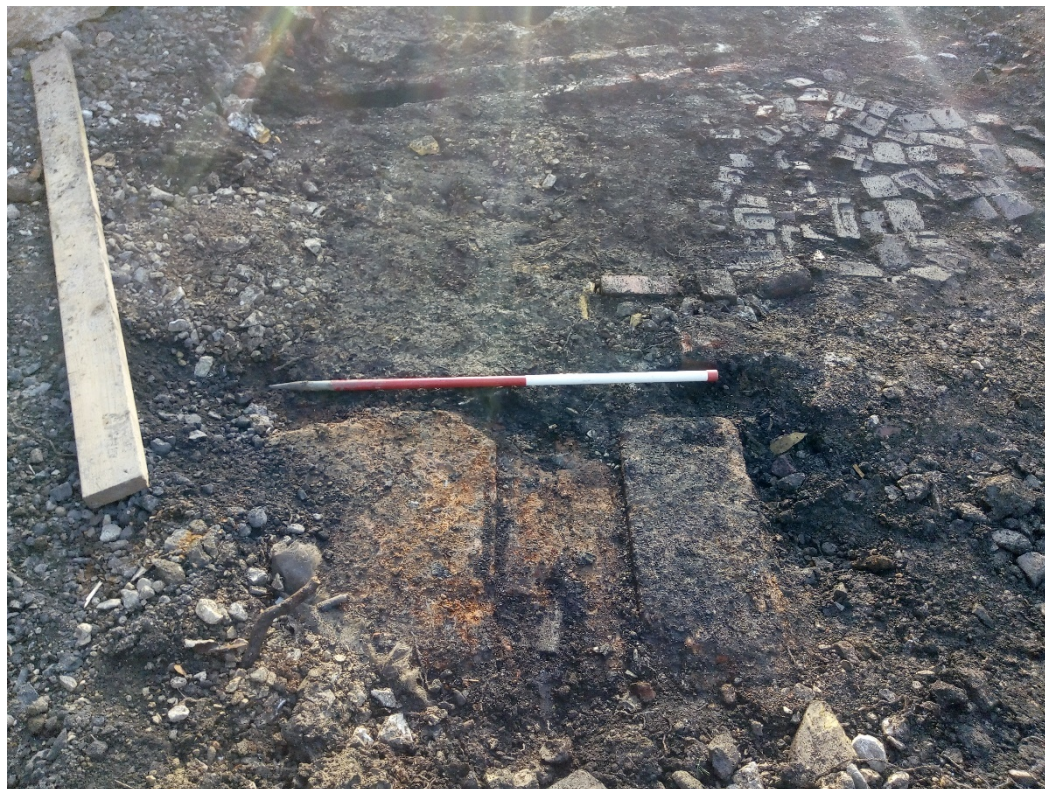
- 3.5.4 Further south and east of this area, however, a series of structural features were observed a short distance from and extending south of Building 8 (Figure 2). The first of the structural features was a short section of wall, extending from the southern wall of Building 8 (context **801**: Figure 2). This comprised a single visible course of non-frogged red brick set in two skins with a white-lime mortar and extended south for approximately 4.5m before apparently being truncated. It is unclear what this wall relates to but may have formed one or more temporary or smaller structures set against the warehouse wall, or else a division of the external yard space. Several metres to the south-west of this wall, a large sandstone block (**1012**), approximately 1.2m by 0.70m in size, appeared to be set within the ground (Plate 5). This had a smaller rectangular facet cut into one end of the block which aided in its interpretation as a machine mount or engine block. Almost immediately to the east of **1012**, two parallel lines of red brick, up to 0.20m apart, were observed to extend over 2m on a north-west/south-east axis (Plate 6). This feature probably represents the remains of a narrow culvert, forming part of the original drainage and sewer system servicing the canal hub, and probably originally had a sandstone cap, as featured elsewhere on site. It appeared to terminate before a slightly irregular surface or deposit (**1011**), of red brick and fragments, measuring approximately 1.5m

*Plate 5. Possible machine mounting block **1012**, south of Building 9. Viewed facing east with culvert **1010** in the immediate distance.*

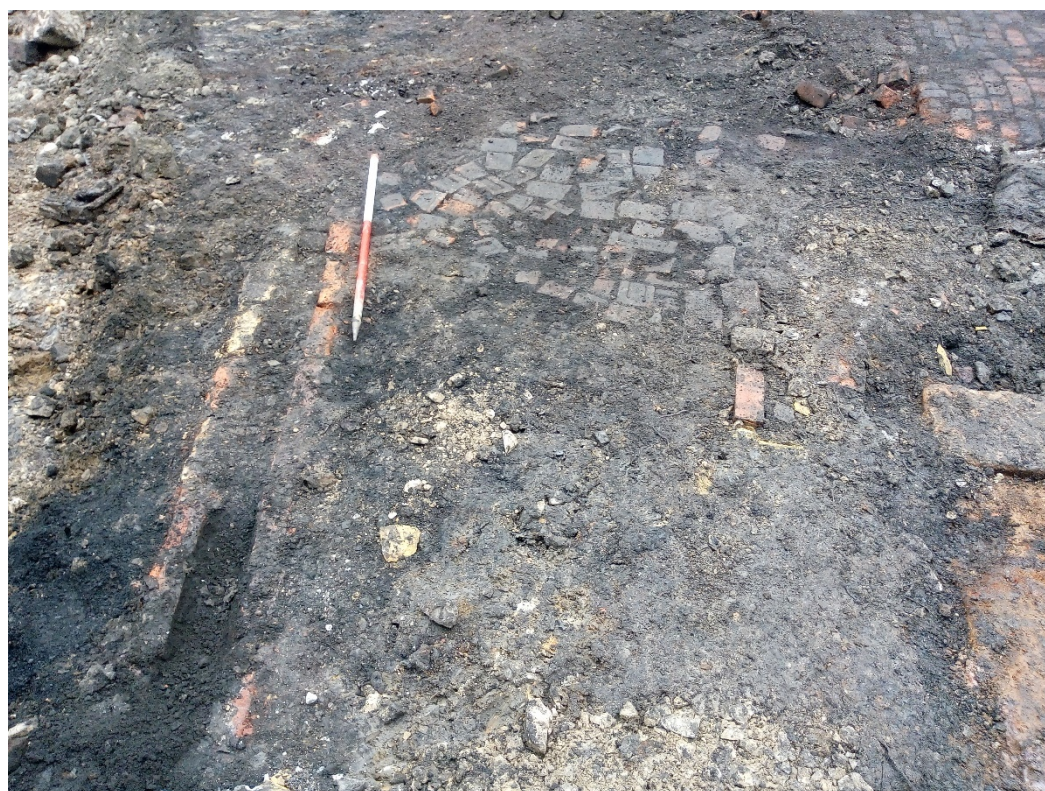
by 1.5m. It was unclear if this represented a floor surface or dump of material, given the lack of bonding material and irregular position of individual bricks (Plate 5 and 6).

*Plate 6. Culvert **1010** and red brick surface/deposit **1011**. Viewed facing south.*

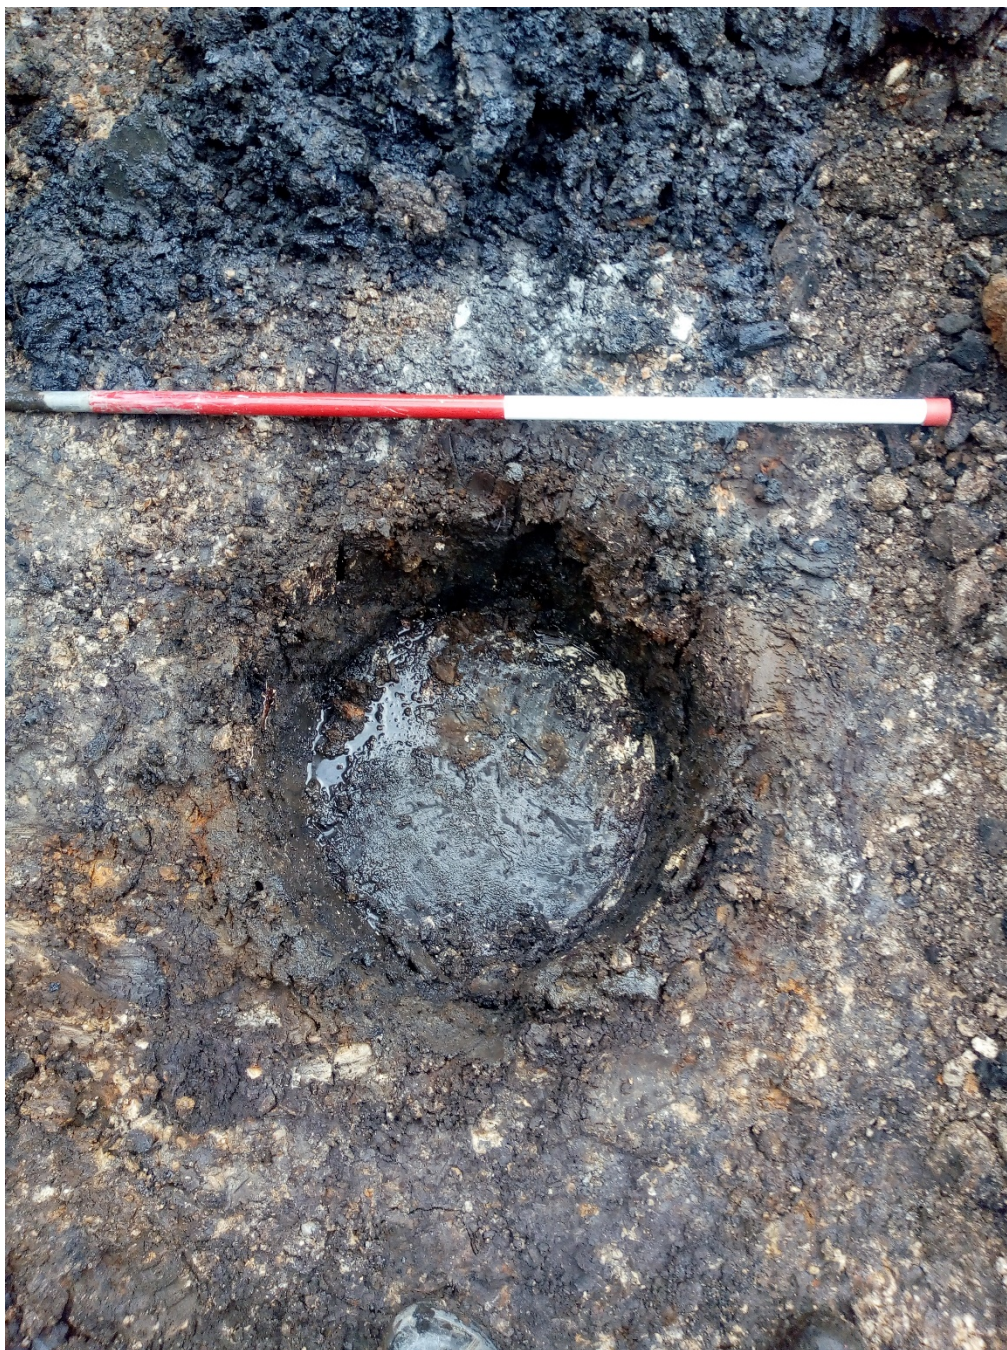
3.5.5 To the east of the northern end of culvert **1010**, the remains of a wooden barrel (**1007**) and its recipient cut (**1006**) were also identified (Plate 7). The barrel was largely devoid of a fill deposit, although the base was not observed, and, while it had clearly been placed upright within its own cut, its function was unclear. It may have acted as a small or temporary well, perhaps with a small shaft extending further, below the limits of the barrel, or else was used for storage within the canal hub yard.

Plate 7. Barrel 1007.

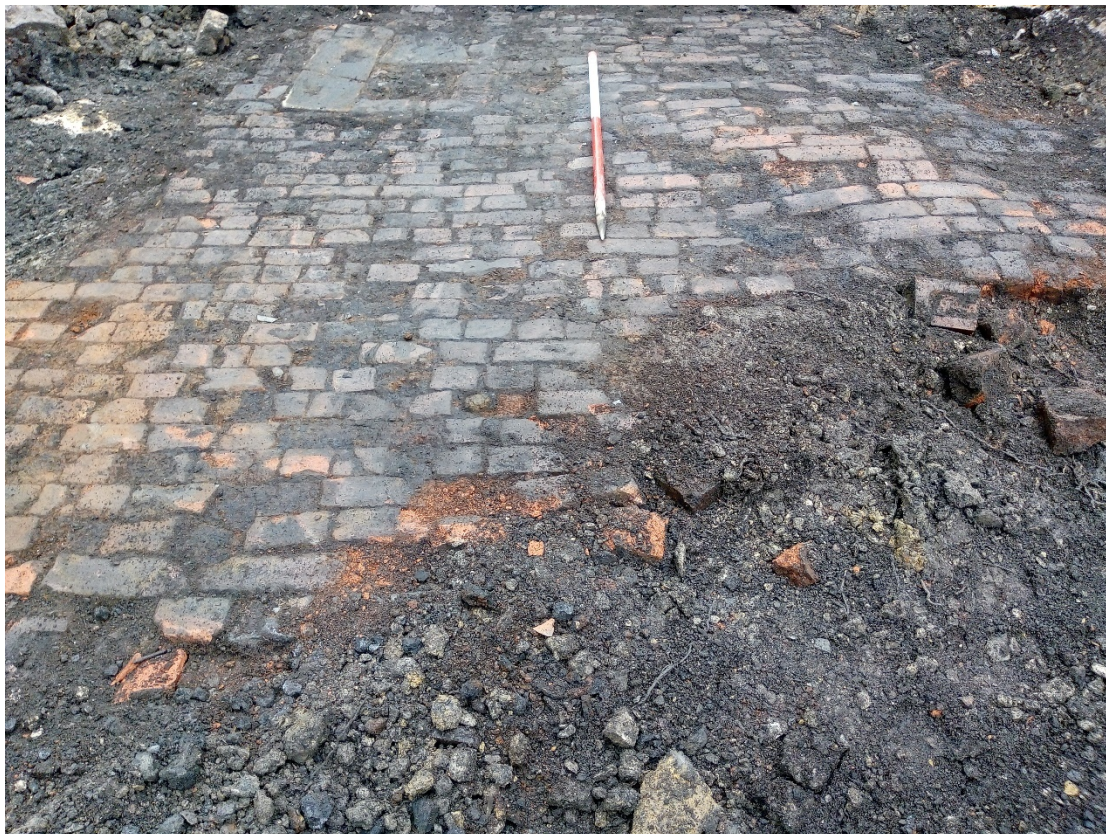
3.5.6 Immediately to the south-west of deposit **1011**, a relatively small section of what must be an external floor surface, measuring 2.9m by 2.7m extending north-south, was preserved (context **1013**: Plate 8: Figure 2). This comprised a single course of non-frogged red brick set end on end with a light grey mortar and contained a series

of sandstone blocks towards its northern extent, that defined a square recessed drain set within the floor. This appears to define a yard surface to the rear of the warehouse, that may have contained at least one working machine given the presence of the potential machine mount (**1012**) further to the north.

*Plate 8. External yard surface **1013**. Viewed facing north.*

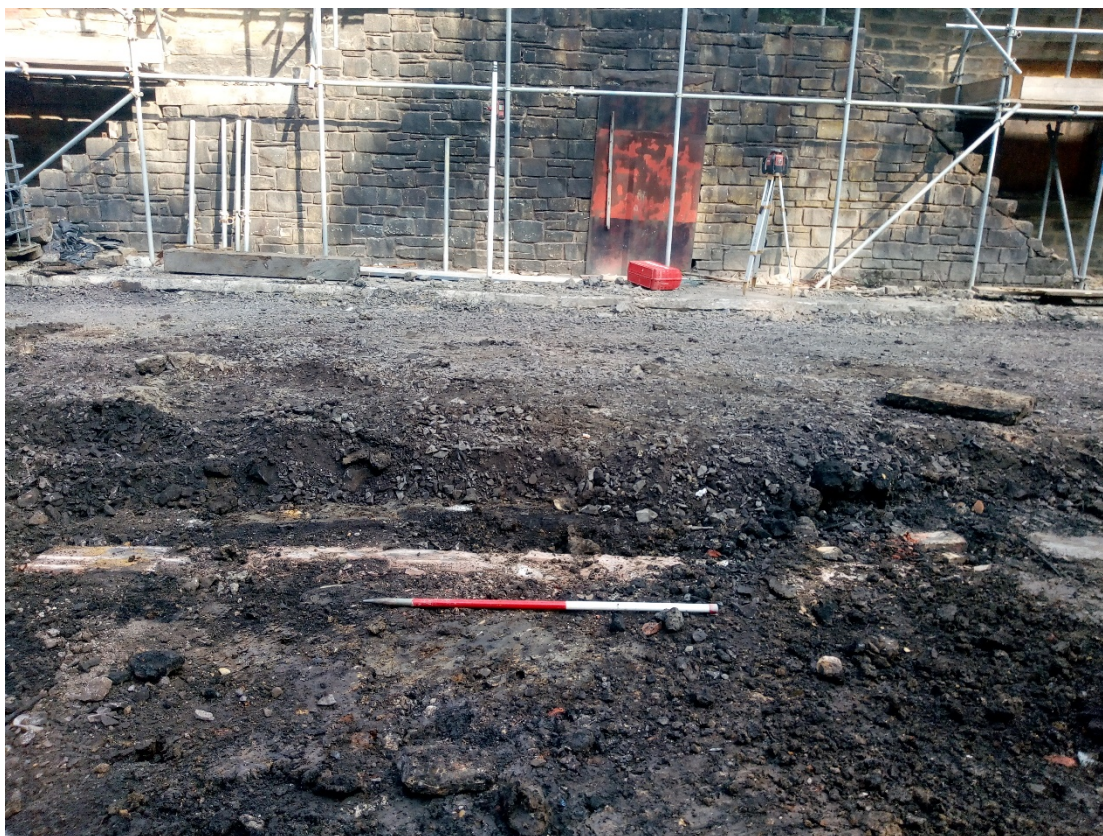
- 3.5.7 Approximately 5m further east of barrel **1007**, and 7-8m south of Building 1-9, a short L-shaped section of wall (**1015**) was exposed, running for approximately 3.5m east/west with a shorter 1m long section extending south from the eastern end. This wall comprised a single course and double skin of frogged, machine-made red brick with a sandy grey cement (Plate 9). The section of wall appears to form the north-eastern corner of a building although this does not appear to relate to any identified on the site plan (see Figure 2). Based upon the limited evidence of the materials involved in its construction this would appear to be a relatively modern addition to the canal hub complex.

*Plate 9. Wall section **1015**. Viewed facing north towards Buildings 7-9.*

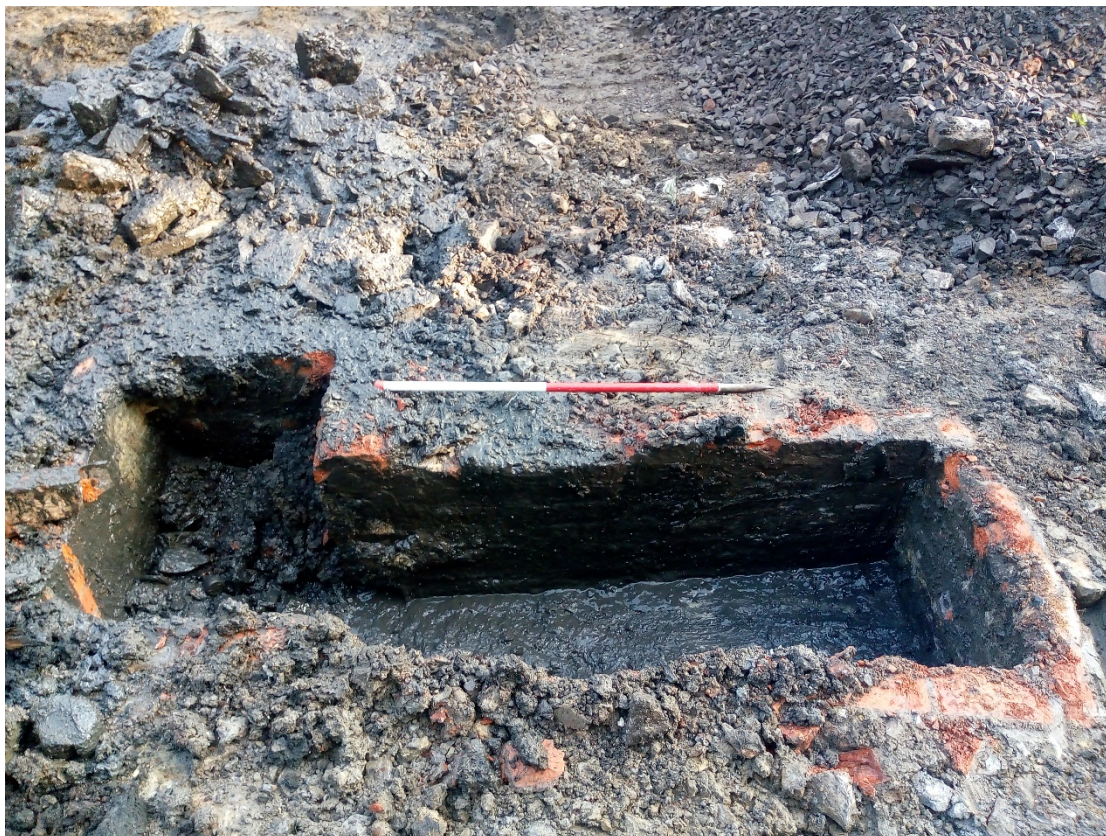
- 3.5.8 A short distance further east and to the south of wall **1015**, but west of the remains of Building 6 (*Section 3.5.8*), another feature was identified, comprising an L-shaped subterranean brick-built structure (Context **1014**: Plate 10). This extended east-west for approximately 2.6m and was up to 0.90m wide, with a short dog-leg north at its north-western corner and extended to a preserved depth of 0.70m. The structure comprised up to five or more courses of un-frogged red brick in a single skin, with a white lime mortar bonding agent, and appeared to be capped by a metal plate. The structure appeared on a similar line and may have interfaced with a culvert observed further to the east (**202**: *Section 3.5.10*), perhaps acting as an inspection and maintenance pit, although in this regard no intake channel was observed. The feature was therefore interpreted as a possible silt trap.

Plate 10. Structure **1014**. Viewed facing north.

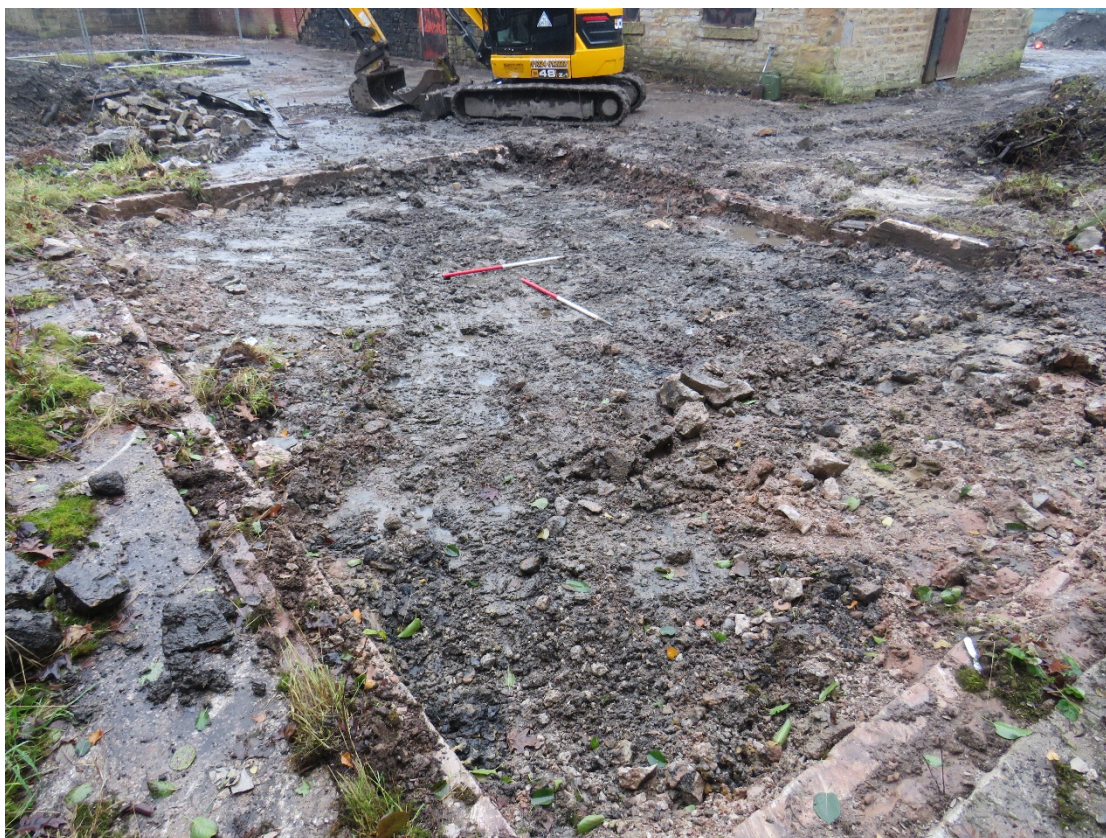
- 3.5.9 Approximately 5m to the south-east of the eastern end of Building 7 and immediately west of Building 5, shallow ground reduction works uncovered the footprint of a further building, which by its location, shape, size and orientation would appear to correlate with the former location of Building 6 (Figure 2). The entire footprint measured approximately 7.5m by 5m orientated on a slight north-west/south-east axis, and was defined by a double skin of modern, perforated red brick with elements of concrete (Context **1005**: Plate 11). No floor surface or other internal features were observed. The building appears to be a much later addition to the canal hub complex, being constructed in modern materials that contrast markedly from those used in the construction of the original remaining post-medieval buildings, such as the forge (Building 5) and warehouse (Buildings 7-9).

Plate 11. The probable footprint of Building 6, Context **1005**. Viewed facing north-west.

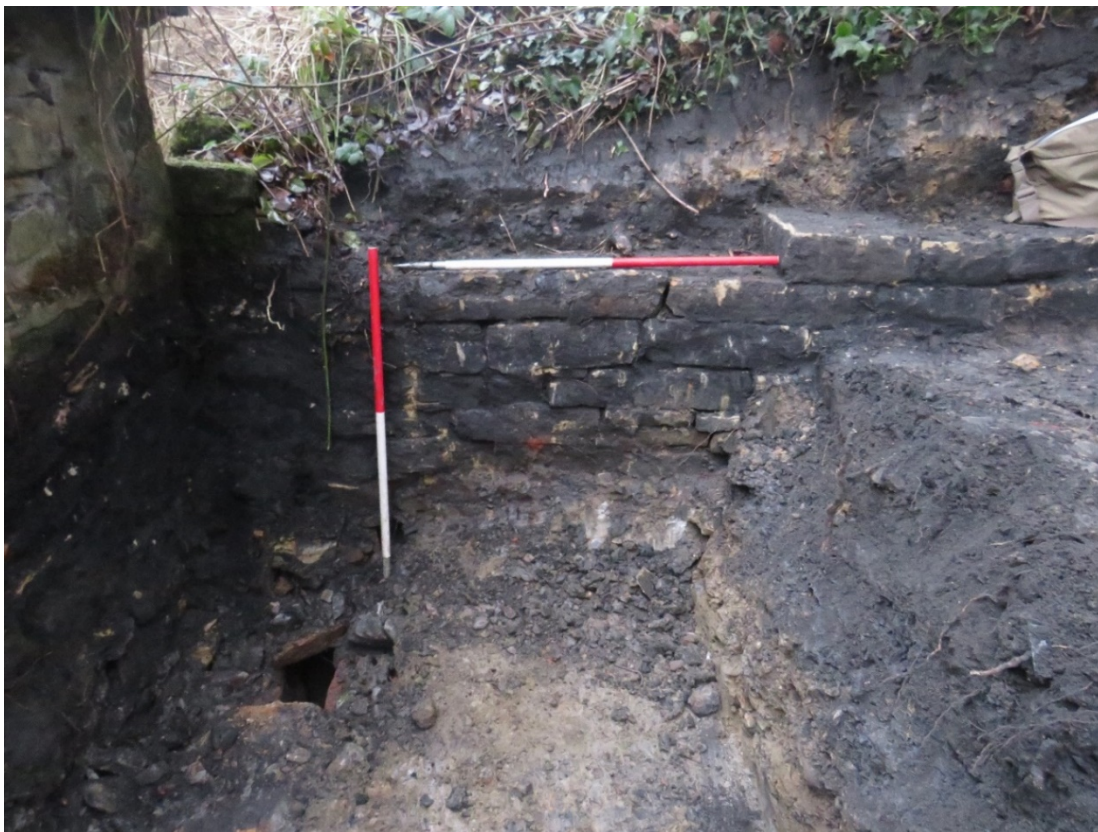
3.5.11 Further and more substantive ground reduction works immediately to the south and rear of the forge (Building 5: Figure 2), also revealed several further features, which appear to relate to construction of the original canal hub complex. Here excavations removed up to 1m of overburden and revealed a retaining wall (**201**) extending from the south-eastern corner of the forge, and comprising up to eight courses of roughly-faced, large, sandstone blocks set in a drystone format (Plate 12). This extended south for approximately 3.6m and then beyond the limit of excavation, although it is likely to be the same retaining wall as identified further west as **1009** (Section 3.5.10). Further to the east of the forge additional elements of this retaining wall had remained exposed and were clearly observed forming external partitions of the canal hub space around Buildings 3 (Plate 13). This external wall continued to form further external space associated with Building 1, as featured in Figure 2, where the wall was preserved to a height of 1.2m and comprised up to 10 courses capped by a further course of rough sandstone blocks set side by side (Plate 14). This wall was retained *in situ*.

Plate 12. Retaining wall 201 to rear of the forge, and culvert 202 partially exposed

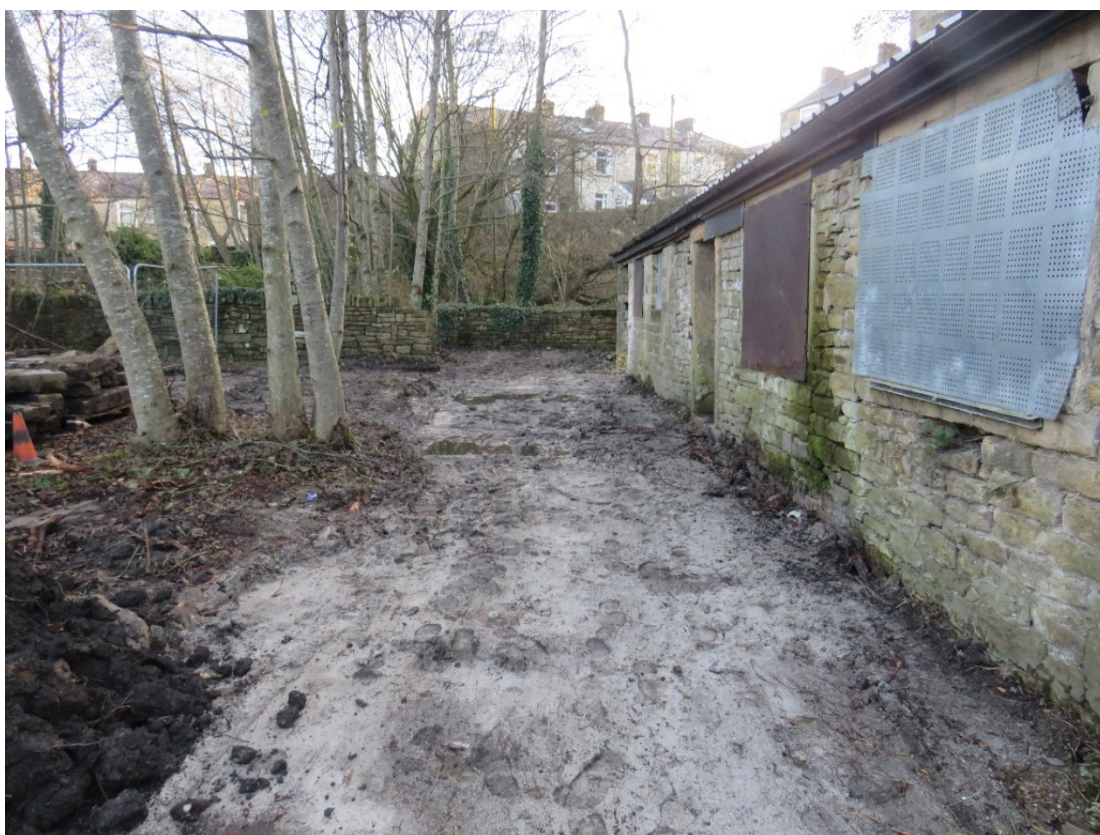
Plate 13. Further elements of retaining wall 202, west of the forge.

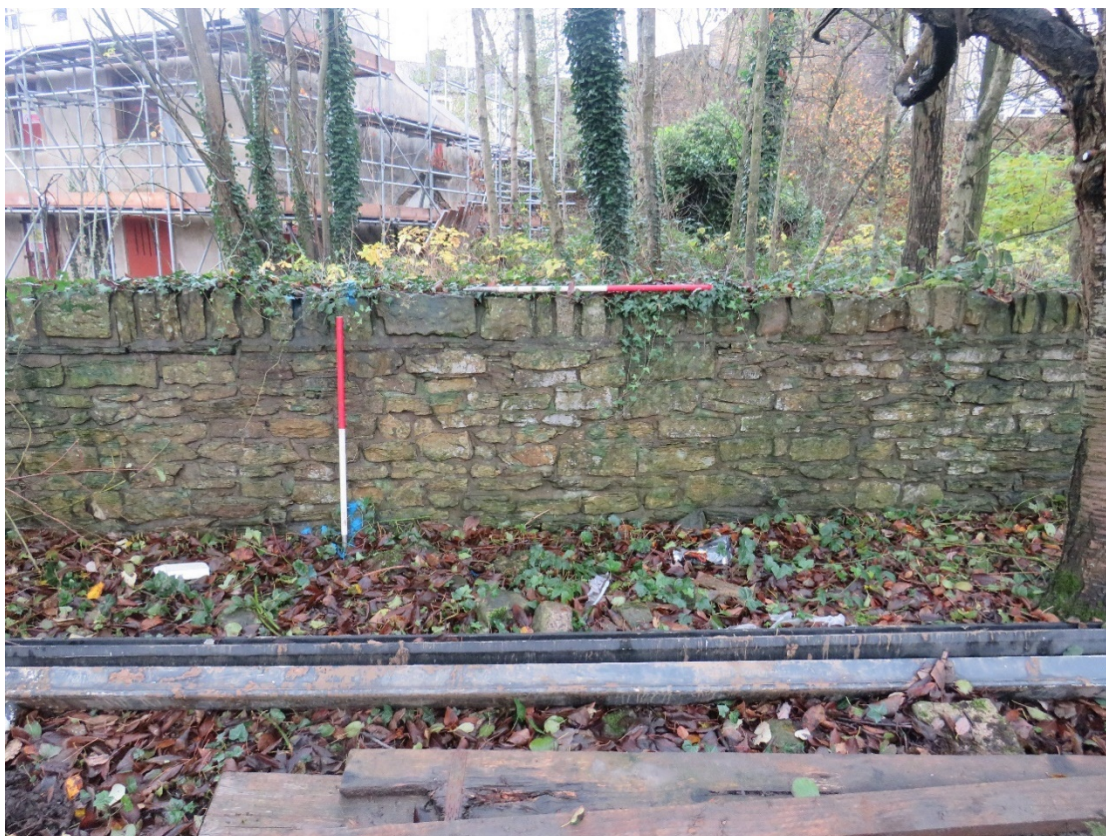
*Plate 14. Continuation of retaining wall **202** north-east of the forge (Building 5), forming an external wall associated with Building 1 (distance).*

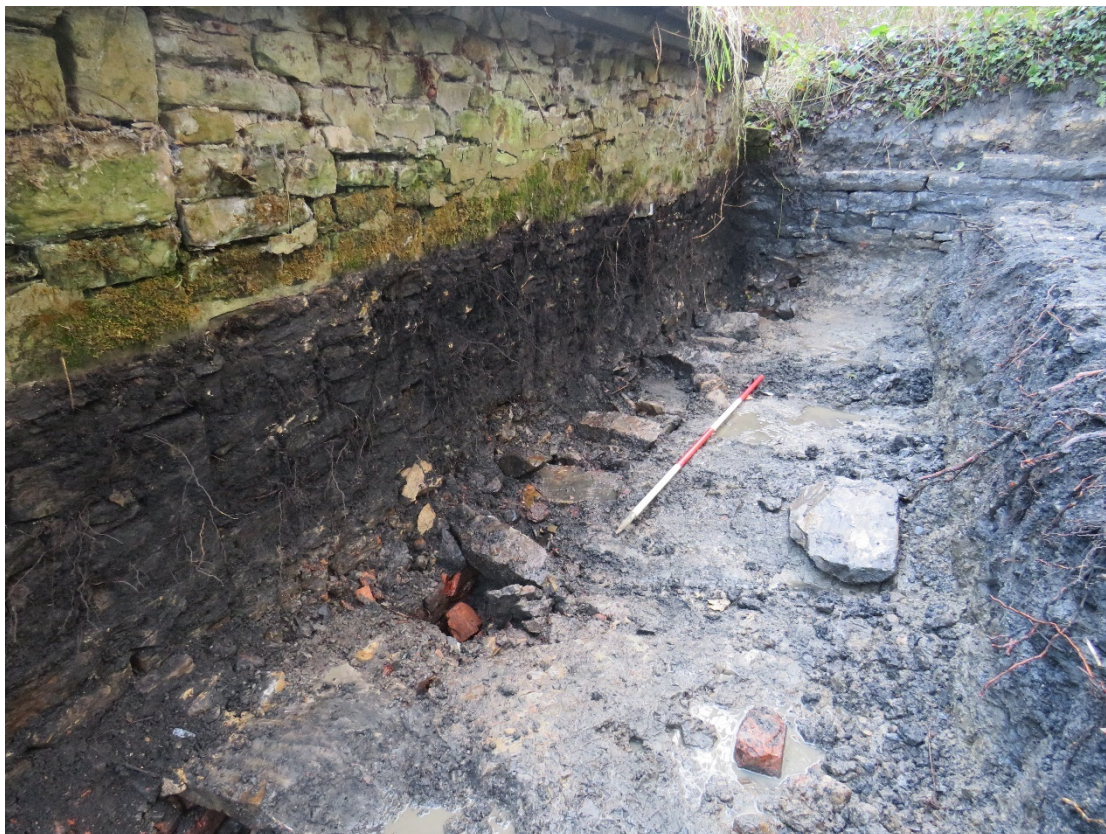
- 3.5.12 Below retaining wall **201**, a red-brick and sandstone block capped culvert (**202**), was also observed (Plate 12 and 15). This ran east-west, parallel to and at the base of the southern wall to the forge and was observed to extend for the entire length of the building before passing beyond the limit of excavation. It comprised a narrow channel, less than 0.20m wide, created by two parallel rows of unfrogged red brick, set end on end and bonded with a white lime mortar, capped by a line of roughly-faced sandstone slabs. The channel was partially infilled and therefore no base was observed, but it is presumed also comprised a single line of sandstone slabs. The culvert obviously relates to a drainage system created when the canal hub complex was first developed.

Plate 15. Culvert **202** exposed at the base of the southern wall of the forge (Building 5). Viewed facing east towards wall **201**.

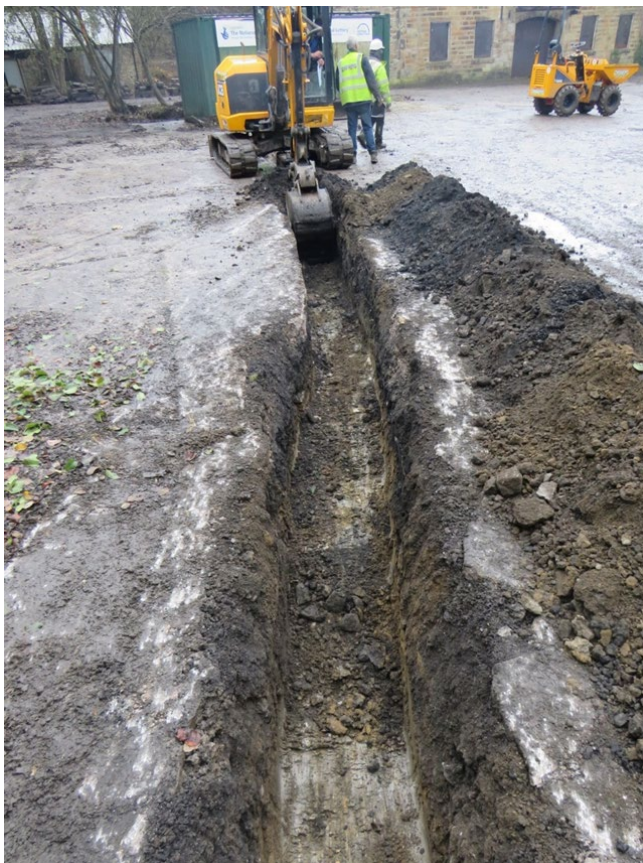
Plate 16. Excavation of a service trench from the site entrance towards Buildings 7-9.

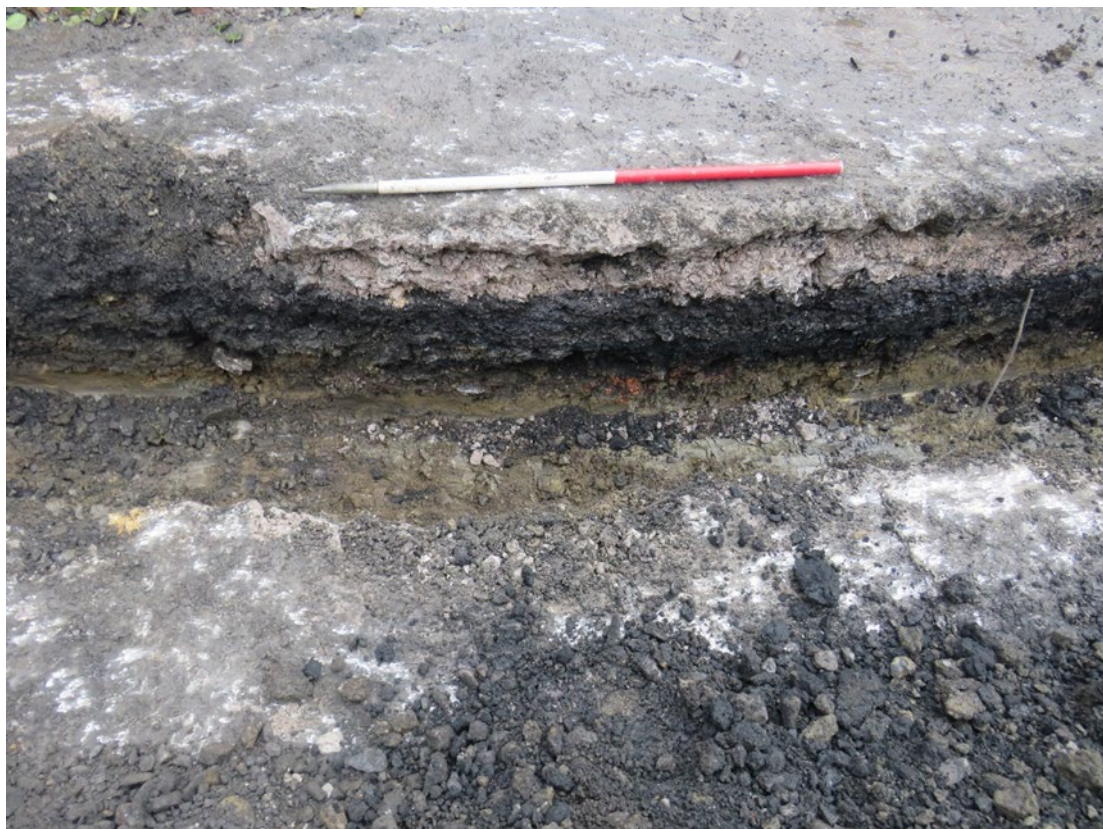
Plate 17. West facing section of the north-south aligned service trench, showing composition of modern surface deposits.

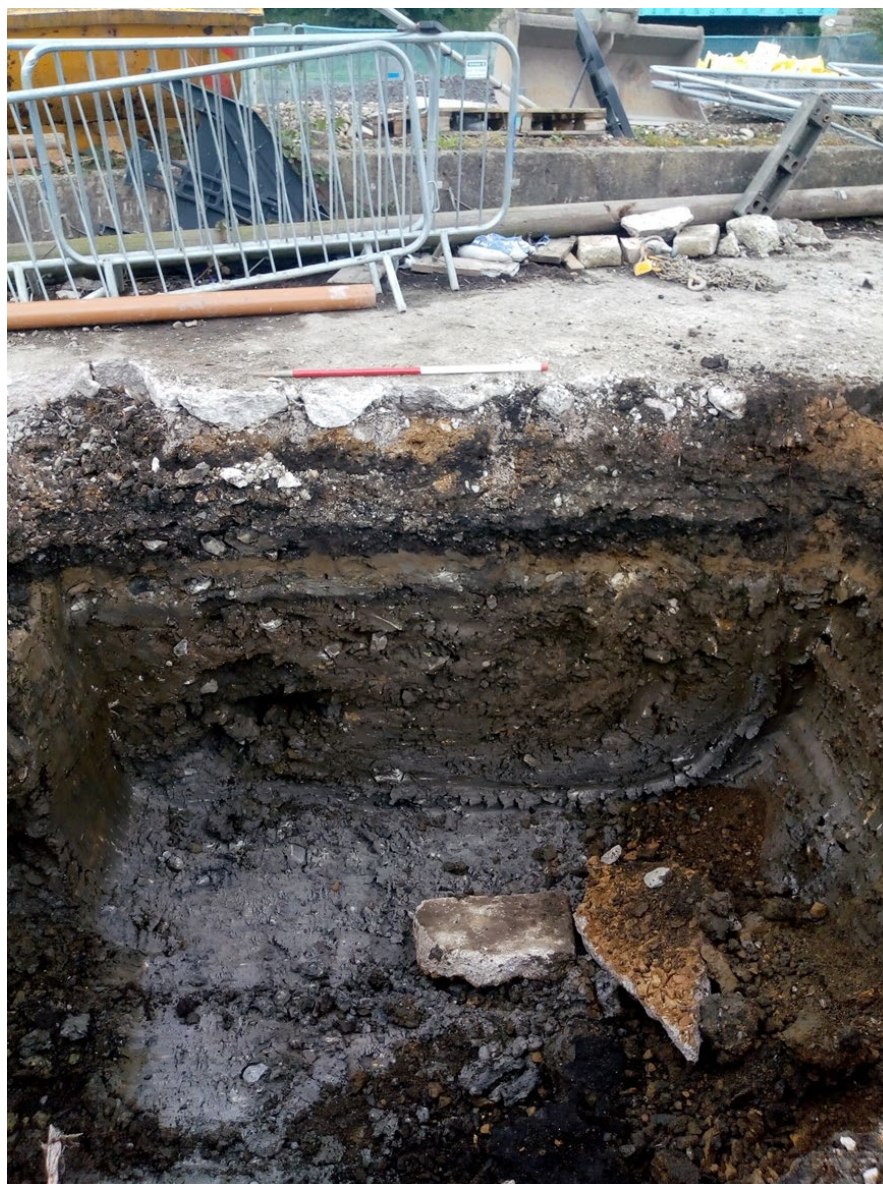
Plate 18. General shot of manhole 2 within the newly excavated service trench to the north of Buildings 7-9, showing general soil matrix encountered. Viewed facing east.

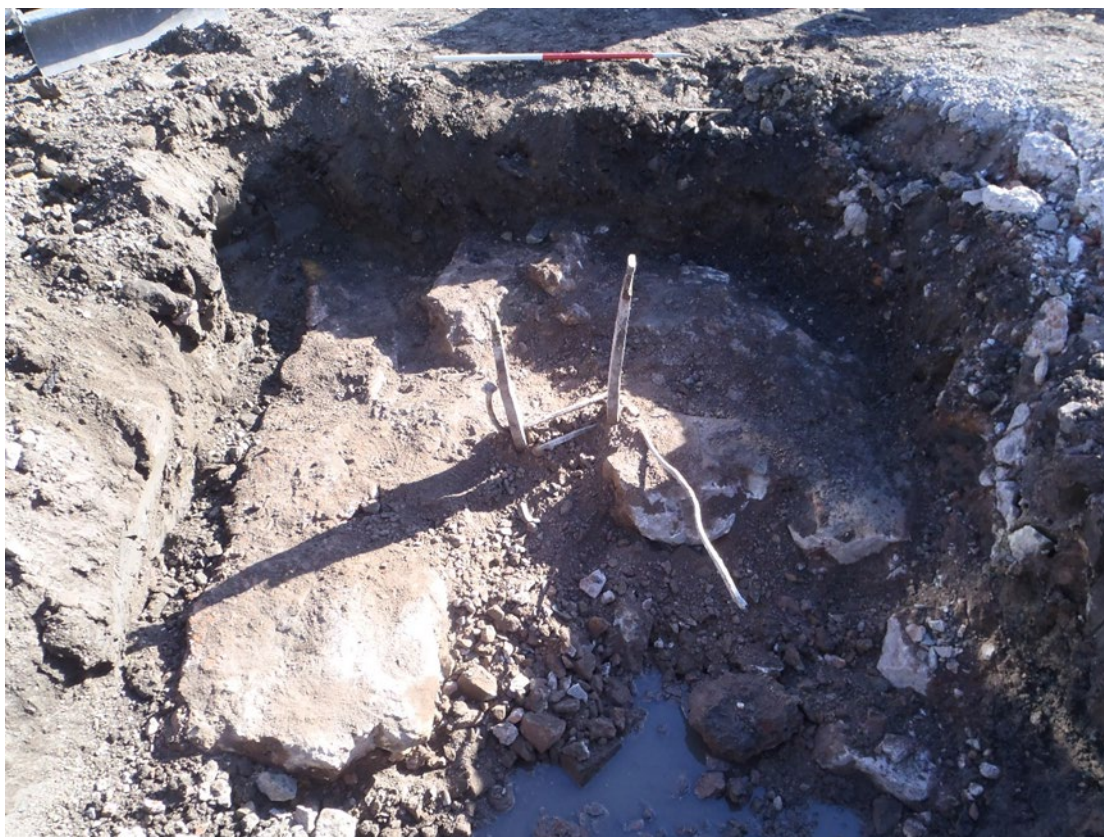
- 3.5.15 Towards the western extent of the area, near the canal edge, excavation of a service trench and attenuation tank revealed a number of features, among which was a large structure, measuring approximately 3m by 2m, seemingly comprising a concrete and rubble construction (Figure 2: Plate 19). This feature had two recesses towards the centre, with the remains of metal struts still in place and projecting upwards. The structure and the metallic elements were interpreted as the remains of a potential crane base or other machinery, potential for unloading canal cargo or lifting of the canal boats themselves, for repair and fitting.

Plate 19. The potential crane base and remains of a crane identified within a service trench near the canal edge.

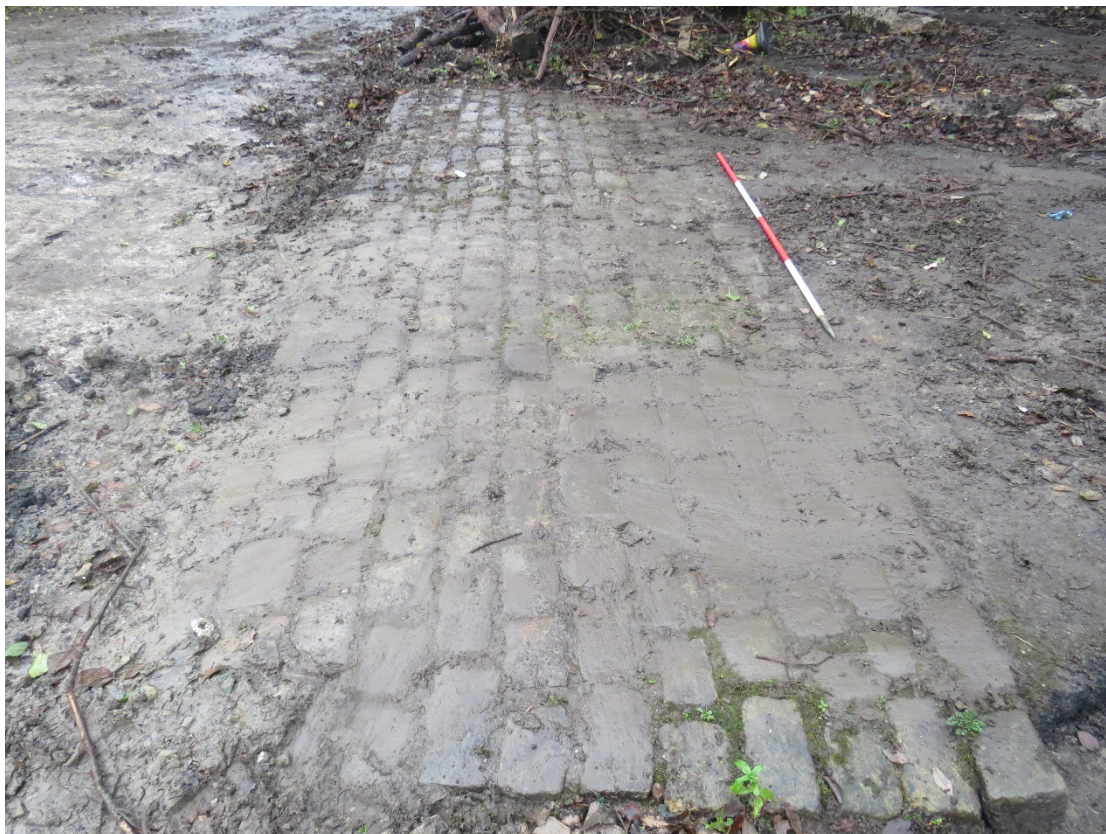
- 3.5.17 In addition to the modern surfaces described above (*Section 3.5.14*), part of what is presumed to be the original external floor surface of the wharf yard was also exposed (**103**). This comprised an area measuring approximately 5m by 2m to the north-east of Building 7-9, in which a section of a cobbled surface was evident (Plate 20). This surface comprised well-dressed, rectangular sandstone blocks, approximately 0.20m in size, laid in a single course, with no visible bonding agent. While the area of cobbles was not observed elsewhere on site, it is probable that the yard surface in this area was originally formed in such a manner and has since been removed and replaced on a piecemeal basis across the site.

Plate 20. Area of cobbled surface (103) exposed to the north-east of Buildings 7-9. Viewed facing east.
