Finsley Gate Regeneration Works, Burnley

Archaeological Watching Brief Report

November 2021

**Client: Donald Insall Associates (on behalf of
the Canal and River Trust)**

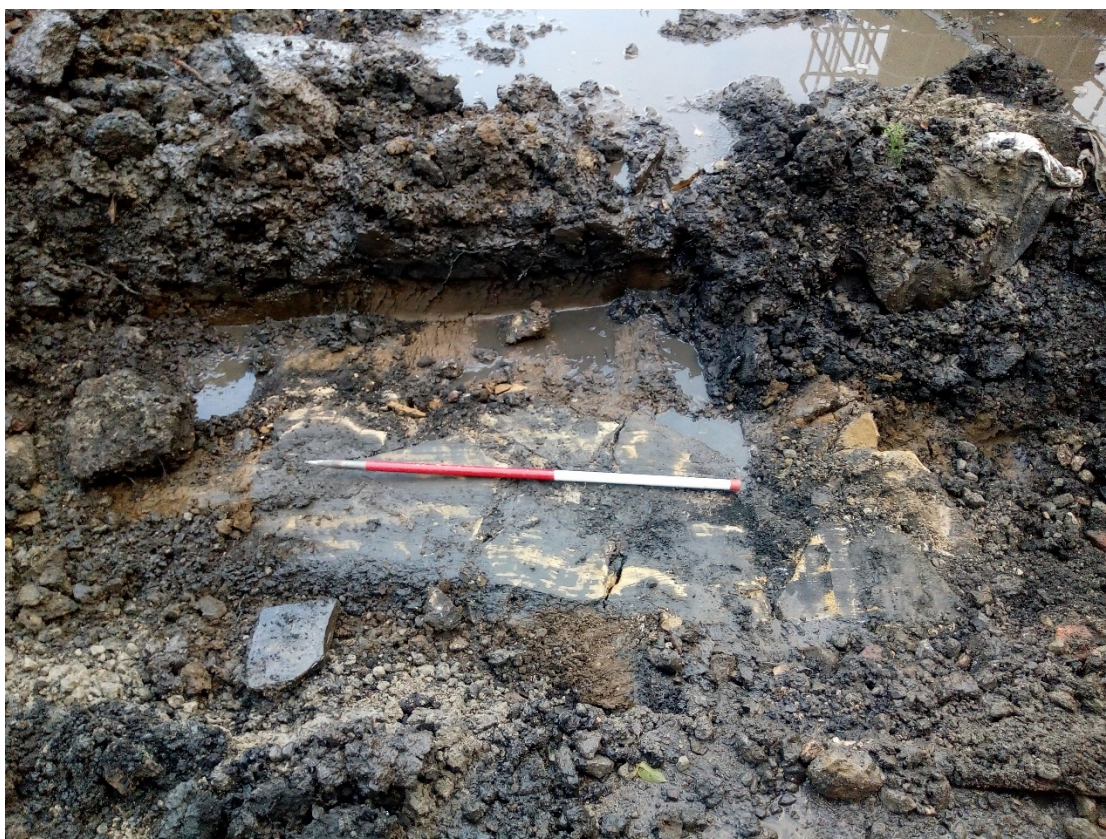
- 3.5.18 Further to the south and east of this cobbled surface (Figure 2), excavation of service trenching identified further examples of red brick and stone slab-capped culverts, forming additional elements of the original drainage systems associated with the wharf. In addition, a potential concrete base was identified close to a section of the retaining wall creating yard space around Building 3. It is unclear what this potentially late addition to the area represents. Further to the east of this again, within the external yard space associated with Building 1, a stone slab floor surface was also identified (Context **1018**: Figure 2). This surface was relatively limited in extent, measuring only 1.5m by 0.80m (Plate 21), and was laid over a deposit of made ground. Given the limitations of the feature it is unclear how this may have functioned, although it likely acted as a path providing access to Building 1.

Plate 21. Sandstone slab surface 1018 located near Building 1.

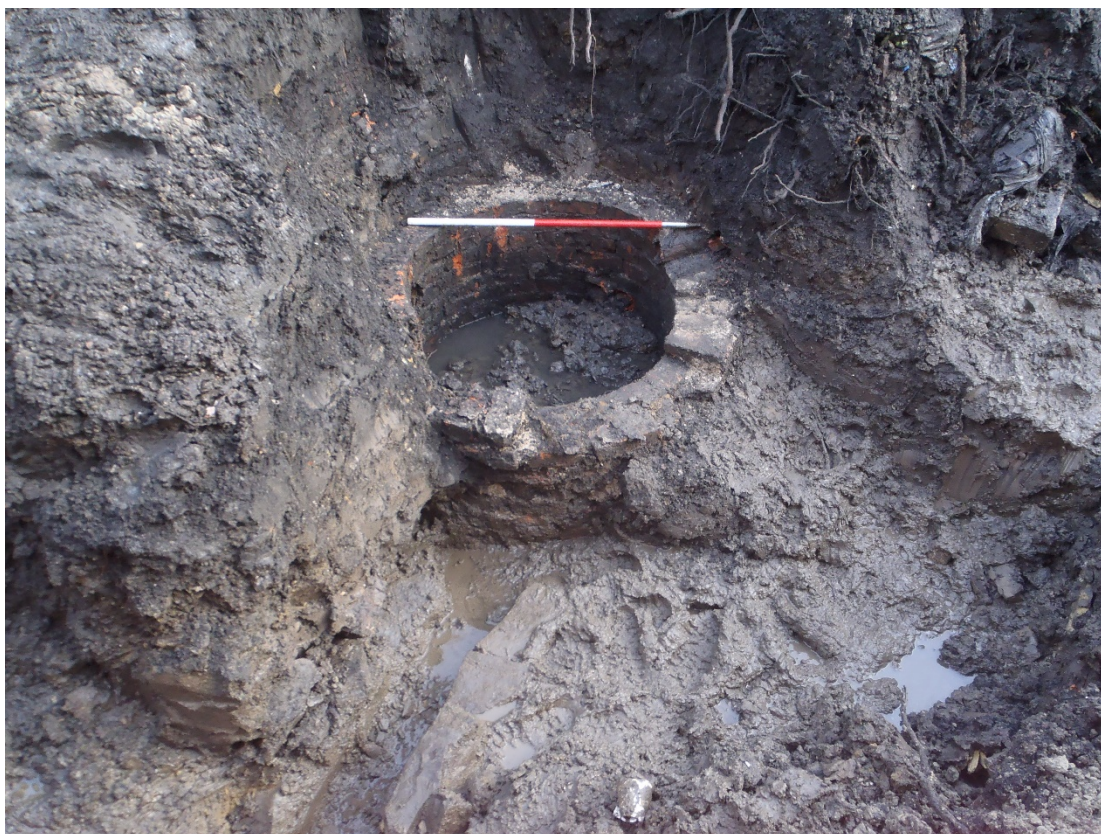
3.5.19 A further and final series of features, again probably associated with original drainage facilities were also identified within a service trench excavated to the east of the site, to the immediate rear and south-east of Building 1. Here the remains of a red brick-built and stone-capped culvert (**901**: Plate 22) were observed to extend for approximately 1.6m from the southern wall of Building 1 on a south-east/north-west axis. At its southern extent the culvert appeared to be truncated by a circular brick-built feature (**900**), with no evidence that the culvert emptied into the structure. The circular structure measured approximately 1.5m in diameter and comprised a single skin of un-frogged red brick preserved in at least five courses and bonded with a white lime mortar. In several places a number of smaller circular apertures were observed within the internal elevation of the structure, suggesting a number of drainage pipes emptied into the feature. While the structure was originally interpreted as a possible well, and it may well represent a repurposed well, the presence of the apertures draining into the feature would suggest that it later formed part of the drainage system associated with the canal hub, perhaps also providing an inspection point.

Plate 22. Structure **900** and culvert **901**. Viewed facing south-east.
