# Stonor Park, Oxfordshire.

Watching Brief during Construction Work  
October - November 1994

Oxford Archaeological Unit  
December 1994

(NGR: SU 7425 8923)

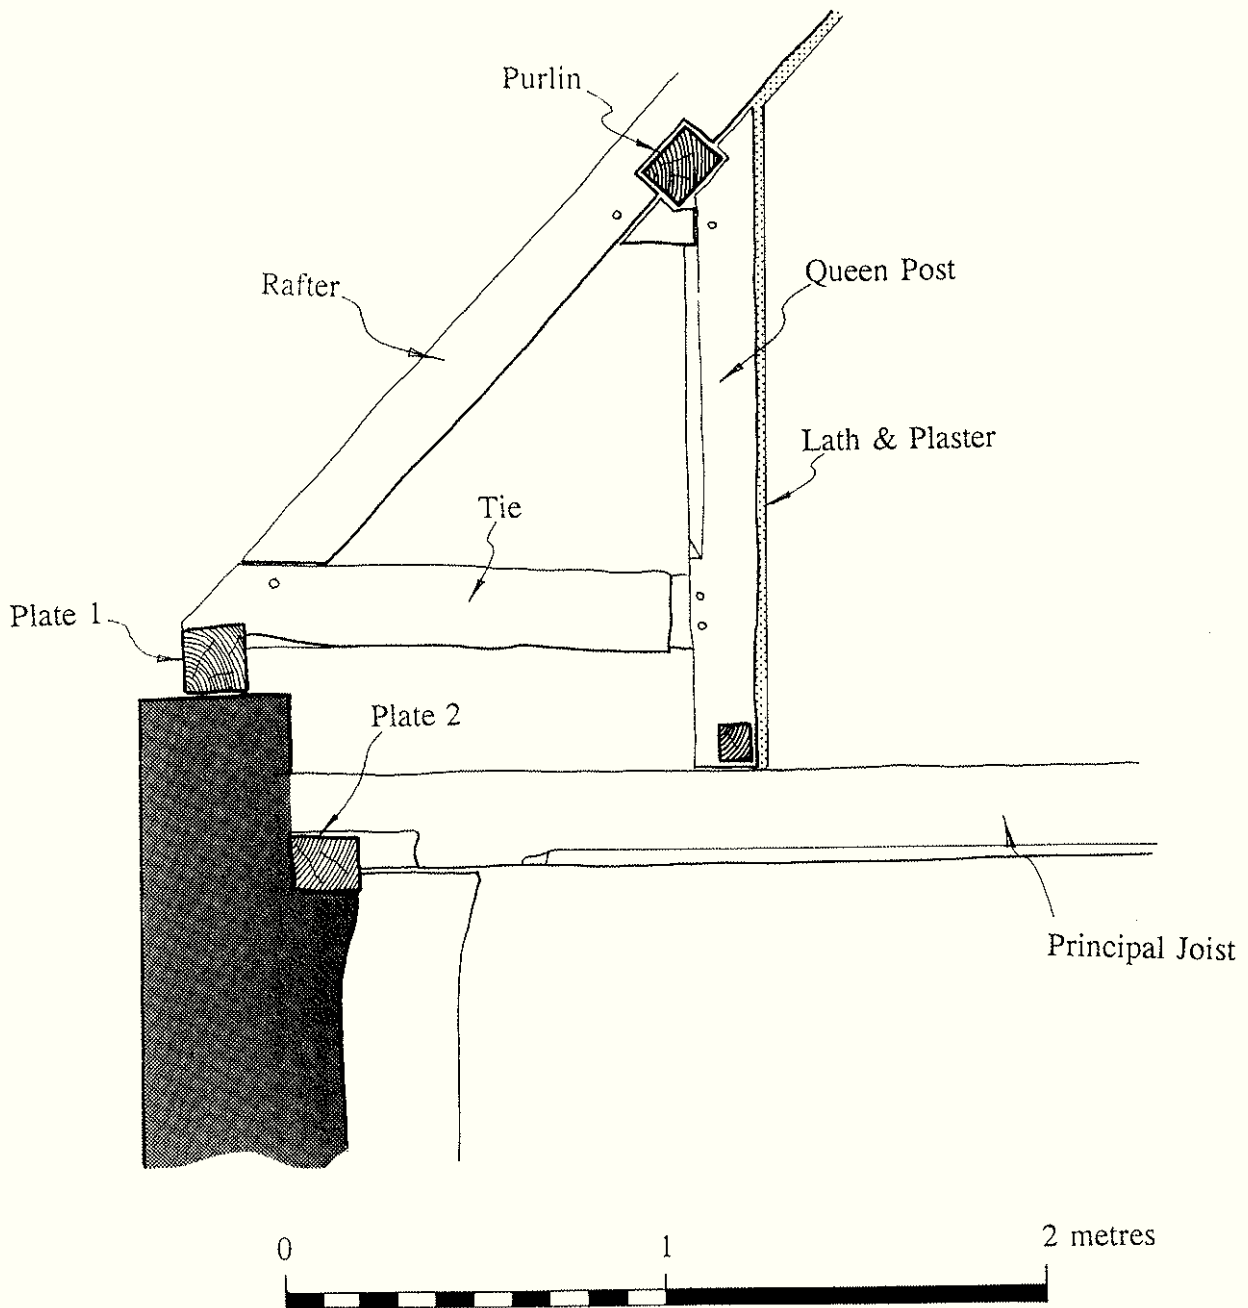
Figure 3: Detail of Roof Construction.

- 3.1.1 Access at attic level to the eastern side of the aisle roof revealed an structure of unusual form. A representative section of the roof construction was drawn at a scale of 1:20 and is reproduced here as figure 3. The western side of the roof was not accessible at the time of the survey.

- 3.1.2 Principal and common joists of the first floor ceiling rest upon a wall plate running along the internal edge of the flint constructed wall (wall plate 2, fig.3). A queen post rises from the principal joists of the ceiling structure to support a clasped purlin and principal rafter construction. Tenoned into the lower queen post on its eastern face is an interrupted tie beam which is lapped over a second, upper wall plate (wall plate 1, fig.3) at its eastern end.

- 3.1.3 It would appear that the roof and ceiling are of contemporary build and a mid 15th century date is suggested by the jointing details employed in the ceiling construction (see fig.5). The queen post and interrupted tie beam arrangement would appear to be original and as such implies that the present layout of the attic storey was established at an early stage.

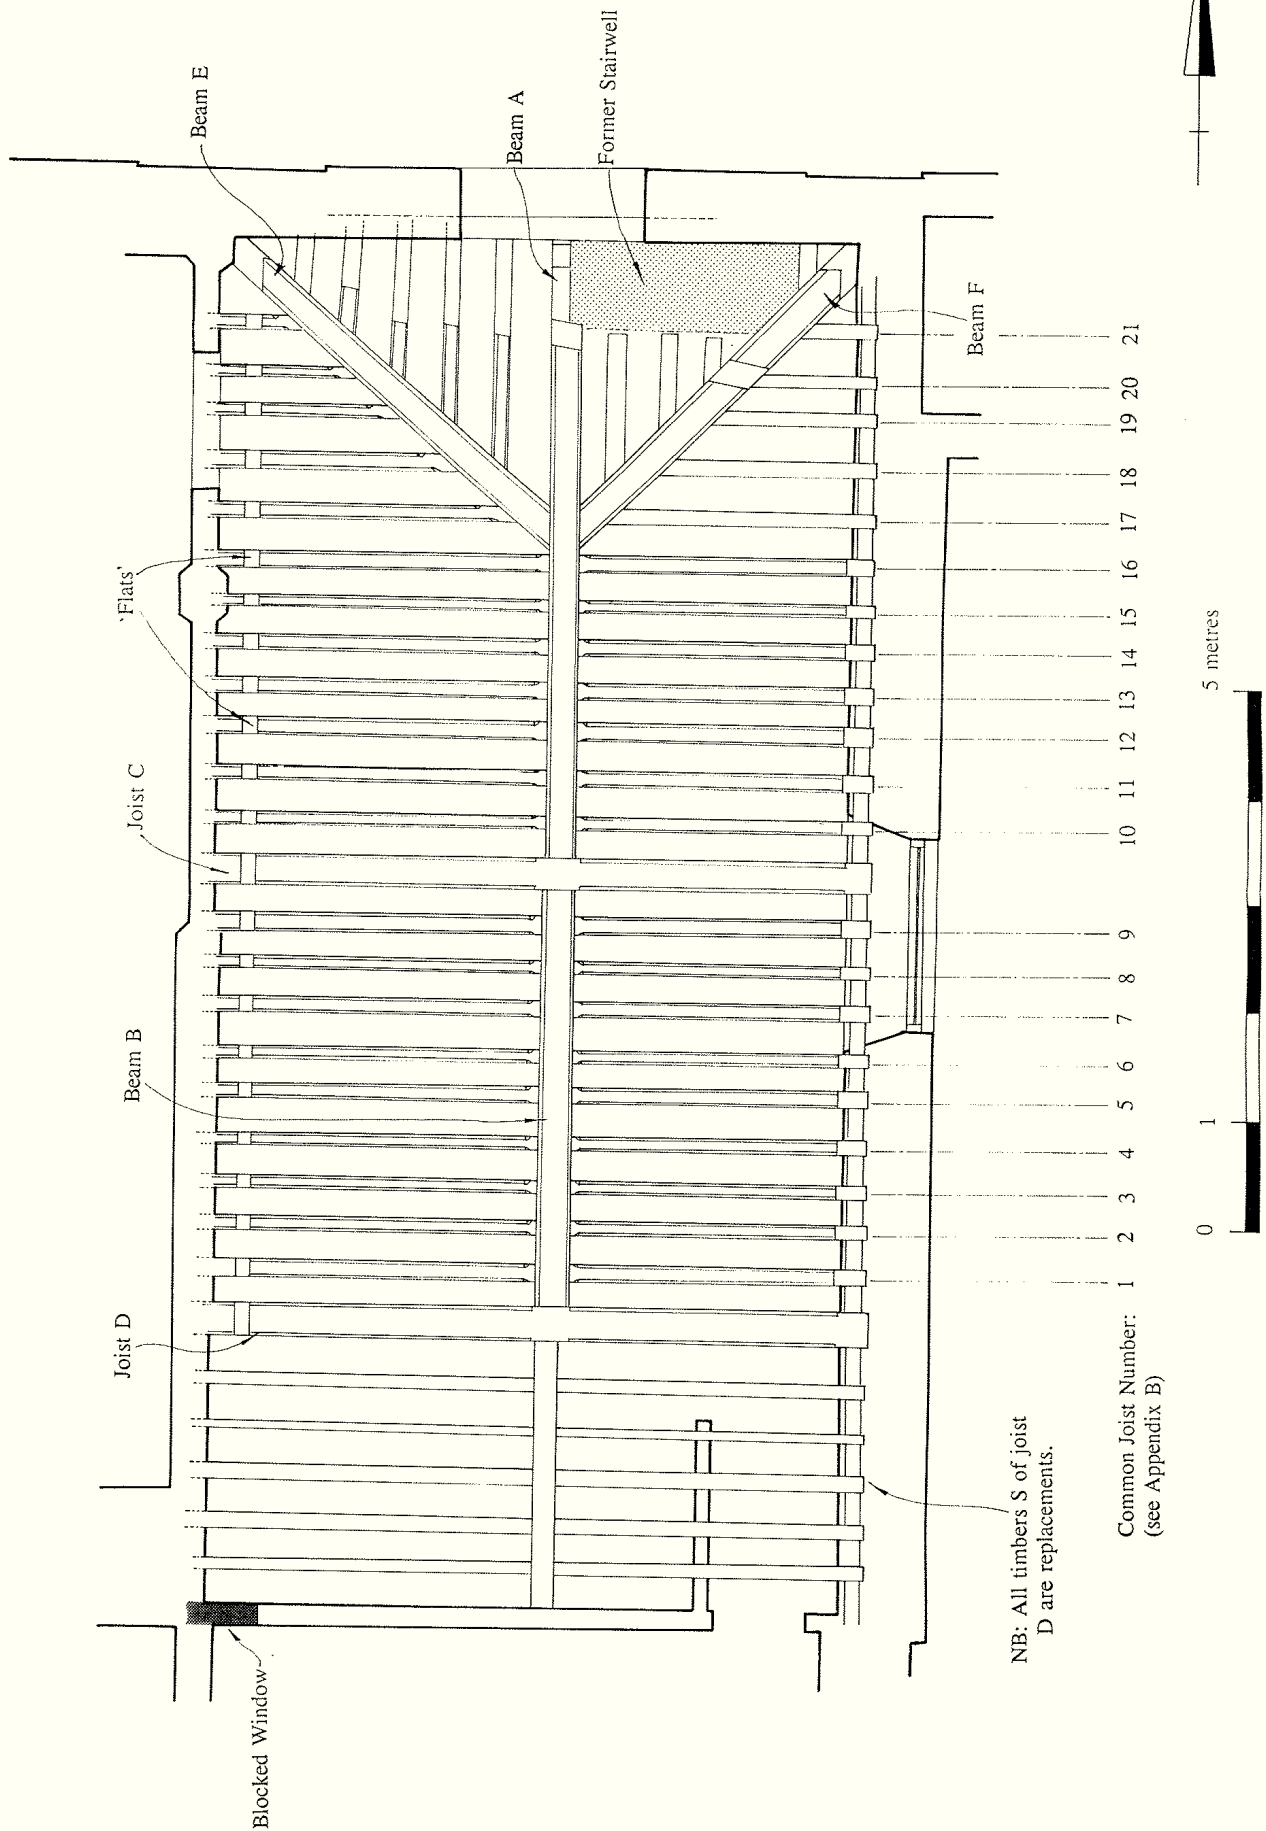
Figure 4: Plan of second floor ceiling timbers.

- 3.2.1 Subsequent to the stripping out of internal partition walling and ceiling rendering at first floor level, a substantial timber ceiling was exposed. An overall plan was made at a scale of 1:50 and is included here as figure 4 (NB: this plan illustrates soffit details of the ceiling timbers). Jointing details were recorded at a scale of 1:5 (see fig.5). Colour slide and black and white negative photographs were taken.  
*Timber was made of all visible carpenter marks - appears to be*

- 3.2.2 The ceiling as exposed comprised a substantial central N-S beam (0.26m x 0.26m scantling) in two sections (A and B on fig.4) and tenoned into principal E-W joists of similar scantling (C and D on fig.4). At the northern end two raking timbers (E and F), again of similar dimensions, ran diagonally from a point c.2.60m S of the N wall to the NE and NW corners of the aisle respectively. All principal timbers in the ceiling construction had straight chamfers on their soffits and were rebated for floorboards on their upper surface. Common joists had battens applied on their upper surface for the support of modern floor boarding. Both principal joists (C and D) had mortices for stud partition walling on their soffits. Common joists (0.17m x 0.13m scantling) ran between the lower wall plate (Wall plate 2, fig.3) and the central N-S beams. Common rafters were chamfered on their soffits with straight stops to the E and lamb's tongue stops at the junction with the main N-S beams. At the W wall of

NB: All timbers S of joist D are replacements. (see Appendix B)

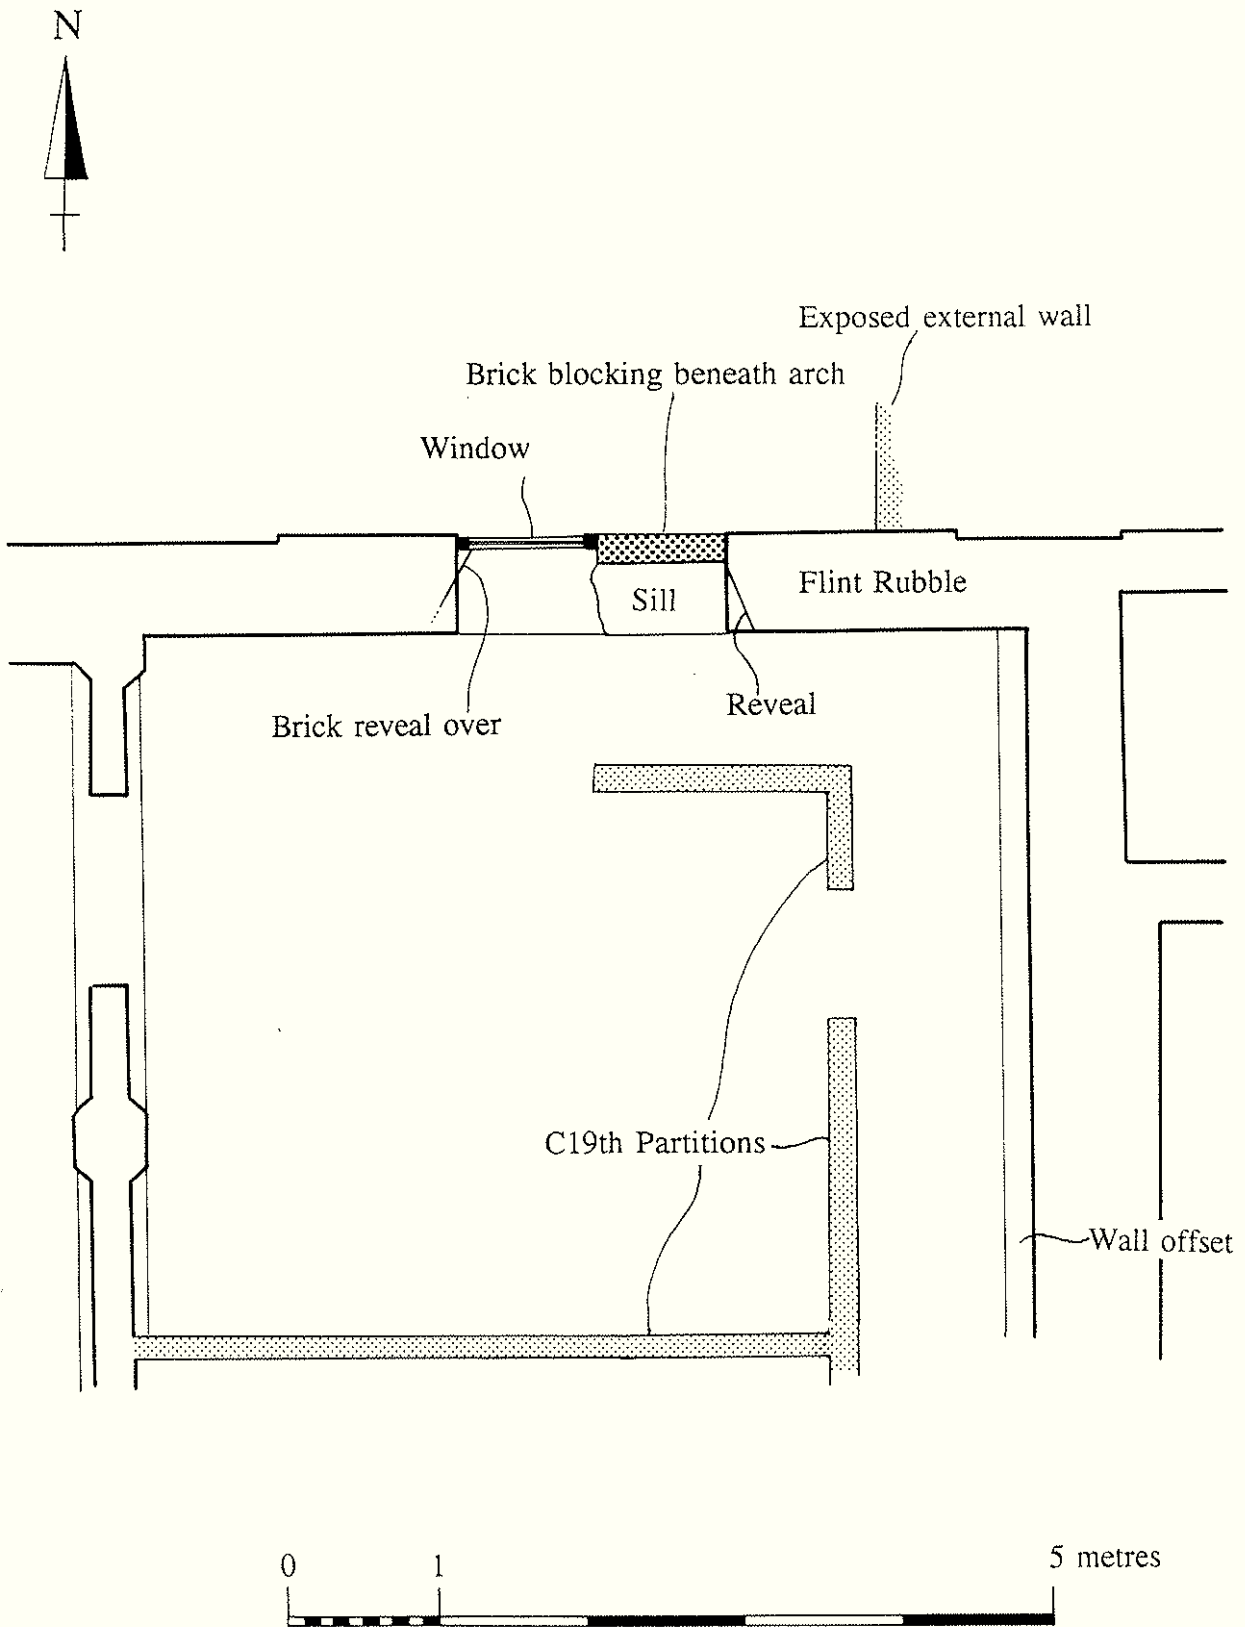
Figure 6: Plan of north wall and exposed external features.

- 3.3.1 An intervention was made in the north wall of the east aisle of the former hall to convert an existing window opening into a doorway. This intervention revealed the original form of the wall construction, and also exposed a former window reveal.
- 3.3.2 The intervention in the north wall was located within an area of brick blocking of a former window opening below a segmental brick arch. The brick arch matched the width of an internal splay at the eastern end (and a fragmentary brick splay at the western side). There was no evidence to suggest that this opening was medieval in origin. Below the blocked window the new opening was cut through the original north wall which was noted to be of flint rubble construction.

- 3.4.1 An integral part of the construction work to the E aisle was the reduction of the external ground surface by c.1.0m to facilitate access to a new doorway in the N wall at first floor level. These excavations revealed a north-south oriented wall adjoining (straight joint) the north wall at a point 0.90m east of the eastern edge of the blocked archway. The wall was of brick and flint infill construction. The wall was seen to extend for c.1.00m to the north of the external aisle wall though this did not represent its full extent.
