Sutton Place Guildford Surrey

Archaeological Investigation and Building Recording

April 2008

Document Type: Historic Building Recording

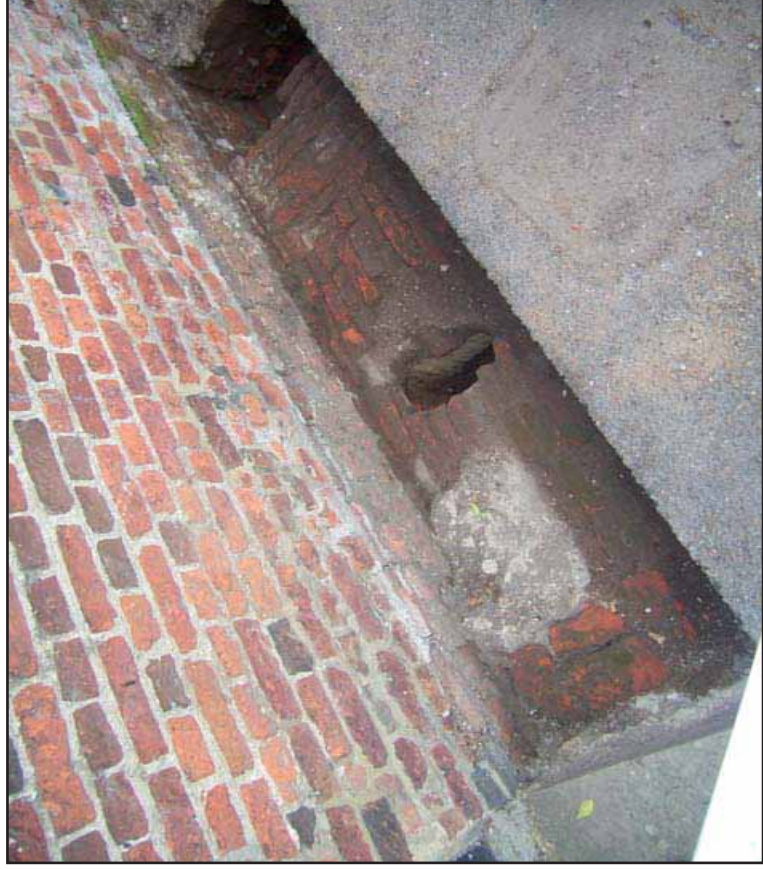
Plate 2: Brick paviors

- 7.2.1 A localised area of brick paving was revealed in a foundation inspection trench, abutting the external wall west of the Oak Stair Hall. The bricks were set on end into yellow sand bedding. The bricks were handmade, pinkish red, soft-fired and measured on average c 230 mm x 45 mm x 105 mm. The bricks appear identical to those used in the external wall, which potentially dates to the late 17th century (VCH 1911, p390). However building recording work (see attached report: Opening WWG3) noted alterations and inserts to this wall. The use of yellow sand as bedding material as opposed to a more lime based bedding/mortar suggests a modern date and re-use of the bricks. Supplies of original bricks for re-use would have been abundant after the demolition of the gatehouse range in c. 1786 (Pevsner 1962, p398).

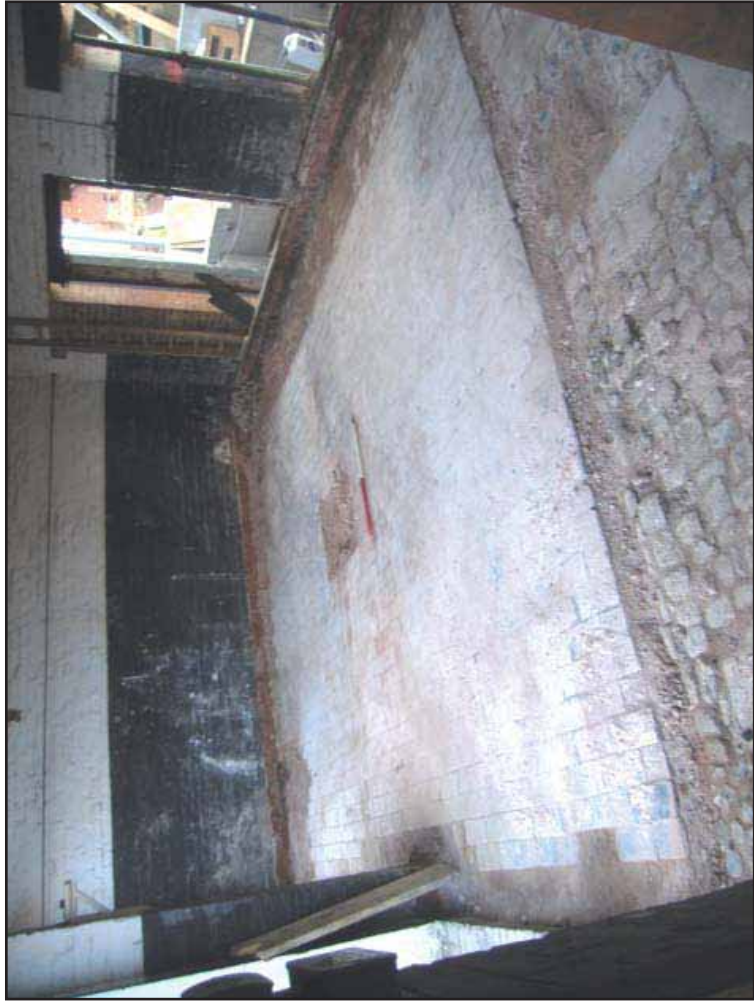
Plate 3: Brick hard standing in garage

- 7.3.1 Initial reduction of the concrete stable block/garage floor revealed earlier floor levels below the modern surface. A central brick-paved surface comprised hard grey industrial, frogged bricks measuring 235 mm x 115 mm x 54 mm. This surface is slightly lower than the existing courtyard surface level and was not apparent in the area of the JP Getty 'car bonnet extensions' (see above), so is presumably a modern surface immediately preceding the adaptation of the stable block/garage.
- 7.3.2 To the west of the garage, the central brick surface was abutted by a surface comprising stone slabs and cobble setts formed into bays. This is likely to be the remainder of the original 18th century floor of the Stable Block.
- 7.3.3 A test pit within the garage and excavated below the exposed surfaces revealed a c 0.5 m depth of 18th century garden soil overlying natural sand (see Section 1).

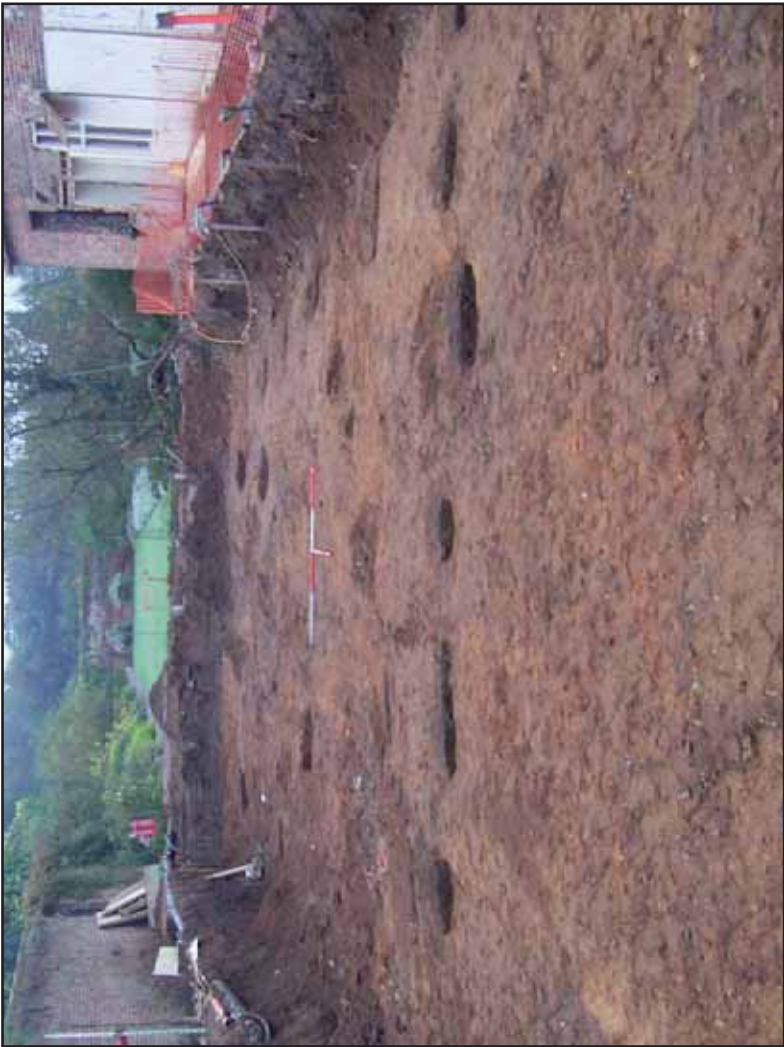
Plate 4: Excavation area

- 7.4.1 Archaeological stripping of the swimming pool area revealed features related to various arrangements of the north-south aligned post-built courtyard division, first visible on the 1881 OS first Edition (cut contexts 121, 125, 127, 129, 131, 133, 137

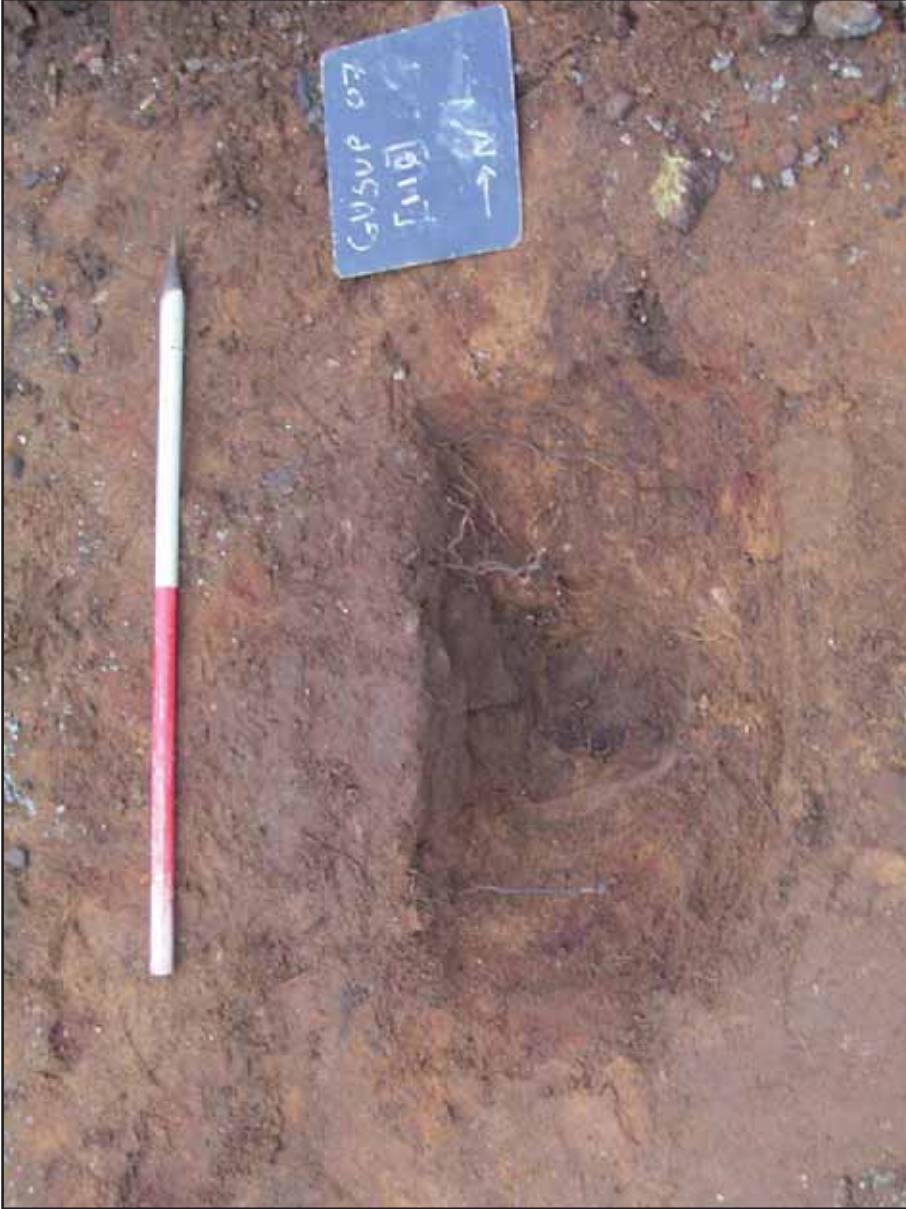
Plate 5: Posthole section of possible 16th-17th century post built structure

- 7.4.3 The most interesting group of archaeological features comprised ten postholes (cuts 101, 115, 117, 119, 149, 139, 141, 143, 145, plus one unexcavated/unnumbered feature) in a rectilinear arrangement. The postholes were shallow (c 0.20 m max) generally 0.6 m in diameter and although heavily disturbed by modern rooting (negating potential for C14 dating), 0.3 m diameter post-pipes were visible in many of the features. Twenty-eight fragments of Ceramic Building Material (CBM) were retrieved from eight of the postholes. Five fragments retrieved from 5 of the postholes are tentatively dated to the 16th-17th century date (although the problematical dating of the CBM - see Appendix 3 and obvious disturbance of the fills does not allow for a certain assignation of this date for the structure). The structure measured c 9 m x 7 m.

- 7.4.4 The postholes represent a fairly simple timber building. There are numerous functions such a building could perform at this close proximity to the Manor House. For example, Malcolm Airs in his publication on Tudor and Jacobean Country Houses (Airs M, 1995, p183) discusses many documentary financial accounts for basic workers lodgings, workshops and storage buildings associated with the construction of comparable 16th-17th century residences. Although visible in the accounts, graphic depictions are rare due to their low status and temporary nature.

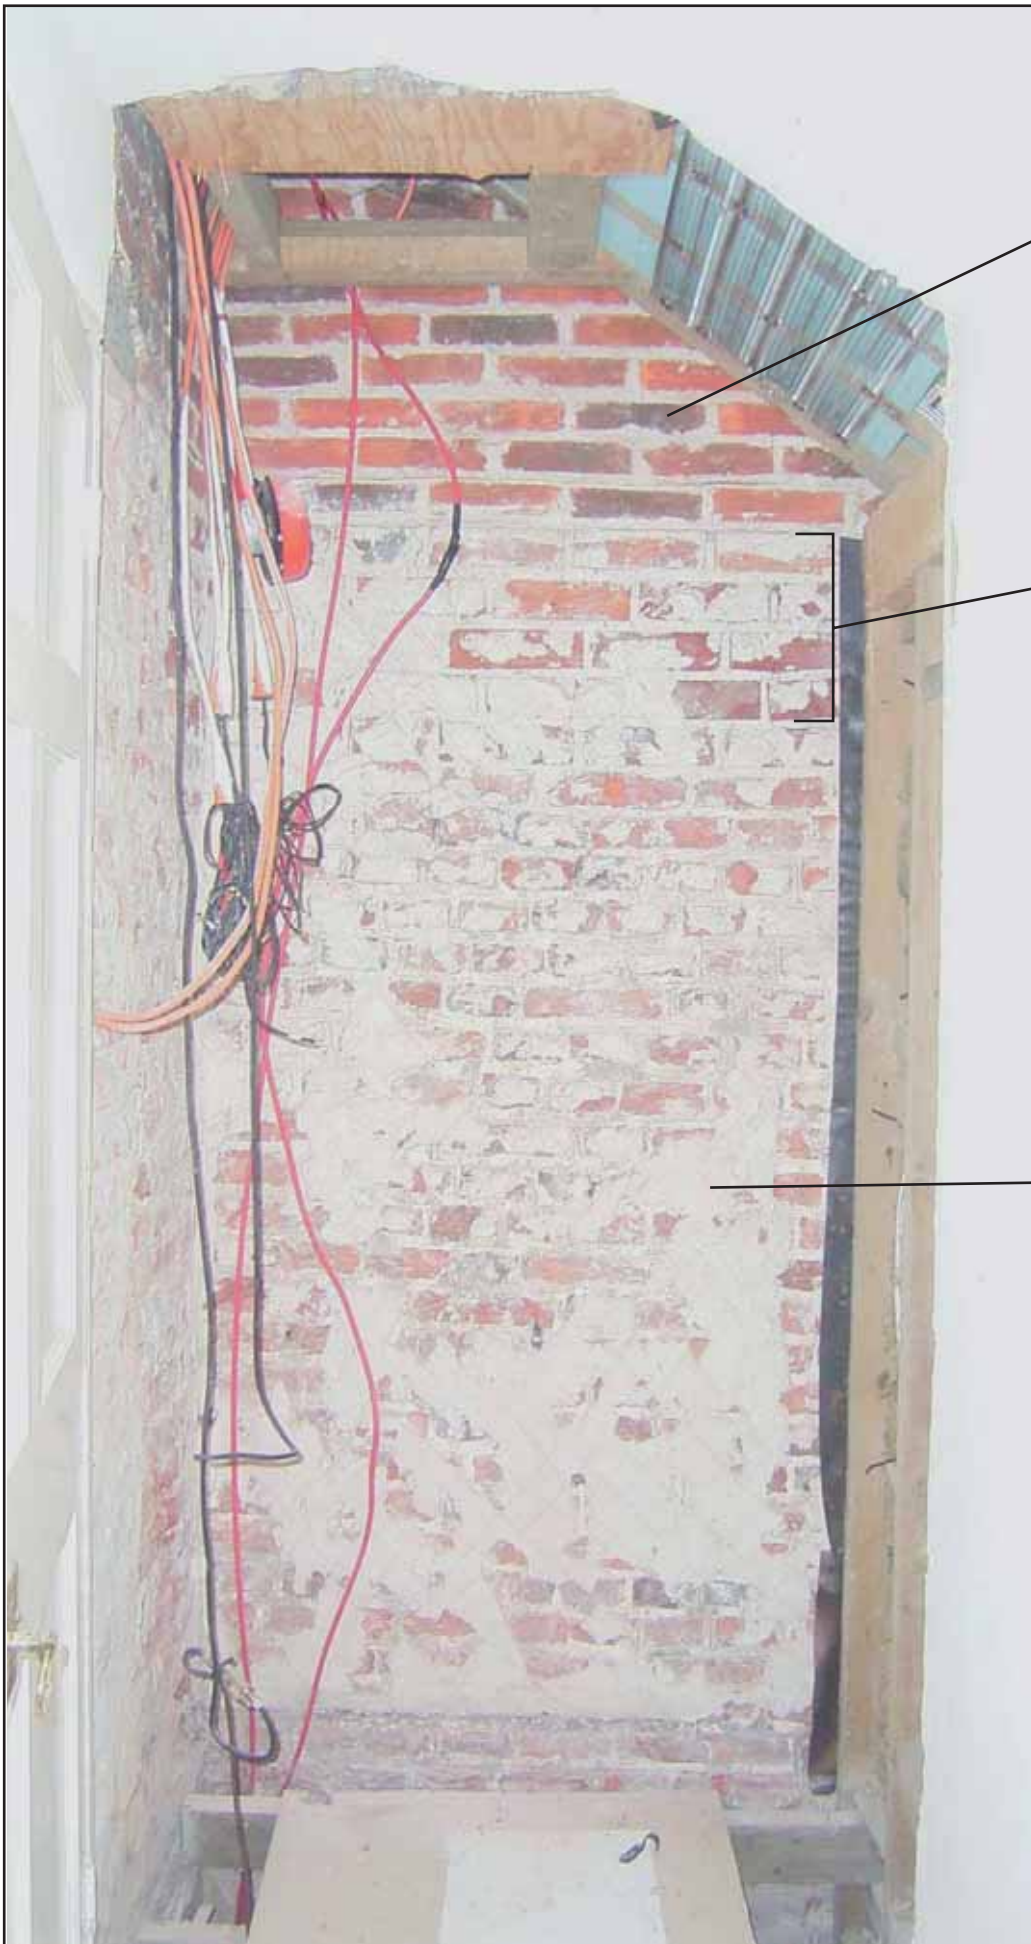
Figure 2: Sutton Place – Opening DF53 as seen from corridor 6 (east facing)

The walling at the west end of corridor 6 (opening DF53) was found to consist of primary bricks phase, topped with 20th century, brickwork. However, the method of pointing on the early phase brickwork is different to that seen on extant primary phase brickwork and therefore it was concluded that this wall had been built reusing early bricks.

Modern bricks probably 1980s

Rebuilt with new bricks, mortar is scored date uncertain

Rebuilt using c. 16th century bricks, mortar is scored, date uncertain

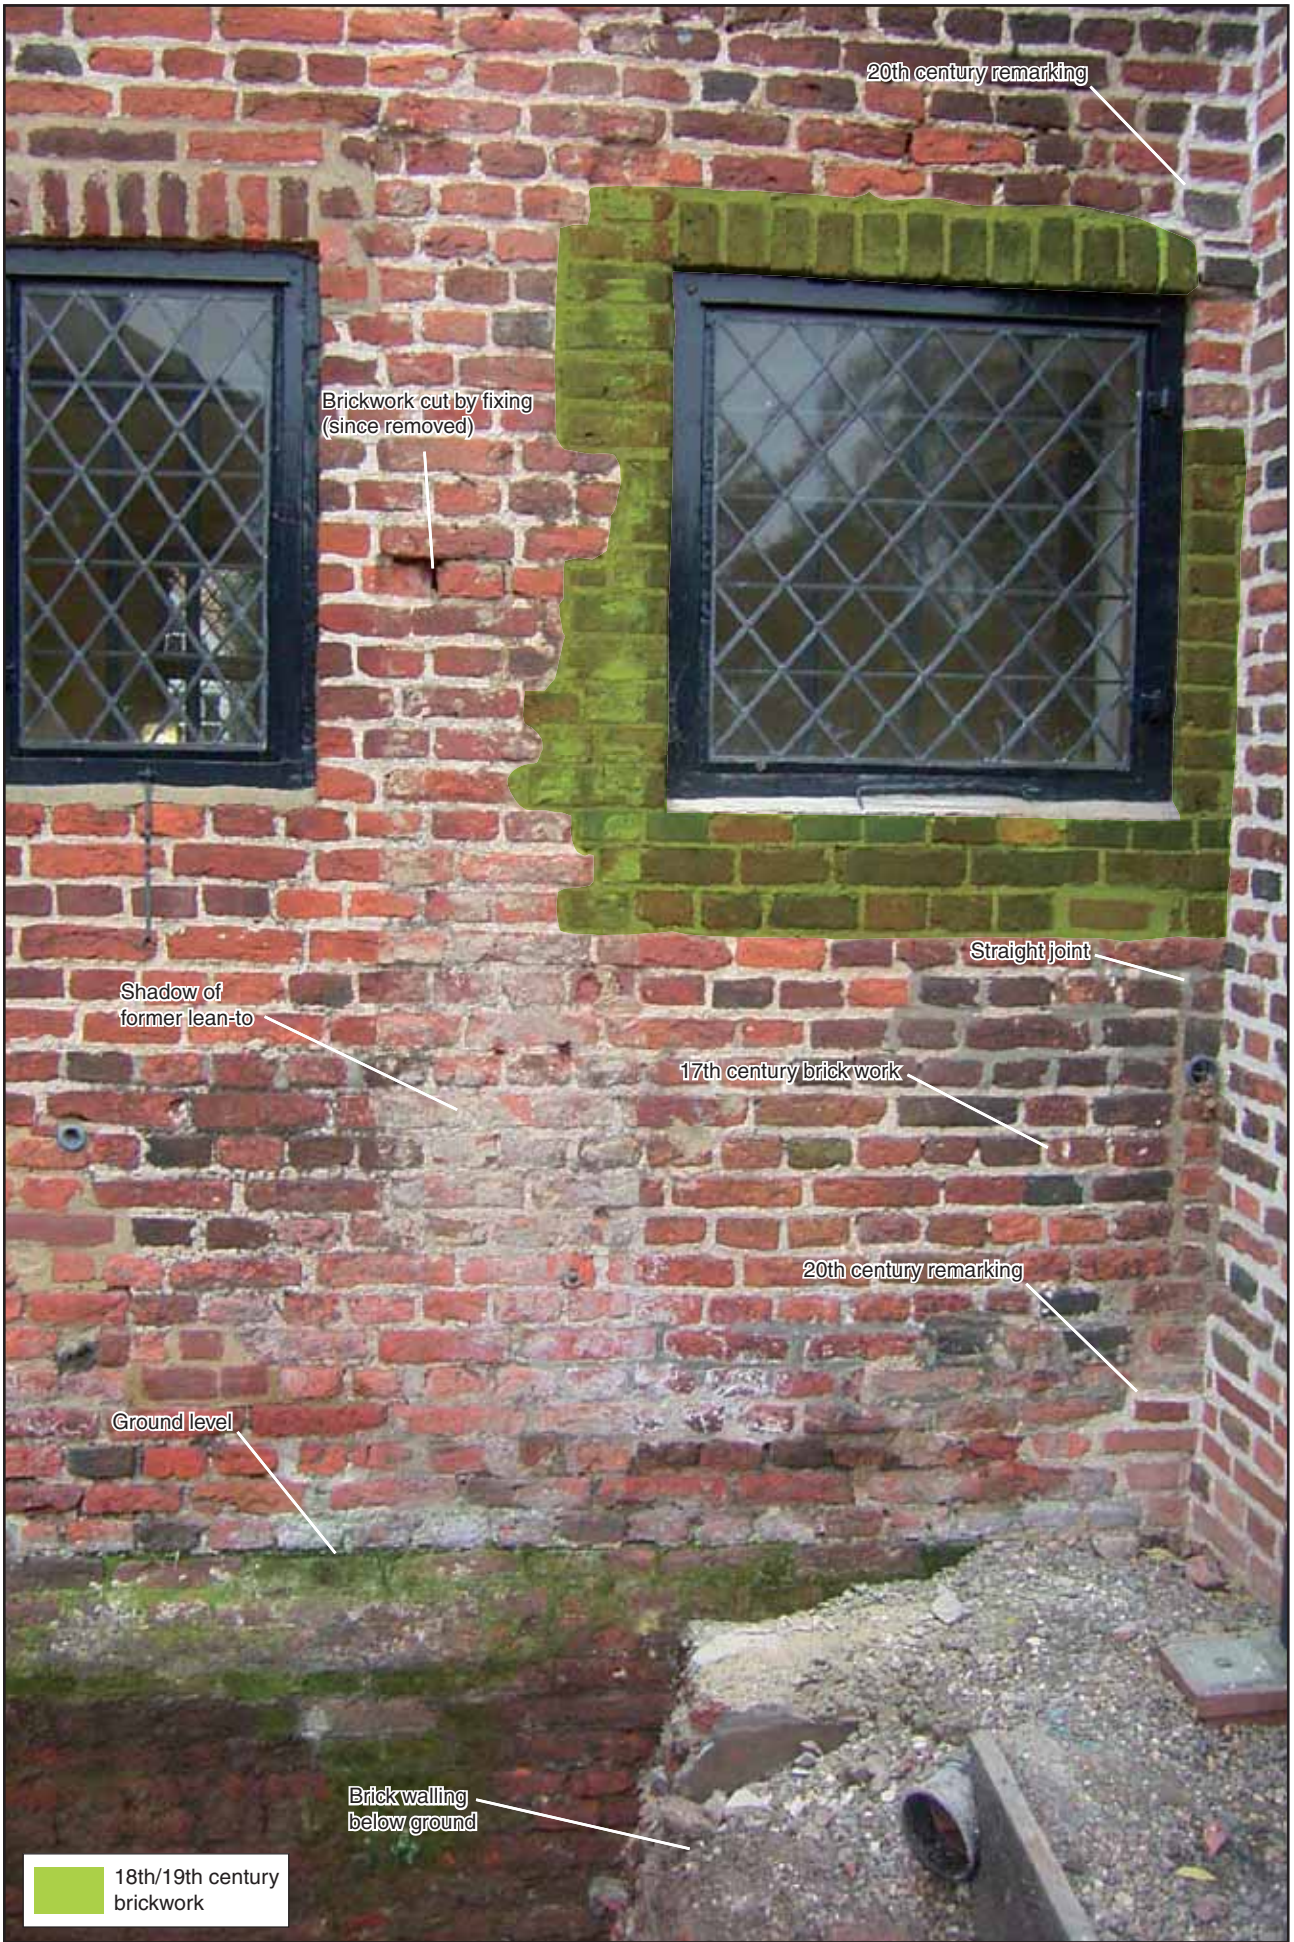
Figure 5: Sutton Place – Opening WWG7 as seen from exterior (west facing)

- 3.5.1 This area (fig 5) involves the removal of a ground floor window and walling to make an access door.
- 3.5.2 The interior shows rough mortaring to the Tudor brickwork, the mortar being creamy coloured with lime inclusions as before. The three courses of brickwork directly below the window is later in date and indicative of an earlier insertion or replacement of the window. There is modern brickwork to one side and a concrete lintel, the sill is timber. There is a blocked vent beneath the window opening.

- 3.5.3 The exterior shows extensive mortar repairs using various mortars and infill bricks (19th/20th century in date). There is also a shadow of a structure which abutted the building and it is likely that this was the position of either a wall enclosing the area between the main house and the stables or the location of a small lean-to structure. There are cuts in the brickwork to allow for fixtures and fittings, since removed. The ground level brickwork is extremely weathered.

- 3.5.4 There is a straight joint in the 17th century brickwork, which is not reflected on the interior elevation and does not appear to relate to any door opening. This is most likely connected either with repairs to a pipe opening above or the addition of the adjacent extension which can be seen on the 1851 plan and which currently houses the oak stair (inserted in the 1990s). The exact construction date for this extension is unknown but it was constructed using early bricks laid out in an English bond, possibly reclaimed from elsewhere in the building. The extension has been subject to a complete remortaring in recent years which means the bedding mortars cannot be compared.
