Battles Hall Barns Maggots End Manuden Essex

Historic Building Survey

May2012

Historic Building Survey and Archaeological Monitoring

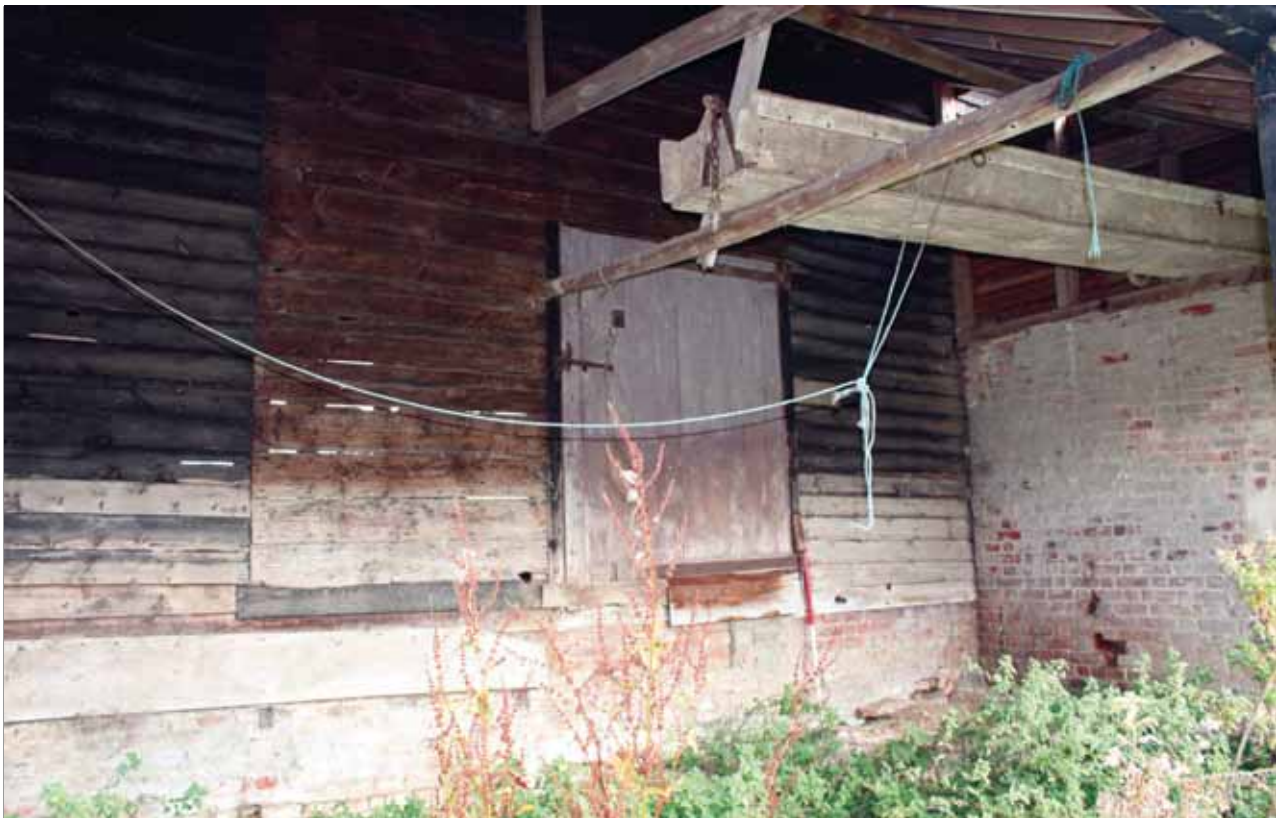
Plate 10: Detail of door on south-facing elevation of Building 5 (from inside Building 2)

- 4.2.4 From inside the other part of Building 2, a large door is seen on the south side of Building 5 (Plate 10). Replaced boards around it would suggest it was once a larger

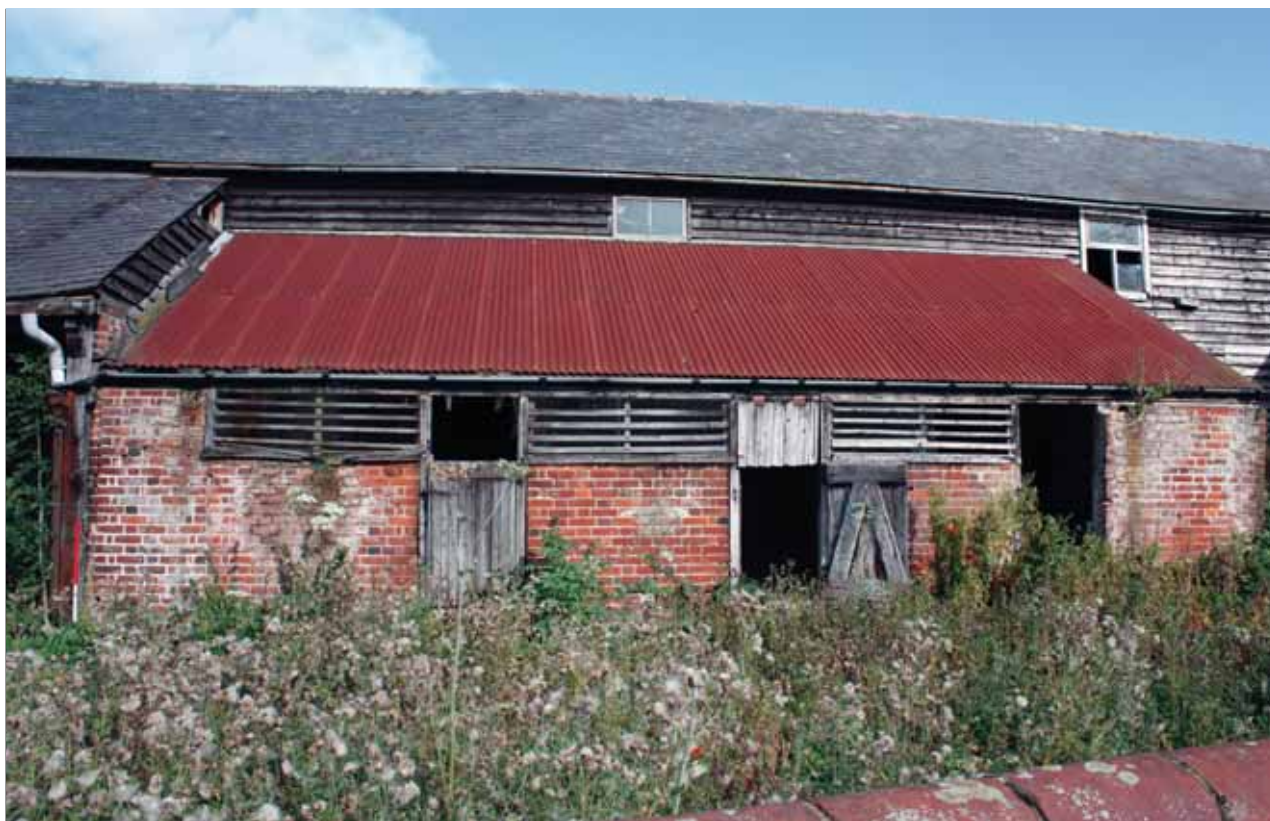
Plate 11: South-facing elevation, Building 3

- 4.3.3 Between the doors are angled wooden boards/slats which provide ventilation, these slats are covered with modern chicken wire.
- 4.3.4 On the western end of Building 3 is evidence of rebuild or repair to the brickwork or perhaps in-fill of the remains of an earlier building in this location as the brickwork at this end is different (Plate 11).

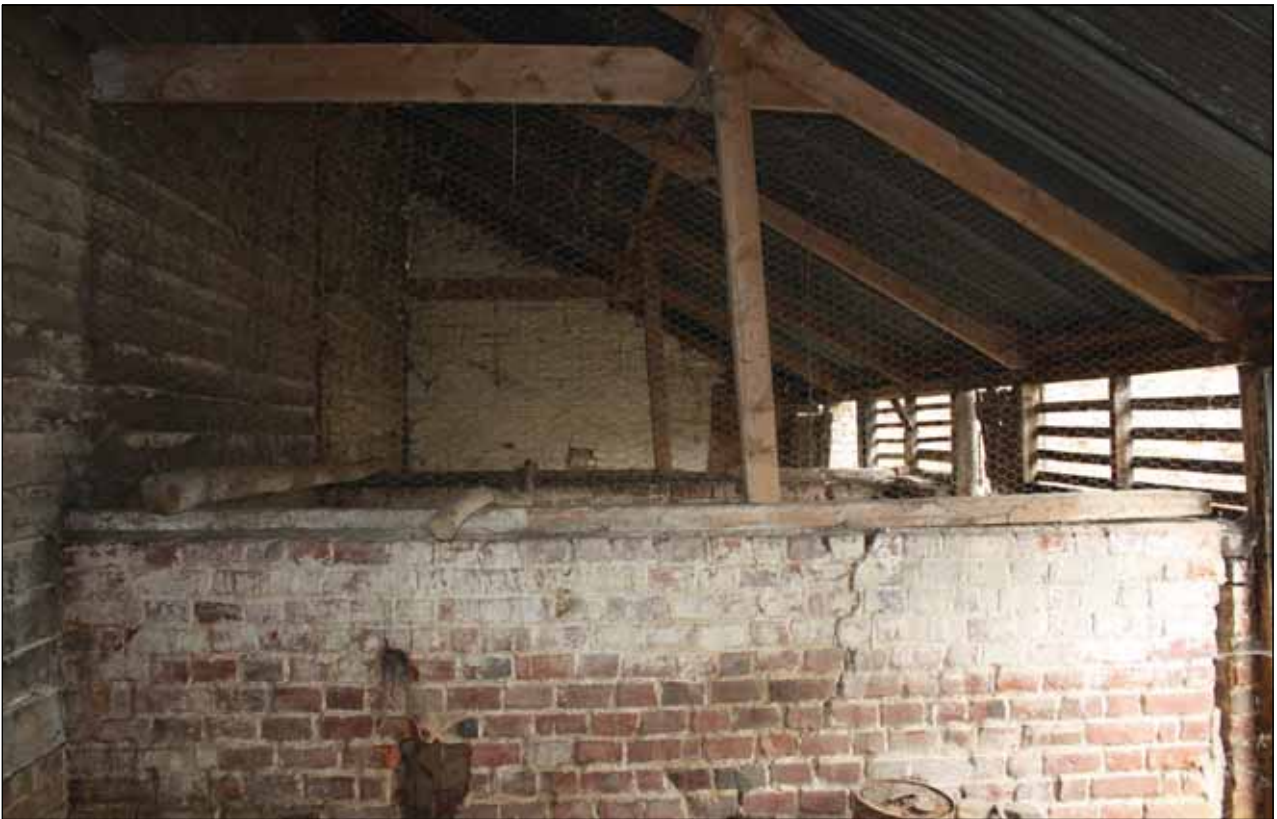
Plate 13: Internal view, Building 3

- 4.3.5 Internally there are two low-level, sub-dividing brick walls which correspond to the three doors recorded externally. The brick walls are 1.25m high, constructed from mostly broken bricks and are not tied into Building 4 at the rear. Chicken-wire has been used to sub-divide the area to the roof.
- 4.3.6 Like Buildings 1 and 2 the roof appears to be a later addition/replacement using modern machine-cut timber rafters which rest on the wooden frame of the elevation and supported with ties which are also inserted into Building 4 (Plate 13).

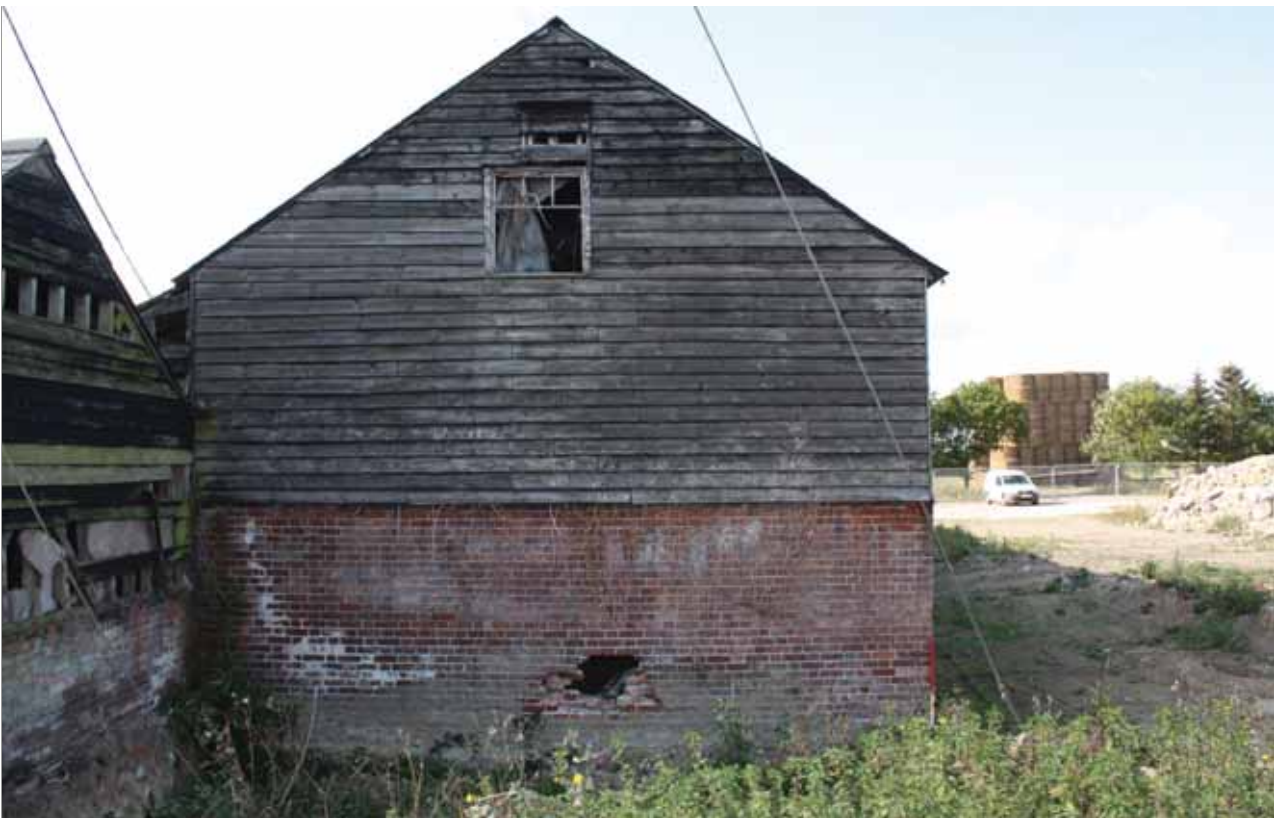
Plate 16: East-facing elevation, building 4

- 4.4.4 The east-facing elevation (Plate 16; Figure 11, Elevation 5) comprises the same 33 courses of Flemish bond-laid brick as noted on the north elevation. Some damage has been sustained during recent work inside the building resulting in a hole in the brick plinth. There is a wooden-framed window inserted within the roof pitch, however there is no glass surviving.

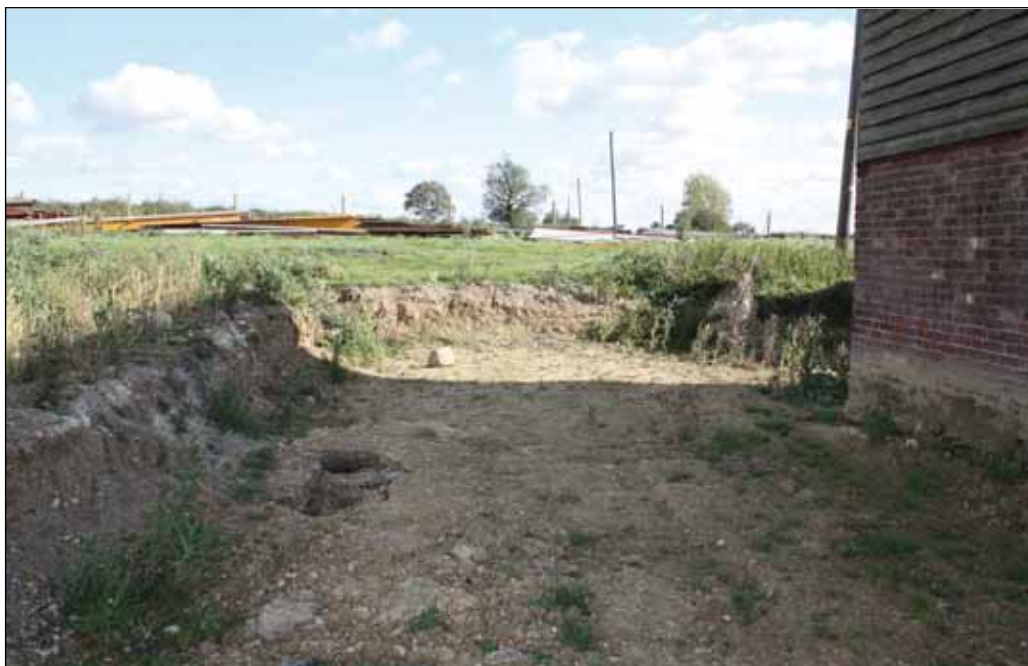
Plate 17: Reduced ground level on north side of Building 4

- 4.4.5 The area of ground immediately in front of the north and west-facing elevations of Building 4 had been reduced prior to the start of the survey (Plate 17). It was noted that approximately 0.75m of soil had been removed over an area no more than 4m from the edge of the building. The stratigraphic sequence of deposits was noted as 0.10m of top soil, 0.16m of subsoil and 0.48m into natural chalk and clay. There was no suggestion of any archaeological features in the sections or any evidence of brick foundations.

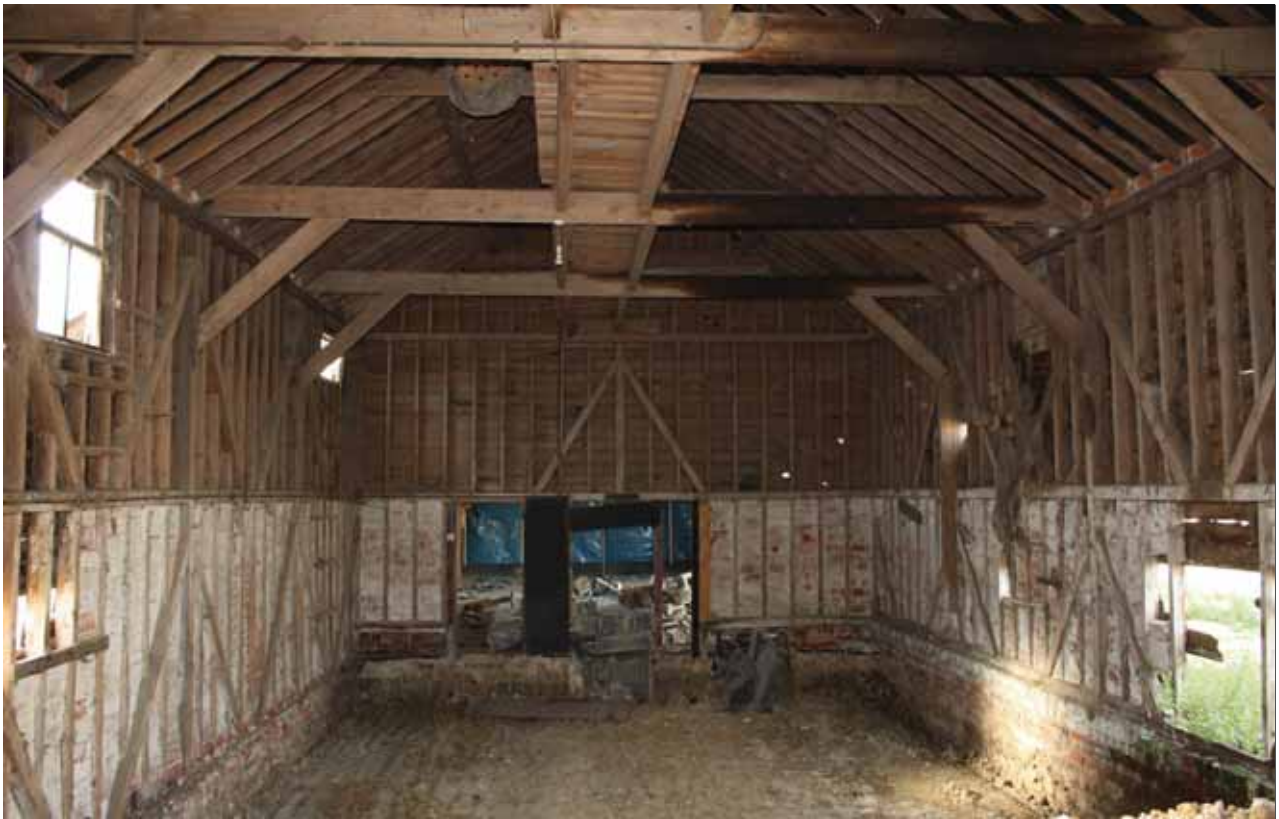
Plate 20: Internal view, Building 4

- 4.4.7 The timber frame structure and wall plates all appear to be original with areas of ad-hoc repair and replacement with re-used materials as is to be expected in an agricultural building. The protruding entrance/cart shelter on the southern elevation also appears to be contemporary with the rest of the building. The frame is constructed from straight, machine-sawn timbers which rest on the original brick plinth. There are areas where the plinth has been repaired, as noted on the external elevations and also where modern bricks measuring 22cm by 11cm have been used as an in-fill within the frame (Plate 20).

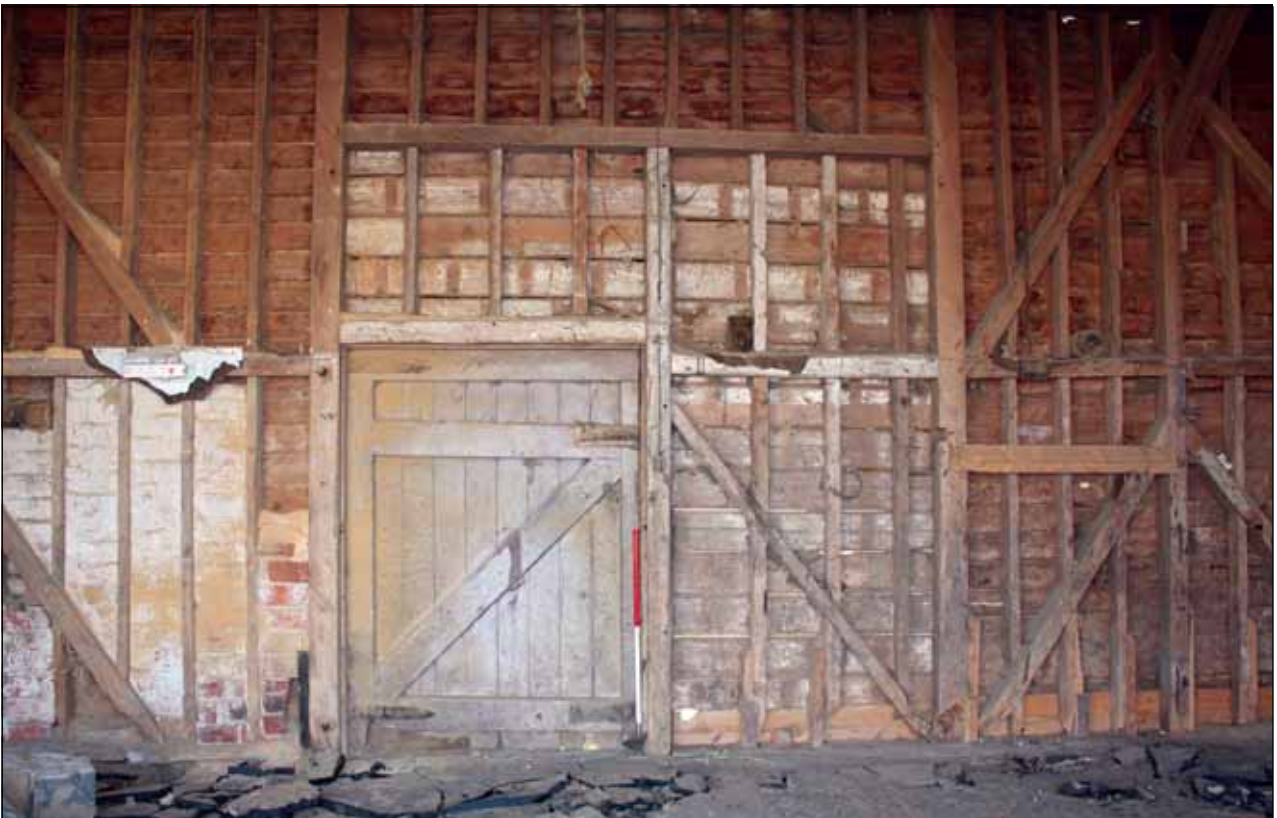
Plate 27: Detail of door from inside Building 5

- 4.6.7 The long, southern elevation has the door as recorded from inside Building 2 (Plate 27). As noted on the other side (inside Building 2), there is a larger frame around the current door indicating an earlier, possibly double set of doors directly opposite one of those noted on the north-facing elevation.

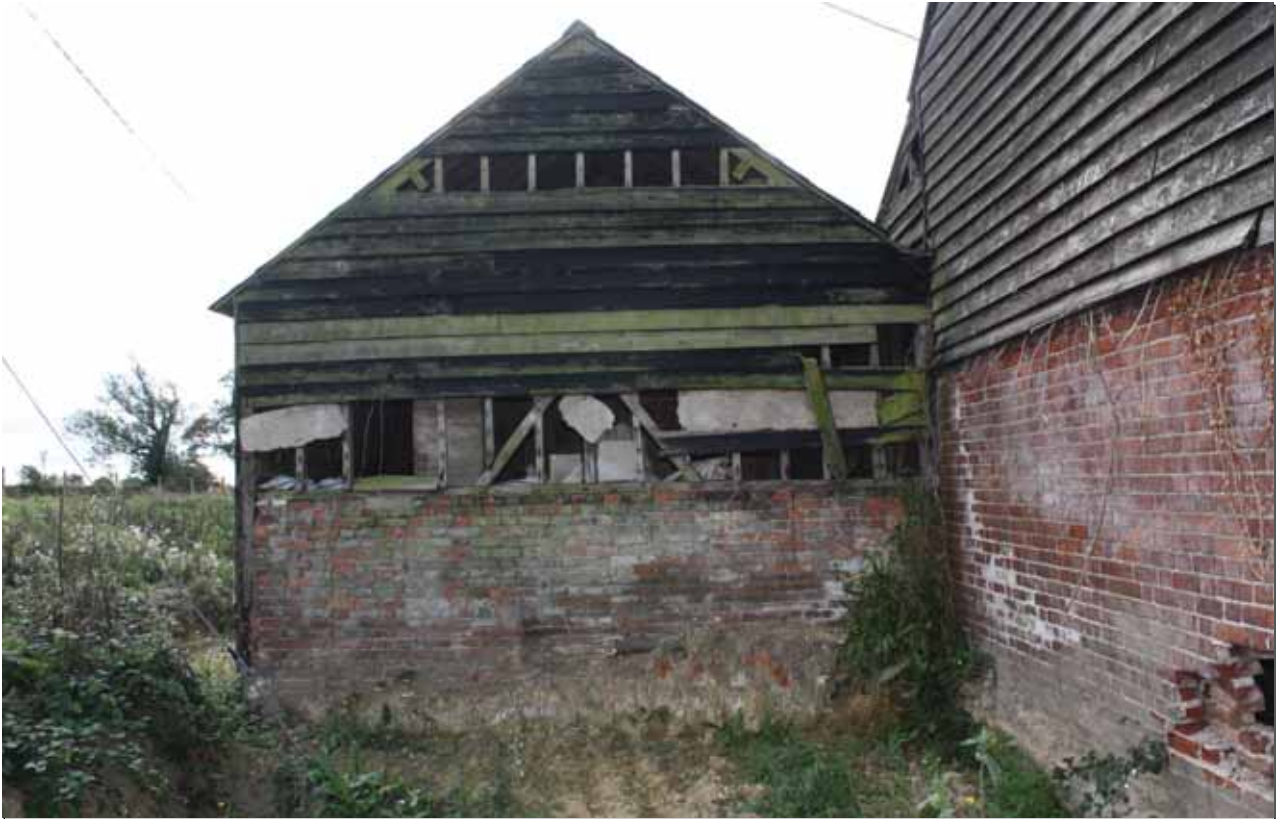
Plate 31: North-facing gable-end, Building 6

- 4.7.3 The north-facing elevation (Plate 31; Figure 10, Elevation 4) is constructed from approximately 20 courses of orange coloured, hand-made bricks with diagonal pressure marks and laid in a Flemish bond. Above the brick, horizontally laid weather-board continues to the roofline. Some of the boards have fallen off exposing the timber frame behind and on one of the wall frame studs a carpenters mark "III" was noted. No other corresponding marks were found. The reduced ground level directly in front of the building did not reveal any evidence to suggest this building ever continued further northwards.

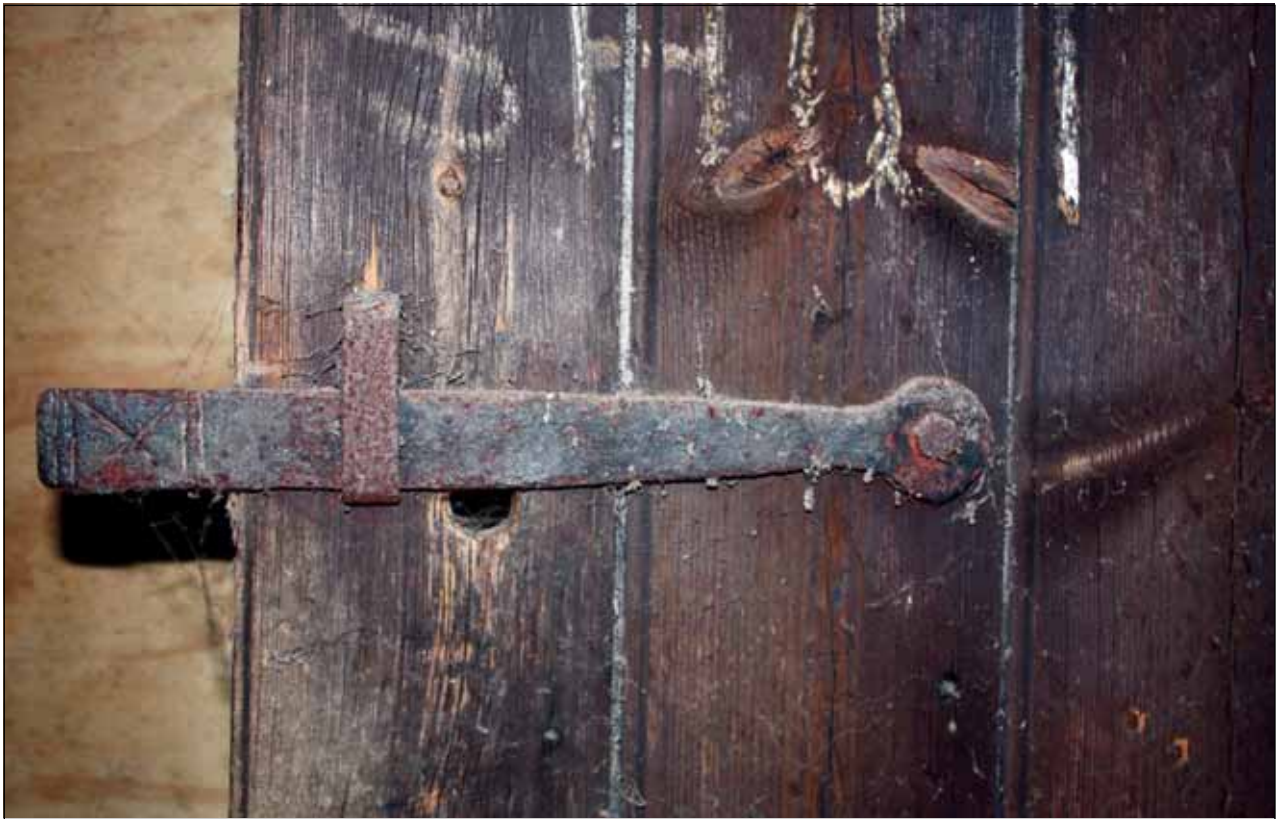
Plate 36: Detail of latch on internal door, Building 6

- 4.7.8 The location of the only original internal dividing wall is shown on Figure 2. The door has a datable latch and hinges, compatible examples of these have been found which date to the 19th century (Plate 36).
- 4.7.9 The southern-most room in this building has been most recently used to house poultry with chicken-wire and remnants of bird cages (Plate 37). The walls and ceiling have been covered with plasterboard and the floor concreted with a drainage gully.

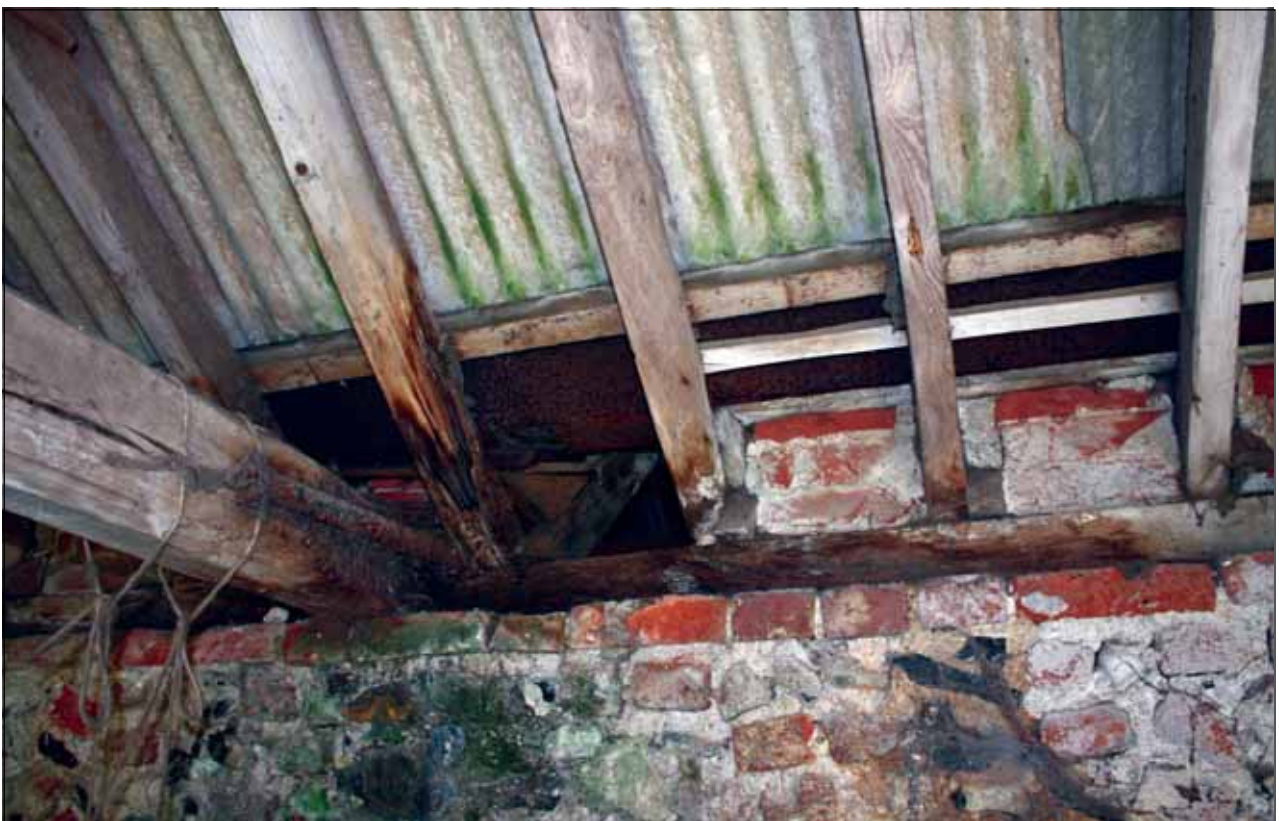
Plate 45: Detail of wall-plate, tie beam and common rafters inside Building 8

- 4.9.5 The internal roof construction is the same as those recorded in the other buildings, however the tie beams running between the external and rear walls are not straight, machine sawn ones, as previously noted. These five beams, which represent the bays of Building 8's roof construction, may have been re-used or are part of the original roof structure and are the only elements not to have been replaced. The replaced common rafters and collars appear to sit on the original wall plate. Later bricks have been added between the rafters to support the eaves gully between Buildings 8 and 9 (behind) (Plate 45). The roof may have been replaced when Building 9 was added.
