# Church of St. Mary the Virgin Iffley, Oxford

Archaeological Watching Brief Report

**Church of St. Mary the Virgin  
Iffley, Oxford NGR SP 5206 0304  
Archaeological Watching Brief Report**

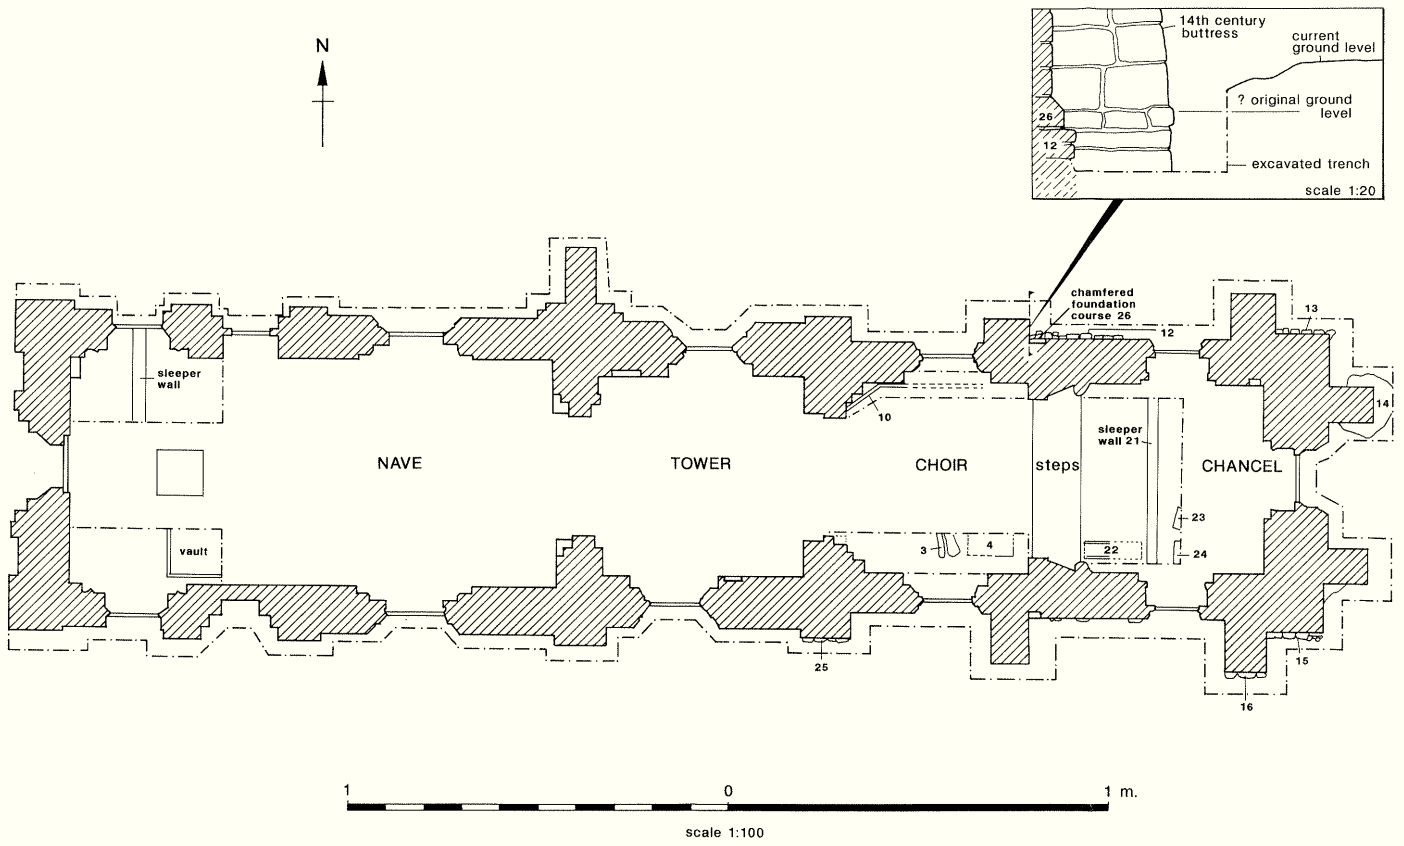
figure 2

Two areas were opened within the nave to a depth of 0.22 m. A documented brick vault, with an entrance, was observed against the south wall of the nave. An insubstantial brick-built sleeper wall, aligned N-S, was observed in an open area against the north wall of the nave.

The stone slabs comprising the floor of the choir (context 1=11) were lifted, and the ground level reduced by 0.22 m. The earliest deposit identified was a layer of undated mid-dark grey sandy loam (7), into which was set a brick-built vault (4). A second vault, represented by a large capping stone was also observed. Both vaults were sealed by a layer of concrete (9), which in turn was overlaid by a thin layer of sand (2) on which the stone floor slabs were bedded.

A shallow channel (10) incorporated into the concrete ran E-W alongside the offset footing of the N wall of the choir, and was filled with decayed wood fragments.

Works in the chancel consisted of the removal of a stair, and a reduction in the ground level. Three brick vaults (22, 23, 24), two of which contained lead coffins, were observed beneath make-up debris (20). Layer 20 butted a one-course brick-built sleeper wall (21), which ran N-S beneath the stone slab floor. Layer 20 contained several decorated floor tiles, of the same pattern as those at the east end of the chancel.

Some of the foundations of the church [Fig. 2] were revealed, and four phases of construction could be identified. The earliest phase must relate to the original construction of Iffley Church. A 1.50 m length of an offset footing (12) was observed beneath the N wall of the church. The footing consisted of roughly hewn limestone blocks, of which 2 courses were seen, and projected 0.25 m away from the wall face. The footing lay below a course of chamfered blocks which rest 1.85 m below the base of the window in the north wall of the church. The chamfer course probably represents the level of the ground surface in the Norman period. The churchyard level today is up to 0.25-0.40 m higher than the chamfer course. The footings beneath the S wall were irregular, with occasional limestone blocks visible as offsets. It is possible that comparable offsets to those beneath the N wall lie beneath the excavated depth of the trench.

Beneath the NE and SE corners of the chancel lie offset footings comprising roughly hewn limestone blocks. Two courses of stone were visible beneath each corner. Footing 13 projected 0.18 m away from the N face of the NE corner. Footing 15 projected 0.15 m away from the S face of the SE corner. The similarity of stone type and construction method suggests that these offsets were constructed at the same time. These are surely the foundations for the C13 century eastward extension of the chancel.

Two substantial buttresses appear to have been added to the N wall of the chancel. The bases of each buttress clearly overlie and project well beyond the offset footings 12 and 13. Two opposing buttresses are incorporated into the S wall of the chancel. The base of the more easterly buttress overlay the offset footing 15. The construction technique of these four buttresses is different to that used for the corners: each buttress is built upon large, well hewn limestone blocks, which are not offset.

The buttresses at the east end of the chancel are clearly the latest additions, comprising fresh looking ashlar masonry, constructed upon irregular courses of limestone rubble mixed with sand and gravel.

A shallow offset footing (25) was observed beneath the SE corner of the tower. The offset was a single course of limestone 0.14 m deep, and projected away 0.12 m from the corner of the tower. The footings of the other corners of the tower were not offset.
