St Giles Church Imber Wiltshire

Phase One Repairs

**Historic Building Investigation
and Recording**

August 2006

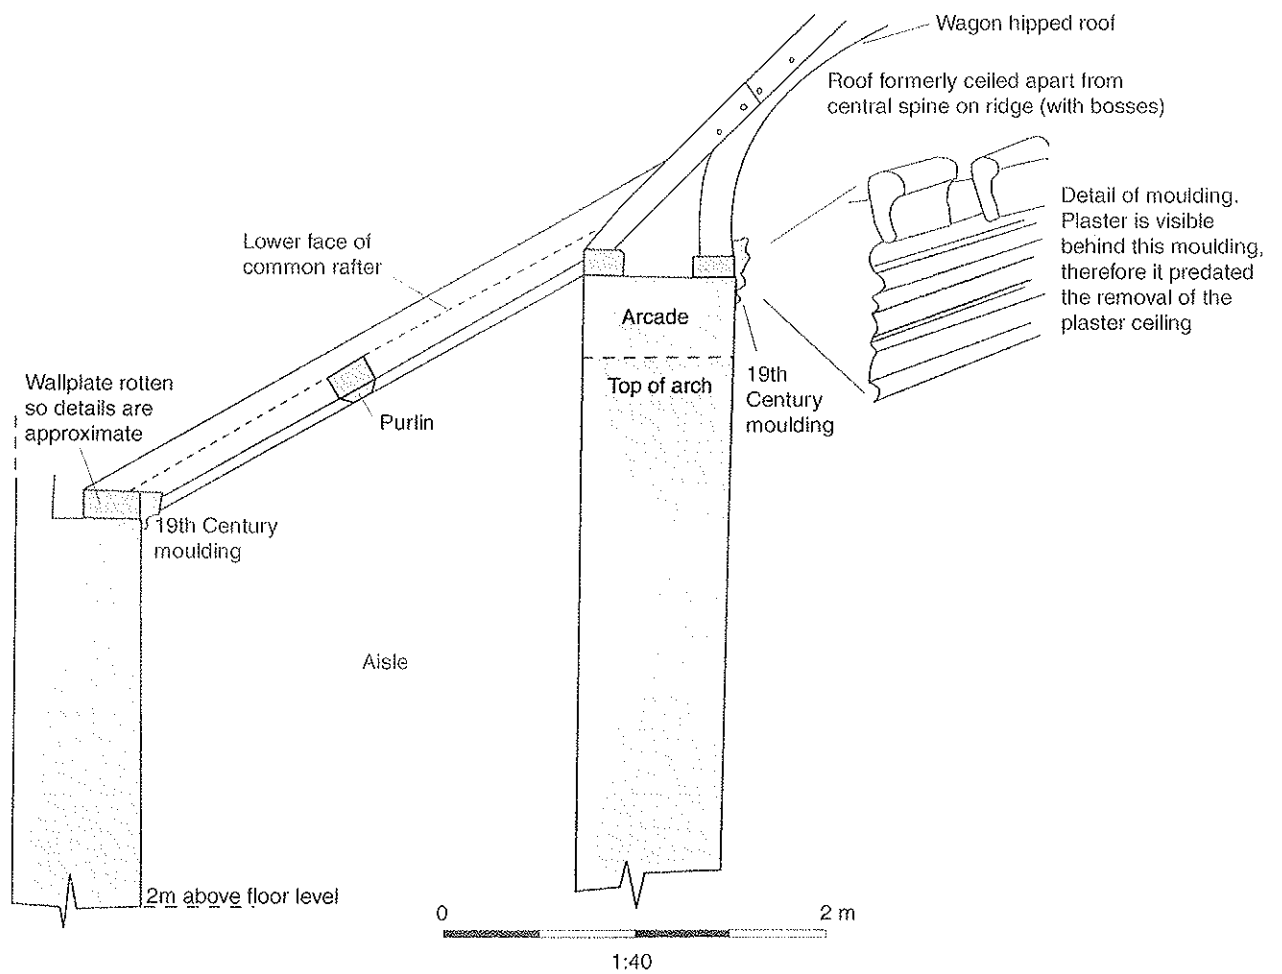
Figure 3: Section through South Aisle showing roof construction

- 4.3.6 The main rafters extended to a wallplate sitting on the south side of the aisle wall (Plate 6) they were jointed into this plate and then extended to join the backs of the nave rafters which are also seated on this plate. The common rafters of the aisle sit on this plate and also extend to join the nave rafters (Fig. 3, Plate 7). Separate

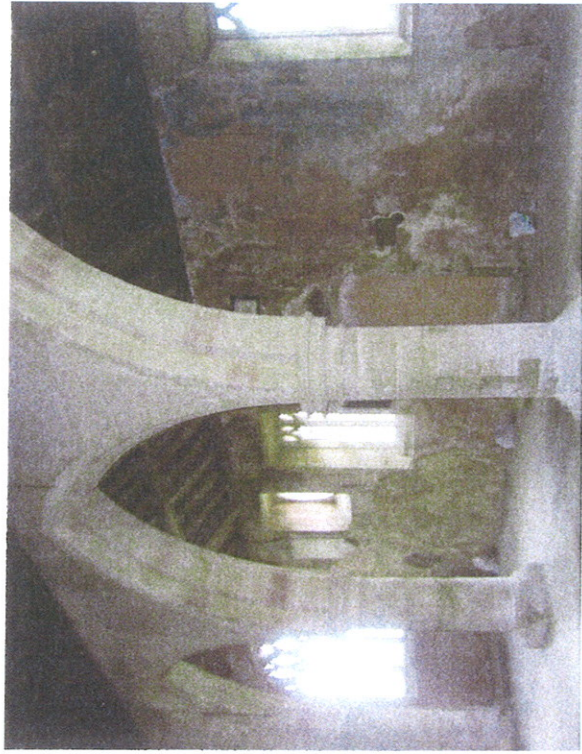
- 4.3.2 The major focus of the 2005/2006 work was the repair of the roof of the south aisle. This roof had been leaking badly for some time and the ingress of water had begun to present a threat to the wallpaintings of the arcade (Plate 1). The work involved the removal of tiles from the aisle, the replacement of rotten wallplates and the rebuilding of guttering to improve rainwater run off.

Plate 1: General view of south aisle

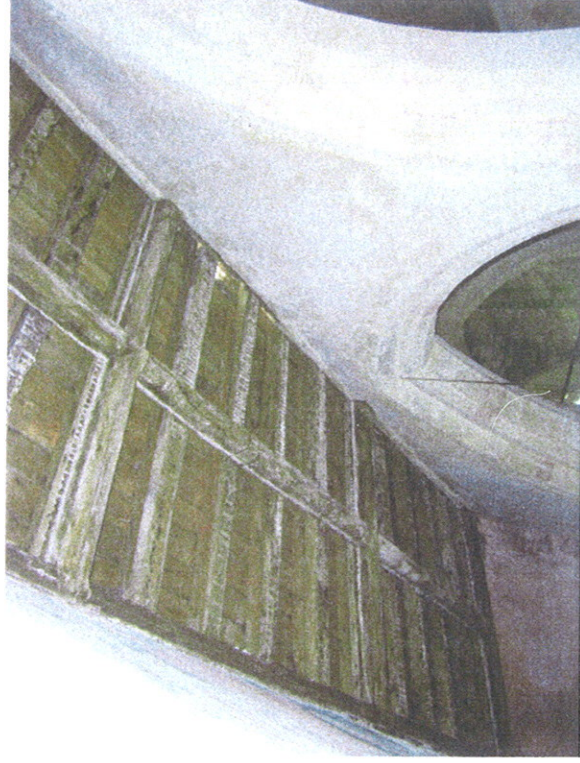
- 4.3.4 The roof is all of one build and in detail and construction it appears to be late medieval and is presumably the aisles original 15th century roof. The roof is divided into five bays by large moulded principal rafters all joined by a moulded purlin (Fig. 2, Plates 3 & 4). Above this lie the common rafters. It is clear that there was once a ceiling nailed to the common rafters with the moulded timbers projecting downwards from its surface. Above the rafters was a planking roof made of stained pine (1950s?). The planking was clad in lead sheeting and this was in turn covered in clay peg tiles fixed on battens.

Plate 3: General interior view of south aisle roof

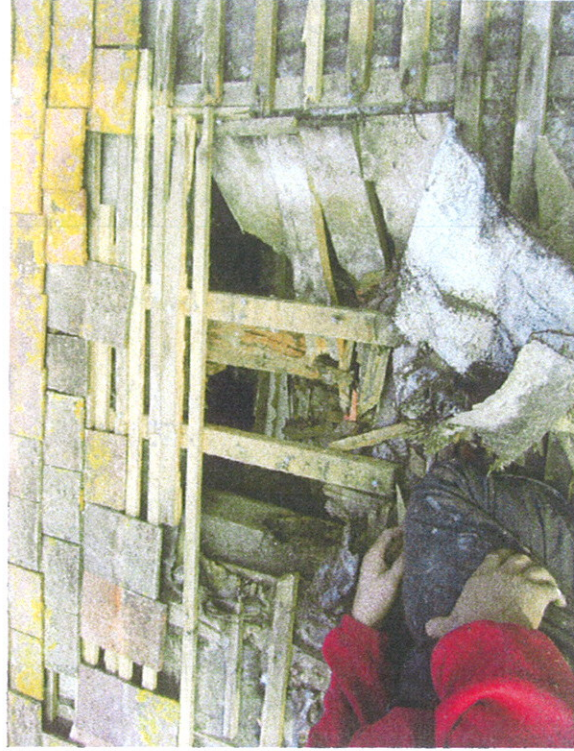
- 4.3.3 During restoration a large hole was found in the roof, this had been inexpertly repaired with wood and painted sacking (Plate 2). The splintering of the common rafter beneath the repair and the size of the hole strongly suggests that some form of military projectile had hit the roof at some point.

Plate 2: Hole in south aisle roof

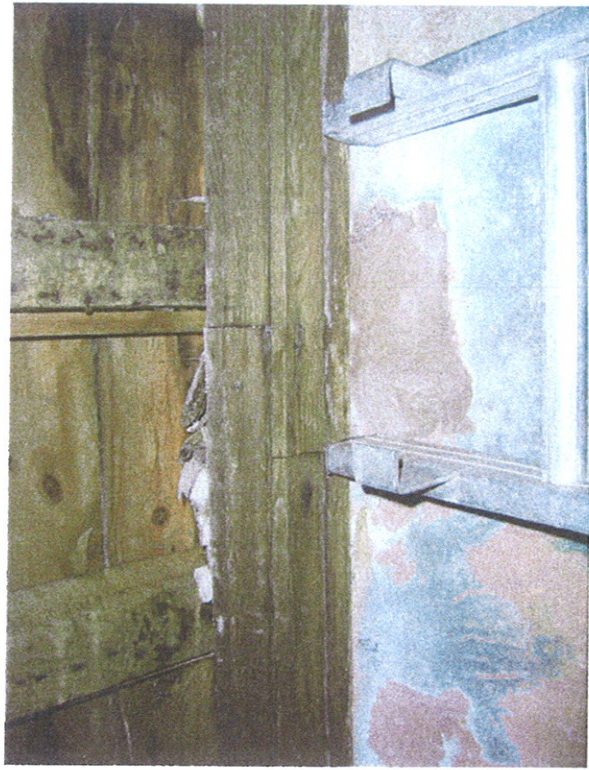
- 4.3.5 The main elements of the structure rested on a wallplate on the south wall; this was hidden from the interior of the church by a 19th century wooden moulding (Plate 5). When the moulding was removed the wallplate itself was seen to be very rotten in several places and detailed examination and recording was not possible. The state of the timber was so poor that in places it fell away to the touch.

Plate 5 :19th century moulding at top of aisle wall

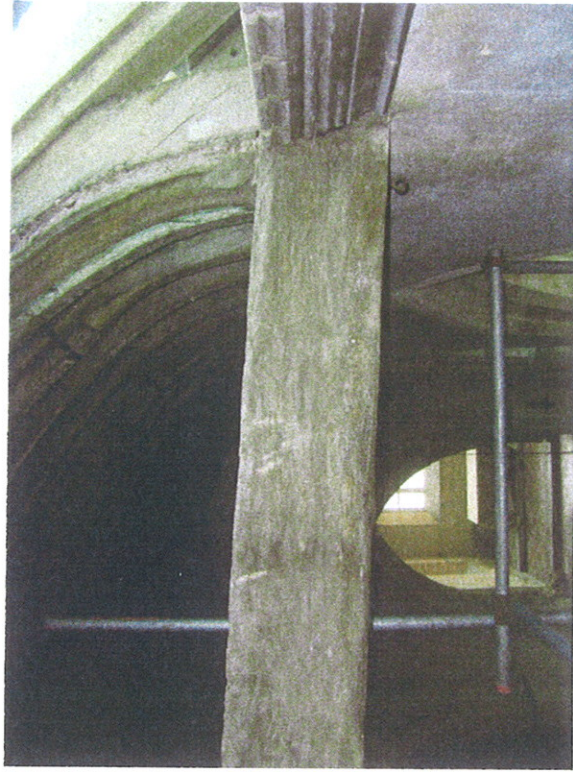
Plate 7: Nave roof showing aisle rafters attached to nave rafters (on right)

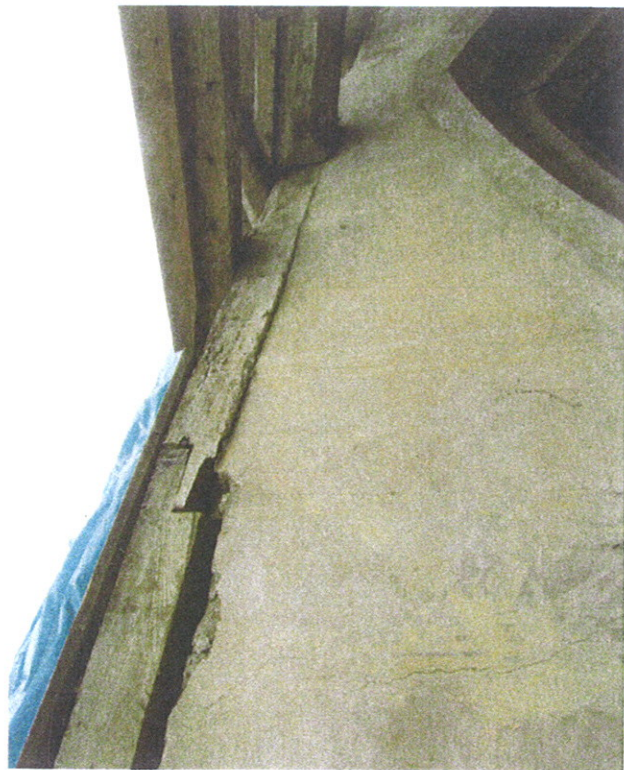
timbers making up the wallplate are joined with edge-halved scarf joints which are known from the 14th century onwards and are consistent with a 15th century date for the roof (see Plate 6).

Plate 6: Wallplate on south arcade wall

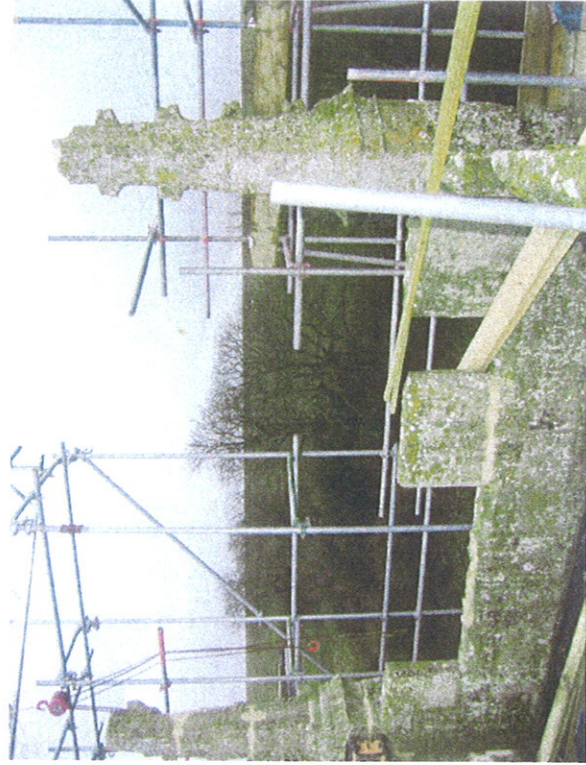
- 4.3.11 Two merlons were completely missing from the tower parapet, one from the west side and one from the south side. The south-west and the south-east pinnacles were in poor condition having suffered heavily from weathering and required repair (Plate 8).

Plate 8: South tower pinnacles during repair

- 4.3.13 The existing stonework of the pinnacles was repointed and a new carved finial was fitted to the south-east pinnacle. The south-west pinnacle had the crocketed member immediately below the finial renewed and the existing finial was refitted on the new block (Plate 10)

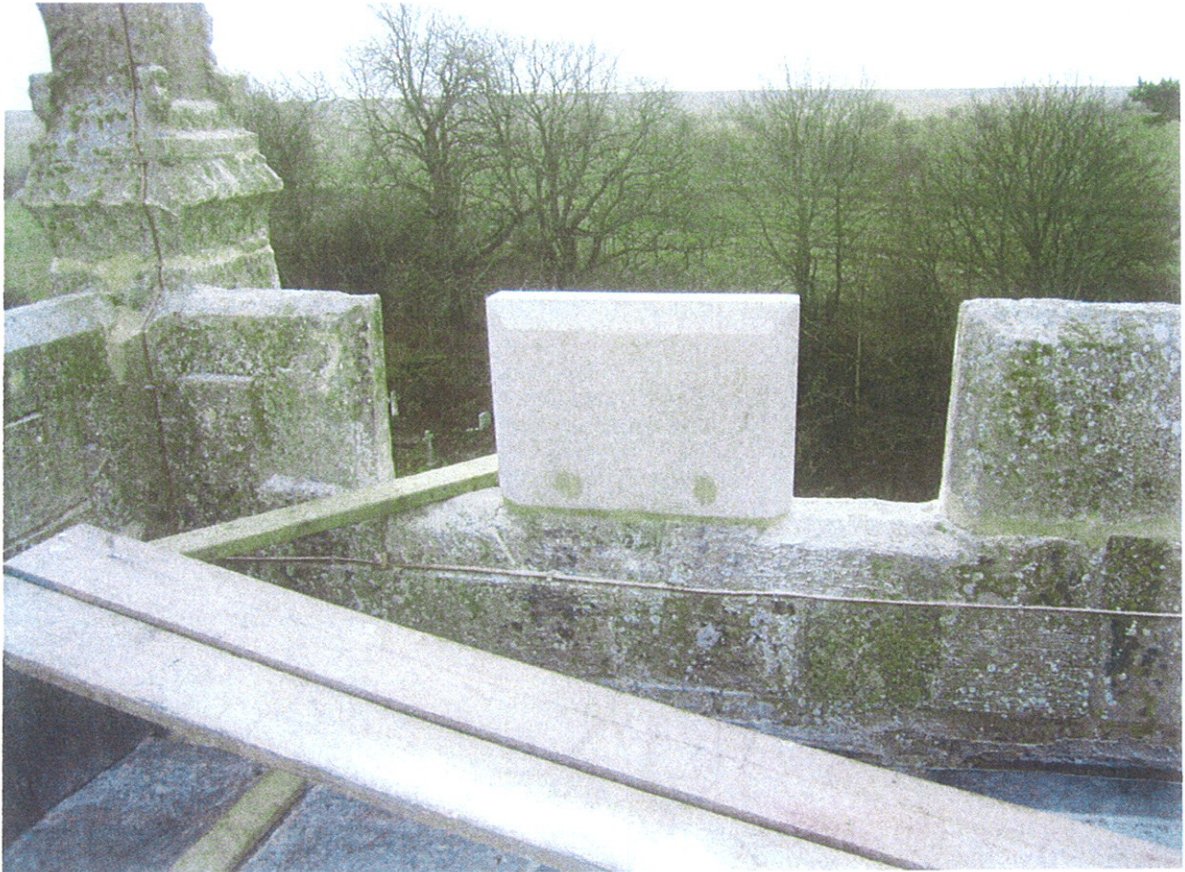
Plate 9: Rear view of replaced merlon

- 4.3.12 The existing merlons were each carved from one block of stone with moulded upper and side faces chamfered at the rear. The two missing examples were replaced with identical newly carved blocks matching the existing mouldings. These were bonded to the existing parapet using lime mortar (Plate 9).

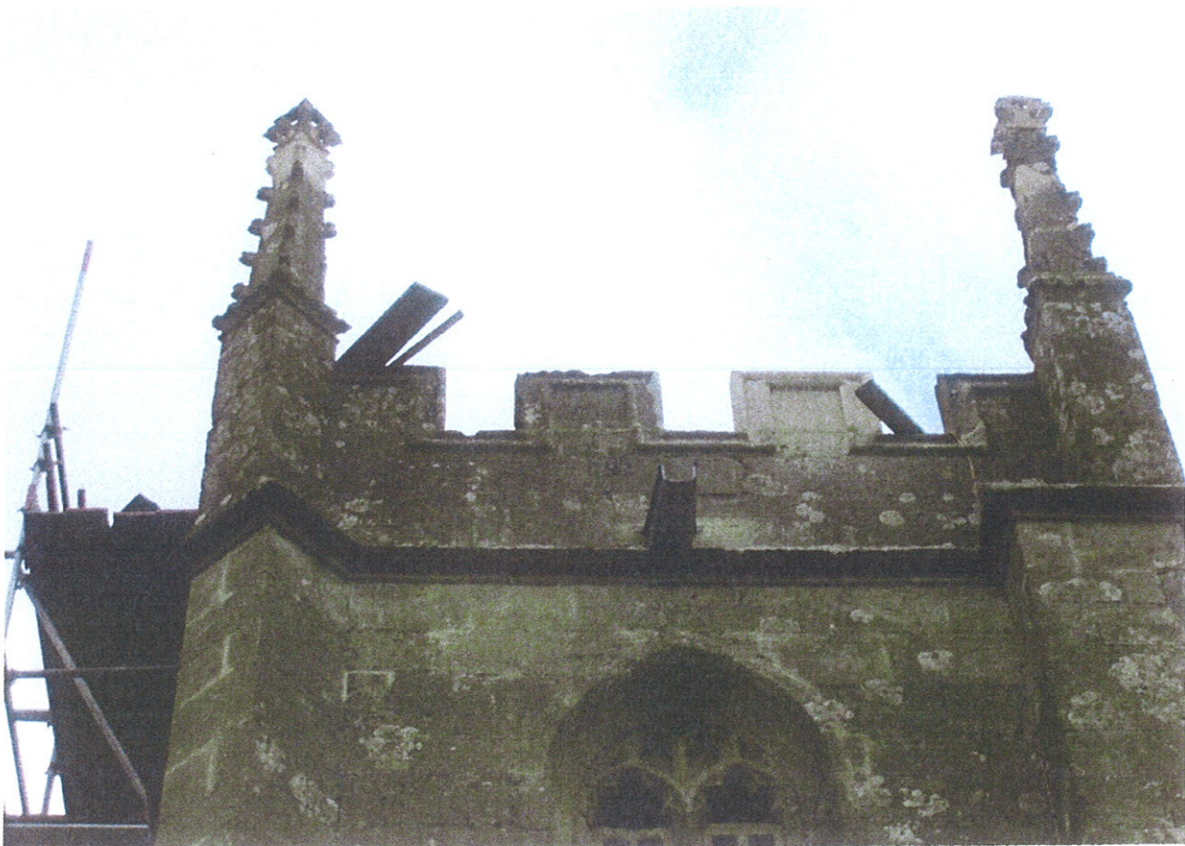
Plate 10: Upper south side of tower showing repaired pinnacles and merlon
