# St. Mary's Church Guildford Surrey

## Archaeological Investigations

August 2012

Issue No: 1  
OA Job No: 4760  
NGR: SU 9960 4930

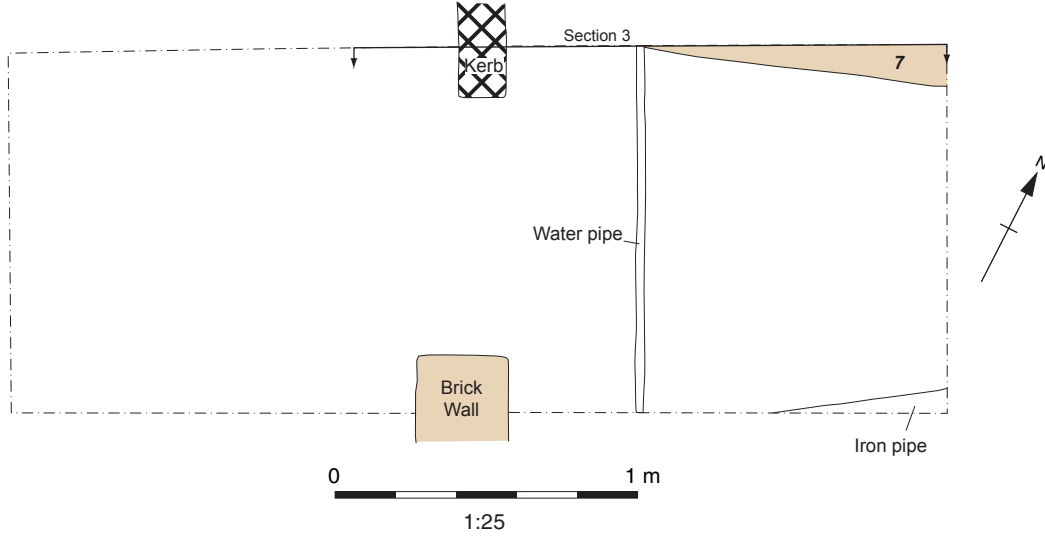
Figure 3: Plan of trench 1

- 3.2.4 Excavation of the trench revealed two features (Figs 3 and 4), the first was a NW-SE orientated modern service trench (3). This cut extended across the trench and measured 0.42m wide and had its base 0.8m BGL. The second feature (8) was located in the north-eastern corner of the trench and was only partly uncovered. It extended for 1m along the northern side and 0.16m on the eastern side and was 1.52m deep. The fill of the cut (9) was identical to burial soil (1) making the feature very hard to see. At its base was a brick structure (7) which took up the entire revealed length and breadth of the cut and stood 0.44m high (Plate 5). It consisted of six courses of brick, two of which made up the walls whilst the other four made up the revealed portion of a vaulted roof. Whilst originally thought possibly be a brick lined and vaulted shaft tomb the further investigations show that it was a post-medieval culvert.

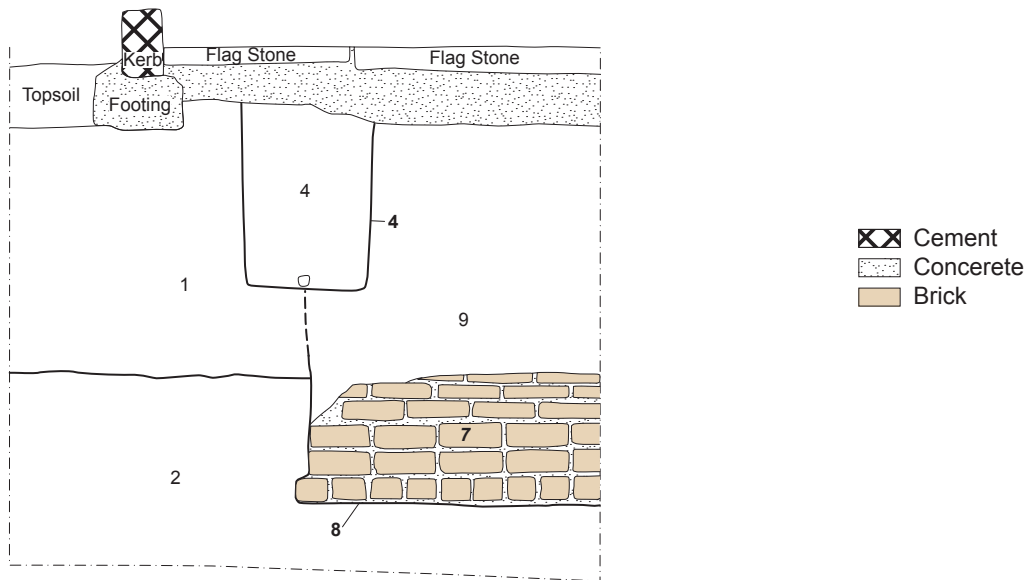
- 3.2.3 Throughout Trench 1 and its extension a friable dark-brown silty loam extended up to a depth of 1m BGL (1). Beneath this lay a compact light grey-brown silty loam (2), which extended down to a depth the working depth of 1.86m BGL in the eastern half of the trench and 2.0m in the western half. These were interpreted as a graveyard soil, and an old graveyard soil respectively.

Figure 4: Section 3 - south-east facing section of trench 1

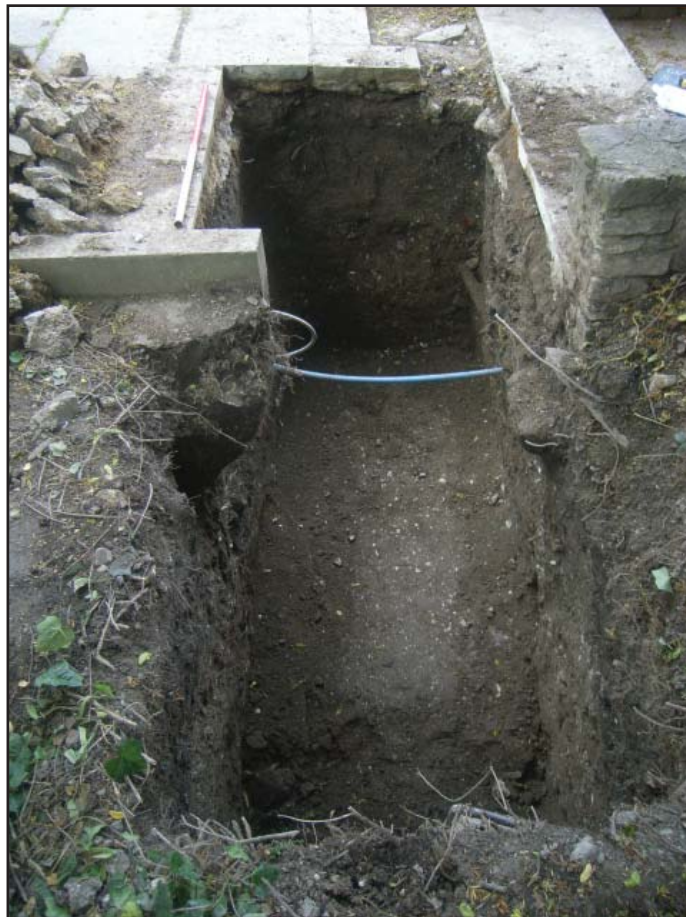
Plate 4: Trench 1

- 3.2.1 Trench 1 was located to the south-west of St Mary's Church (Figs. 2 and 3) It was aligned NE-SW and measured 3.1m by 1.2m (Plate 4). Prior to the excavation of the trench flagstone paving, some kerb stones and their footings had to be removed from the north-eastern half of the trench. The south-western half of the trench was excavated through the churchyard's topsoil which was also present in Trench 2.
- 3.2.2 A north-south aligned extension to Trench 1 measured 4.3m in length, 0.4m in width and up to 0.8m was dug for the drainage pipes. Flagstone paving slabs and their bedding also had to be removed from this extension

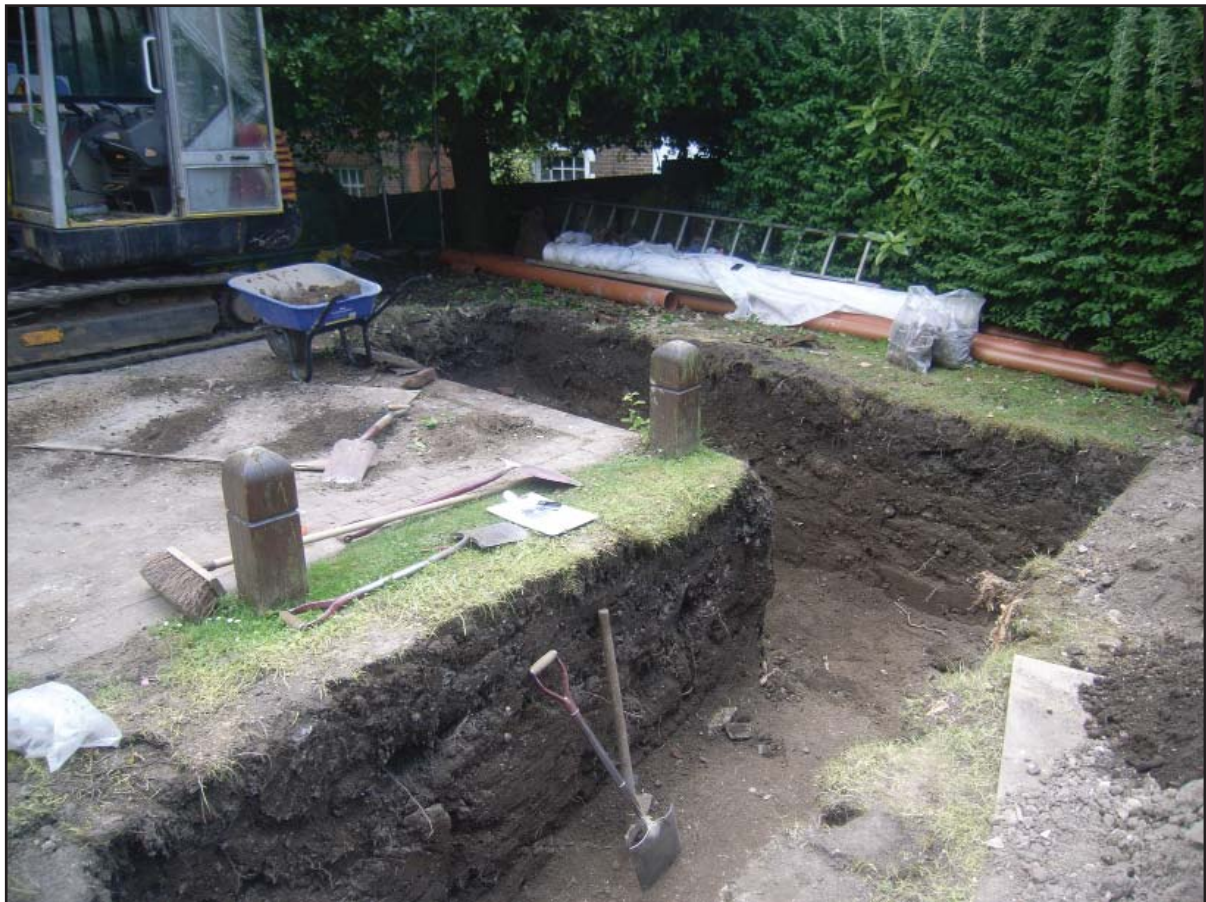
Plate 6: Trench 2

- 3.2.8 The shape and target depth of Trench 2 was altered to allow the necessary volume of the soakaway to be constructed without disturbing any more burials or damaging the Church's car park. An extension was excavated on the western end of the trench measuring 4.0m in length, 1.3m wide and orientated north-south, making Trench 2 into an L shape in plan (Plate 6).

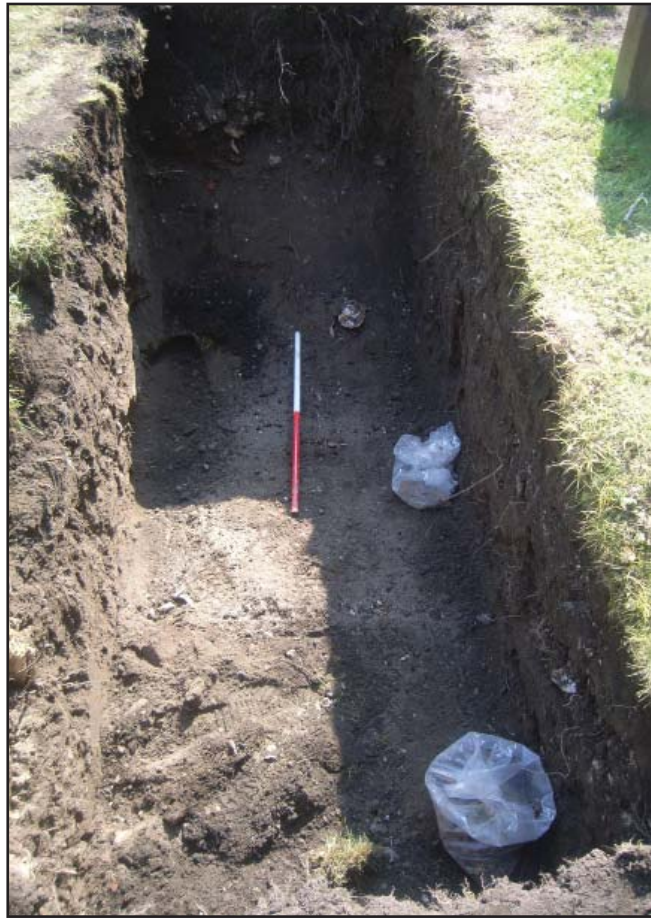
Plate 7: Burials 10 and 11

- 3.2.7 At a depth of 1.3m BGL two human skeletons were partly uncovered (skeletons 10 and 11) (Plate 7). The skeletal remains of a juvenile (11) were located central to the trench and an adult skull along with the decayed remains of a coffin (10) were located next to the eastern end of the trench. Neither skeleton was fully excavated and were covered over to prevent any further damage or disturbance to them. The grave cuts could not be seen due to the similarity between the backfill and the surrounding soils and as such were not recorded.

- 3.4.3 Despite their shallow depth of burial at only 1.3m BGL it is likely that the two burials from Trench 2 (**10** and **11**) are post-medieval. This is due to evidence of a coffin with SK 10; the practice of placing the corpse within a coffin for burial was relatively rare in the medieval period (Gilchrist and Sloane 2005), but became increasingly popular from the seventeenth century, and ubiquitous from the early eighteenth century onwards (Litten 1991). Given the good condition and low degree of fragmentation of skeleton **11** it seems unlikely that is of a medieval date and it is entirely possible that it was too interred in a

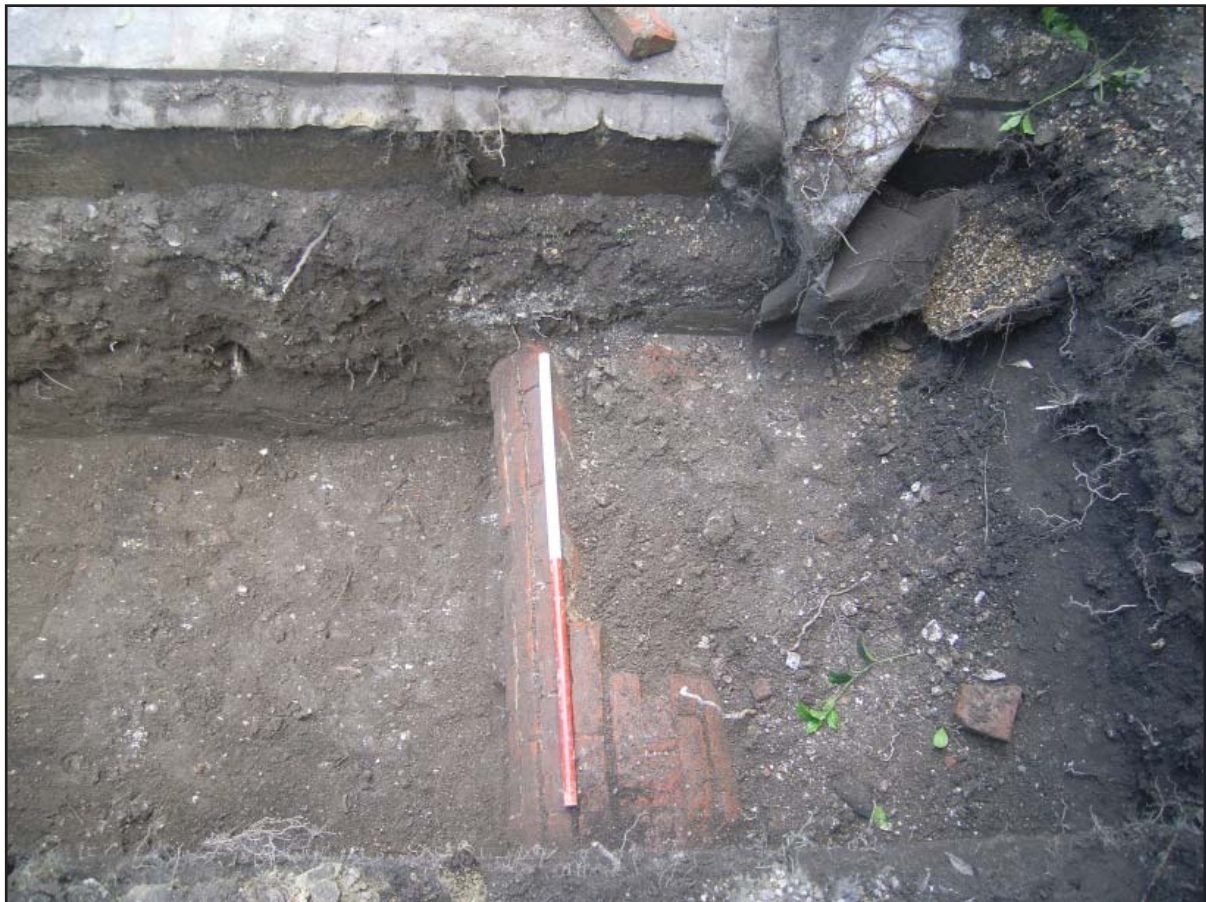
Plate 8: Culvert 12

- 3.2.9 No further burials were uncovered during the extension of Trench 2, but a post-medieval brick culvert was uncovered (12) (Plate 8). It was orientated on an east-west alignment and measured 0.44m wide and 0.44m high. Its construction was found to be identical to culvert (7) in Trench 1. Once it was established that it was fully out of use it was demolished to allow for the construction of the soakaway. A target depth of 1.3m was obtained without the discovery of any further archaeologically significant deposits.

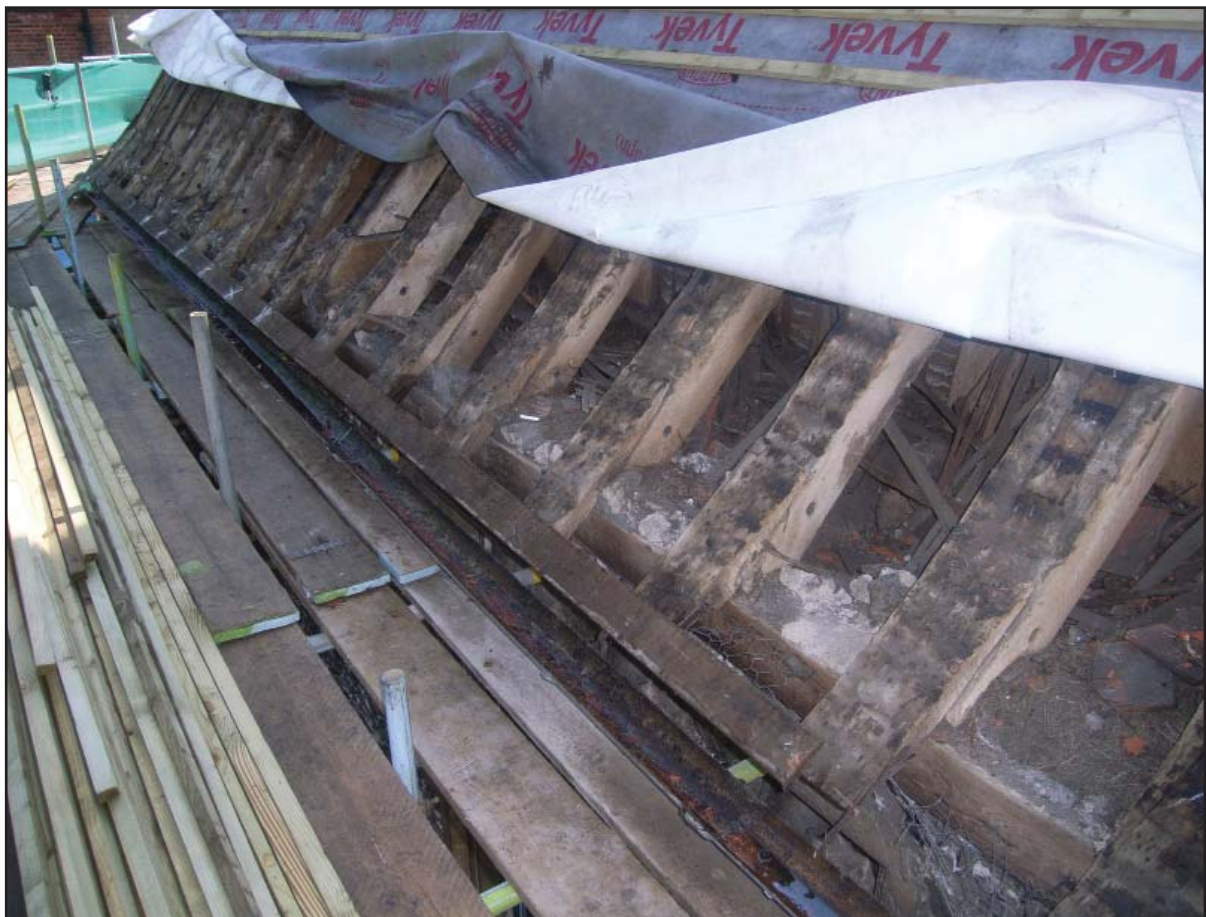
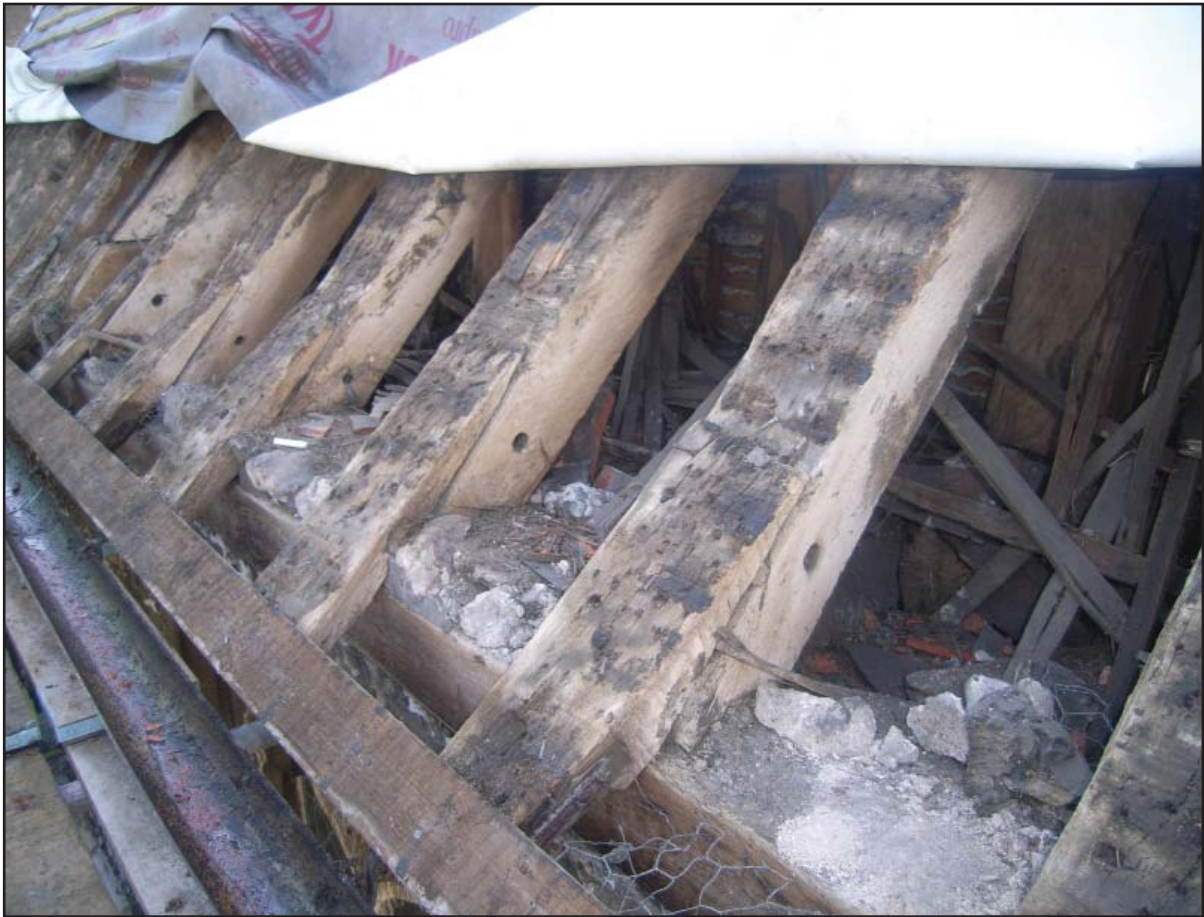
- 4.2.8 One minor feature of some interest in the roof is a single circular hole visible in the east side of almost all the rafters, c.20 cm up from the base (Plates 10-11). The holes are c. 2.5 cm in diameter and they are generally just in the east side so they clearly don't extend right through the rafters. Similar features have been noted by OA and other buildings archaeologists in other historic roof structures and their function has been the subject of speculation in a number of articles (see Johnson B, 1987). It is believed that they may have related to the initial temporary setting out of the roof timbers on the ground before all the joints are firmly fixed together. It may be that there were small ties in these holes to hold the roof together.

Plate 10: Rafter feet exposed on north side of roof

Plate 11: Rafter feet exposed on north side of roof

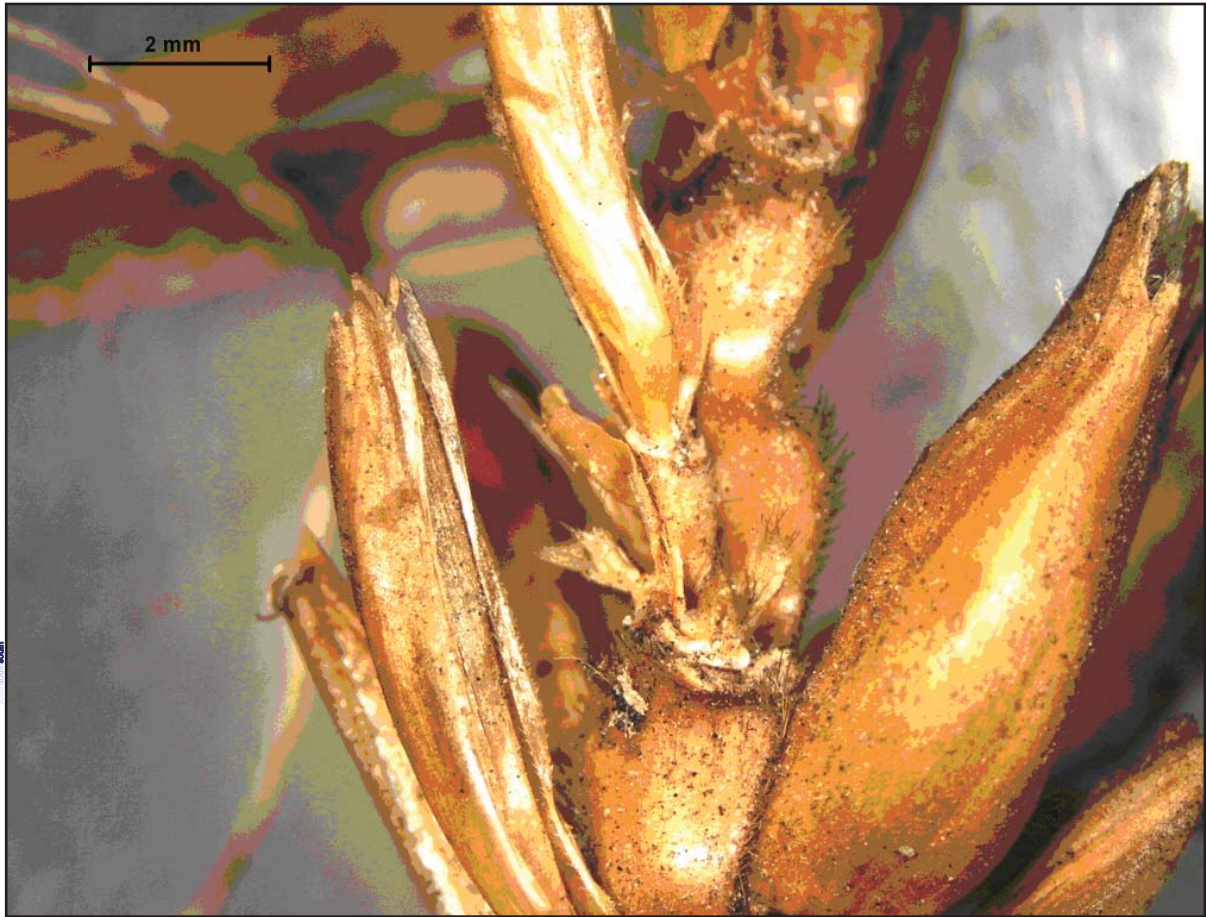
- 5.1.1 A sample of desiccated organic packing was taken by OA from between ceramic roof tiles from the north end of the chapel roof and from the south and north sides of the chancel roof of St. Mary's Church, Guildford, Surrey. The packing was clearly primarily cereal straw and there was no obvious lime/mortar binding it to the tiles. It appears to have been held in place simply through the weight of the tiles, which were pinned into position with wooden pegs. The church architect has suggested that this material most likely is derived from repairs to the church roof recorded in either 1825 or 1863.

Plate 29: Bread wheat rachis segments from the tile packing in the east end of the north chapel roof

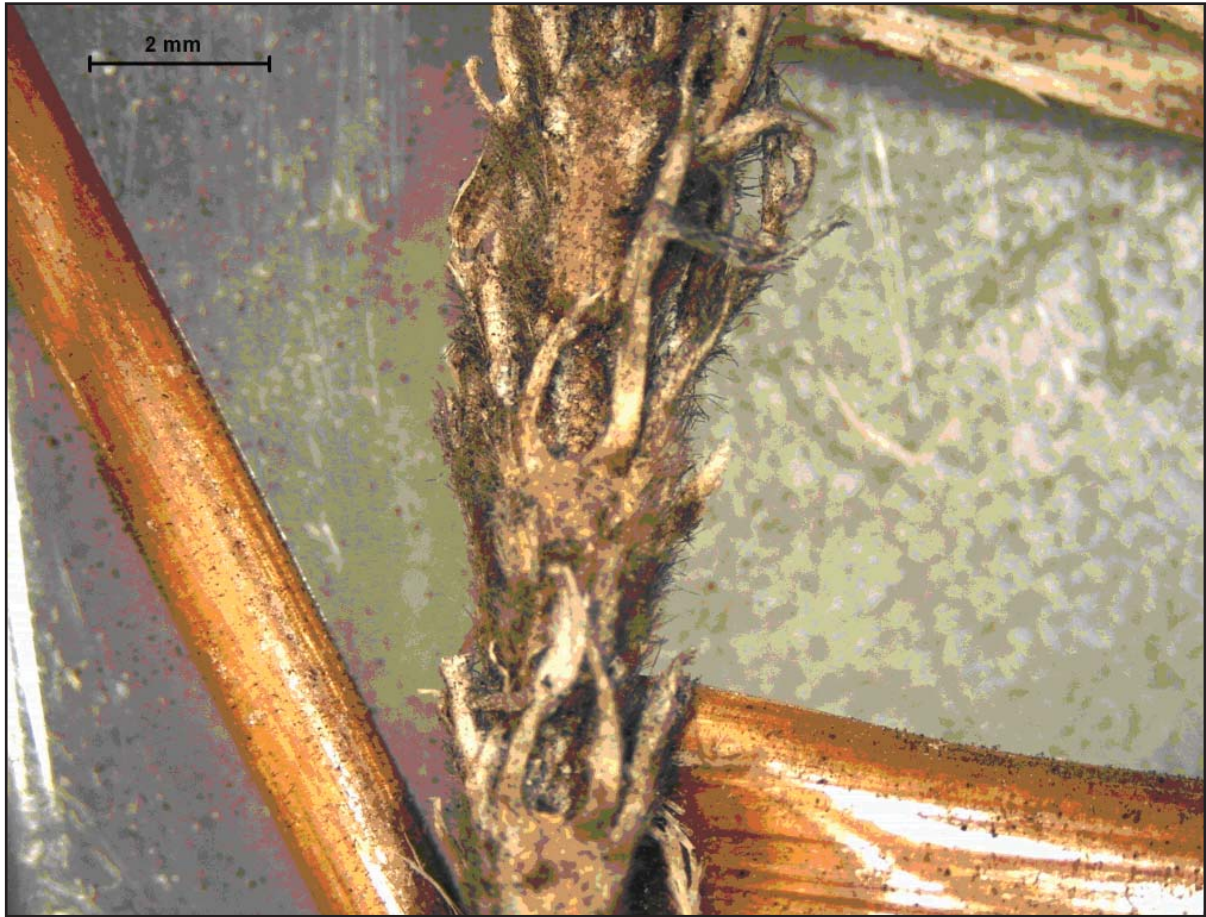
Plate 30: Rye rachis from tile packing on north side of Chancellery roof
