18th Century Stables
of the Former
Debden Hall
Debden
Essex

Historic Building Survey

July 2011

OA East Report No: 1282
OASIS No: oxfordar3-102361
NGR: TL 5495 3334

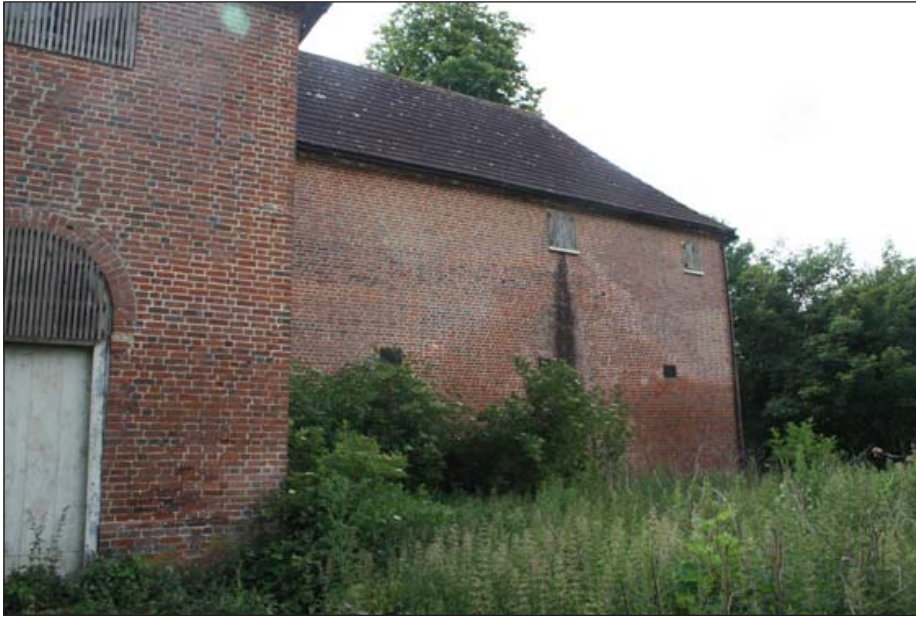
Plate 3: North-West facing elevation

- 4.2.5 The southern end of this elevation has little detail (plate 3). Close inspection of this external elevation was hampered by considerably over-grown thistles and shrubbery. There are two original window openings at first floor level (concealed with wooden slats) and three small square-shaped voids added later, possibly for ventilation at ground floor level. The mortar of the brickwork suggests some evidence of repair/re-pointing and there is also heavy water-staining due to inadequate rain-water guttering.

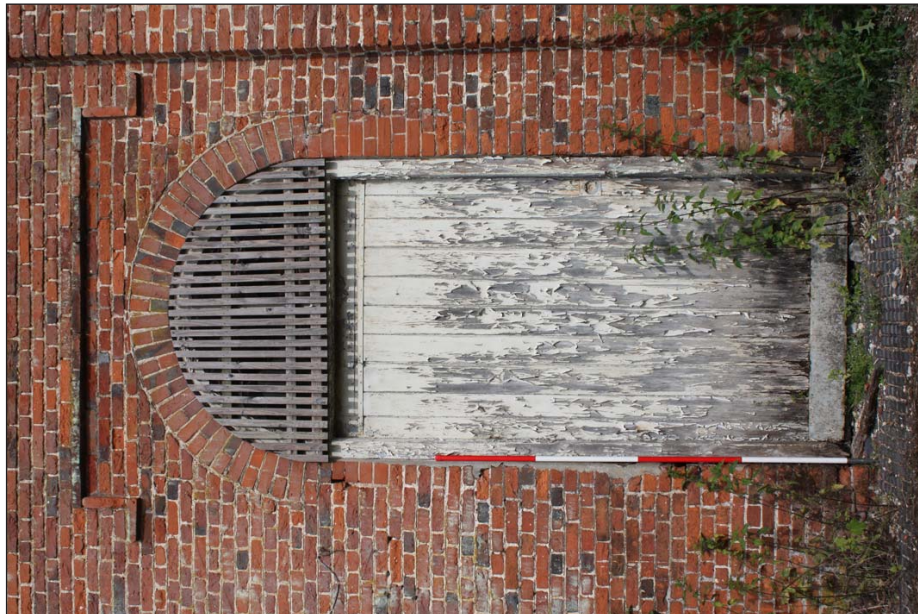
Plate 9: Detail of door on South-East facing elevation

- 4.2.13 Other than the sliding doors, there are two original doors still present on this elevation of the building. Both doors are constructed of ten vertical panels beneath a semi-circular fan-light (concealed) (plate 9). The original handles and locking mechanism are still present and are of particular interest (plate 10), consisting of a hinged looped handle for closing the door and a central "button" which releases the internal latch allowing for opening. Although a comparable datable type could not be found, they are likely to be an original fitting and possibly 18th century in date.

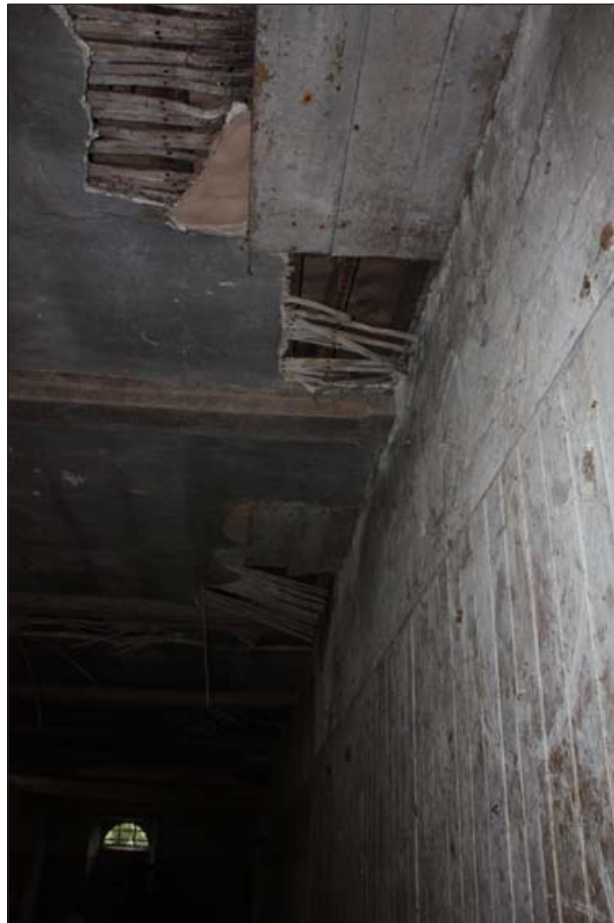
Plate 16: Detail of "hatches" in ceiling of G1

- 4.3.5 Most of the original ceiling covering has been repaired and replaced, however, at the northern end, there are four small rectangular hatches within the ceiling running along the western side of the room (plate 16). Three hatches would have provided access from above to throw down the hay into troughs located on the wall below. Their positions also correspond with the locations of the stalls below as indicated by the evidence on the walls.

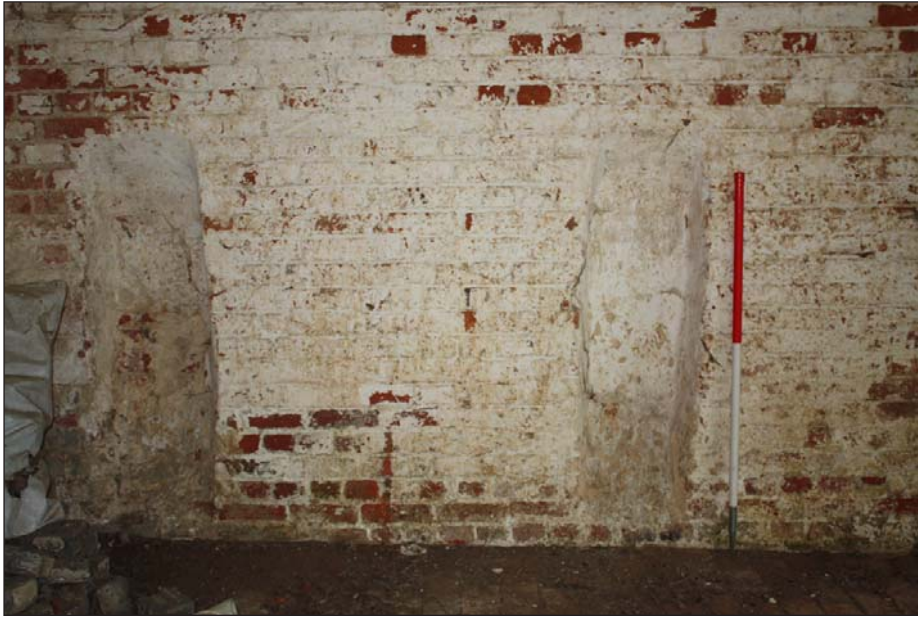
Plate 21: Detail of brickwork, G2, showing Cart Wheel “supports”

- 4.3.11 This part of the stables is most likely to be the “large coach house” referred to in the 1914 sale catalogue. Evidence of this is found on the rear of the internal wall where the grooves caused by, or created for, coach or cart wheels can be seen (plate 21).

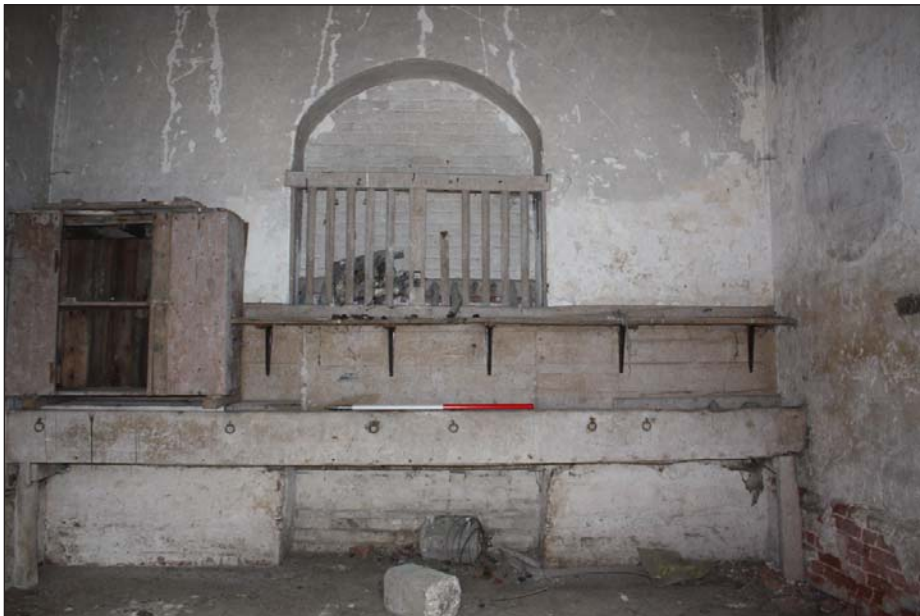
Plate 26: Internal view, G3

- 4.3.16 This room too contains fixtures and fittings associated with the stabling function which are in good condition (plate 26). A wooden trough spanning the full width of the room is still present, complete with small iron rings for tethering horses. It has a wooden shelf above and an arrangement of wooden slats within a recess to hold hay behind. This room was referred to by the current owner as a “foaling room”, and certainly the size of the room and its fixtures would fit the suggestion that it housed young horses and foals. The fixtures are likely to post date the blocking up of the doorway and therefore likely to be 19th century in date.

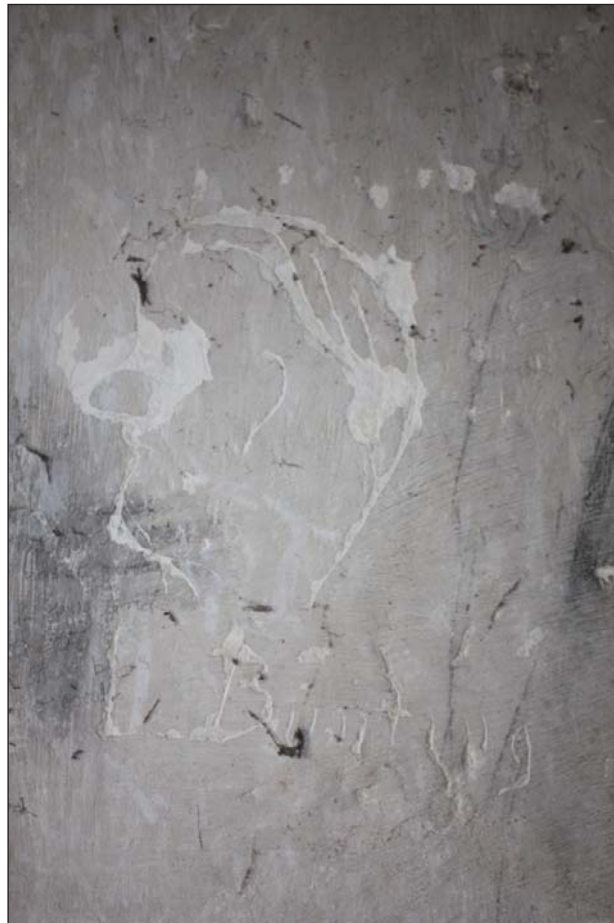
Plate 27: Graffiti, G2

- 4.3.18 On the internal wall, on the left as the room is entered, was the profile of a face graffitied into the wall plaster (plate 27). The name “?. BUNTING” appears below, however, it was agreed during the survey that the profile bears a good resemblance to Adolph Hitler and as the building is known to have been occupied during World War Two, it is a possibility that this profile is meant to depict the German leader. Further evidence for occupation during the war is to be found on the first floor. Background research has found a strong connection with the surname Bunting in Debden (www.debden.org/list.php), perhaps it depicts or was drawn by a member of this local family.

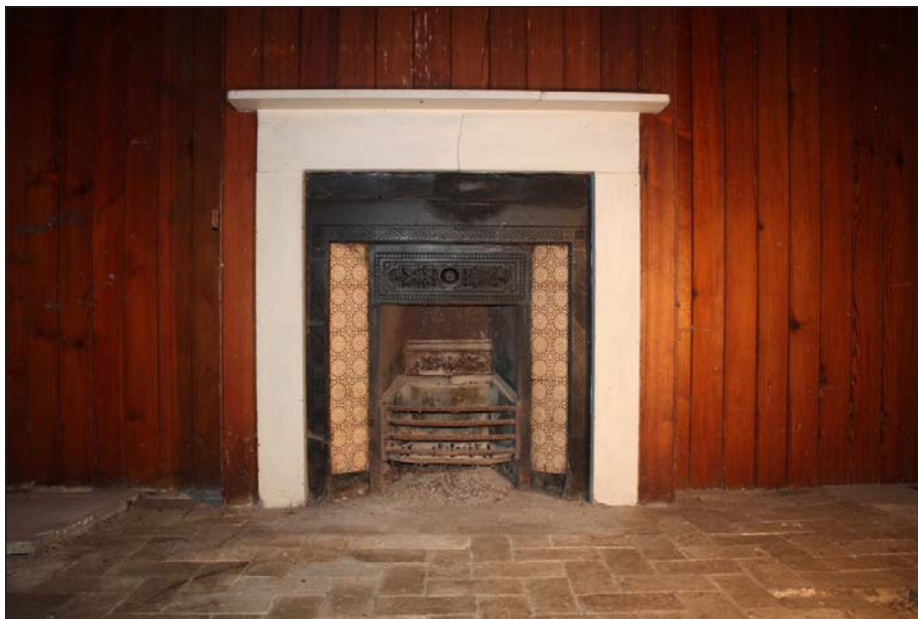
Plate 30: Fireplace, G5

- 4.3.25 All four walls of this room were entirely covered by vertically laid tongue and groove panels, painted in a dark wood stain. There is a small fireplace (plate 30). The fire surround had decorative brown patterned tiles down either side and a simple wooden outer surround and mantel. There is an iron patterned fireback and hood.

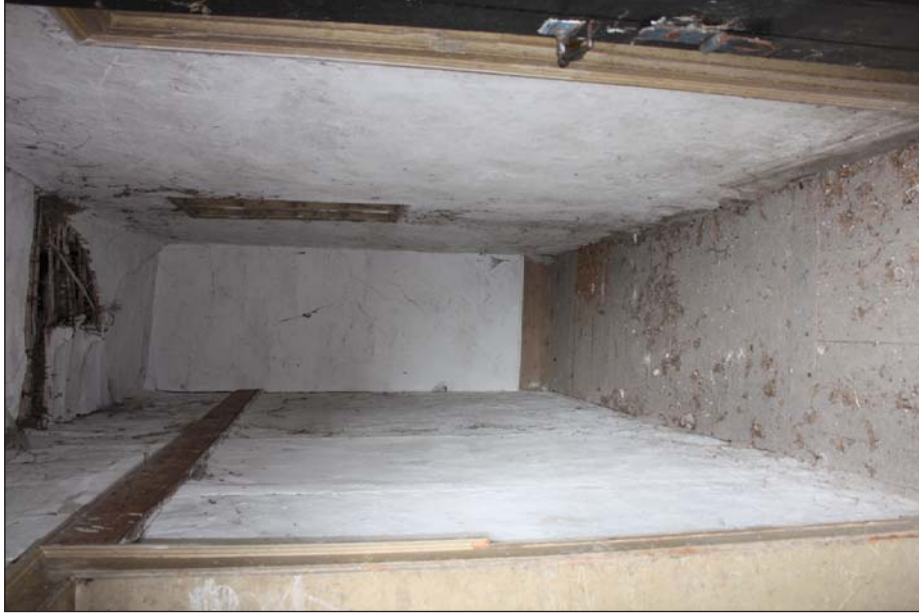
Plate 48: General view, F4

- 4.3.48 This area is a narrow corridor which has no obvious function or use (plate 48), measuring just 4.78m by 0.98m.
- 4.3.49 It appears that the floor boards have been replaced in this area and that the glassless “window” in F4 has been used to provide light into this space. There is also evidence in the ceiling of G5 directly below, that this was the site of the original access between the two floors. If this were the case the stairs, or most likely a simple ladder, would have linked G5 with the corridor area of F5 (which was lit by the window from G4 (plate 49)). This would provide a small contained area of accommodation over two floors perhaps for a coachman or more senior stable worker. This accommodation was most likely created in the early 19th century, however the access was altered when the external staircase was added.
