St. Nicholas' Church, Hedsor, Buckinghamshire

Archaeological Watching Brief Report

Oxford Archaeological Unit

June 1996

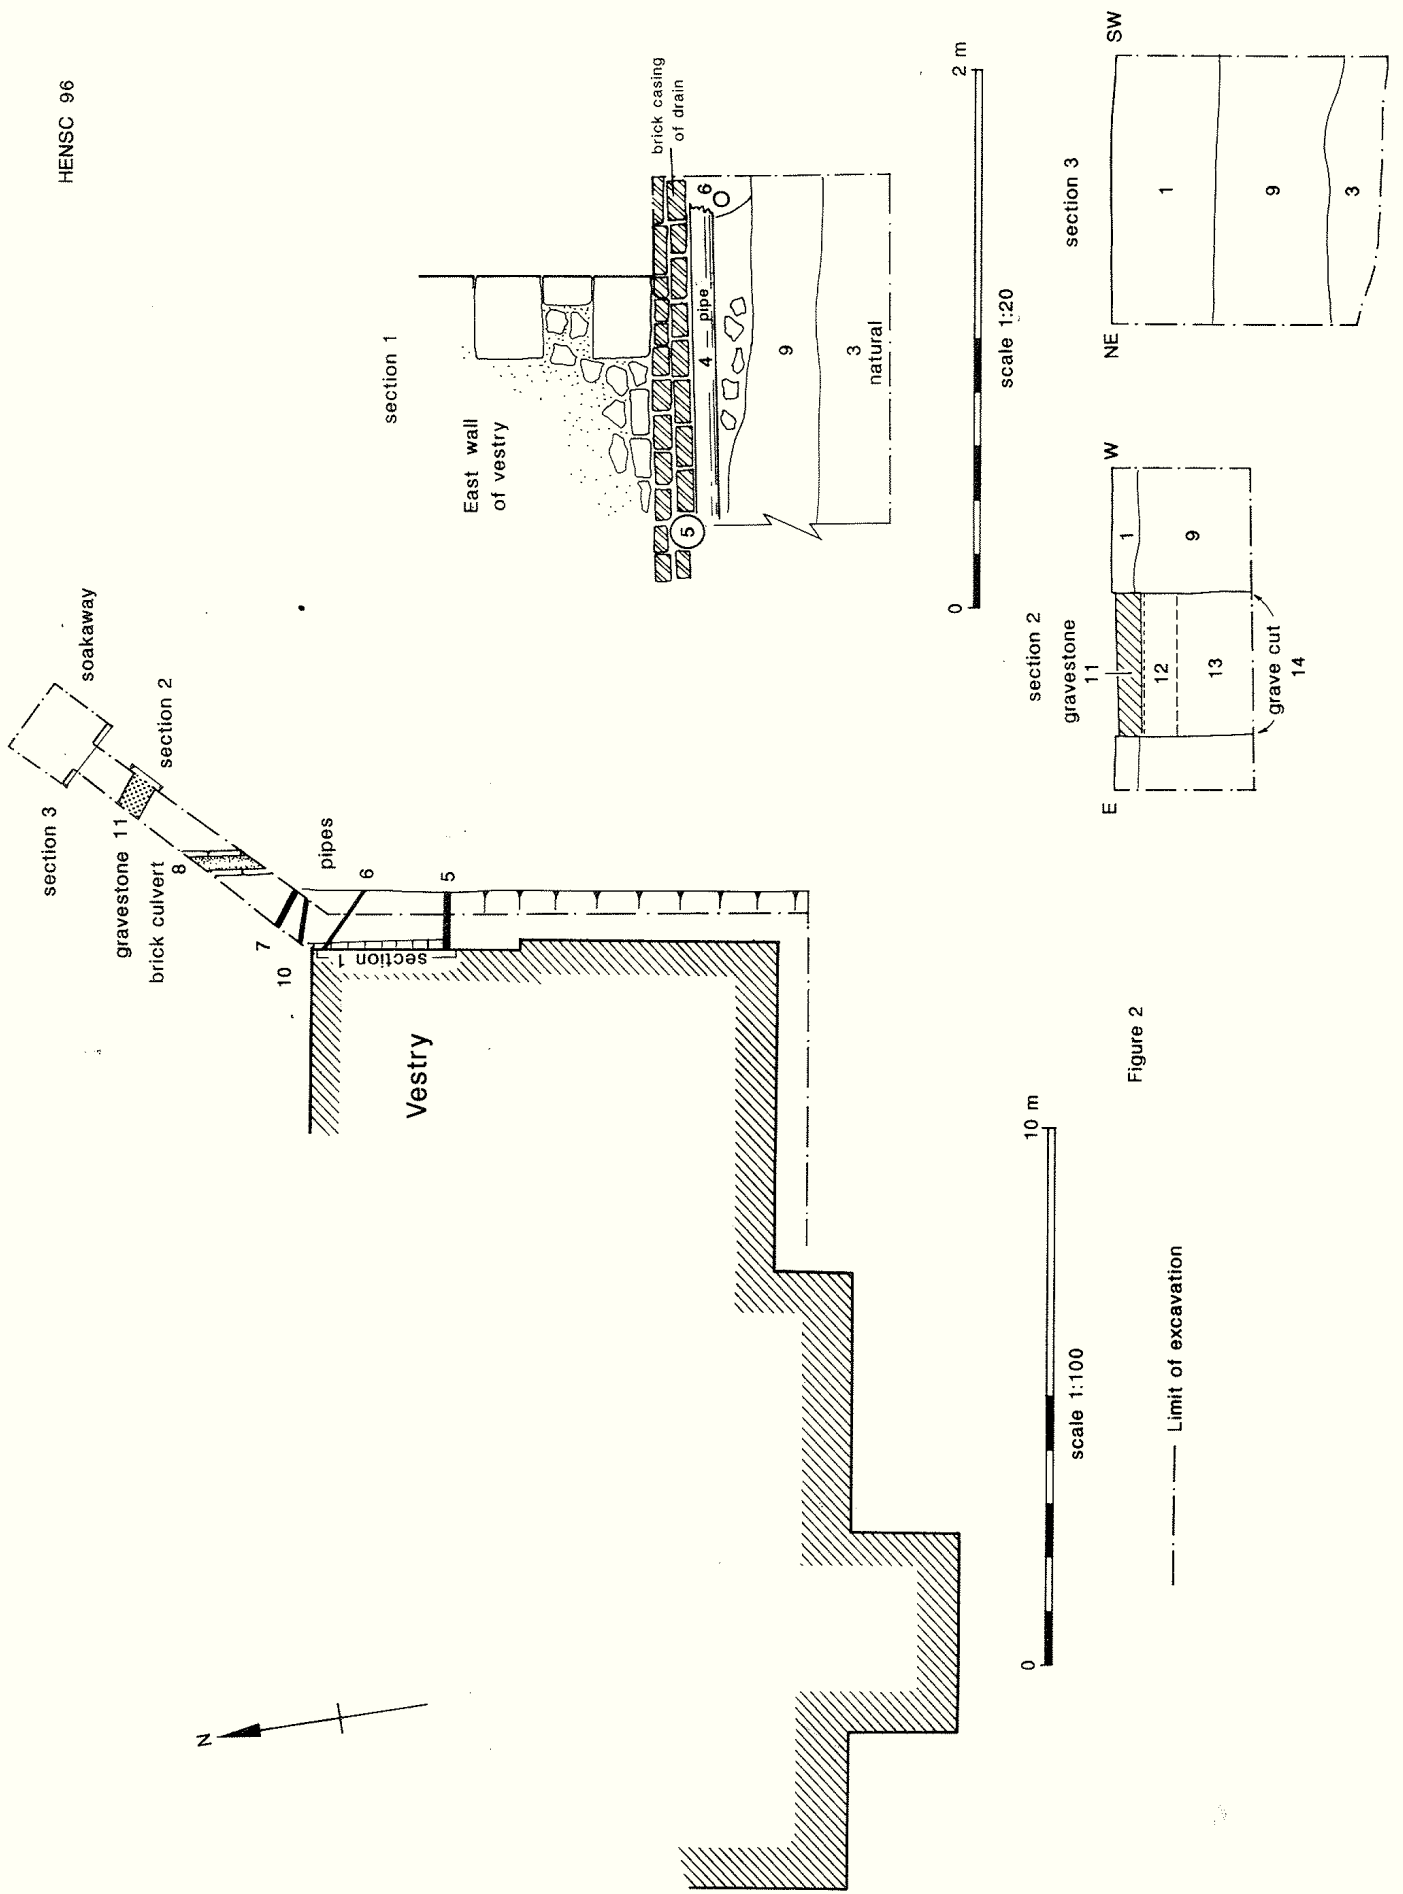
Figure 2

A new trench was excavated alongside the south and east walls of the church (Fig. 2), and was routed away from the north-east corner of the east wall to a soakaway pit. At the south side of the building the new trench was excavated to a depth of 1.8 m below the present ground level. The depth of the trench shallowed progressively around the east wall of the church, where the ground surface slopes to the north. At the north-east corner of the building, the base of the trench was 0.86 m below the ground surface. The section of trench leading to the soakaway pit was 0.5 m deep.
