All Saints Church Shirburn, Oxfordshire

Archaeological Evaluation: Part 1

ALL SAINTS CHURCH, SHIRBURN, NR. WATLINGTON, OXFORDSHIRE

ARCHAEOLOGICAL EVALUATION REPORT NGR SU 6965 9592

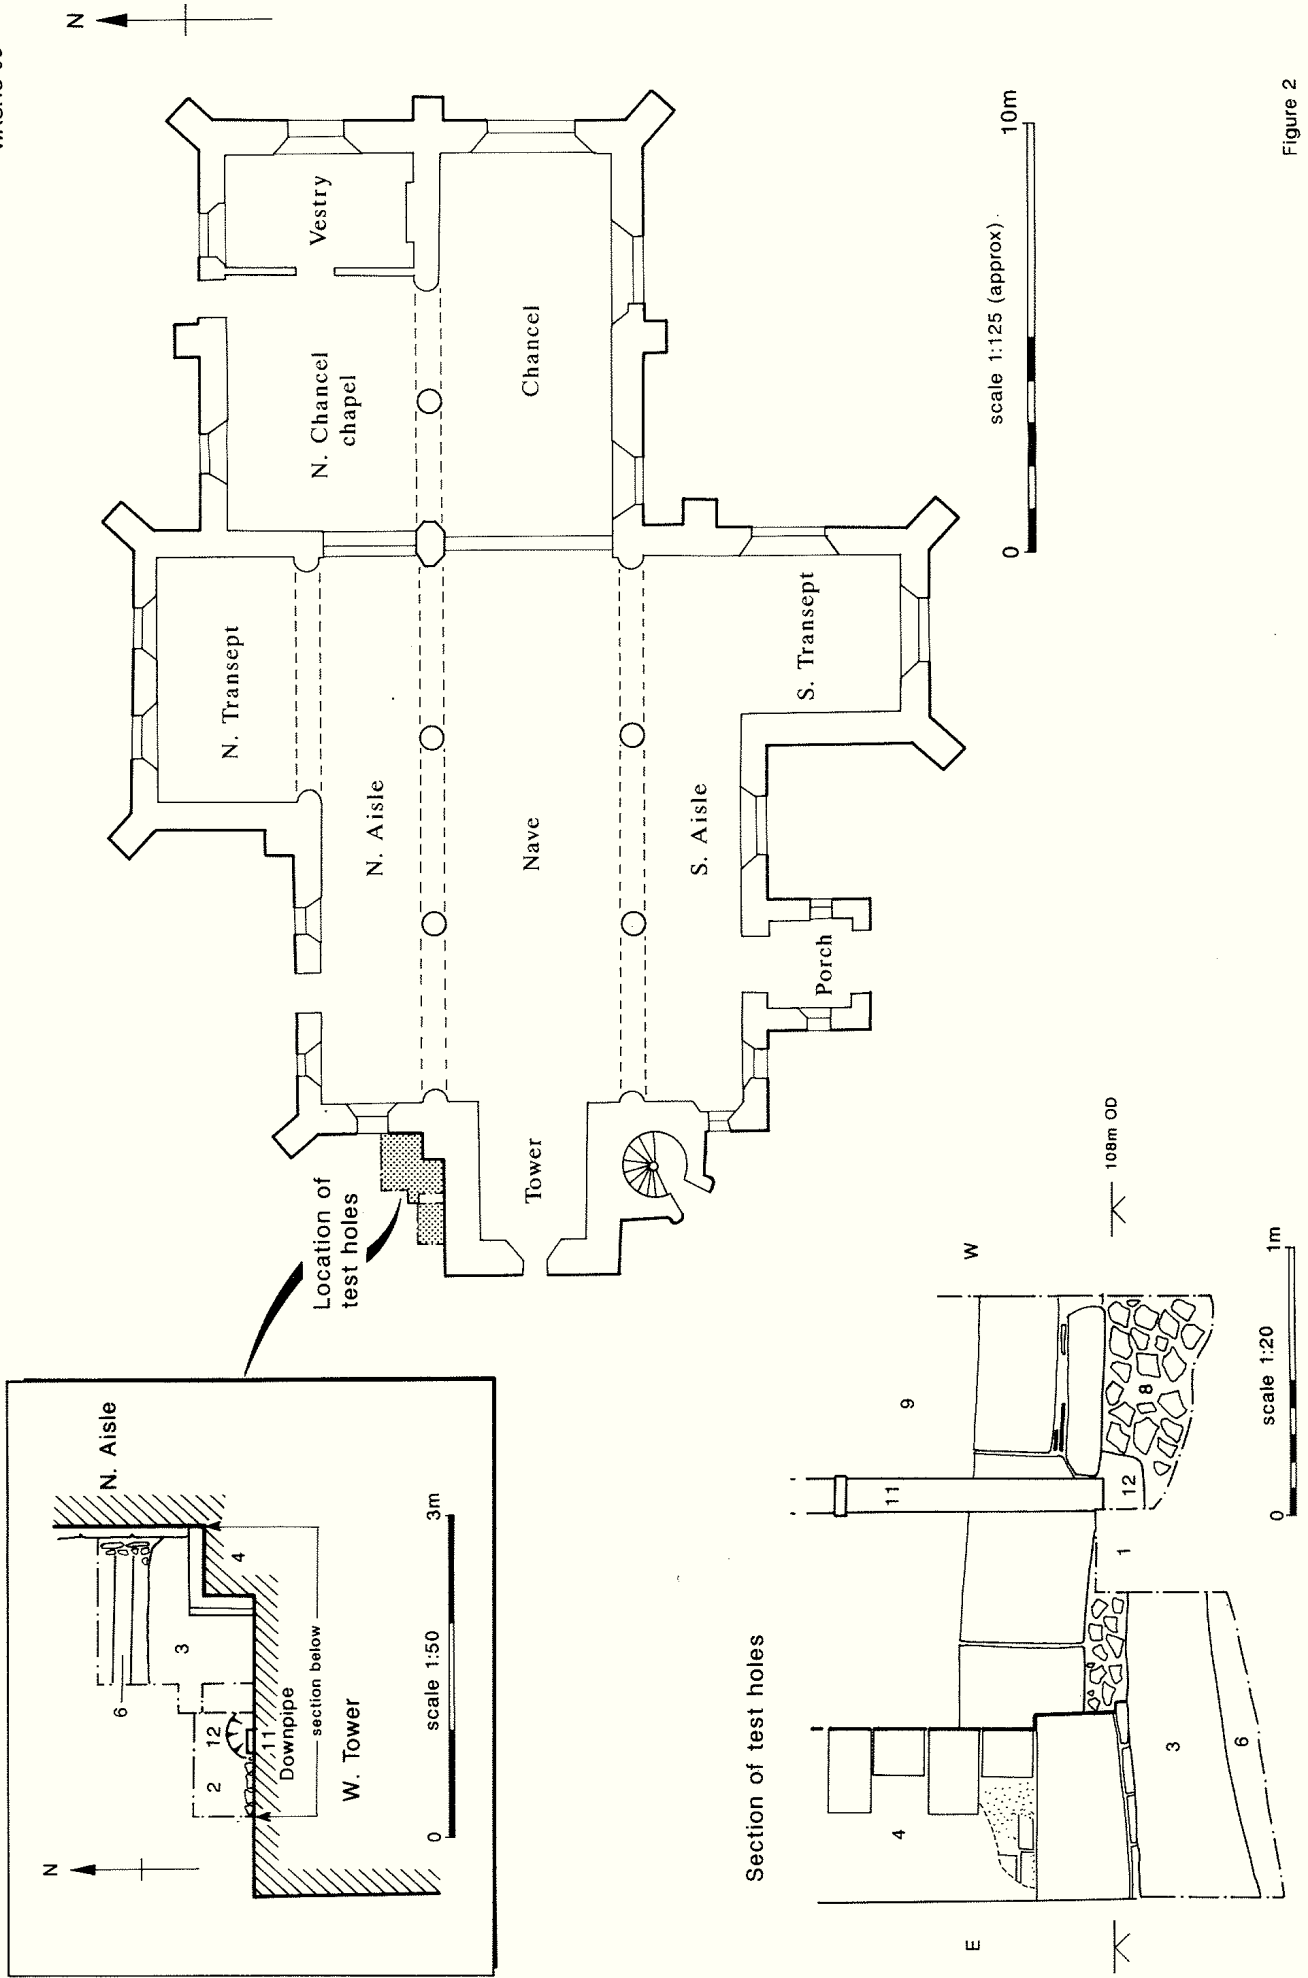
Figure 2

What was thought to be natural subsoil was uncovered 0.65 m below the ground level. The soil (6) was a dark brown sandy clay loam, and was very clean. The base of the foundation (10) of the North Aisle wall (7) was observed at this depth. The foundation consisted of a mix of whole flint nodules and chalk pieces bonded in a matrix of sand and mortar. The foundation was 0.52 m deep, and supported the wall proper.

The southward extent of this foundation was truncated by the insertion of later foundation material for a buttress (4) at the junction of the North Aisle wall and the Tower. Foundation 3 was between 0.38 m and 0.52 m thick, and consisted of a concreted block of sand, mortar, flint and brick. The base of the buttress was offset by one course of bricks at its west face, but there was no comparable offset at its north face. The buttress was constructed of red bricks, some of which show where the stucco has fallen away from the Tower wall.

A small hole was excavated against the north wall of the Tower, which revealed that the foundation material (8) was of the same type as that below the North Aisle wall. The flint and chalk footing was observed to be at least 0.35 m deep.

The base of an iron downpipe (11) against the north face of the Tower wall was investigated: the pipe was found to be blocked with leaves which had the effect of causing the pipe to fracture at a number of places, with the result that water was seeping down the walls from the cracks in the pipe. The base of the pipe was sunk into a concrete block soakaway.
