130a-130c Junction Road, Islington, London

Historic Building Survey

May 2013

OA East Report No: 1462

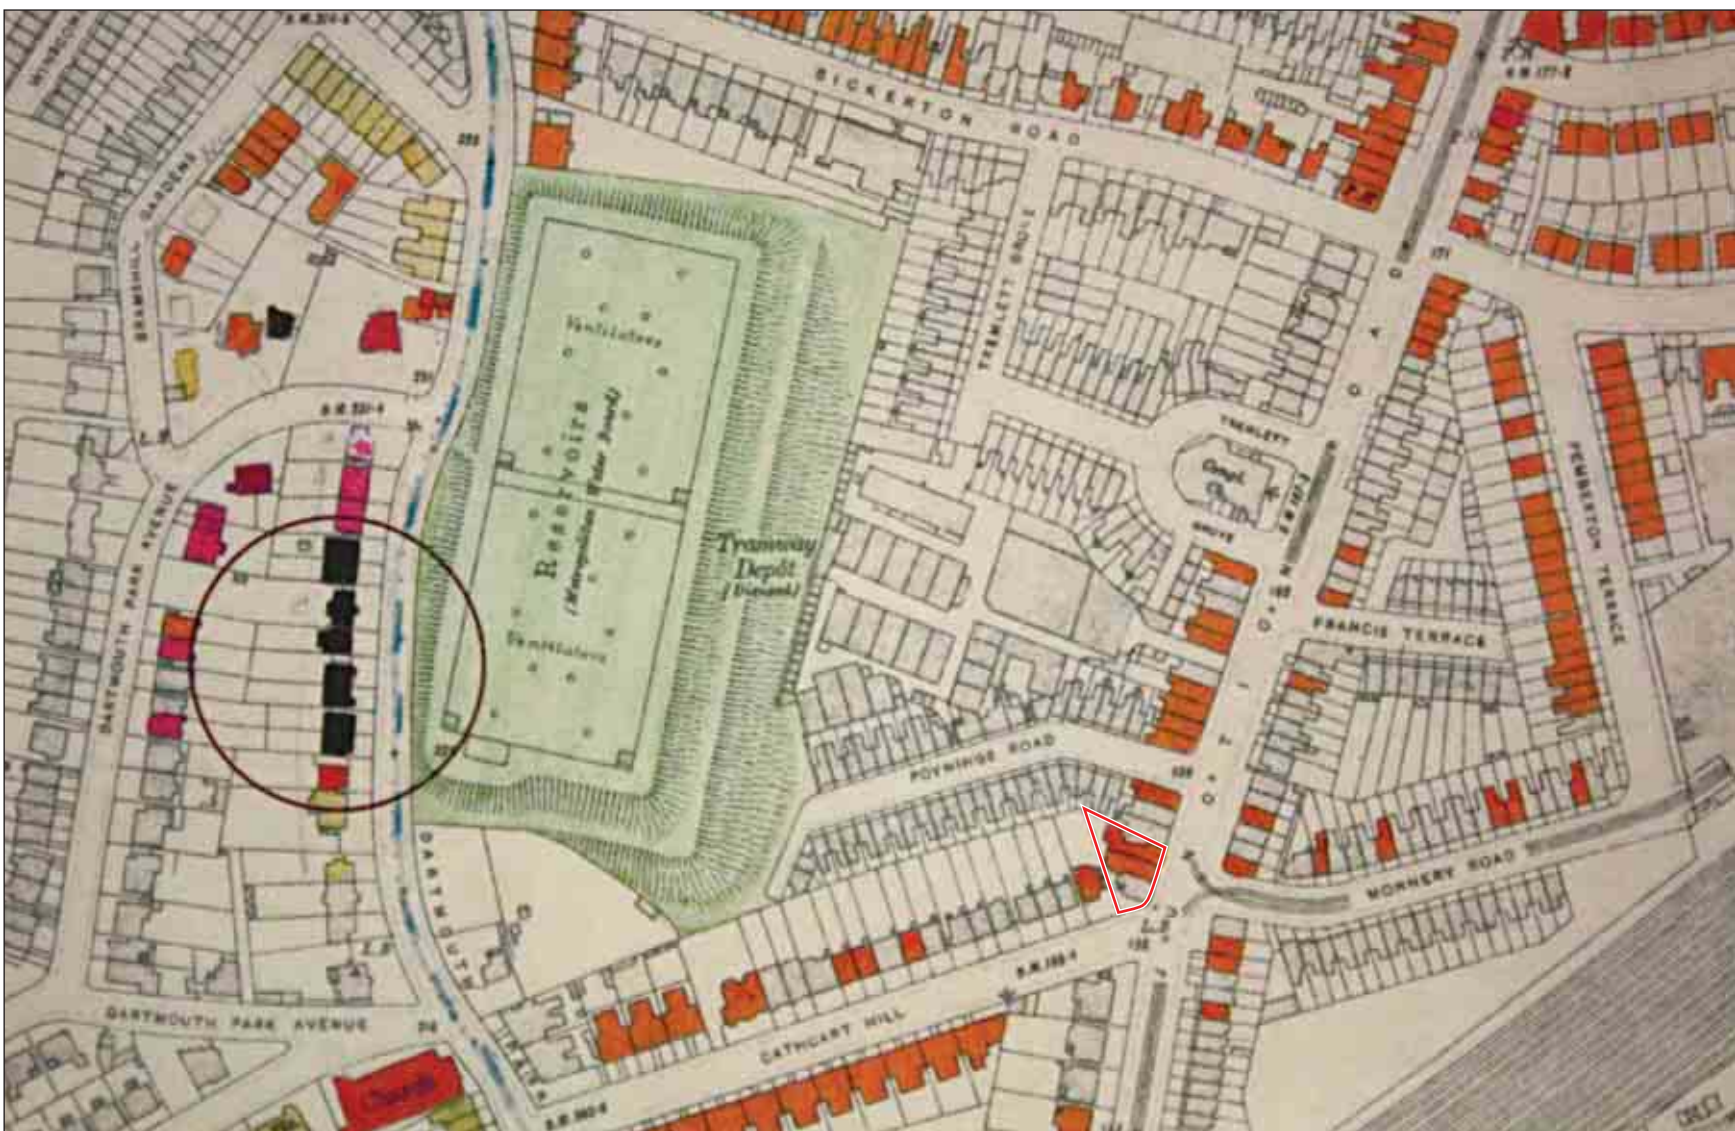
Figure 10: Extract from map of LCC War Damage Maps (1:2500), showing location of development area (red)

- 3.2.26 The LCC War damage map created to show the impact of bombing during the Second World War was most likely based on an existing Ordnance Survey map and so does not show any changes to the site at this time. It does however reveal that the buildings within the study site were damaged during air raids at this time. The accompanying key shows that 130b and 130c, coloured orange, sustained “general blast damage, minor in nature”.

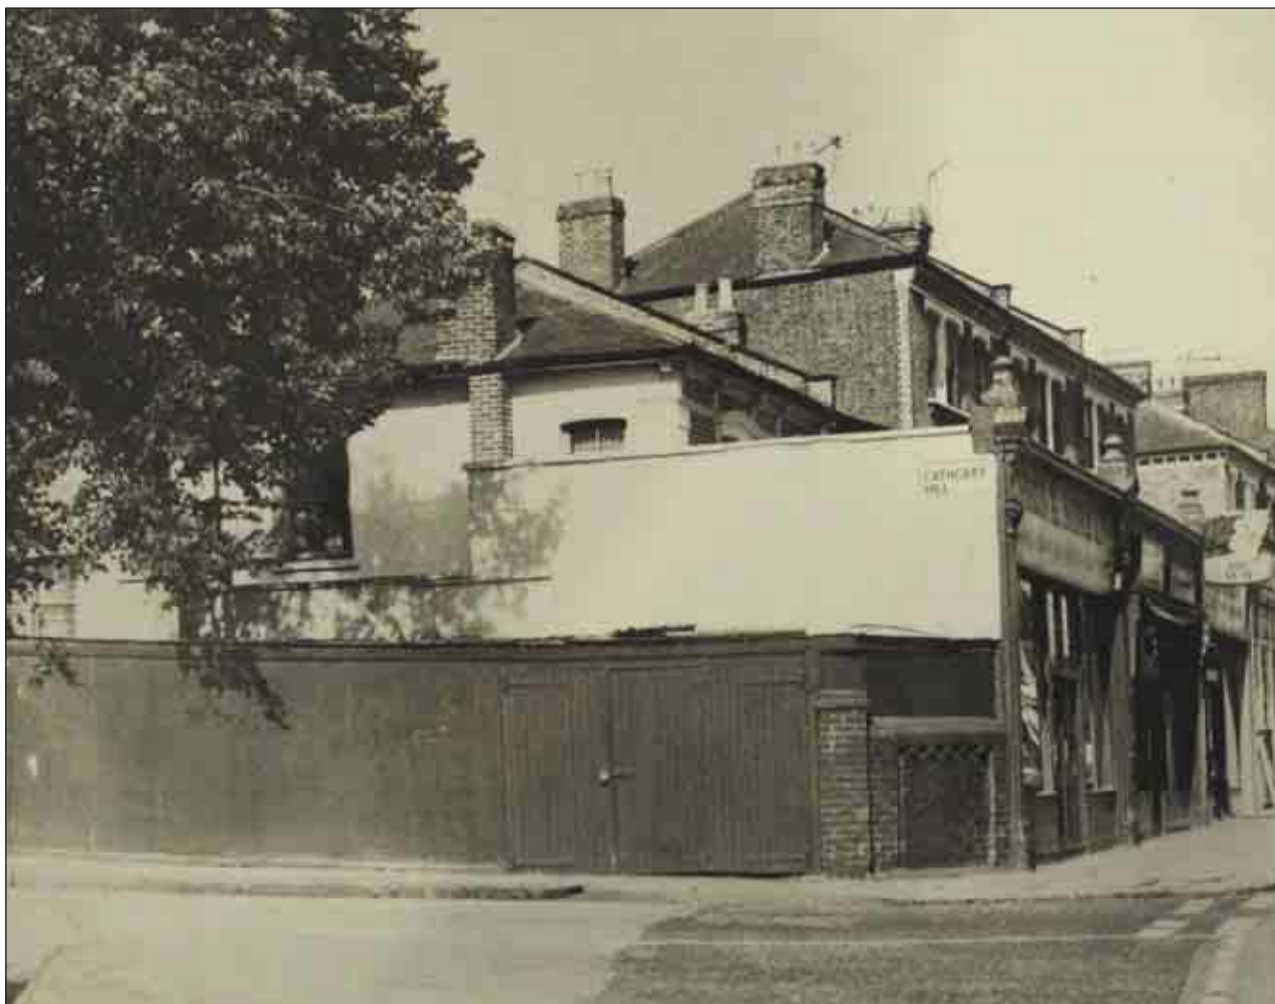
Figure 13: Photograph of 130a Junction Road, as viewed from Cathcart Hill, 1978 (IHC Ref B7154)

- 3.2.30 Figure 13 shows a photograph of the site, taken from the corner of the road, on the junction with Cathcart Hill. This image, taken in 1978 depicts a number of changes since the previous photograph from this position taken in 1904 (Figure 7). Since 1904, the original house/villa enveloped by the shops development has been rendered on the southern elevation and the blocked-up/blind central window has been brought back into use. The same elevation of the late 19th century shop has also been rendered and the extension to the rear as first noted on the 1952 Ordnance Survey Map (Figure 12), is also clearly visible.
- 3.2.31 A fascia board displaying the name “Chris and Sons” has obscured the fanlights/upper glazing as seen on the 1904 image and the letter box has been removed from the pavement outside.

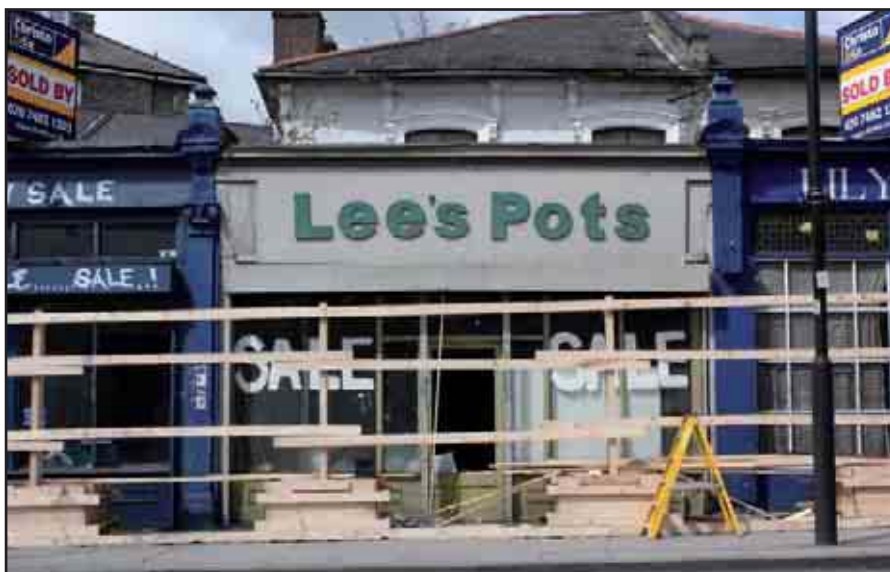
Plate 7: Shop frontage, 130b junction Road

- 4.1.4 The middle unit is 130b and was most recently “Lee's Pots”. The large sign/fascia board has obscured or replaced the coloured glass panels as recorded on the frontages on either side (Plate 7). This shop unit has the same central door and large shop display windows on either side as recorded on 130a and has the same stall riser with applied moulded detail. The pilaster/column between this unit and 130c is less decorative than that between 130a and 130b and the corbel is missing (present on the photograph of 1904, Figure 8), however it retains the same capital.

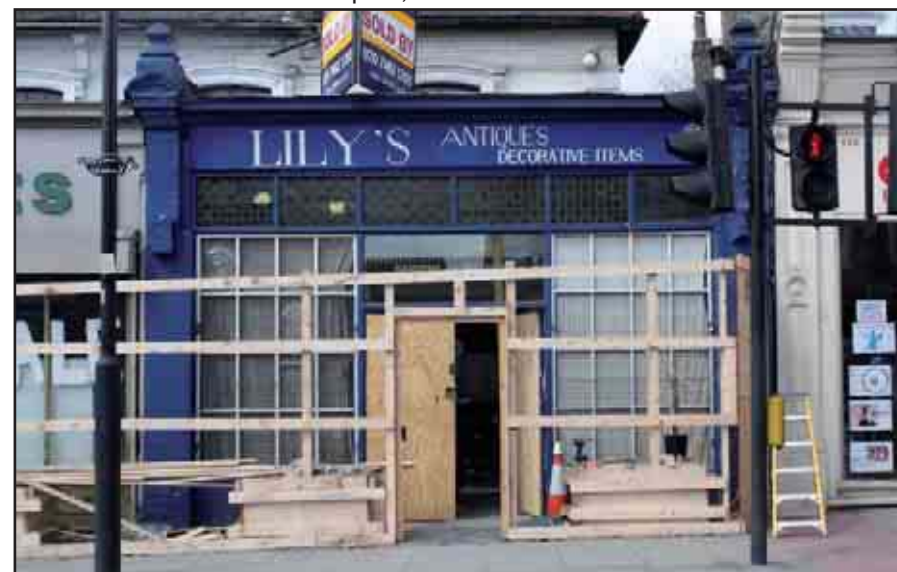
Plate 8: Shop frontage, 130c Junction Road

- 4.1.5 The unit on furthest right of this elevation is the shop frontage of 130c and was most recently “Lily's Antiques” (Plate 8). Like 130a, this unit has retained the coloured glass panels below the fascia board (Plate 9) and it also has the same moulded stall risers as noted on the other two existing units. The entrance to this unit is wider and the large window displays on either side comprise 16 smaller panes, some with an antiqued “bullseye” effect. The pilaster/column is the same as that noted between 130a and 130b.

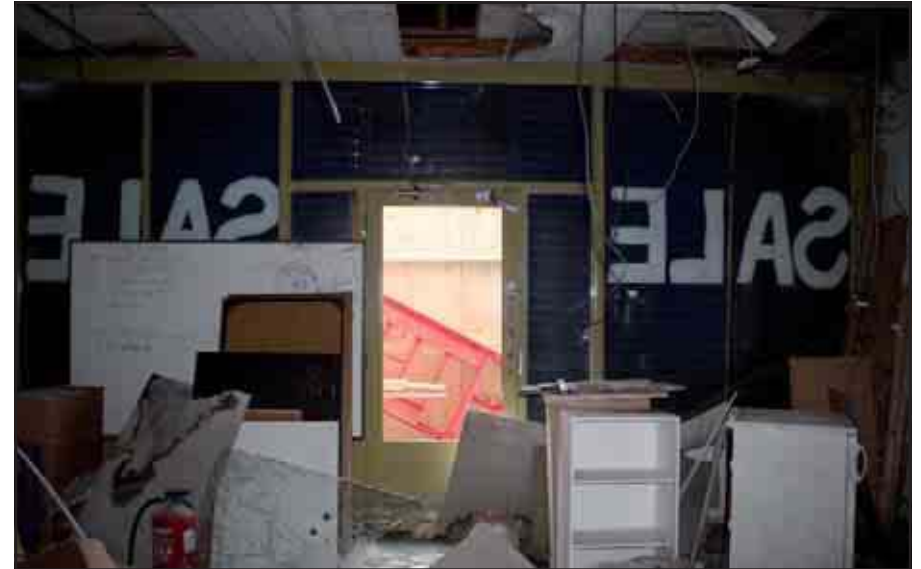
Plate 14: Interior view of shop frontage, 130b

- 4.2.8 This area comprised the the recent commercial space at the front of 130b and is accessed from the shop frontage on Junction Road. At the time of the survey, the shop was full of large bulky pieces of broken furniture as well as general rubbish (Plate 14).

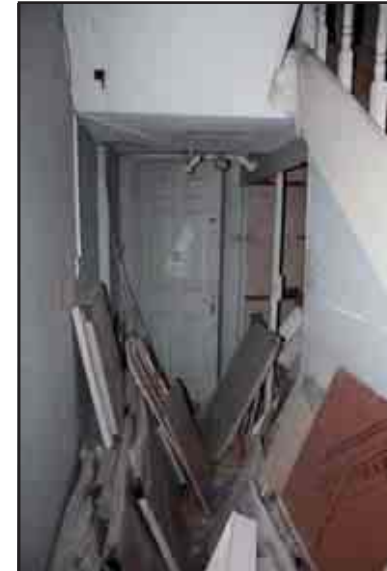
Plate 24: Corridor and staircase, 130b

- 4.2.19 A doorway within G5 provides access to the hallway and foot of the staircase. At the time of the survey, the hallway was obstructed by building material and due to inadequate lighting, close inspection was limited (Plate 24). A door at the end of this hallway provided access onto a small room (not accessed) and blocked up doorways were thought to be present due to hollow sounds within the solid walls on either side.

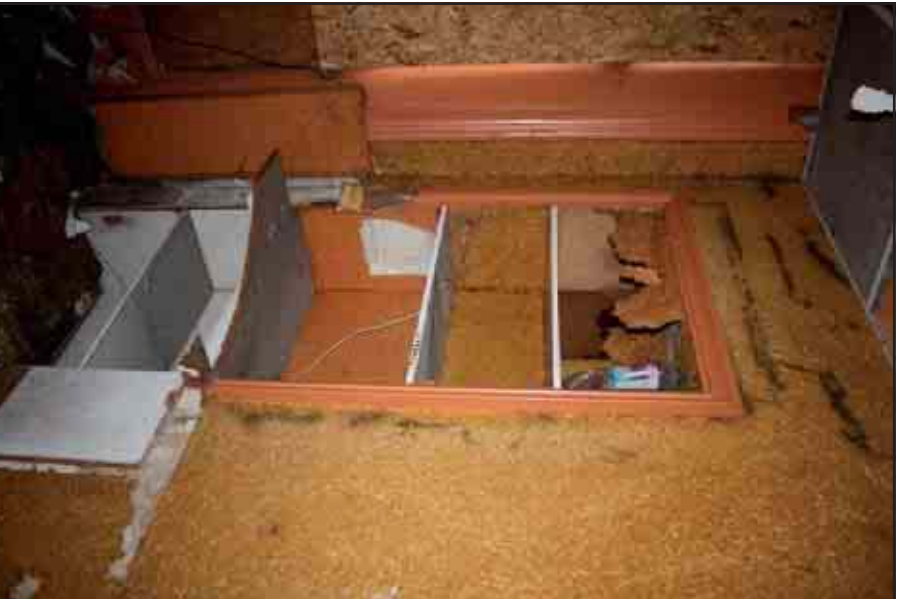
Plate 27: Cupboard/former doorway, F5, 130b

4.2.34 The walls had been covered with an identified material which may have been damaged lining paper from a this wall covering (Plate 27). There was a window located on the eastern elevation (see external description) which had been boarded up and a recess for an opening or cupboard within the corner which corresponds with that noted within F1. All of the woodwork (window and door/cupboard surround) had been painted orange.

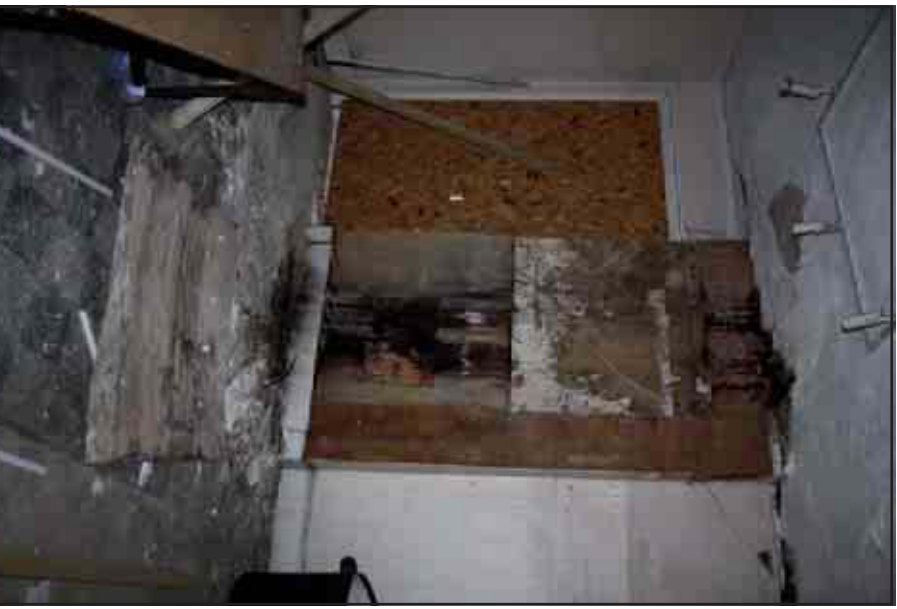
Plate 28: General view of room F1, 130b

- 4.2.23 Accessed from the first floor landing, this room was in a poor state of repair at the time of the survey, having suffered from water damage (Plate 28). The room had two windows, one on the eastern elevation and one on the southern elevation and a fireplace on the southern wall (Plate 28). Both windows were boarded up and all record of these windows were made from the external elevations.
- 4.2.24 This room had a skirting board and ceiling cornice all around and the moulded window frame continues to floor length. The walls and ceiling were plastered and painted and the floor had a modern linoleum covering.

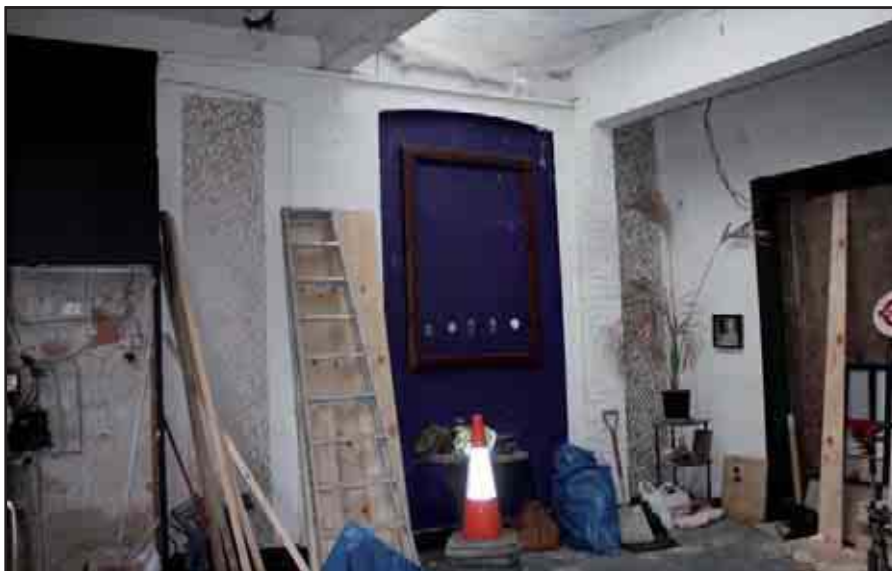
Plate 33: Archways with internal wall, G7, 130c

- 4.2.38 On the left (from entering from Junction Road) were two arches within the wall (Plate 33). A corresponding arch was noted in G4 of 130b. These are considered to be structural arches as opposed to former openings. A skylight was located within the roof which spanned the width of the room but was concealed by plastic sheeting.

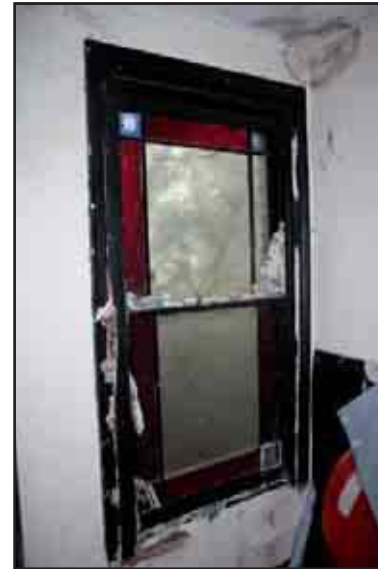
Plate 42: Window above removed stairs, 130c

- 4.2.51 Although the stairs had been removed, access was possible to the first floor via ladders. Half-way up the stairs, there would have been a 180 degree turn and on the external wall was a window (Plate 42). This two-part, two pane vertical sliding sash had applied beading around the outer edges and red coloured glass outer panels with blue etched star-burst decorative inserts in each corner. The window had suffered some damage and newspaper had been inserted around the frame.

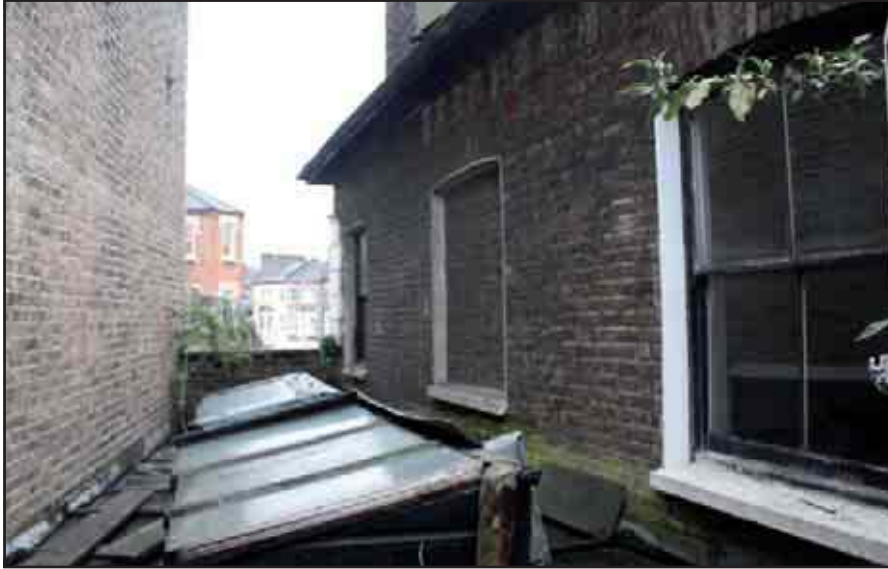
Plate 45: First floor windows on eastern elevation of original house as viewed from window in F9, 130c

4.2.56 From the first-floor hallway area, the north-facing elevation of the original c.1850's house was visible (Plate 45). This elevation comprises the windows as noted in F6 and F7 with a central bricked-up window for which there was no internal evidence. The position of this central window corresponds with the internal partition wall between F6 and F7 and is therefore considered to be a "blind window", one which was never in use however added for symmetry.
