# Great Barn Farm, Gayton Thorpe, Norfolk

## Historic Buildings Recording

OA East Report No: 1216

*Historic Building Survey*

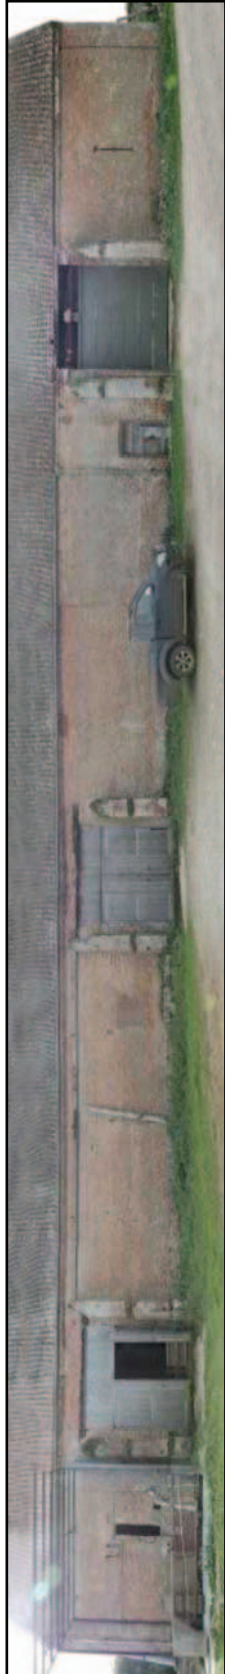
Plate 3: East-facing elevation, Building 1

- 4.1.2 The eastern elevation (Figure 9 and plate 3) has three large sets of double doors, all modern replacements, and a number of bricked-up narrow ventilation slots. A brick arch is located above the southern-most door and the remains of a recently removed, large modern iron structure is located to the immediate south. There is a blocked up window between the southern and central double doors. There are buttresses on this elevation which appear to be a later addition, perhaps to offer extra structural support. The join between the two phases of barn was clear from this side, indicating the northern third of the building is a later construction.

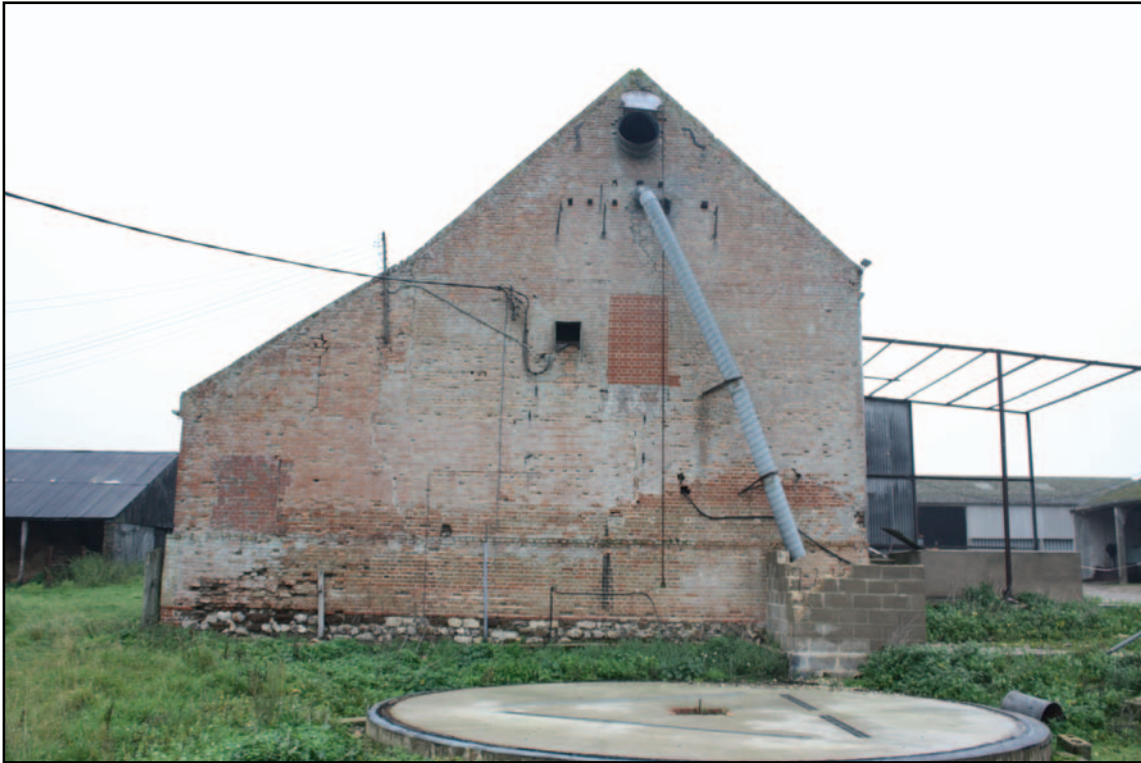
Plate 5: South-facing elevation, Building 1

- 4.1.4 The southern elevation (Figure 9 and plate 5) shows the moderate pitch of the roof with continuous contemporary outshut to the west. Built on a plinth of carstone and flint there is also tumble-in brickwork visible at the roofline. This elevation has three bricked-up windows, a bricked-up narrow ventilation slot and evidence of movement where the outshut on the western side meets the main building. Modern agricultural use has required some damage to be made into the brickwork. Iron support ties have been inserted at roof level to secure the gable end to the roof and prevent further movement.

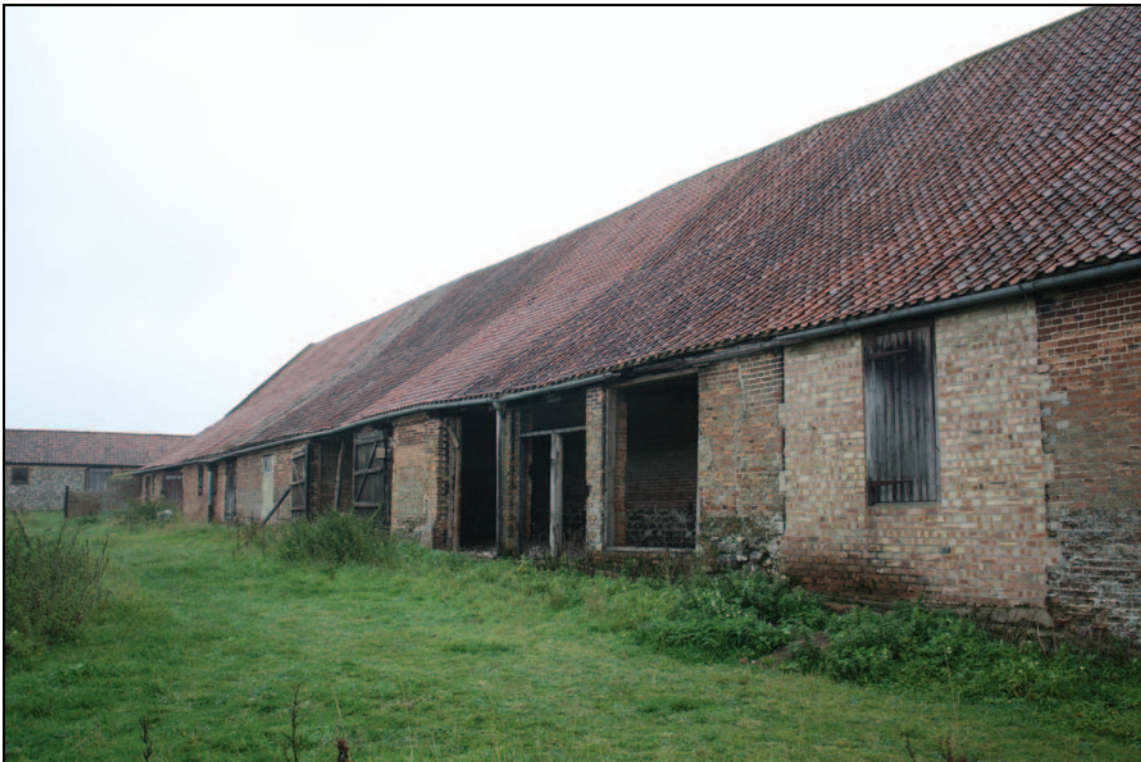
Plate 6: Detail of west-facing elevation, Building 1

- 4.1.3 The western elevation (Figure 9 and plates 4 and 6) shows a number of phases of alteration and repair. This side of the building was designed for storage and incorporates an open loading/cart area, part of which has been filled in with brick at a later stage (plate 6).

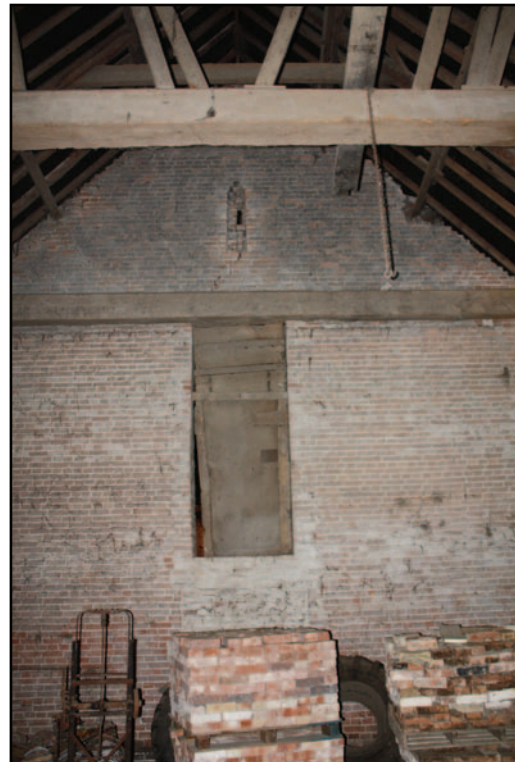
Plate 9: Detail of blocked opening, Building 1

- 4.1.13 On the northern end of the building two openings were noted (plate 9); a narrow slot for ventilation and/or light and a larger door underneath which had been bricked up or repaired beneath.

- 5.2.4 At the north-facing end of the barn was a large opening high up in the elevation (plate 9). Pitch holes were often found at the ends of barns such as this, used to pitch the corn or hay directly into the barn from a cart or wagon standing outside. This might be necessary if the barn doors needed to be kept shut, if access was restricted or if perhaps there was already a cart loading on the threshing floor.

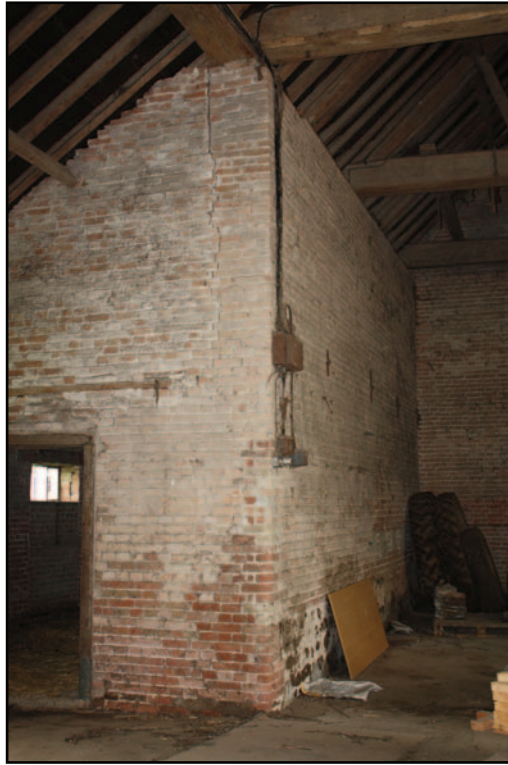
Plate 10: Internal detail, Building 1

- 4.1.14 Areas for storage built into the sides of the principal openings the were accessed from inside the building (plate 10). There was evidence of movement and cracking on the return walls on the western side, possibly caused by the weight of the pantile roof.

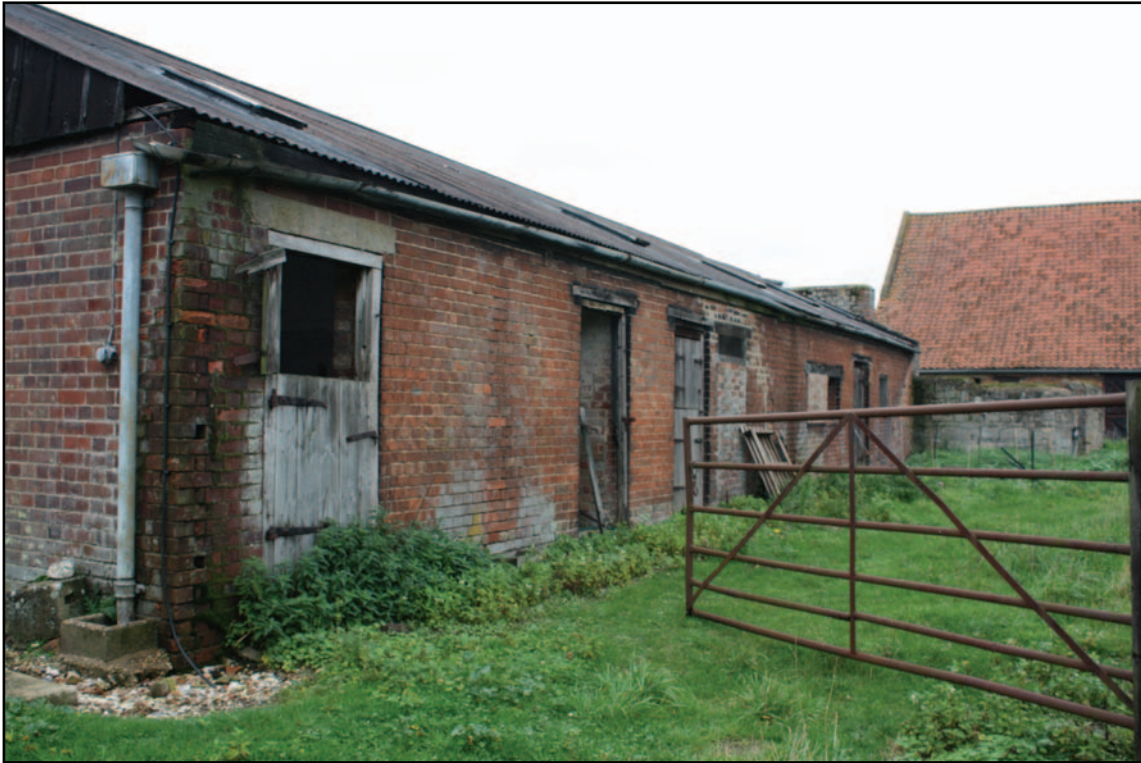
Plate 16: South-facing elevation, Building 3

- 4.3.3 The south-facing element to this building (Figure 9 and plate 16) was entirely brick built using an orange coloured brick laid in English bond. It had four doors, all with what appear to be original two-part stable doors and one additional doorway had been blocked up. There were two window openings, both had been covered over as this part of the building was still in use for sheltering birds and was not fully accessible. There had been some repair/replacement of the western gable end using a darker red brick.

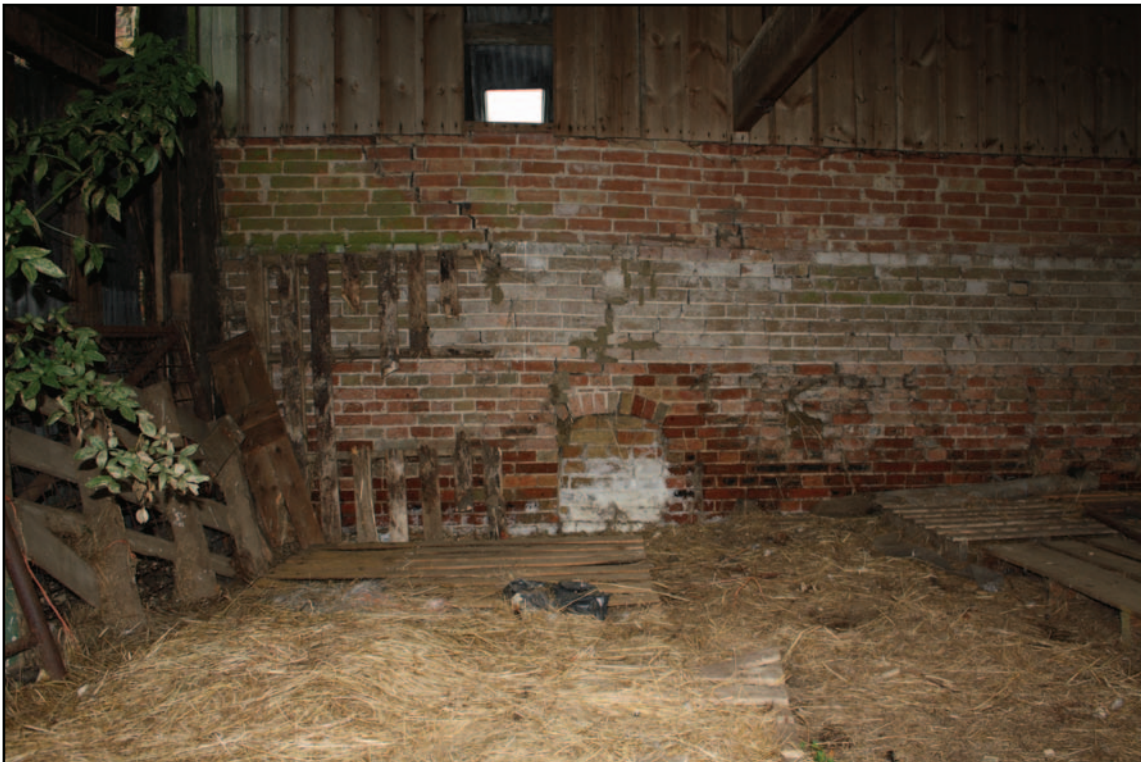
Plate 17: Internal view of North-facing side of building 3

- 4.3.5 The inside of the northern side of barn 3 was being used to store hay at the time of the survey. From inside it was possible to see the dividing wall between the two elements of this building (plate 17). It was constructed using brick and three phases of construction and repair were visible. The part which comprised the lower fourteen courses was constructed in an English bond. Within this wall was a small arch which had been blocked up and may have been an access for small animals or for drainage. The next eight courses of brick appear to have been added later which were slightly larger bricks, laid in the same English bond. The upper eight courses were obviously later still and laid in a Running bond.

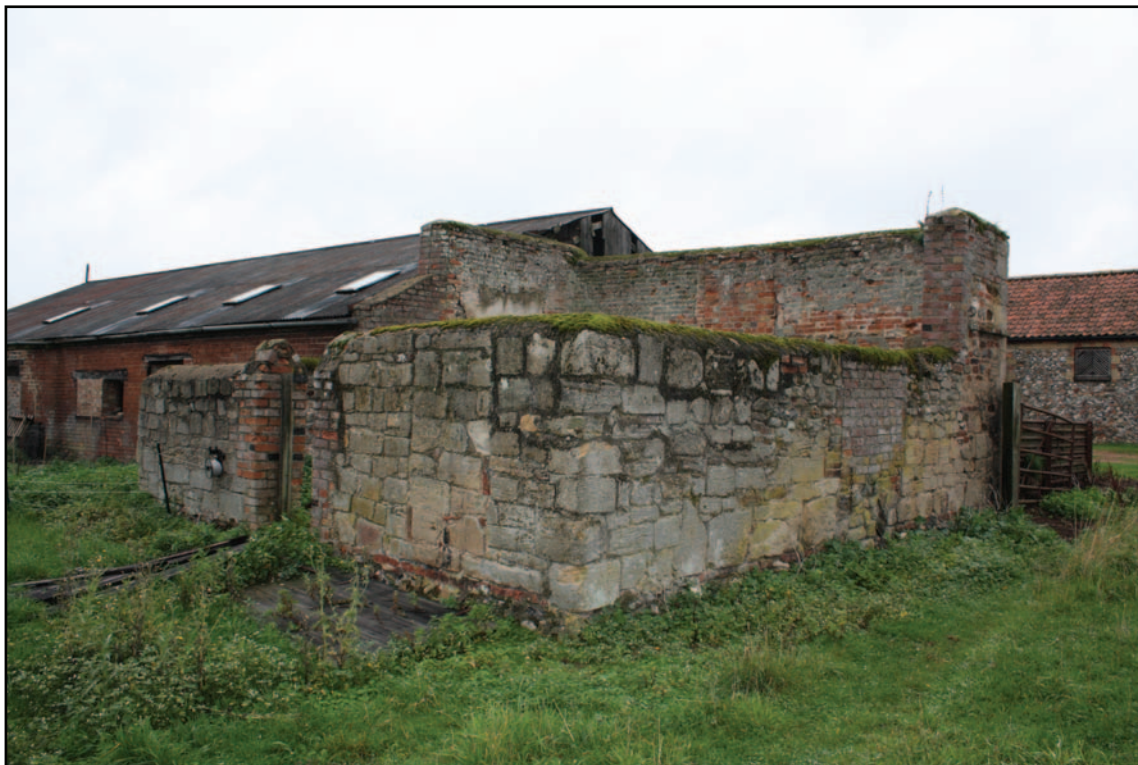
Plate 18: Remains of Dovecot (?) at eastern end of building 3

- 4.3.9 This derelict building is square-shaped in plan, measuring approximately 6.80m by 6.80m and located on the eastern side of Building 3 (plate 18). This small building is constructed primarily using a combination of limestone on the outside faces and red bricks on the internal walls. There have been various stages of repair using brick, flint and undressed limestone rubble with dressed quoinstones at each corner. The roof is missing and the inside has become overgrown with plants.

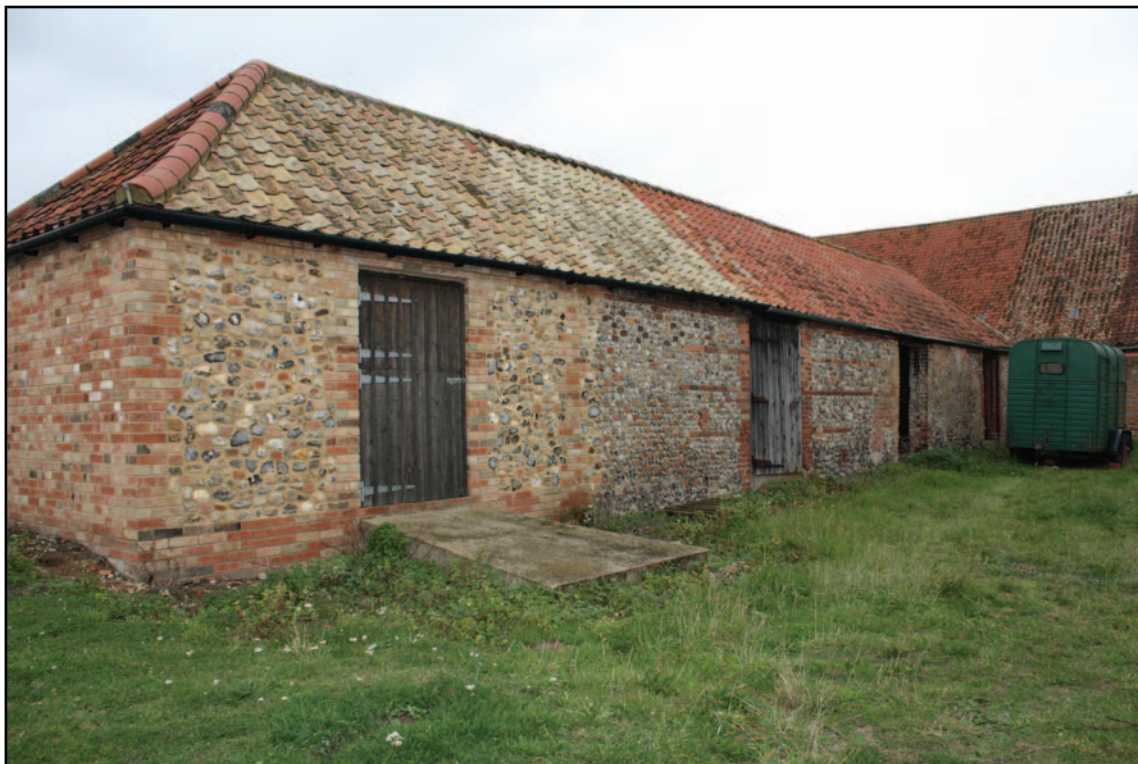
Plate 19: South-facing elevation, Building 4

- 4.4.2 The south-facing elevation (Figure 11 and plate 19) shows this building has four doorways; all have replacement doors, however the third opening along appears to have been added and is not original to the build. There has clearly been some repair or rebuild to the western end and a modern two-part stable door added. The flint render on this building is slightly different to that used in Building 2, as the flint used is much smaller and there is a more frequent use of brick in the wall which is very roughly coursed. This building also has three decorative bands of brick running across it. The eastern gable end shows little detail, the western end shows a modern orangey red brick used to repair/rebuild it.

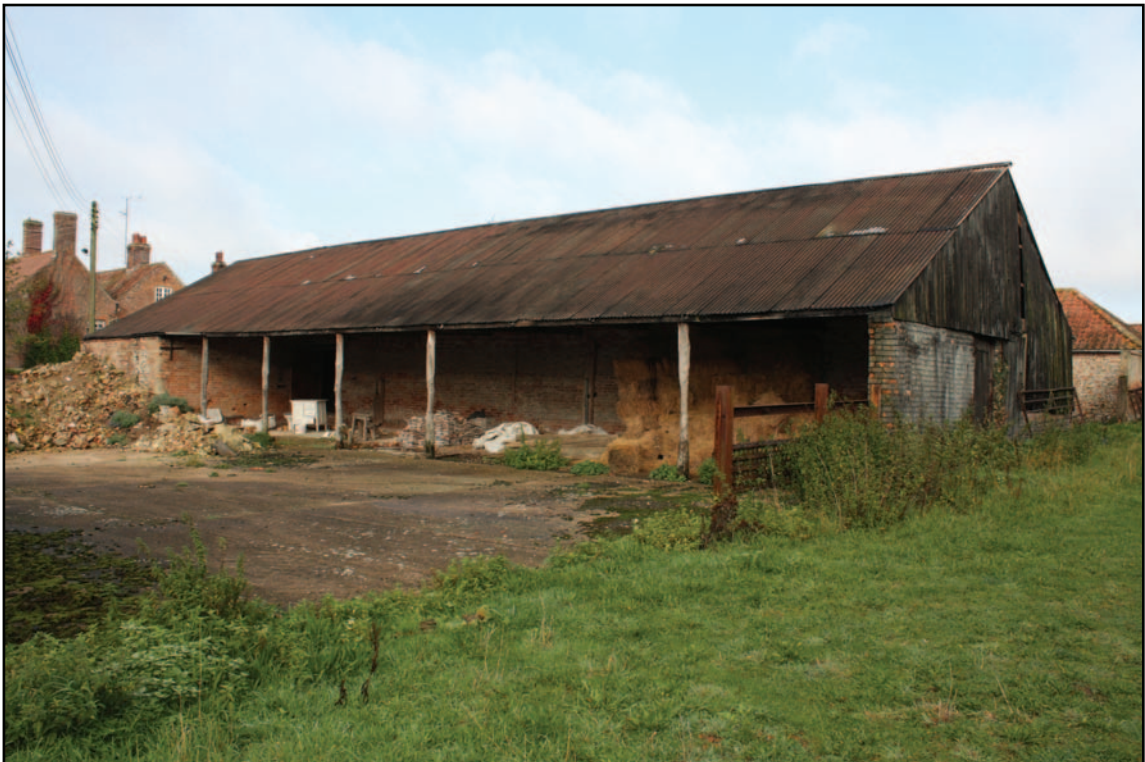
Plate 25: South-facing elevation, Building 5

- 4.5.4 The south-facing elevation shows two elements on this side (Figure 11 and plate 25). It has an orange coloured brick-built element at the far western end with a door which has been blocked-up door using flint and then five vertical posts with open front on the east side. There were originally six posts, but one has been removed/decayed.

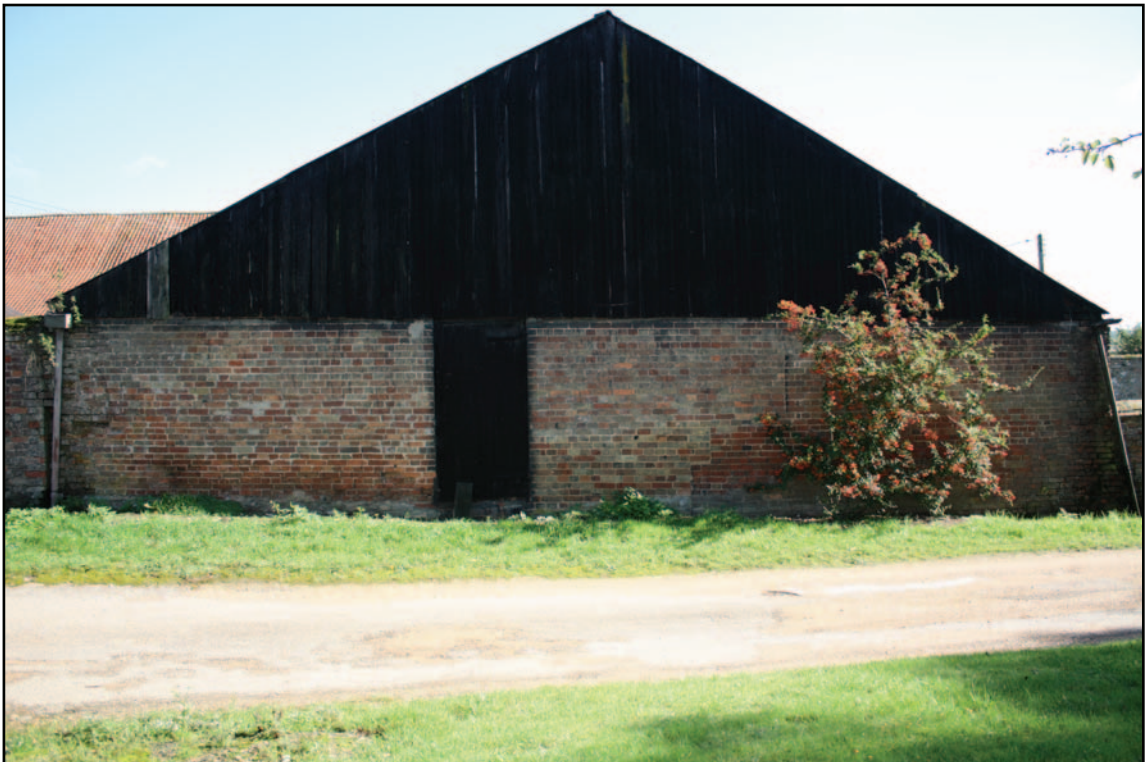
Plate 27: West-facing elevation, Building 6

- 4.6.2 The west-facing elevation (Figure 11 and plate 27) shows construction using bricks of various colour suggesting re-use and also repair/rebuild. There is a door providing access to the northern side of the building, which is original to this part of the building and vertically laid timber boards continue from the brick wall to the roof-line.
