SS Mary and Edburga Stratton Audley Oxfordshire

Historic Building Recording

June 2010

Document Type: Historic Building Recording

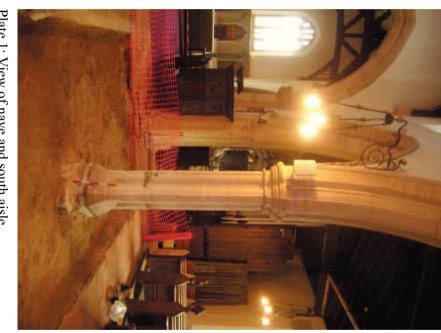
Plate 1: View of nave and south aisle

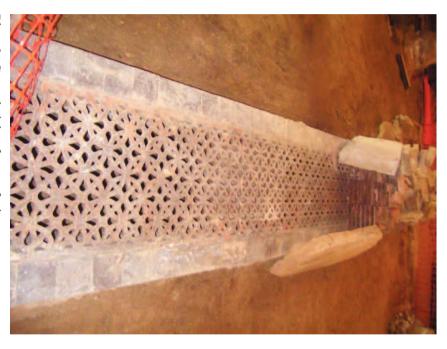
Plate 2: Central aisle of nave, facing west

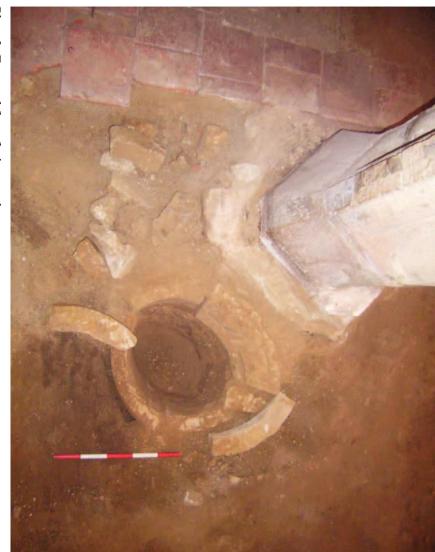
- 3.2.2 Buried Font: Next to the south east side of the north east pier is a buried stone font. It is made up of at least eight separate pieces clustered together in an elliptical shape (Plate 3) and inside were some further loose stones which appear to be pieces of the rim. This arrangement, from the outside of the rim is approximately 610mm across north west to south east and 820mm north east to south west. It is 460mm deep from the rim of the font and 600mm deep from the surface of the floor.

Plate 3: Exposed font, facing north

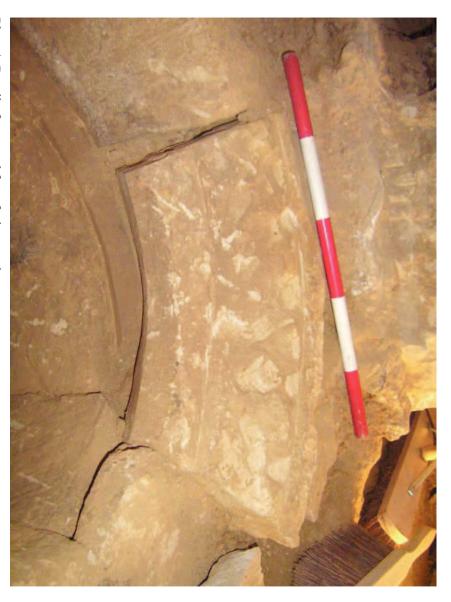
- 3.2.3 It is possible that it is made up of more than one font as some of the stones don't quite match each other. In fact, the largest and most ornate stone on the south west side is possibly part of a small medieval window arch (Plate 4). Around the font is an area of darker ground. This may indicate a cut but it is more likely to simply represent an area where the historic floor surface has been removed in the clearance.

Plate 4: Detail of exposed font, facing north west

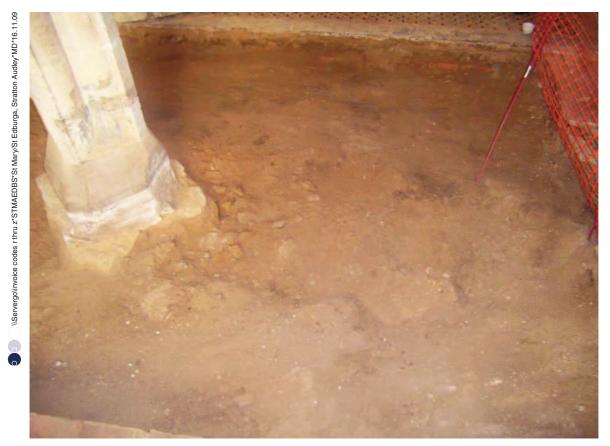
- than the aforementioned features and, as above, may indicate an area where historic floor surface has been removed..
- 3.2.5 Immediately to the east of the south east pier is an area which may be the remains of a plaster floor (Plate 5). This is characterised by a paler and rougher surface. Immediately south of this is the edge of a brick lined vault. Just three bricks appear from under the terracotta tile floor but a cut is clearly visible (Plate 6). It appears to orientated east to west

Plate 5: Evidence of possible plaster flooring in south east corner of nave, facing north

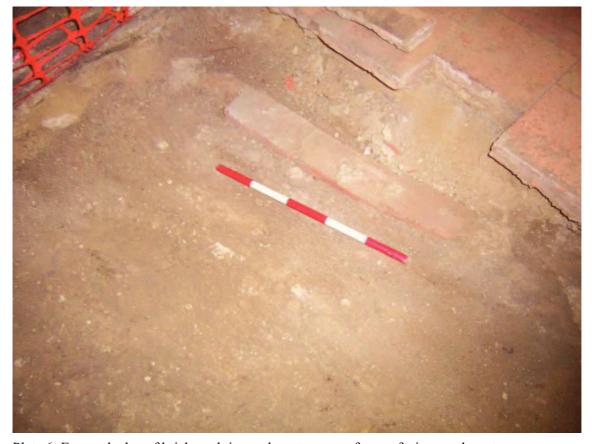
Plate 6: Exposed edge of brick vault in south east corner of nave, facing south east

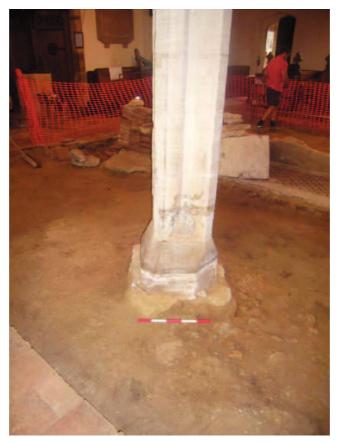
- 3.2.6 The foundations of the piers are made up of large stones which form a 0.6m x 0.6m base (approximately) on the south side and 1m x 1m base on the north side (Plates 7 & 8). Much of these foundations have been broken away and damaged, perhaps during works to lay the modern floor.

Plate 7: Base of south east cluster column, facing south east

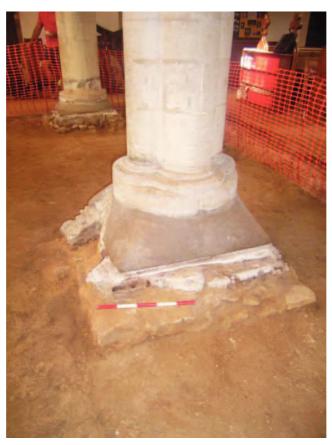
Plate 8: Base of north east cluster column, facing west

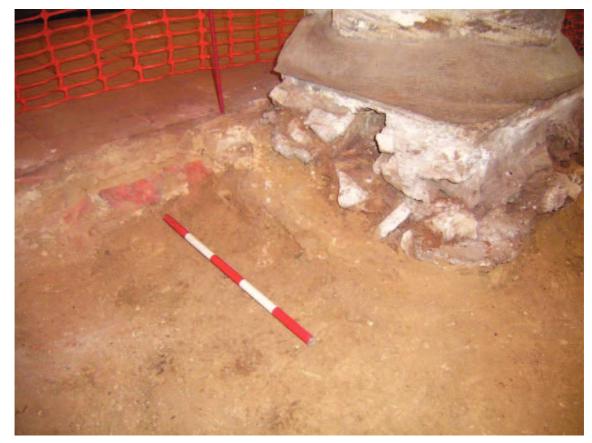
- 3.2.7 In section, lower bricks, below the level of the mortar surface, can be seen (Plate 9 & Fig. 2, Section; fill no. 5). This may suggest that there was a lower brick floor surface at some point. A low brick floor surface can be seen in a small opening in the south west corner of the nave (Plate10). Above this is the hard mortar surface (Fig. 2, Section; no.1), consistent throughout much of the exposed floor. Above this is a loose, rubbley mortar fill, likely to have been laid down in the 19th century to level the floor. There are large stone inclusions as well as fragments of tile and organic material such as wood chips within this fill. In areas, at the same level as this rubbley fill, is a yellow, loose and friable lime mortar. Between these fills and the terracotta tiles is a thin layer of grey chalky lime mortar.

Plate 9: Exposed lower level of brick next to north west column

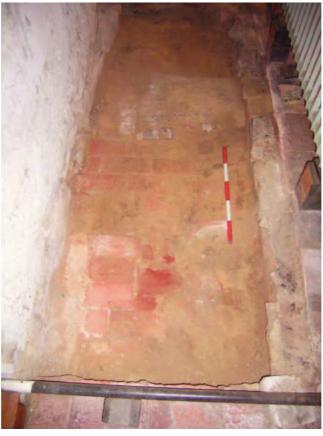
Plate 10: Exposed area of brick in south west corner of nave, facing north
