**WELLINGTON DOCK,
REGENT ROAD,**

**Closure of the Dock Gates
Archaeological Watching
Brief Report**

June 2012

United Utilities

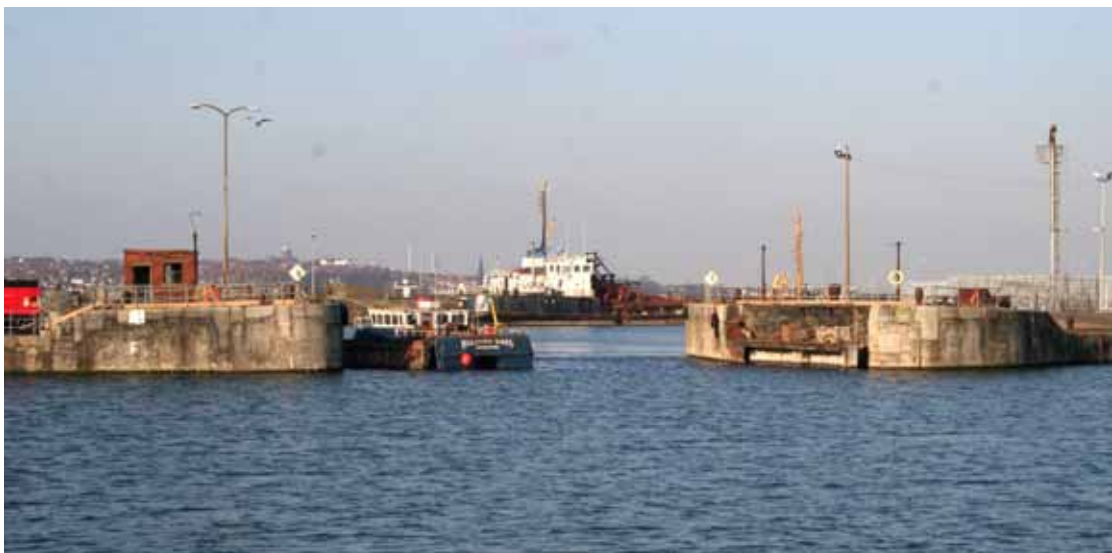
Plate 2: North and south gate piers prior to gate closure

- 3.2.4 **The Gates:** the Wellington Dock gates are typical of those of the North Dock complex having a twin leaf design (Plates 2 and 3). Twin-leaf gates are symmetrical in design with each gate measuring a little longer than half the width of the neck of the dock so that the centre line of the closed gates points in the direction of the impounded water (within Wellington Dock and not Sandon Half-Tide Dock), and the water pressure forces the gates closed, ensuring a good seal. The gates are constructed of Greenheart frames with substantial squared heel posts and mitre posts and a number of cast-iron fixtures and fittings, including rivets, chains, metal plate and bracing (Plate 4).

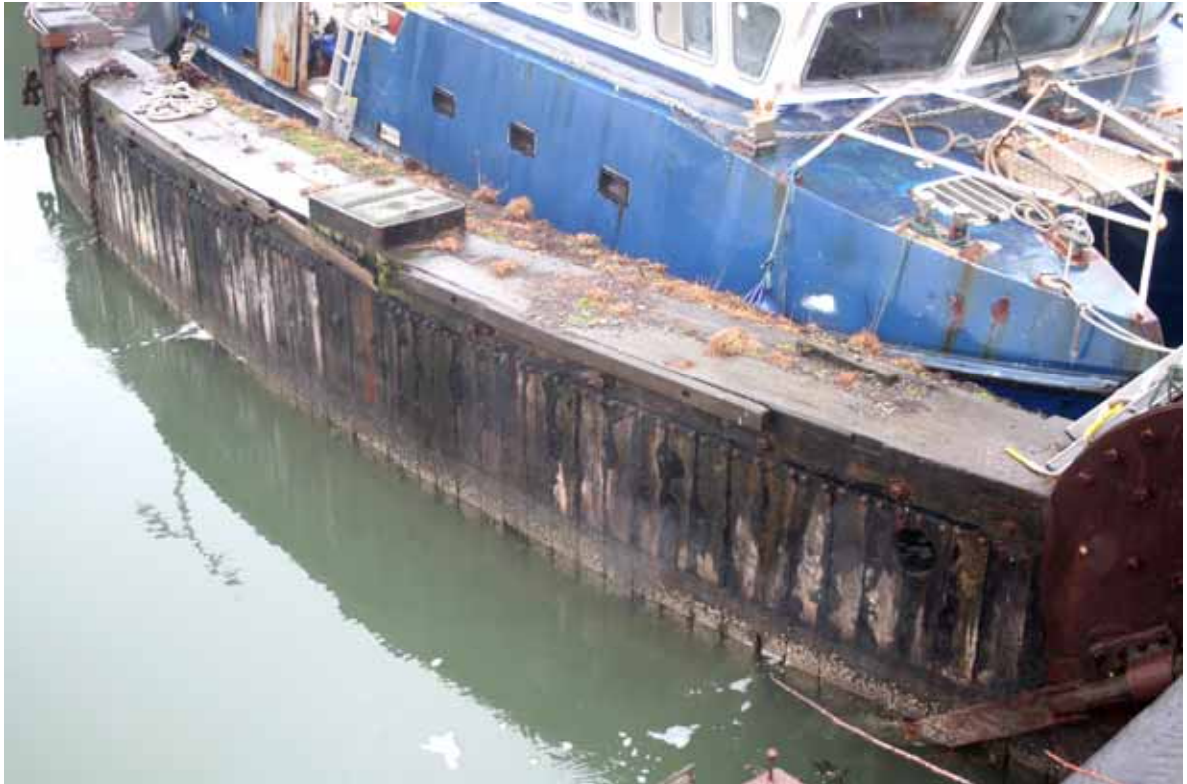
Plate 5: Interior elevation (east-facing) showing skin plates, brace and metal rivets

- 3.2.5 The inside (east-facing) elevation of the gates (Plate 5) are convex and covered with skin plates (timber planking) which are held in place with a parallel arrangement of cast iron rivets attached to the web plates; only the rivets above the water line were visible during the watching brief. The east-facing elevation had a number of cast iron fixtures, including chain connection points and L-shaped metal plates, spanning the front of the mitre post and the lip of the deck plate to a depth of five skin plates (Plate 5). The upper edge of the east-facing elevation was also trimmed with thin sections of timber beading which acted as a cushion between the concave face of the gate and the stone walls of the dock gate recess.

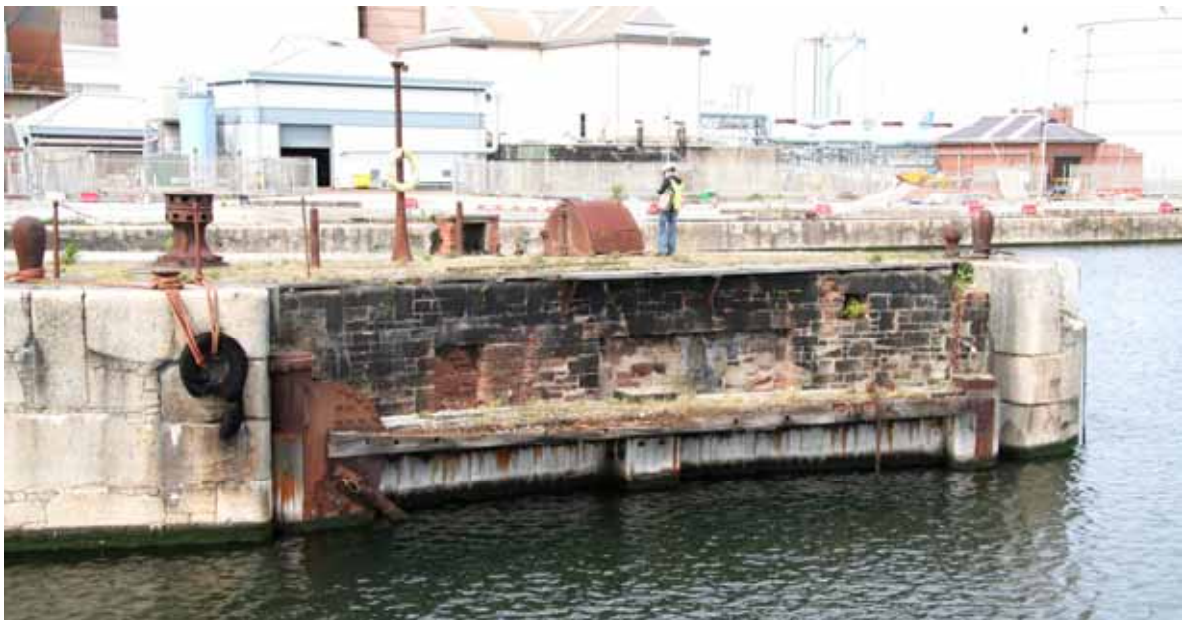
Plate 6: Exterior elevation of dock gates (while still housed in dock gate recess on the north gate pier)

- 3.2.6 The outside (west-facing) elevation is a vertical face without skin plates and the web plates are clearly visible (Plate 6). Due to access limitations and the fact that the dive support vessel, *Halcyon Days*, was still moored against the west-facing elevation of the gates, it was not possible to study this portion of the gate at the time of closure; however, this face of the gates was recorded during the original photographic and laser scanning process (OA North 2011). The top of each gate is capped by a curved deck plate (Plate 7) which is recessed around the mitre posts. The deck plates were covered in foliage and detritus and, while their shape was clearly visible, the surface of the timber was not. The mitre posts themselves are braced with a cast iron collar.

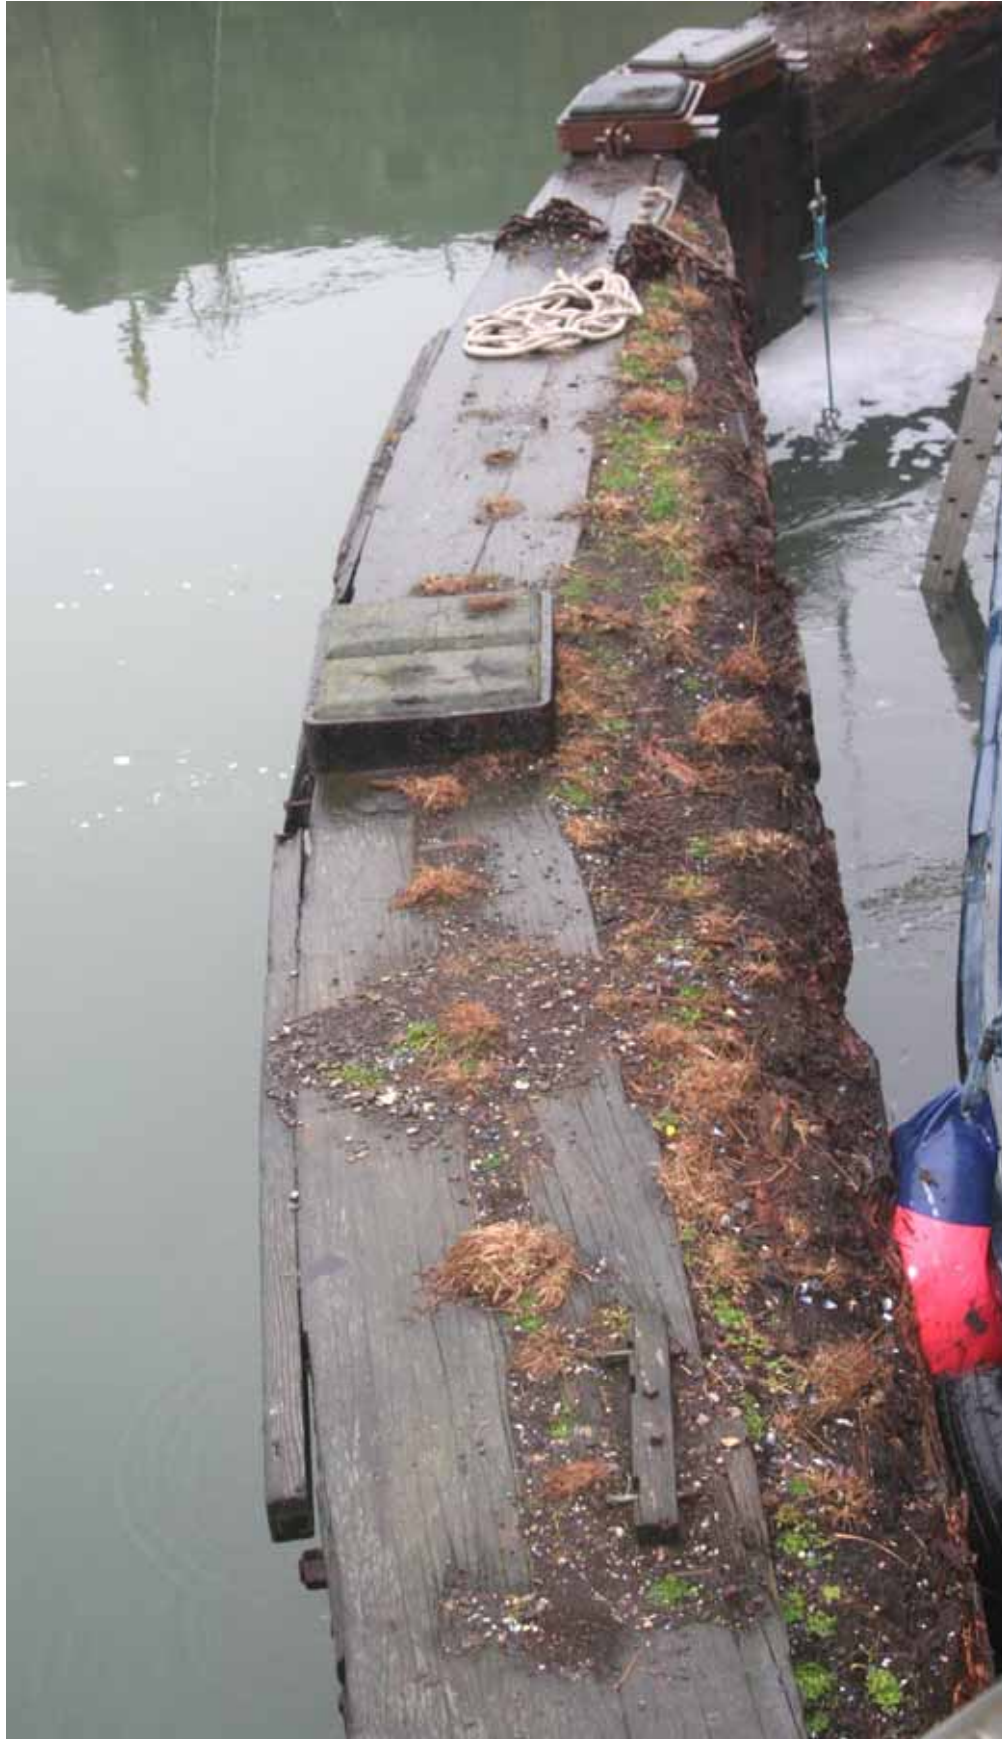
Plate 7: View of deck plate on the north dock gate

- 3.2.7 Less than 1/7th of the dock gates are visible above the high water mark and the exposed areas appear to be in generally good condition despite some damage caused by environmental factors, such as water and mechanical erosion and exposure to the effects of sun and wind. A number of small holes are visible in the skin plates of the southern dock gate, as well as a small patched area adjacent to the heel post. A circular hole is present on the upper section of the north dock gate

which suggests the loss of a metal fixture or chain connection point rather than a hole caused by damage or erosion.

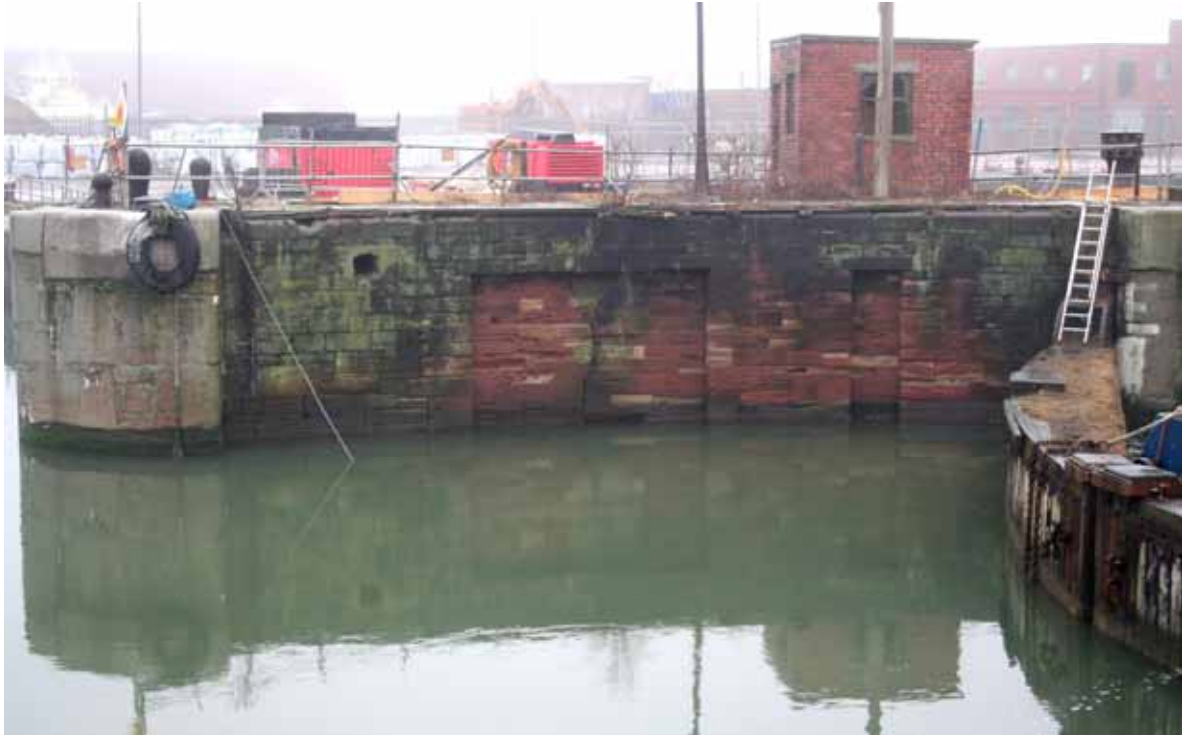
Plate 8: Gate recess in the north-facing elevation of the south gate pier

- 3.2.8 **The Gate Recesses:** following the closure of the dock gates, the southern and northern side recesses for the gates were fully exposed above the water line (Plates 8 and 9). The gate recess situated on the northern gate pier is constructed of pink sandstone, some of which shows signs of wear through erosion, arranged in an irregular bond type which is markedly different from the dock wall and the perimeter wall of the gate pier. The rest of the dock and gate pier is built from large granite blocks arranged in the Cyclopean Granite-style pioneered by Dock Engineer, Jesse Hartley. The side recesses are curved in form and sufficiently deep to admit the gate, allowing it to recede beyond the line of the walls of the gate piers, thus ensuring that they were not at risk of being struck by vessels as they passed in and out of the dock. The gate recesses terminate in two returns; the hollow quoin and the square quoin. Within each gate recesses are further vertical rectangular recesses which are present as mirror images on both the north-and south- facing elevations of the recess.
