Chapel Court
North Facing Elevation
Hampton Court
P a l a c e

Historic Building Recording

May 2007

Client: Historic Royal Palaces

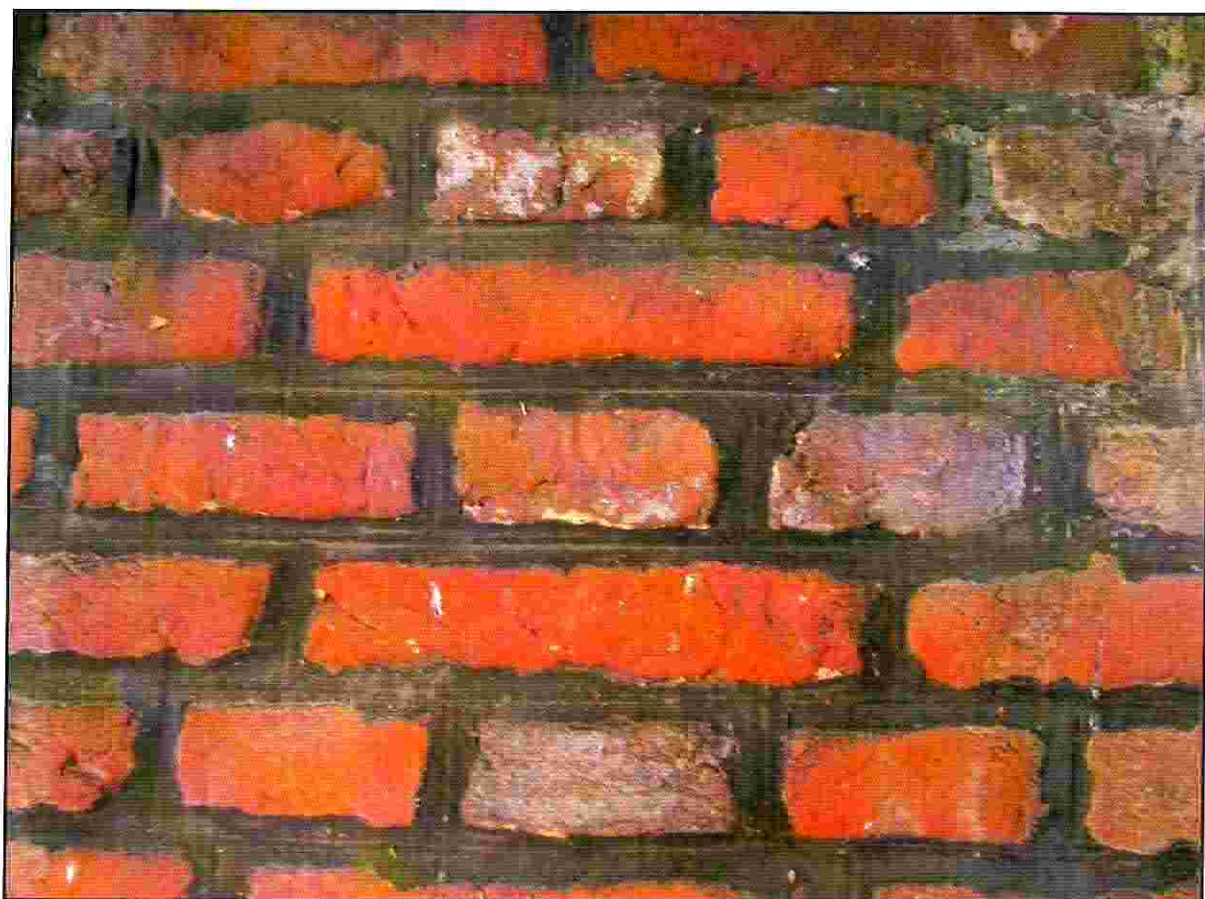
3.3.1 The majority of the elevation brickwork was pointed in a thick layer of black ash mortar that was applied during Victorian works, most likely after the diaperwork (see § 4.1) and replacement of windows (plate 3). The black ash mortar is very solid to the touch and the colour ranges from dark grey/charcoal to almost black. There is a high amount of small to medium sized gravel and pebbly inclusions giving the mortar a rough texture. The pointing has extensive penny rolling with mostly horizontal lines but there is vertical scoring between the bricks in some parts of the mortaring. Patches of the black ash mortar were removed prior to raking out as part of the investigative process for the building works.

Plate 3: Chapel Court, North Facing Elevation - The black ash mortar

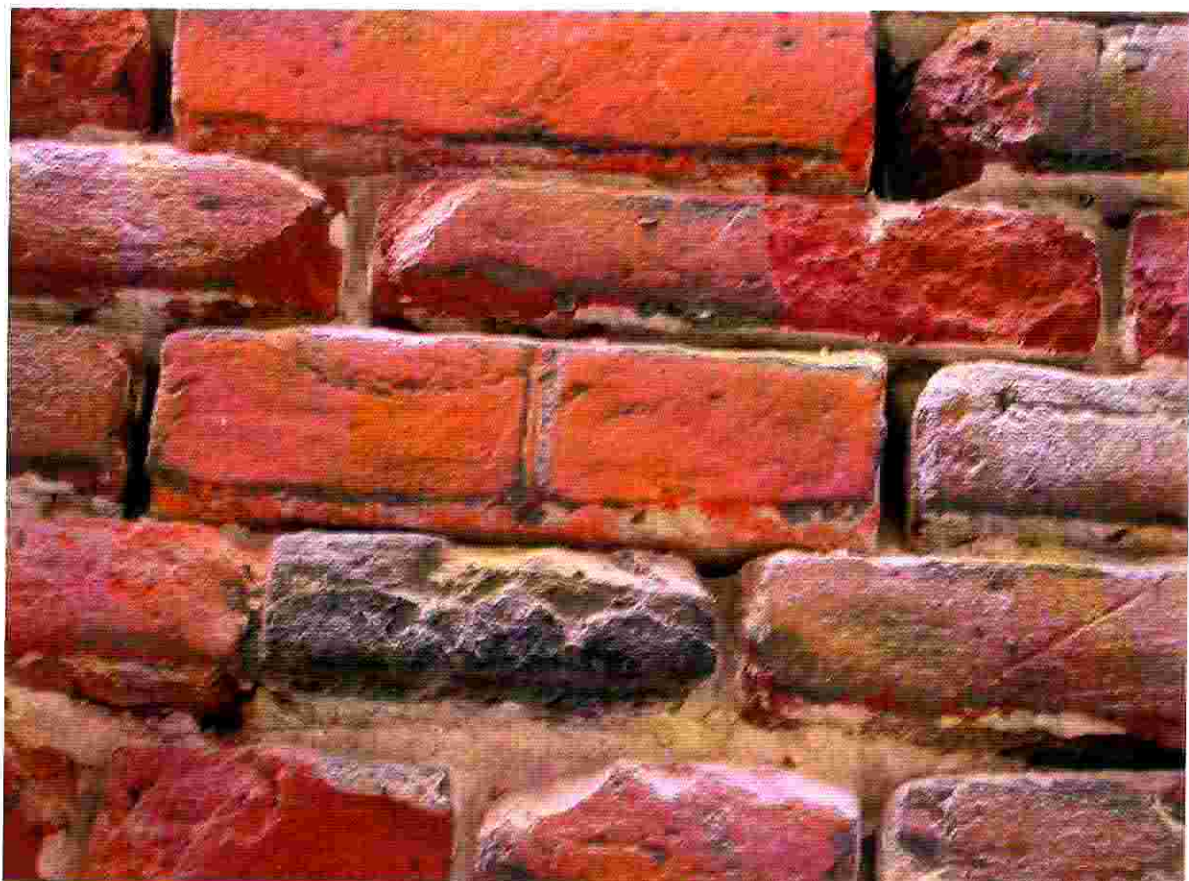
3.2.7 There are patches of replacement brickwork within the elevation which have used using Type T 19th century stock bricks. In many cases care has been taken to match the bond and coursing of the existing brickwork with the use of tiles and stretchers which have been cut to look like two headers (plate 8).

Plate 8: Chapel Court, North Facing Elevation - 19th century repair with stretcher cut to look like headers

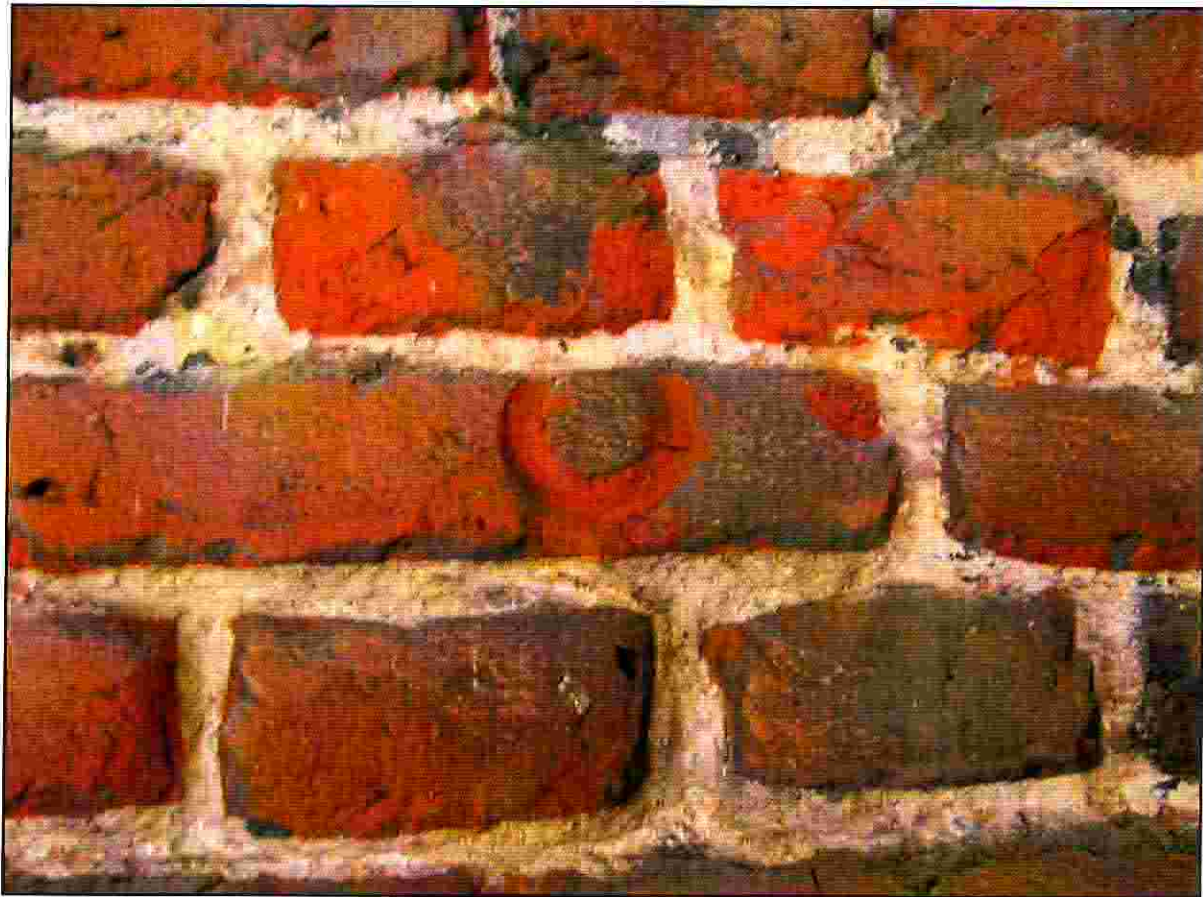
4.2.1 There are marks located throughout the extreme north-eastern section of the elevation. The marks are approximately 50mm in diameter and formed by a hollow tube rubbing against the brickwork creating a slightly oval shape (plate 11). The absence of weathering or signs of pollution within the worn shape suggest that these have been formed since the last phase of Victorian works in which the elevation was cleaned. Tubular scaffolding was developed at the beginning of the 20th century but only really became widely used from the 1920s onwards after the commercial development of the 48mm diameter tube. The marks were found in Bay D of the elevation and so could be related to the 1980's remortaring works on the adjacent antechapel wall.

Plate 11: Chapel Court, North Facing Elevation - 20th century scaffold mark

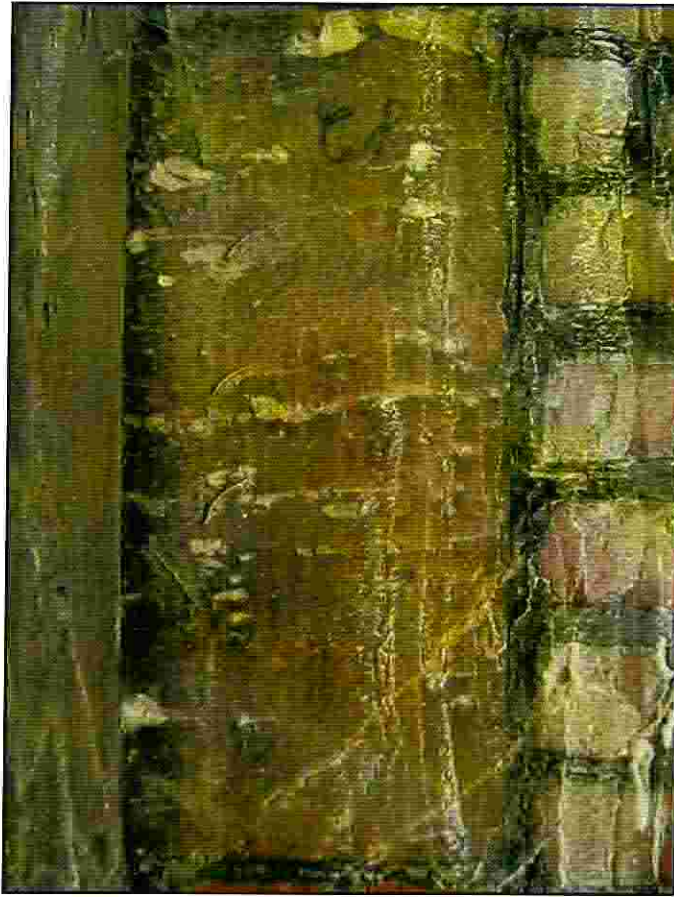
4.3.1 Two examples of graffiti were found at ground level. On a lower level stone (17.5 x 39.5cm) forming part of the pilaster between Bays A and B there are pencil markings (Appendix V, A and plate 13) showing the initials 'CP' and some illegible signatures. This is possibly a list of workmen's names and is similar in style to those found upon stonework within the chapel. Close to this stonework is a replacement brick (23 x 6cm) which has been decoratively inscribed with the initials 'PT' and the date of '1864' (Appendix V, B and plate 14). The size of brick is consistent with brick typology type 'T', a red face brick used in the construction of the plinth and therefore may date to repairs made at the same time as the plinth construction.

Plate 13: Chapel Court, North Facing Elevation -
Pencil graffiti upon lower stonework

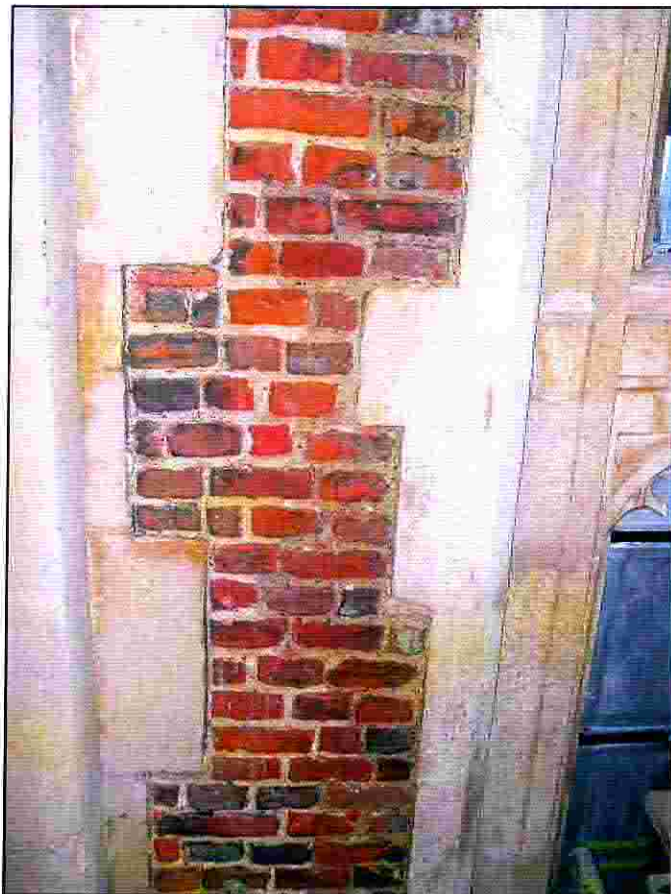
3.3.5 The stone pilaster buttresses have a different mortar which is creamy/pale grey with a small amount of small to medium sized mixed inclusions including lime and occasional small dark pebbles. It is therefore assumed that the current stonework replaced earlier stonework in a separate phase to the 19th century replacement windows. It is worth noting that within the thin sections of brickwork that run between the pilasters and the window jambs, there are patches of original bedding mortar which indicate that both the pilasters and the windows were inserted with care not to disturb the original fabric as much as possible (Fig 5 and plate 16).

Plate 16: Chapel Court, North Facing Elevation -
Three main bedding mortars (see also fig. 5)

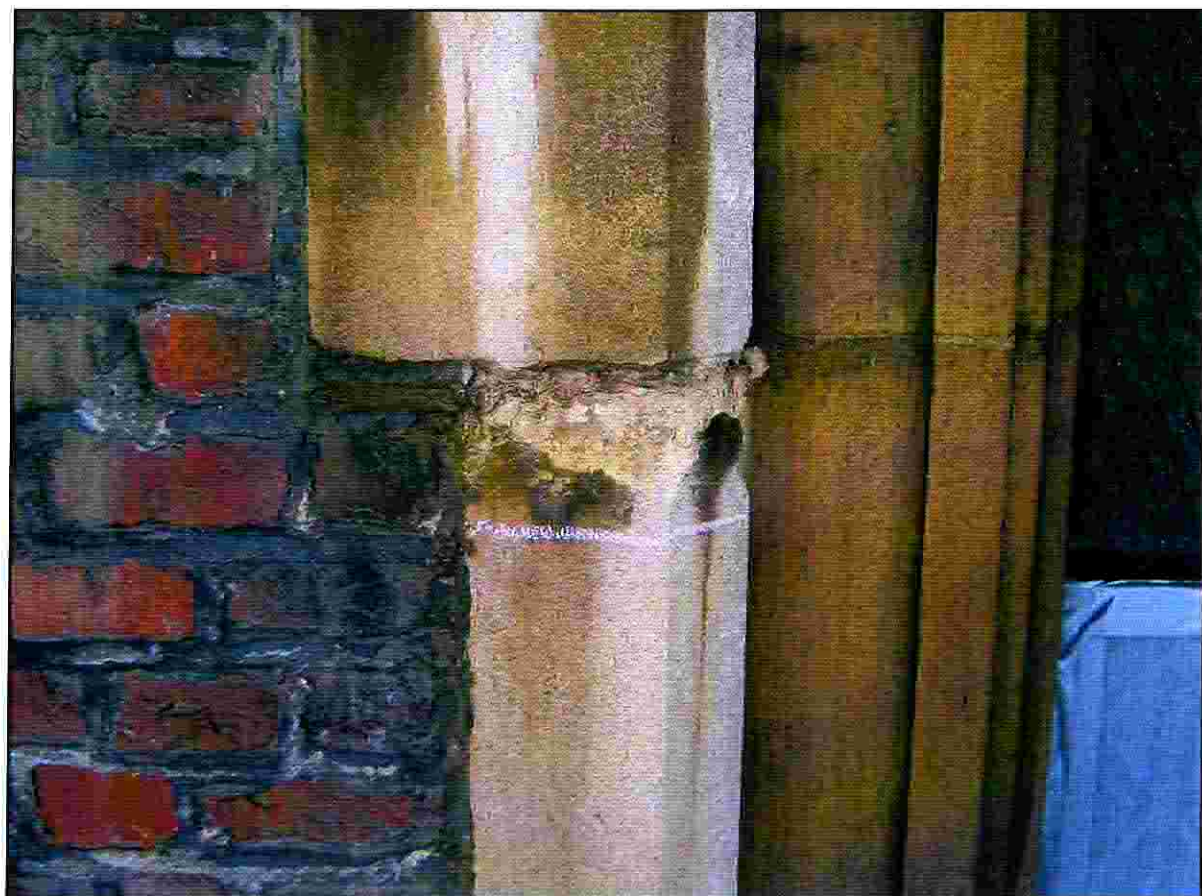
Plate 17: Chapel Court, North Facing Elevation -
Blistering on window stonework

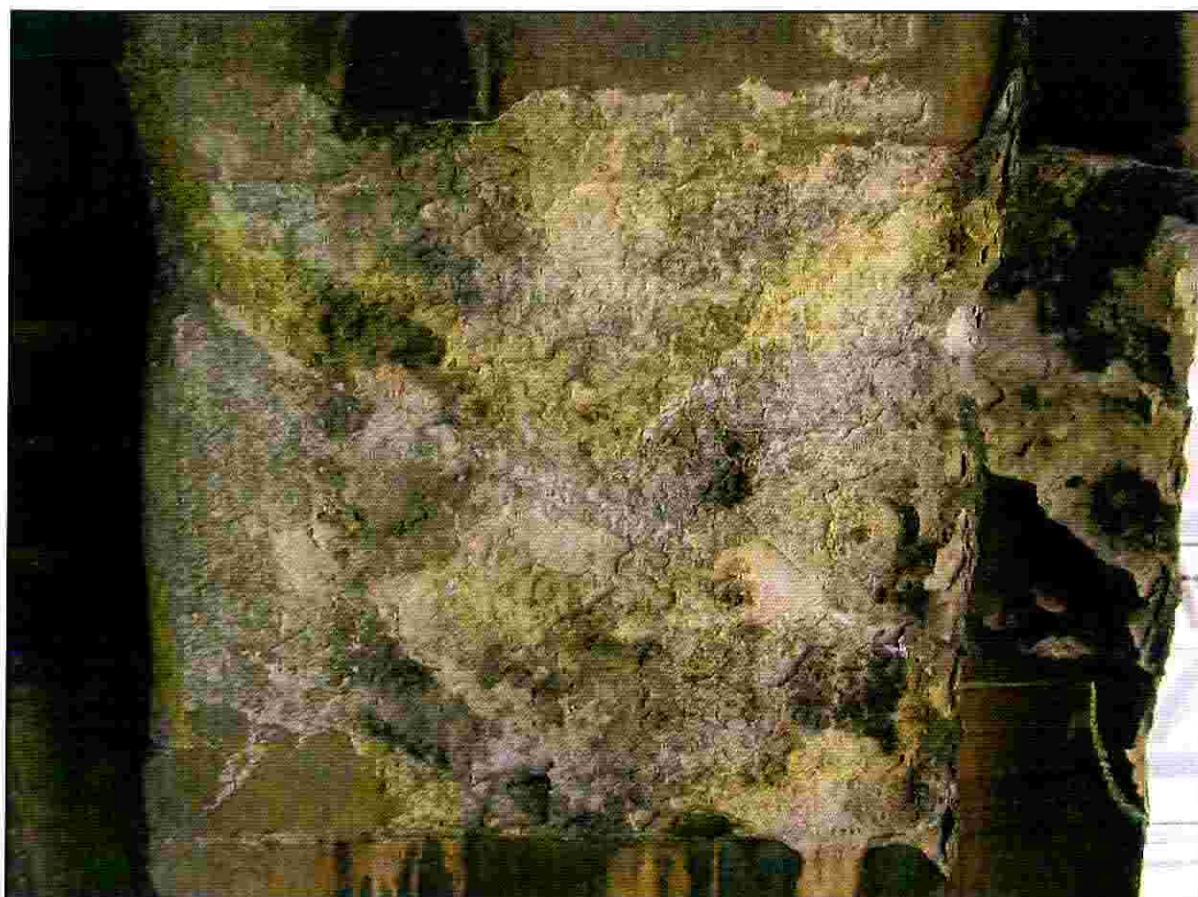
3.4.2 The remainder of the elevation mostly consists of Bath stone. The pilasters show two different types of blistering caused by weathering suggesting there have been two instances of replacement. According to Robin Sanderson, Bath Stone was not readily available in London until after the Kennet and Avon Canal was opened in 1814. Therefore it is surmised that most of the present stonework is after this date. The difference in bedding mortar beside the pilasters is evidence for a separate phase for the pilasters replacement, i.e. it was not contemporary with the insertion of the windows.

Plate 18: Chapel Court, North Facing Elevation - Blistering on lower pilaster stonework

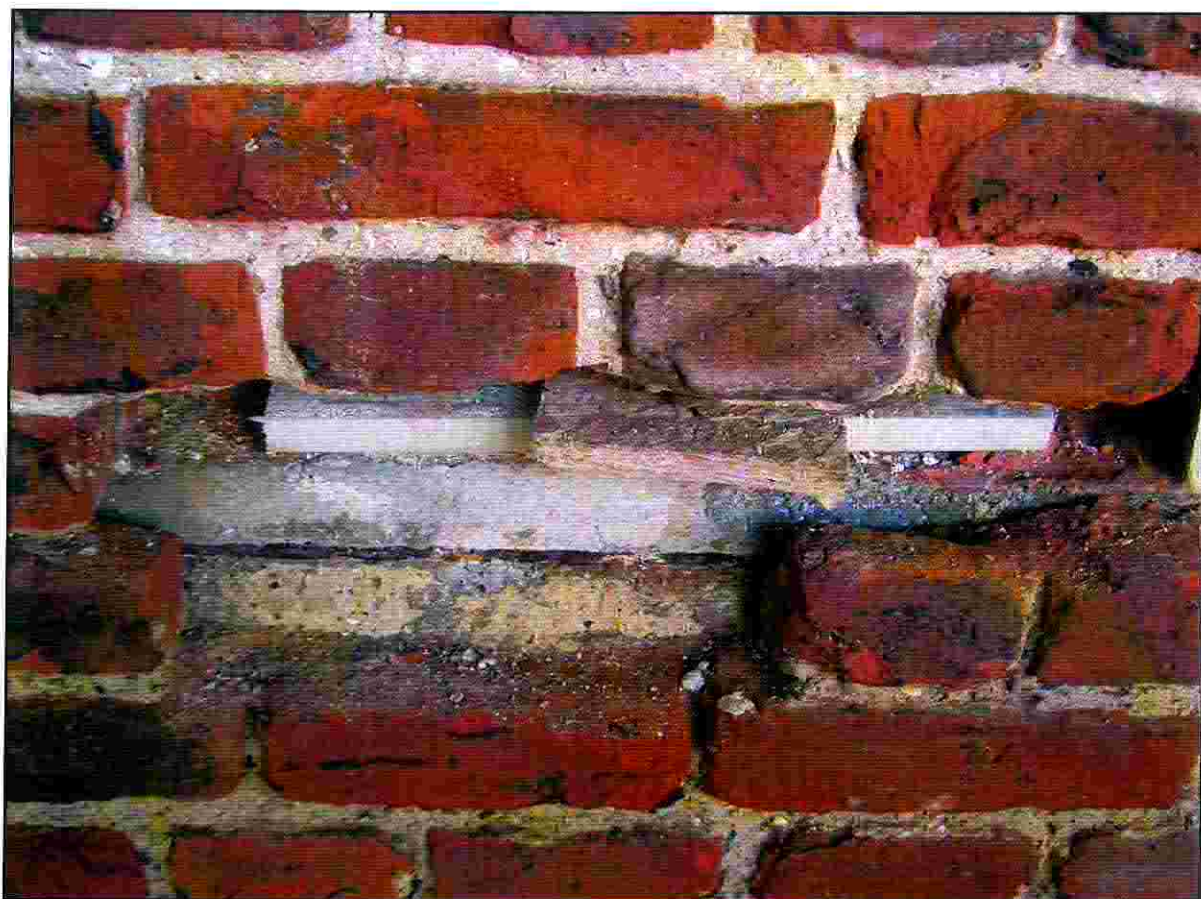
3.2.8 Removal of damaged brickwork has revealed a concrete lacing piece behind the outer skin of bricks at the top of the rebuilt brickwork (plate 22). The lacing piece rests upon a thin layer of wood and above the concrete is a layer of grey/blue coloured slate. The 3.8cm thick concrete is failing in parts - probably due to damp. The extent of the concrete lacing pieces was not revealed during the works but the assumption is that they run the width of the rebuilt brickwork.

Plate 22: Chapel Court, North Facing Elevation - Concrete lacing piece located behind window insertion brickwork

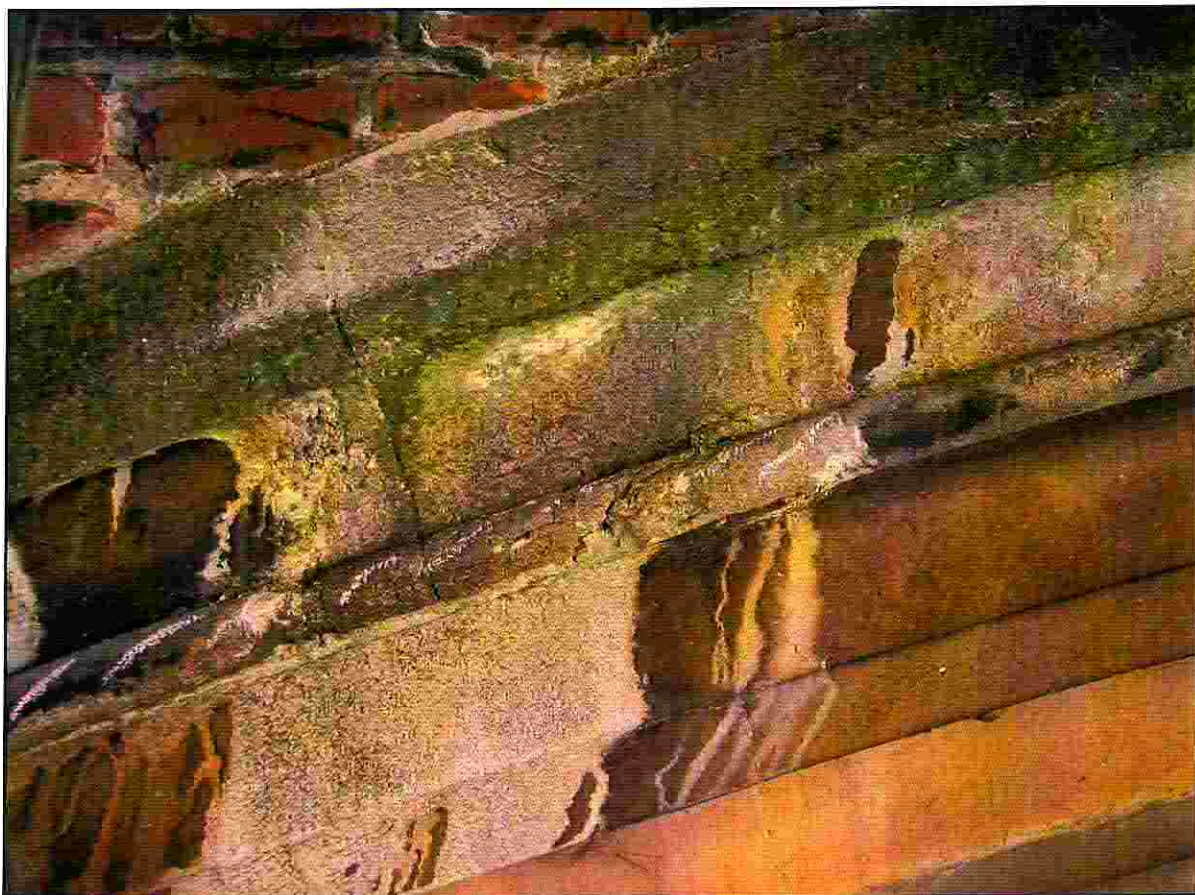
Plate 23: Chapel Court, North Facing Elevation - Window stonework before replacement

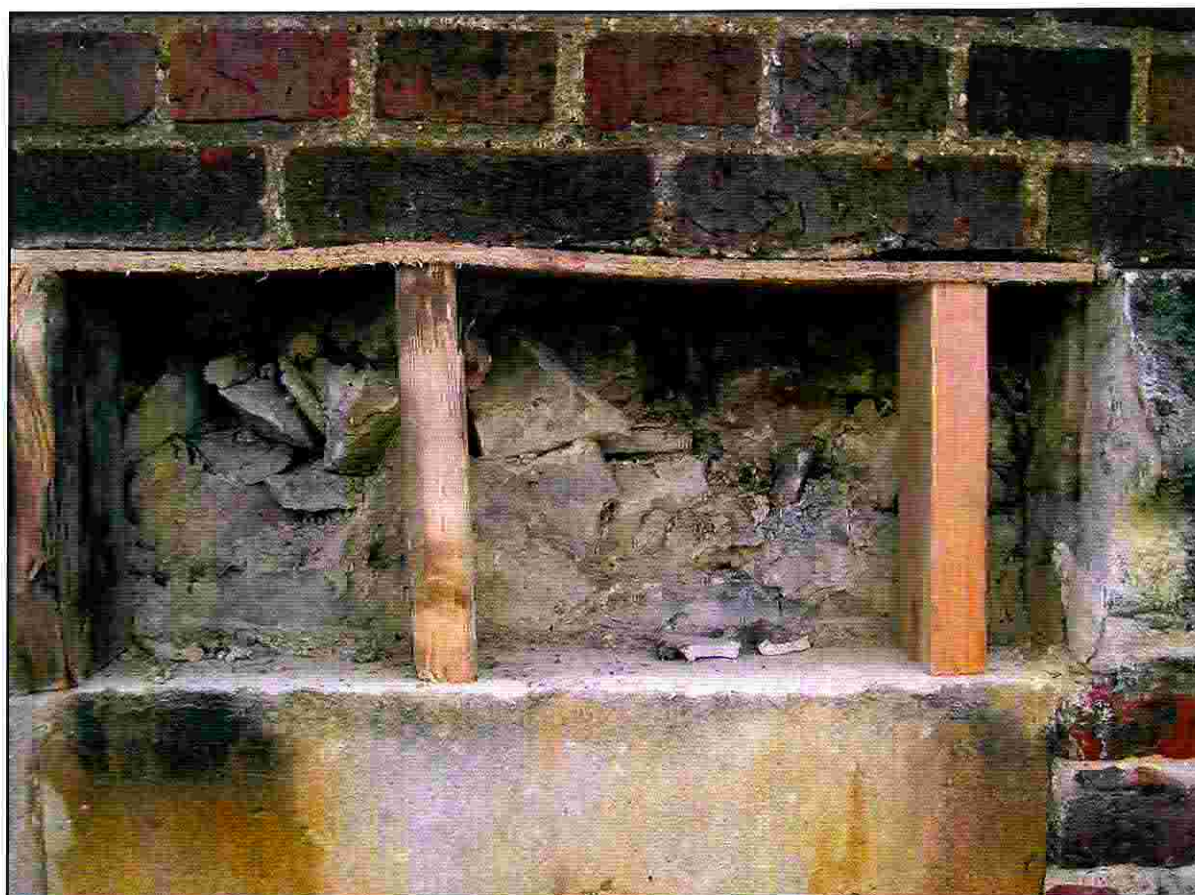
3.4.5 Removal of stonework from the upper string course revealed a loose fill of plaster, mortar and stone fragments with the inner brickwork of Type B Wolsey stock bricks and primary phase mortar behind (plate 24).

Plate 24: Chapel Court, North Facing Elevation - Brickwork and fill from behind upper string course stonework

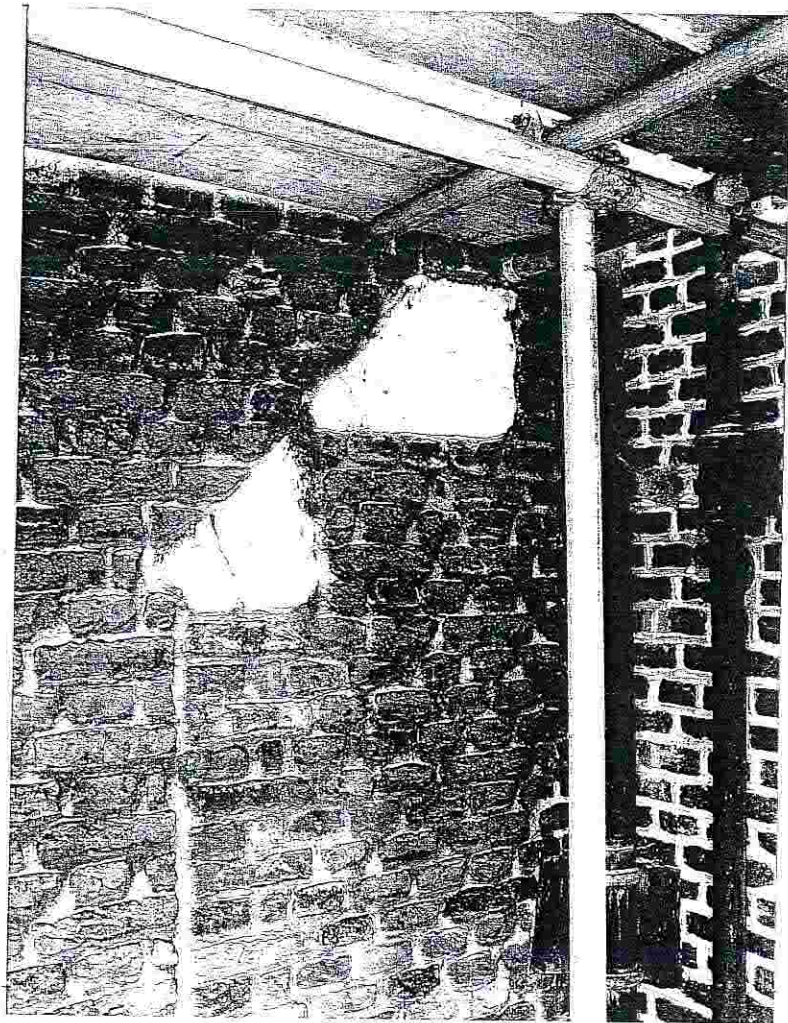
Fig. 2. Calcaire grossier weatherings to Tudor period buttress.

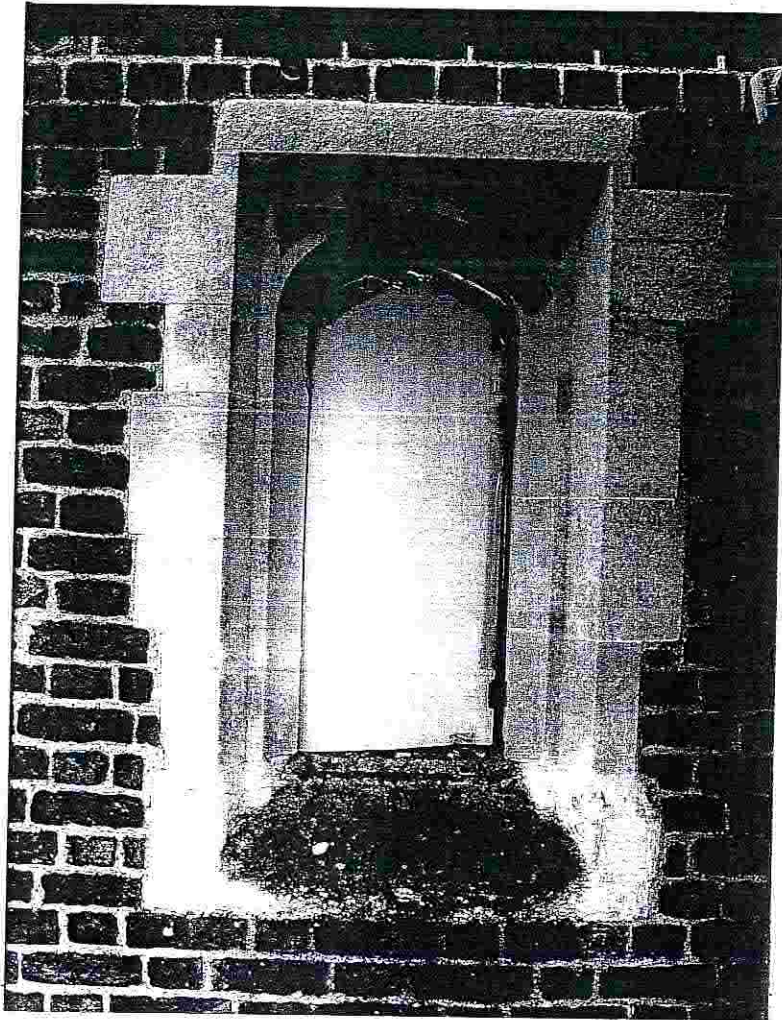
The first, second and third floor windows and string courses are of pale sparsely shelly stone showing variable degrees of decay. The more exposed sills and string courses show most decay, but there is no sign of fire reddening from the 1886 fire (Fig.4).

Fig. 4. Bath Stone window, 3rd floor of Elevation SF4. Note accelerated decay of the sill.

Fig. 4. Bath Stone window. 3rd floor Elevation SF4.

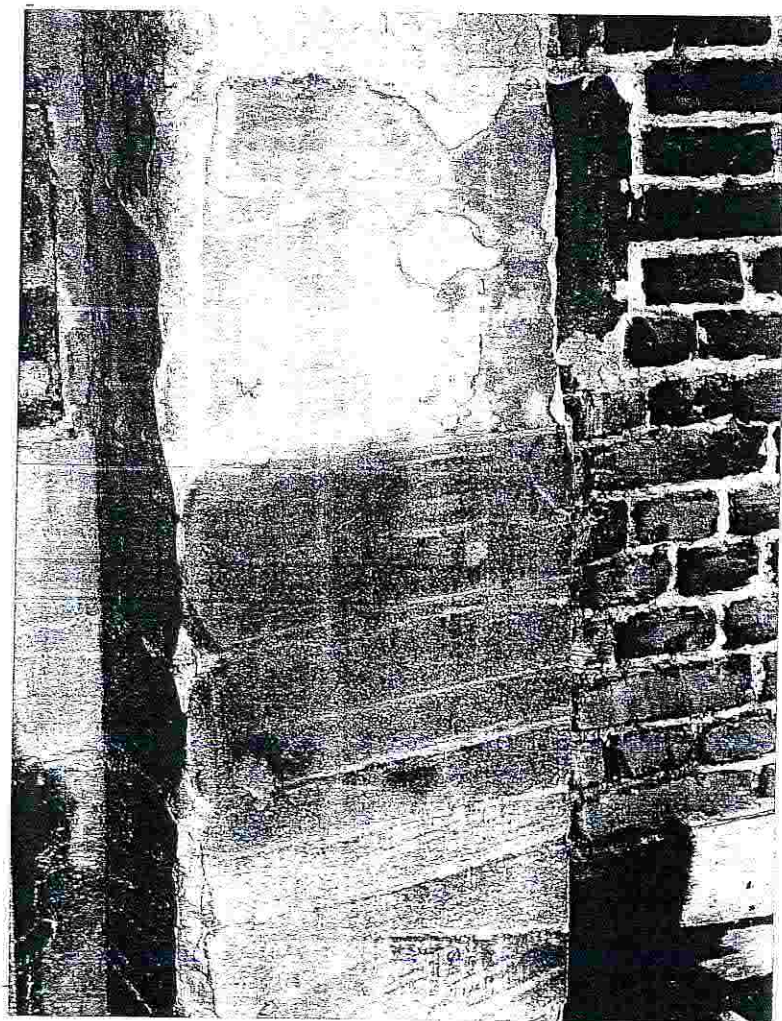
The pilaster buttresses are faced with strongly brown sulphated stone, which commonly shows powdery decay and blistering (Fig. 7). These are thus of earlier date than the windows (compare Fig.7 with Fig. 6).

Fig. 7. Chapel Royal. Decayed Bath Stone buttress.

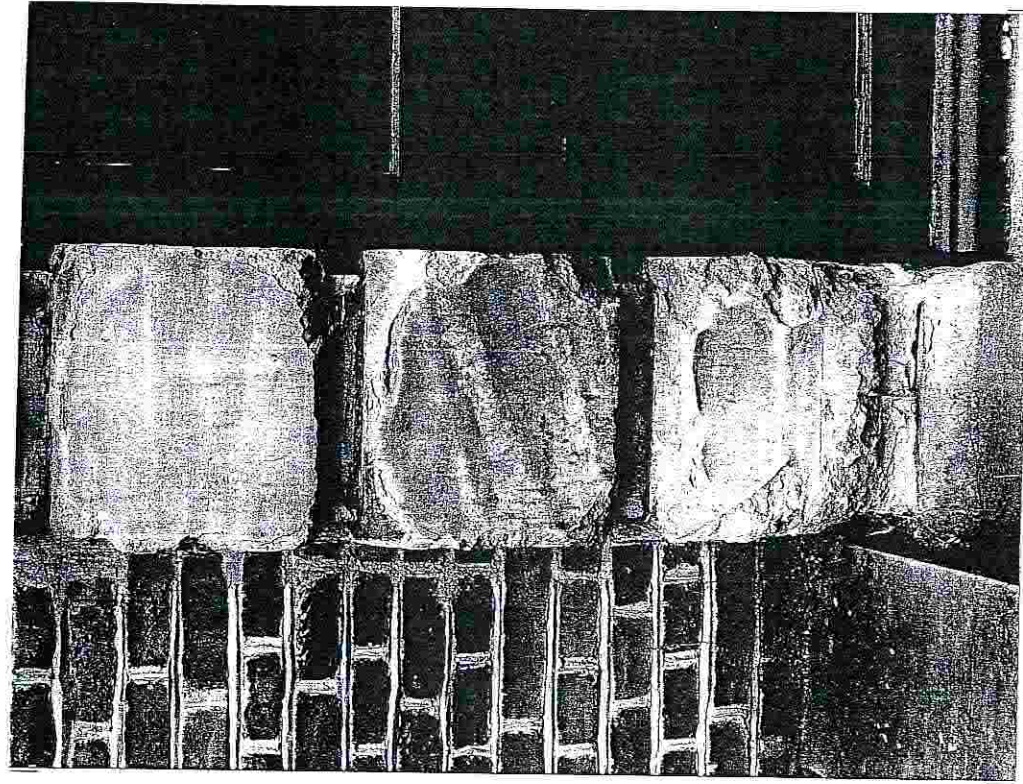
Fig. 9. Duke of York's Lodging doorway.
Weathered Taynton stone and Bath stone.

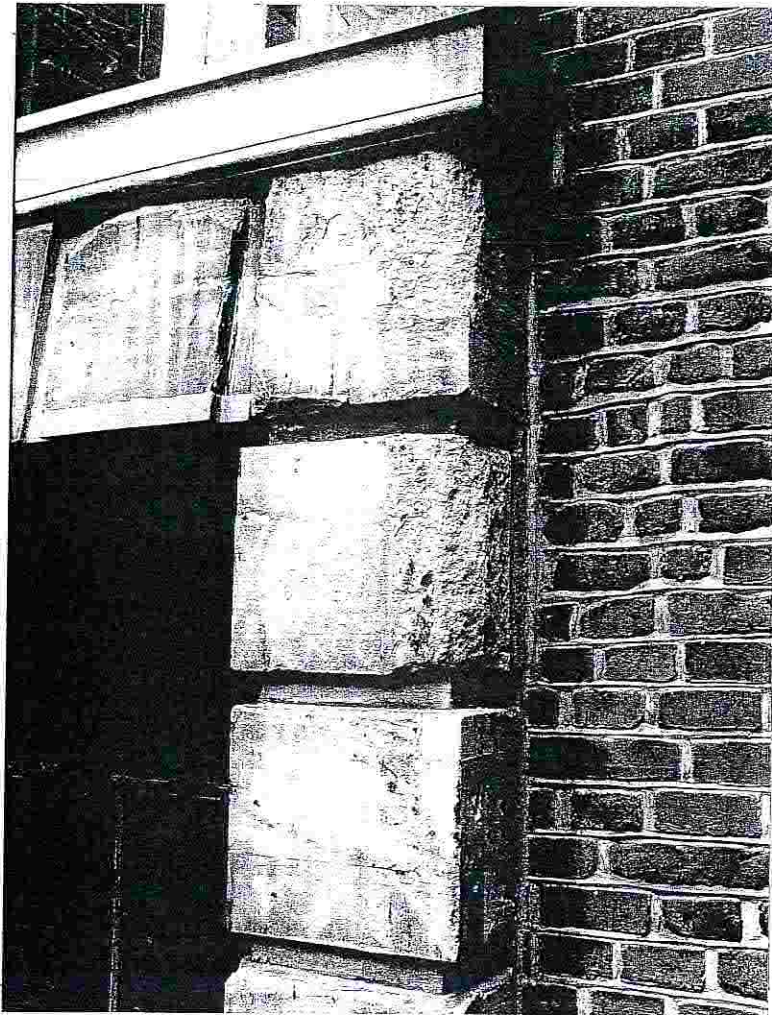
The stone is somewhat decayed and the upper courses of the jambs and the pediment are much replaced and patched with Bath Stone (Figs 10, 11). A single course at the base of both jambs appears to be Bath Stone similar to the stone of the 1894 windows of the Chapel Royal.

Fig. 10. Duke of York's Lodging doorway. Patching & replacement of Taynton stone with Bath stone.
