KINGSWAY BATHS AND BRIDGE HOUSES, LANCASTER

Archaeological Building Investigation

Oxford Archaeology North

March 2005

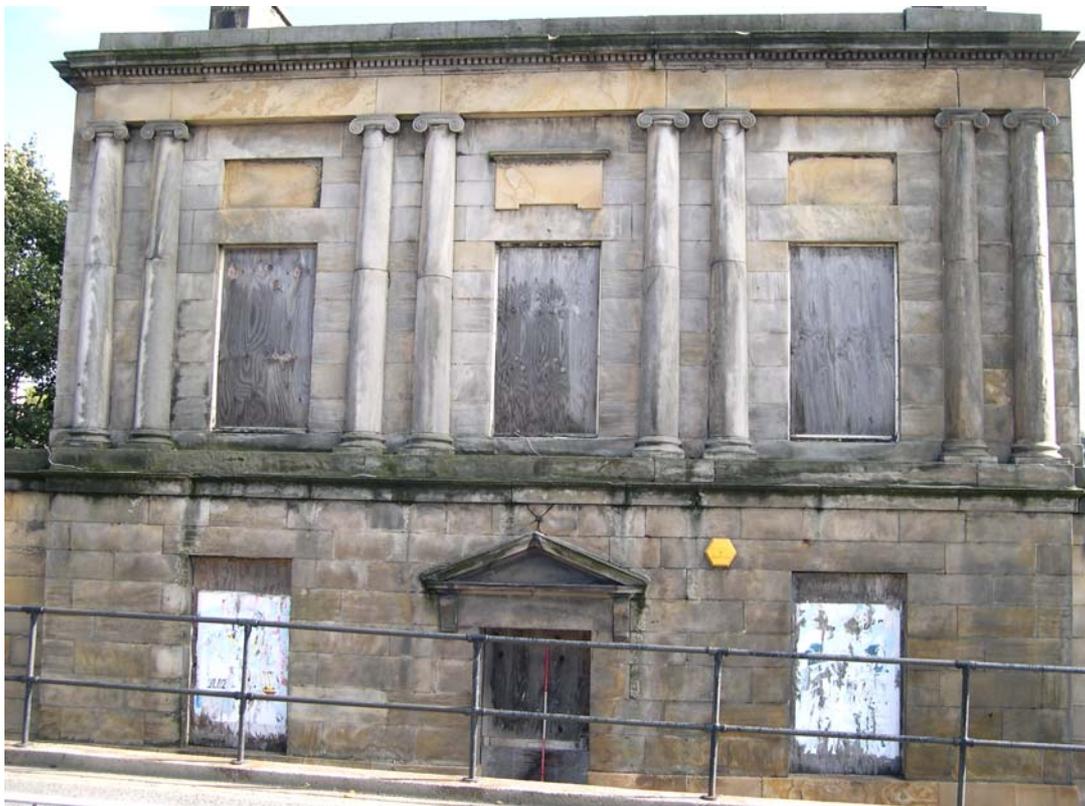
- 4.2.5 **Fabric:** all of the three bridge houses and the link walls are constructed from local yellow sandstone (Plates 7-9) which is in relatively good condition. The walls and decorative elements forming the main façade and entrance porches are compound walls faced with square cut flush-faced ashlar. The visible elevations of the east and west Bridge Houses are constructed from coursed, squared and tooled random stonework (Plate 6) and the rear elevations are a mixture of coursed and uncoursed random rubblework with large sandstone quoins. The majority of the roof covering has been removed leaving only modern roofing felt, although this was originally probably slate (stacks of roof slates are present in the modern restaurant).

Plate 7: Front (north) external elevation of the central Bridge House

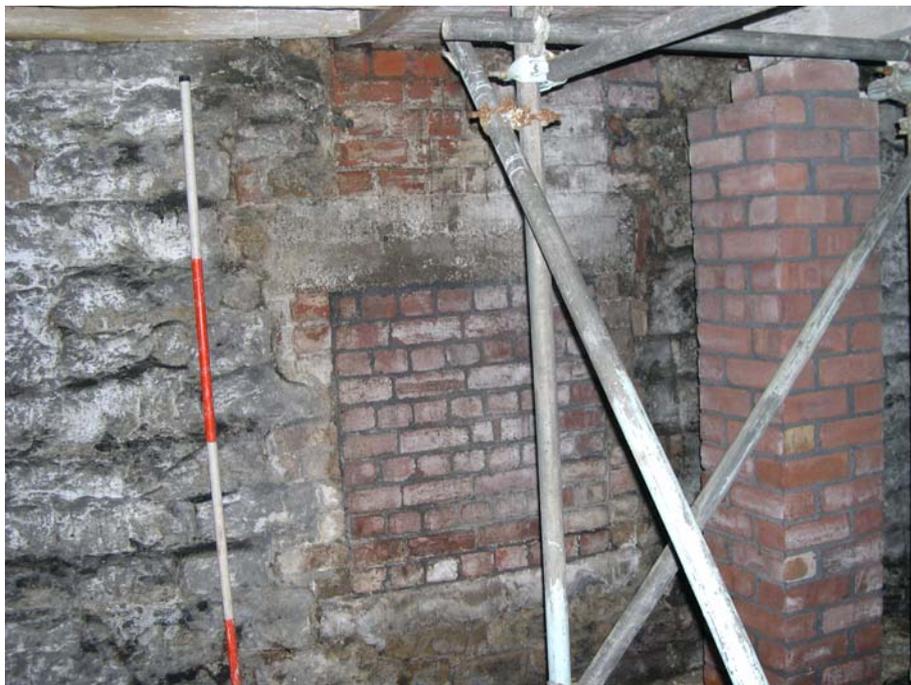
Plate 12: Blocked apertures and inserted brick pillar in Room 2, east Bridge House

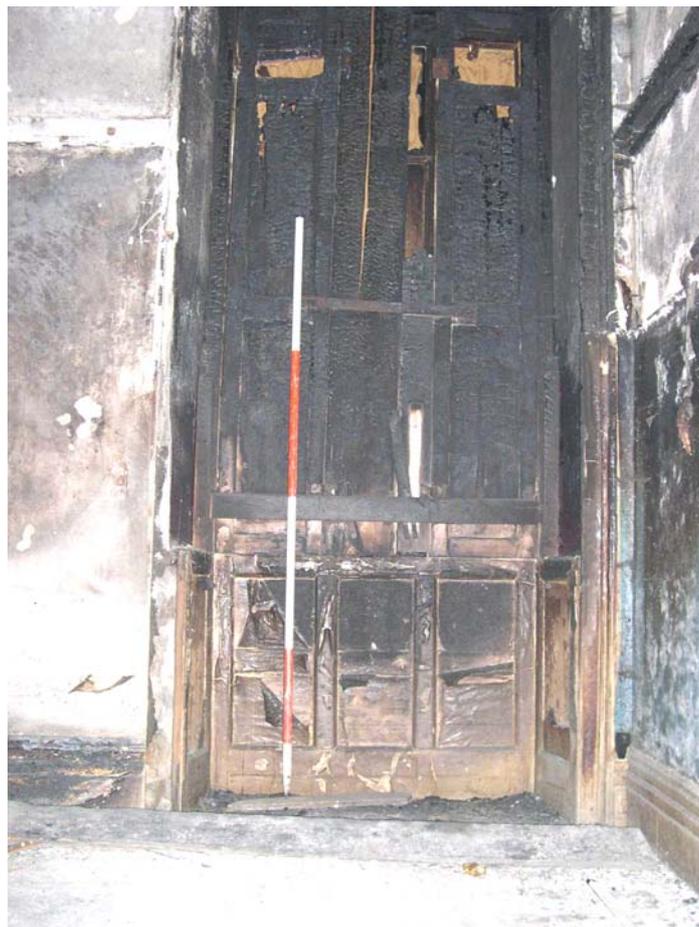
- 4.3.16 **Room 7:** the entire room is decorated with a skirting board and dado/picture rail (although much of this has been lost due to fire damage). A simple moulded cornice, or its remains, is also present throughout. There are two large windows in the north elevation with splayed jambs and a relatively late sliding sash window. The easterly window of the two has the badly fire-damaged remains of panelling and shutters *in situ* (Plate 14). The west elevation has a central chimney-breast, 0.16m deep, in the centre of which is a fireplace with a relatively modern tile surround, which has been blocked with brick. The south elevation is a stud partition and has a doorway on the east side into the hall, and a radiator attached on the west side. The east elevation is also a stud partition but is otherwise plain. The floor comprises floorboards and the ceiling is lath and plaster.

Plate 14: Window in Room 7 of east Bridge House, showing remains of badly damaged shutters and surrounds

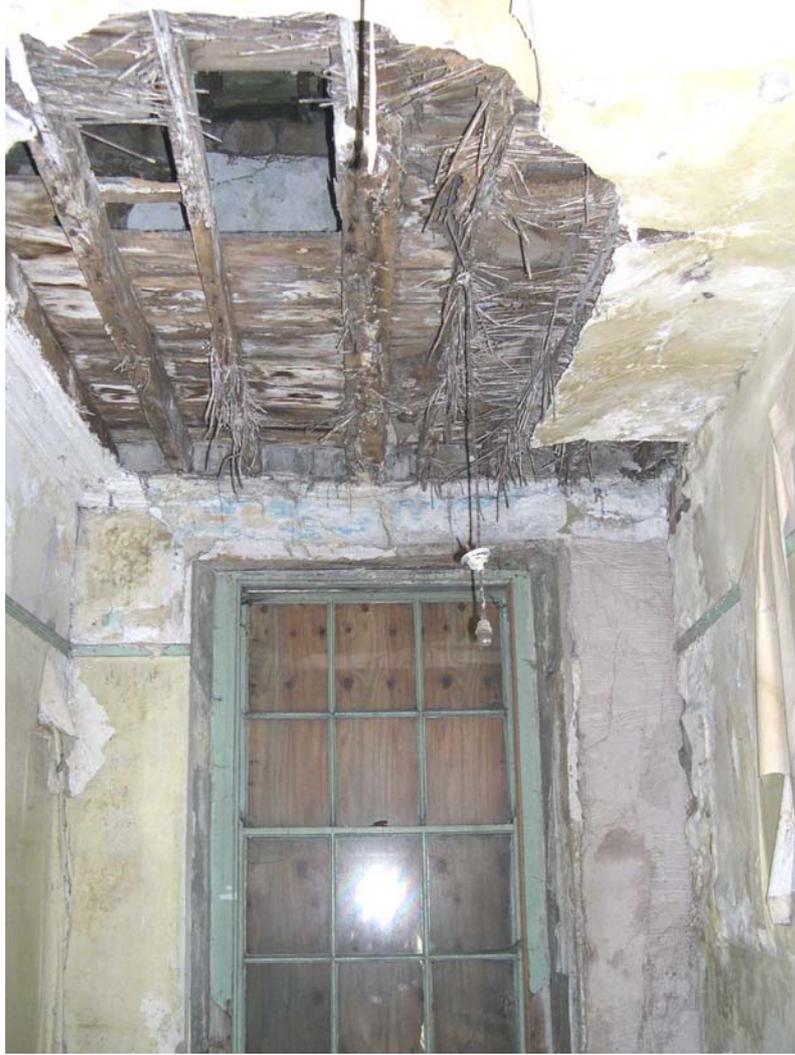
- 4.4.18 **Room 11:** between Rooms 10 and 12 is a smaller room. This too is very plain, although there is a dado/picture rail and the remains of a cornice. In the north elevation there is a window with splayed jambs (Plate 19), which is missing its surround. All of the walls apart from the north are stud partitions and there is a door in the south.

Plate 19: Exposed reed-plaster ceiling and window in Room **11**, central Bridge House

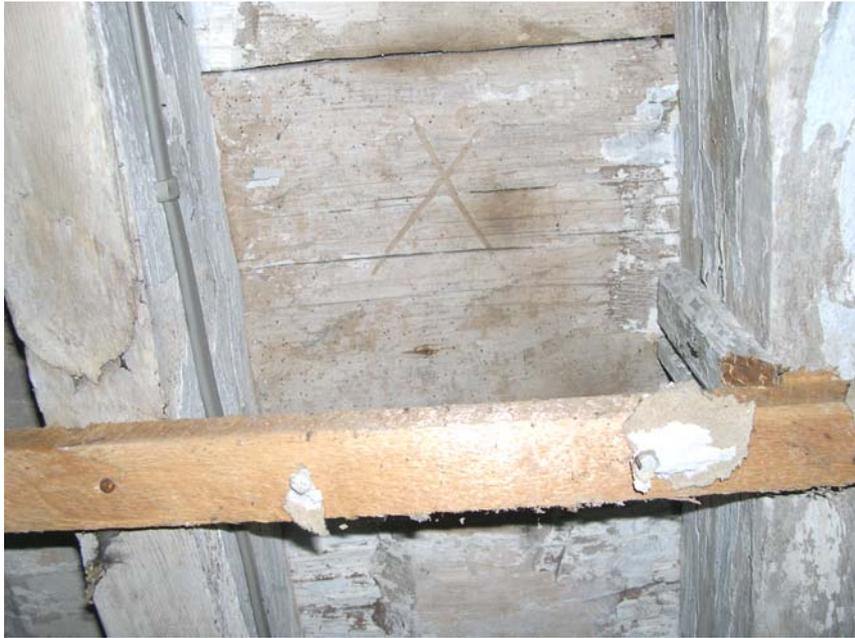
- 4.5.7 **Room 2:** this is the north-east room. This is particularly large, probably due to the removal of an original wall on the south side. There is a small vent in the north elevation, utilising a former coal chute. The walls are all tiled and there is a large modern pizza oven in the south-east corner, partially inserted through the wall. There is a large aperture to the north of this in the east elevation leading into the restaurant, with iron lintels. The ceiling is mostly a later replacement on the north side and there is a further iron beam supporting it to the south, probably marking the position of a former wall. The ceiling to the south of these retains many original thick floorboards, which are hand-finished. Most have had rough soffits cut to fit the beams, perhaps suggesting that they were re-used, and there are at least four Baltic timber visible on them including rows of scored lines, an 'X' (Plate 21) and a '7'.

Plate 21: Timber mark in floorboards, Room 2, west Bridge House

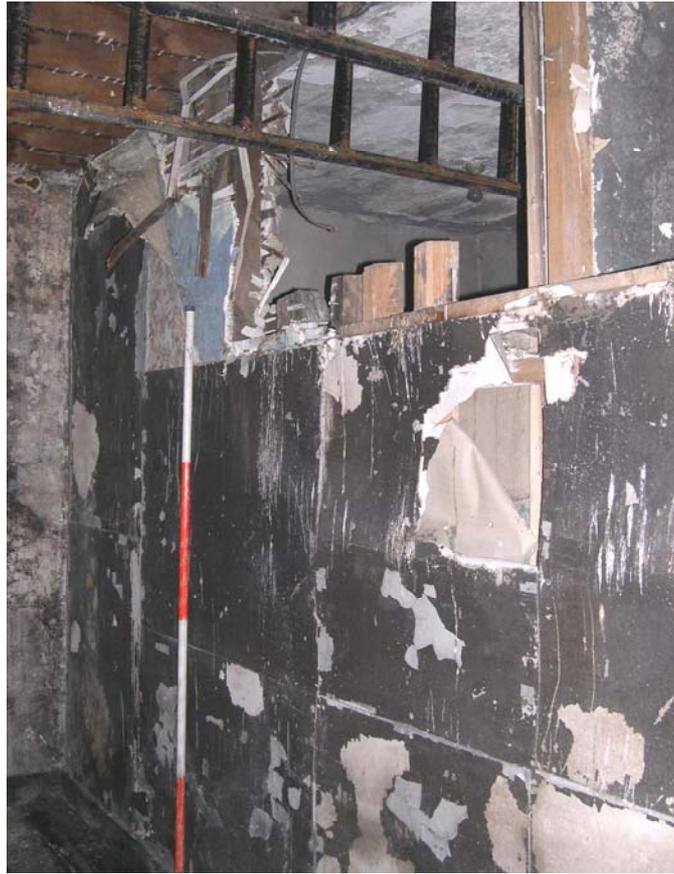
- 4.5.21 **Room 14:** this is a large room in the north-east corner. There is a window in the north elevation with splayed jambs and a fireplace in the east. This has been blocked with concrete blocks, although a small hole has been broken through. The west and most of the south elevations are modern stud partition walls, although the first 2.16m projecting from the east elevation are apparently original (Plate 24).

Plate 24: Junction of modern and early partitions between Rooms **14** and **18**, west Bridge House

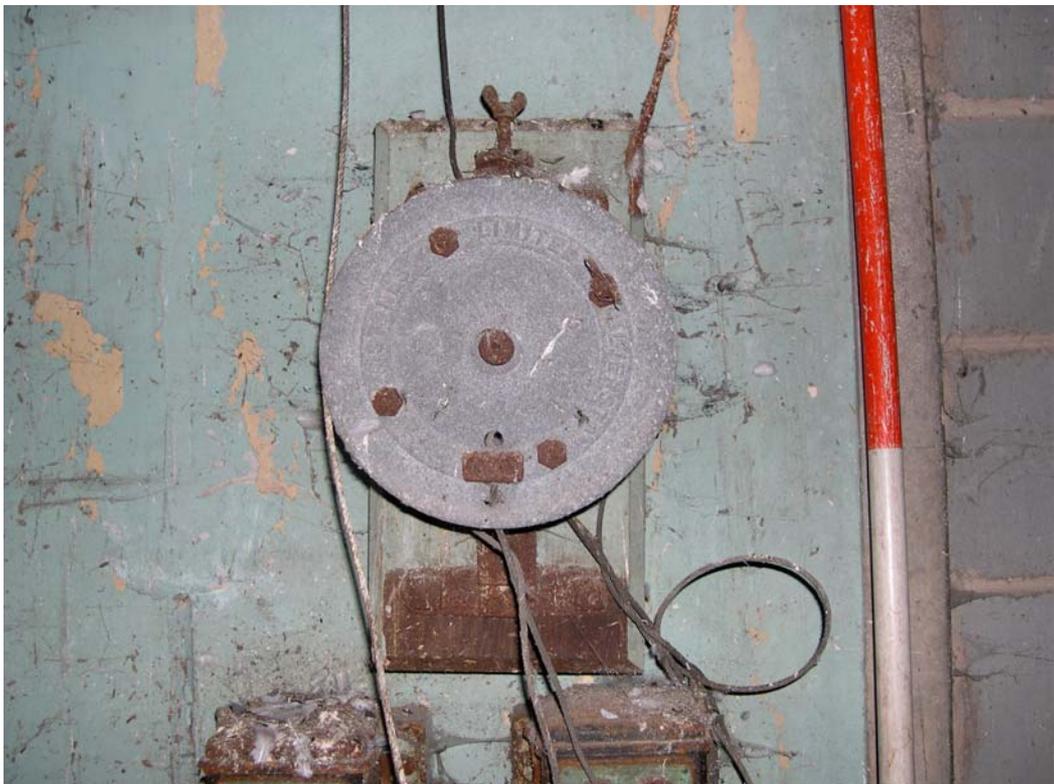
- 4.7.35 **Internal Detail, Room 26:** this is a large room to the north-west of Room 25, which originally formed a stage overlooking the main pool. It is tall, extending to first floor height, with nine-light windows in the east and west elevations at first floor level and two larger blocked windows in the north elevation at the same level. The ceiling is original but plain, and supported by three concrete beams. The floor is finished with badly damaged timber blocks and there are the remains of a skirting board along most of the walls. There are blocked doorways in the north sides of the east and west elevations and an inserted doorway in the south side of the east. The ground floor level of the north elevation mostly comprises a single large aperture filled with concrete blocks. Within the blocking three smaller apertures have been left, but these have subsequently been covered by timber boards (which are finished with tiles on the pool side). Above the original large aperture is the remains of a mechanised curtain and long strip-light, and on the west side the electric drum for the curtain remains *in situ* and is marked 'STONES LIMITED ULVERSTON' (Plate 37).

Plate 37: Cable drum for stage shutters marked 'STONES LIMITED ULVERSTON', Room 26, baths
