De Montalt Mill Combe Down Bath

Archaeological Evaluation Report

February 2006

DE MONTALT MILL, COMBE DOWN, BATH.
ARCHAEOLOGICAL EVALUATION REPORT
ST 7622 6200

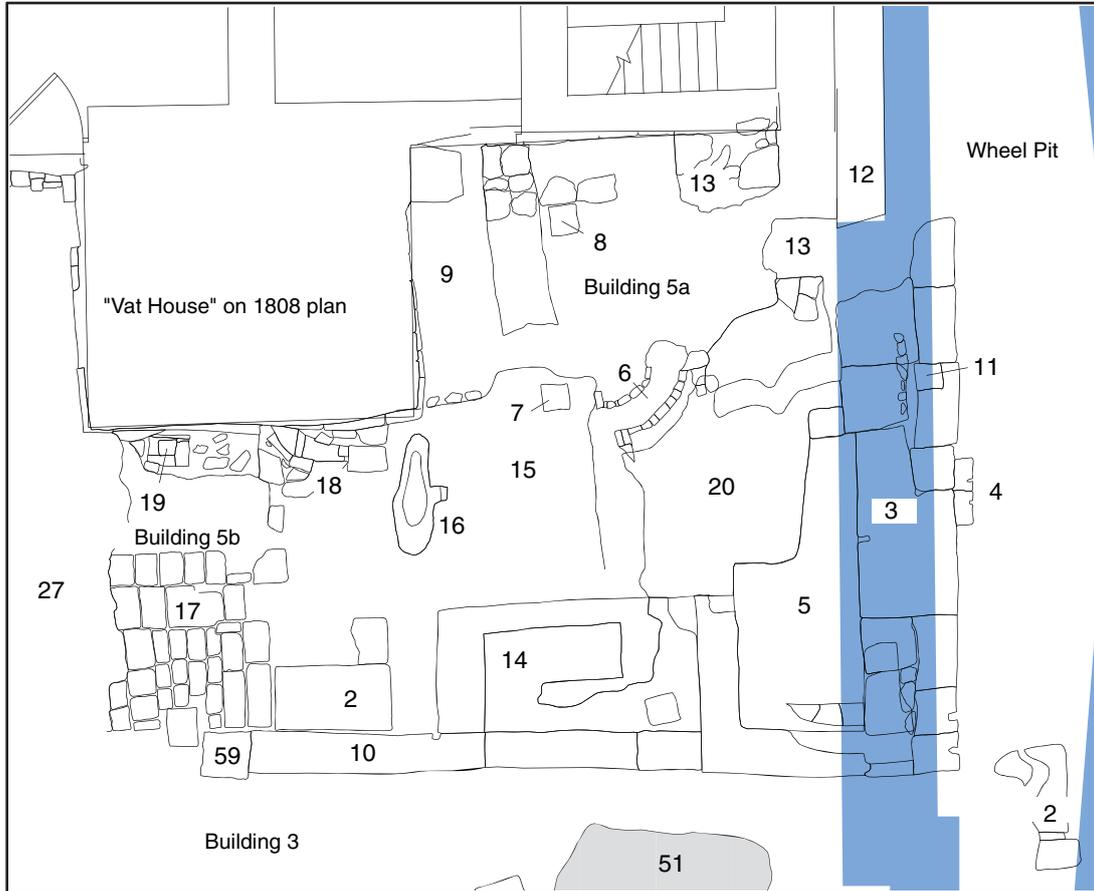
Figure 4: Detail of Buildings 5a and 5b

- 4.1.4 **Phase 2:** Phase 2 comprises the elements added and augmentations made to facilitate the addition of the Steam engine in 1808. Towards the centre of 5a a red brick curvilinear structure (6), a rectangular depression (14), a flue-like vertical hole in the floor masonry leading to an underground chamber (16), and two floor surfaces (15 and 20) were noted (Fig. 4). This arrangement is thought to reflect the addition of the Boulton and Watt steam engine in 1808, as indicated in a drawing from Boulton and Watt showing the proposed installation, dated May 1808 (Fig. 11). However, the proposal drawings do not match what was found. The question is discussed below. Context 6 comprised two curvilinear arrangements of red brick and contained some highly oxidised clay. It is probably constitutes the remains of a flue coming from the boiler. To its south, a rectangular depression (14) sunk into the floor surface with a second smaller rectangular depression in its centre, is probably where the machine mount for the steam

Key	
	Wheel pit (from historical sources)
	Area outline (as in figure 3)
9	Wall described as temporary in 1808. The boiler was probably sited between 9 and 13
6	Part of the boiler ducting
14	Thought to be the site of the steam engine itself
16	Small shaft leading to the void under 15

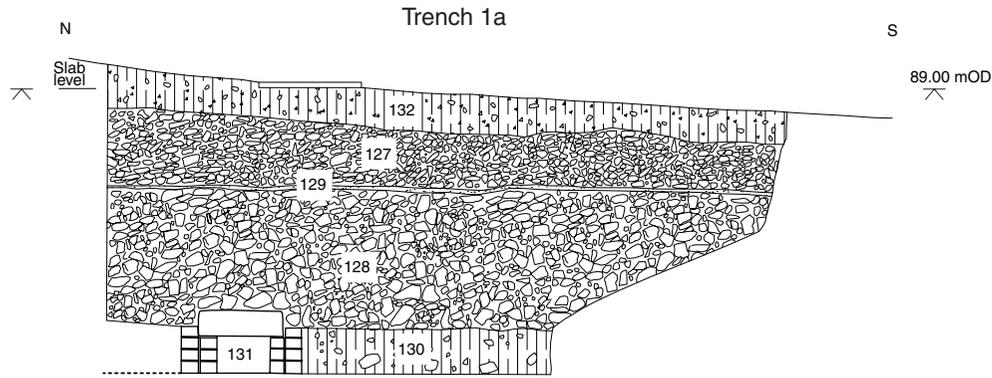
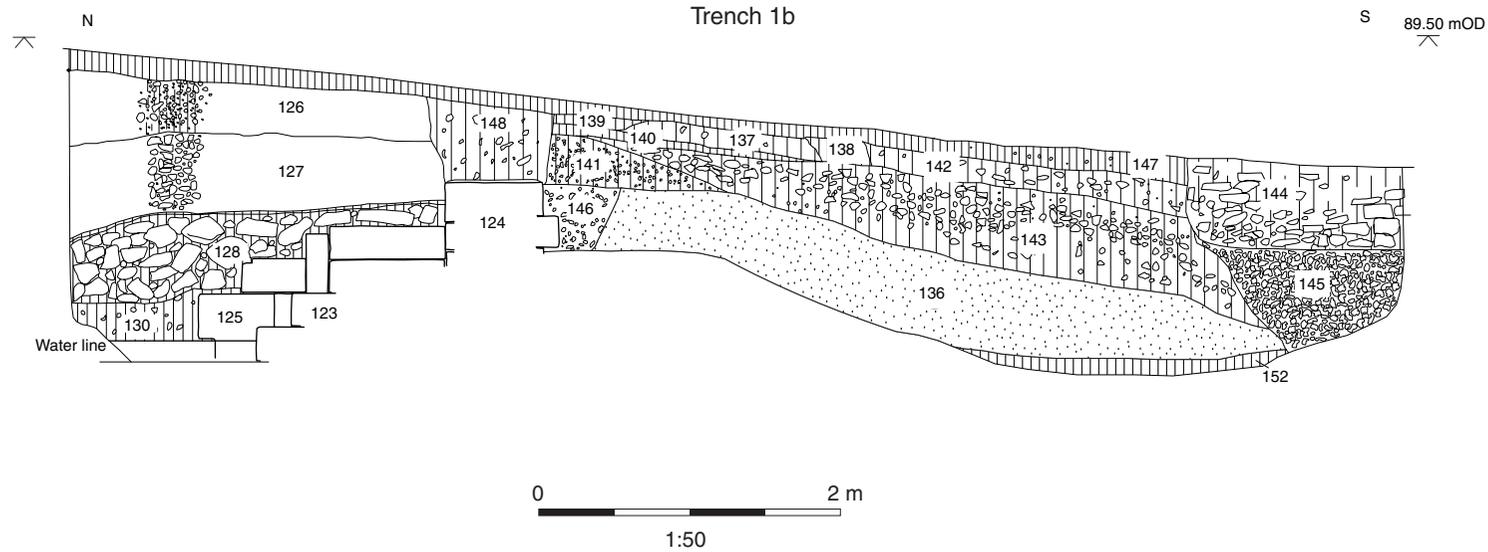
Figure 6: Trench 1a and b

- 4.3.11 Excavation of the rest of Trench 1b continued alongside this structure, revealing its external structure of large, rough blocks and its minimum depth of 1.3 m. A better-finished and wider section at the south end indicated that the wall may have had external finishing blocks removed. The cistern wall was shown here to cut through a series of soily dumps that predated the demolition of the western cellar (137-143), and the first phase stone chipping dump (136), see Fig. 6.
- 4.3.12 At the southern end of the trench a rather odd, loose, but relatively orderly, piling up of squared and not so squared stones seemed to represent the dry stone footings of a small building shown in this area in the late 19th century mapping (Fig. 6, 144 & 145)

Left; Trench 1a, the northern part of Trench 1. The cellar floor and the brick and stone conduit are shown, as well as the massive amount of rubble infill in the cellar. Note the silting predating the infill.

Below; Trench 1b, the southern part of Trench 1. The cellar structures are shown. Layer 136 is the original stone chip makeup of the 1805 yard, covered by later 19th century makeup. 144/145 appear to be part of a demolished later 19th century building.

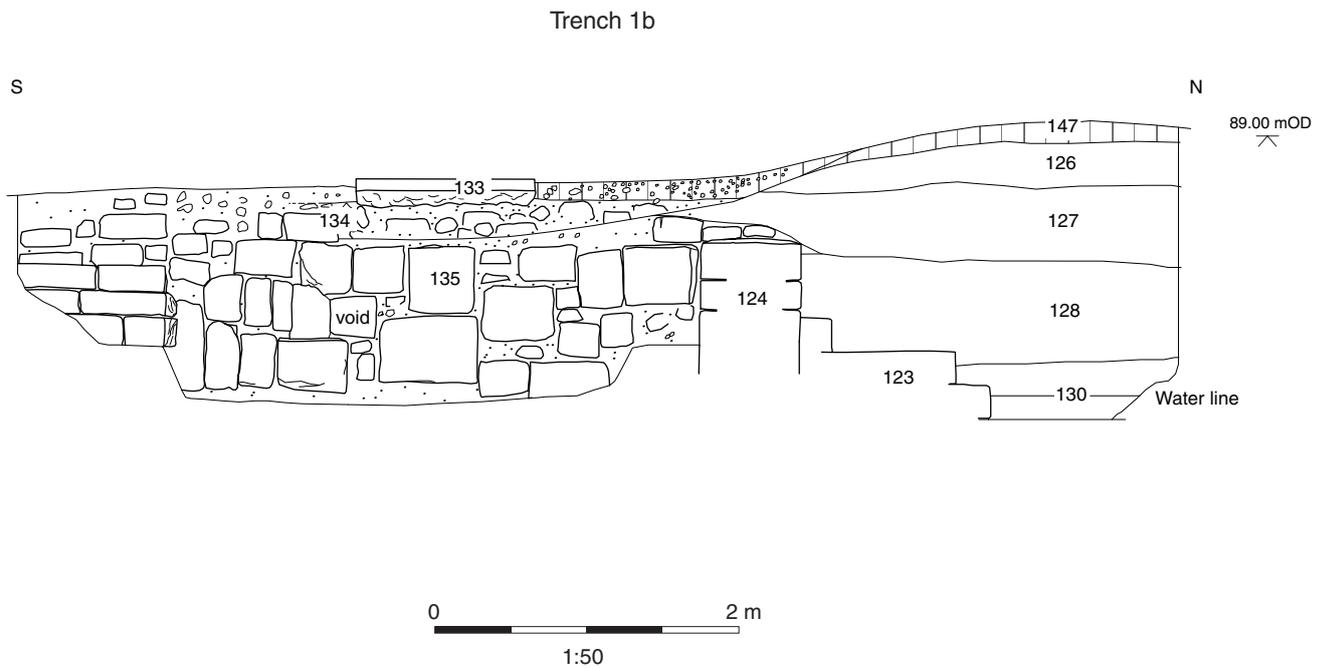
Figure 7: Trench 1b, the southern part of Trench 1

The cellar structure and infill is shown (the latter schematically). The side of the stone chambers, interpreted as water tanks (contexts 134 and 135) are shown, probably robbed of facing, some of which survives on the south, and the manhole, 133.

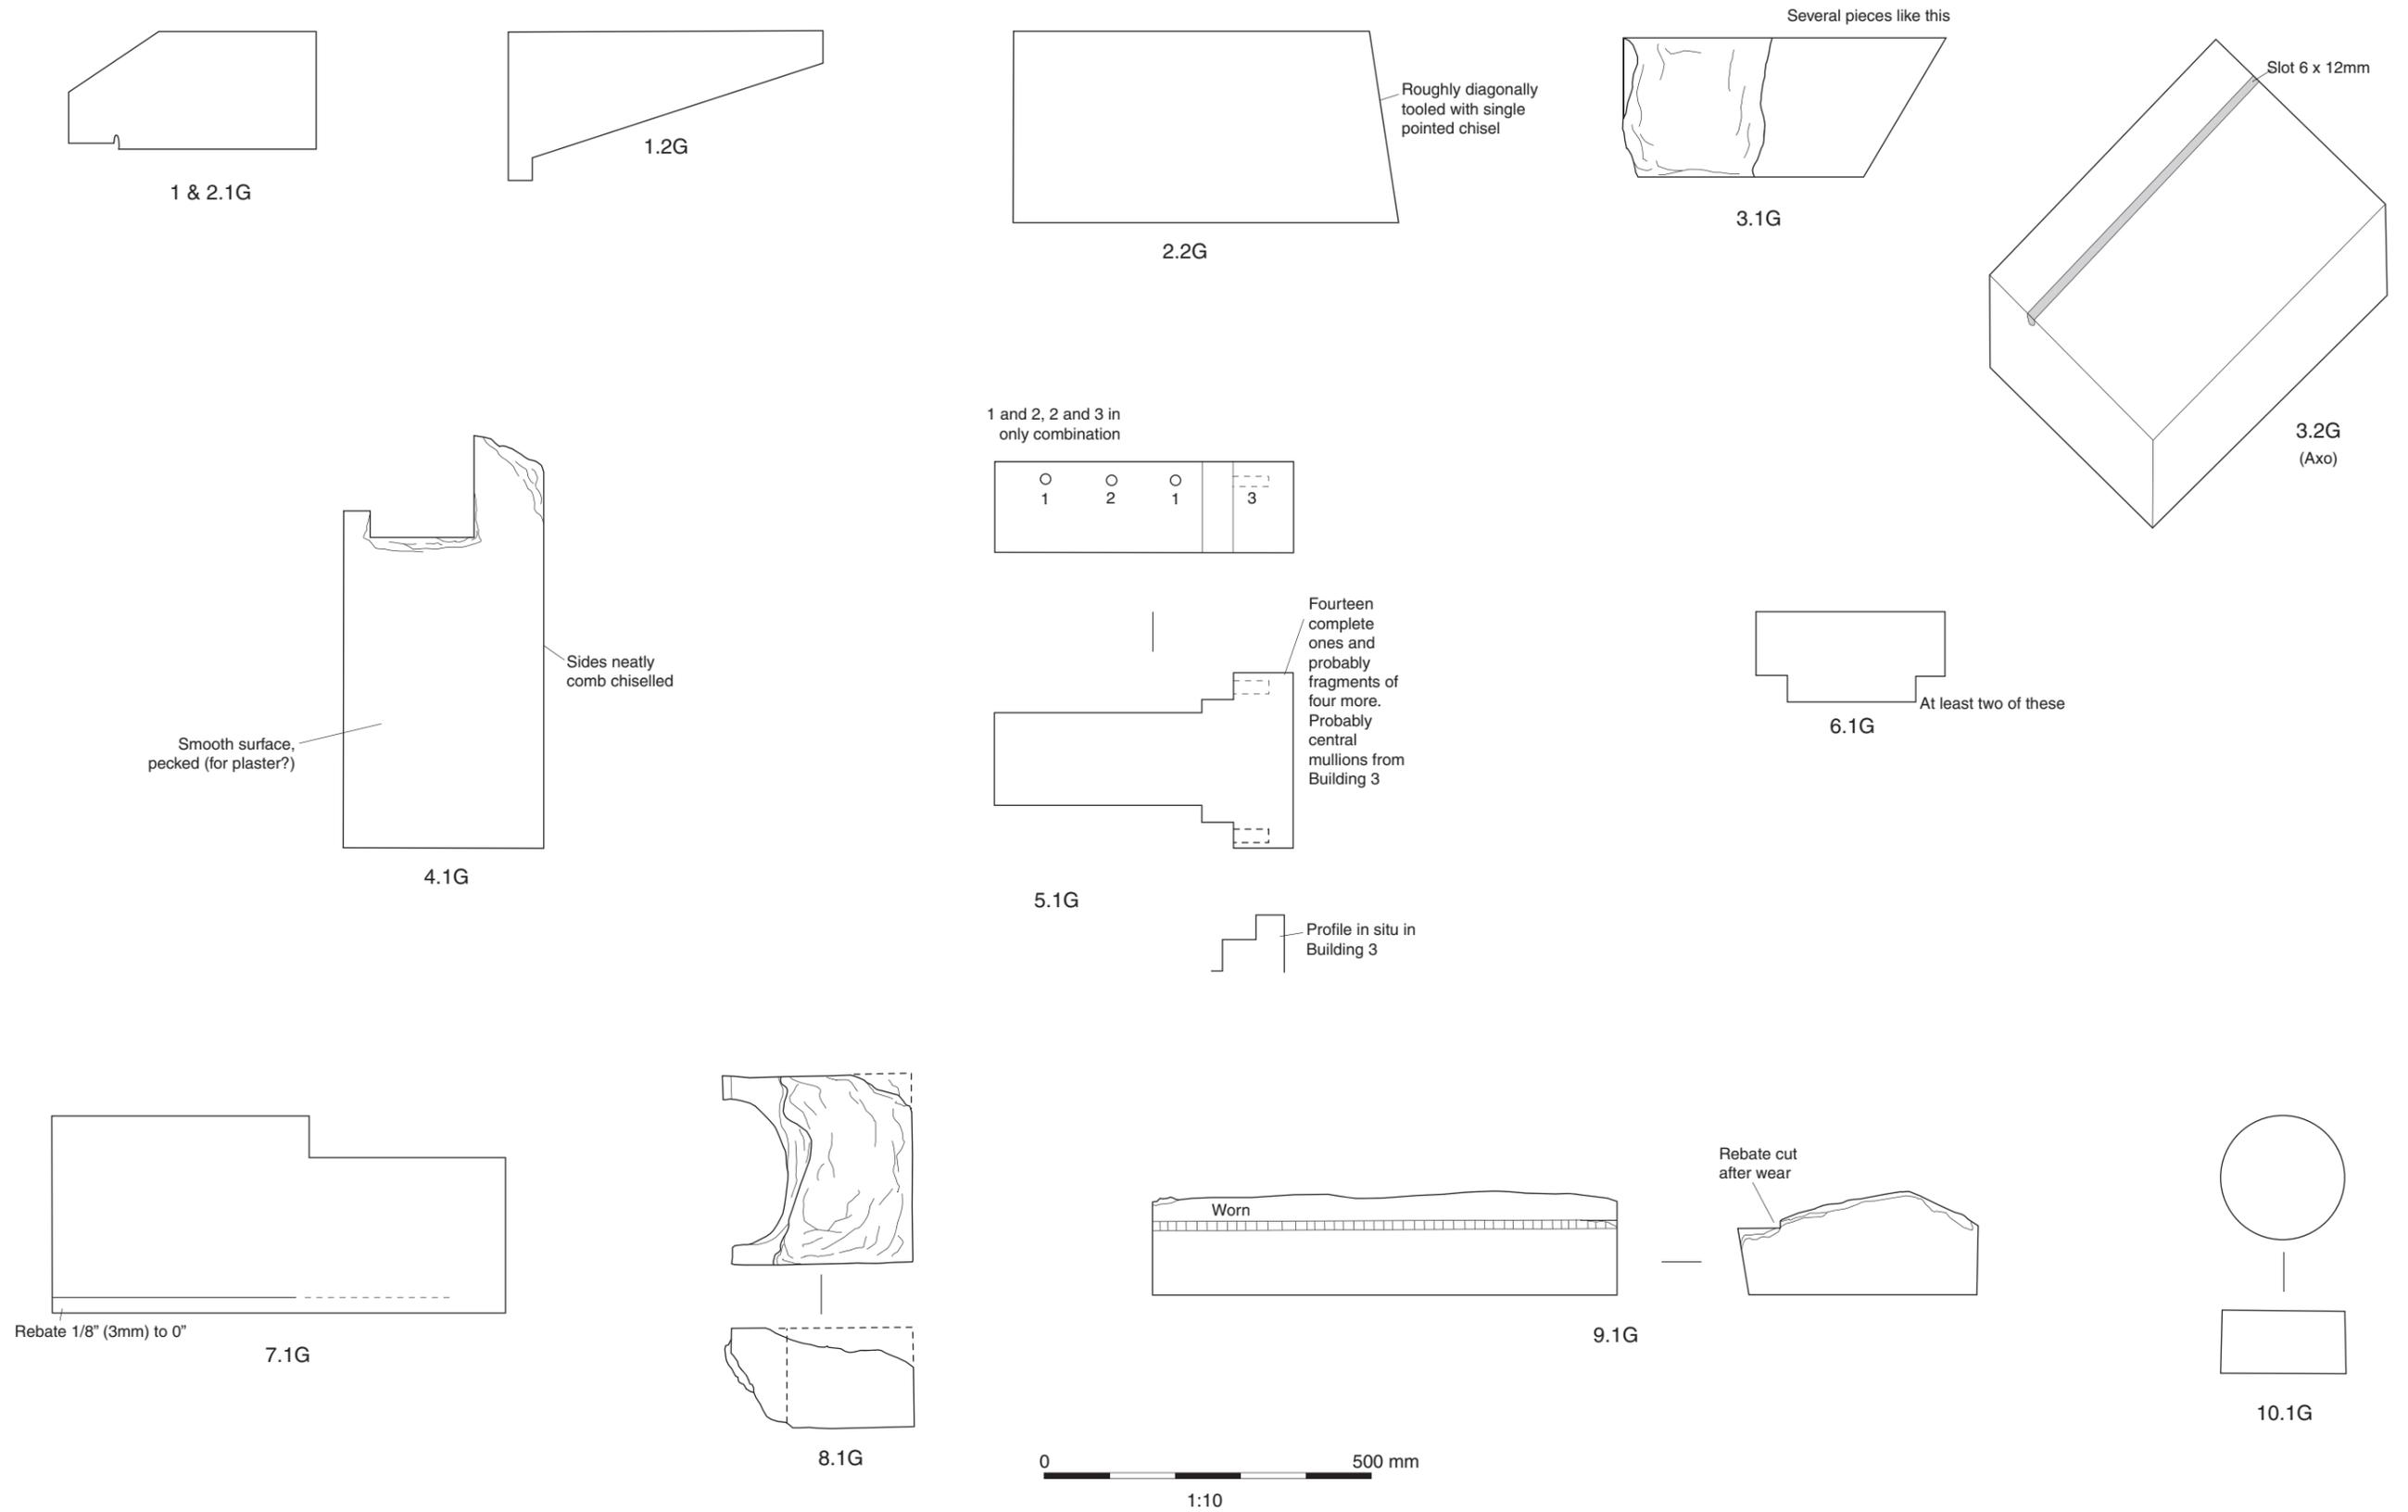
Figure 13: Architectural ashlar from Groups 1 and 2

Two blocks were found against and inside the south wall of Building 3, which might well be window cills (1.1G and 2.1G), giving a window width of about 120cm.

1.1G Cuboid block with chamfered upper surface and rebated and grooved lower. 380mm wide x 180mm thick x 1240mm long. Probably a window cill from Building 3 south face. Found lying below south wall on north side.

- 2.1G Cuboid block with chamfered upper surface and rebated and grooved lower. 380mm wide x 18mm thick x >1150mm long (broken). Probably a window cill from Building 3 south face. Found lying below south wall on north side.

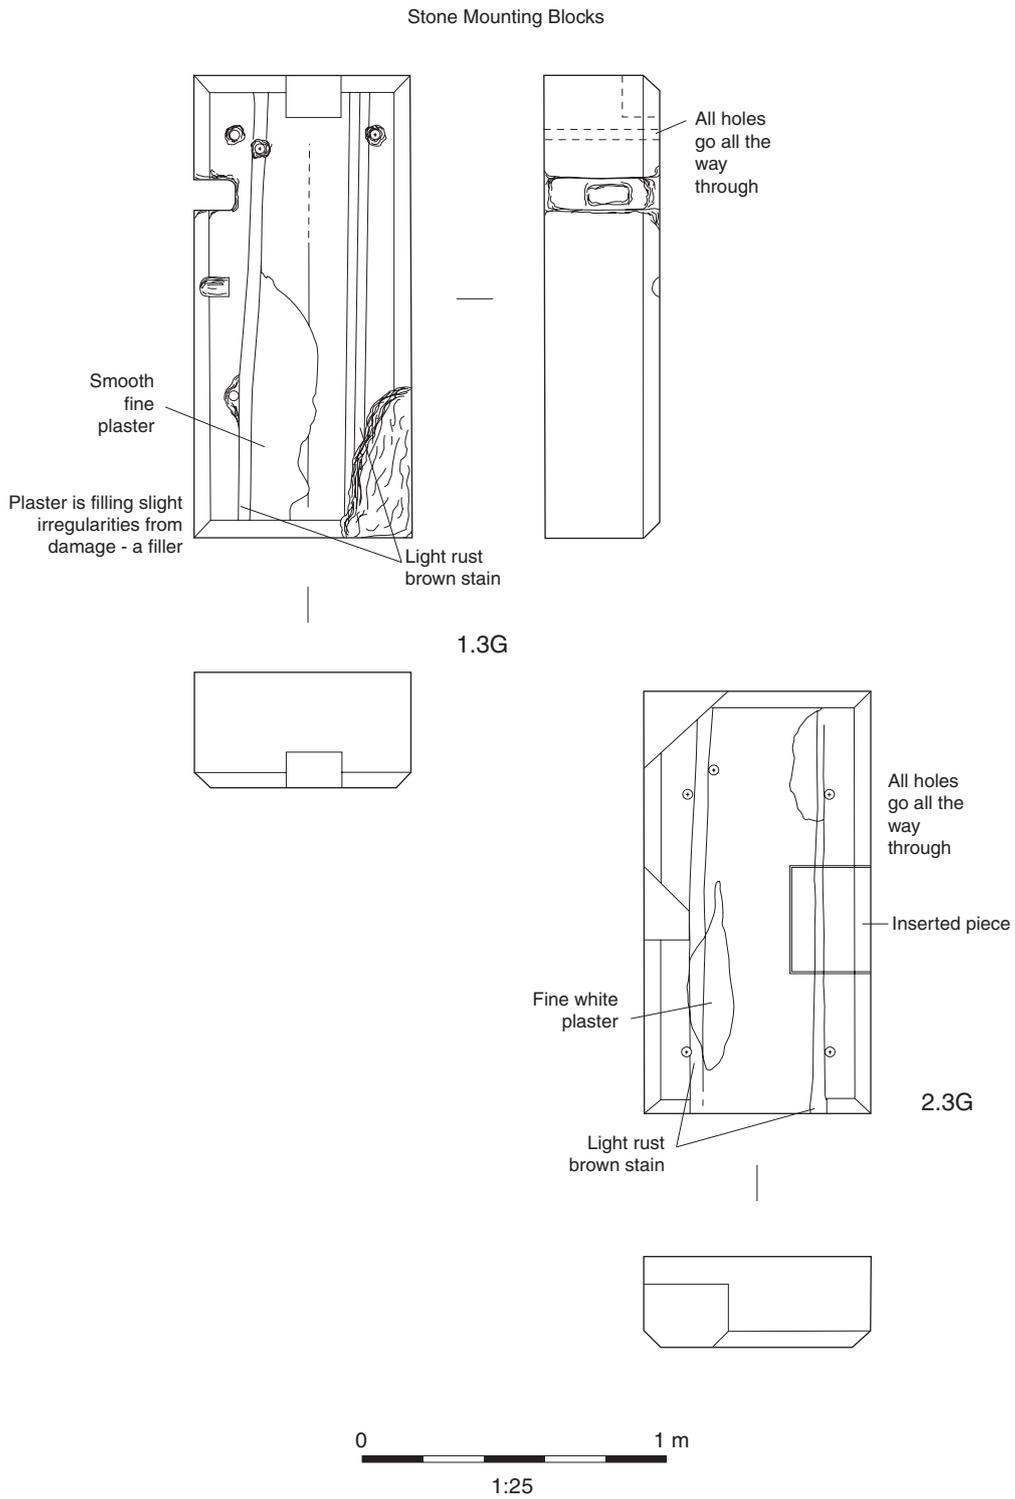
Figure 14: Stone machine mounting blocks from Group 3 on the site Building 3

Four blocks in particular were noted. These were clearly machinery mounting blocks, similar to those still in place in room G2 in building 2.

1.3G and 2.3G were very similar indeed. 1.3G was longer than, but identical in width and height to 2.3G and shared the chamfer around the top edges. Both were pierced by holes for 1" bolts three of which in 1.3G lined up perfectly with three of the four in 2.3G. It is clear for other reasons that the two blocks were not superimposed, but they may have carried matching (parts of) machinery. Both were marked with two rust brown stained strips running inside the bolt holes as if the result of rusting iron mounting rails. Curiously, both had thin layers of plaster laid to fill irregularities in the surface prior to machine mounting. Both had various slots and rebates cut into the surface but 2.3G had one of these carefully repaired as if there had been a change of plan or a mistake.

- 1.3G Large cuboid stone block with upper chamfered edges, various rebates and recesses and four bolt holes drilled all the way through. Three of these form the corners of a rectangle and the fourth is "random". Depressions in the finely finished upper surface have been filled with plaster prior to the placing of iron strips (now missing but shown by ferrous staining). 720 mm x 380 mm x 1520 mm. This is presumably a machine mounting block from Building 3 or 5c.

- 2.3G Very similar to 1.3G but with more complex angled cut outs and top chamfer interrupted at one end. Same plaster infill and iron staining. 750 mm x 305 mm x 1400 mm. It has four bolt holes forming a rectangle of the same size and relationship to the sides as 1.3G. They cannot fit together but may have supported similar sized machinery.

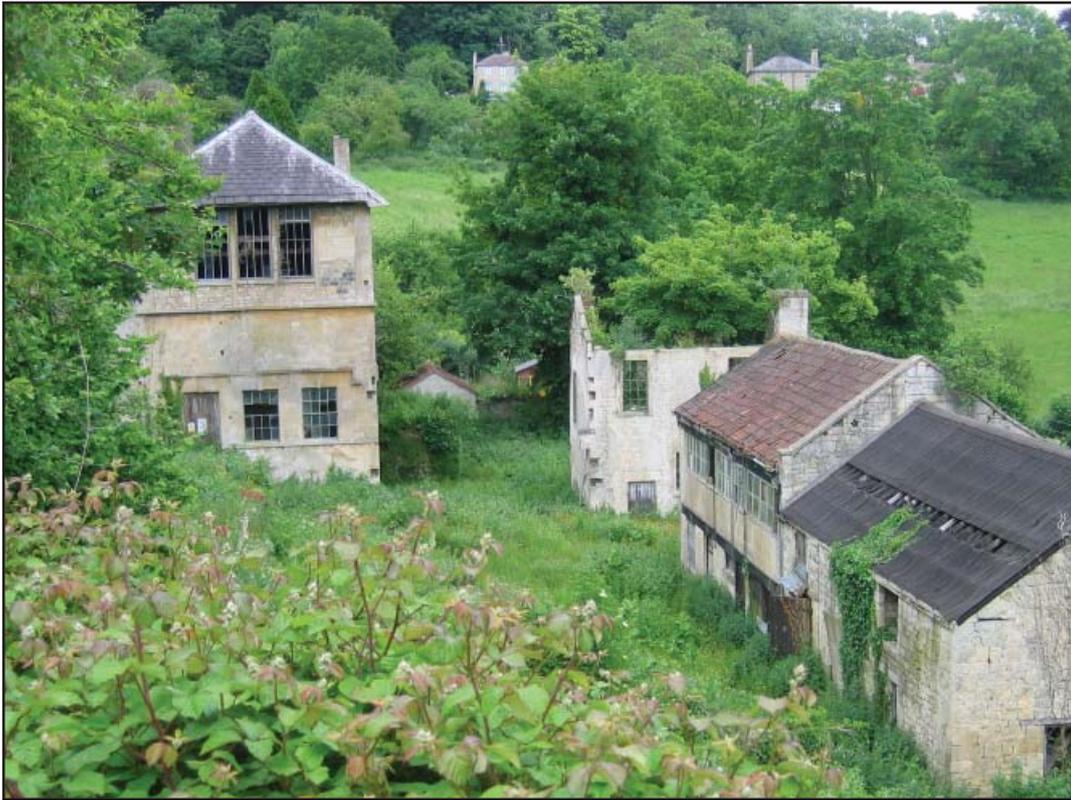
- 5.2.10 What is clear is that one continuous structure was erected between Building 3/4 and 2 by 1852 and that this probably incorporated 5a, 5b and 5c. 5a would have had its monoslope roof replaced by the flat one represented by the continuous run of joist pockets. If 5b & c were single storey buildings predating this change then they gained a storey. The two storey west elevation of Building 5 is clearly indicated by the remains of masonry dogging on Buildings 2 and 4 and the remains of a first floor window with a stone cill at the junction with Building 4 (plate 1).

Plate 1: General view of mill from west with Building 2 to left rear and roofless Building 4 to right rear. The low range bottom right is Building 1, subject of a separate report

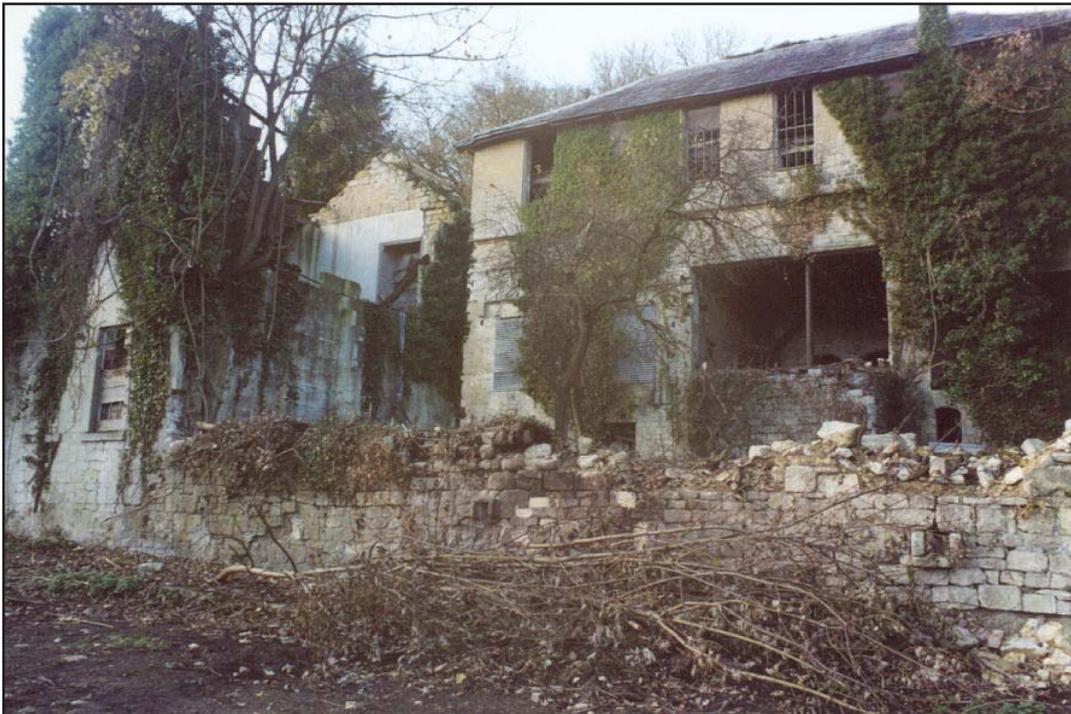
Plate 2: View from south with the platform of Building 3 in foreground (Building 4 to left) and Building 2 in the background

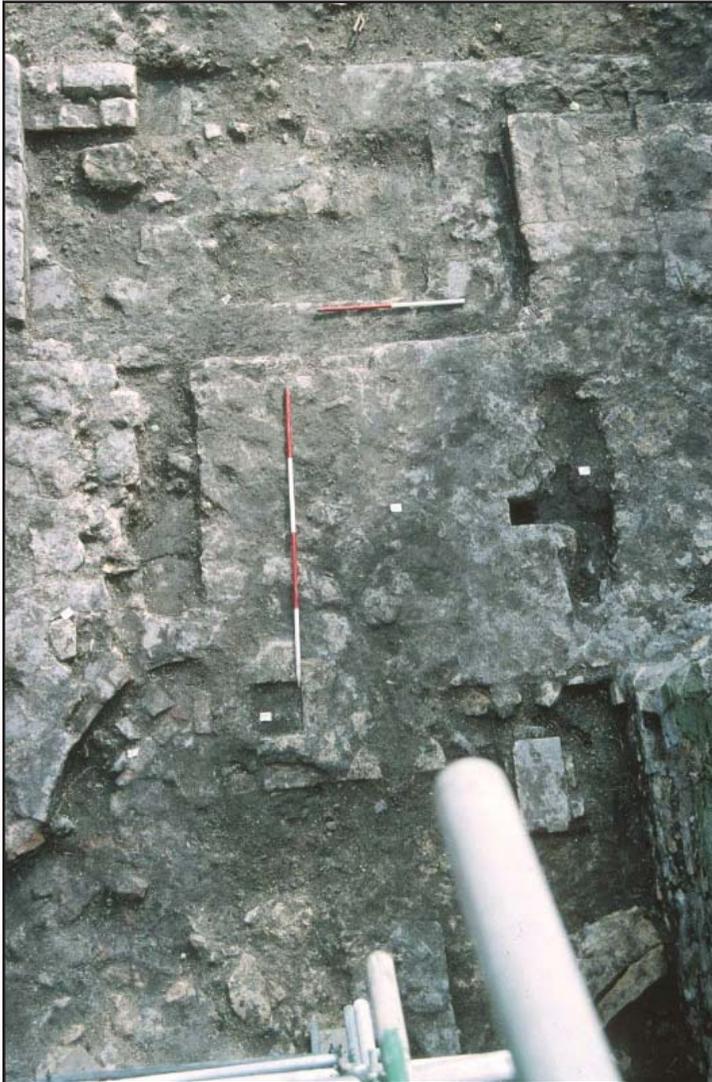
Plate 3: Building 5a seen from above and north. Suggested steam engine position at top and boiler position below

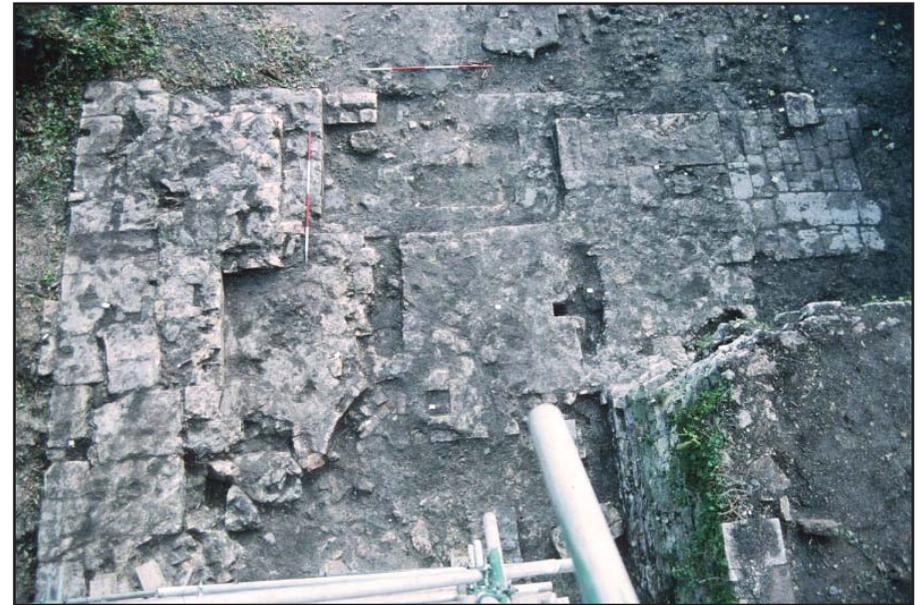
Plate 4: Building 5a and 5b seen from above and north. Building 5b to right of picture

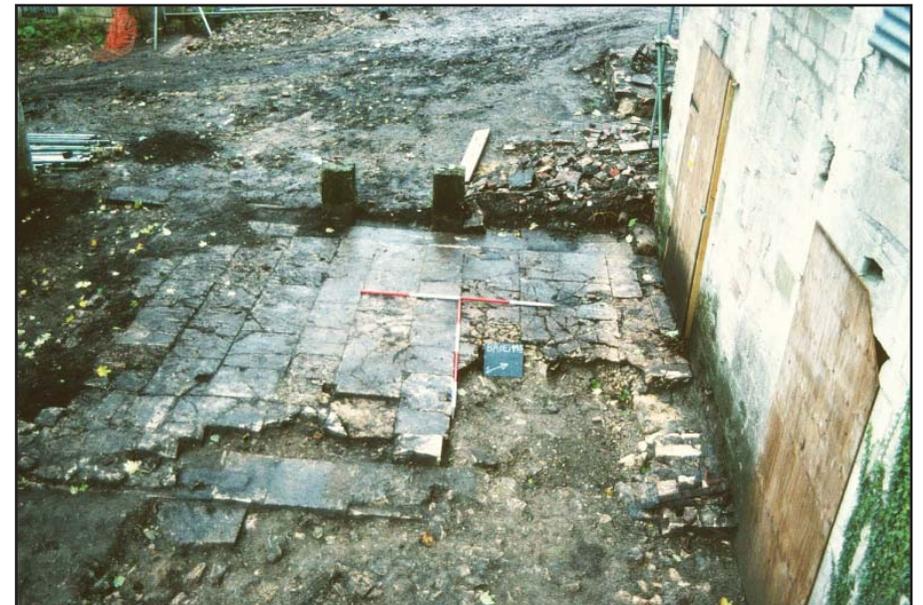
Plate 5: Building 5c seen from the east

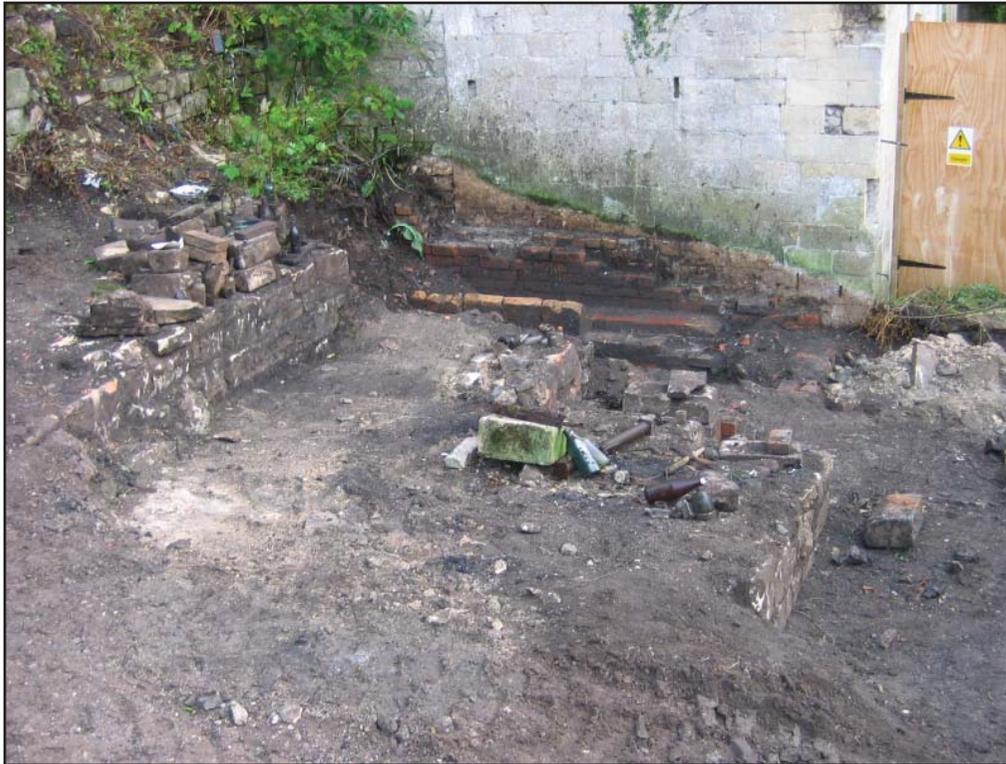
- 5.5.1 The brick and firebrick construction in Structure 1 and the abundance of burning products in the adjacent stone built element make it clear that a hot process was going on here. A structure is shown on the 1886 OS map in this position and not in 1852. A likely date for its construction would be the establishment of Whitaker's cabinet works here in 1875.

Plate 6: Structure 1 seen from the west. The stone walls and robbed floors of the terracing are evident in the foreground and the brick steam cabinet base in the background. The pre-excavation ground surface is still shown by the mark on the wall of Building 2 in the background

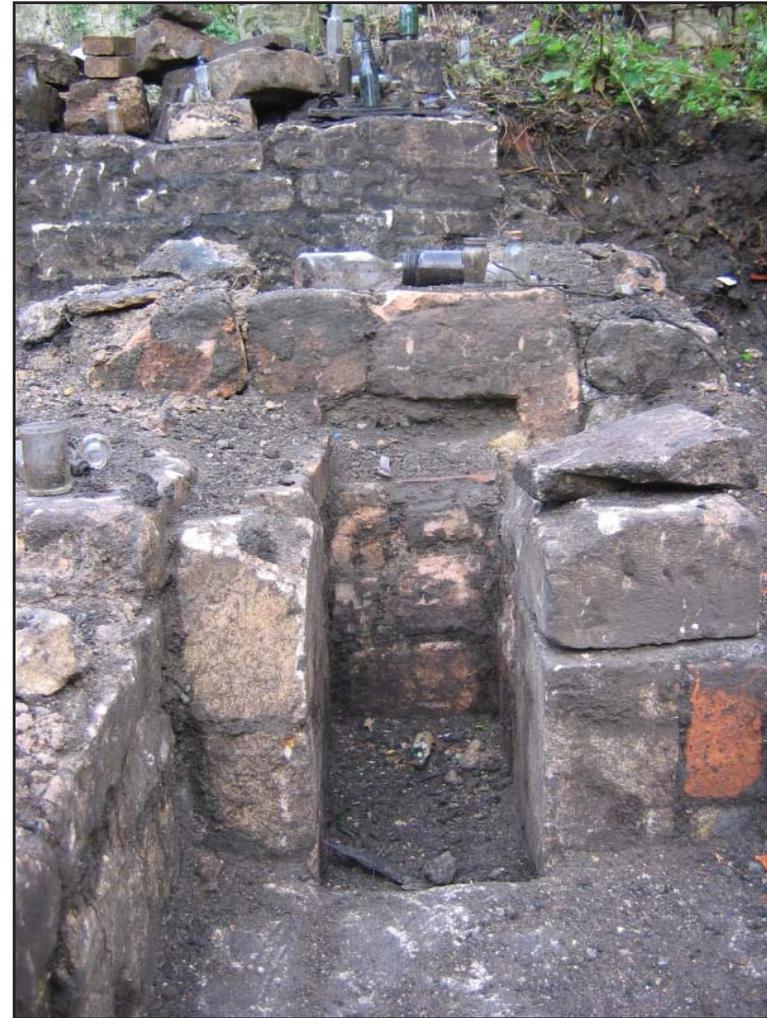
- 4.4.7 The stone structure attached to the brick one had probably had stone floors on its two higher terraces, as on the lowest, but only the soft mortar make up remained *in situ* (114 & 116). It was mixed with much carbonised material and coal ash that had presumably accumulated over the stone slabs and had been dumped back on the make up when the slabs were lifted (110). This burnt material also spread over the lower slabs (104). In the east side of the lowest revetment wall (101) a deep and narrow recess was formed with its base just below the level of slabs (104) at the base of the wall (103). It was built of brick and stone and looked like the stoke hole of a forge or small boiler which would have stood over it but is now gone. The small surviving fragment of revetment wall that formed its north wall was stained pink with heat (Figs 5 & 8).

Plate 7: Context 3, the slot in Structure 1 lowest terrace. This also shows the structural interlocking of the brick and stone parts of the structure. Note the pink heat discolouration of the stones at the rear of context 3

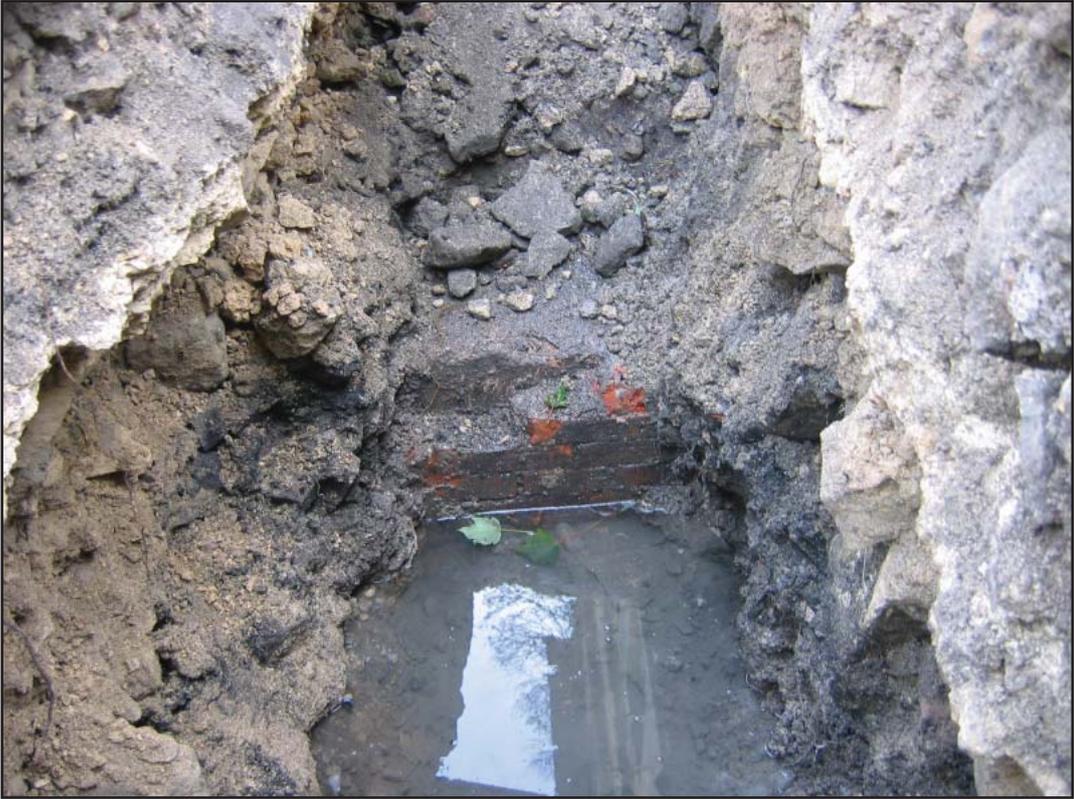
Plate 8: The brick culvert in Trench 1a seen from the south, just after discovery. Note the strong ledge formed by layer 129, the mortar layer between rubble fills 127 and 128

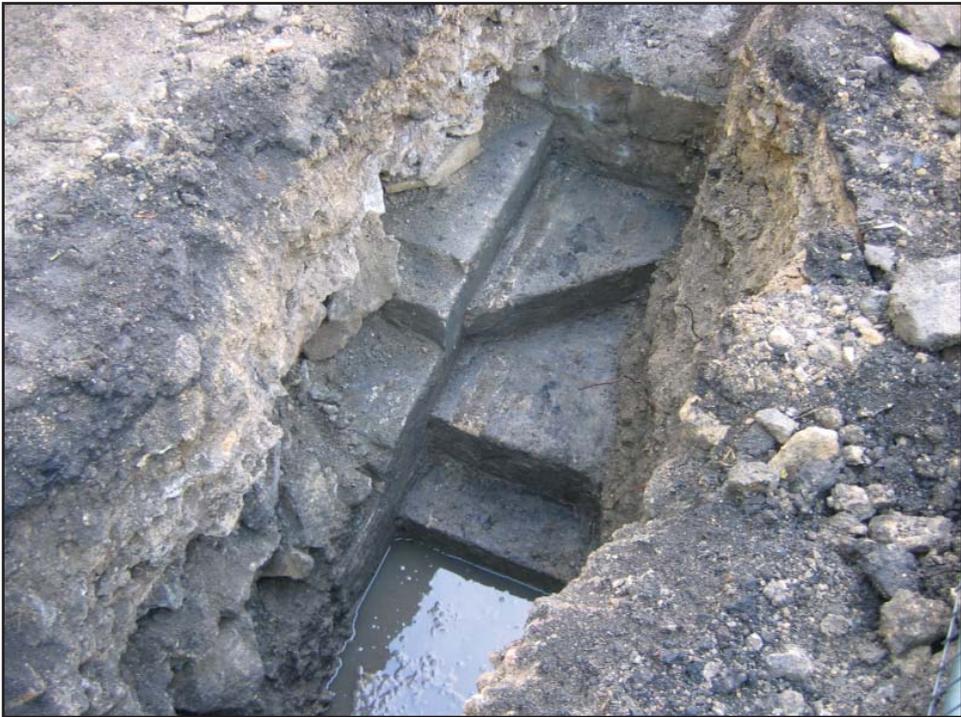
Plate 9: The stone steps down to the “western cellar” seen from the north in Trench 1b. Wall 124 to top of picture

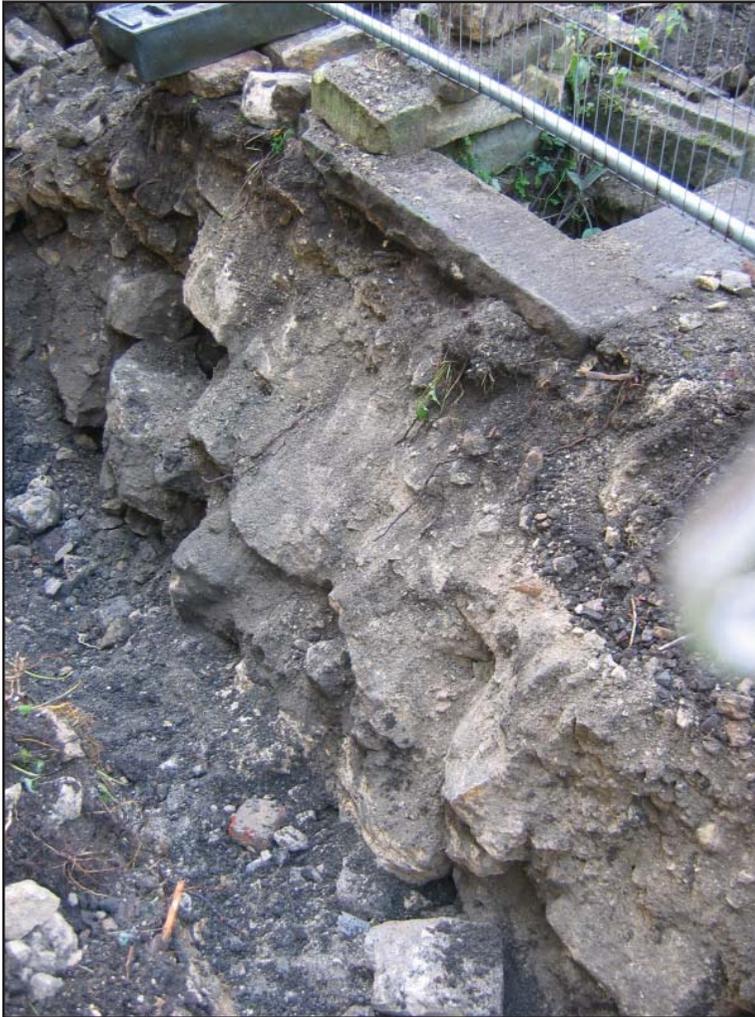
- 4.3.7 There were more structures to the south and west of the cellar, however. A pennant-stone-framed manhole survived at ground level immediately west of the centre of Trench 1b (133) and this gave limited visual access to an ashlar-built, cellar-like room, with a segmental, ashlar-vaulted roof (134). This was also inspected via two holes where stones were missing (Plate 11). This enabled its internal width to be measured, at 1.28 m, and one end to be identified, 6.3 m from the south external face of the western cellar wall (Fig. 5). The northern limit could not be ascertained.

Plate 10: The west side of Trench 1b, showing the water tank's robbed (?) east side and the pennant framed manhole, 133

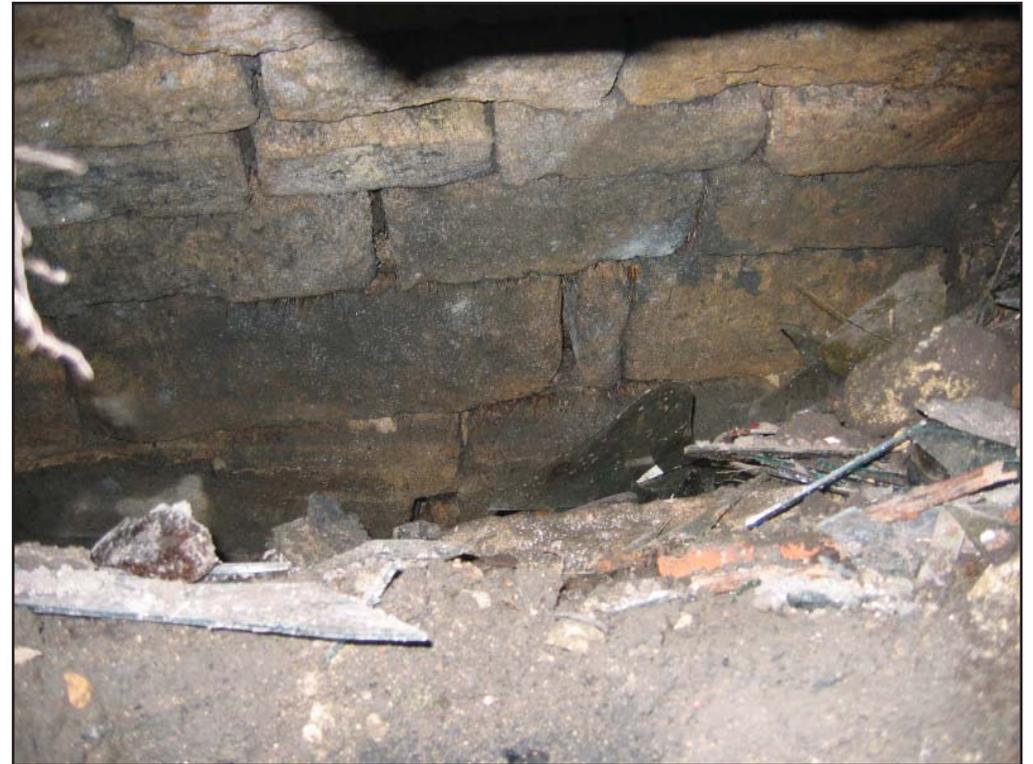
Plate 11: Interior of the water tank next to Trench 1b seen through a void in the side wall, showing it almost full of rubble and rubbish
