Apprentice Store De Montalt Mill Combe Down Bath

**Historic Building Investigation
and Recording**

May 2006

Document Title: Historic Building Recording and Investigation

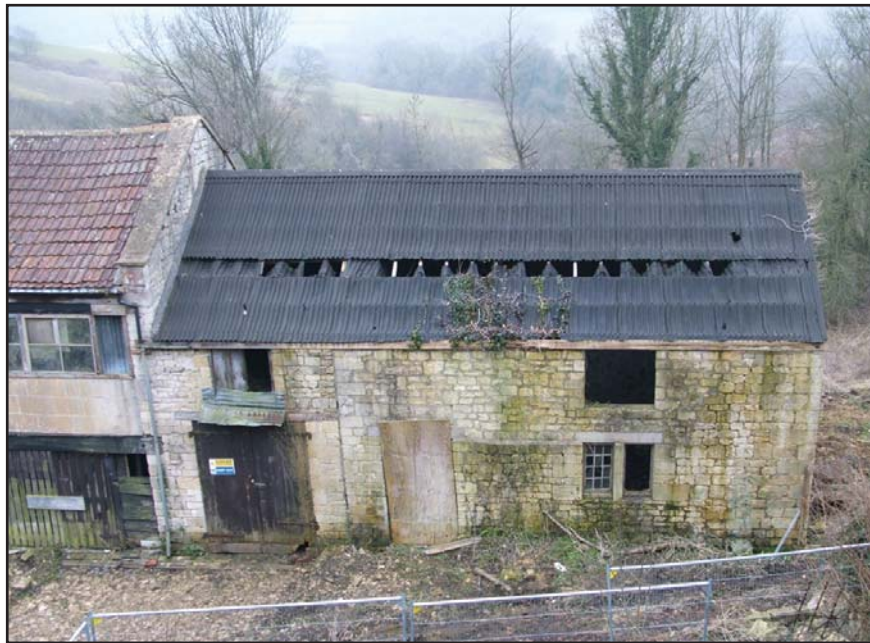
Plate 2: Phases 1 and 2 looking north, phase 1 on right.

- 3.1.1 **External Description** (plates 2 & 3). The oldest part of the structure is at the west end. This is a single cell two storey structure built of snecked rubble with better finished quoins and jambs. The pitched roof is a modern replacement with softwood frame clad in corrugated sheeting. There is a door opening in the east end of the north wall and a ground floor two-light mullion window in the west end of the north wall with an empty opening into the first floor directly above it. There is a similar mullioned window in the west end wall with a ventilation slit in the gable above. In the south wall there are two ventilation slits high up above the roof of the later lean-to.
- 3.1.2 The plain two light mullion window in the north front ground floor has a rectangular stone mullion with no chamfering (in Gloucestershire this is

- 3.2.1 **External Description** (see Plate 2). This is a small one bay two storey extension built onto the east end of phase 1 consisting of a waggon house with hayloft over (Plate 6). On the north wall there is a straight joint with no attempt at bonding the two phases but on the south the joint dog legs several times where phase 2 has been bonded in to some extent to the earlier structure.

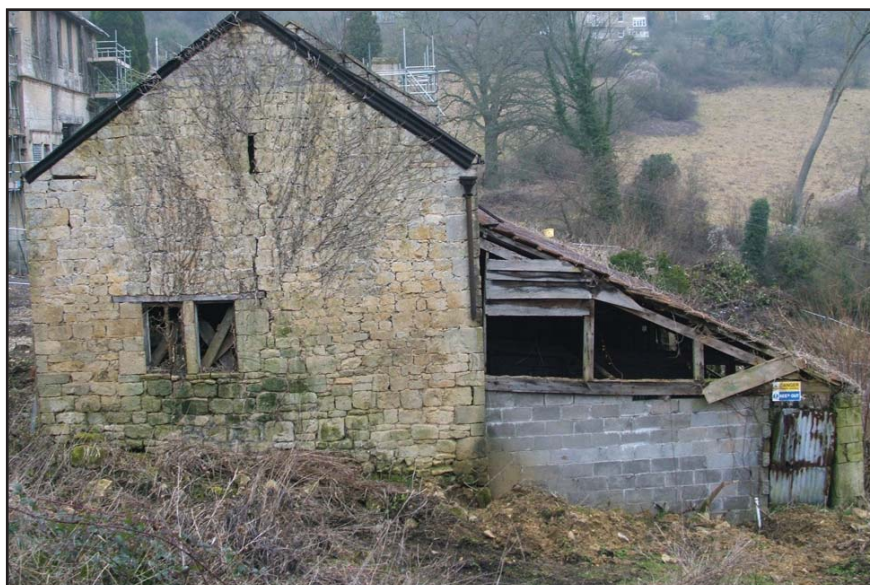
Plate 3: West end gable wall.

- 3.1.5 The top of the west gable wall has also been rebuilt suggesting that there may have been a half-hipped roof originally.
- 3.1.6 The former exterior east wall is now within the later coach house extension.

- 3.1.7 The previous owner, Heather Mann, in whose memory the rebuilding was carried out confirmed that the western gable previously had a half hip (Davenport 2001). The eastern half hip would have been replaced when the coach house extension was added at a much earlier date.

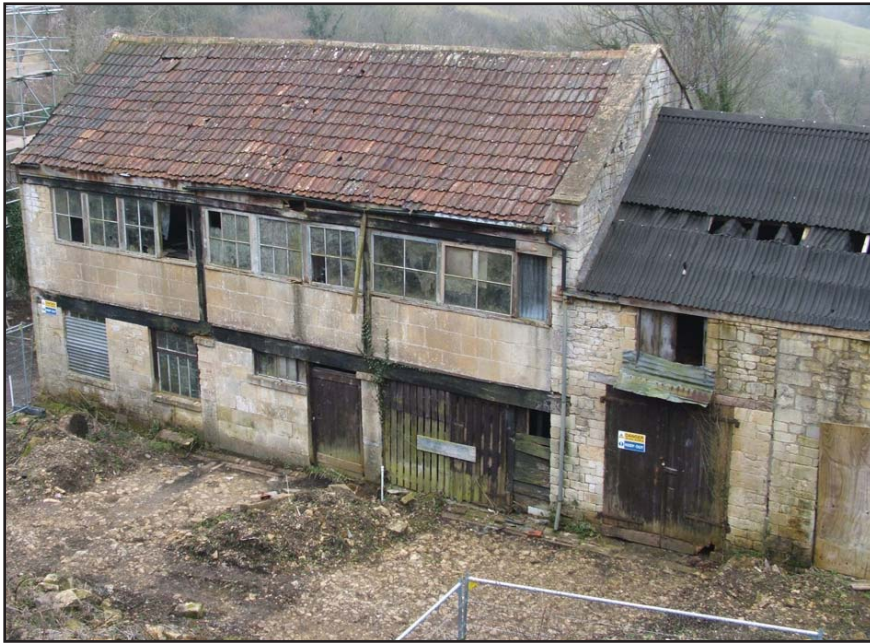
Plate 4: Phase 3 looking south east.

- 3.3 **Phase 3: Workshop/Timber store**
- 3.3.1 **External Description** (Plates 4-6) This is a further eastward two-storey extension to the existing range consisting of three bays. The extension is the same width as the previous phases but taller. The west wall is formed by the east gable of phase 2 which has been raised and capped with a flat coping course. The east gable is plain and the pitched roof is clad in ceramic tiles.

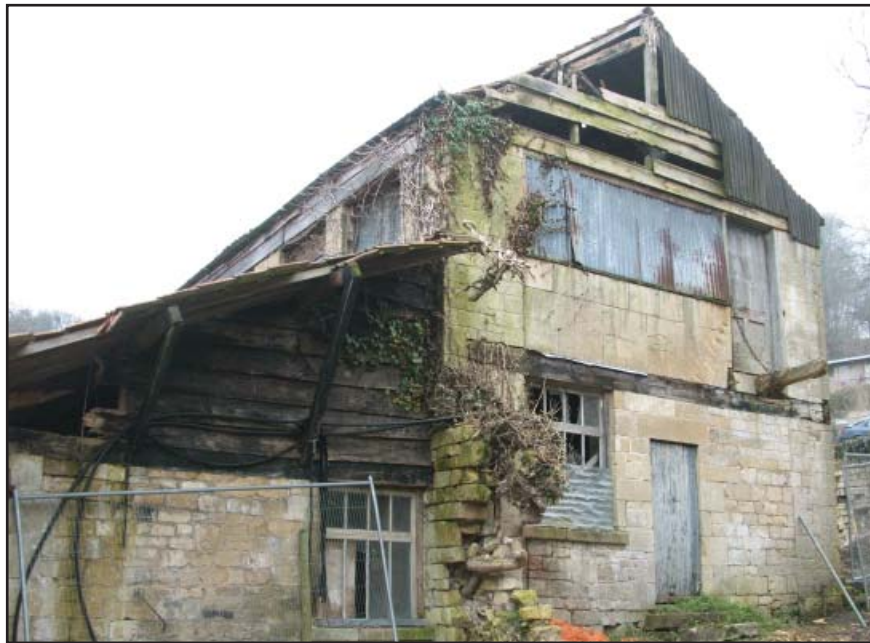
Plate 5: East end gable wall looking north-west.

- 3.1.10 The east wall wall exhibits two primary ventilation slits at head height and a blocked slit in the gable. There is a blocked doorway at the south end with a wooden lintel 'fossilised' in the stonework. The top of the gable above purlin height has also been rebuilt as at the west end which tends to confirm that this building had a half hipped roof in its primary phase (plate 5).
