**BELMONT
BLEACH WORKS,
EGERTON ROAD,
BELMONT,
BLACKBURN WITH
DARWEN**

**Historic Building
Investigation**

October 2015

Millson Associates
Planning Application 10/12/0590

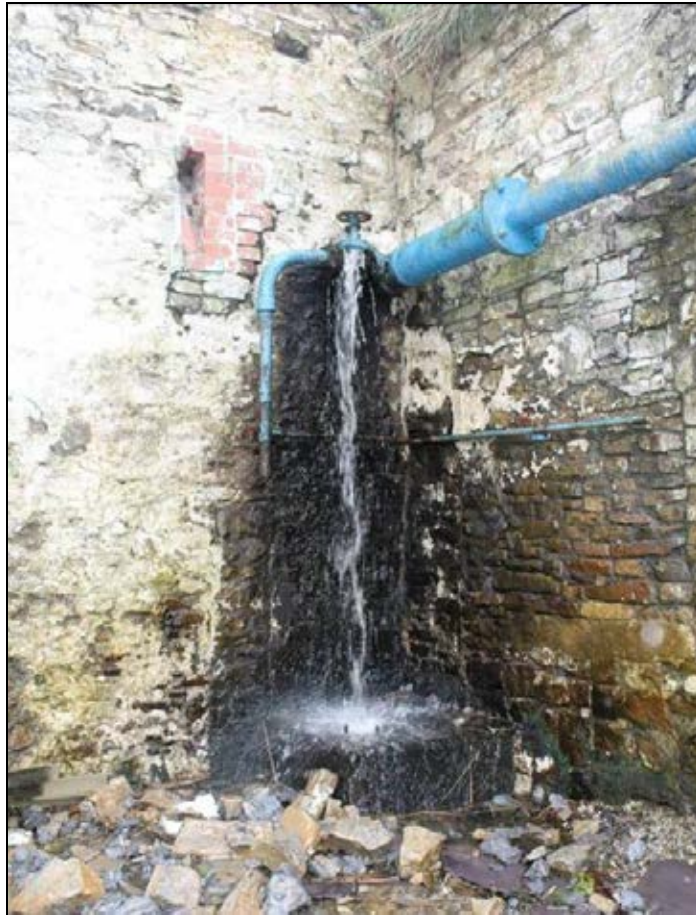
Plate 12: Water pipe with blocked opening to left in north-east corner of Building A

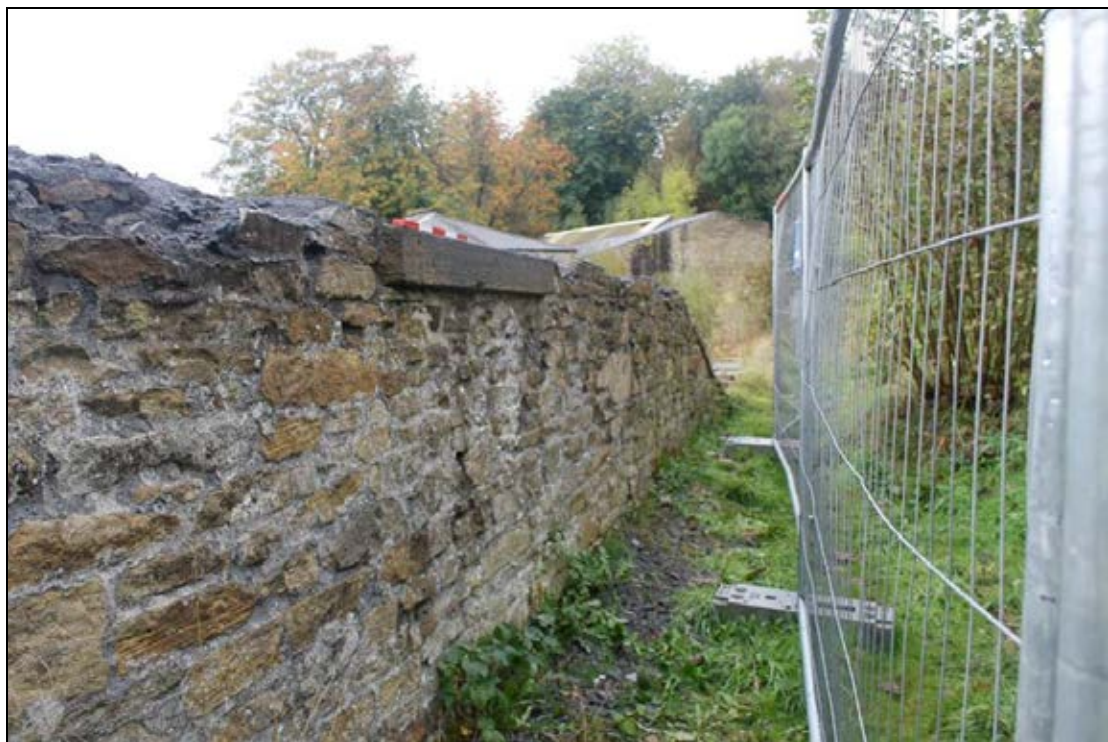
Plate 13: External elevation of northern wall of Building A, showing surviving window sill. 0.5m scale

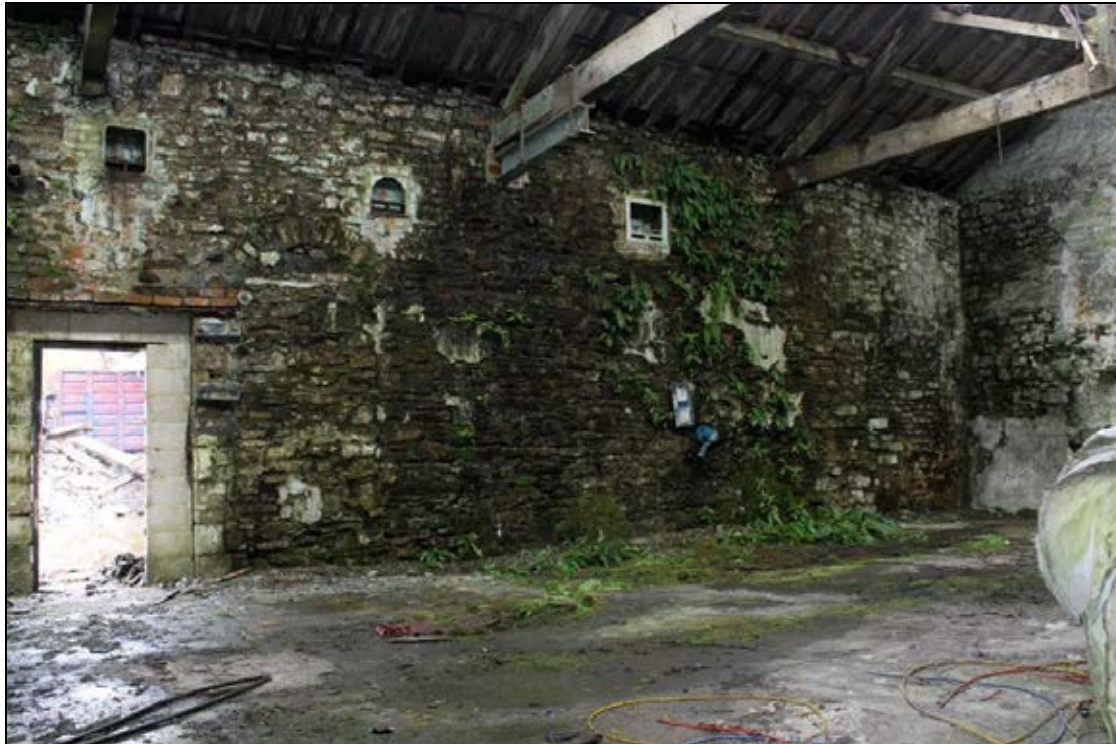
Plate 16: Northern end of the eastern wall. Note the blocked window to the right of the present doorway. A change in the character of the stone work at the northern end of the wall indicates the position of another window

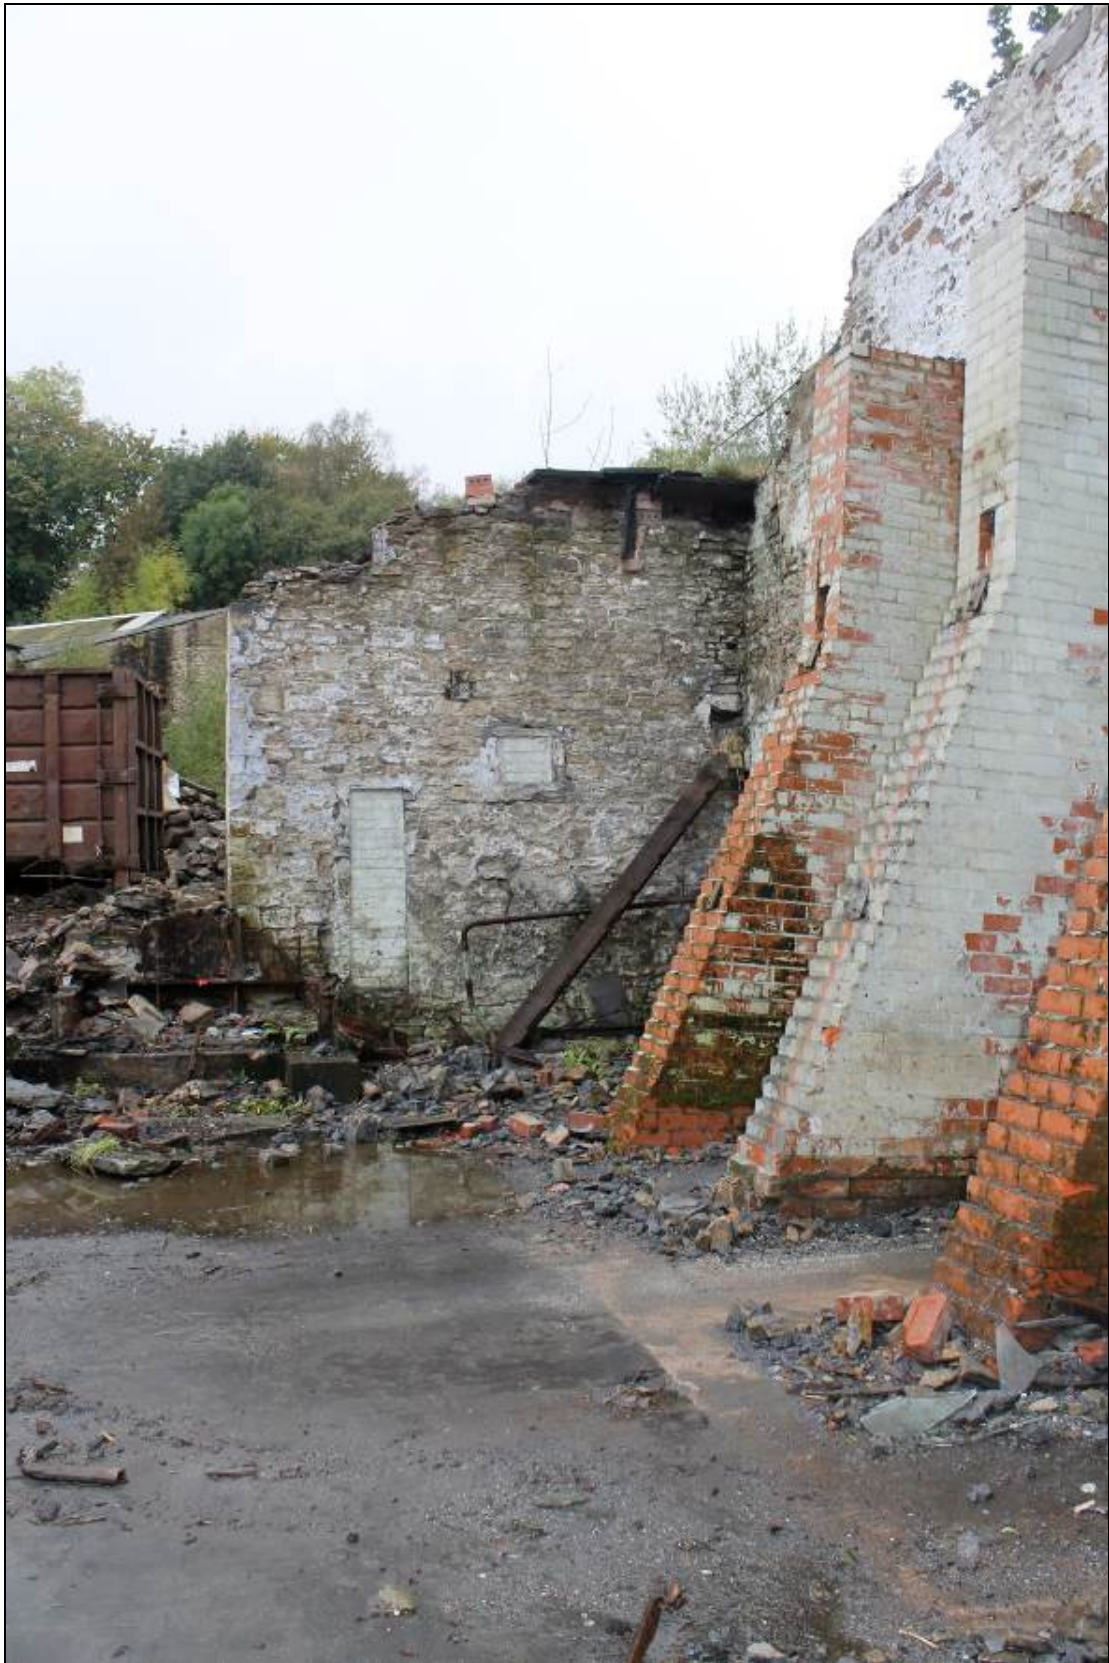
- 3.2.11 **Western Wall:** only the northern end of the western wall survived. Notably, this was rubble built rather than being constructed of coursed rectangular blocks as to the south (Plate 20). No extant openings were observed, but a tall narrow blocked opening at the southern end of the remaining wall had presumably facilitated the transfer of power through the wall. To its north there was a small square opening at about head height, which probably housed a bearing box. It too had been in-filled in brick (Plate 20).

Plate 20: Remaining fragment of northern end of western wall, facing west

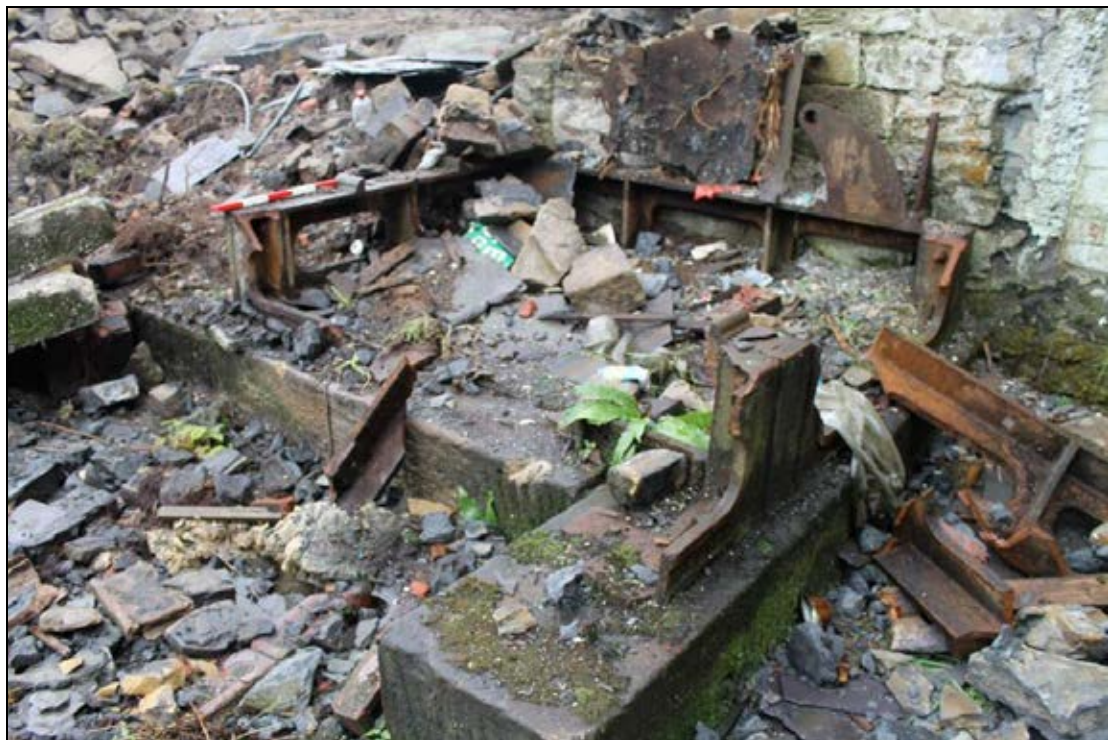
Plate 23: Concrete platform in north western corner of Building A, indicating the location of a now removed piece of equipment. 0.5m scale

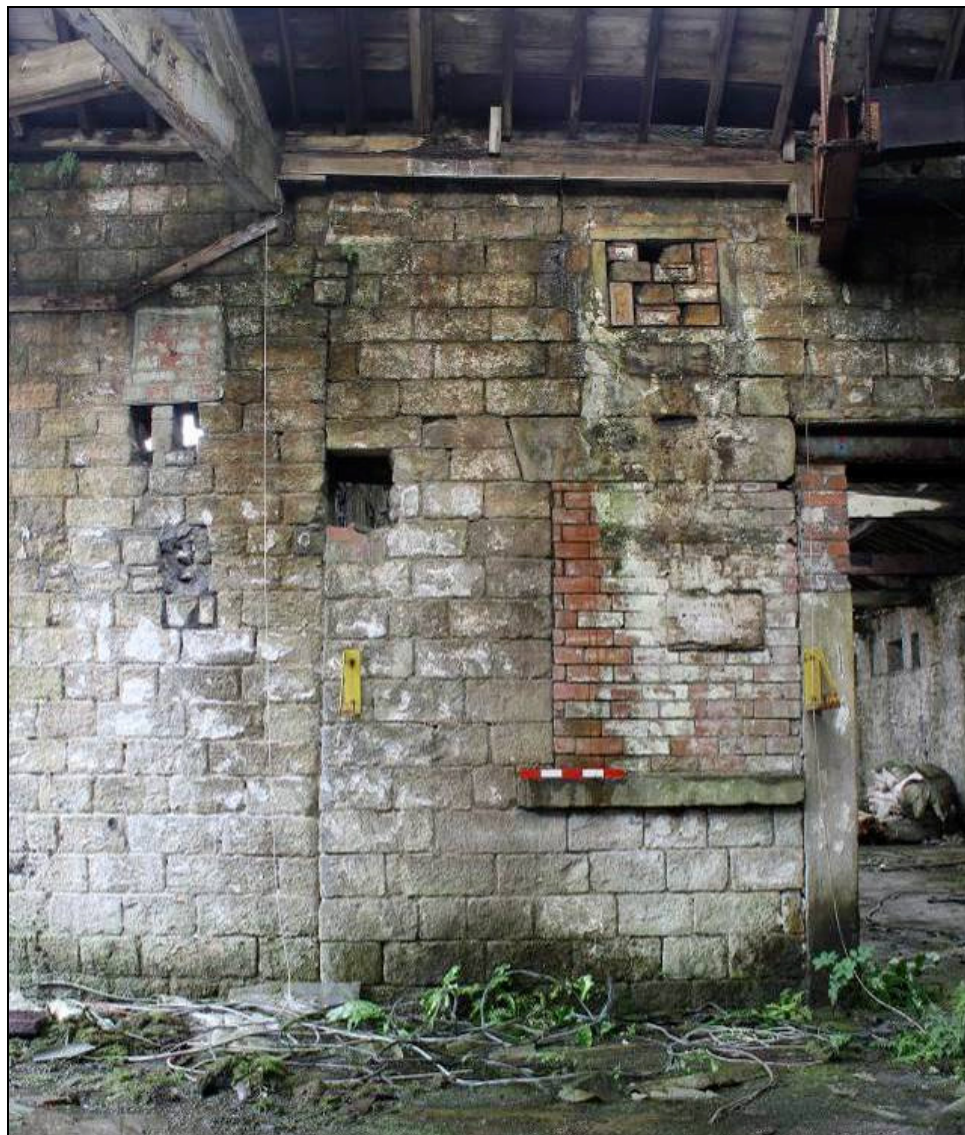
Plate 25: Butt joint between southern walls of Building B and A, facing north. 0.5m scale

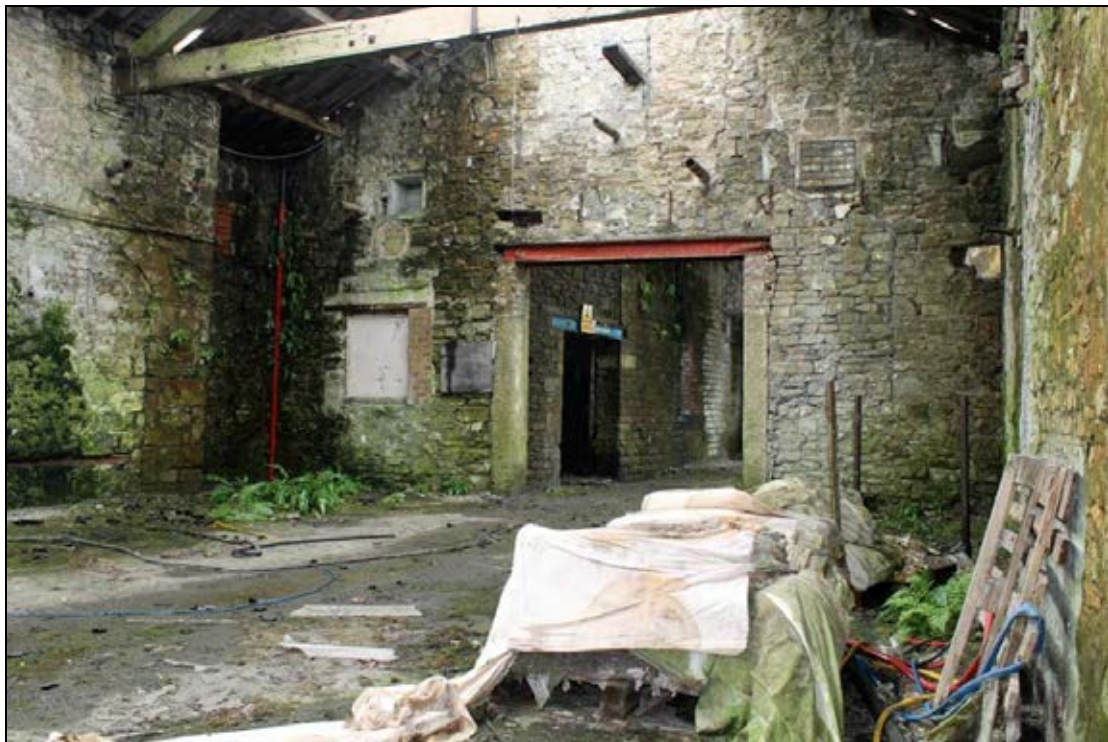
- 3.3.7 The internal elevation was rubble faced with traces of plaster surviving in places. The outline of a blocked first-floor window could be traced immediately above the doorway (Plate 27).

Plate 27: Internal elevation of southern wall of Building B. Note the outline of a first-floor window above the central doorway

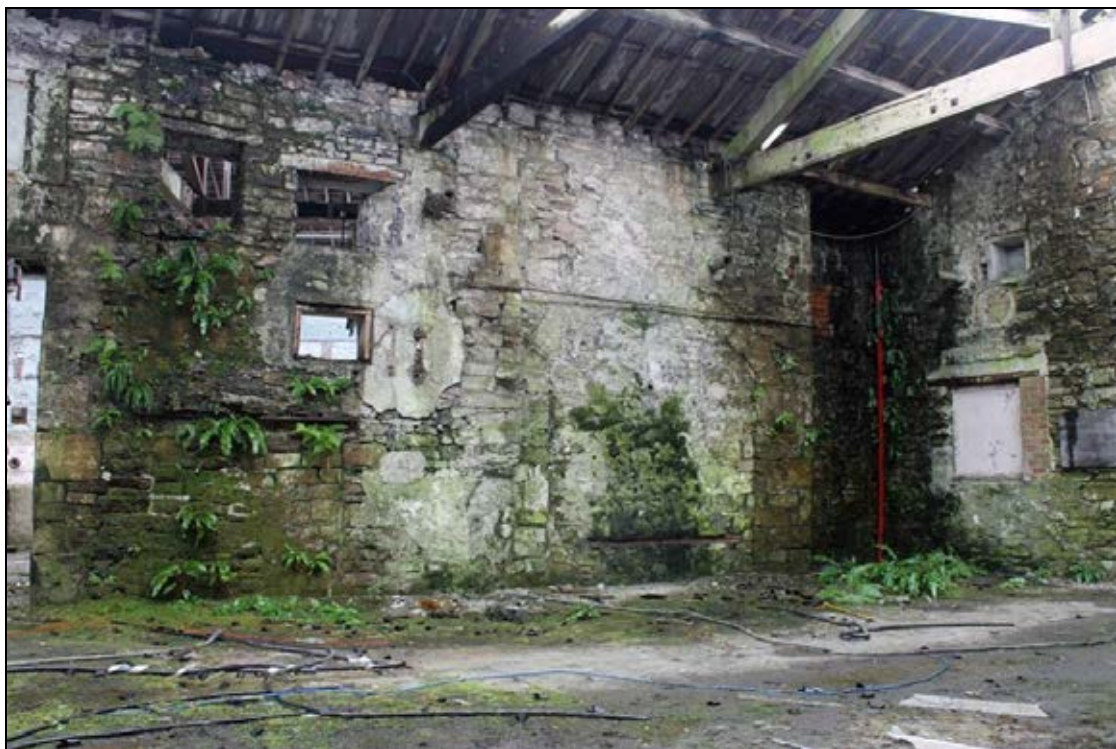
Plate 31: Southern end of internal elevation of Building B's eastern wall, facing east. The blocked arch can be seen to the right of centre with a butt joint immediately to its left

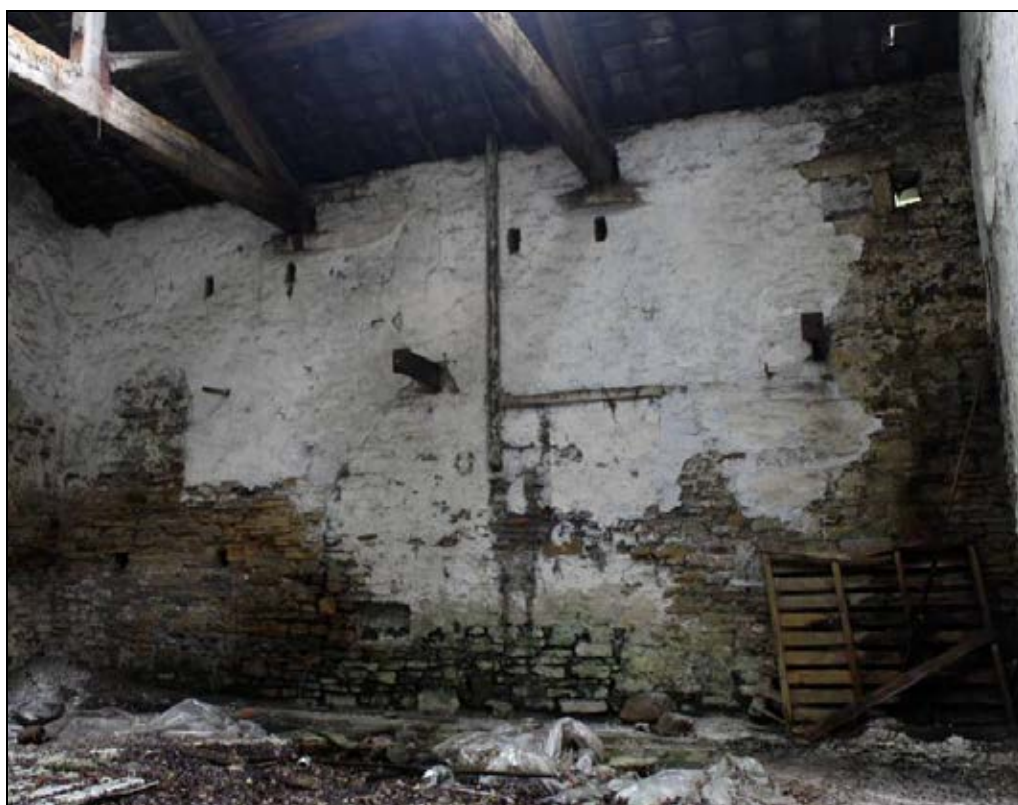
- 3.4.8 **Eastern Wall:** the internal elevation of the eastern wall was also rubble built and included two iron beams, identical to that discussed on the western wall, projecting from the northern end of the wall face (Plate 43). Two pairs of empty joist sockets were identified just beneath the present tie beams at thirds along the length of the wall. The square stone lined aperture noted externally was record at a similar height near the centre of the wall (Plate 44), with a smaller rectangular opening immediately to its south, which had not been identified from outside.

Plate 43: Northern end of the eastern wall of Building C facing north-east. Two projecting iron beams can be seen at mid-height, with empty sockets above

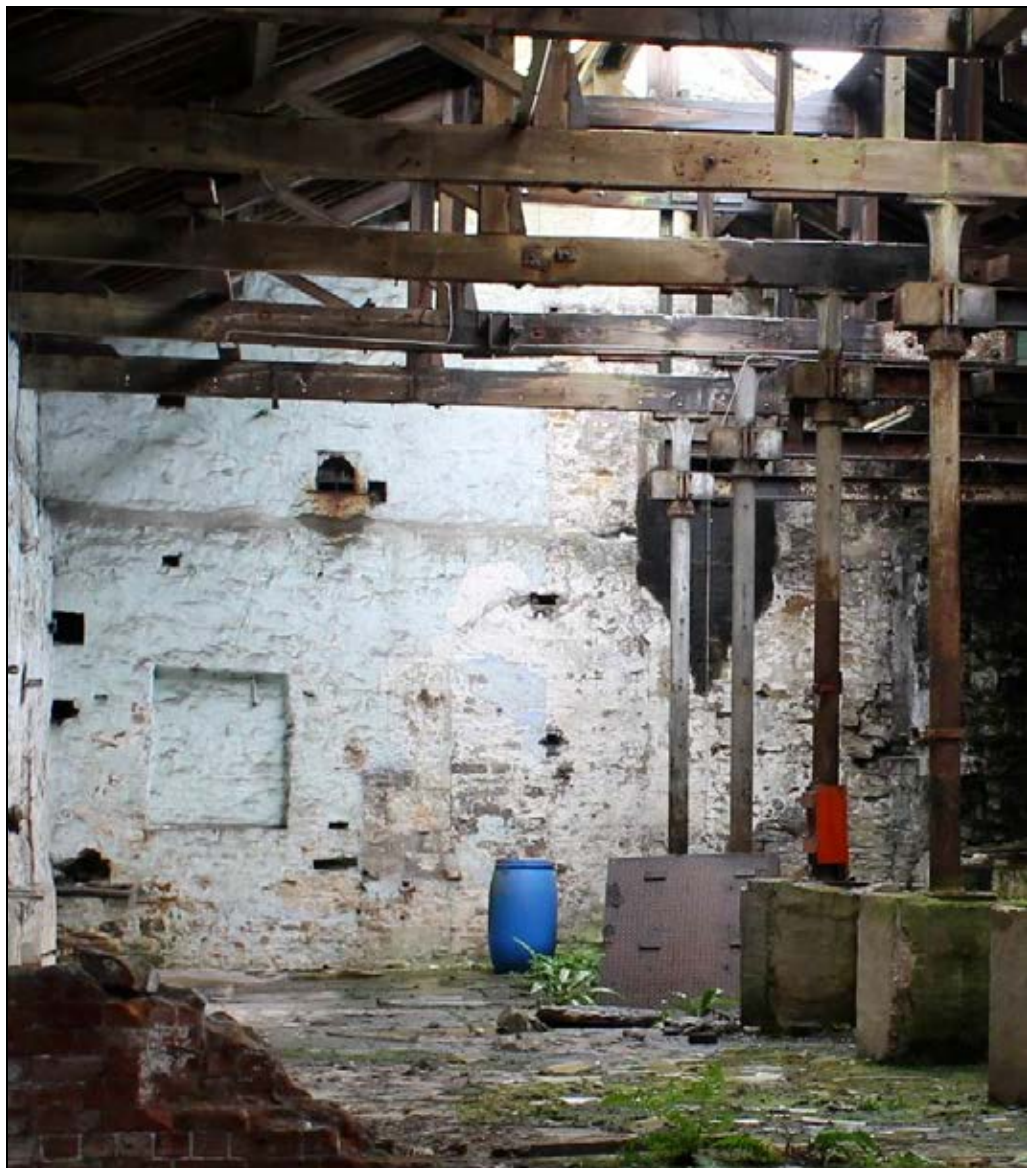
Plate 56: Interior of Building D, looking south towards southern wall. Blocked arched doorway to centre and blocked window to left

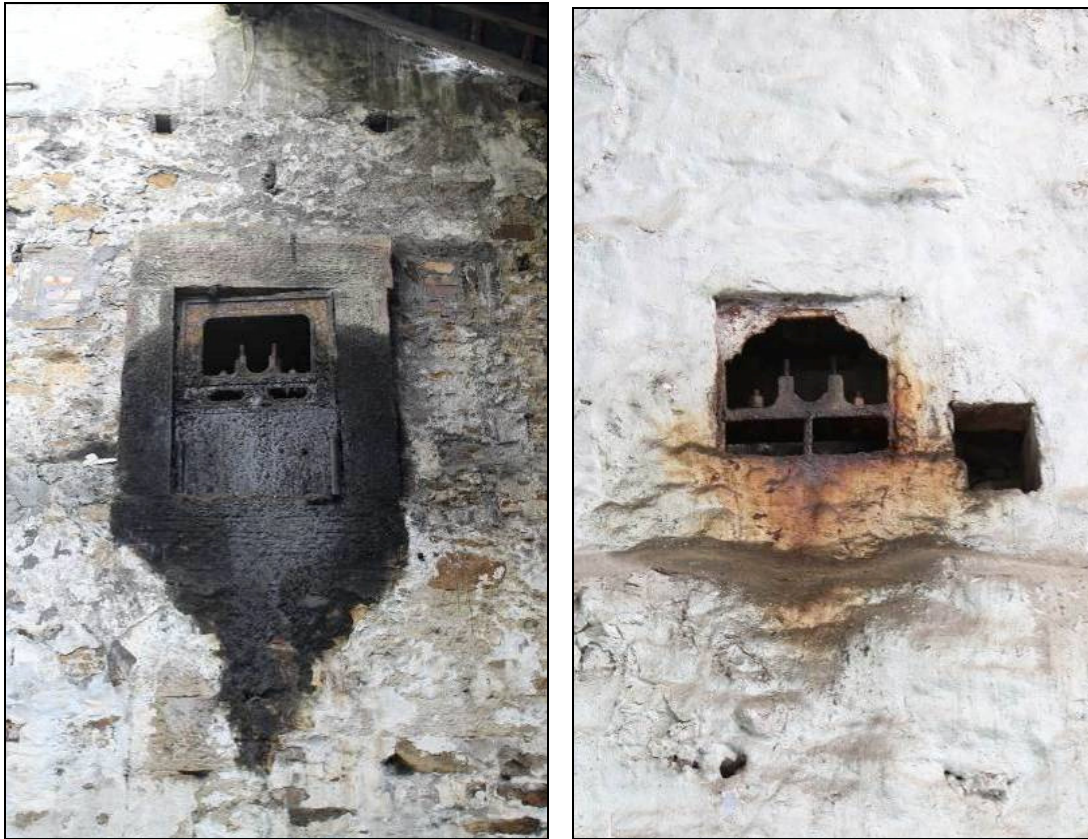
Plate 57 and 58: Cast-iron bearing box on southern gable wall, looking south. Note the intentional slew in its positioning. Smaller bearing box to right, retaining the lower half of its pillow block

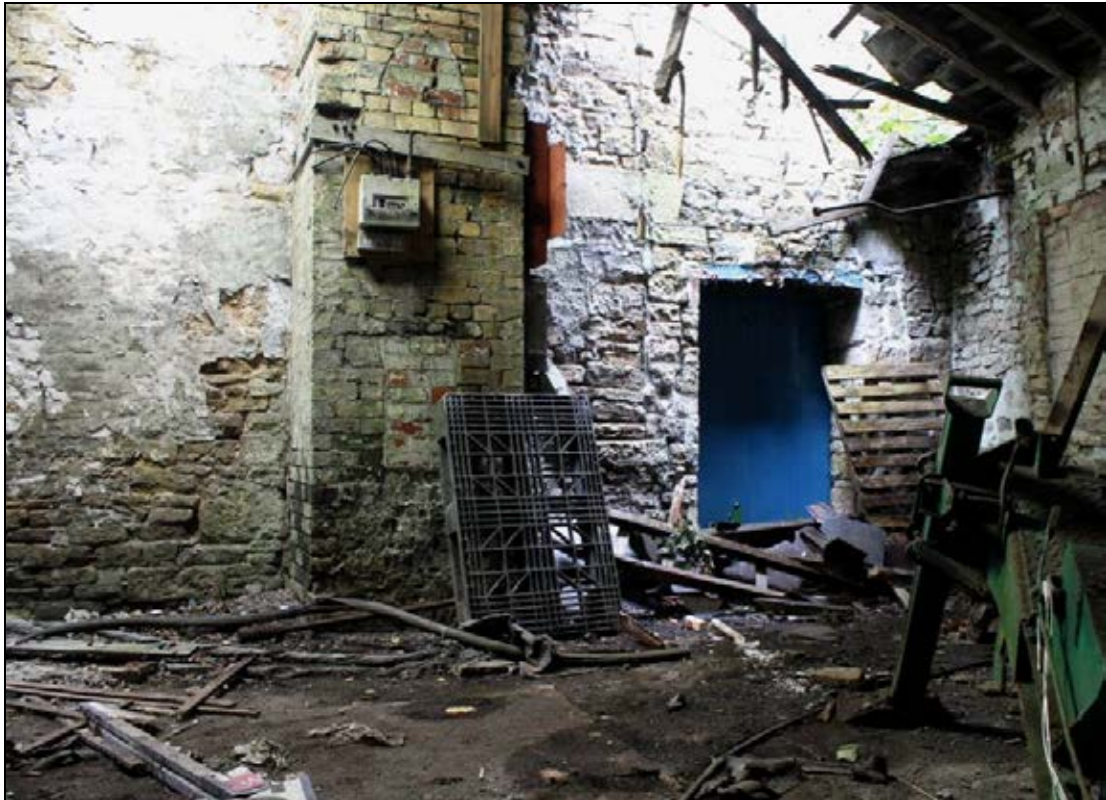
Plate 81: Building F, southern elevation, facing north. Note the blocked window to the right of the inserted chimney breast

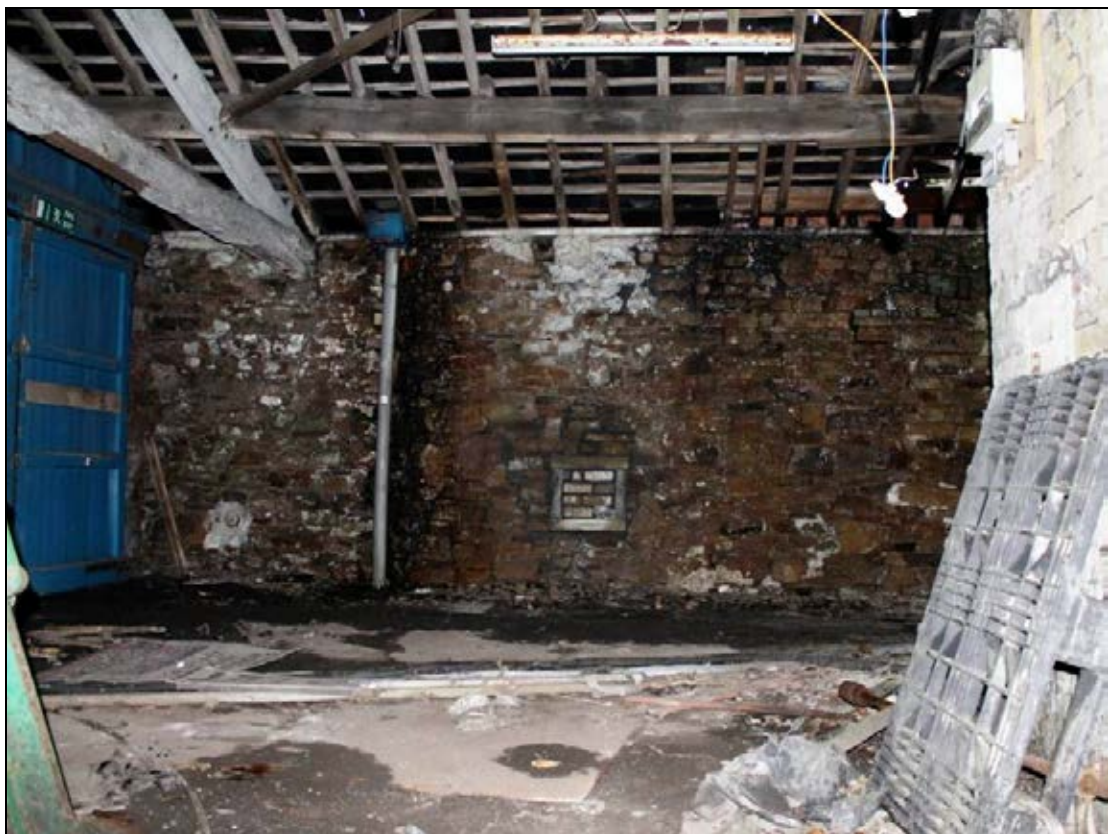
Plate 87: Internal elevation of the western wall, with blocked aperture to centre and wall clamp to left

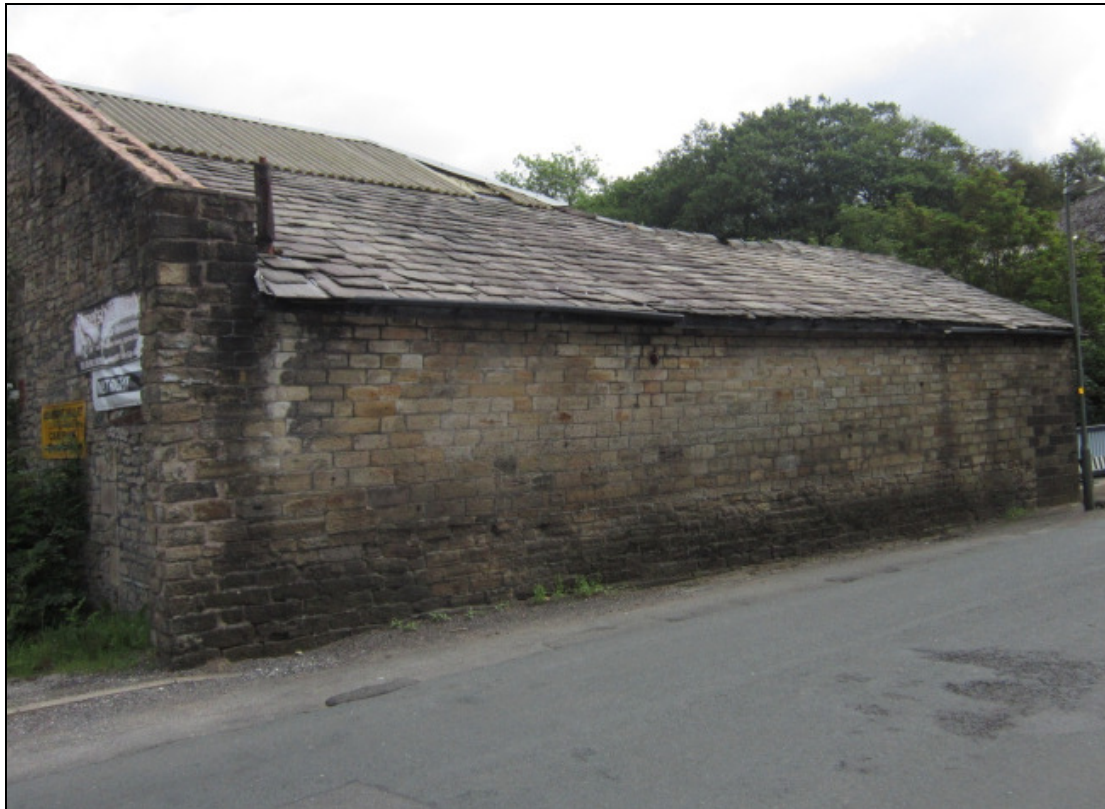
- 3.9.3 The southern elevation of the southern wall was laid in coursed sandstone blocks laid in water-shot fashion, but contained no visible openings of any kind (Plate 90). Its lowest 1m had been stained and eroded by roadside pollution. The western end of the wall projected past the south-western corner of the building slightly, suggesting that originally the structure was longer than at present.

Plate 90: Building H, southern external elevation (Griffiths, 2014)

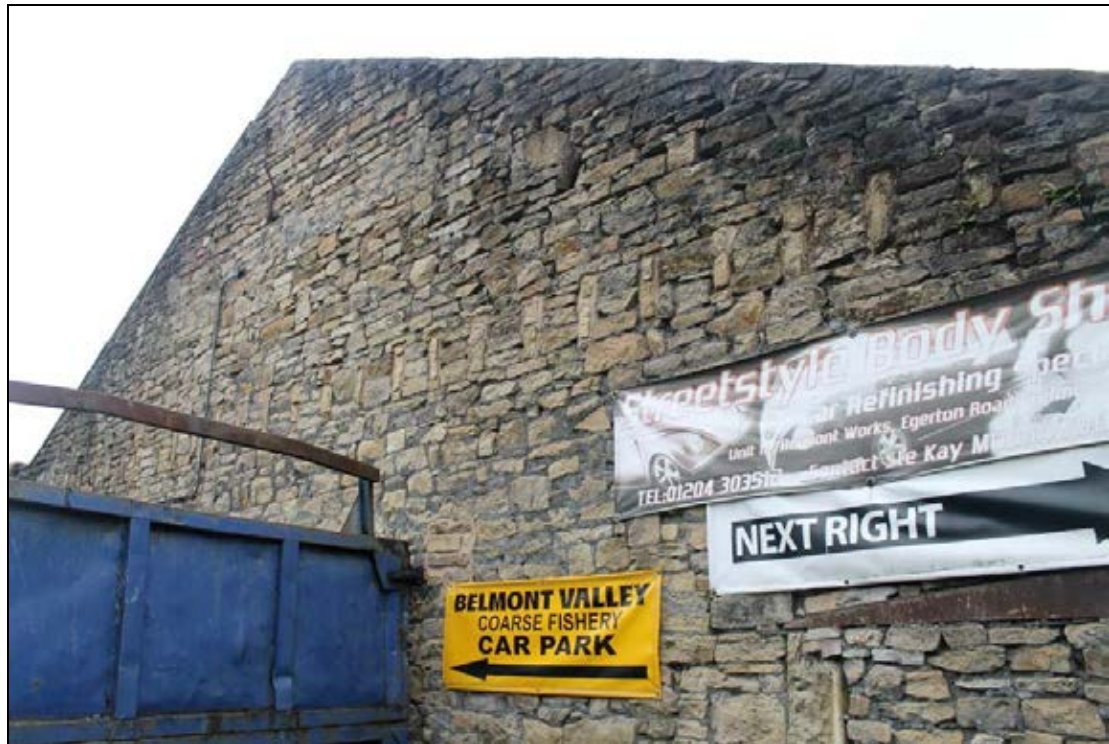
Plate 93: Blocked joist sockets on western gable wall. 0.5m scale

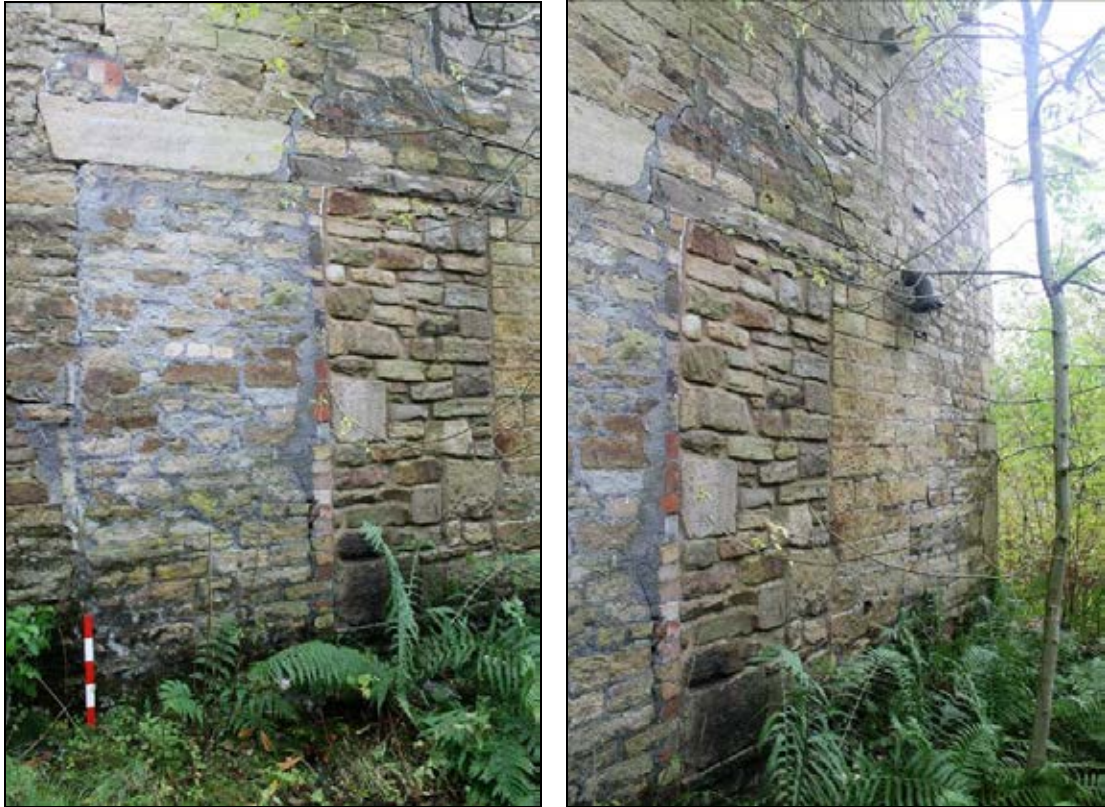
Plate 108 and 109: Blocked doorways at yard level on south-eastern elevation, 0.5m scale. The photograph to the right shows the northernmost doorway again but with the blocked rectangular aperture above

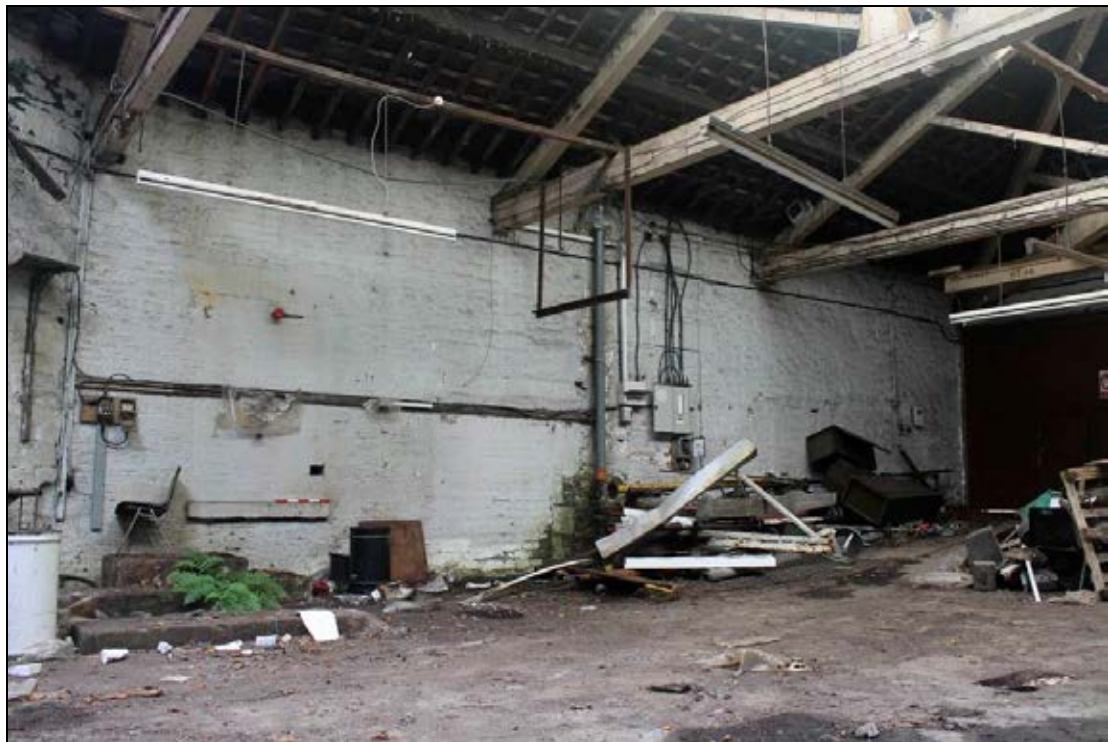
Plate 115: North-western wall of Building K, facing south-east from within Building L. Several blocked openings visible across its length

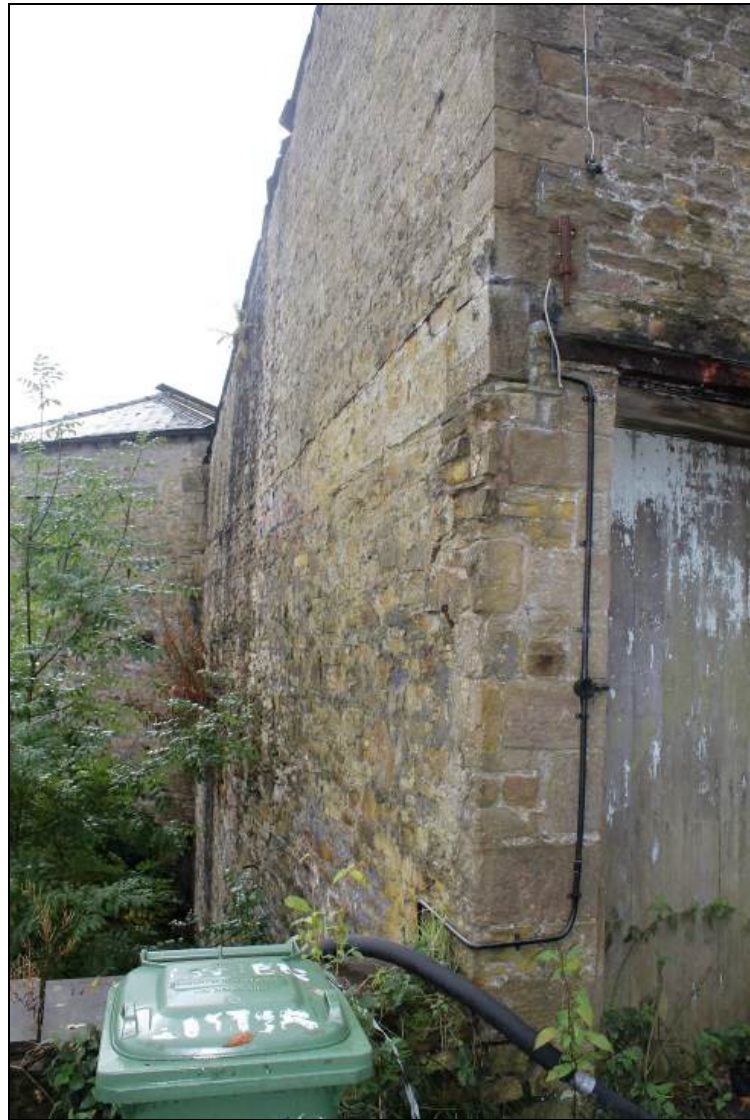
Plate 125: Looking south-east along the line of the north-eastern elevation of Building L. The roof scar of a demolished building can be seen at around mid-height
