CANONS ASHBY HOUSE  
NORTHAMPTONSHIRE

**ARCHAEOLOGICAL WATCHING BRIEF REPORT**

September 2001

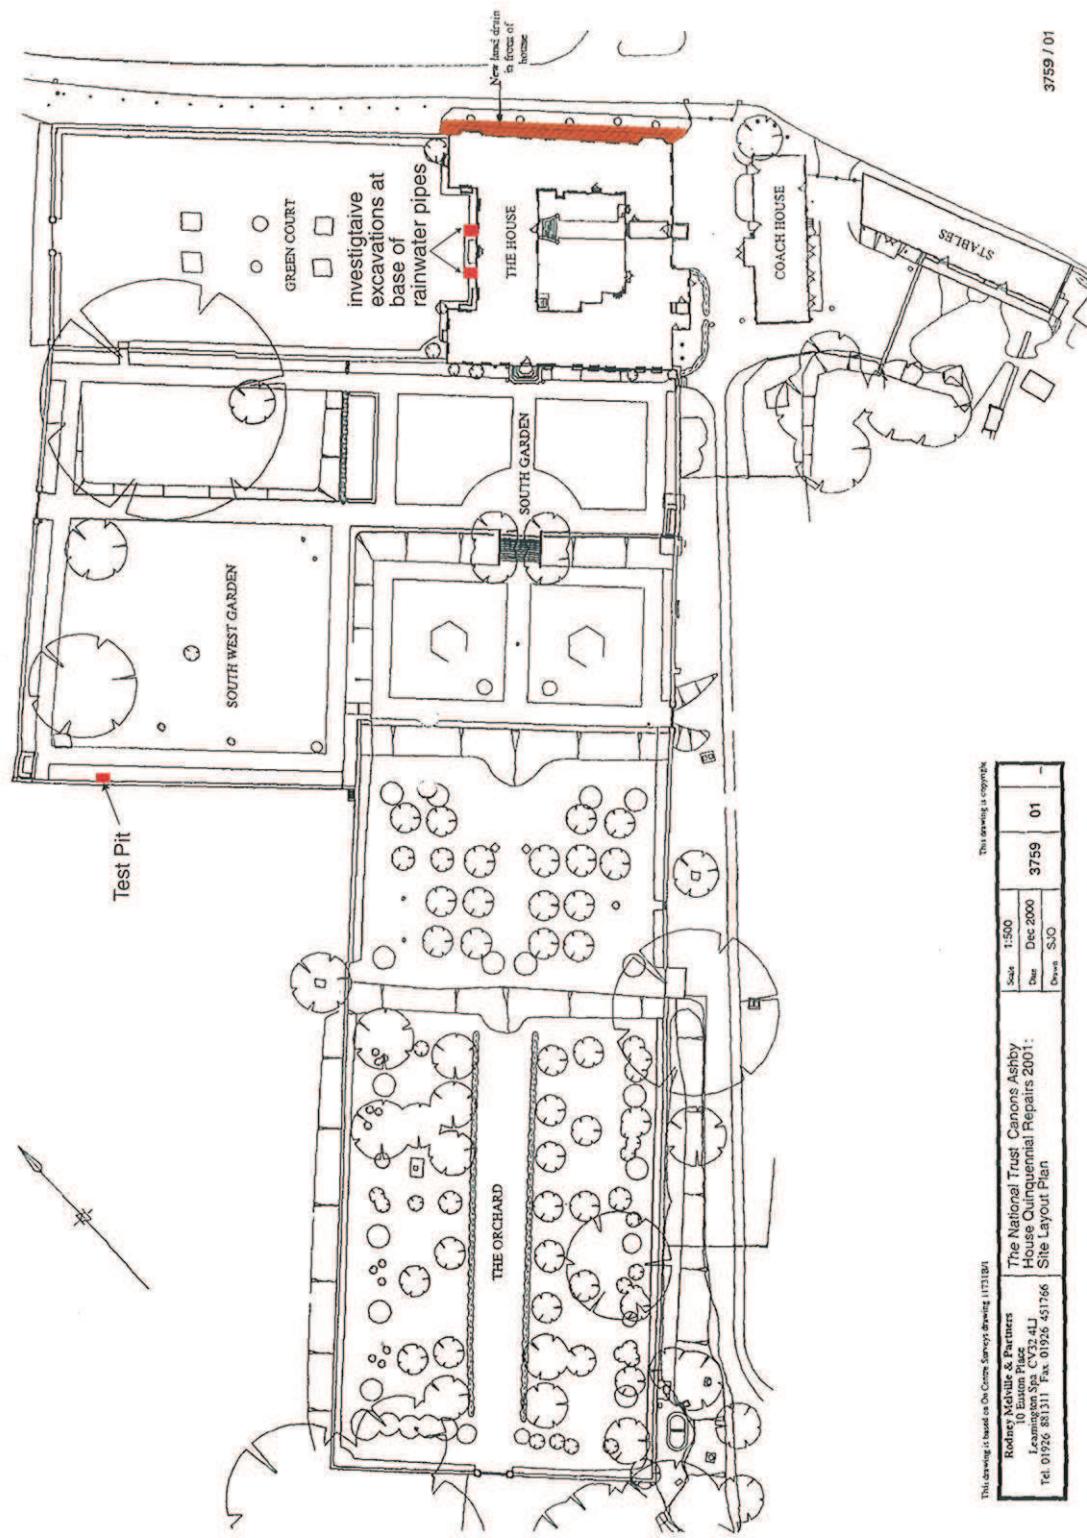
Figure 2: Site plan.

5.3.1 The paving slabs on either side of the north door were removed to inspect the drainage channels beneath. These were planned and photographed but no further recording was deemed necessary as they will remain *in situ*.

5.4.1 No significant archaeological features or deposits were observed during the excavation of the drainage trench.

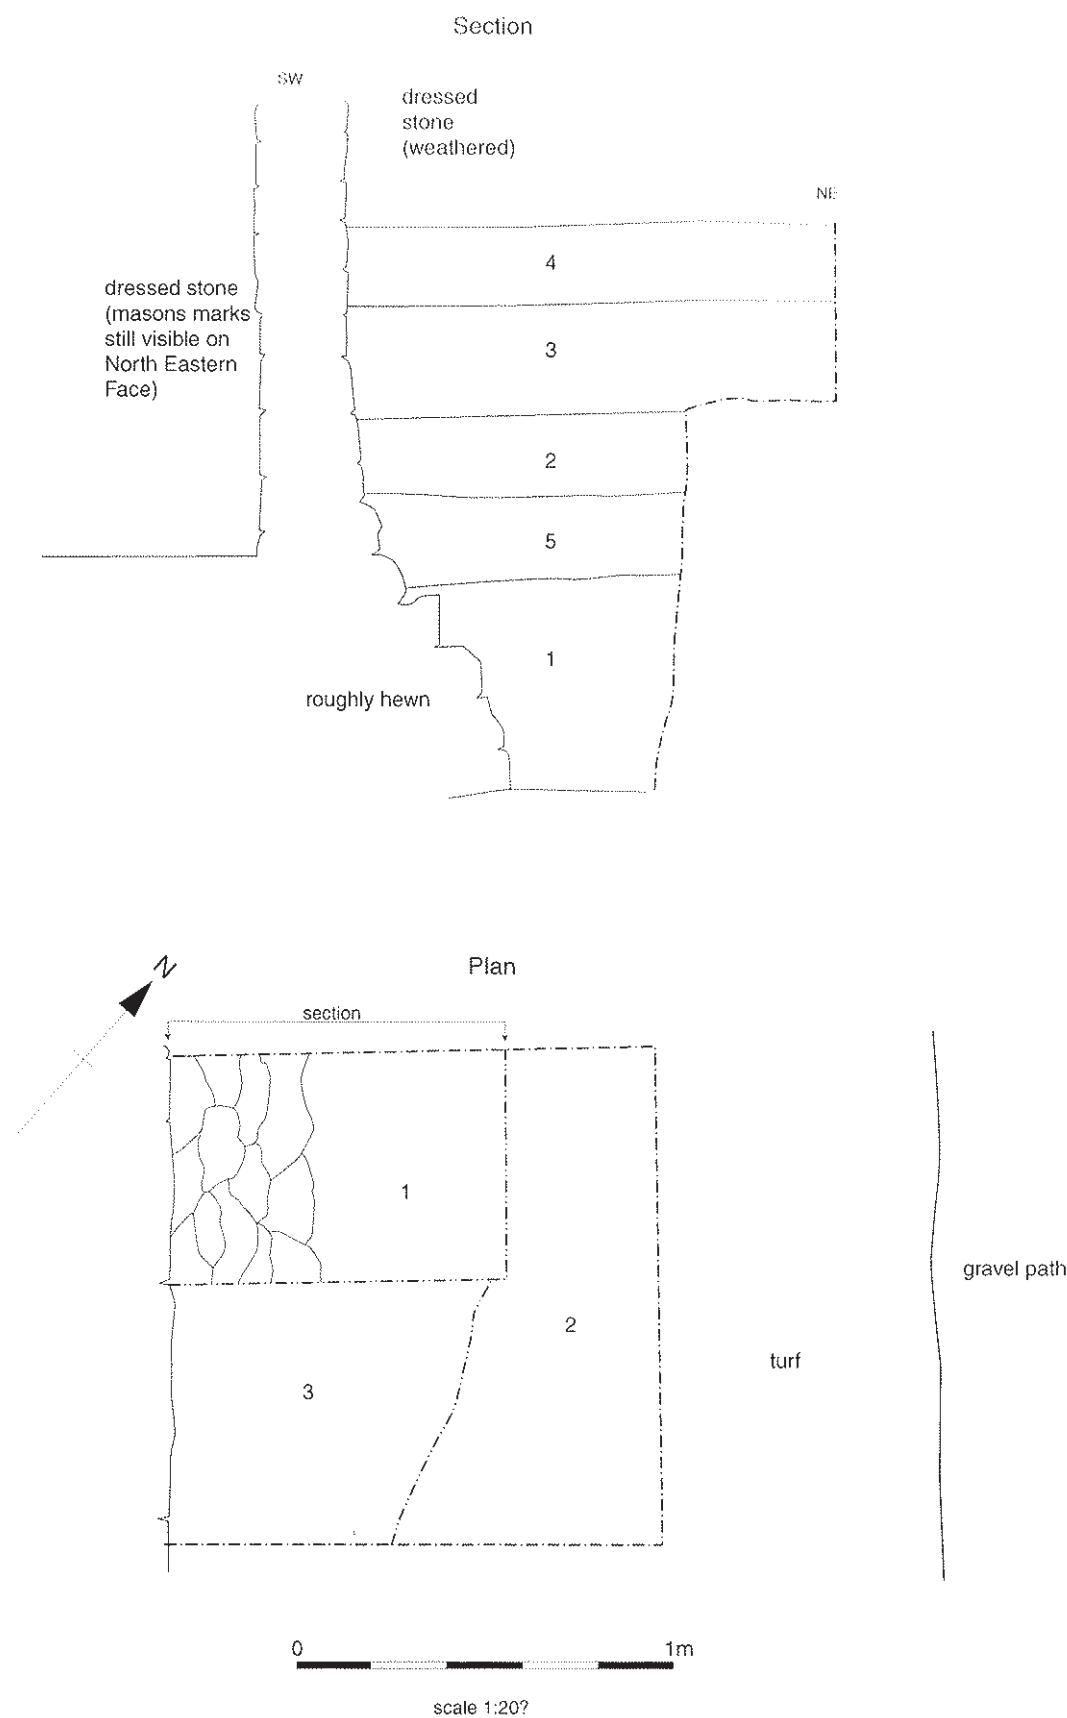
Figure 3: section and plan of test pit in SW garden.

5.2.1 The test pit was excavated against the retaining wall to the west of the South West Garden. The ground level within the garden is approximately 1 m above the ground surface to the west of the wall.

5.2.2 The stratigraphy revealed comprised a mid-dark grey clayey silt (1) overlain by a mid grey clayey silt (5) which was in turn overlain by a deposit of mixed gravel, stone and sand (2). Overlying deposit 2 was a mid-light grey silty clay subsoil (3) overlain by topsoil / turf (4).

5.2.3 The dressed stone of the retaining wall was visible to a depth of 0.8 m below the present ground surface of the garden (bg). The foundation of roughly hewn stone was also revealed to a depth of 1.5 m bg. The dressed stone below the present ground level of the garden was not weathered (indeed, chisel marks were still clearly visible), although it was considerably weathered on the western side where the original ground surface survives.

- 6.1 It seems clear from the results of the test pit in the South West Garden that the deposits of made ground (2, 3 and 4) are contemporary with the construction of the retaining wall. Deposit 1 almost certainly represents a buried ploughsoil, whilst the top of deposit 5 is more-or-less consistent with the present ground surface to the west of the standing wall. The deposit (2) overlying the buried topsoil appears to be a general make up deposit and was overlain by garden soil (3) and turf (4). The stone has been dressed to such a depth because it is visible on the western face where the original ground surface has not been affected. As buried topsoil was observed below the make up layers, it is reasonable to assume that the site has not been levelled prior to the construction of the garden 'terrace' and that archaeological deposits may survive beneath the made ground.
