CLAIFE STATION AND COTTAGE, FERRY KNAB,

WINDERMERE

Archaeological Building Survey Report

National Trust

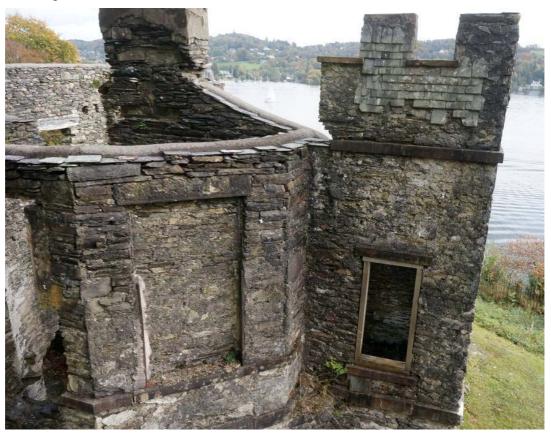
overhung the wall face slightly (Plate 27; Fig 3). Where surviving the parapet wall was partially clad in slate and careful inspection of the remainder of the western wall of the southern wing revealed numerous iron nails consistent with tile cladding.

Plate 27: The crenelated parapet wall of the southern wing with some surviving slate cladding

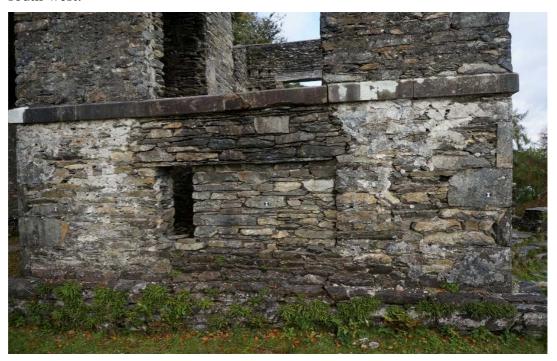
- The walling above this ground floor window looked as if it had been rebuilt and perhaps the opportunity had been taken to replace the original lintel with slates at this time. The parapet wall had kneelers at each of the corners
- 4.1.10 As with the western elevation of this wing the entire southern elevation had been clad in slates, of which now only the nails and occasional fragments of tile remained in place. The occurrence of slates on these two faces presumably reflects the desire to protect the building from the direction of the prevailing weather to the south-west.

Plate 28: The lower window (WS6) of the southern elevation (Elevation 2)

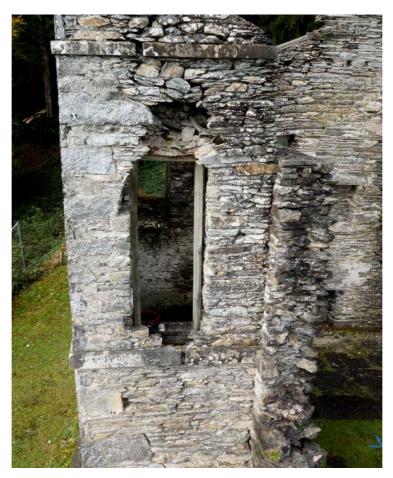
Plate 29: Detail of the easterly window (WS7) which formerly had a pointed arched head

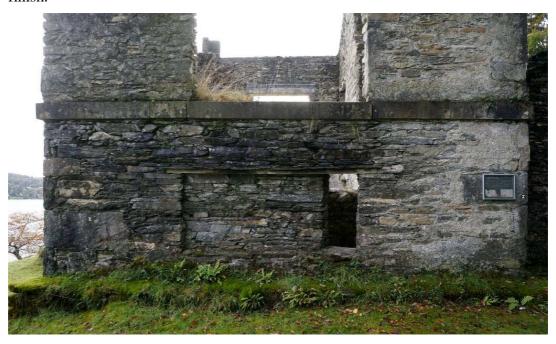
sandstone sill, appeared to have been blocked, leaving a recess of some 130mm from the external wall face. A single timber lintel ran across the head of the larger blocked window and the narrower squint window at the western end. There were no surviving crenelations along the parapet wall on this elevation but the western side of the elevation preserved the best evidence for an external roughcast lime mortar finish.

Plate 30: Detail of the lower squint window (WS12) of the northern elevation

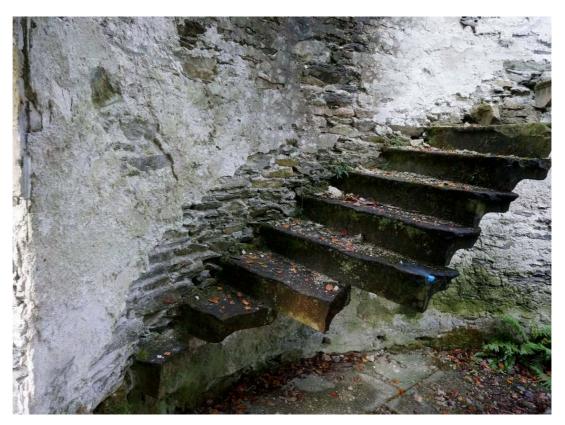
Plate 31: The extant remains of the stone staircase in the stairwell

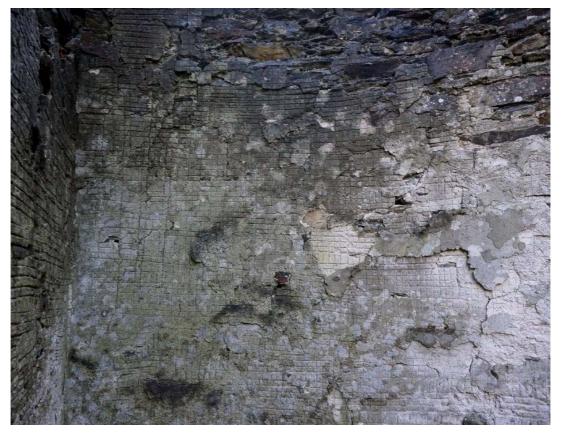
Plate 32: The criss-cross key pattern of the lime plaster scratch coat in the stairwell

- 4.2.2 The walls were lime plastered, with the scratch coat using a criss-cross keying pattern which survived across a good portion of both elevations (Plate 32). If the first floor window on the south-western face of the canted western bay had been blocked then the plaster has obscured the evidence. However less plaster has survived to the north and here there is no indication of a blocked window within the north-western face of the canted bay. It is plausible, therefore, that both these windows were constructed blind to maintain an external architectural uniformity rather than being blocked at a later date. There was also no visible evidence to suggest that any part of the stairwell had ever been floored over and the space may always have been open to the roof.

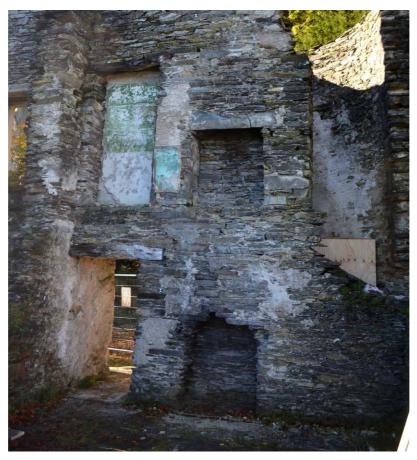
- 4.2.8 The western wall (Elevation 8), which divided the space from the stairwell beyond, incorporated a small fire place at the centre (Plate 33; Fig 4). It had rubble jambs and no formal lintel above, with a flue rising to a low rectangular chimney stack at the top of the wall. The outline of a small rectangular hearth projected into the room in front of the fireplace and small portions of criss-cross keyed plaster scratch coat were preserved on the wall to the north and south of the fire place.

Plate 33: The western wall (Elevation 8) of the central room showing the ground floor fireplace and doorway

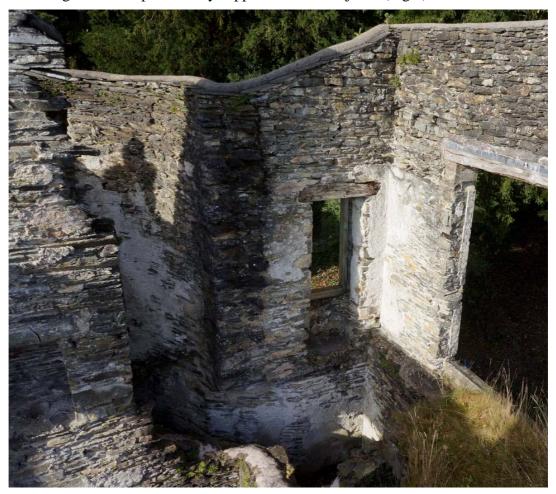
Plate 34: The western first floor elevation of the north wing showing the window and recess below

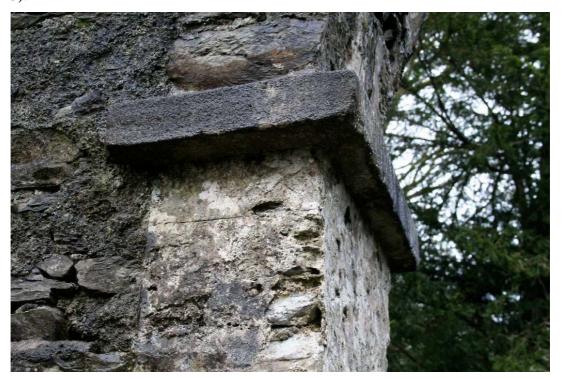
Plate 35: Horizontal scoring below the imposts of the Stations flanking wall arch

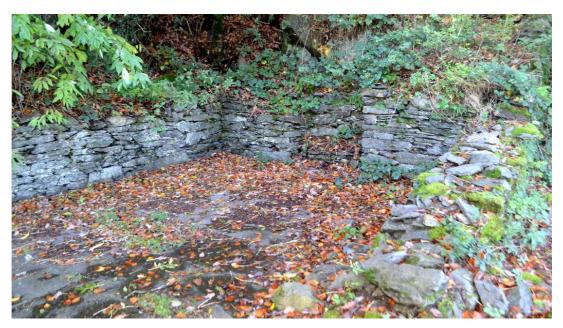
Plate 38: The small ruined kitchen to the north of the flanking wall

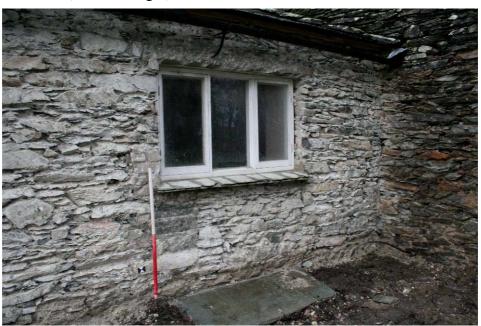
Plate 41: Blocked opening below sill of WC2

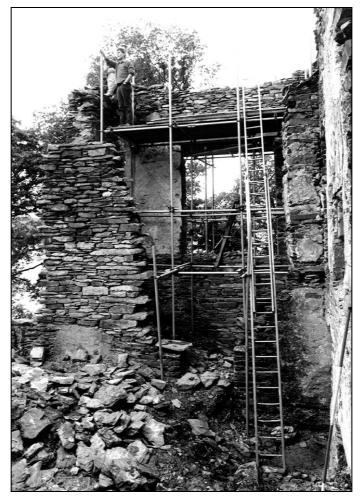
Plate 48: The southern internal elevation of the station (Elevation 11) during the 1986 consolidation works following the rebuilding of the upper-eastern part of the elevation

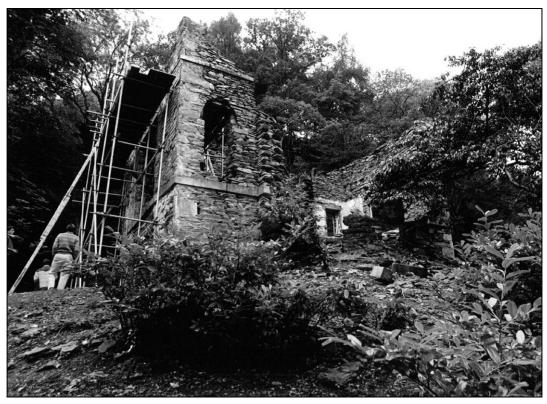
Plate 49: The eastern elevation (Elevation 3) of the southern wing in the mid-1980s showing the outline of the former voussoirs of the window
