# Manor Farm Courtyard Gazeley

## Level 2 Historic Building Survey

December 2016

**Client: Dalham Estate**

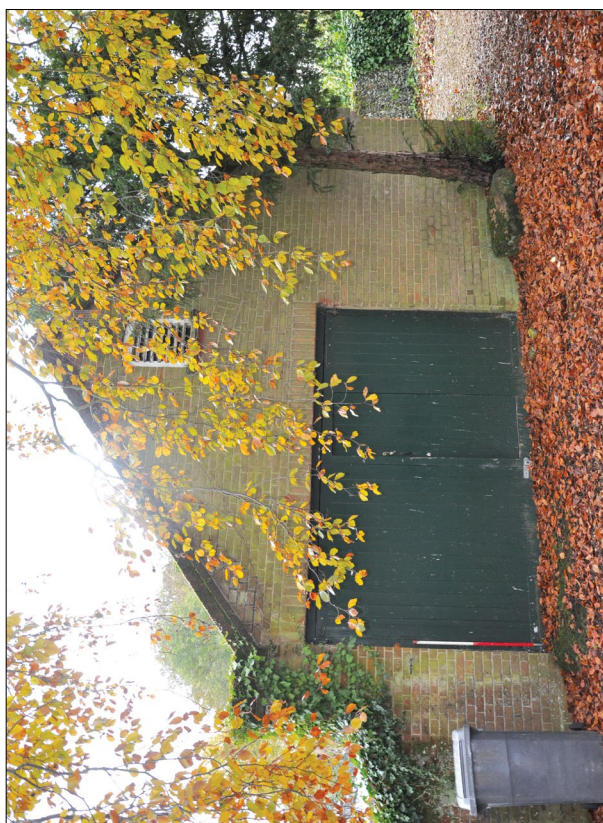
- 3.3.7 The northern elevation consists of red brick, to an apex height of 4.50m. Into this, a double wooden garage door had been inserted (Plate 10). This door replaced an earlier one that became unsuitable when the building was changed from stabling to an automobile garage. It measured 6.25m by 2.06m and, although locked at the time of survey, would open centrally. A small access door was set into the right side of the double door.
- 3.3.8 The only embellishment to the elevation was a small, seven slated louvre ventilation window which is set into the wall under underneath a segmented arch (Plate 11). The window is constructed from wood

Plate 10: North-west facing elevation of Building A and detail of modern doors, viewed from the north

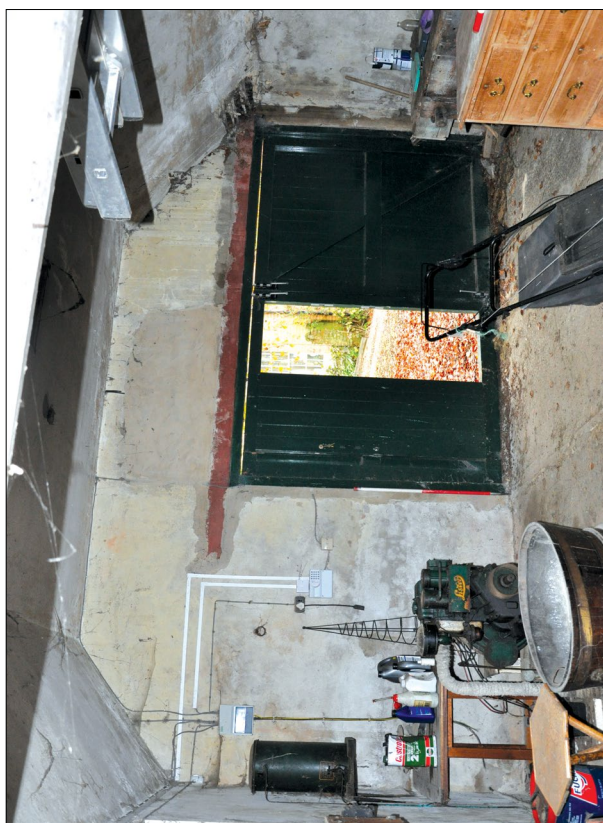
Plate 26: Modern double doors in northern elevation of Room 1 of Building A

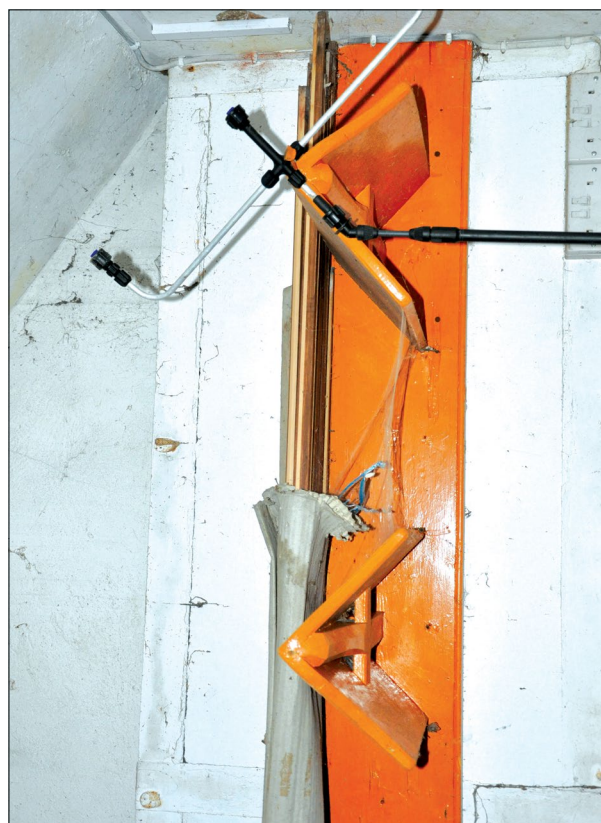
- 3.3.22 Saddles were stored on the western side of the room. The saddle rail is less ornate and constructed of wood (Plate 32). There would have originally been storage enough for six saddles. The rail is now broken but the parts are still stored within the room. The horse stall in room **A** has enough space for one or two horses so it is possible that the building range that extended south from building **A** (Fig 6) housed extra stabling.

Plate 32: Detail of saddle rail in Room 2 of Building A

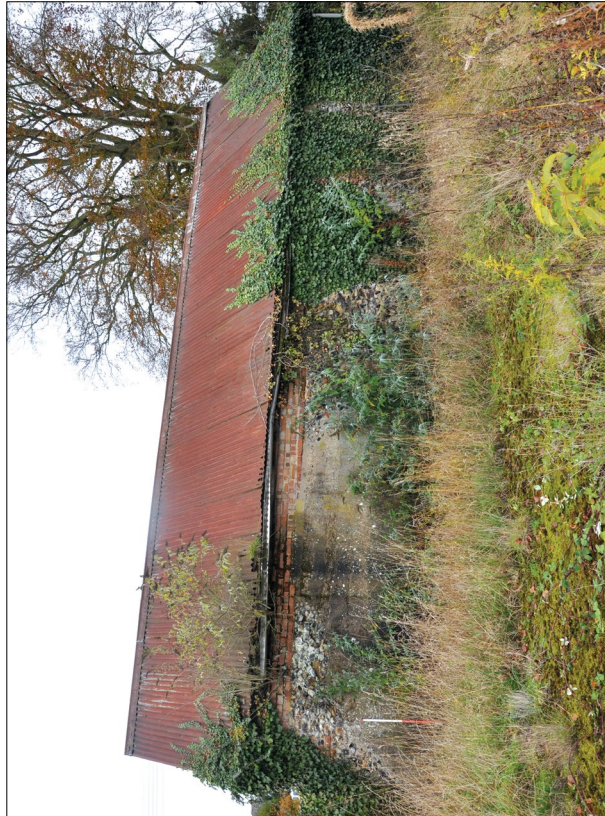
4.1.9 Only the rear flint and brick wall of the building (Plate 37) is original but this too has been unsympathetically repaired with modern brick (Plate 41). This wall would have once continued to meet the southern boundary of the courtyard. This wall now only extends a few metres from the southern end of the building (Plate 38).

Plate 37: North-east facing elevation of Building **B**, viewed from the east

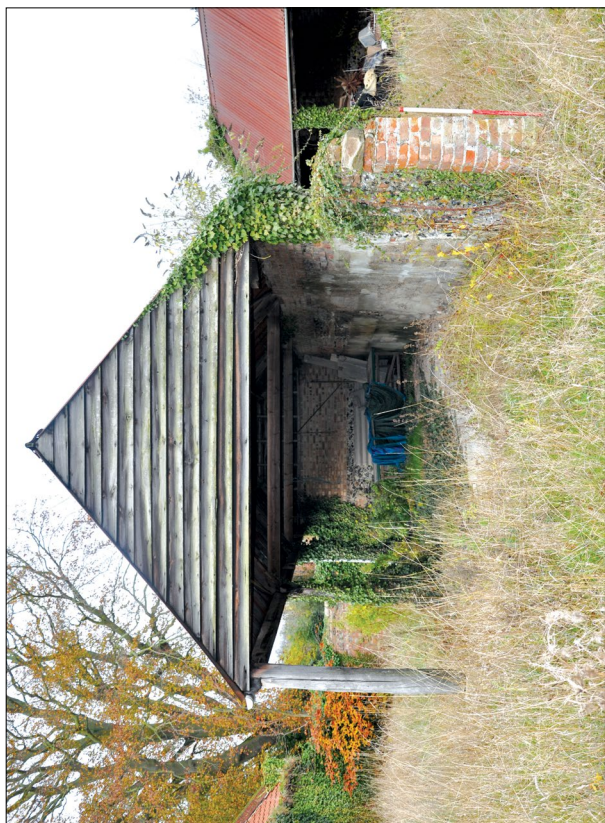
- 3.4.3 The south-eastern elevation has a width of 4.21m and is open to the elements, the upper is weather boarded to the apex of the building (Plate 38). This weather boarding is not original and was probably replaced when the shed was re-roofed. The pier

Plate 38: South-east facing elevation of Building **B**, viewed from the south

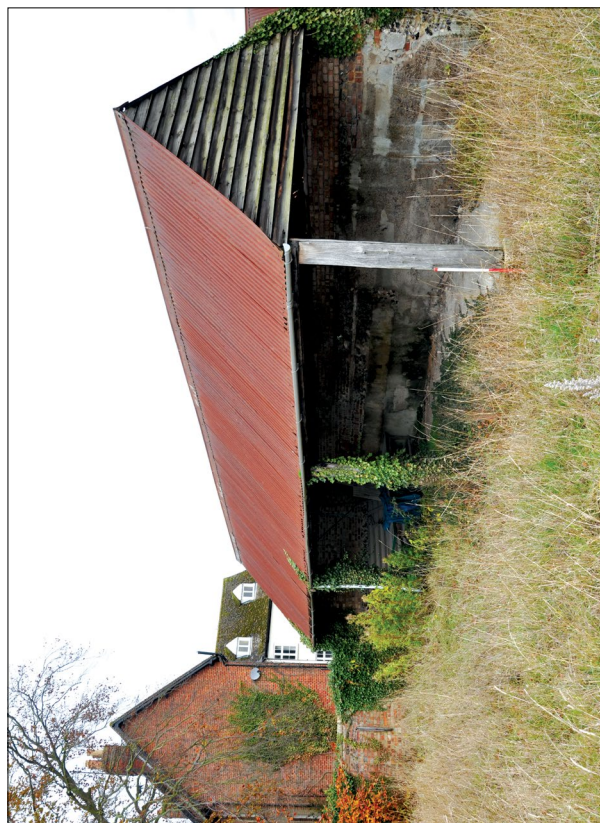
- 3.4.4 The building has three open fronted bays that measure between 3.86m and 3.90m wide and 2.45m high. These are separated by re-used telegraph poles which have replaced earlier timbers (Plates 39 & 40).

Plate 40: Oblique view of Building **B** and farm house to the rear, viewed from the south-west

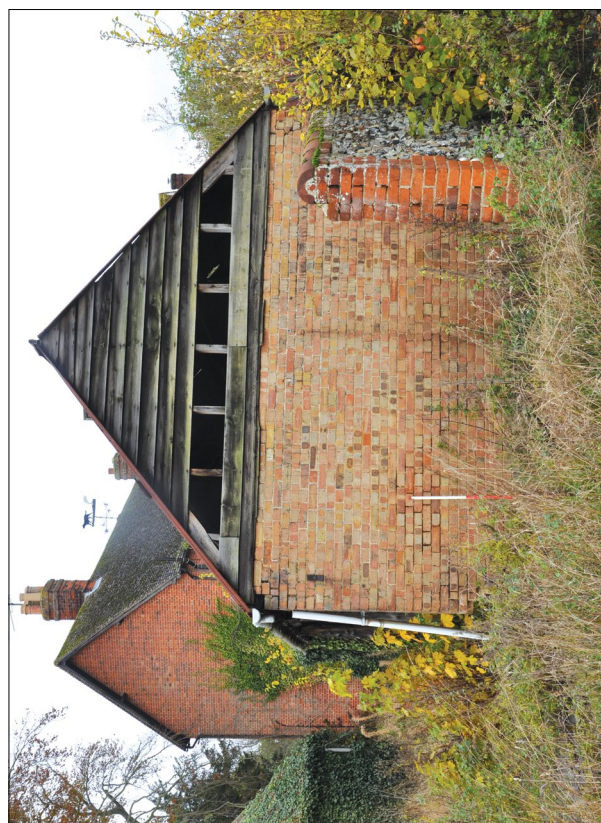
- 3.5.4 The south-east elevation of the building had been bricked in at sometime during the late 19th or 20th century. A wall was constructed of re-used soft red brick, repaired with fletton type bricks to the height of the weather boarded gable end (Plate 44 & 46).

Plate 44: South-east facing elevation of Building C, viewed from the south-east

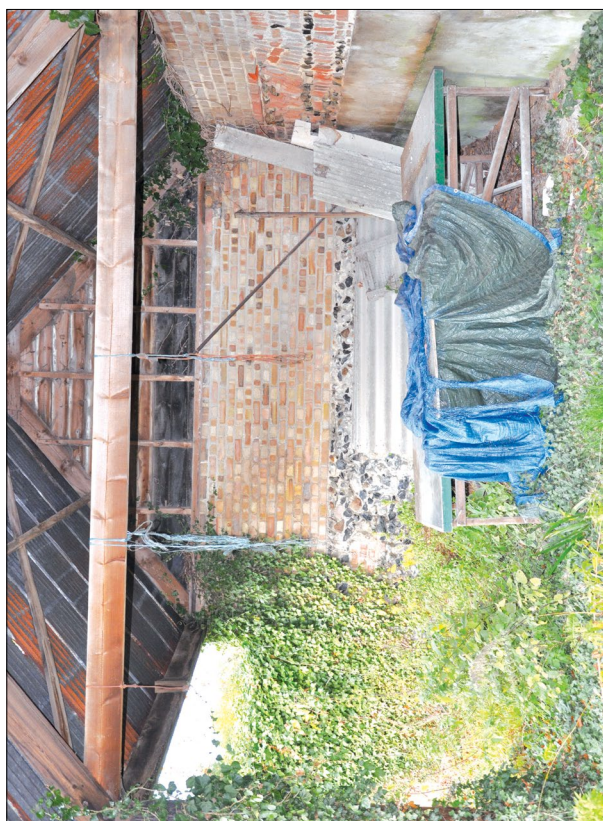
- 3.4.5 The northern elevation of building **B** could only be viewed internally, externally the wall was covered in bramble and ivy. Originally a small flint wall existed to a height of 1.22m, this had been built upon using Fletton type bricks to a height of the 2.3m (Plate 41). Above this the building was weather boarded in a style similar to the southern end.
- 3.4.6 The floor of the building consists of compressed chalk and earth. The roof structure of the building has been completely replaced and the wall plate heightened by a single brick width. All timbers are machine cut and of a twentieth century date (Plate 41). The original roof covering probably consisted of slate or tile. Some slate was found during the archaeological evaluation carried out at the same time (Fairbairn 2016).

Plate 41: Northern wall of Building B showing additional building to top of existing wall

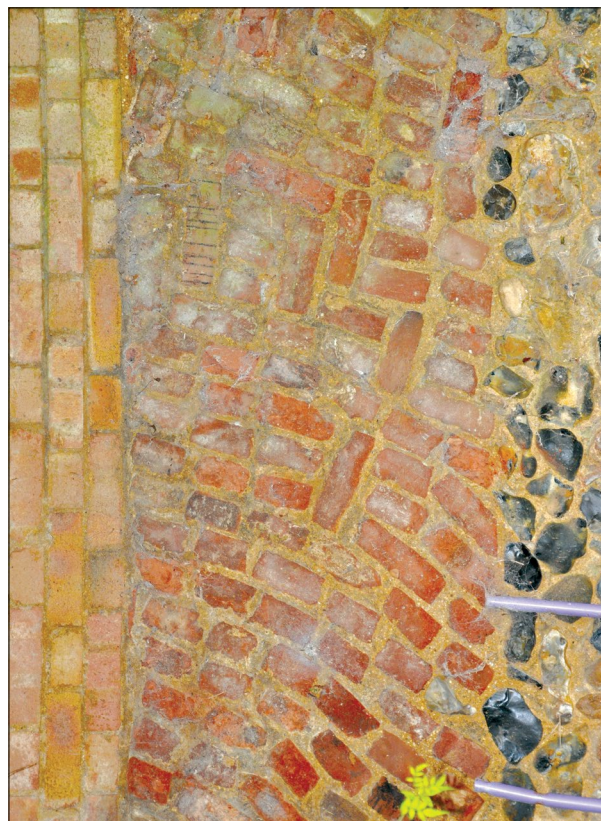
Plate 48: Detail of brick repair to the north-east elevation of Building C

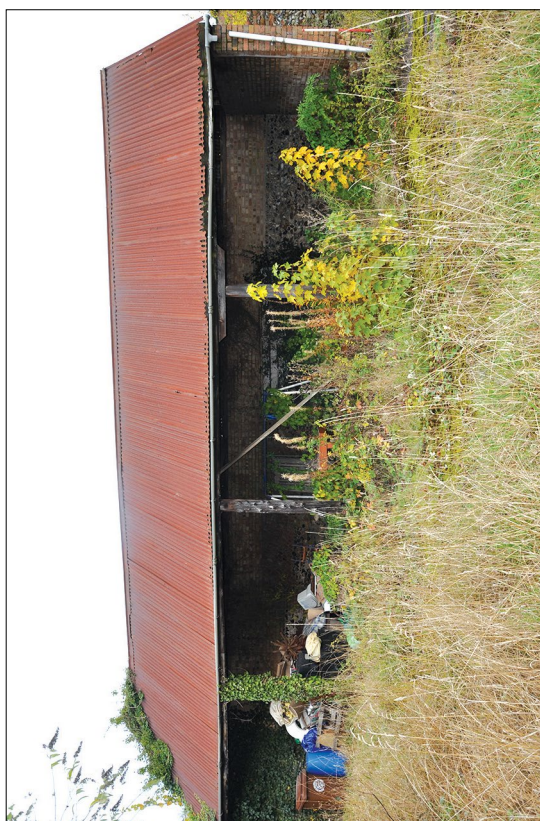
4.1.10 Building **C** is of a very similar design and construction as building **B**. It also started life as an open fronted barn with four bays (Plate 45) and once again it has seen drastic and unsympathetic alteration and repair. The roof structure has been replaced with modern timbers and re-roofed using corrugated iron. The bay divisions have been replaced with telegraph poles mounted onto concrete plinths (Plate 47).

Plate 45: South-western elevation of Building C, viewed from the south-east
