# Croome Park Worcestershire

## Building Assessment Report

April 2002

**Document Title:** Croome Park, Worcestershire: Building Assessment Report

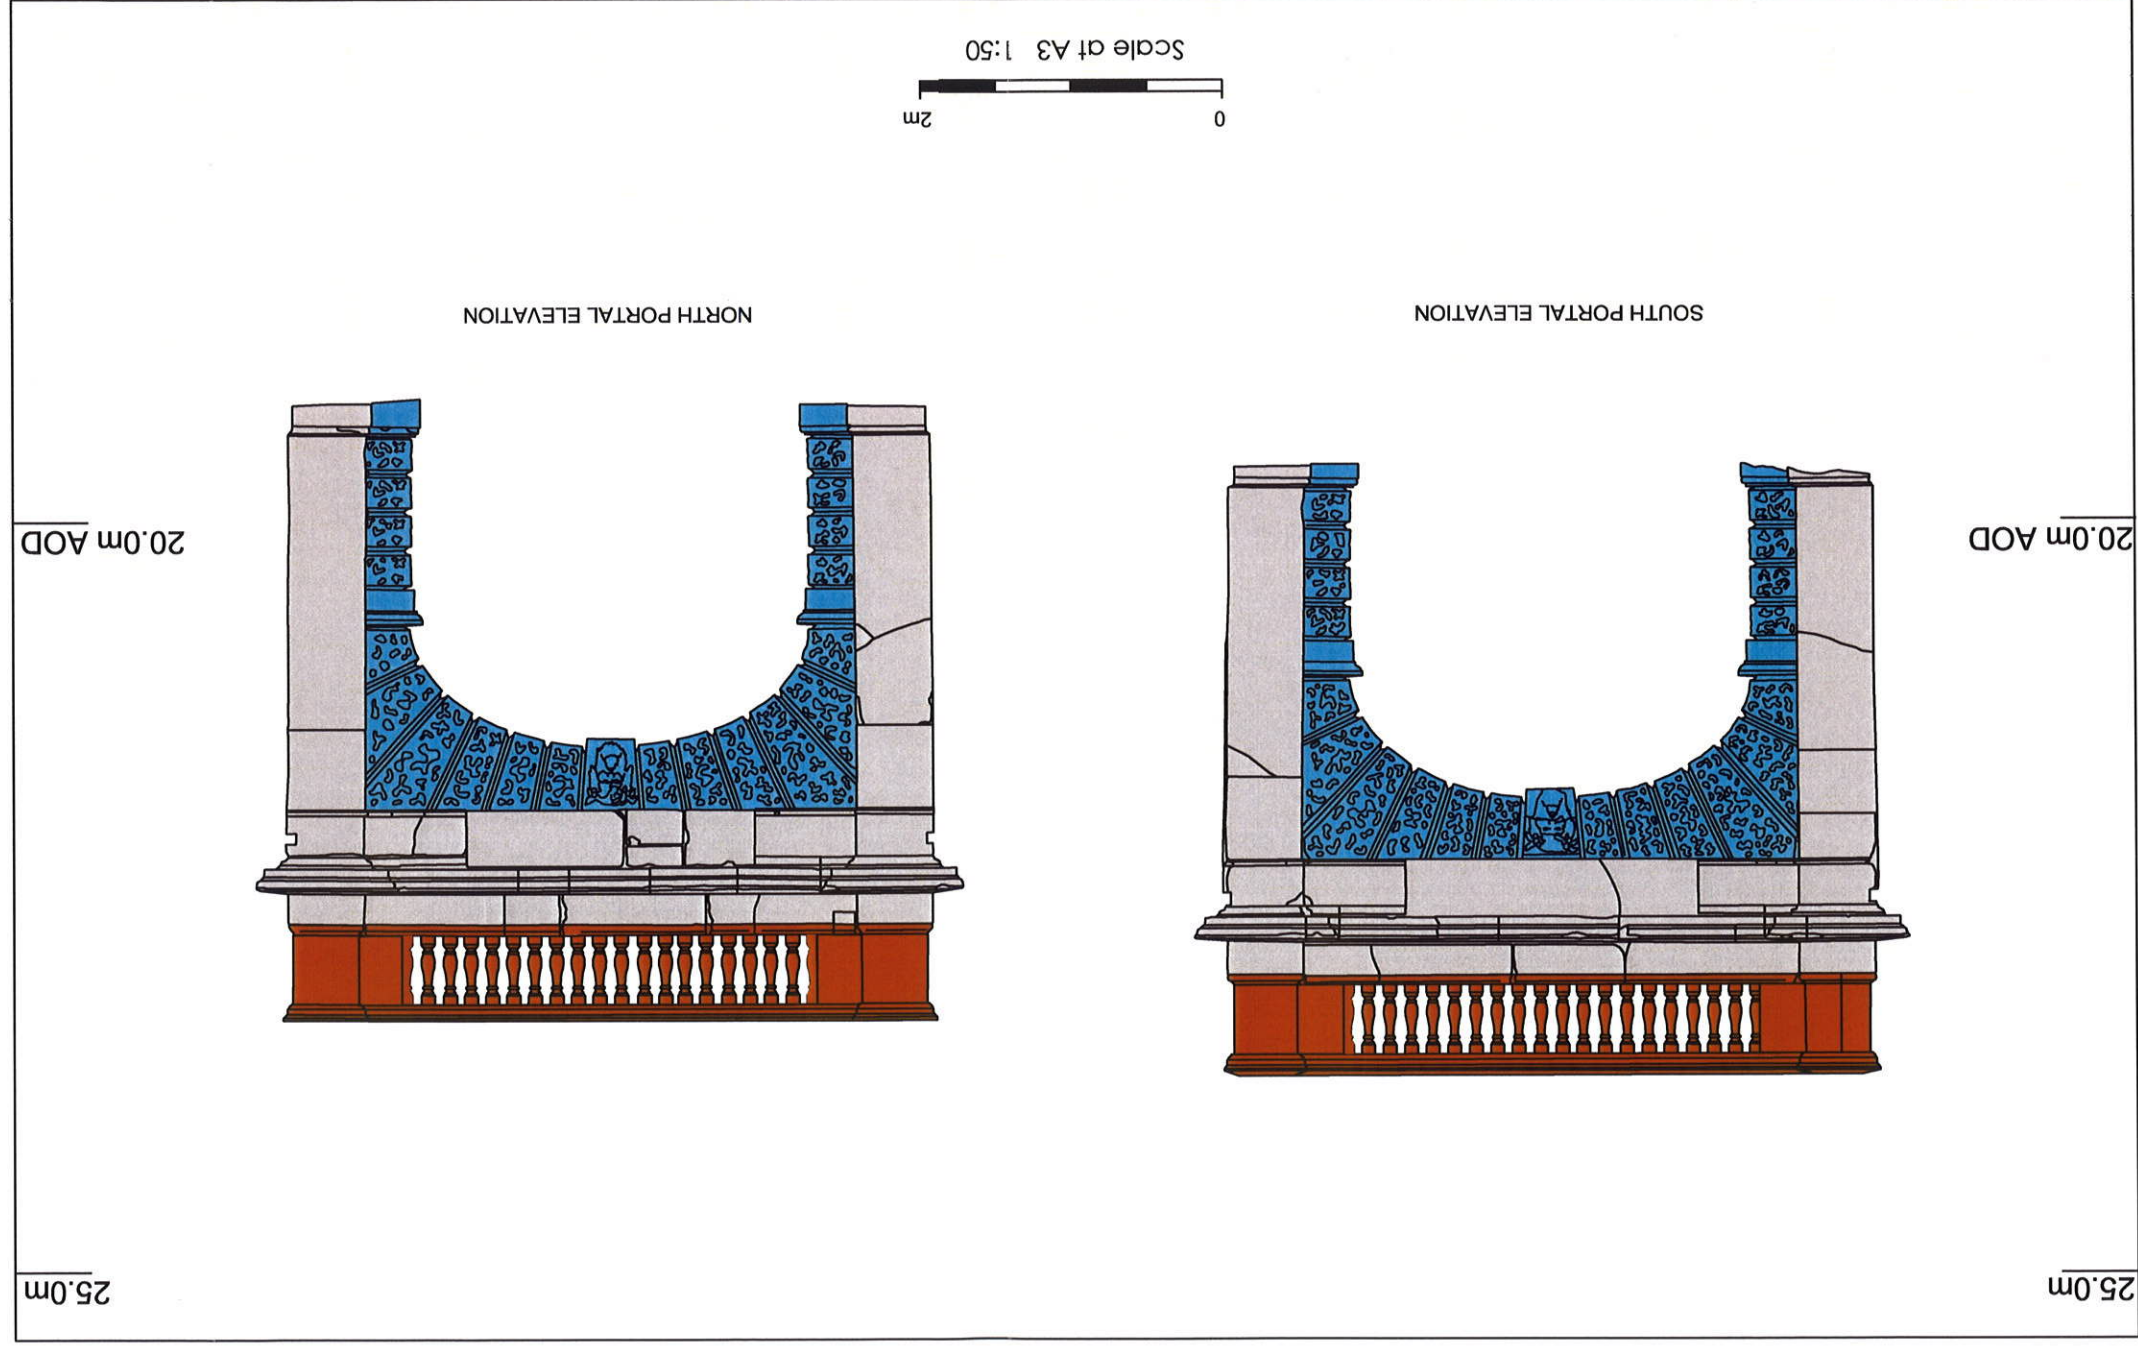
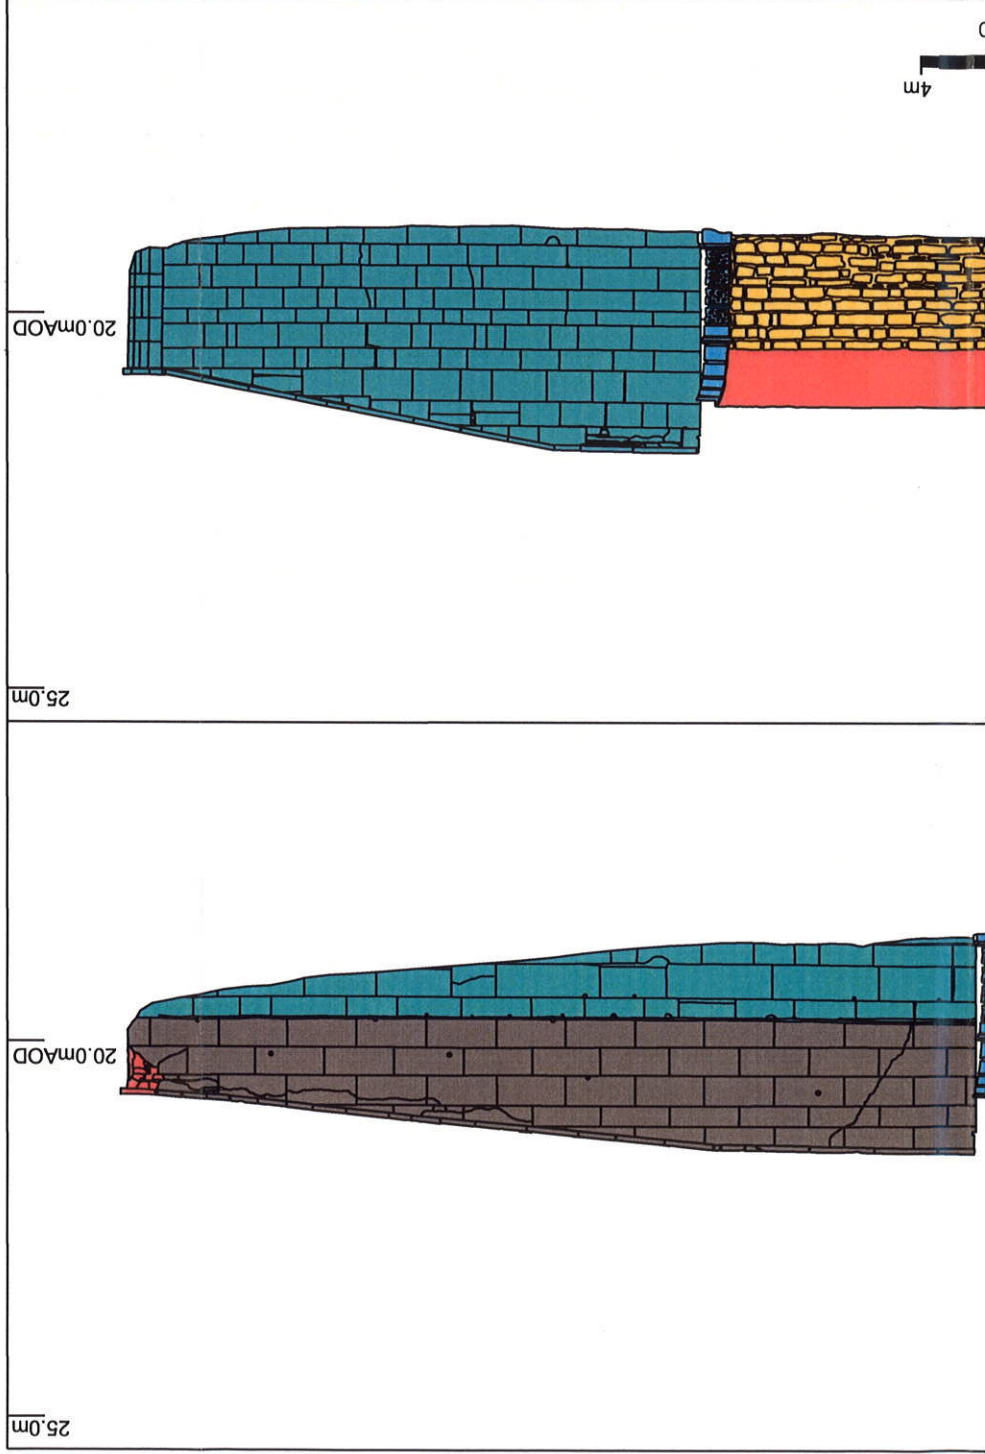
Figure 2: Dry Arch Bridge Elevations.

2.1.5.1. The overall condition of the Dry Arch Bridge is moderately good. The brick-vaulted tunnel together with the entrance portals, particularly the Coade voissorts and rusticated quoins, is in good condition. This sadly contrasts with the Coade Baccus keystones which are in poor condition having been partially lost and heavily patched in modern render.

2.1.5.2. The condition of the wing walls flanking the approaches to the passage is also uneven. The upper half of the west wall to the north of the bridge has been lost (possibly only partially) and rebuilt unsympathetically in rendered brick. The lower half of this wall, however, together with the other three wing walls is in relatively good condition and appear to be structurally sound although there are some cracks and areas of structural alteration.

2.1.5.3. The historic balustrades flanking the drive over the bridge have been lost and replaced by modern structures.

1. The west wall to the north of the bridge is in a poor condition and it is anticipated that it will be rebuilt or repaired in a more sensitive manner than the modern render. The removal of the render has shown that the brickwork behind is of probable 19<sup>th</sup>-century date and it is therefore of some historic value in its own right. It may therefore be decided to retain the brickwork or to replace it with stonework similar to that on the east wall which would be aesthetically closer to the original form of the structure. The drainage pipes should be removed from the west wall and the drainage redirected to fall away from the Dry Arch Bridge towards the north-west.

2. It is also anticipated that the existing timber balustrading will be replaced by more appropriate stone balusters and all attempts should be made to determine the historic form of the balustrade to allow this. This may be possible from early to mid 20<sup>th</sup>-century photographs showing the Dry Arch Bridge which are likely to survive either in a public archive or a private collection to which it may be possible to arrange access. It is likely that the existing wooden balusters are replicas created using the surviving previous stone balusters as models and it should be possible to confirm the previous number of balusters from the holes within the plinth which should be visible when the wooden balusters are removed.

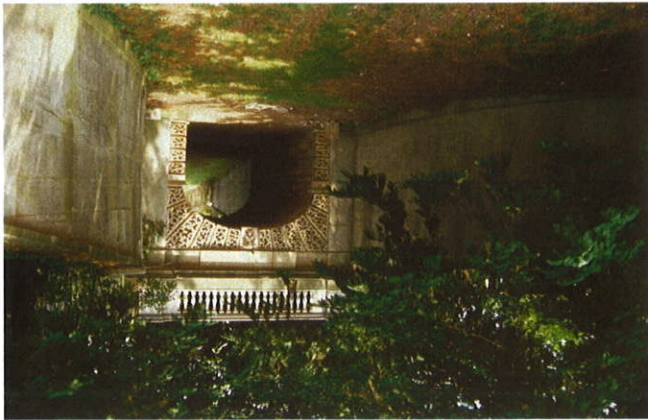
Plate 1 : Southern approach to tunnel showing retaining wing walls and portal

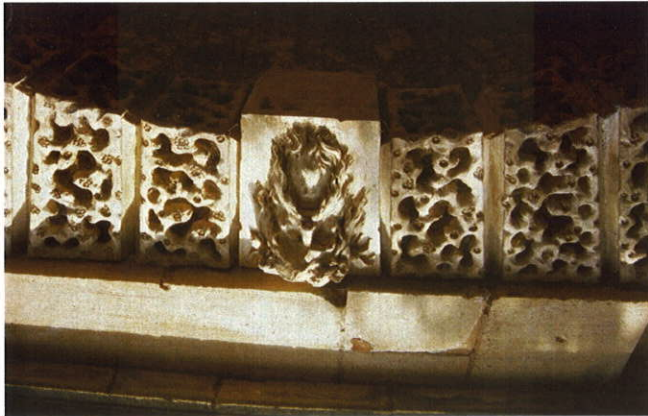
Plate 2: Coade stone Bacchus keystone within southern portal

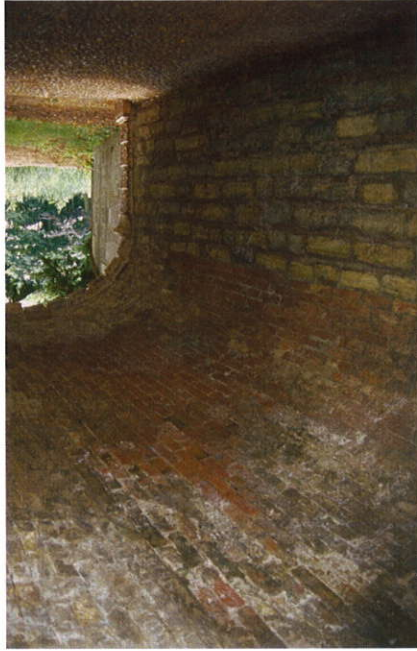
2.2.1.9. The tunnel is formed of a shallow red brick vault bonded with white mortar and supported by non-dressed limestone blocks. Traces of a pale paint are visible (presumably a limewash) on the arch suggesting that the interior was originally painted white to unify the stone walls with the brick arch (Finlay, 2001). The floor is cobbled with small pebbles. Repair works undertaken after the site work of the current assessment have shown that the arch is three brick courses deep.

Plate 3: Interior of brick-vaulted tunnel

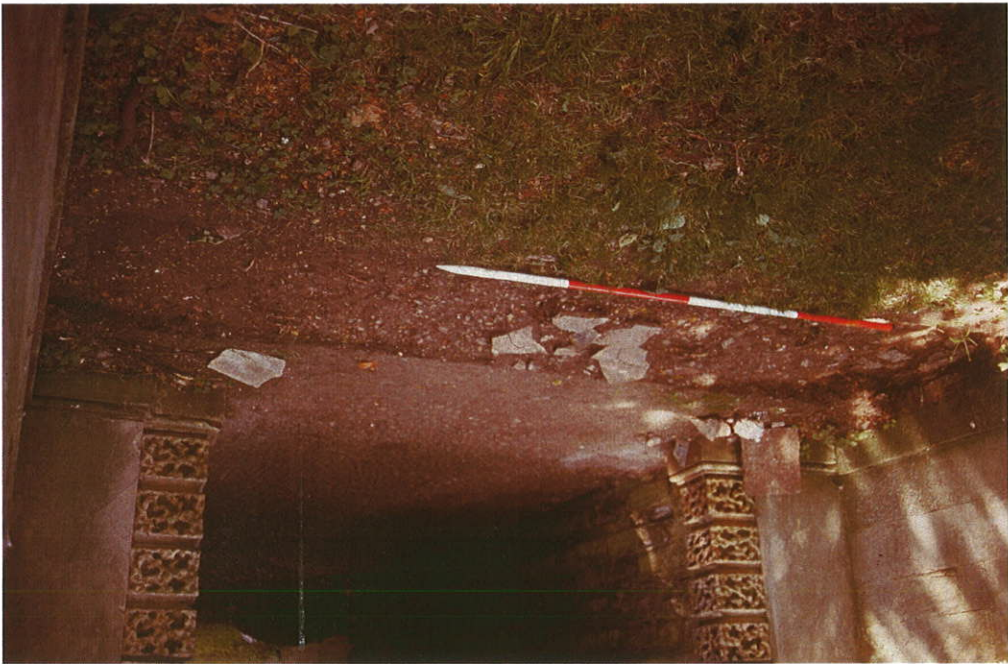
2.2.2.2. **Trench 4:** The investigation revealed the extent and form of the 18<sup>th</sup> century path (403) to the south of the Dry Arch Bridge. The path was 3.74m wide, consisting of well-sorted rounded pebbles. Several pieces of flat limestone were recovered from the overlying layer (402) but no recognisable architectural fragments were noted.

2.2.2.3. A deposit of plaster was also noted within the modern topsoil (401). This was fragmented due to tree root action and hence in an extremely poor condition. It was however possible to discern that there was an impression within the plaster surface of remnants of wood and a small sample was recovered for further analysis. Unfortunately the plaster could not be related to any part of the Dry Arch Bridge but it is possible that it originally belonged to the balustrades along the upper level of the bridge.

2.2.2.4. The most significant feature revealed within Trench 4 was what appears to have been the foundations of the longer primary tunnel (Structure 404). These foundations are formed of compact mortar and limestone, which differ in character from the later Dry Arch Bridge structure and also from foundation layers for paths and carriageways examined during this project. The foundations can therefore be attributed to the earlier c. 1760's bridge.

Plate 4: Dry Arch Bridge, , south side, trench 4. Possible fallen Balustrade and gravel surface

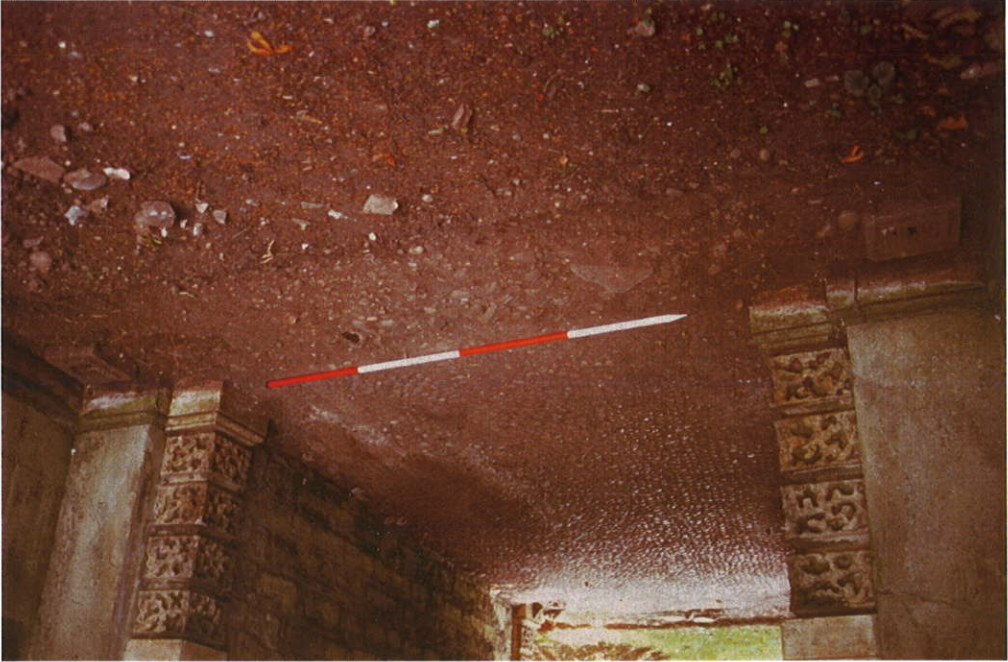
2.2.2.6. **Trench 5:** No foundations were revealed in the trench north of the bridge suggesting that the original structure did not extend further to the north than the current bridge. The trench revealed that the extent and form of the 18<sup>th</sup> century path (502) to the north of the bridge was broadly similar to that to the south. The path was 3.45m wide, again consisting of well-sorted rounded pebbles and again several pieces of flat limestone were recovered from the overlying topsoil layer (501) but with no recognisable architectural fragments. The limestone deposit contained similar material to the limestone layer 402 in Trench 4, and was similarly fragmented and unstratified.

Plate 5: Dry Arch Bridge, north side, trench 5. Gravel surface and drains

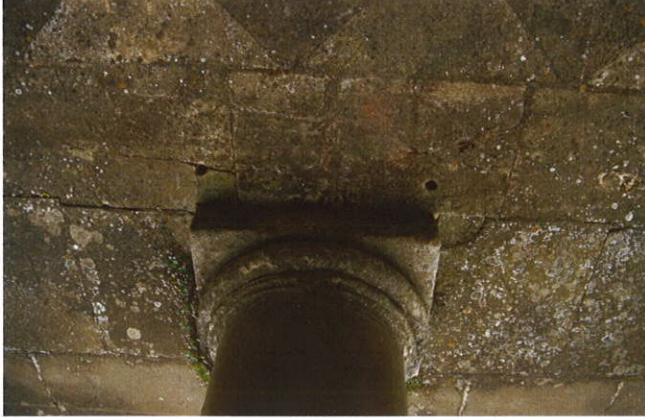
Plate 8: Small holes in floor which formerly held sash posts

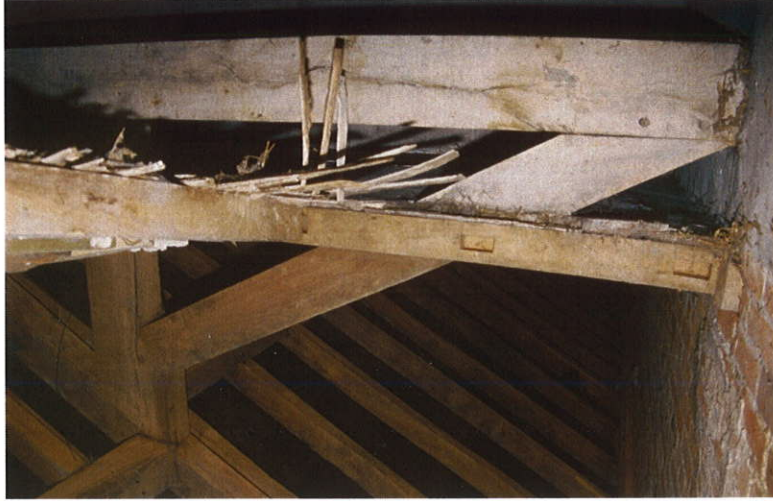
3.3.1.7. The bothy at the east end of the lean-to appears to be a secondary alteration and that in the original building the open room was four full bays wide with a smaller single bay room at the east end. This is principally suggested by a distinction in the floor surface in which the red pavers found in the open room continue up to the line of the first truss from the east while the eastern half is formed of blue pavers.

Plate 10: Roof truss above bothy with secondary ceiling abutting

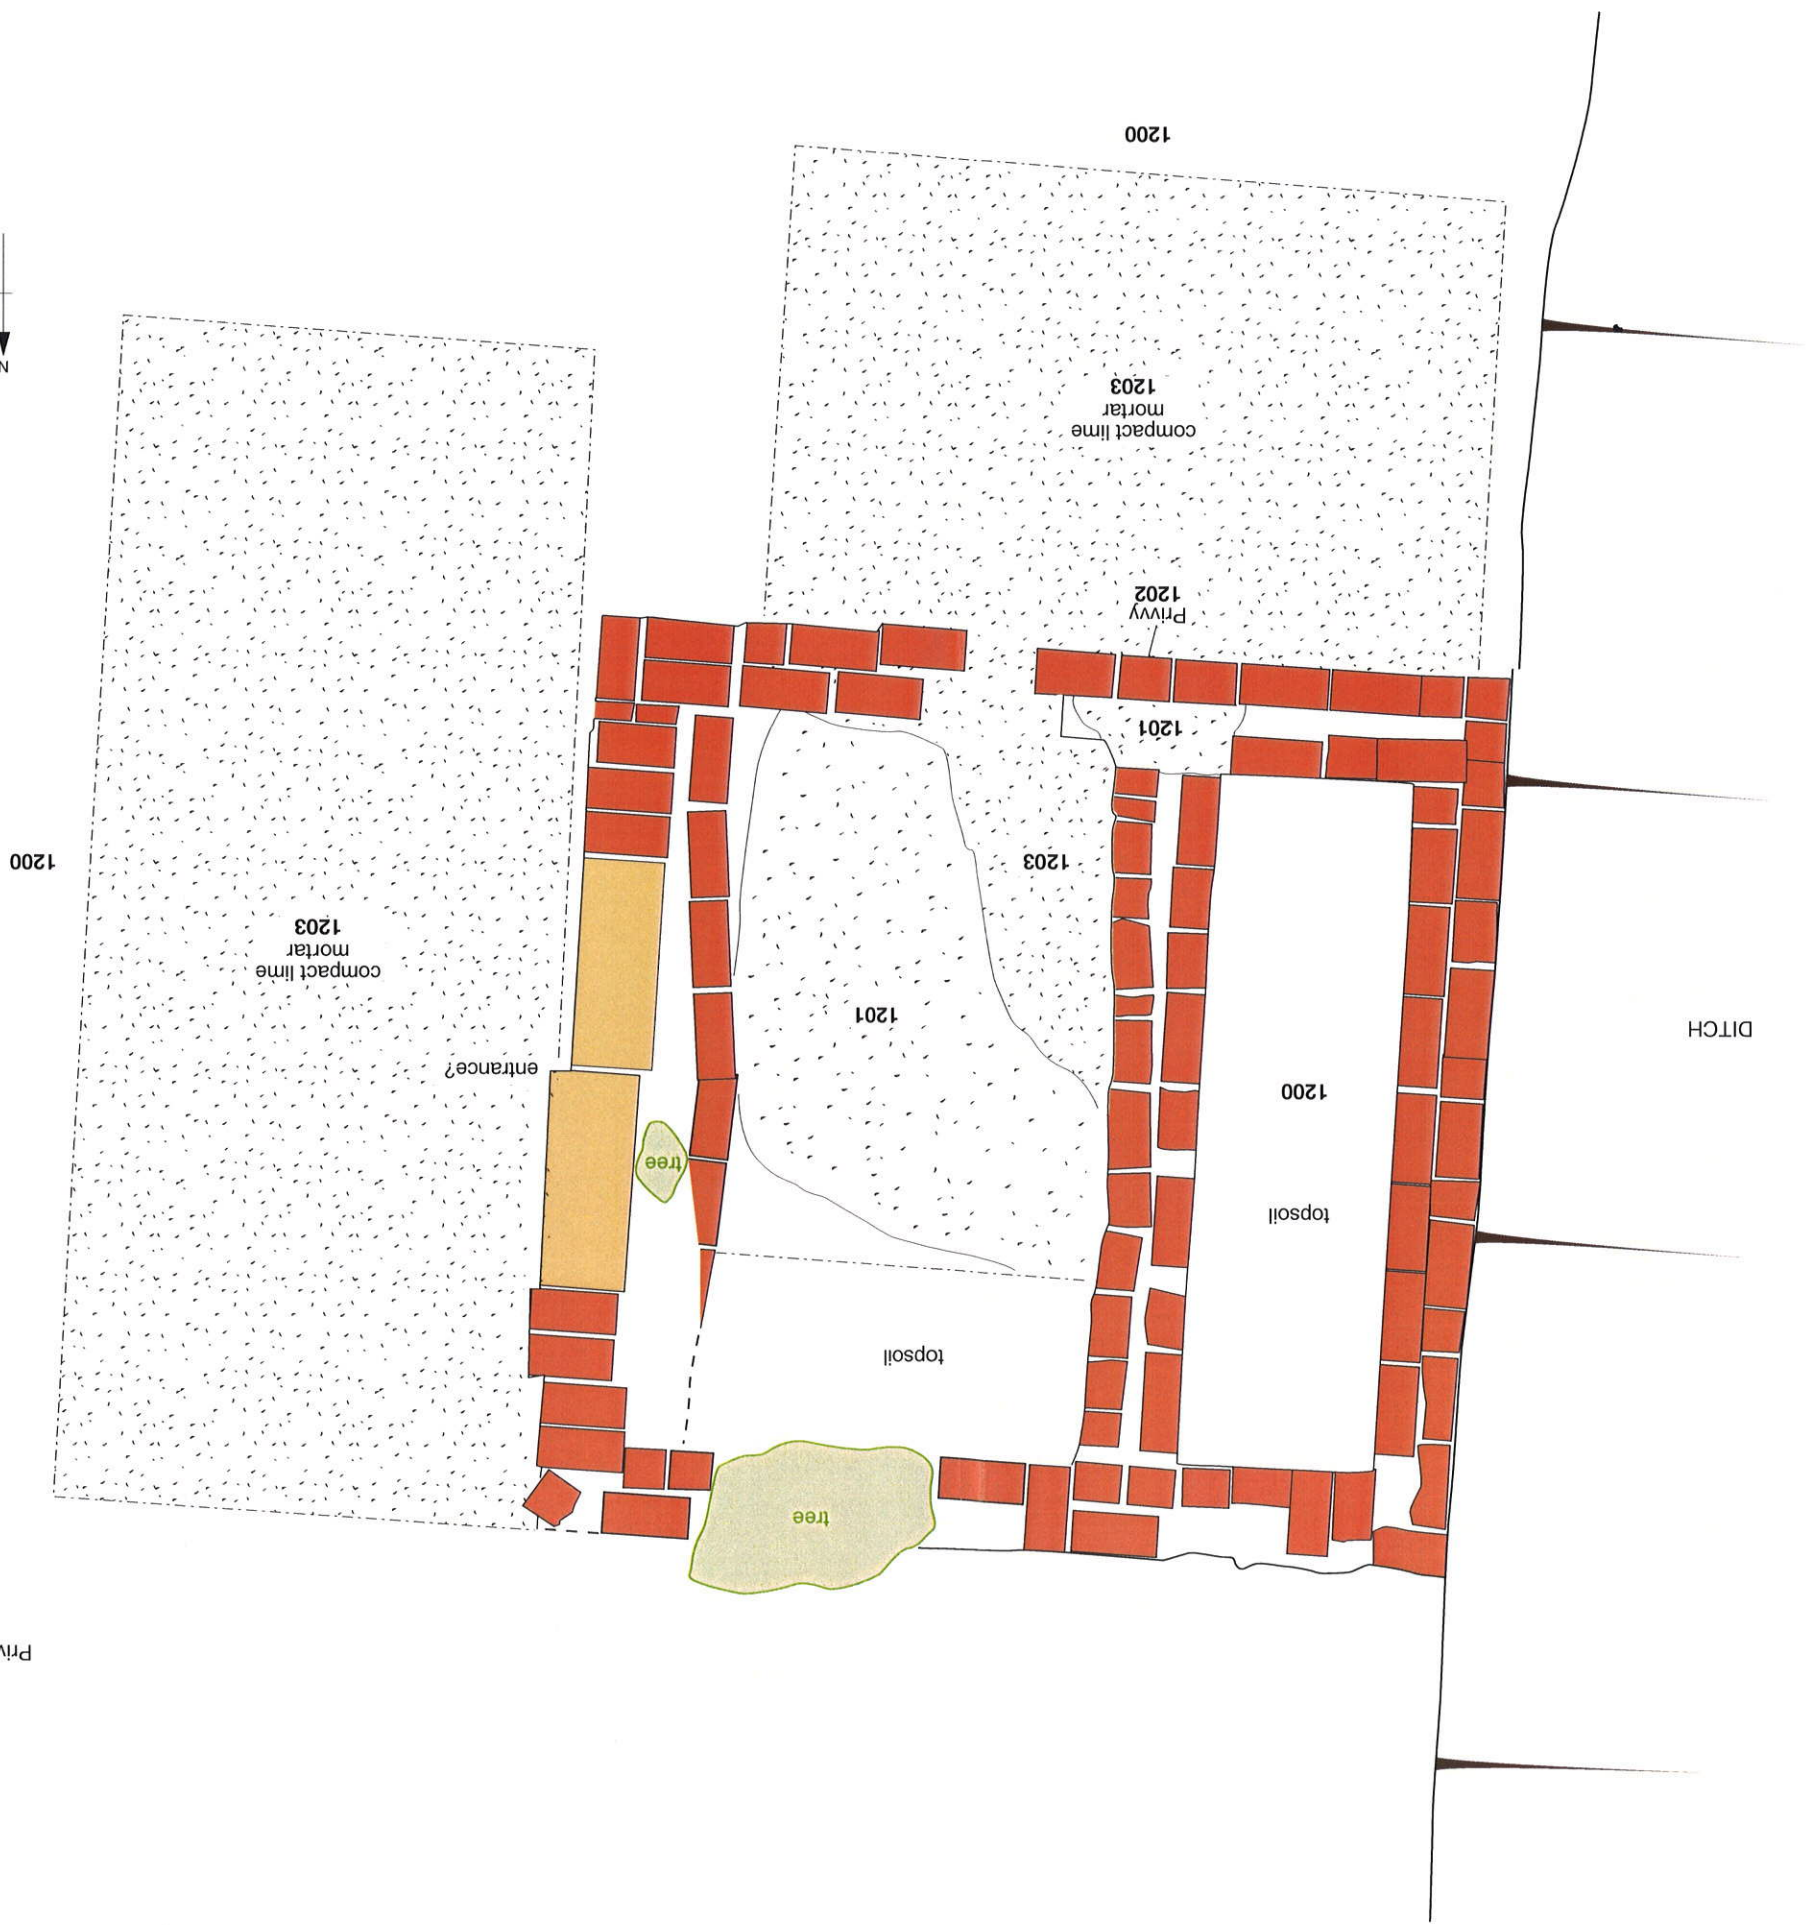
Figure 9: Trench 12 plan

4.1.5.1. The current condition of the privy block is clearly very poor with only low footings surviving. It is situated in an area of scrub woodland and was prior to the excavation works covered in dense vegetation.

4.2.2.1. The privy structure stands to a height of two courses at the eastern end and seven courses towards the west, where the structure has been terraced into the bank of a ditch. The structure has been divided in two by a centrally placed north-south brick wall, with the latrine situated at the western end in close proximity to the external ditch. The construction cut for the foundation of the structure probably cut layer 1203, although no evidence for a cut was noted. The entrance to the privy was to the east and was represented by two centrally placed stone blocks. There was no evidence for external

surfaces on either the eastern or southern sides of the structure. An internal layer of lime mortar, 1201, has abutted the eastern wall and is the only evidence for an internal surface or surface foundation.

1. The Privy should be conserved in its current form and should be included as an archaeological feature within the overall interpretation of the park to the public (ie briefly referred to in guidebooks, marked on site plans etc).

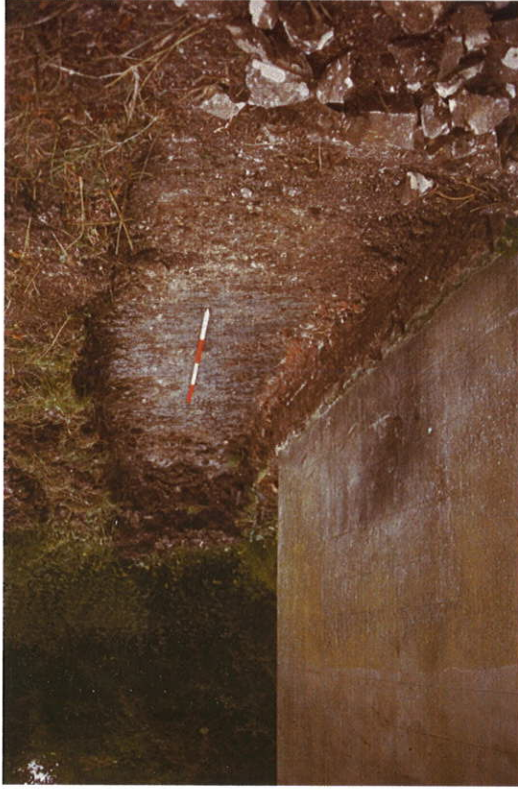
Plate 12: Park Seat, southern side. Feature 2104 and associated architectural fragments
