Croome Park
Worcestershire:
Archaeological excavations
of the Ha Ha

Volume 1

**THE NATIONAL TRUST**

Document Type: Buildings Survey

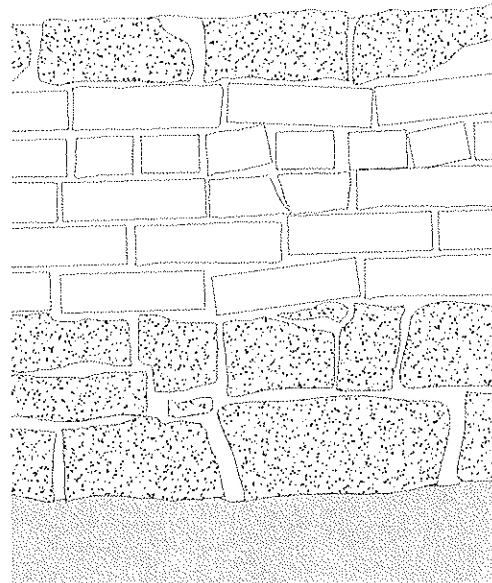
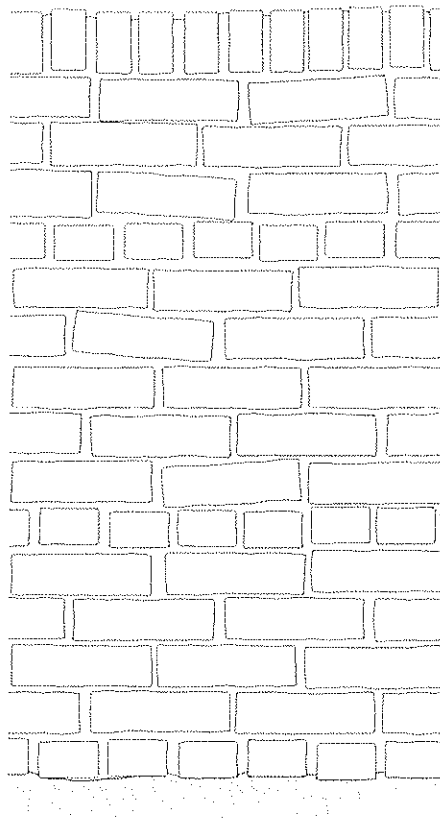
Figure 1: Primary Phase Elevatio

1.2.1.2 Overall, much of the upper section of the wall needs to be removed and replaced. The style of this replacement could easily follow the earliest phase of works, of which there are possible full height sections (reproduced in figure 1)

- *The primary build* – Several courses of roughly squared lias stone blocks, topped with seven courses of brickwork, with at least a single course of lias stone above this. Possibly 18th century
- *The second phase of building* – The removal of damaged material, and the installation of sandstone copings and railings, the later of which have been removed for some time. Possibly mid 19th century
- *The third phase* – Repair of the copings with salvaged items from elsewhere, and reinstallation of most of the upper few course of brickwork. Early to mid 20th century.
