BOLTON GILL AND HEBDEN GILL LEAD WORKINGS, HEBDEN

Archaeological Survey Report

Oxford Archaeology North

May 2015

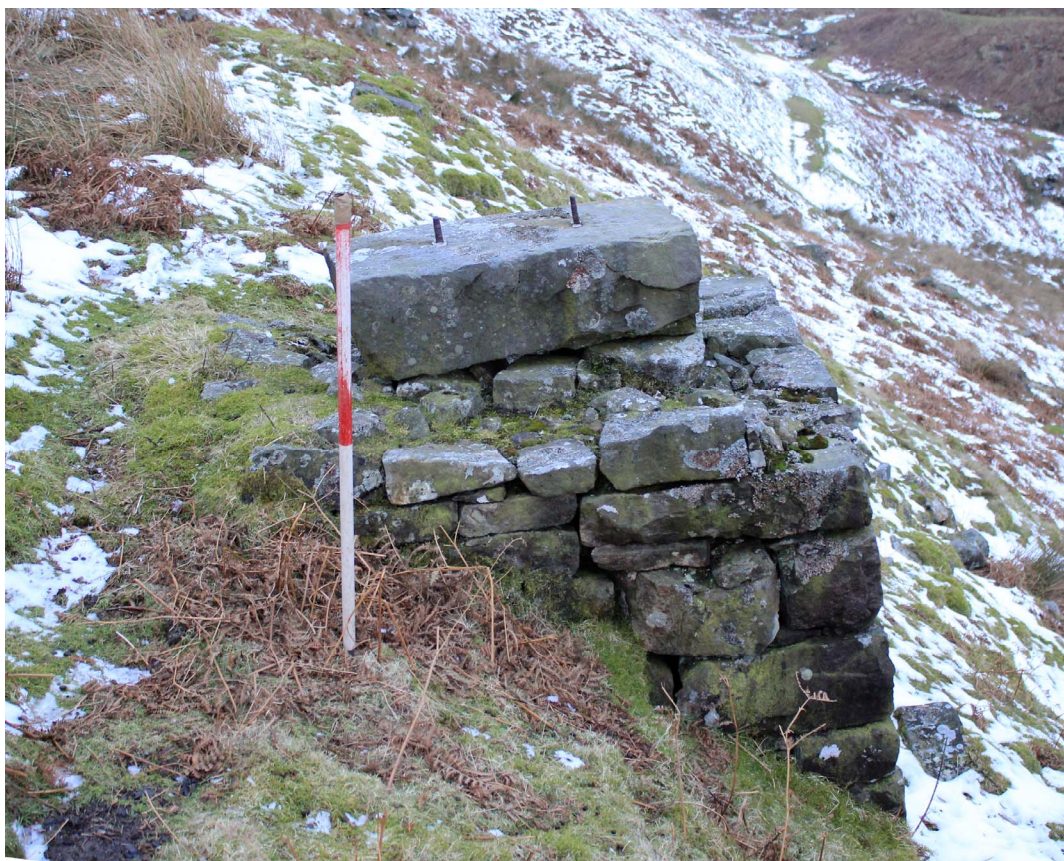
Plate 17: A stone pillar for the pump rods looking west with two bolts extending from a bearing mounting block (Site 7.3c)

- **Pump-rod Pillar Bases (Sites 7.3 and 17.2):** a series of pillar bases extending between the power transfer house and the Engine Shaft. They are in variable condition; the four easternmost pillars (Sites **7.3c-f**) are in generally good condition, whereas Pillars **7.3b**, **7.3j** and **7.3k** are in a very poor condition. Pillar **7.3b** was constructed on a spoil heap, which afforded only poor foundations, and it is now only a mound of collapsed stone. Pillar **7.3a** is in a poor condition but some of it is still in-situ. A further line of pillar bases extending east from the power transfer house also has a variable condition. Sites **17.2a** and **17.2c** are mostly collapsed and are in a poor condition; whereas **17.2b** is in good condition and stands to original height.

- 6.6.5 **Engine Shaft Pump Rod Pillars:** the four easternmost pillars (Sites **7.3c-f**) are reasonably intact, but in order to prevent any further decay, the tops of each pillar should be consolidated by taking off and rebedding the top course of stone. Pillars **7.3b**, **7.3j** and **7.3k** have virtually disappeared and there is insufficient surviving to be able to reconstruct accurately. Pillar **7.3a** could be reconstructed but would need better foundations, and it is considered that complete reconstruction would not be economically justified.

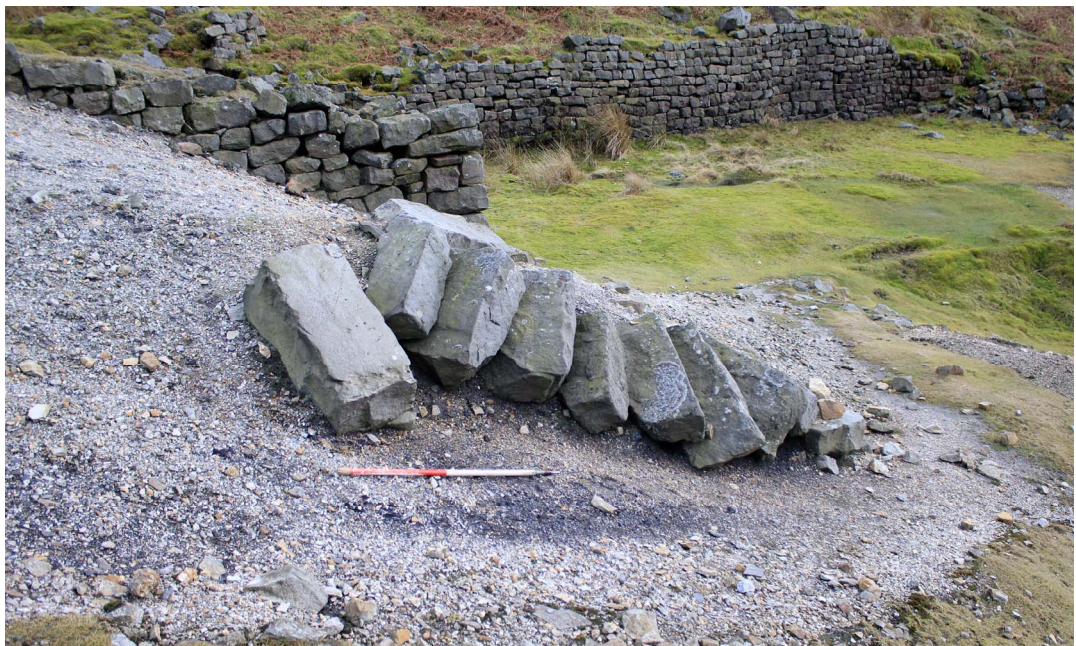
Plate 19: The collapsed steps (Site 9.4a) adjacent to the bouse team

- **Bolton Gill Dressing Floor Bouse Team, Wheel Pit and Steps (Sites 9.2, 9.3 and 9.4):** the bouse team (Site **9.2**) has sustained considerable collapse and is in a poor condition. It has a retaining wall, which is bulging substantially and is in need of consolidation. Adjacent to the bouse team, is the wheel pit area (Site **9.3**) which has also sustained considerable collapse, and is in a poor condition. Being set above dressing floor, it is vulnerable to further decay. Adjacent to the bouse team was a set of steps (Site **9.4**) which were originally into a spoil mound of fine dressing floor waste, which has been subject to water erosion, undermining the steps. They have collapsed as an integral feature

- 6.6.7 The steps are a collapsed row of stone treads. It is proposed that the only meaningful way of preventing further decay would be to rebuild them with a rubble masonry wall to carry the west side of the treads. This would prevent further erosion.

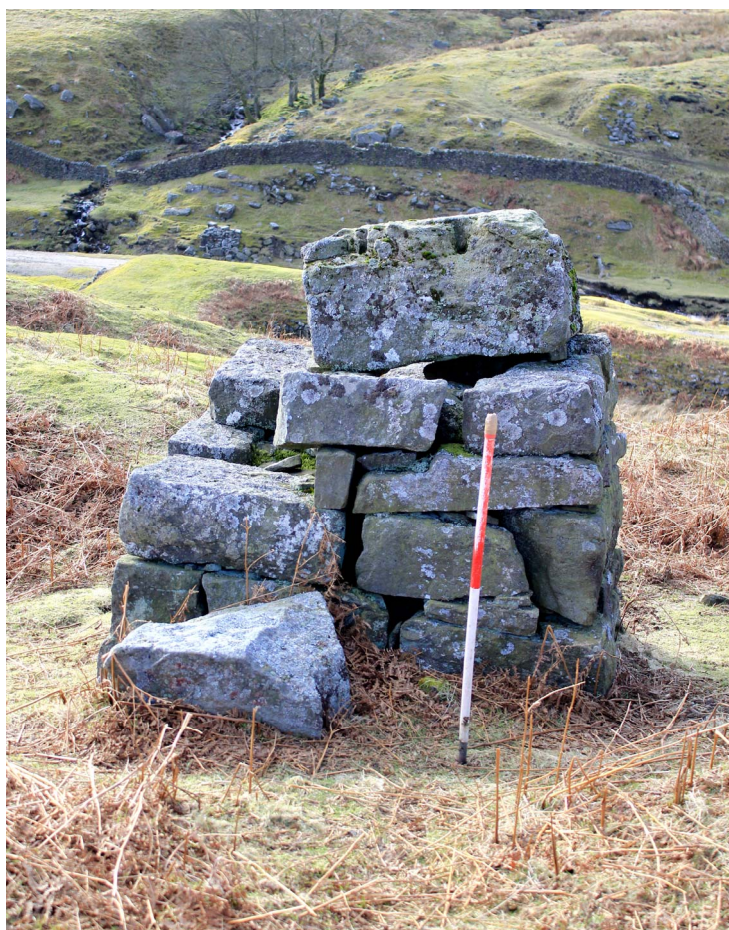
Plate 22: A square, stone plinth supporting the powered ropeway (Site **17.2**)

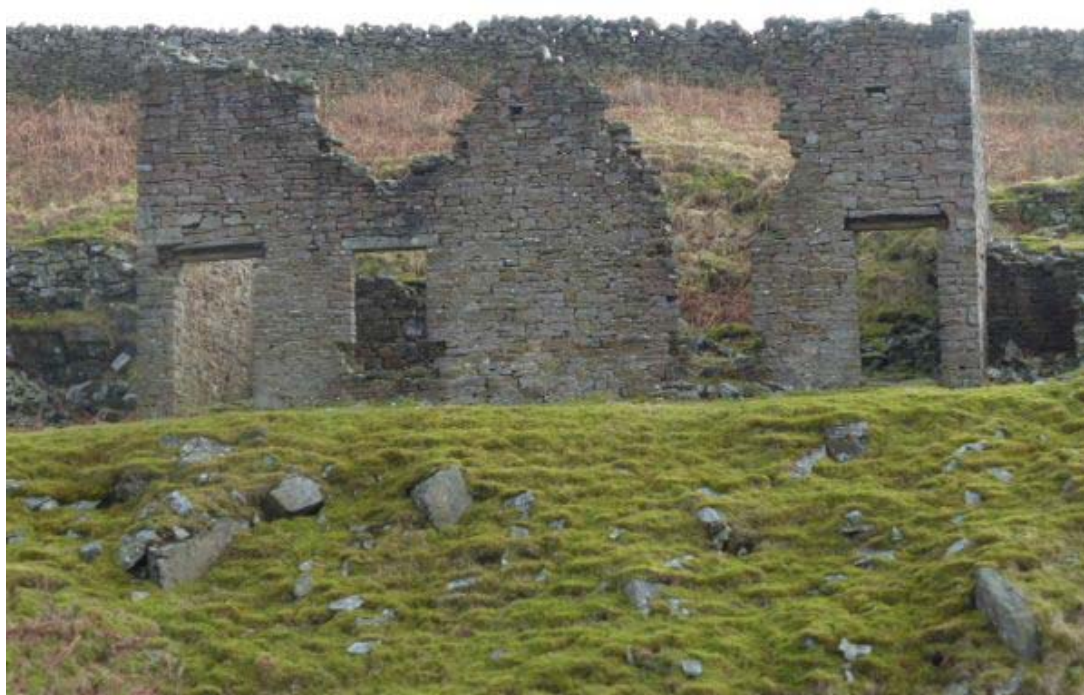
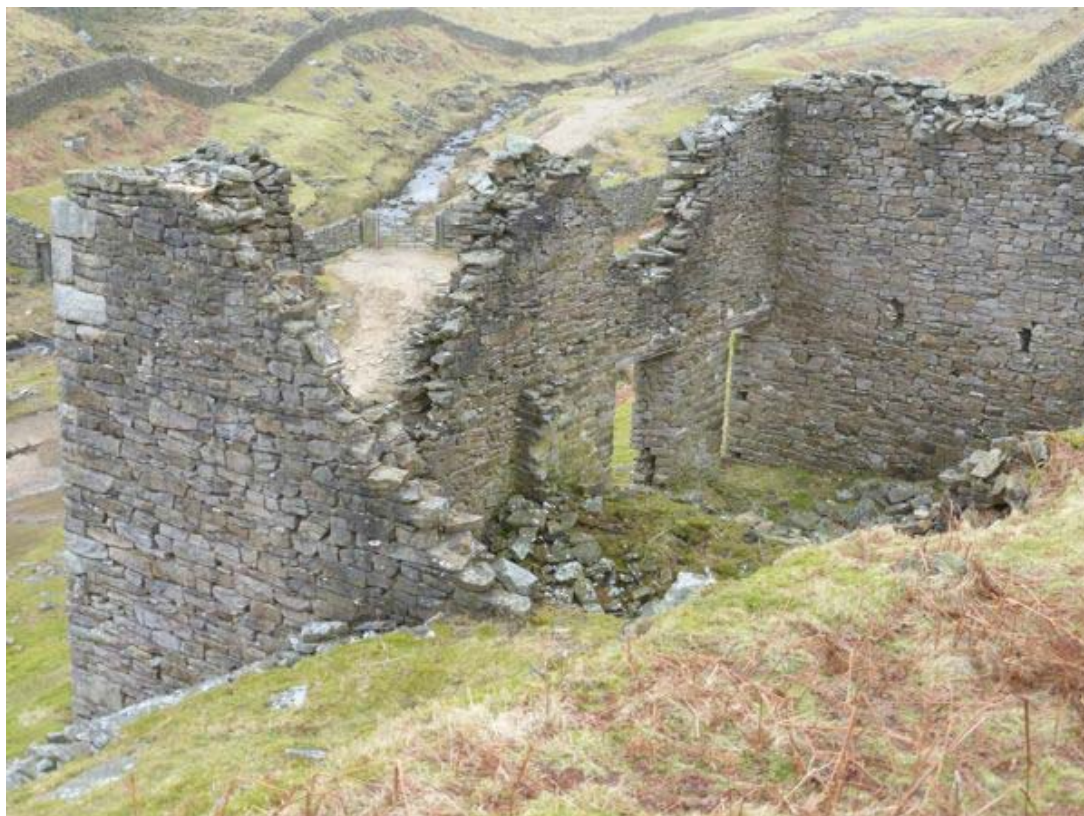
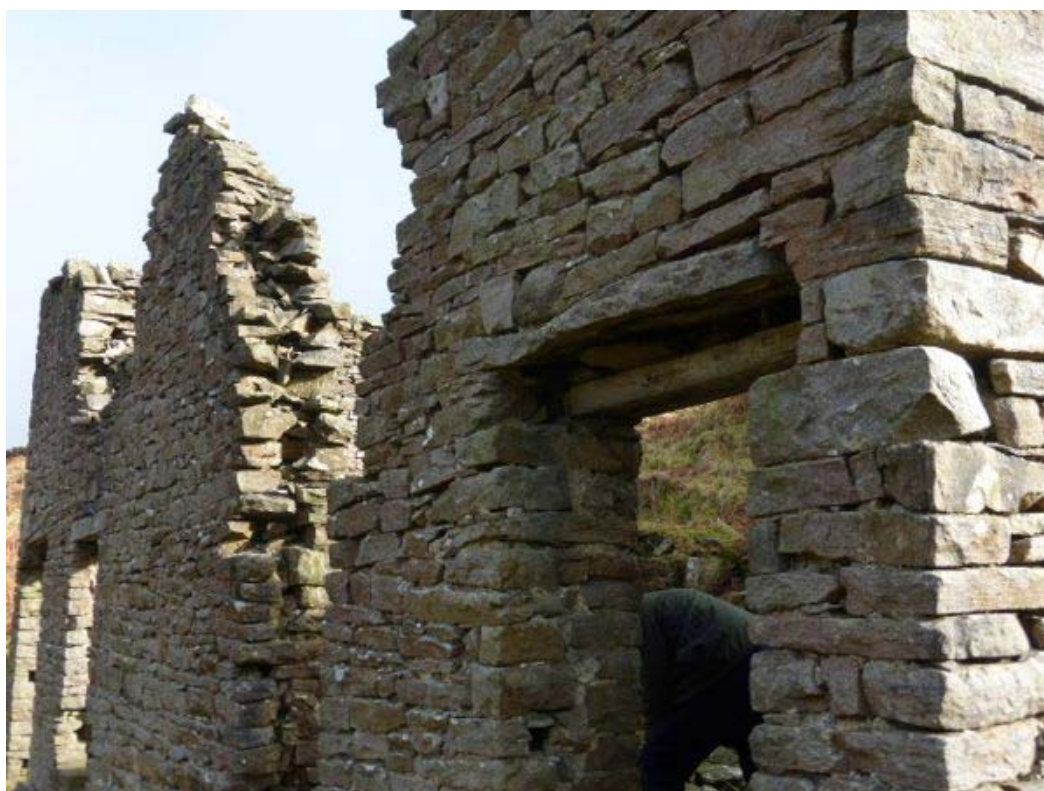
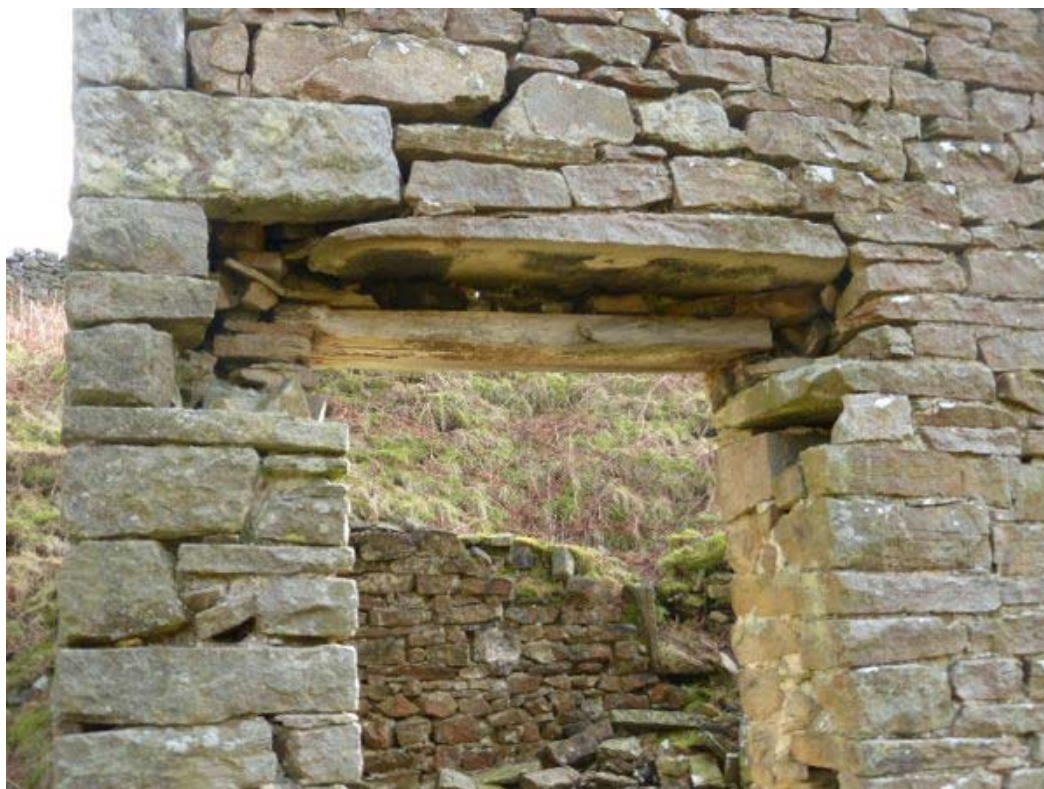
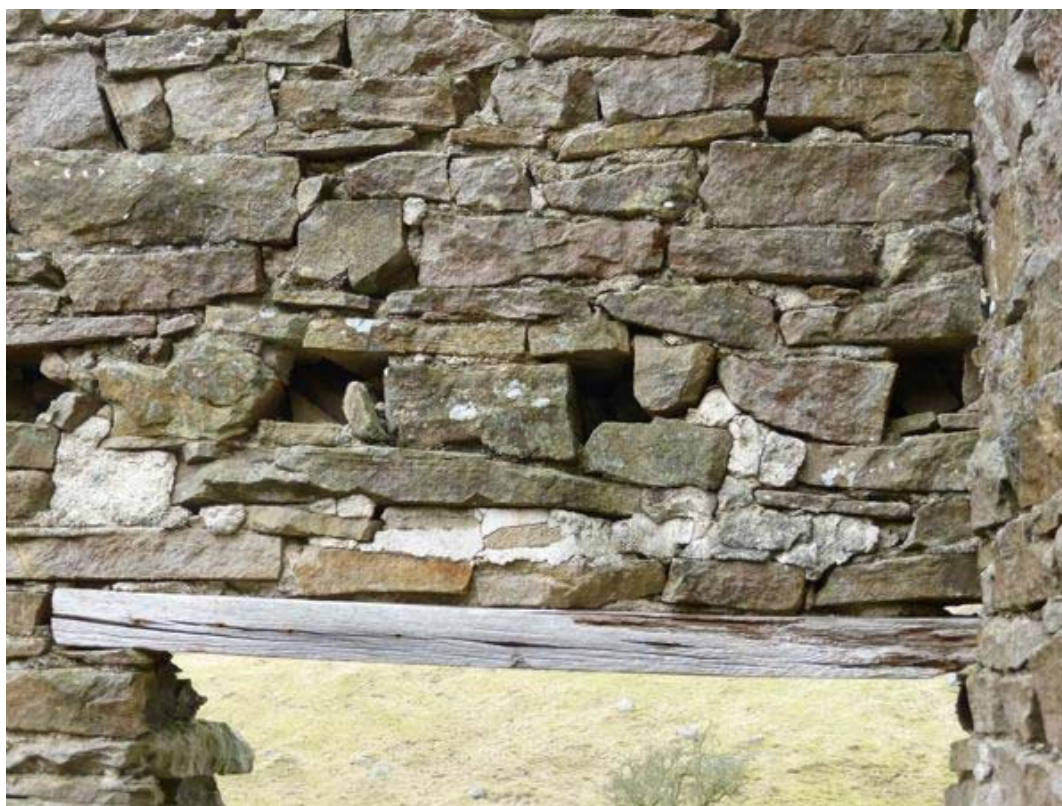
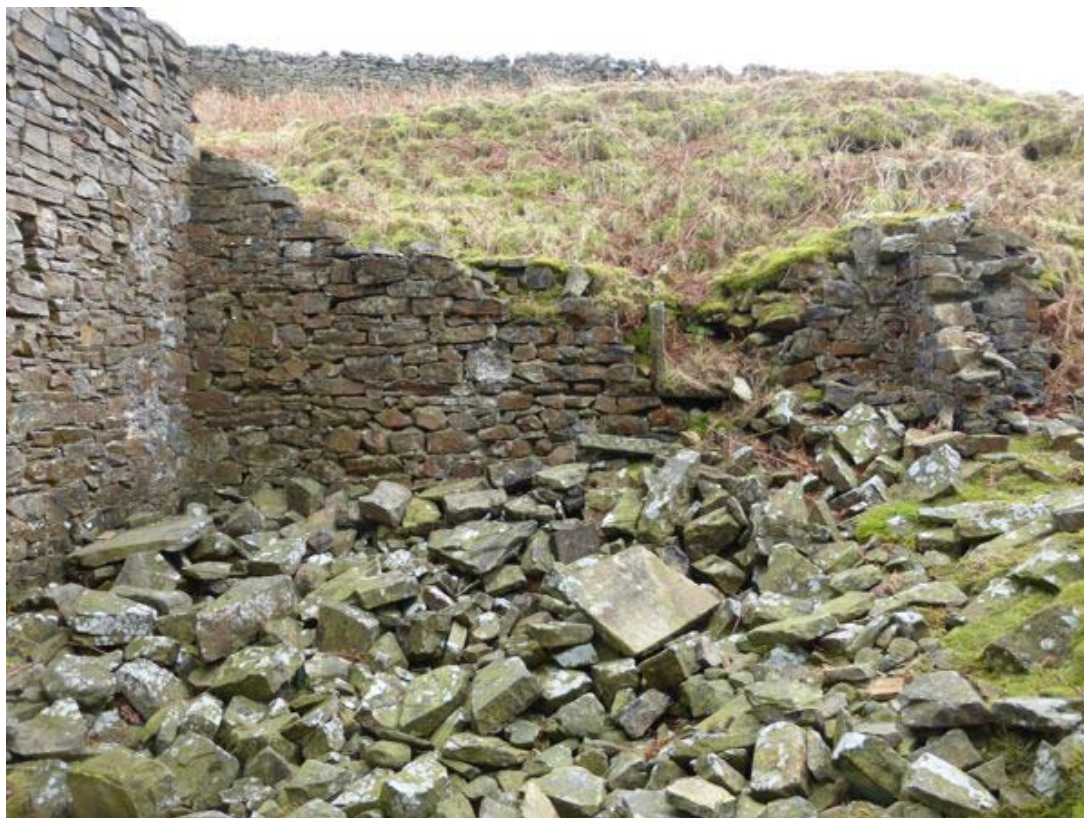
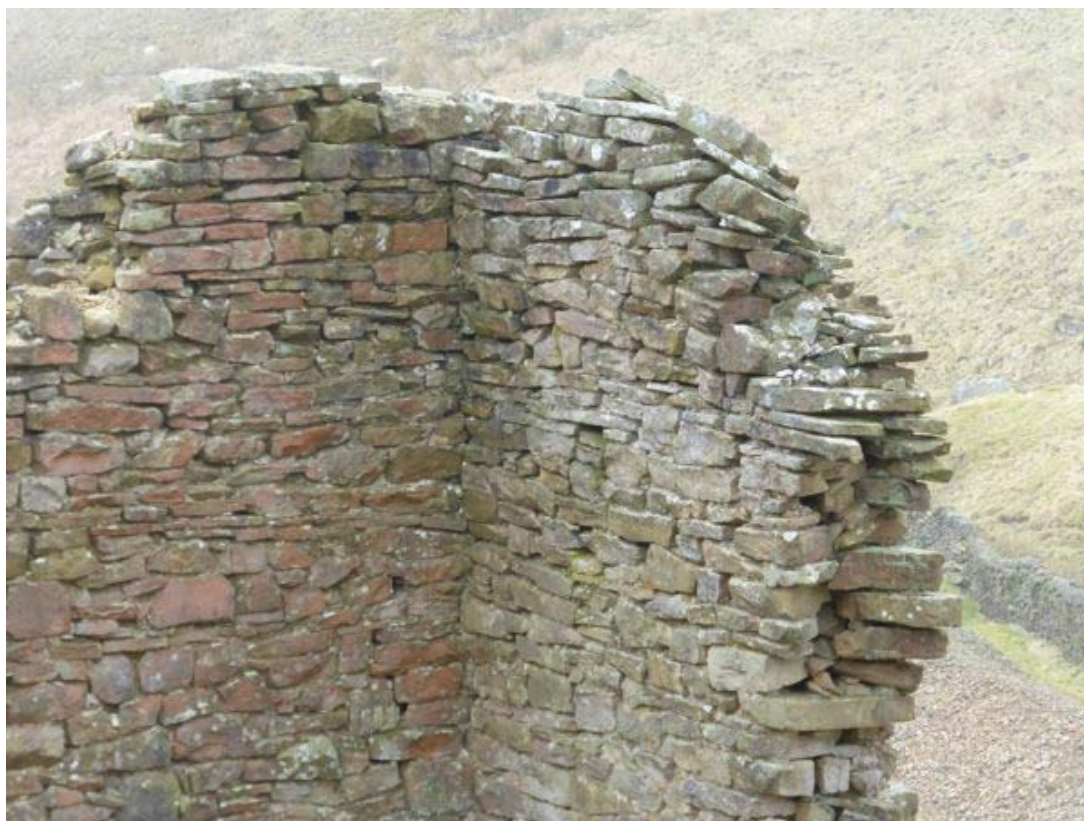
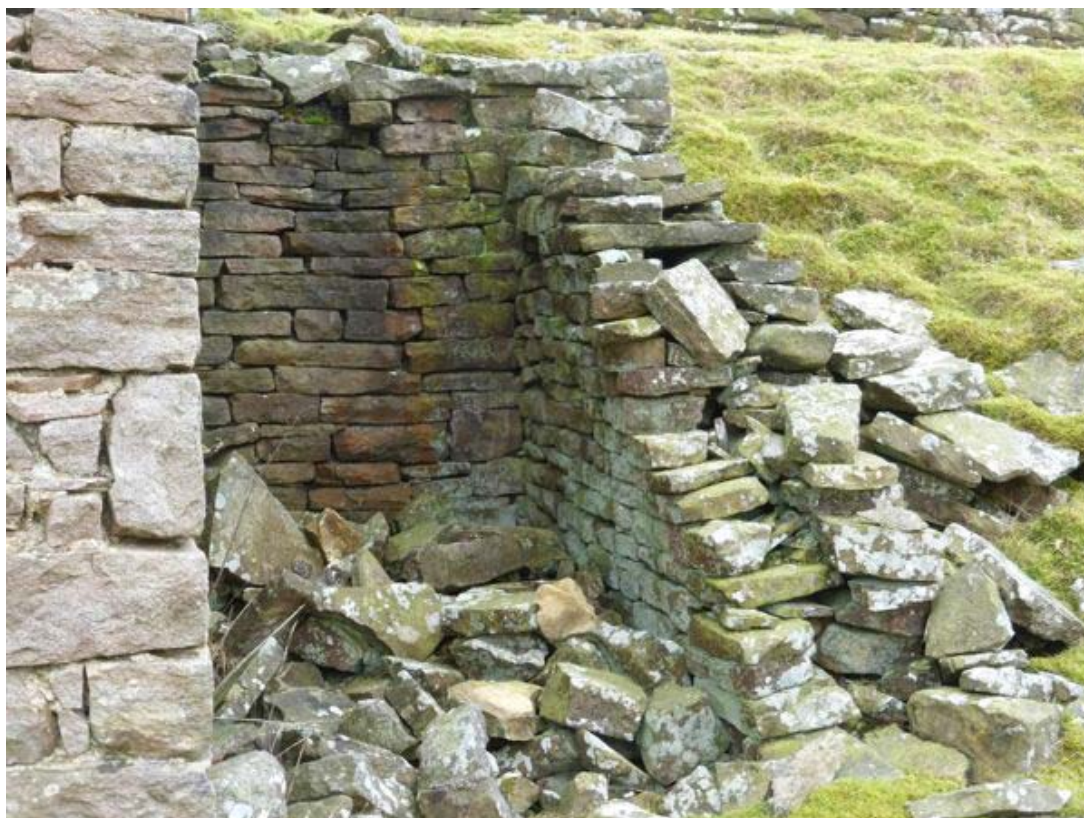
- 6.6.1 **Site Office:** the main cause of structural damage to the building has been the removal of stone window and door lintels, and timber decay in those that remain. Stone sills would be most appropriate provided there is not a risk of them being stolen, otherwise the lintels can be replaced in oak or concrete. The masonry walls that are standing are vertical and reasonably safe, but there is inevitably loose masonry on the wall tops (Plates 27-34).

Plate 27: Site Office Front Elevation

Plate 28: Site Office Interior

Plate 29: Office – Right-hand Door Lintel

Plate 30: Office – Left-hand Door Lintel – External

Plate 31: Office – Left-hand Door Lintel – Internal

Plate 32: Office – Interior Left-hand Cell

Plate 33: Office – Inside Front Right Corner

Plate 34: Office – Privy

- 6.6.2 For stability, it is recommended that a section of wall that has collapsed down to ground-floor window cill level is rebuilt. It is proposed that the window lintel is reinstated and some masonry above this rebuilt to give some structural continuity in the front wall.

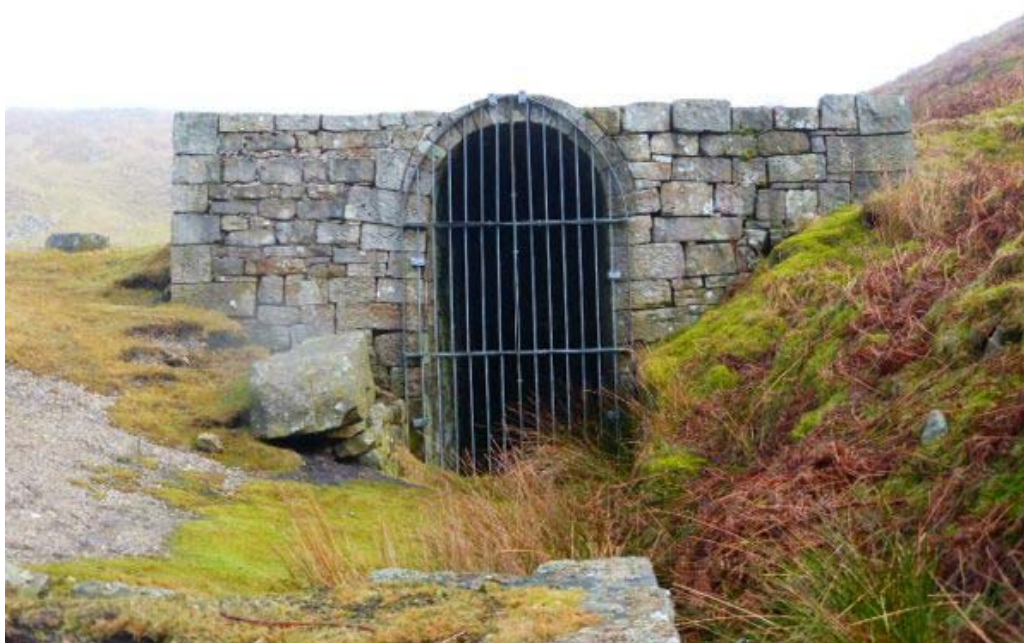
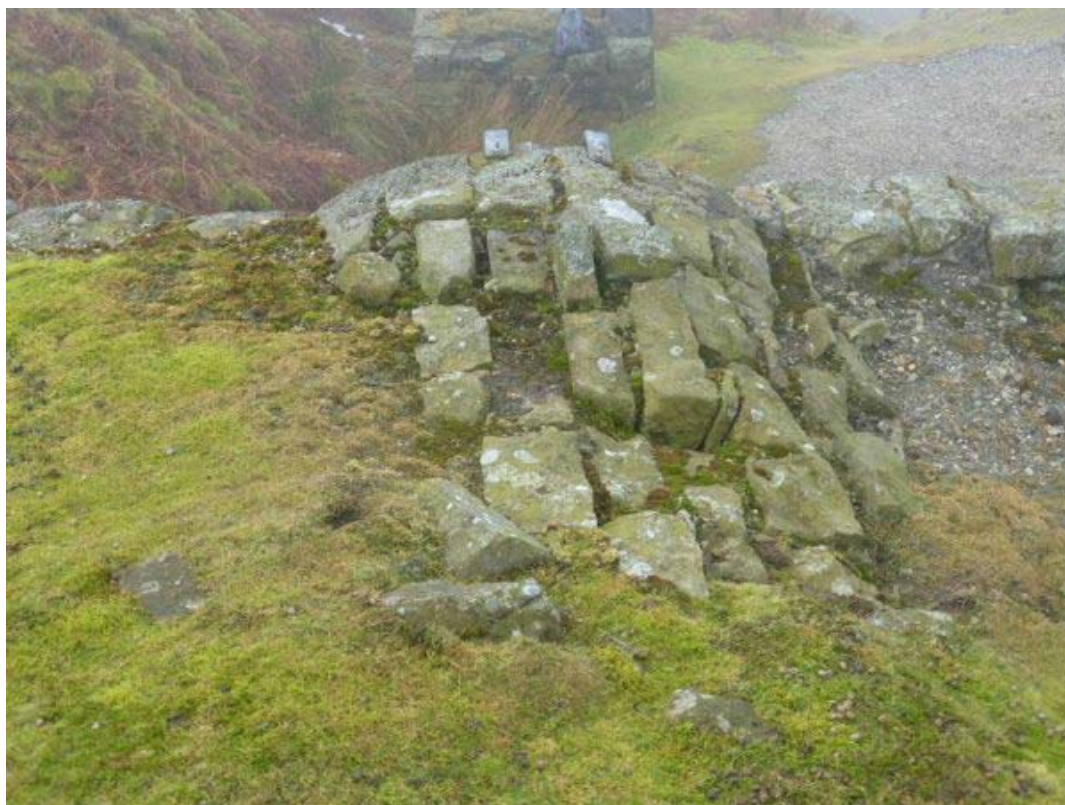
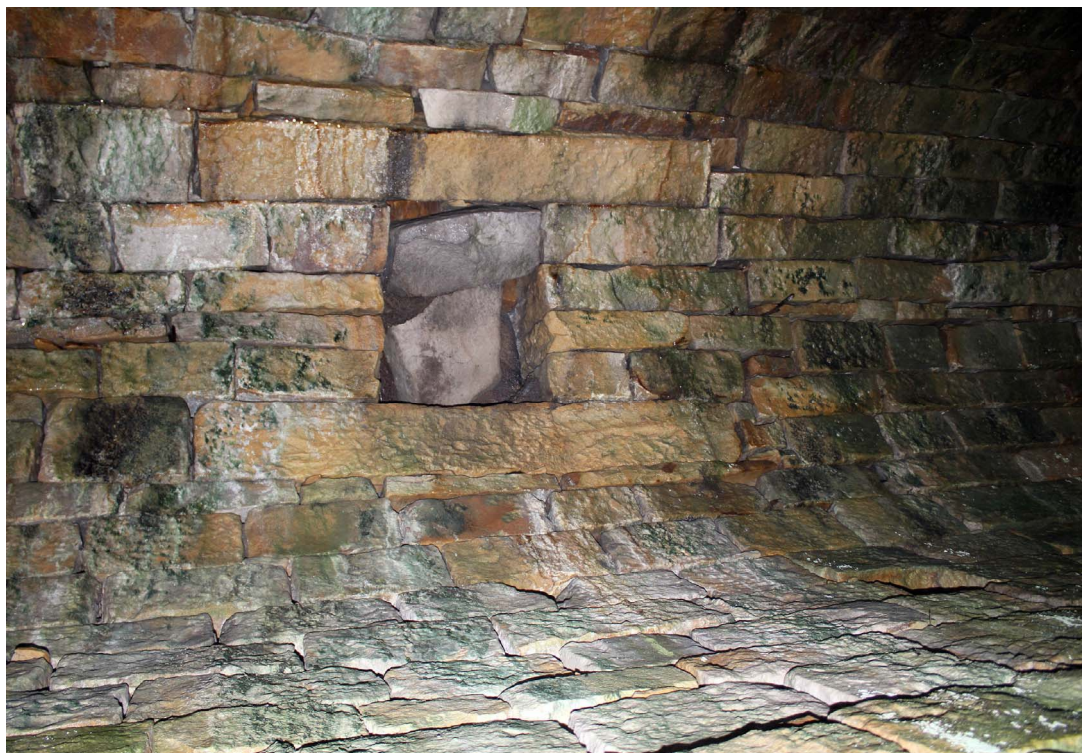
Plate 35: Engine Shaft Portal - Front Elevation

Plate 38: Engine Shaft Portal - Top of Vault

Plate 39: Engine Shaft Portal - Top of Vault

- 6.6.3 **Bolton Gill Engine Shaft Portal:** the only serious issue with the shaft head is a hole in the roof of the vault, approximately 400mm square. The purpose of this is not known, but it appears to be a formed hole and not just a collapse. The hole is blocked by rubble stonework of doubtful structural security, so it is recommended that a steel plate is fixed over the top of the hole, which should then be turfed over.

- 6.6.4 The top of the head wall should be consolidated, and the exposed vault stonework has a single loose voussoir. The vault should be packed with slivers of stone, and pointed from the top with lime mortar. The vault should then be covered with a layer of soil and turf.

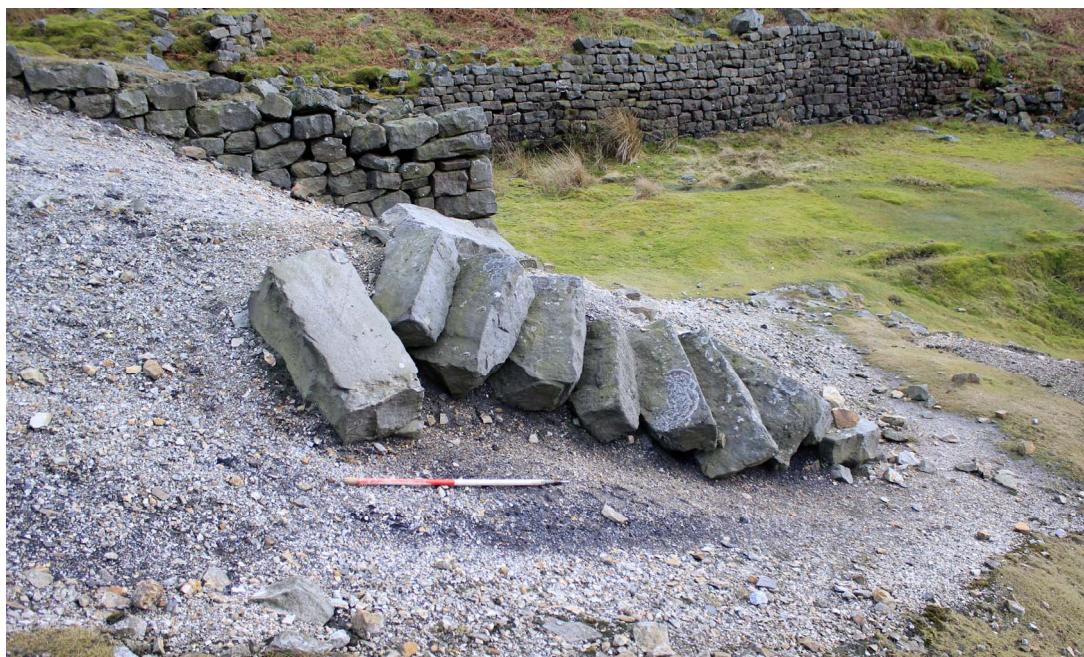
- 6.5.1 The dressing floor has a 20m long rubble masonry retaining wall on its south-east side, and a similar wall but in poor condition along its north-east side. At the west end of this, there is a collapsed flight of stone steps, built onto a heap of tailings which is gradually eroding away, taking the steps with it (Plates 40-44).

Plate 40: Dressing Floor – Collapsed Steps

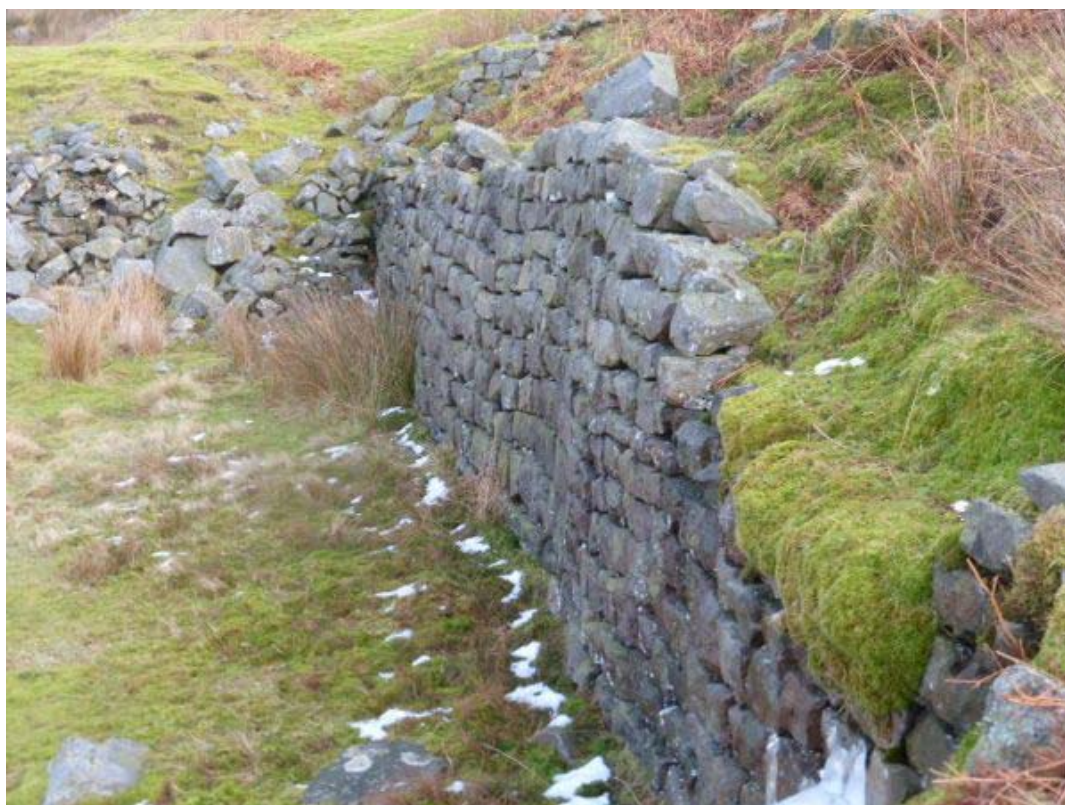
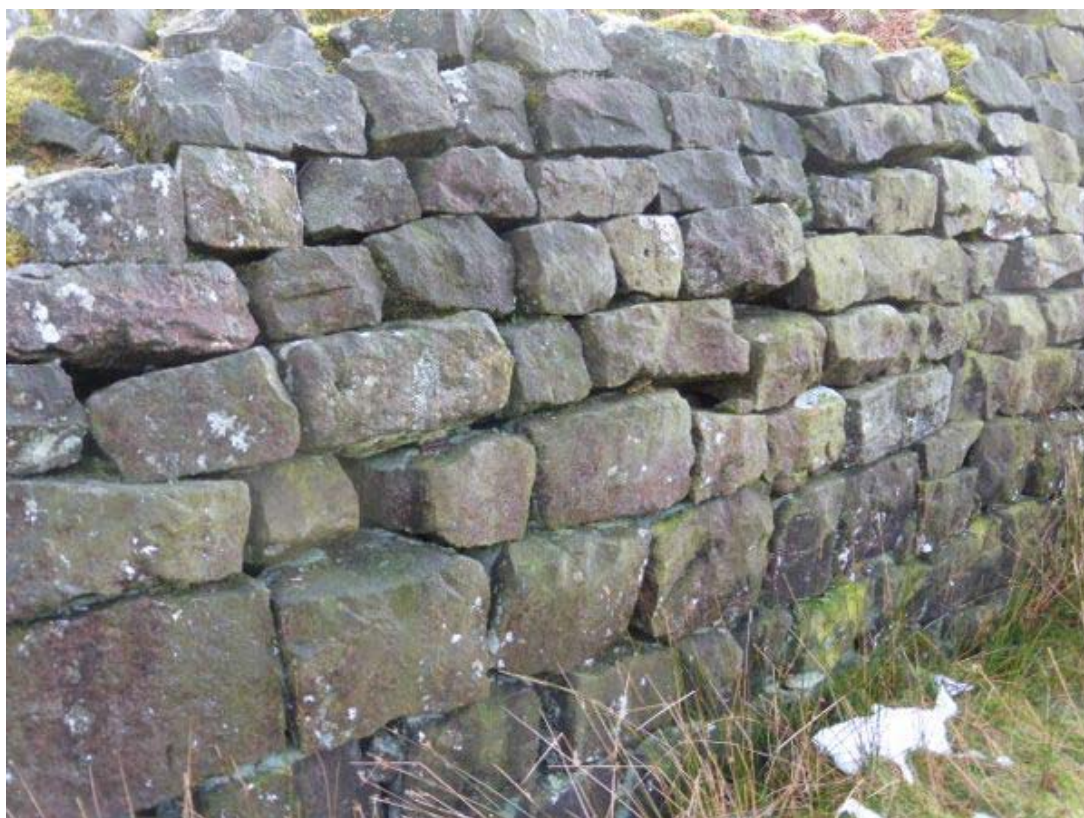
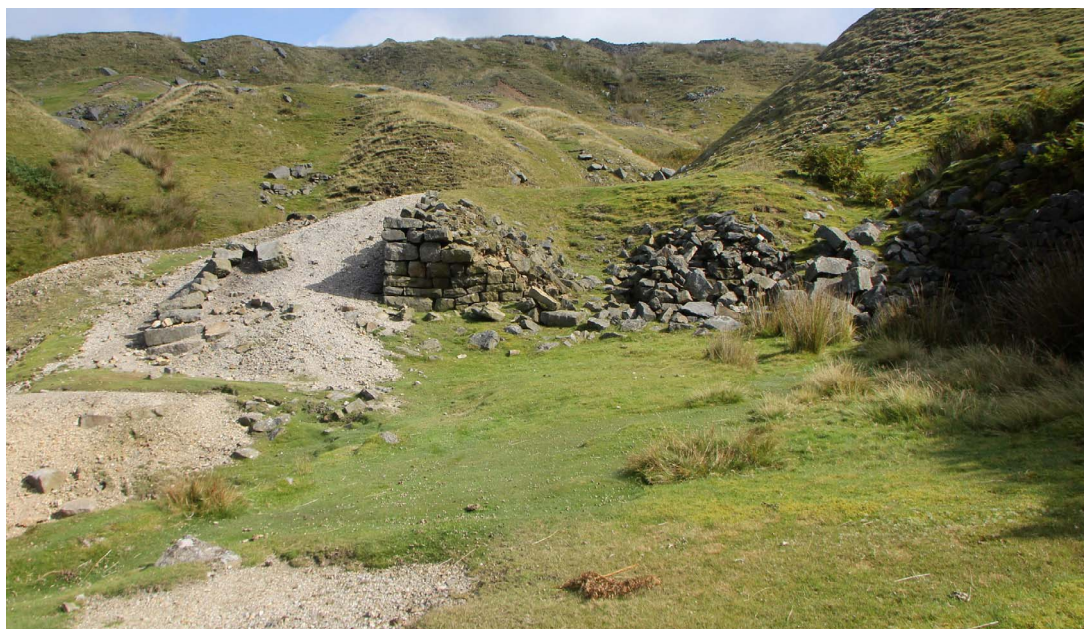
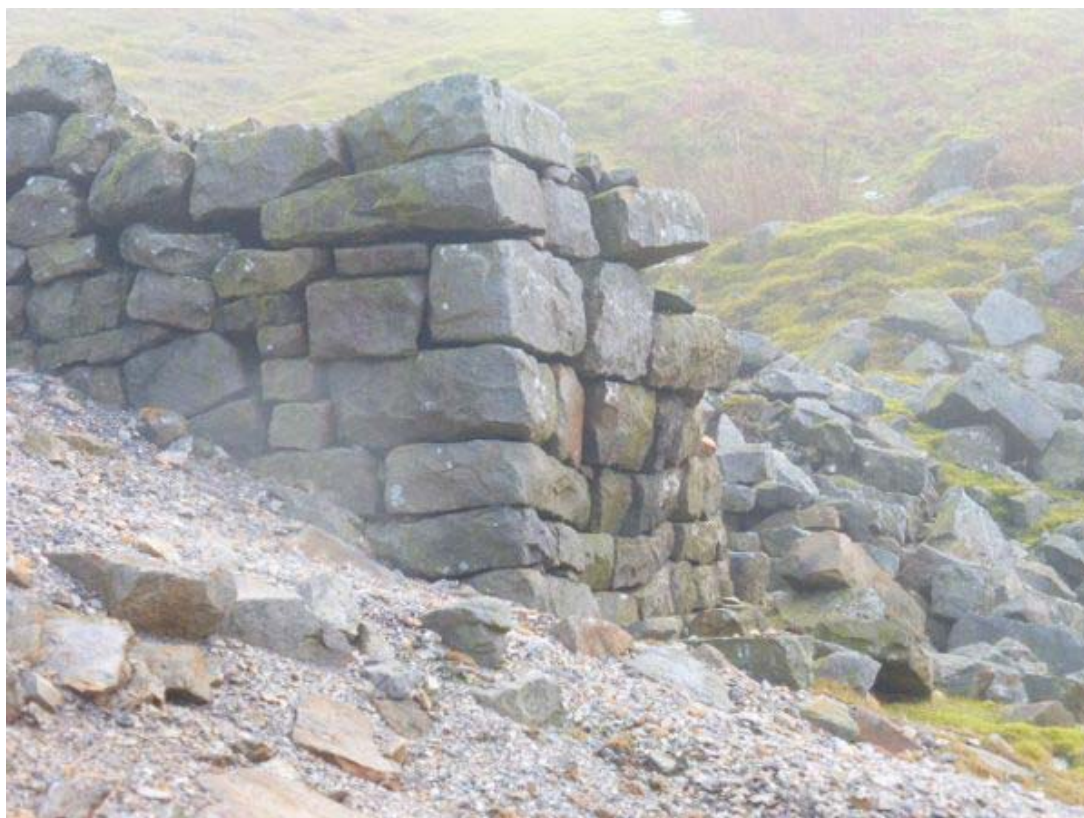
Plate 41: Dressing Floor – East Wall

Plate 42: Dressing Floor – Bulging Wall – (East Side)

Plate 43: Dressing Floor – North Wall

Plate 44: Dressing Floor – Collapsing part of North Wall
