Dairy Farm, Shepperdine South Gloucestershire

Historic Buildings Investigation and Recording

February 2018

Client: Horizon Nuclear Power

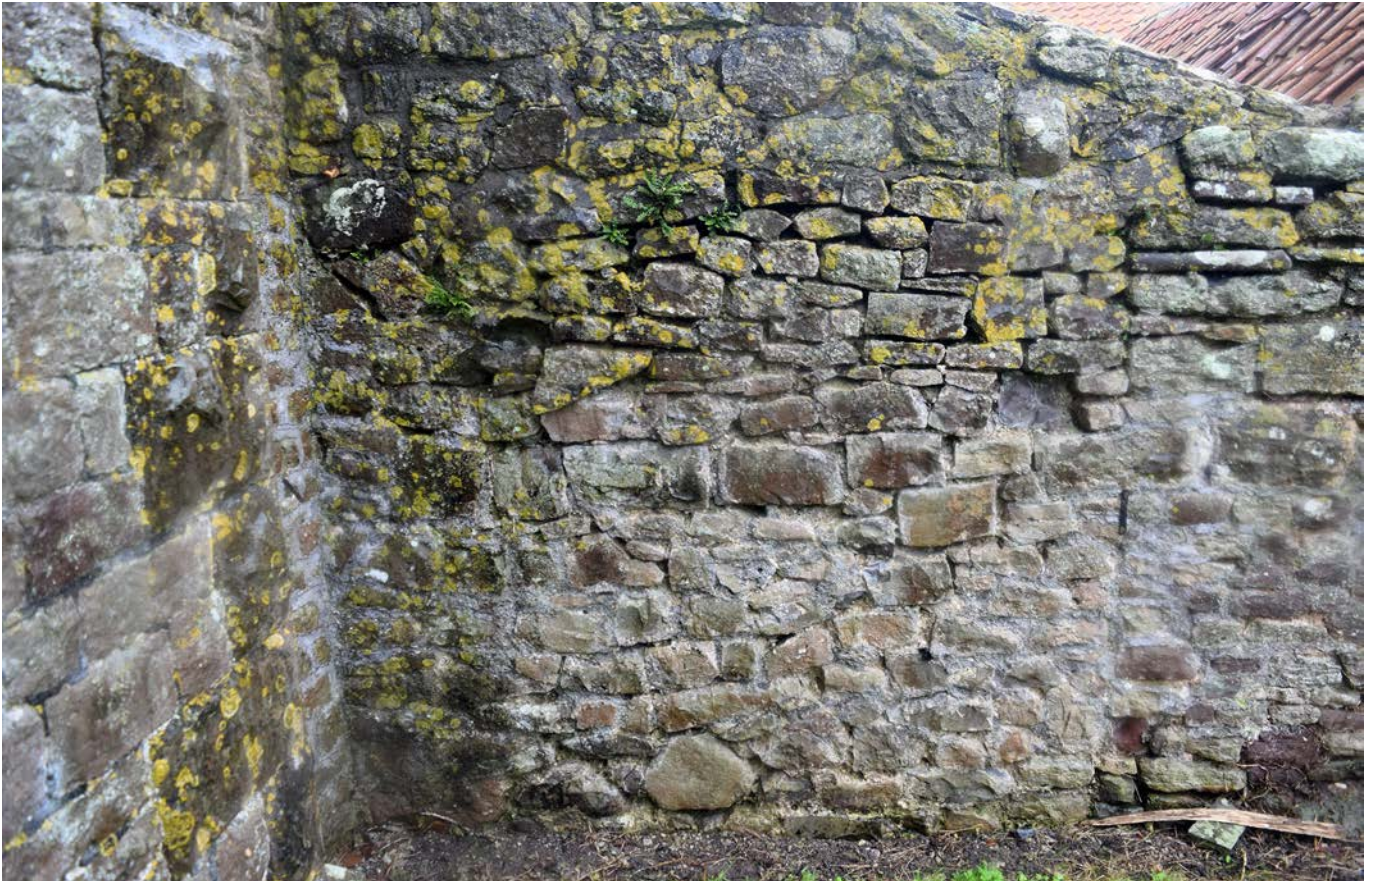
this meets the large abutting barn on the east side of the farmhouse. Closer inspection of this wall shows a butt joint suggesting an infilled opening (Plate 3). This indicates that there was once access between the lane and buildings to the immediate east of the farmhouse, and its façade.

Plate 3: Garden wall on the east side of the front garden of Dairy Farmhouse, looking east

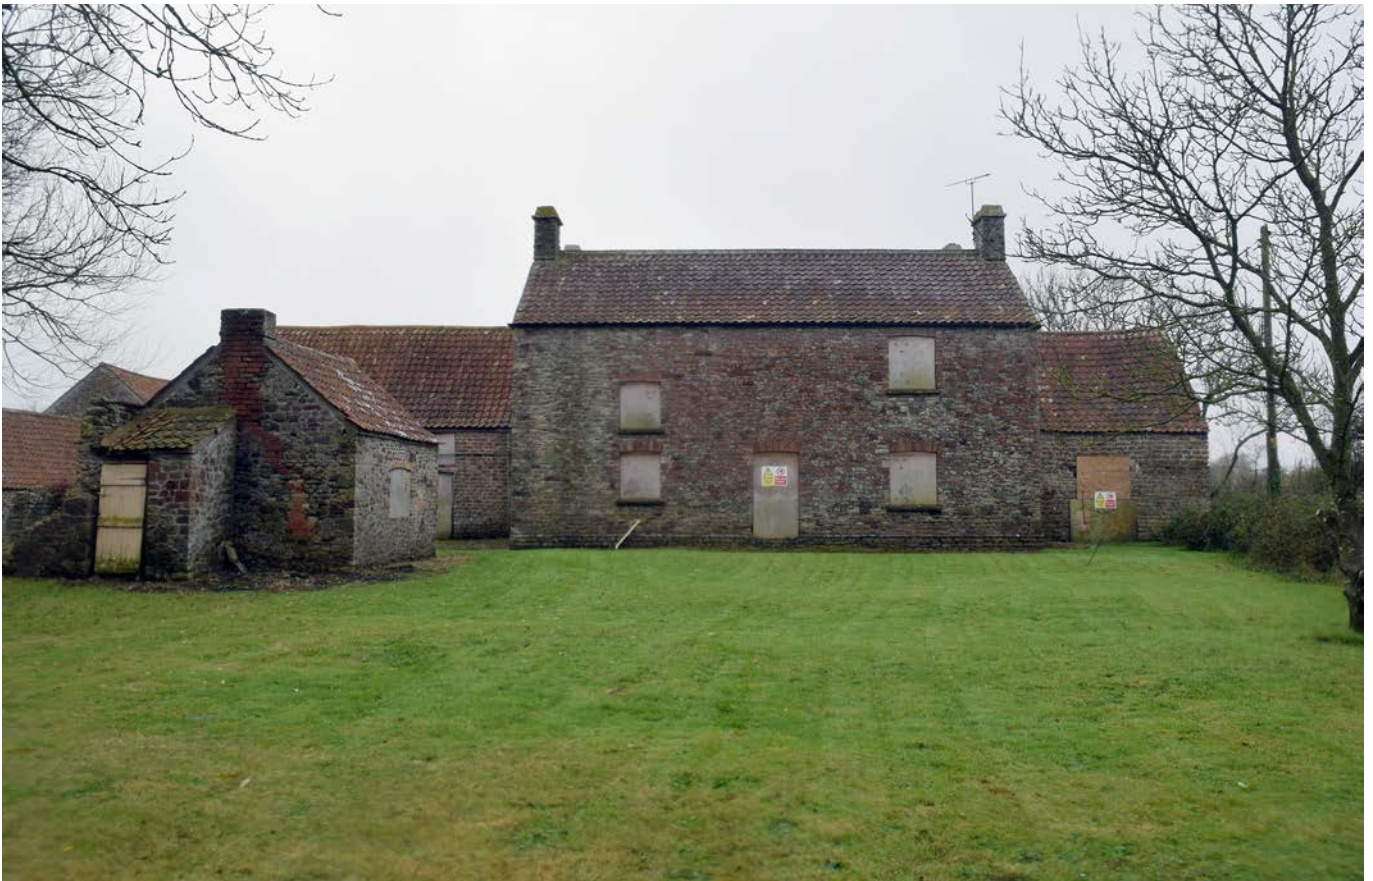
- 3.2.3 *The north elevation* (Fig. 9) The north elevation is the rear of the farmhouse and overlooks a large lawn (Plate 4). High up in the centre of the elevation is a small, stone plaque, bearing the date 1870 (Plate 5). The arrangement comprises a door opening in the centre of the ground floor with windows to each side at ground and first floor levels. The sills of the windows are stone slabs but, unlike the south elevation, there is no quoining and the lintels of the openings are segmental, red brick arches. This elevation is notable for the position of the first floor window on the east side (the window in the north wall of the north-east first floor room). It is lower than that on the right hand side, and sits at floor level of the first floor. This is the exterior evidence of the alternative function of the north-east spaces of the house, which are likely to have been used in a production capacity for the farm rather than servicing the domestic house (See 3.3.13 and 3.3.24). Like the south elevation, a plinth runs across the foot of this elevation and it was observed that original paving remains in front of this. A gully that runs under the eaves of the pantile roof is plastic for the most part but joins an older iron gully towards the west side.

Plate 4: North elevation of Dairy Farmhouse, looking south

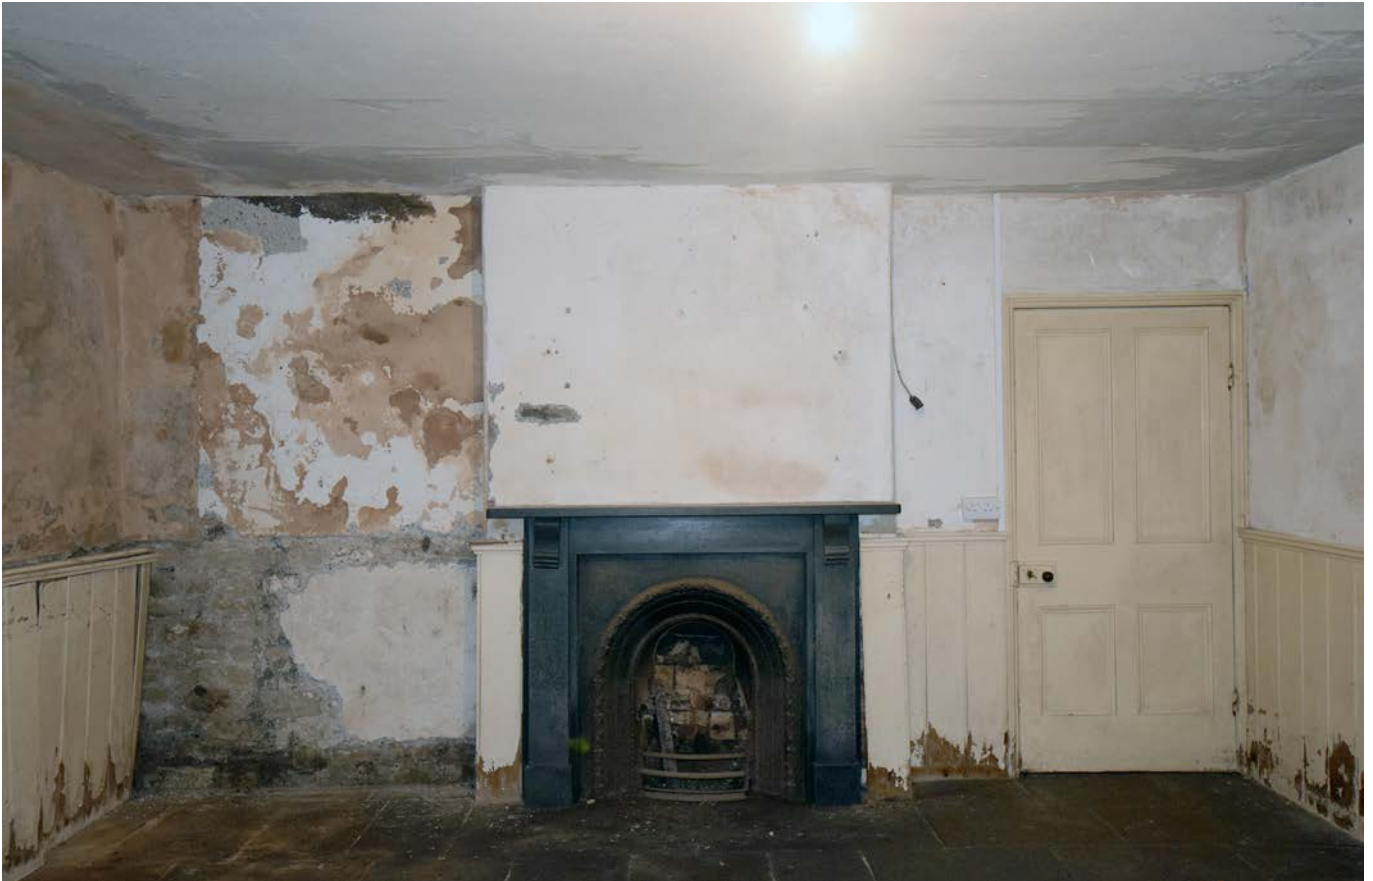
Plate 13: The south-west ground floor room, looking west

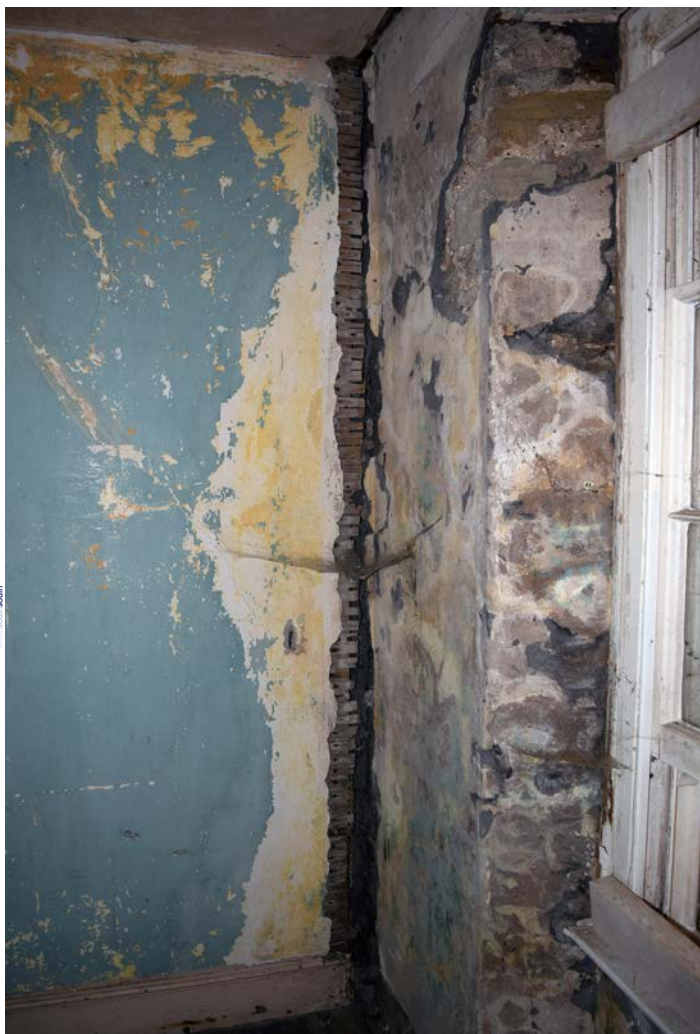
- 3.2.27 Like the south-east room, due to dampness issues, there is a large crack between the interior dividing east wall of the room and the south façade of the house, which forms the south wall of the room exposing laths behind the plaster of the internal partition wall (Plate 34).

Plate 34: Crack in the south-east corner of the south-west bedroom

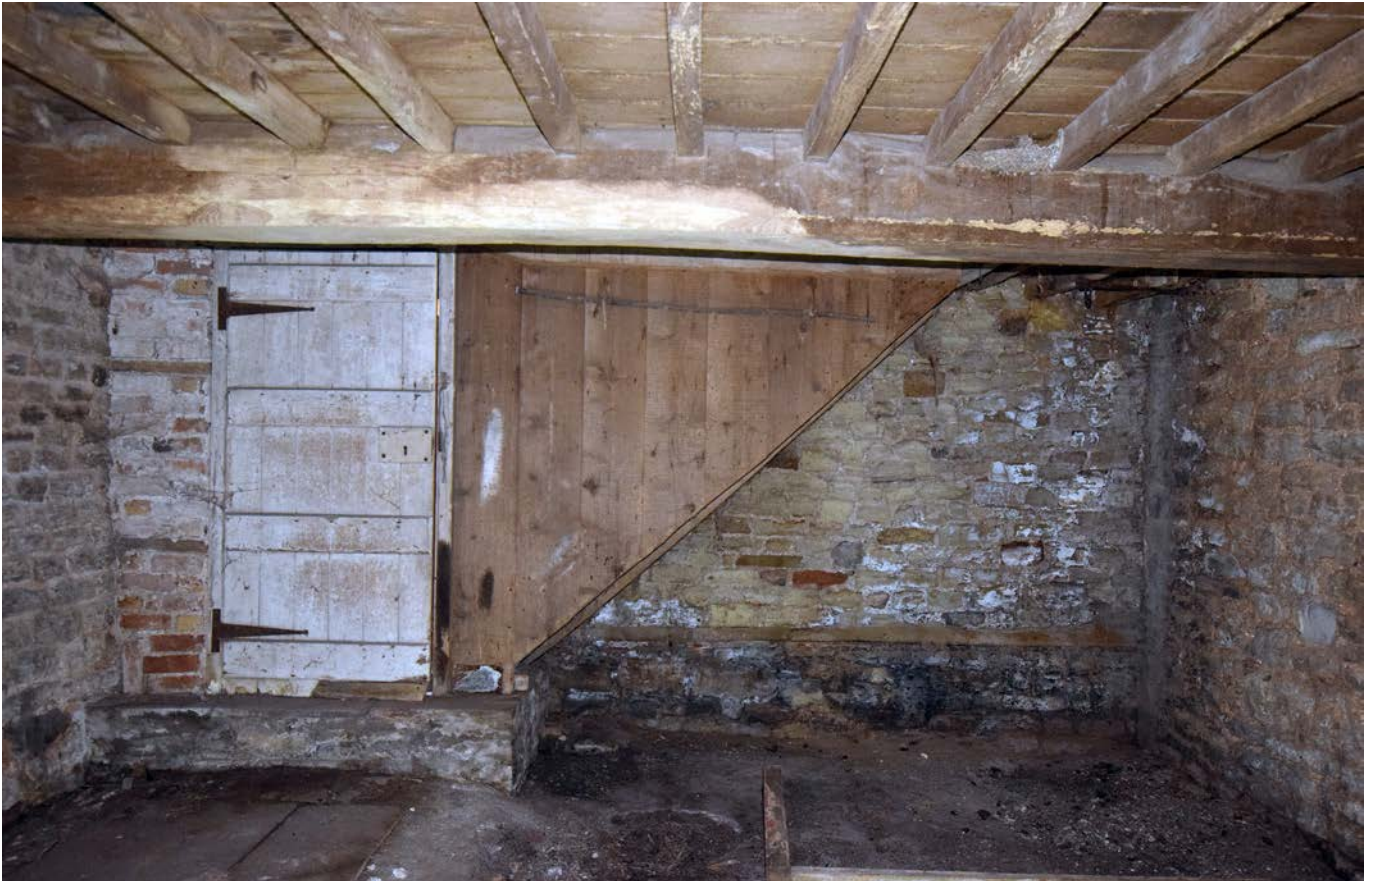
wooden frame on its west side, providing access to the ground floor. The ground floor is an open space, largely devoid of features, except for the boarded stairwell and the plank and batten door of the stairwell on the east side (Plate 51). From here, it can be observed that the antechamber is built on a square, stone plinth and its wall is of red brick, suggesting that it is a secondary addition. The floor is partially paved with flagstones (Plate 52), which are laid on the central axis between the doors on the north and south sides and from the north end to the door to the antechamber on the east side. The floor between the ground level and the attic comprises two huge beams running north to south, housing 12 joists, and supporting boards running north to south. The strength of this structure suggests that its original purpose was to hold a substantial weight at attic level.

Plate 51: The ground floor of the annex, looking east

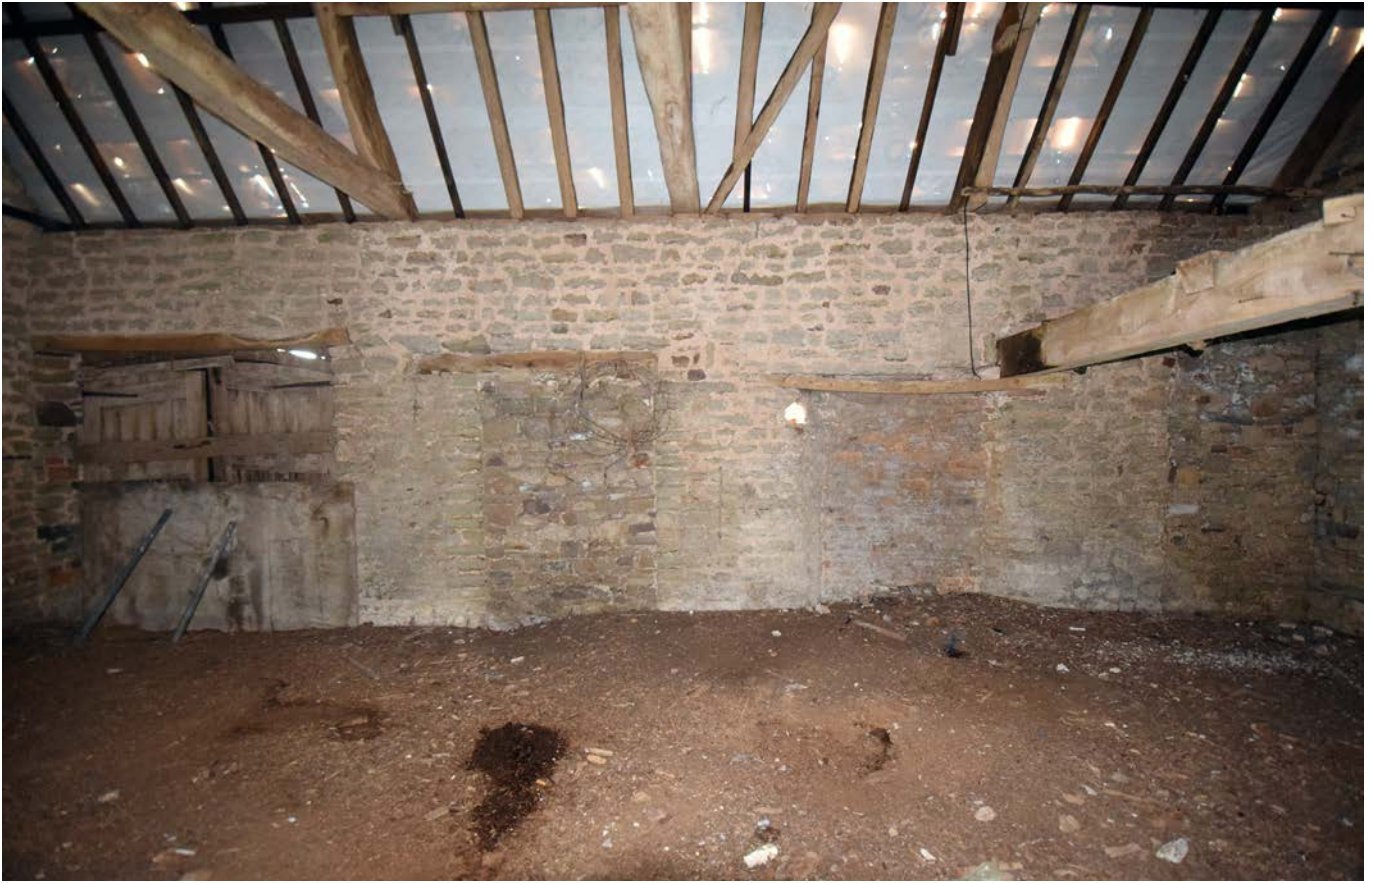
- 3.3.8 The interior of the barn is a large open space (Plate 57). From the interior, the timber lintels of the openings in the south wall can be seen and the splayed opening of the doorway to the west can be observed. The large doorway on the east side has an older,

Plate 57: The interior of the barn, looking south
