Moss House Farm, Cockerham, Lancashire

Archaeological Building Investigation

Oxford Archaeology North

September 2009

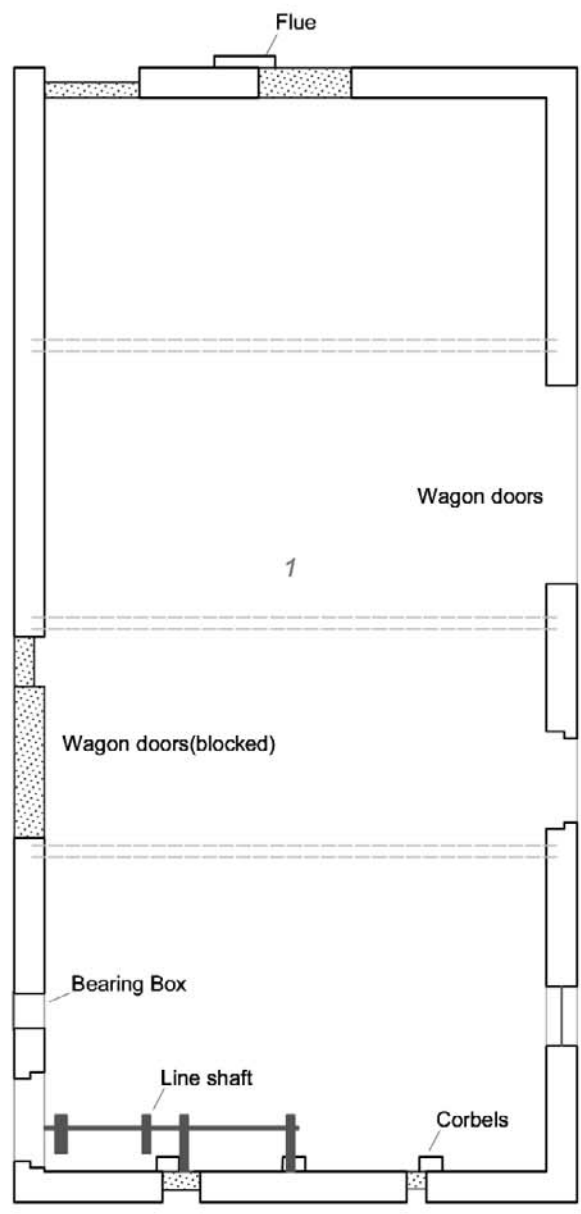
Figure 7: Ground floor plan of Barn A

- 4.3.3 Of particular interest is the lineshaft, complete with two pulley wheels, on the upper reaches of the south wall (Fig 7). This is secured by means of a bearing box within the west wall, and a pair of brackets on the south wall. Apart from the bearing box to the right of the door on the west elevation, there is no other

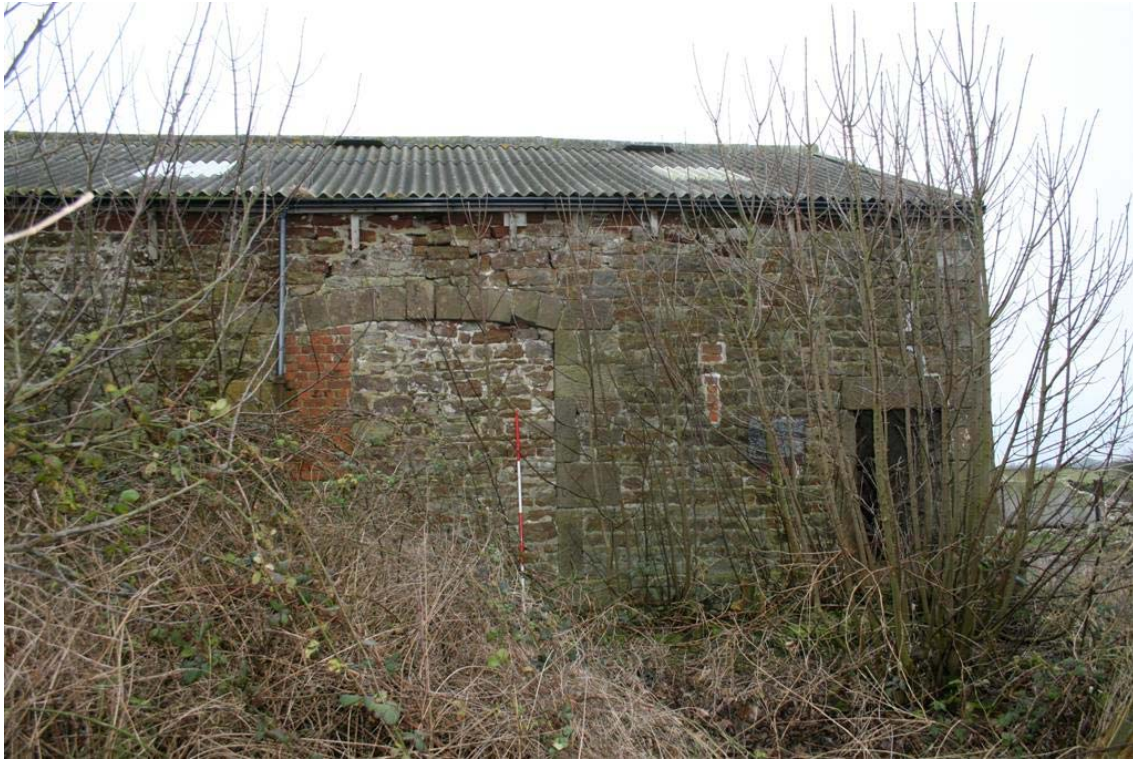
4.2.1 The barn is constructed from squared red sandstone, which is roughly coursed, and which is bonded with lime mortar, and dressed with roughly fashioned quoins (Plate 1). The stone is, for the most part, bare, but the north end of the east elevation shows substantial evidence of an earlier lime wash, whilst the corner itself has been heavily repaired with cement (Plate 2). The reason for this becomes apparent on the adjacent north elevation, where the corner is similarly rendered with the same cement. In addition, the upper section of the corner is rendered with a second patch of cement, but brick repairs are partially visible below the eaves. Similarly, on the corner to the right of this elevation, there is a crude rebuild of brick at ground floor height, with a cement render beneath the eaves.

Plate 1: West-facing elevation of Barn A and the farmhouse

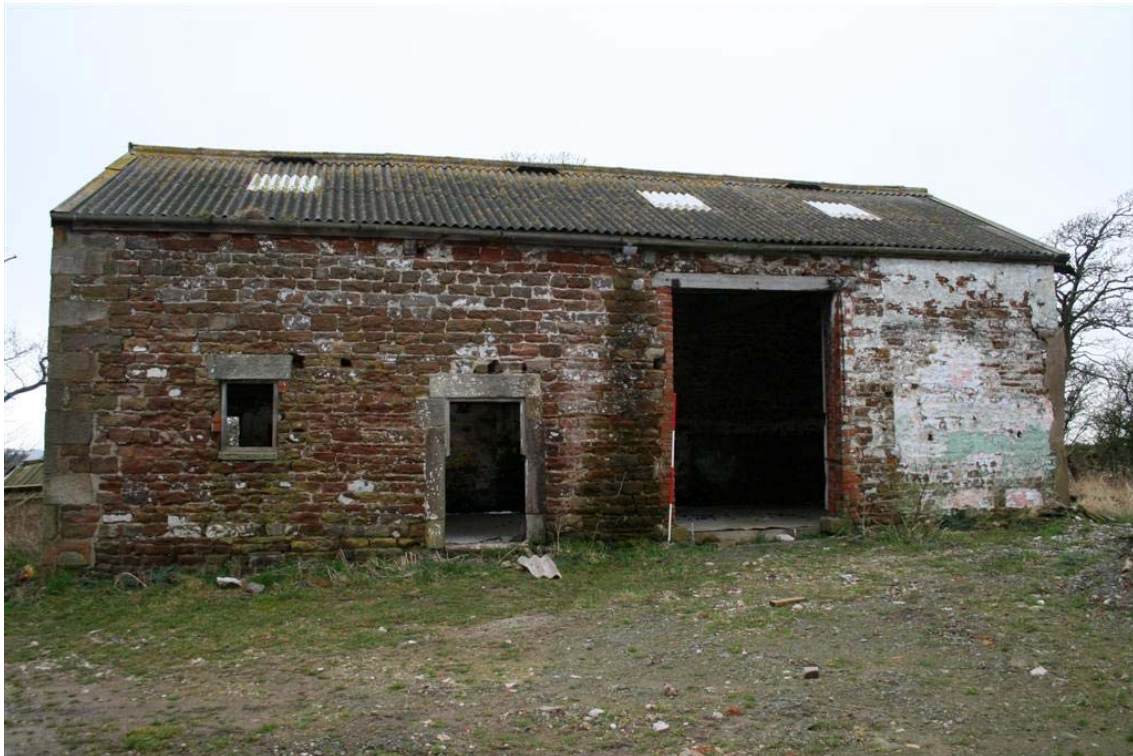
- 4.2.5 The window on the east elevation is a plain open aperture, which has a roughly fashioned stone lintel, projecting sill and timber frame (Plate 2). No quoins are present, but several of the stones in the jambs have evidently come loose and have been crudely replaced with inserted red brick (Plate 5). On the rear of the barn, the inserted window within the former wagon door has been blocked with brick, and judging by the similarity in brick, it would appear that this window was blocked at a similar time to the repairs on the north elevation.

Plate 2: East-facing elevation of Barn A

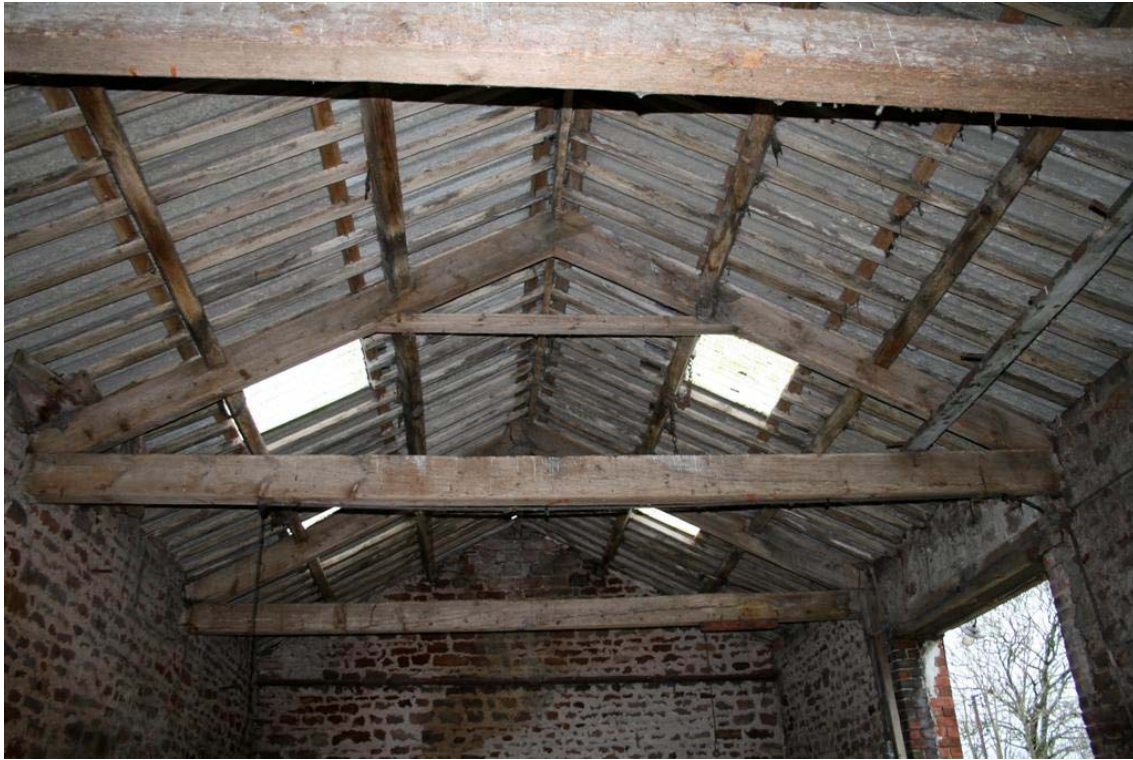
- 4.3.2 The roof is supported by a series of three roof trusses, each comprising a tie-beam and collar brace (Plate 3). The tie-beams are housed within sockets set in the walls. A pair of trenched purlins is present on each slope of the roof. The rafters and slates above are visible, and there are also a number of skylights.

Plate 3: Roof truss in Barn A

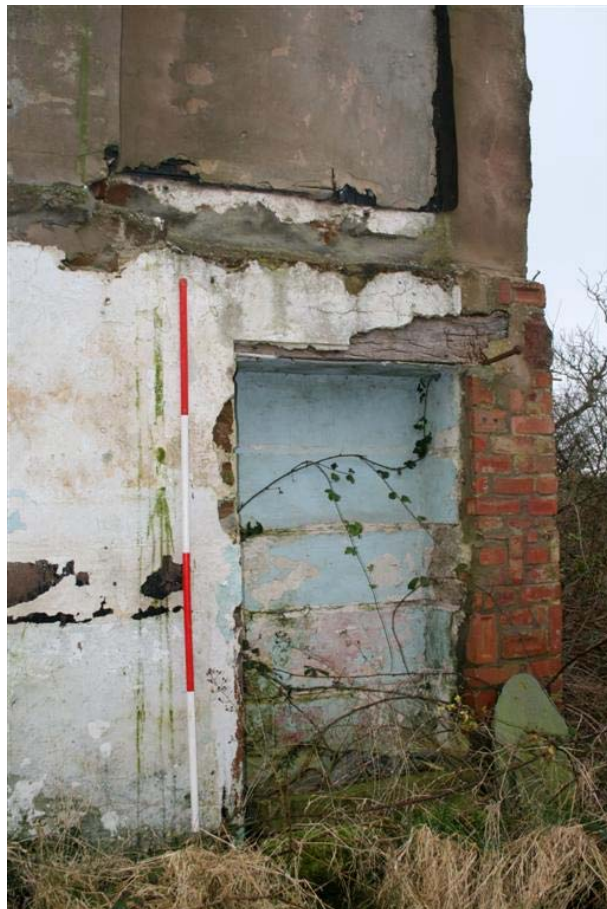
contain the pin sockets of the former harr-hung doors. Moreover, there is little evidence of the head of the doorway having been remodelled, and as such, it is likely that this represents the original design of the doorway. To the left of the wagon doors, is a probable heck-door, though it is now an empty aperture dressed with a rock-faced lintel and quoins of sandstone. On the rear (west) of the building, there is a former wagon doorway featuring a substantial segmental arch with pronounced keystone and quoins (Plate 1). The more elaborate nature of this surround suggests that this may have been the original front elevation of the barn, bearing in mind that the farmhouse originally stood to the immediate south-west. To the right of the doorway, there is a further probable heck door, which is again now an empty aperture dressed with a rock-faced lintel and quoins. To the immediate left of this is a bearing box, which is now covered by a rusted steel plate. This bearing box overlies an overgrown stone plinth, which could conceivably have been the machine base of an engine. In addition, at the north end of the building, there is a probable blocked door, which appears now as a recess within the rendered stonework and brick repairs (Plate 4).

Plate 4: Door on the north facing elevation of Barn A

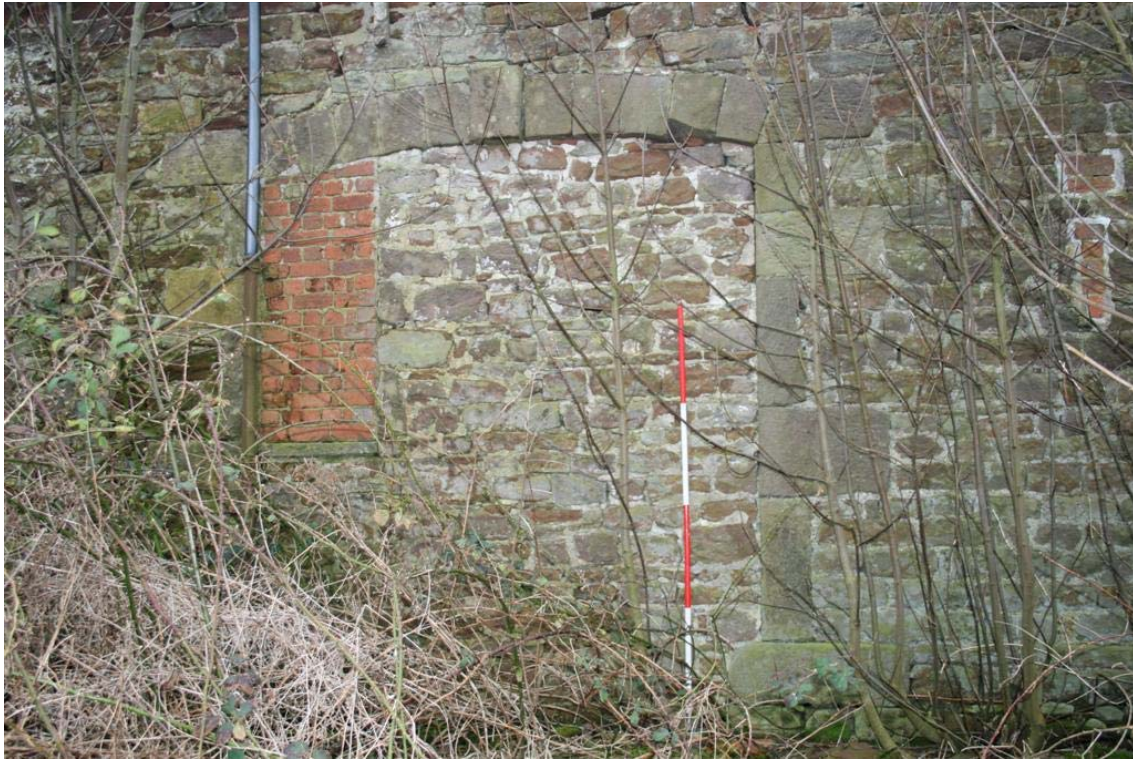
Plate 5: Blocked door and window on the west facing elevation of Barn A

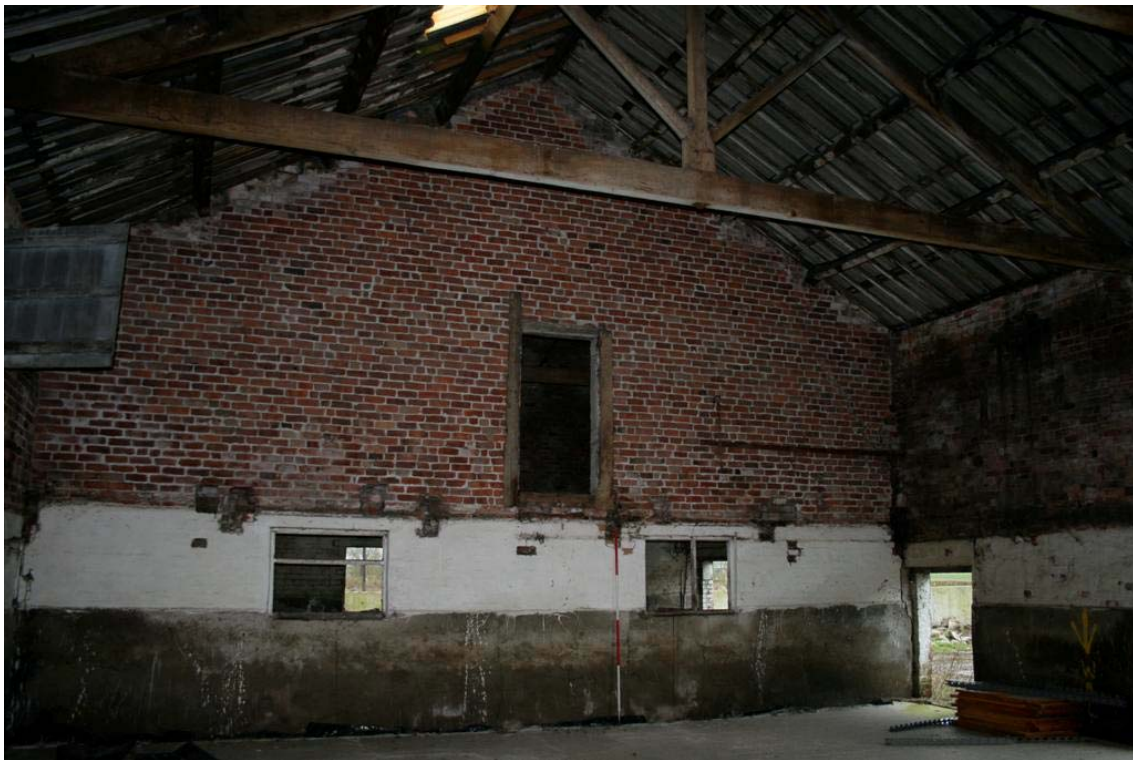
- 4.5.2 At first floor height within *Area 1*, there are pair of hayloft doors (Plate 6). The door on the east elevation is a small ledged matchboard door (Plate 8), which overlies the cattle stalls in *Area 3*, whilst the door on the south elevation is a full-sized doorway with timber lintel, which would have originally provided access to the hayloft in *Area 2* (Plate 7).

Plate 6: Area *I* of Barn B

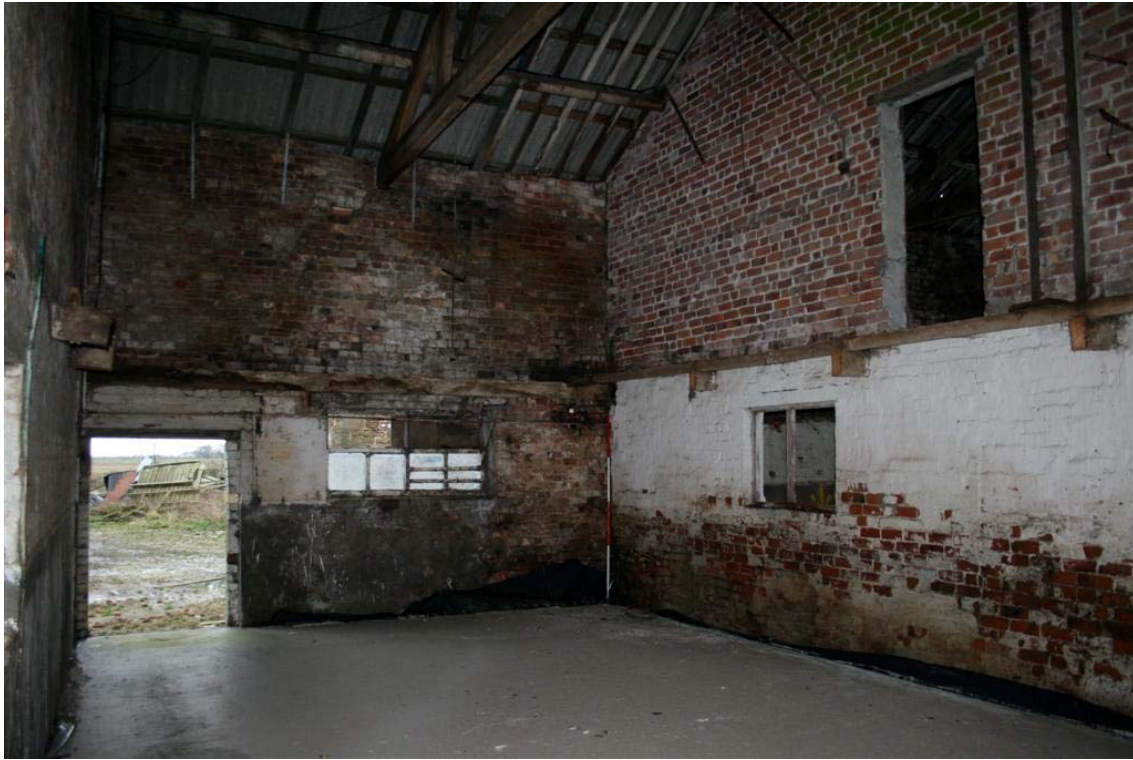
Plate 7: Area 2 of Barn B

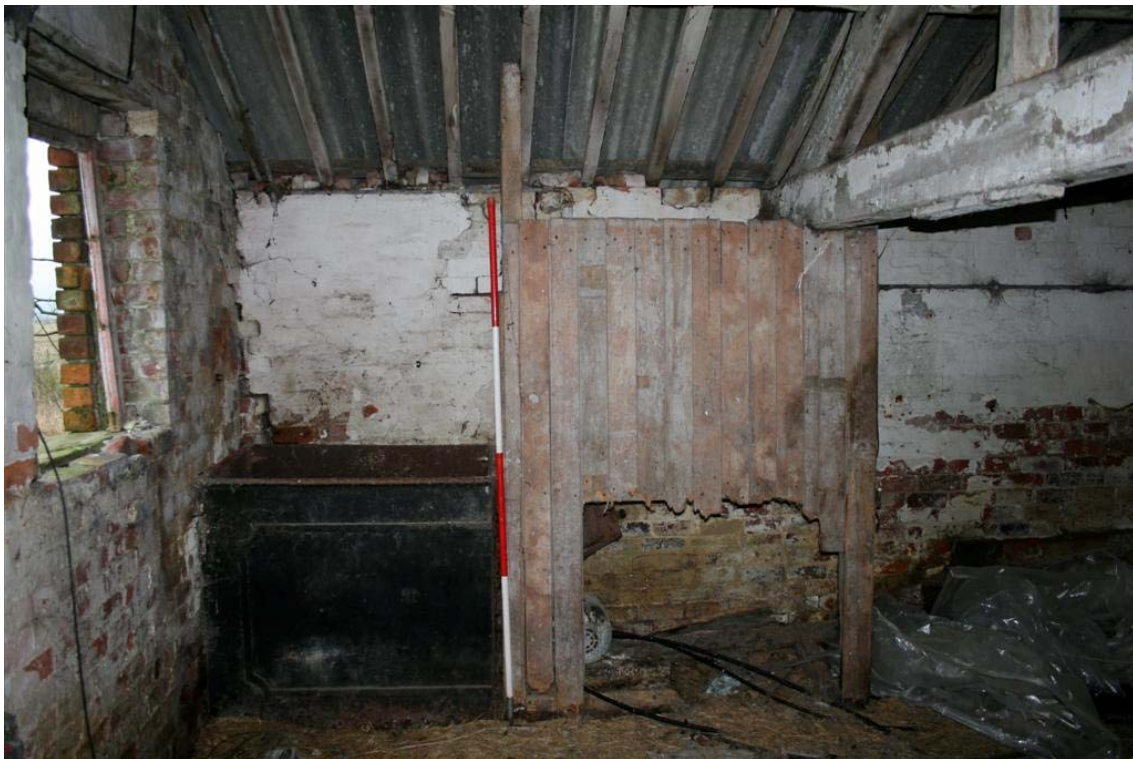
Plate 8: Area 3 of Barn B

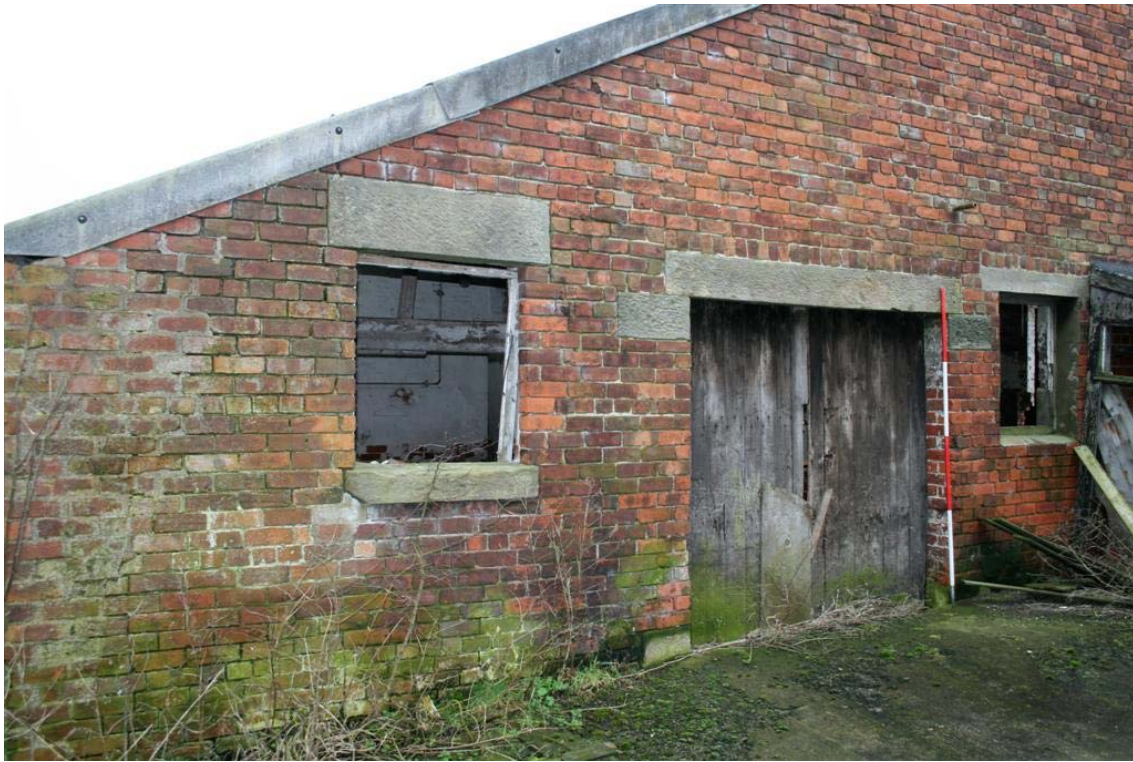
- 4.4.4 The casement window on the west elevation appears to be inserted, since the lintel and the projecting sloping sill are made of concrete, whilst the jambs of the window have been sealed with cement (Plate 9). Similarly, the casement to the right of the double doors on the north elevation would also appear to be a later insertion, as the lintel and sill are again of concrete, whilst the jambs have also be rendered with cement (Plate 10). Moreover, the pair of casements to the right of the north elevation again have concrete lintels, whilst the repairs to the surround are of the same pinkish brick used in the rebuild of the south gable. Although the casement on the south gable is within this apparent rebuild of pinkish-red brick, its lintel and sill are made of stone (Plate 11), which would suggest that the stonework of a comparable casement was retained and reused when the gable was rebuilt. The five light casements on the east elevation have narrow timber lintels and small projecting sills (Plate 12), and would appear to be original features of the barn.

Plate 9: North end of the west elevation of Barn B

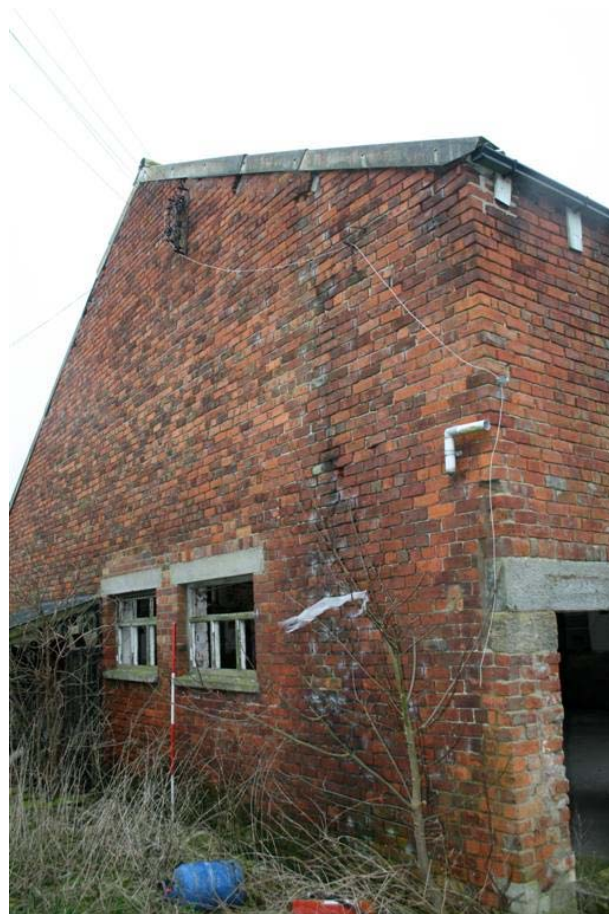
Plate 10: East end of the north elevation of Barn B

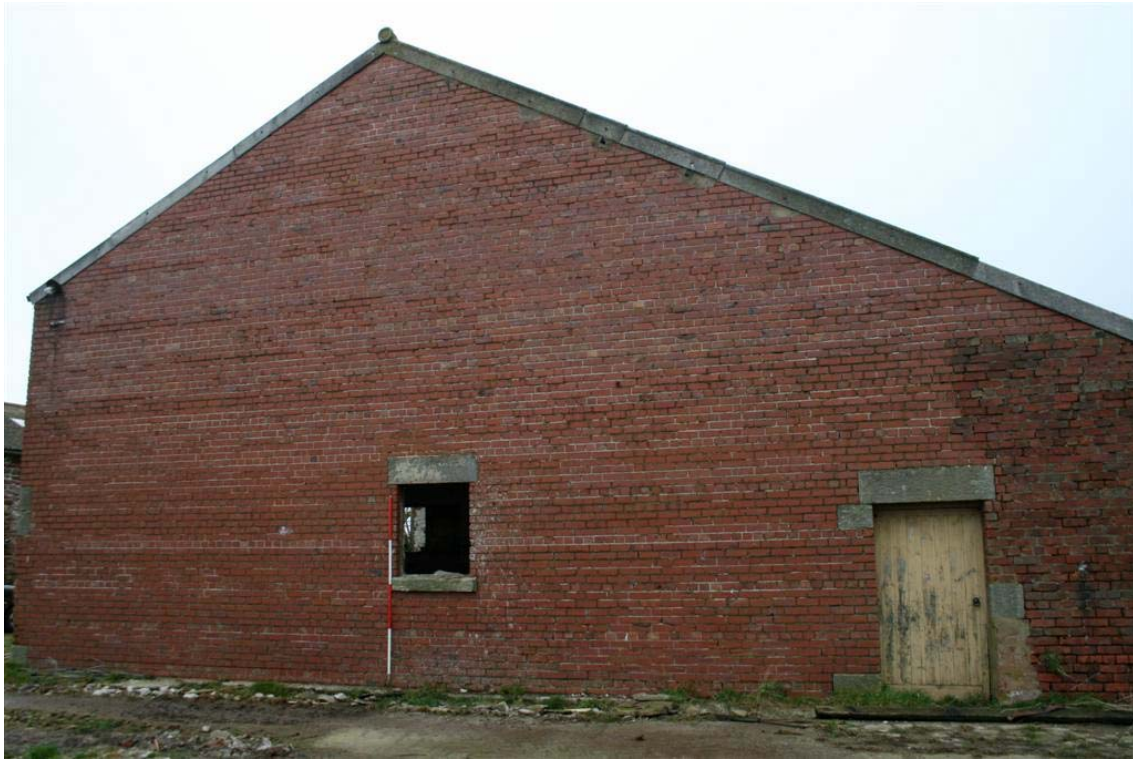
Plate 11: South elevation of Barn B

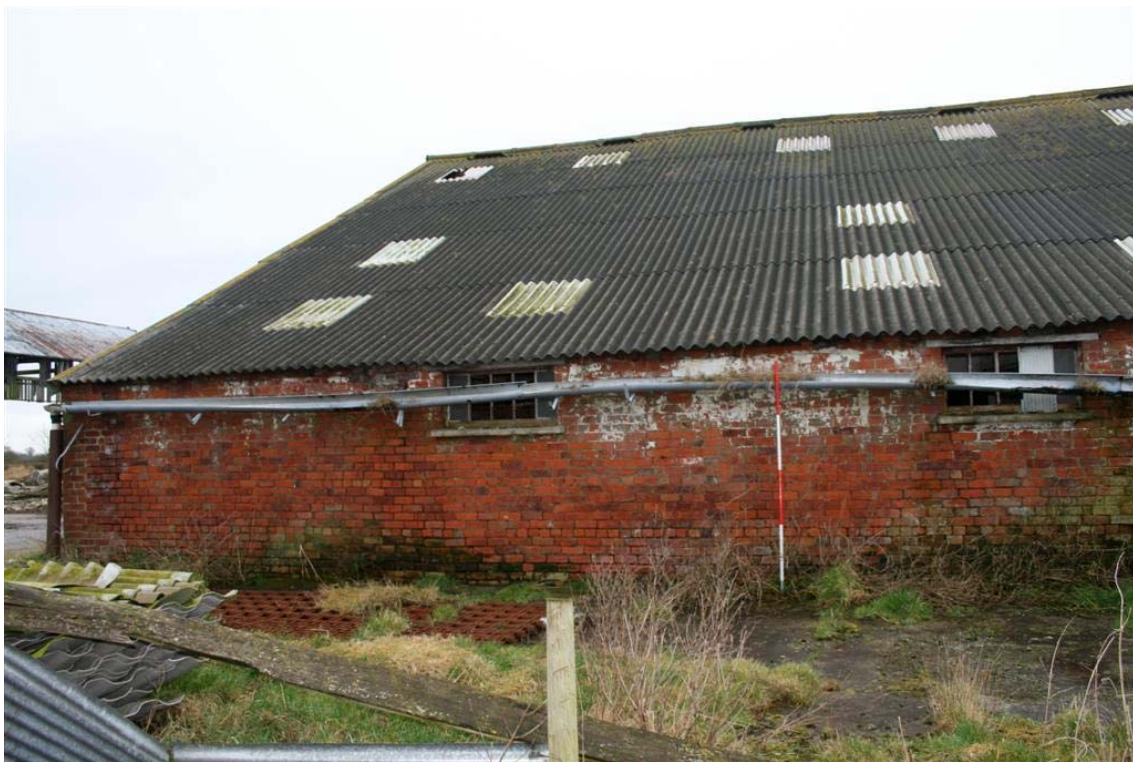
- 4.4.2 The roof is again constructed from corrugated asbestos sheeting (Plate 12), which is supported by a pair of machine-cut King-post trusses and seven trenched purlins, within the main section of the barn (Fig 10). The pitched roof to the east of the barn, is supported by a tie beam, principal rafter and pairs of angled braces. At the south end of the barn, the roof is supported by a composite truss, which is essentially a King-post, with an additional collar, queen struts, and paired truss rods (Plate 6). The seven purlins are not trenched and are affixed to the principal rafters with a series of cleats. At both the north and south ends of the building, there are a series of steel brackets, which secure the purlins to the gables, whilst a series of timber battens beneath the eaves of the west and east elevations provide additional anchorage.

Plate 12: East elevation of Barn B

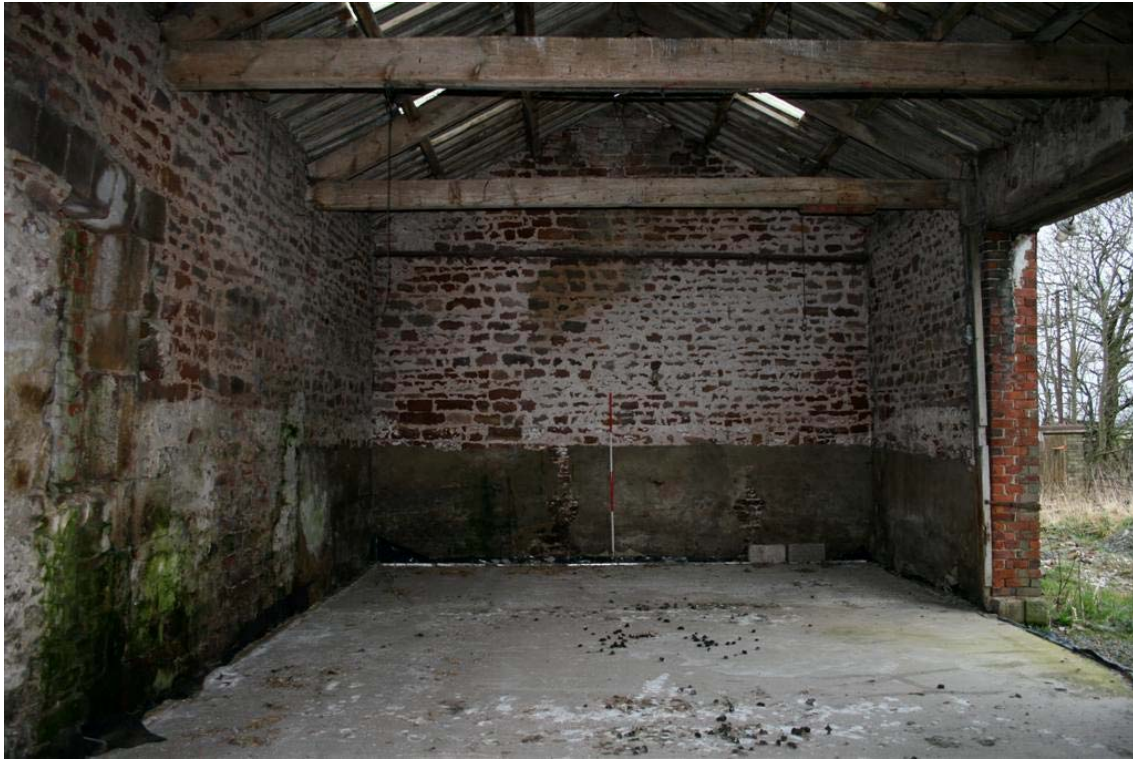
Plate 13: Internal view of Barn A
