# Anstey Hall Farm

**Historic Building Survey**

September 2015

OA East Report No: 1802 OASIS No: oxfordar3-224708

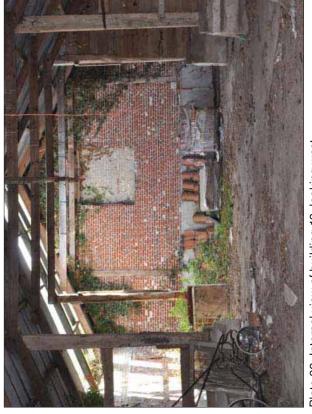
Plate 22: Internal view of building 13, looking west

- 4.1.10 Onto these walls have been placed a sill beam and main post which at from tie beam height has been replaced by a modern roof structure consisting of machined timbers and corrugated iron sheets. The original roof covering was likely to have been thatch or ceramic tile (Plate 22).

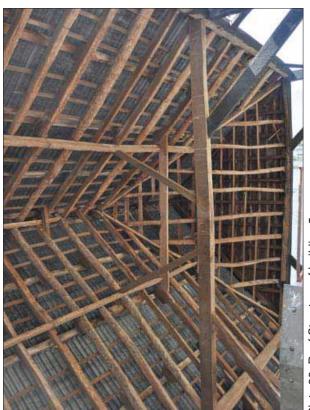
Plate 29: Roof Structure of building 5

- 4.7.3 The southern end of the building has been replaced. This was most probably done when the corrugated catslide iron roof structure was added. The present roof structure is a mixture of re-used and more modern sawn timbers. This can be seen where the tie beams support the vee-struts at the southern end of the building (Plate 29).

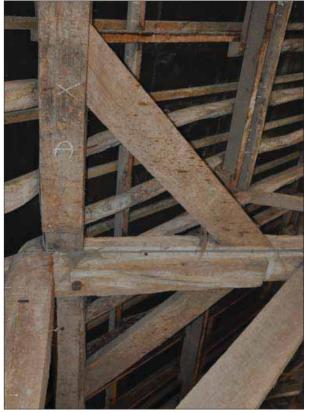
Plate 42: Detail of roof structure of building 2

- 4.4.22 A tie beam supports the roof structure with the aid of angled struts (Fig 14). A further collar rafter for added strength was located towards the apex of the roof. Much of the roof structure has been repaired and a mixture of re used and sawn timber has been used for the common rafters and in some places the new roof structure has been placed on top of the old one. Each of the aisle posts on the west of the barn have had flared jowels added after initial construction (plate 42) to take the extra weight of the roof structure on that side.

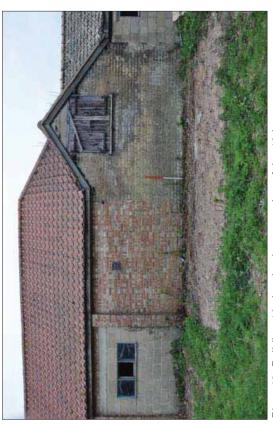
Plate 49: Building 16 showing incorporation of the 19th century range.

- 4.1.21 The brickwork of building 16 has been tied into the gable end of building 15 (Plate 49) and south of this building 16 had been extended to form building 16b (Plate 49). With the addition of another small concrete block. This has also been tied into building 15. I. It is possible that building 16b had replaced an earlier structure which can be seen in a similar position on the 1903 Ordnance Survey map (Fig 8). The existing structure has been built entirely from twentieth century materials.
