LOW HOUSE, HUTTON ROOF, KIRKBY LONSDALE, CUMBRIA

Archaeological Desk- Based Assessment, Buildings Investigation and Watching Brief

Oxford Archaeology North

December 2006

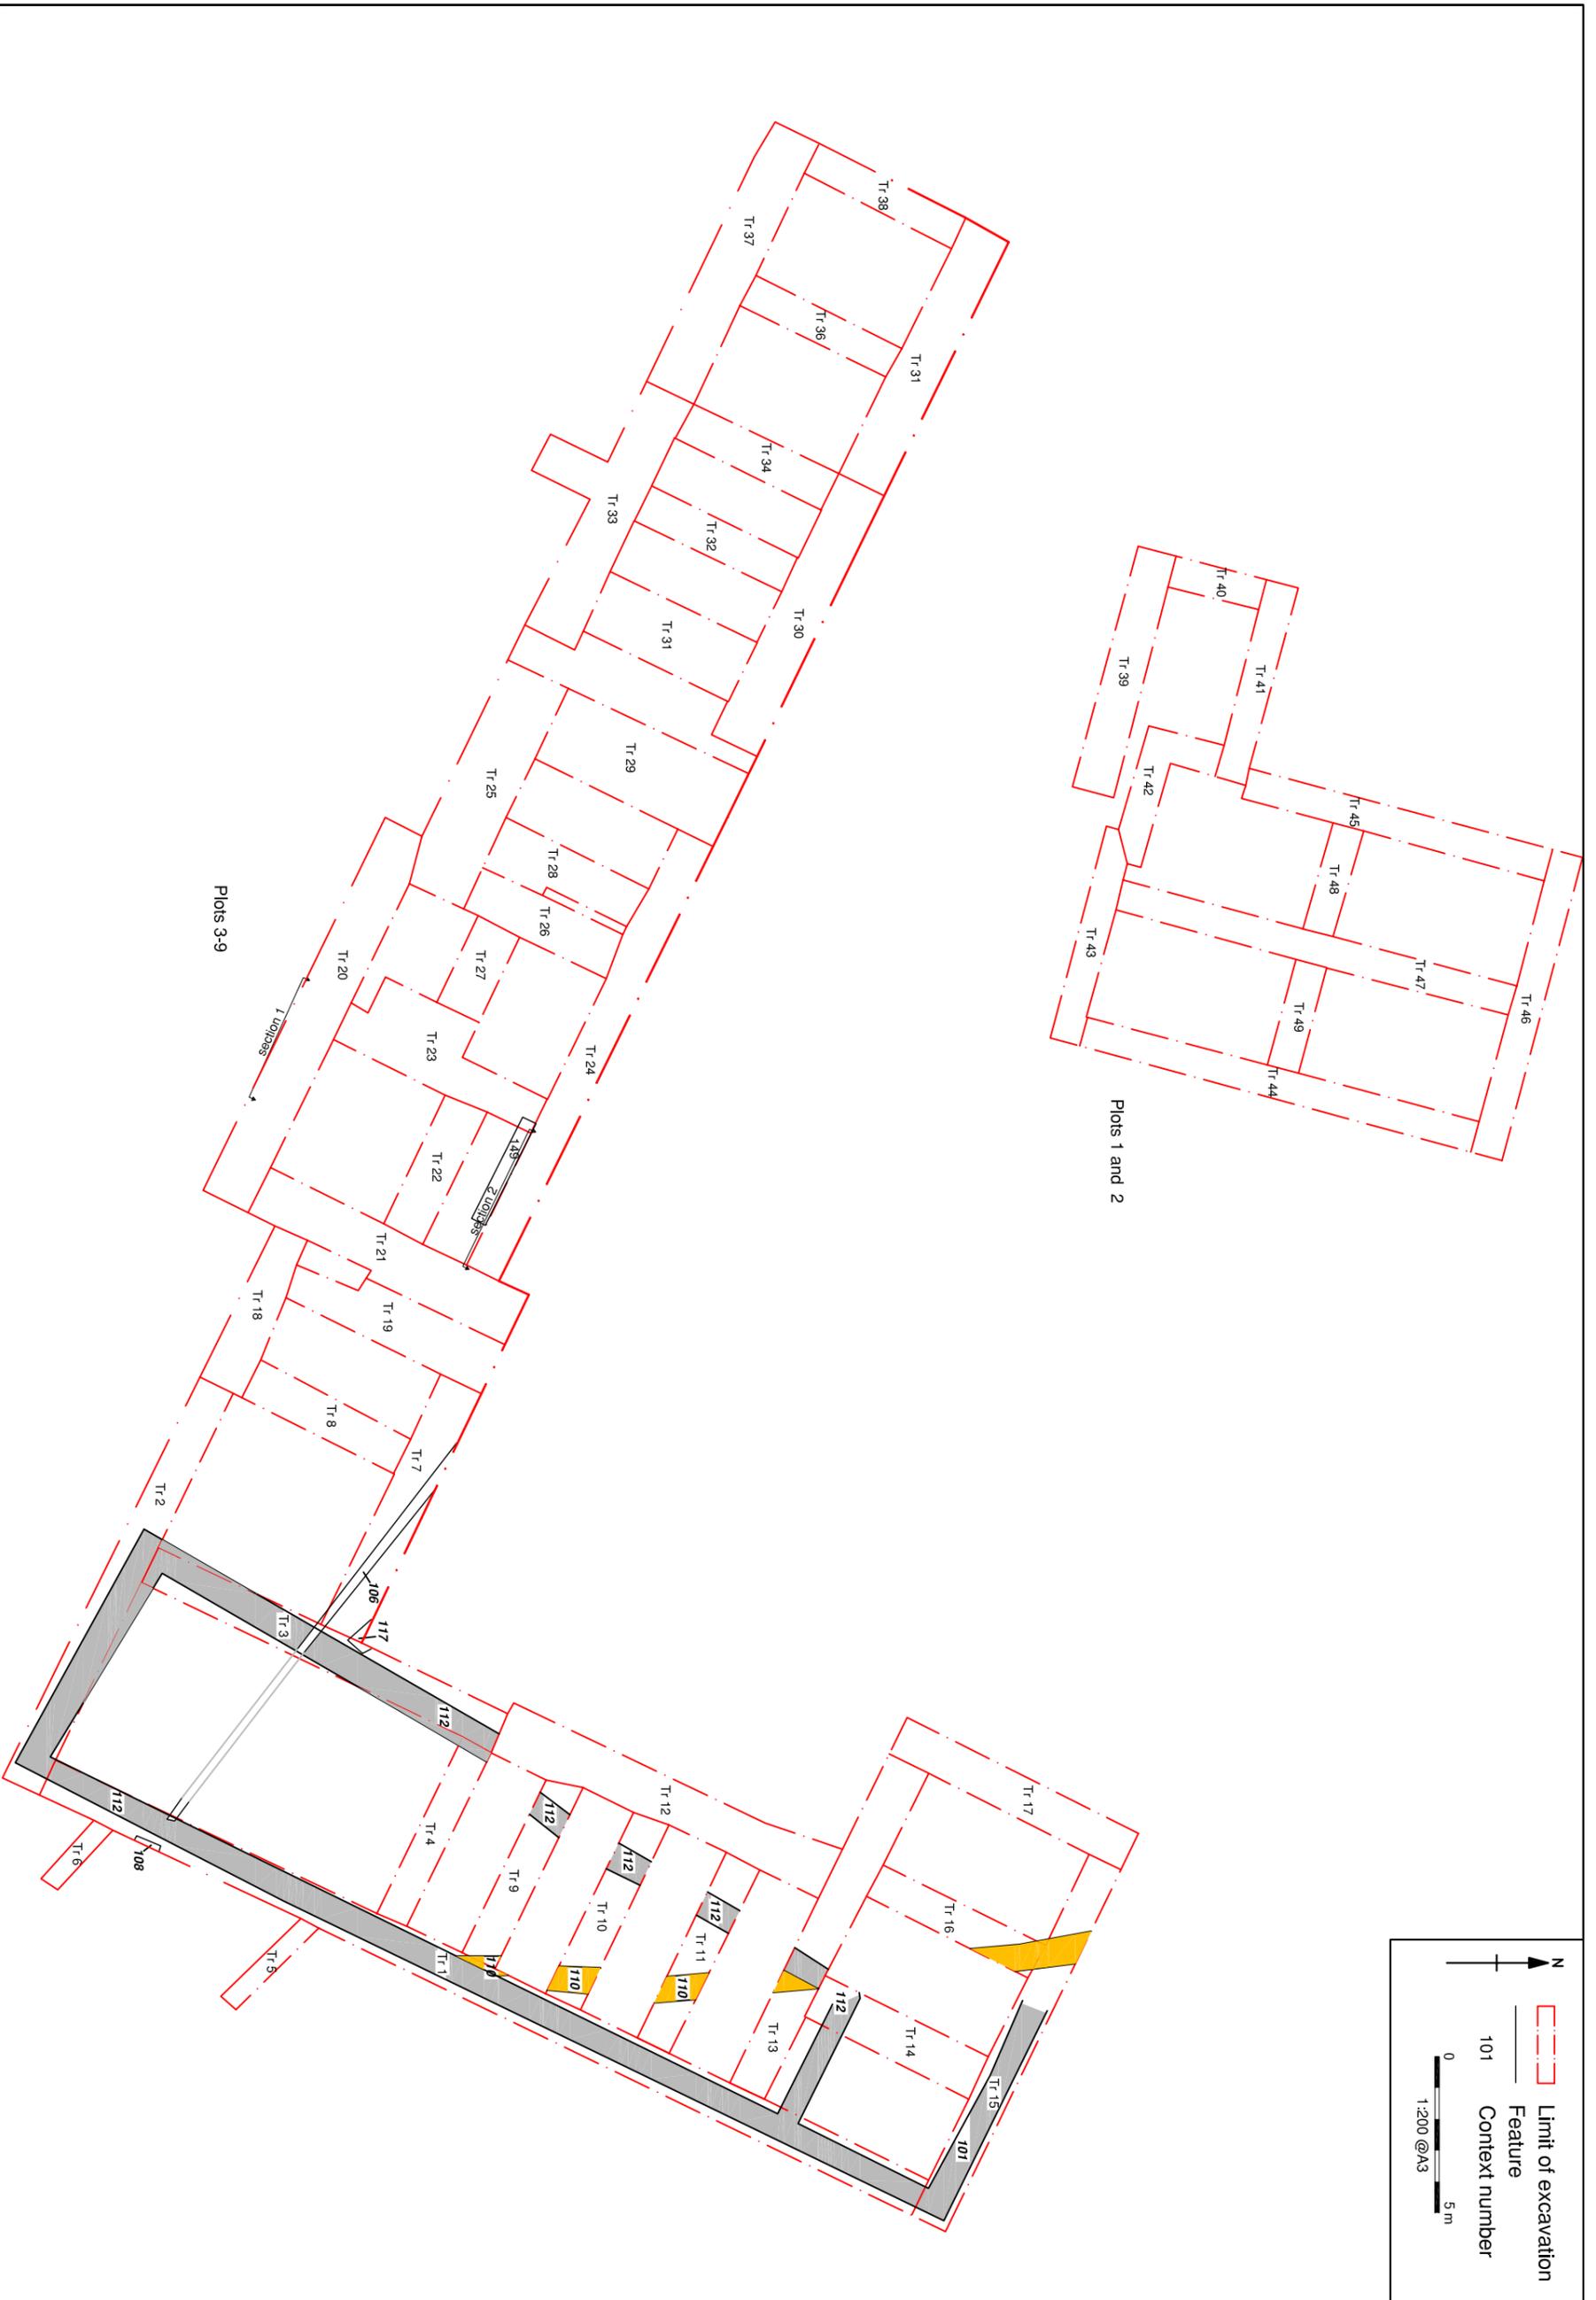
Figure 7: Trench location Plan

7.2.1 Footings and drainage features relating to the demolished structures of the Low House Farm complex were located within several foundation trenches in the eastern half of the development (Fig 7). These included north-west/south-east and north-east/south-west aligned footings **101** and **112** at the north-eastern extent of the new building (Plate 11) and which are likely to represent elements of *Building Five*. They comprised roughly-hewn sandstone blocks measuring a maximum of 1m by 0.6m by 0.2m, forming a foundation 0.8m in width. Of drystone construction, footings **101** and **112** were built within construction cuts into the glacial till and recorded respectively as **102** and **113**. The entire structure was sealed by recent demolition debris of the current groundworks.

7.2.2 Foundation **149**, orientated north-west/south-east and measuring 0.38m in height and 3.2m in length, was located in the southern baulk of Trench 24 (Fig 7). It comprised two courses of roughly-hewn sub-rectangular sandstone, measuring 0.63m by 0.4m by 0.36m and bonded with a dark grey coarse sand. The construction cut, **150**, truncated the glacial till, **148**, by 0.28m, with the remainder of the foundation sealed by overburden **138**.

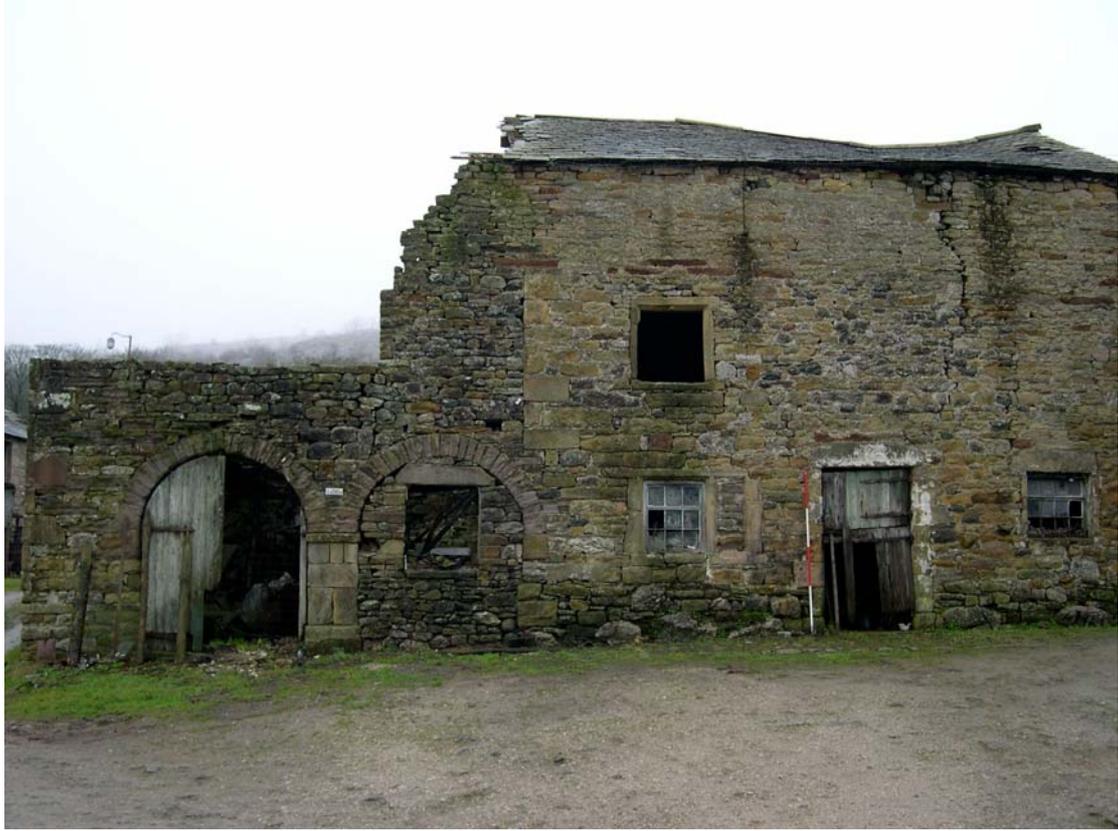
Plate 2: The east elevation of *Building One*, with the south extension to the left of the plate

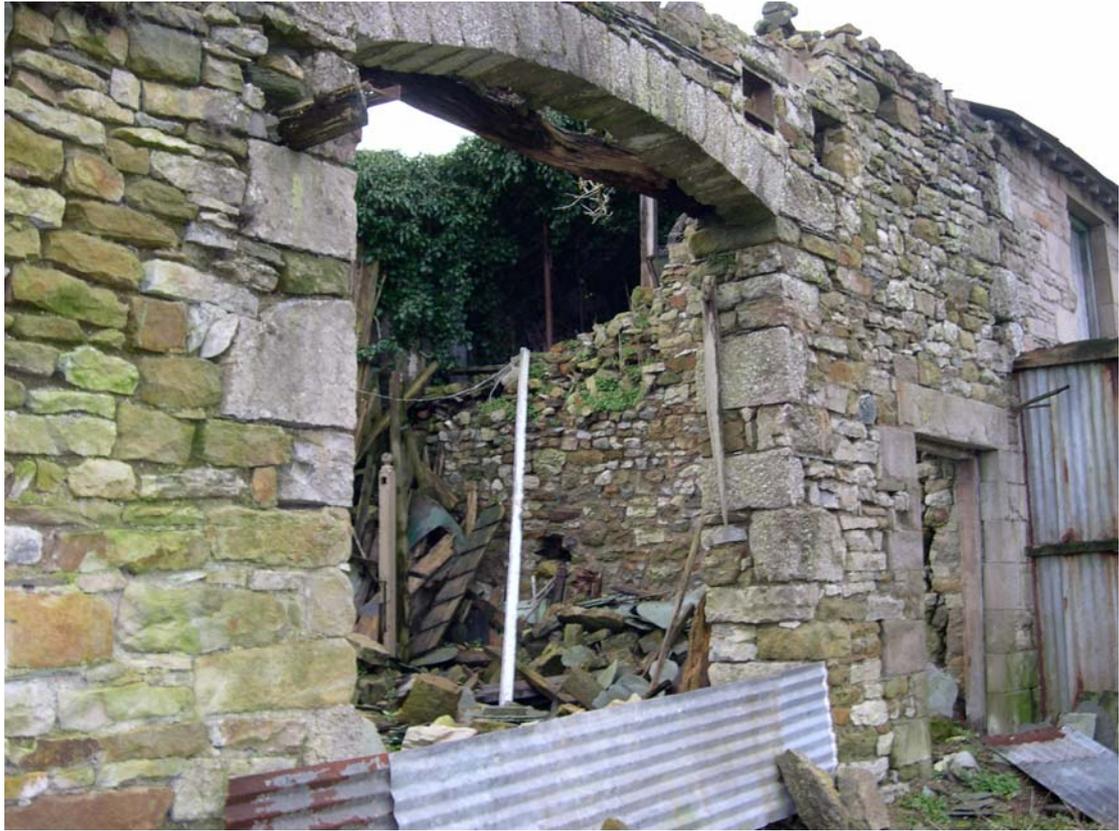
- 6.1.11 **Building Three:** the remains of a rectangular outhouse or barn, which is located towards the west end of the east/west axis of the farmstead. It is constructed of yellow sandstone rubble with limestone dressings and, as is the case with the majority of buildings on the farmstead, the barn is in a dilapidated condition. The roof appears to have been very much in keeping with the fabric and build of those extant roofs of the other buildings, but little now remains. The walls have fared only marginally better, although the gable ends appear to be in reasonable condition compared to the rest of the structure. The west gable reaches up to two storeys high, whilst the east stands at three storeys, and features two strings of through stones and a slightly stepped base of large limestone blocks. In contrast, the north and south walls are in a particularly

poor condition, with the east extent of the south elevation reduced almost to foundation level.

Plate 6: Detail of a wagon door on the north elevation of *Building Three*

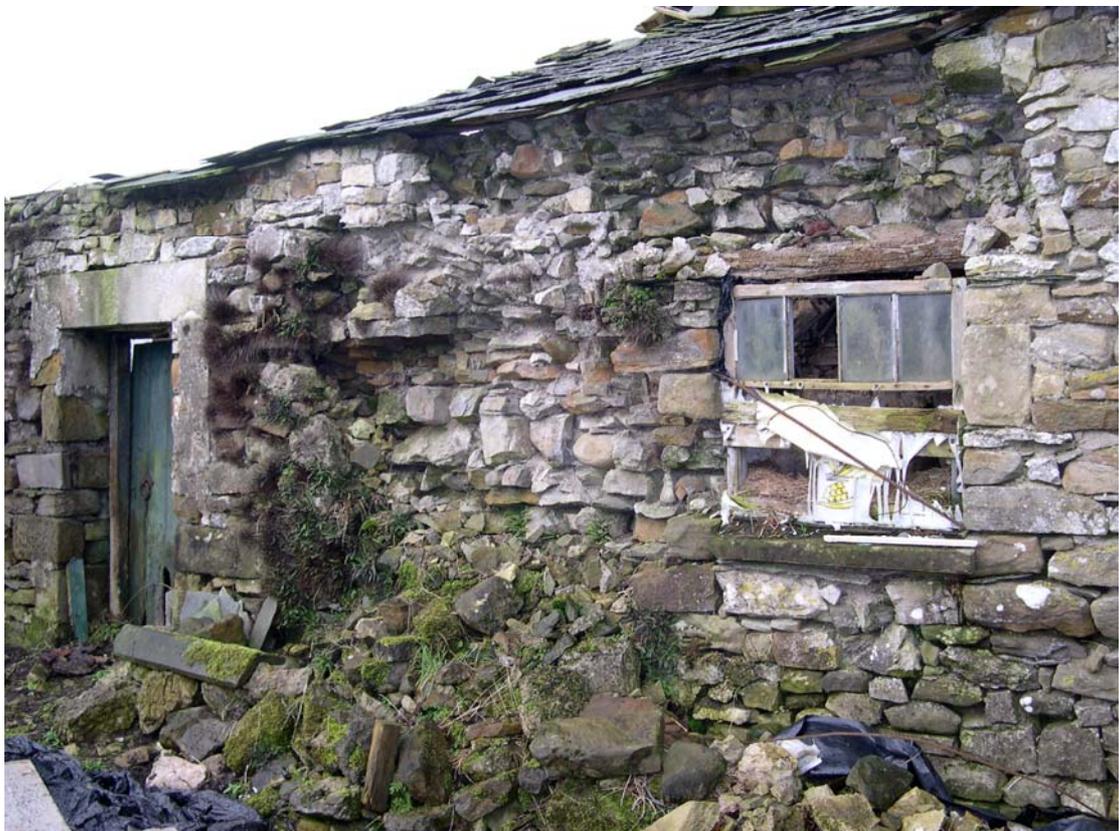
- 6.1.13 **Building Four:** the shippon is a single-storey, rectangular building of yellow limestone rubble, which butts *Building Three* on the east/west axis of the farmstead (Plate 7). The structure stands in a very poor condition, with only half of the Cumbrian slate roof remaining, whilst the external facings of the walls are in a state of collapse.

Plate 7: The north elevation of *Building Four*

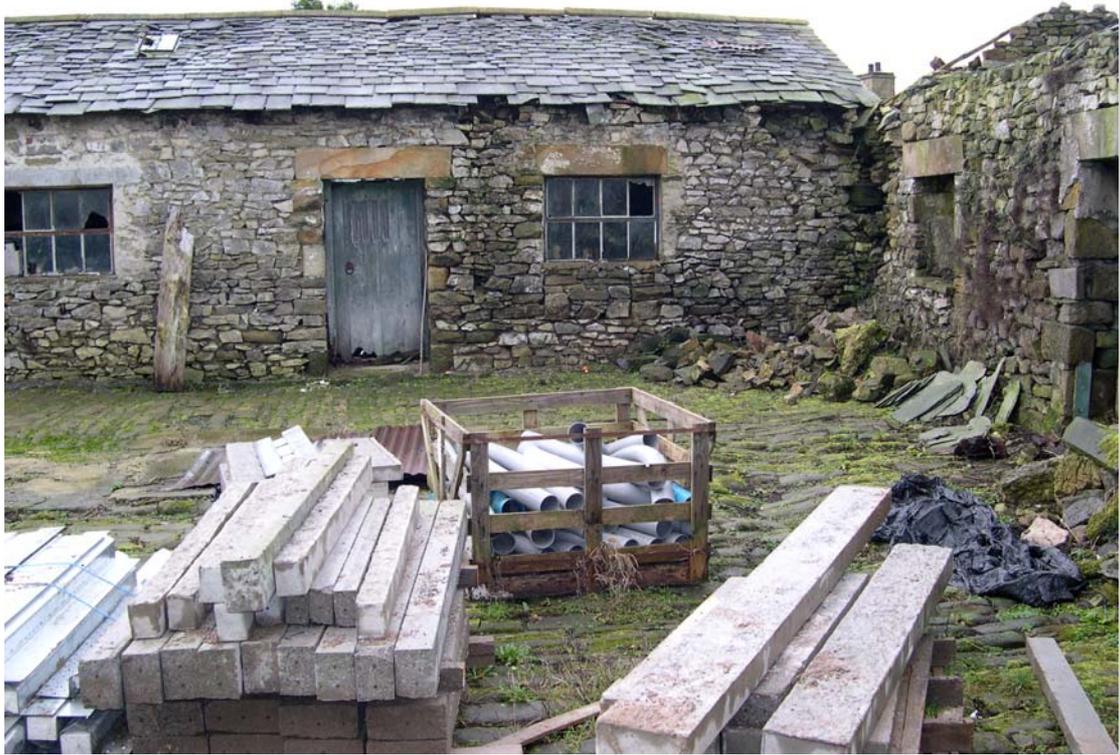
Plate 8: The west elevation of *Building Five*

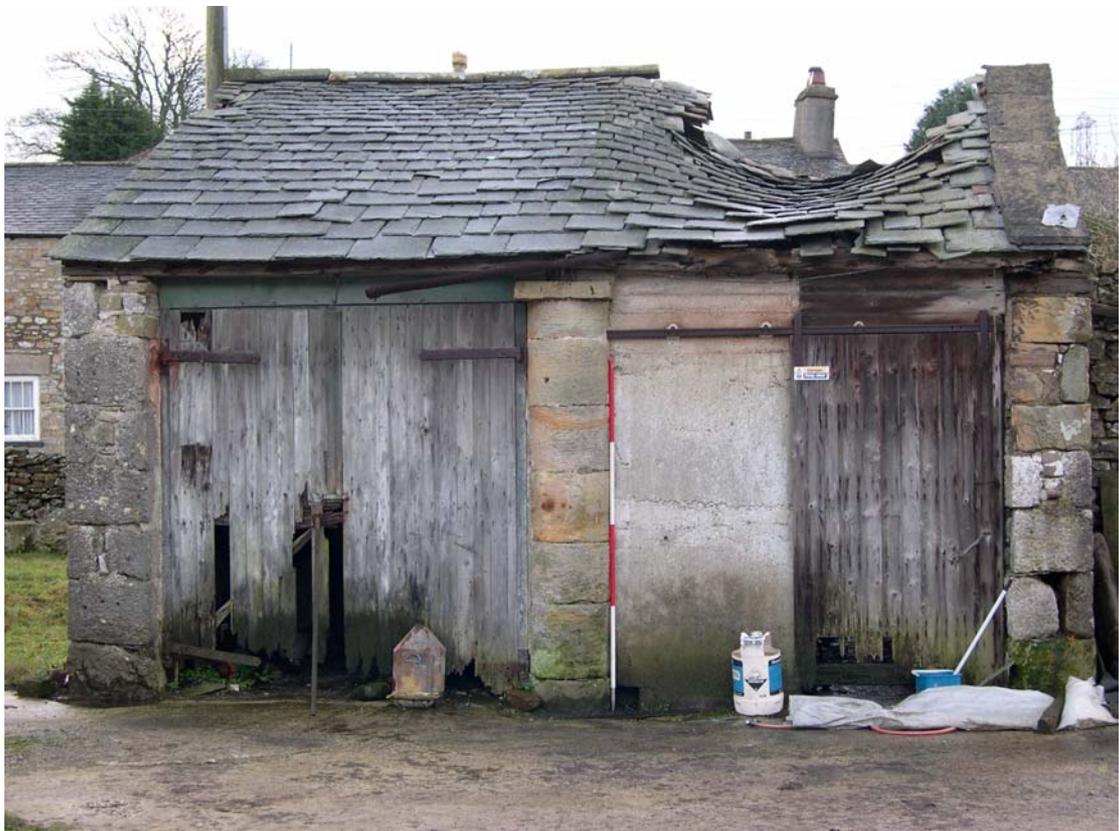
Plate 9: The west elevation of *Building Six*

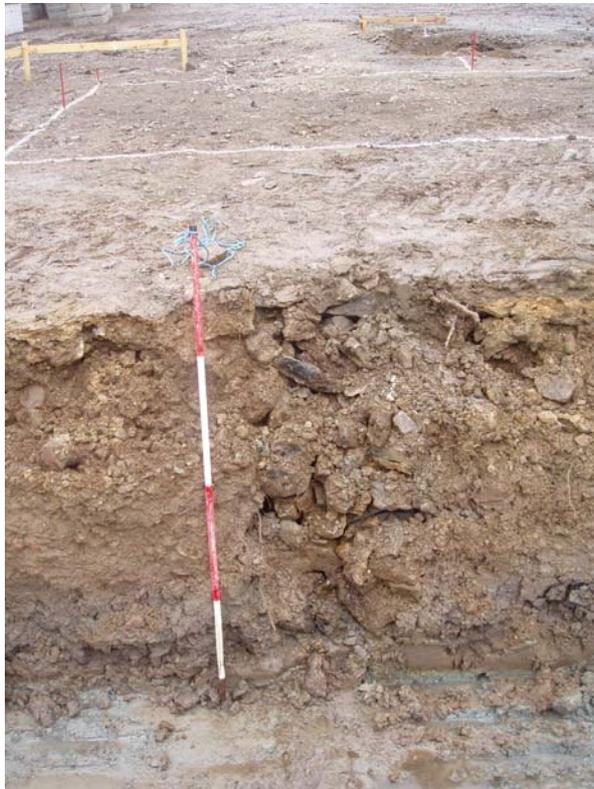
Plate 11: Foundation *101* in Trench 1, looking west

Truncating the top layer of drift geology, as well as those below, were a number of features. At the northern end of the trench, a section of wall foundation, **101**, was seen (Plate 10). The foundation was constructed of roughly-hewn yellow sandstone blocks of varying dimensions, in a dry stone method. The foundations were 0.8m in width and approximately 1.5m in depth with near-vertical sides. The stones had been deliberately constructed within a straight-sided, flat based linear trench, **102**. The present trench was not dug in a continuous manner and this section of wall foundation was recorded separately.

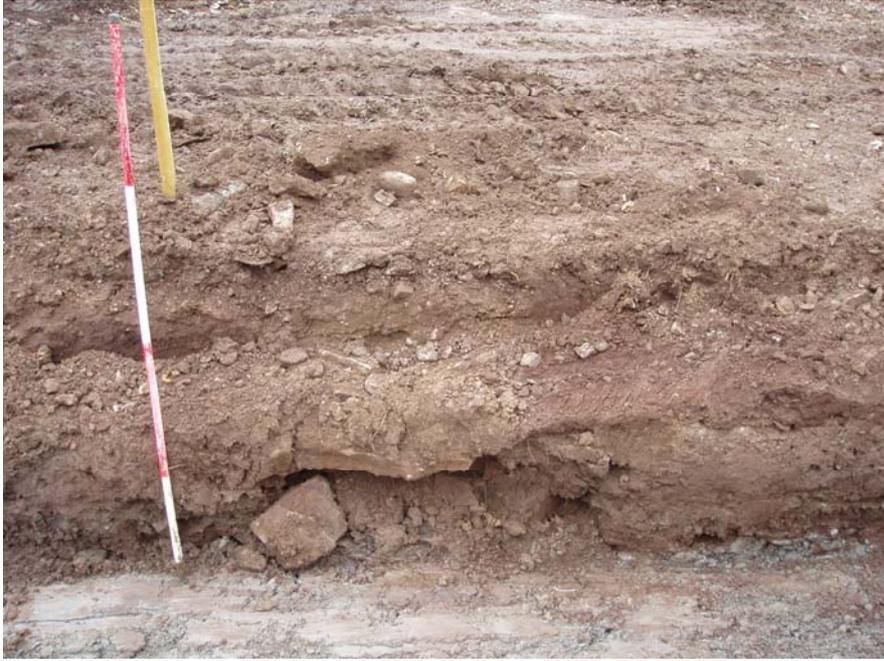
Plate 12: Culvert *108* in Trench 1, looking west

In addition to the wall foundations there were also two culverts and a drain visible within the trench. The culverts were either contemporary with the wall foundations or post-dated them. The southern culvert, **108**, was visible only in the eastern section. It was built of sandstone slabs resting on small sandstone blocks or cobbles, thus forming a channel, allowing water to pass easily (Plate 12). The culvert measured 0.4m in width and was 0.55m in depth from the surface. The culvert had been cut through the earlier surrounding deposits, the latest of those being **103**. However there was evidence to show that layer **122** had accumulated over the top of the culvert and, therefore, post-dated the construction of the culvert.
