The Old Rectory Letcombe Bassett

**Historic Buildings Recording and
Watching Brief**

southsouthsouth
January 2017

Client: Mr Nicholas Ashe

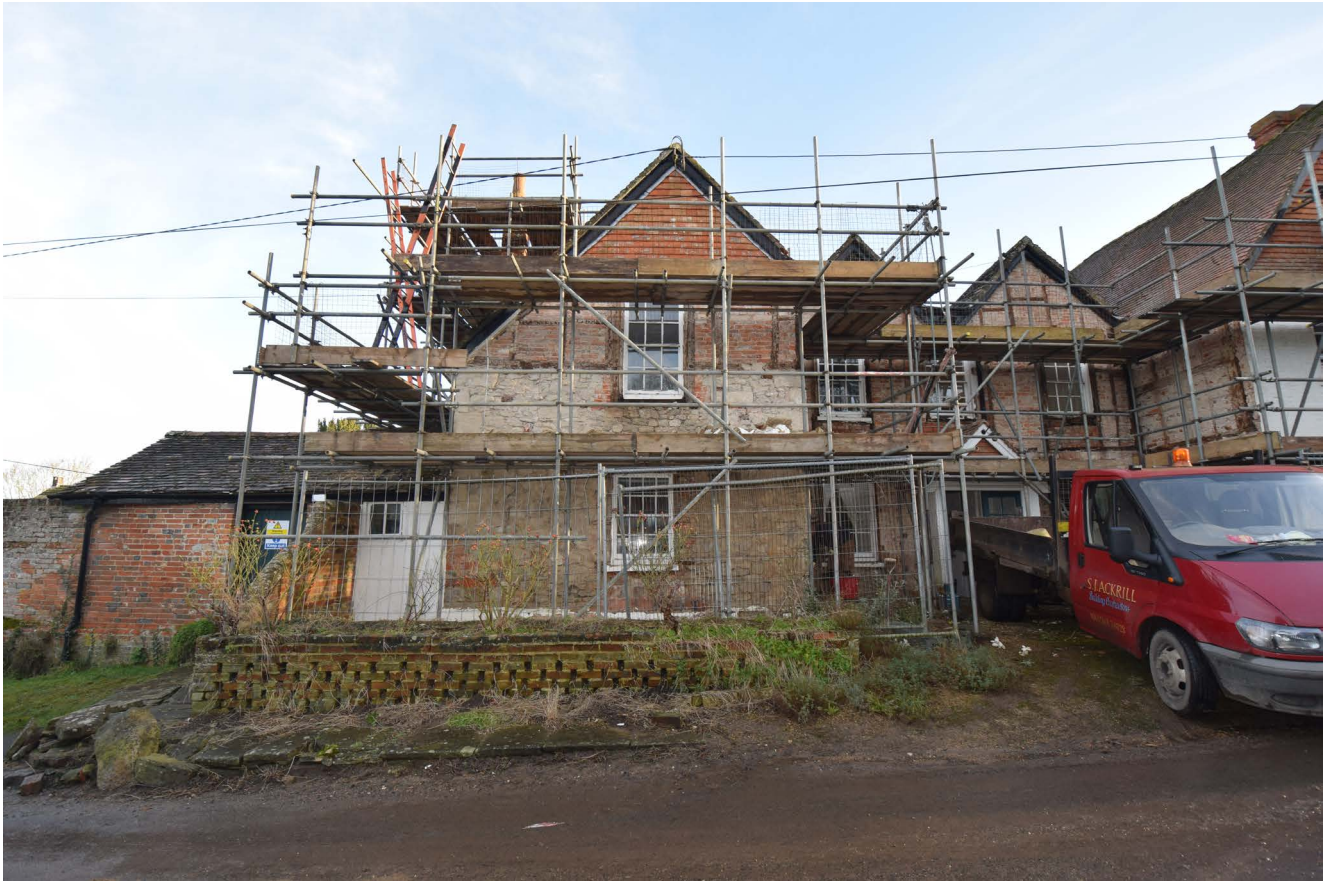
Plate 5: The south west elevation of the northernmost wing after removal of the render

- 4.1.4 The earliest, northernmost, wing of the front south-west elevation is of stone, extending into the second storey to the eaves of the northernmost pitch, with timber framing above (Pls 5 & 6). Brick nogging is up to the level of the eaves of the southernmost pitch with hung tiles fitted over the bare timber frame above this to the apex. Areas of brick repairs are around the parts of the later sash windows which are set into the stonework (Pl 7).

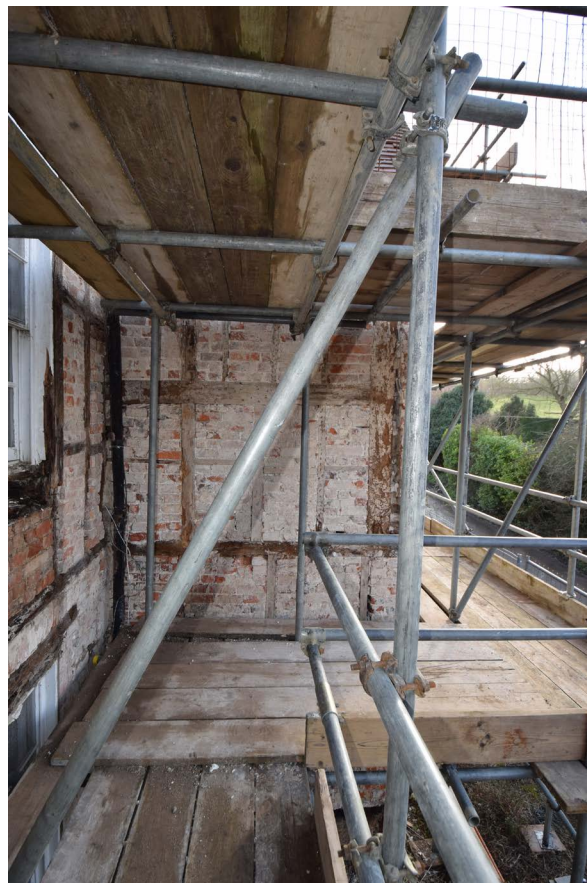
Plate 8: The northernmost return of the southernmost wing

- 4.1.5 The front elevation of the southernmost wing, as discussed, had been largely rebuilt in brick in the late 18th century; the northernmost return between the façade and the recessed bays is of timber frame with brick nogging (Pl 8). The timber frame of the first floor is more substantial than the ground floor, which has largely been replaced by brick.

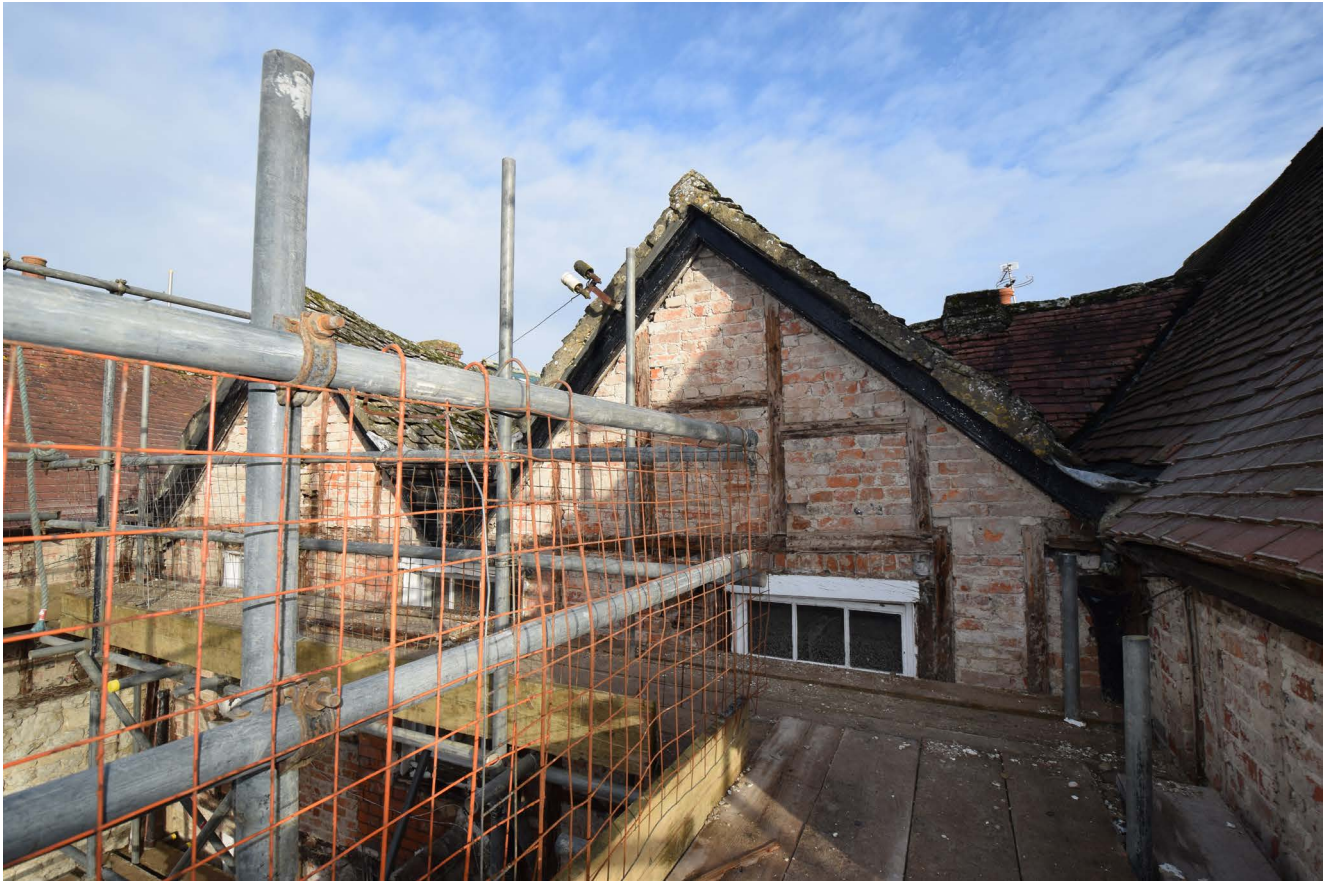
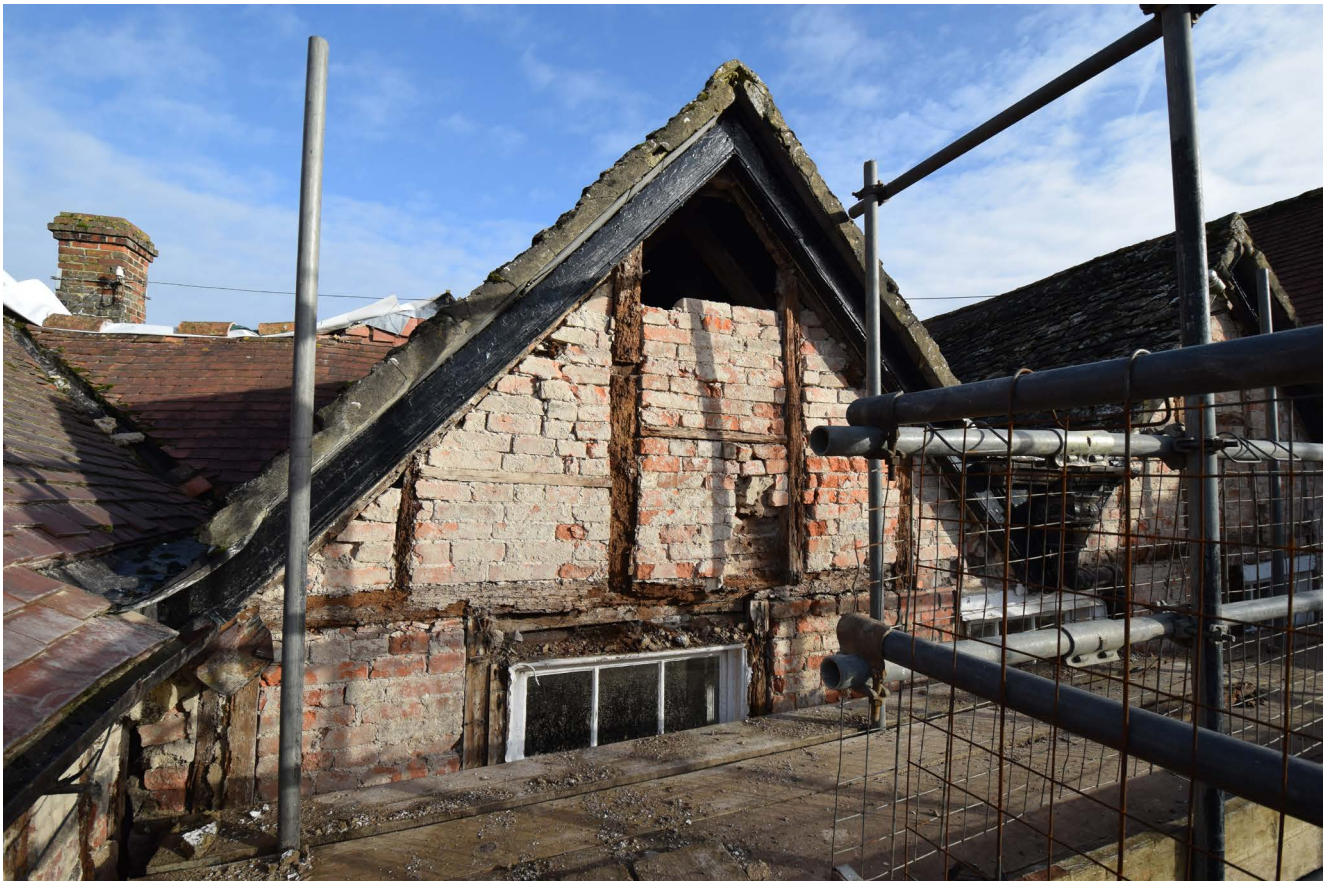
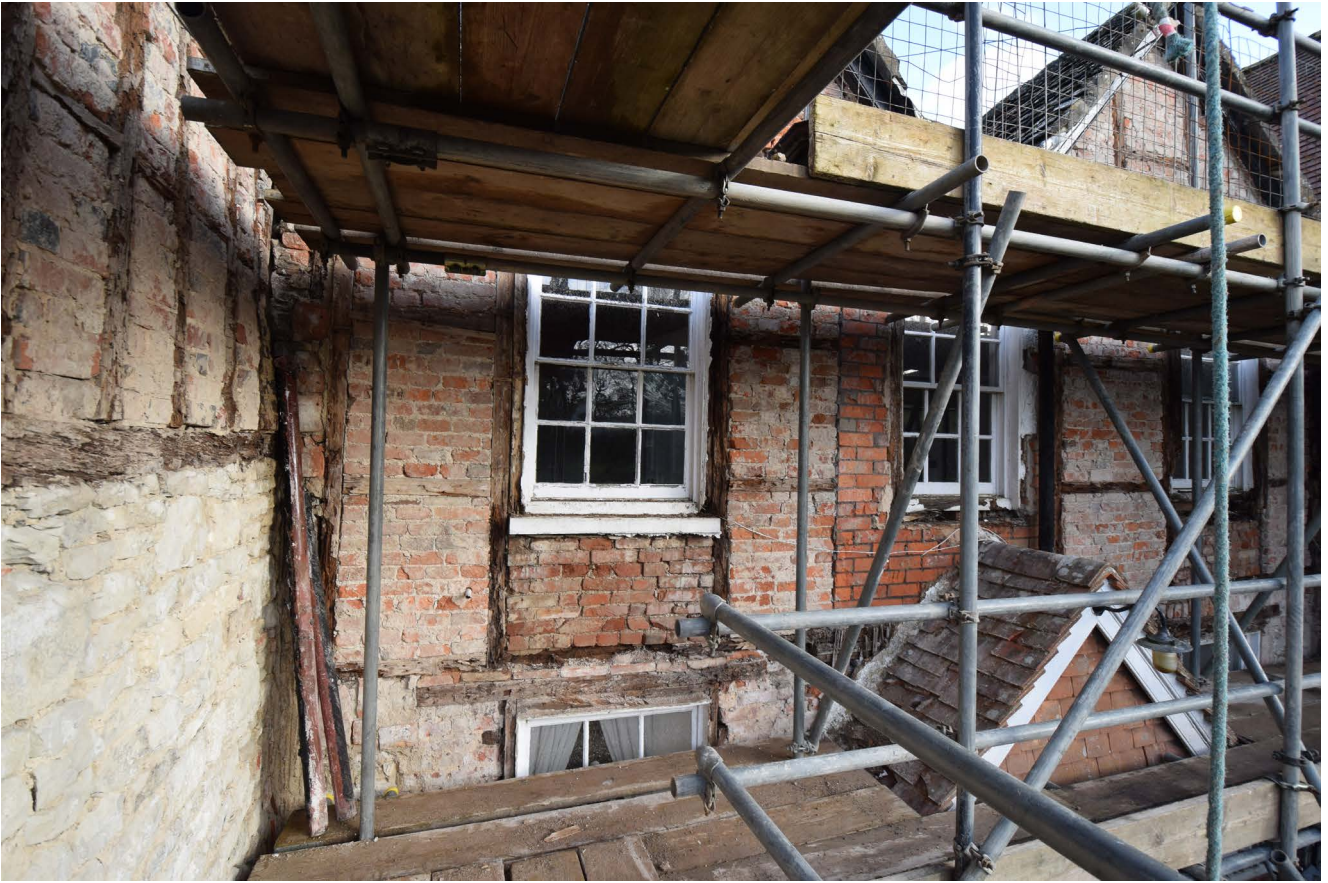
- 4.1.6 The central bays, set back from the two side wings, are timber frame with brick nogging, although, like the southernmost wing, the ground floor is now predominantly brick. There is evidence of several instances of substantial repairs and replacement of material to this area, particularly the area of mid 20th-century brickwork surrounding the central window, above the porch. The brick patching around the windows to either side of the upper floor of the central bays confirms that the windows are later replacements (Pls 9-11).

Plate 9: The south west elevation of the central bays

Plate 10: The south west elevation of the northernmost bay, gable

Plate 11: The south west elevation of the northernmost bay, first floor

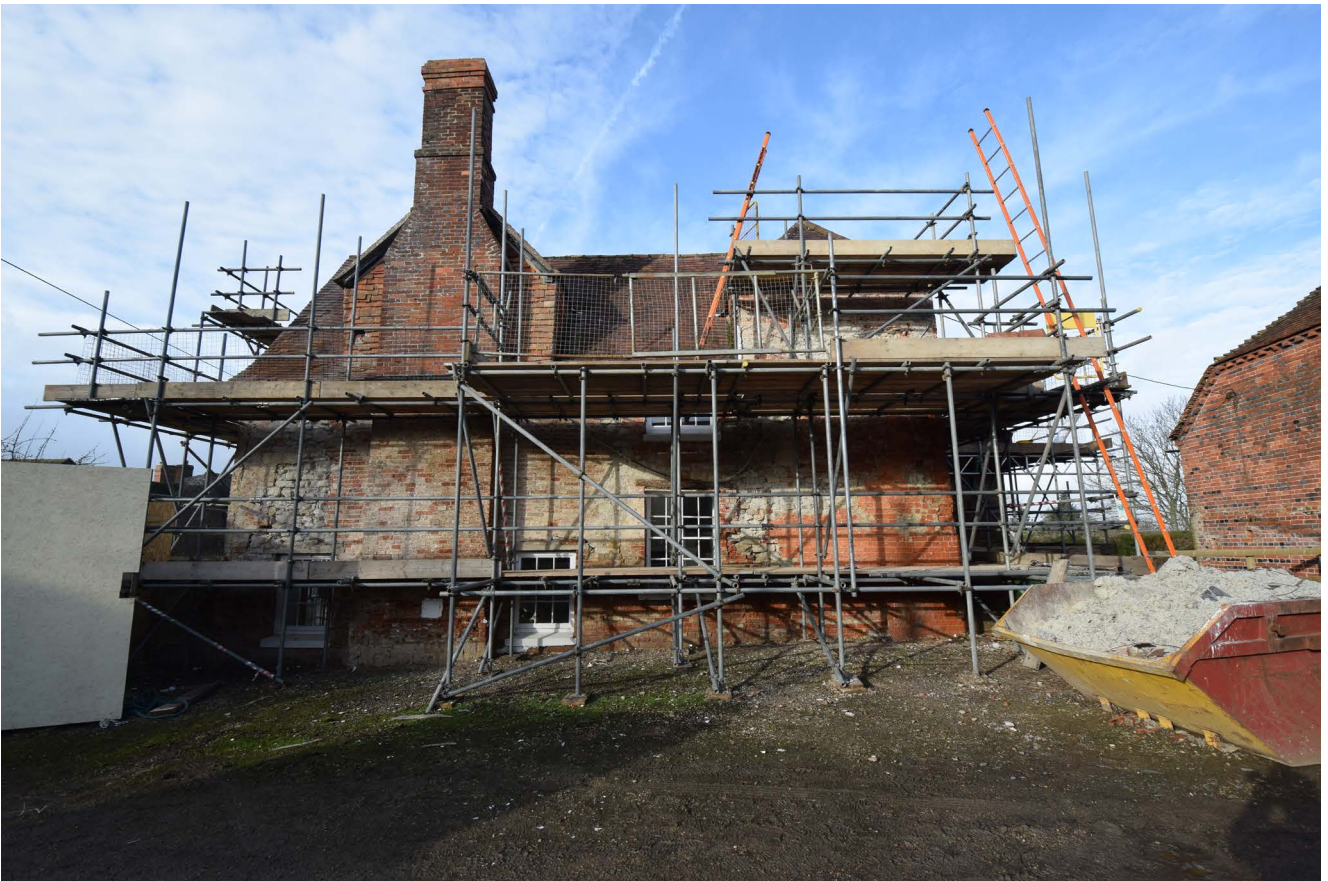
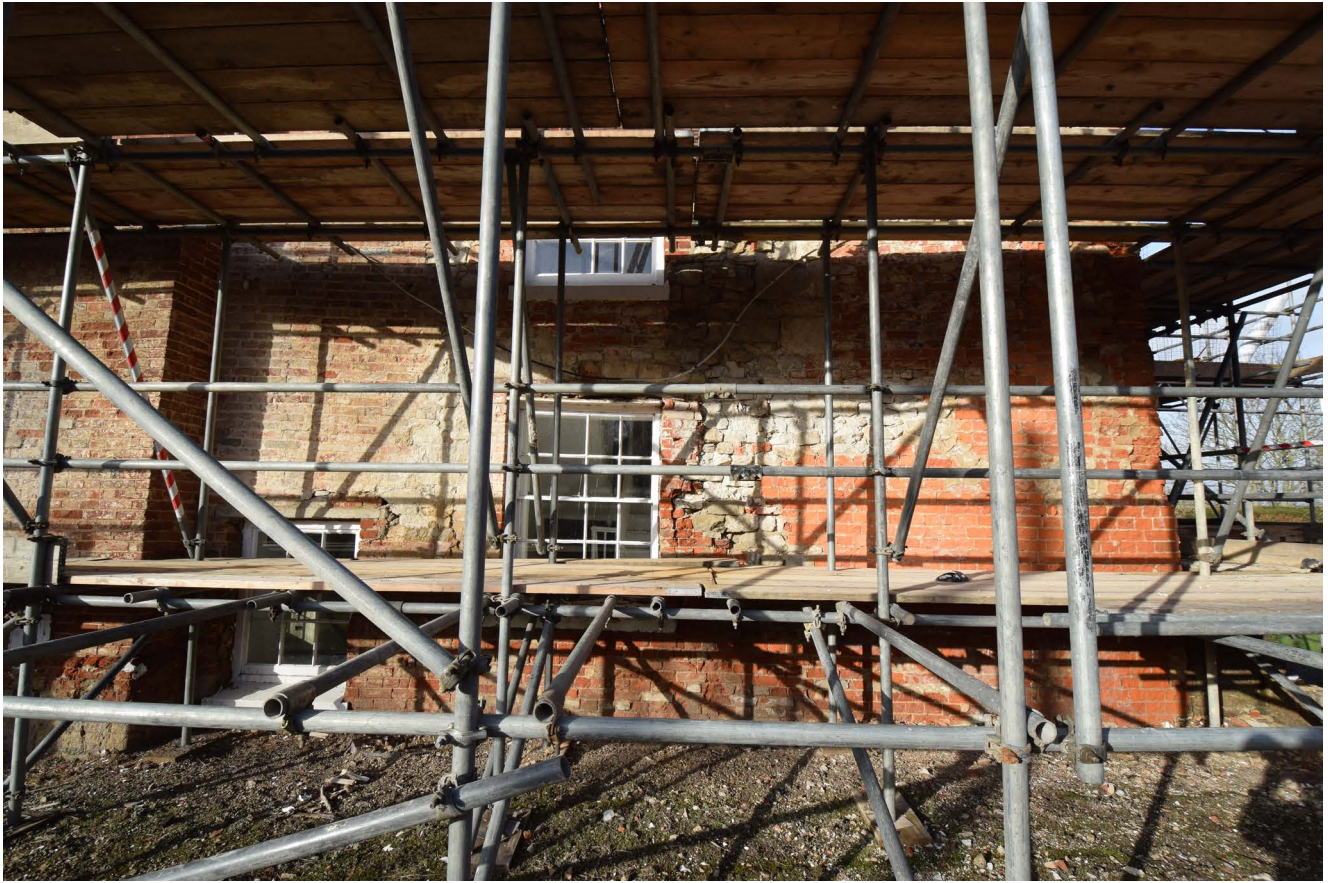
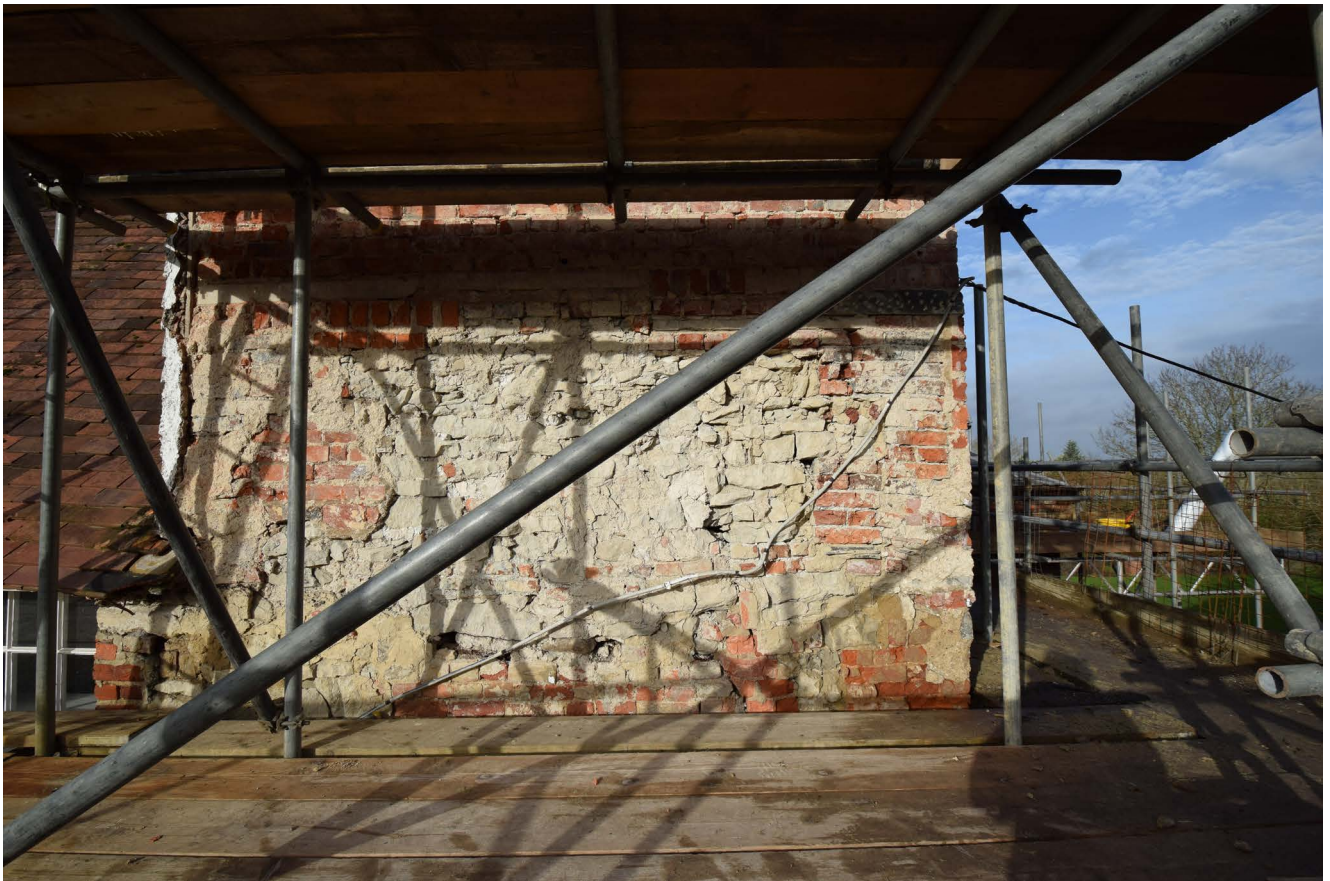
- 4.1.8 The south-east elevation was revealed to be of brick and stone (Pls 12-14). The majority of the brickwork is likely to have been introduced as repairs and alterations to the formerly stone wall, and has gradually become more prevalent, particularly with the addition of the brick-built chimney. There is no timber frame or evidence of timber frame in this elevation.
- 4.1.9 The ground floor windows, which were added in c1993, have concrete lintels and have been cut into the existing stone and brickwork (Pl 15). The upper stairwell window, just

Plate 12: The south east elevation after removal of the render

Plate 13: The north east end of the south east elevation, ground floor

Plate 14: The north east end of the south east elevation, second floor blind dormer

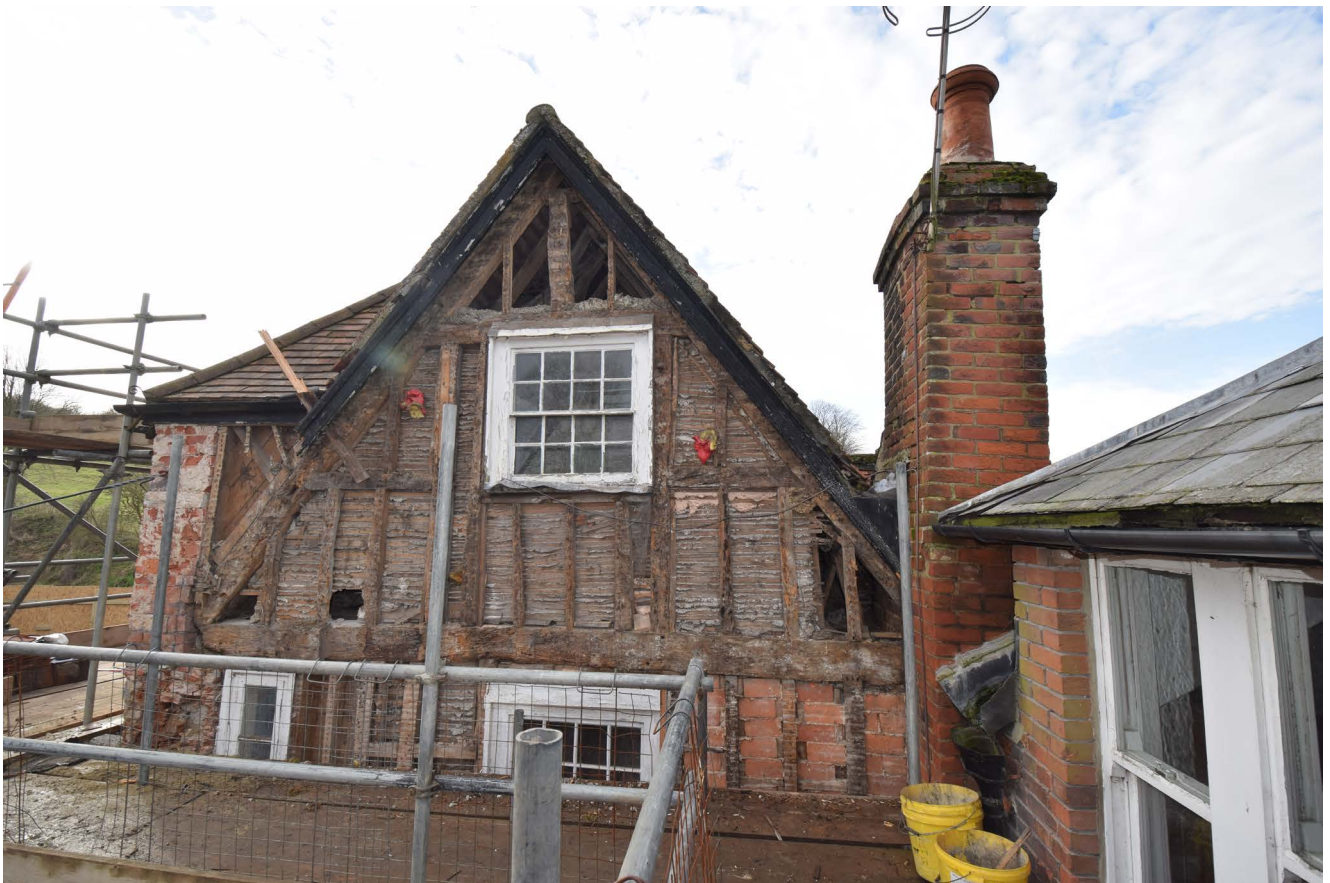
Plate 18: The north east elevation of the southernmost wing, second floor

- 4.1.10 The earlier part of the north-east, the rear, elevation was revealed to be timber frame with brick nogging, laid on edge, to the majority of the first floor and brick and stone infiling to the ground floor with some modern brick and block repairs (Pls 16 & 17). The gable had had hung tiles to the outside and the rear of the lath and plaster of the internal finish was visible when the tiles were stripped (Pl 18).

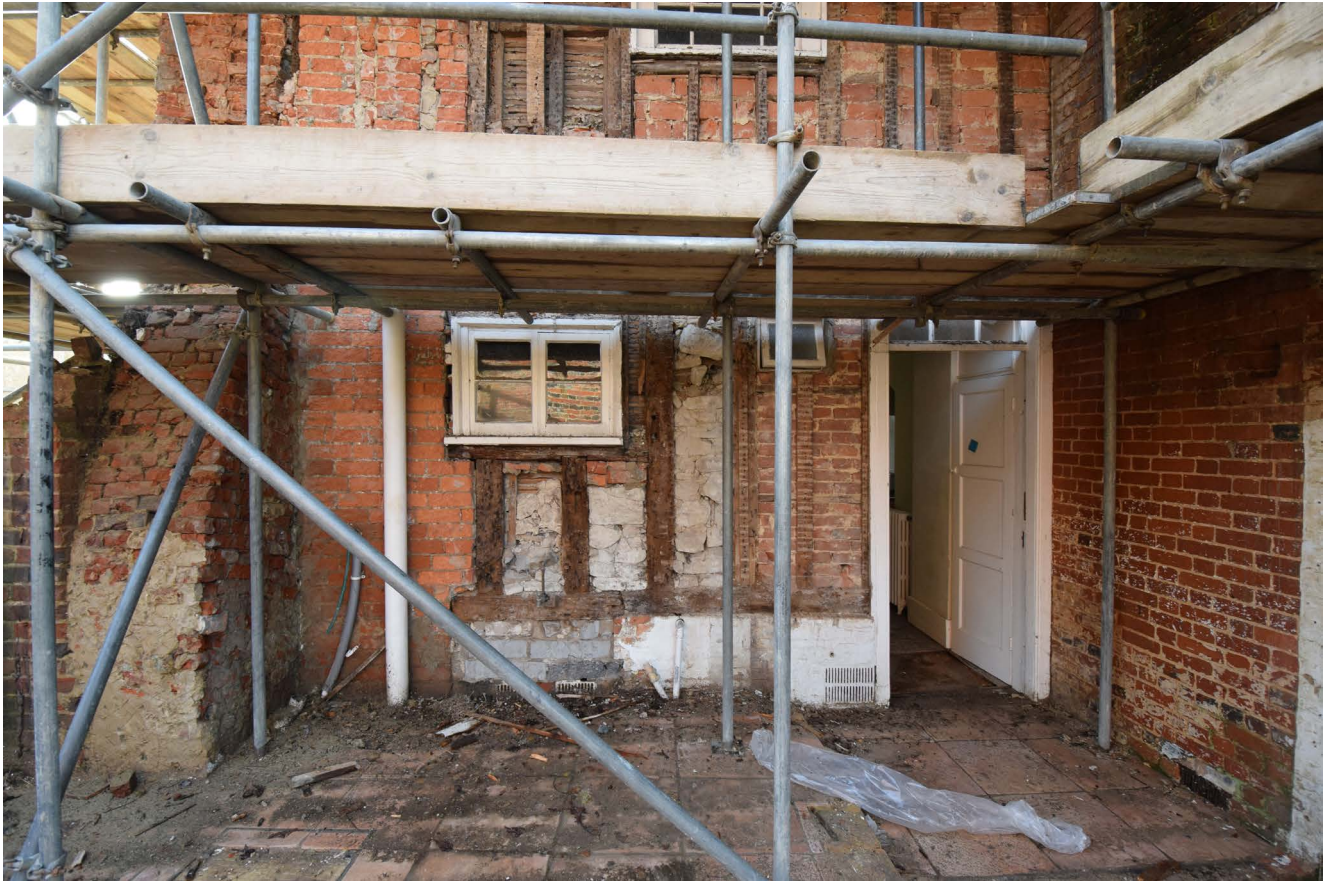
Plate 19: The north east elevation of the southernmost wing, ground floor

- 4.1.11 A large brick buttress had been constructed against the southernmost end of the wall which had been concealed by the modern conservatory. This was removed following correct repair of the wall (Pl 19).

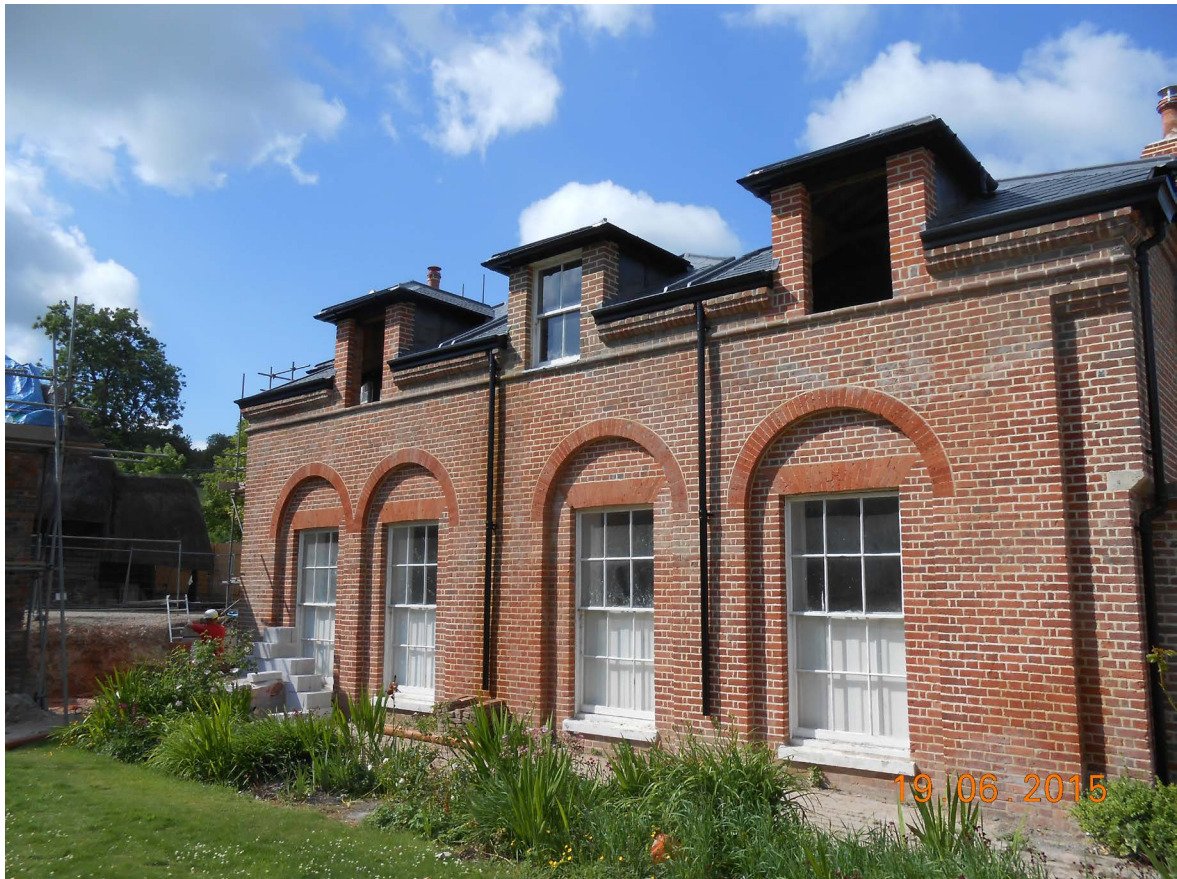
Plate 20: The 18th-century extension after construction of the new dormers. Photograph provided by Nigel Hutt, Clerk of Works

- 4.1.12 The brick-built extension was little-changed, other than necessary repointing and the roofline alterations described later (Pl 20). Plans to extend one of the windows to create a doorway were discarded and the openings remained as they were. The original mortar of the later upper courses of brickwork of the later side dormer was examined following the raking-out and the mortar was observed to be a hard grey lime mortar with inclusions of, what may be, reused lime (Pl 21). The mortar of the original extension is of cream-coloured lime mortar.

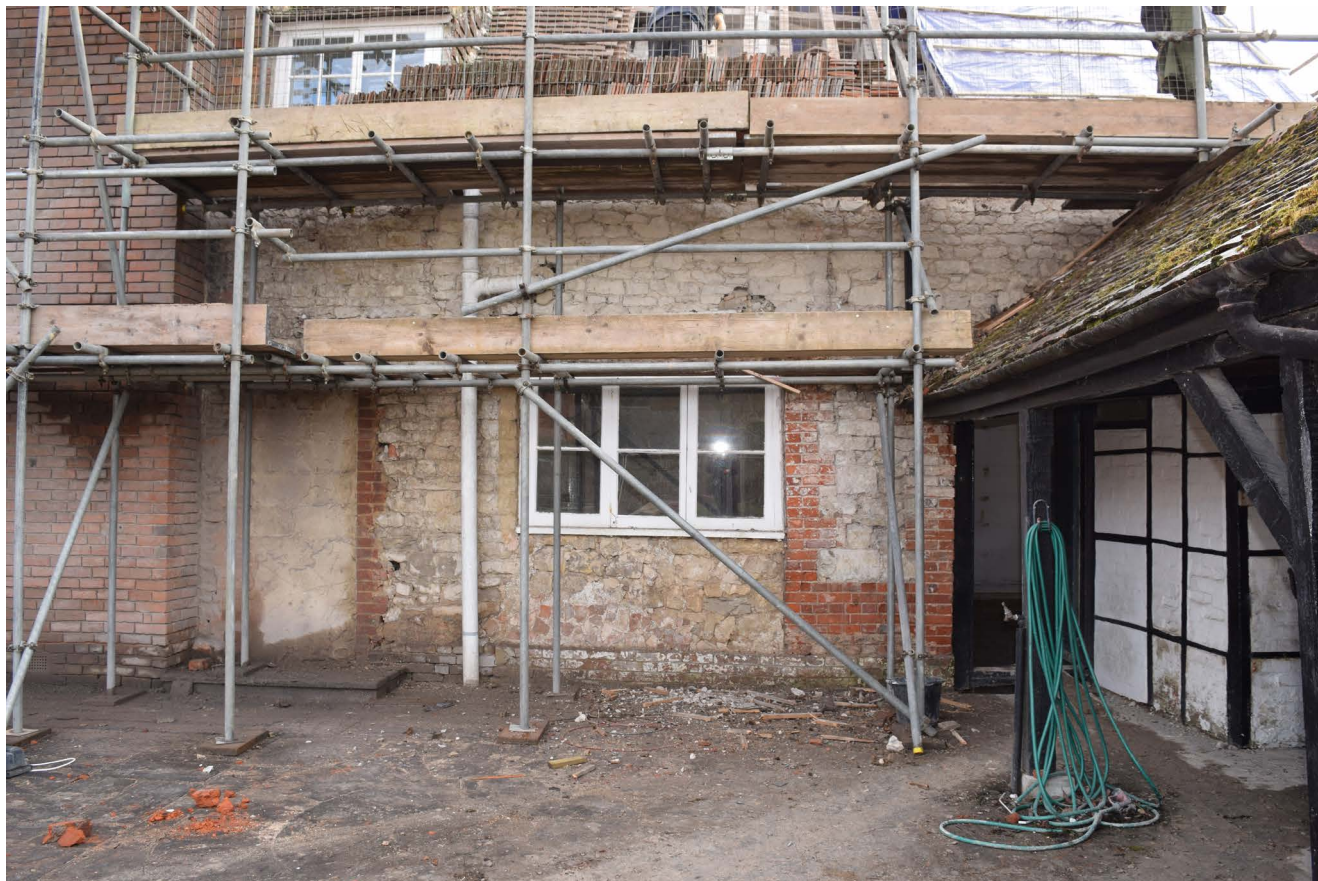
Plate 22: The south west end of the north west elevation after removal of the render

- 4.1.13 Once uncovered, the earlier part of the north-west elevation was revealed to be of stone (Pl 22). Some later brickwork indicates the location of the doorway to the former scullery blocked in the late 20th century, and the reworking of the window and door of the former library (Pl 23). There is no evidence of timber frame having been used in this elevation, and the rebuilding and reworking has replaced much of the original detail.
- 4.1.14 As with the rear elevation, this elevation of the brick-built extension was not altered and has received the necessary repointing as part of this project.

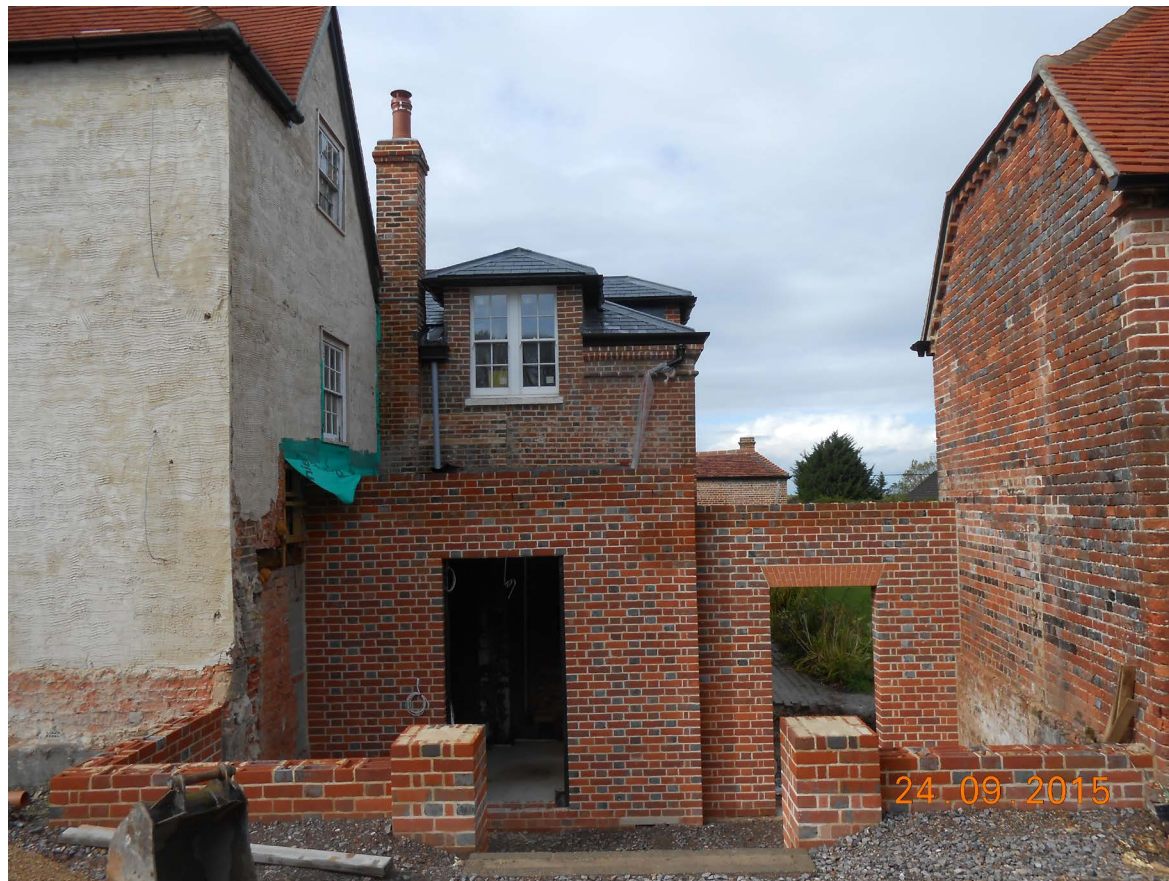
Plate 24: The construction of the new conservatory and new lime render. Photograph provided by Nigel Hutt, Clerk of Works

- 4.1.15 The conservatory, built c1999, was completely replaced (Pl 24). There were no features of historic interest within this structure.

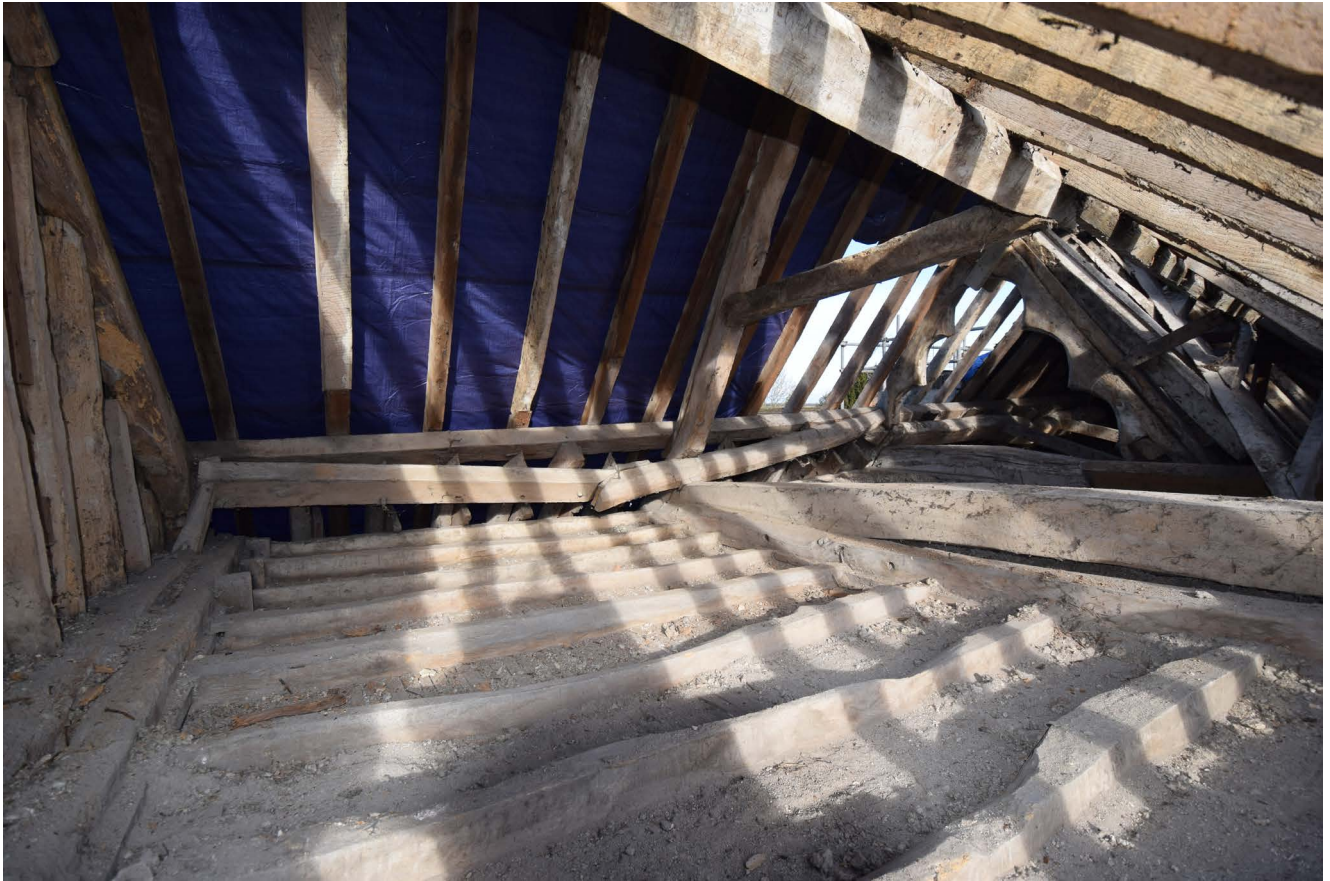
Plate 25: The roof structure of the northernmost wing and 14th-century timbers, looking north

- 4.2.10 Consistent with the haphazard nature of the roof, timber has been affixed to the back of the northernmost principal and abutting the face of the cusped timber of the older roof, the current rafters are fixed to the back of this. Two pieces of timber, roughly spliced together, have been fixed roughly parallel to this and has been accommodated into the northernmost joint of the principal and tie beam, presumably to implement a structural repair (seen in PI 25).

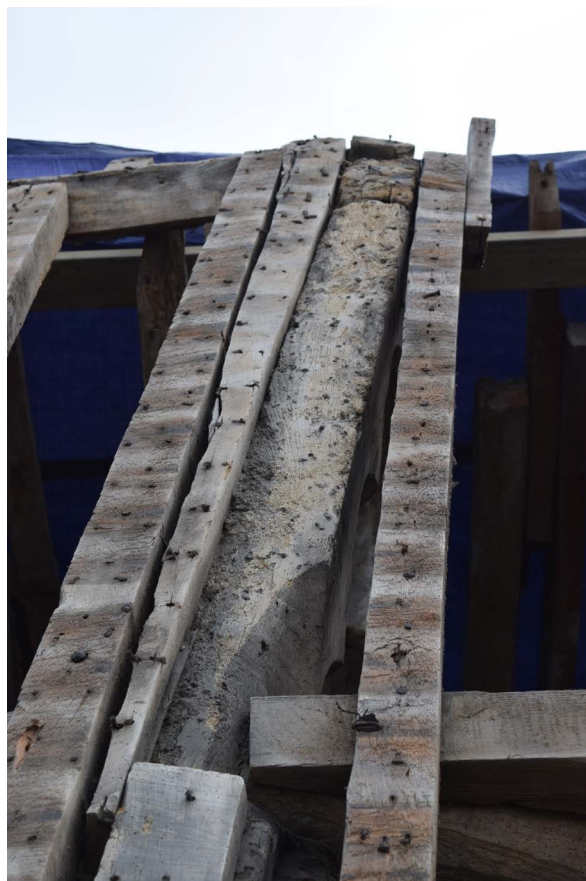
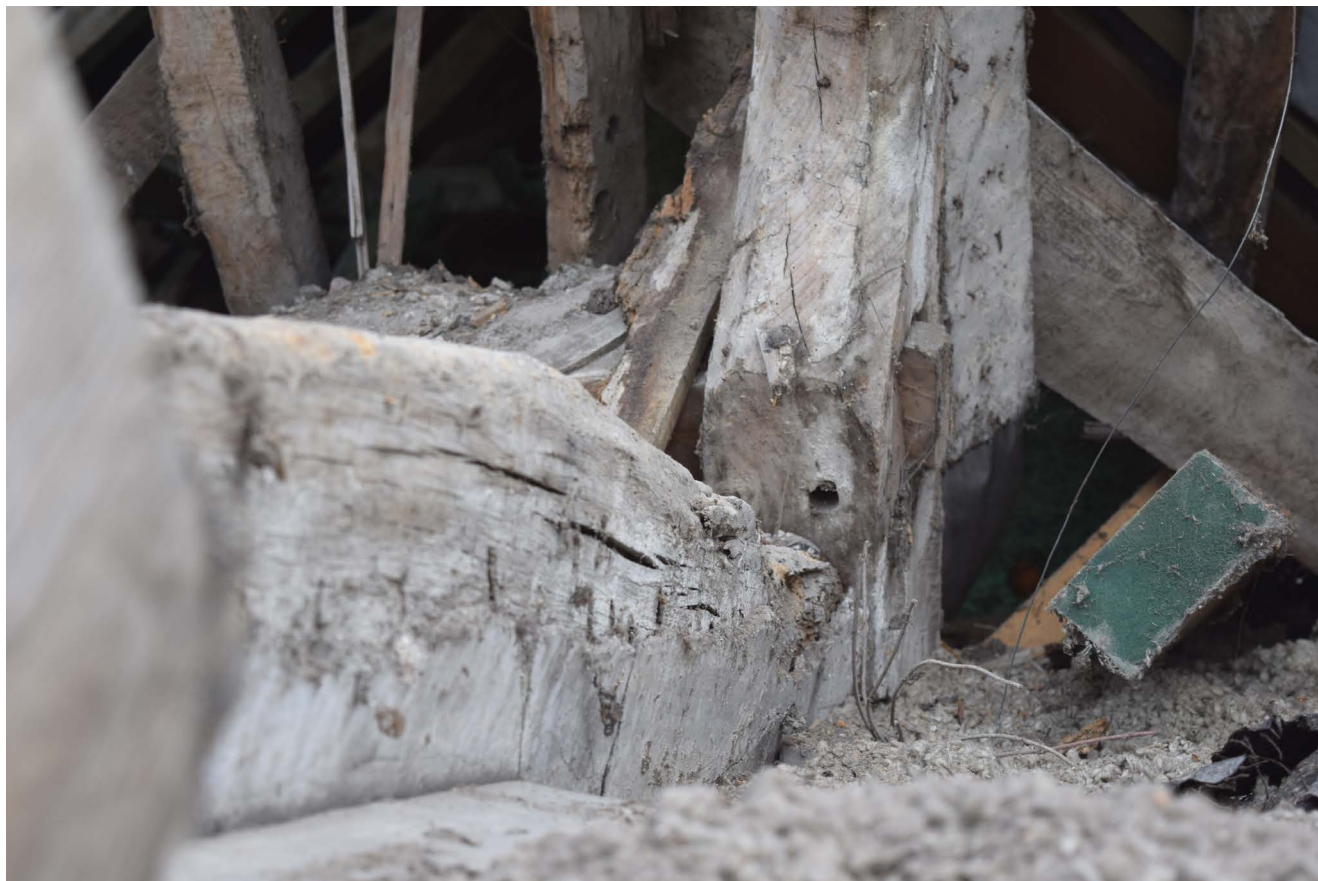
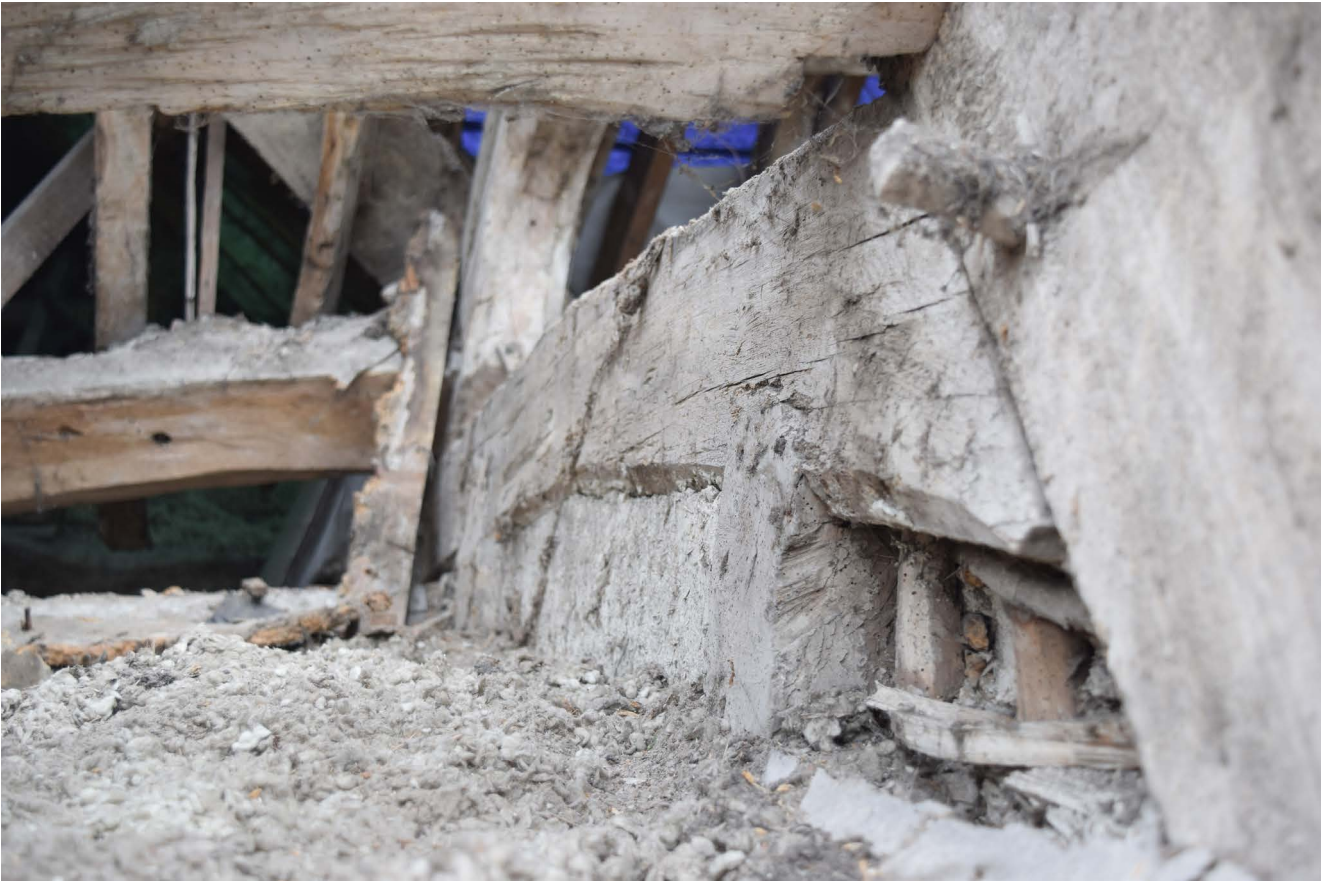
- 4.2.5 It may be argued that the cusped timbers and the cranked tiebeam are reused timber, as only one principal truss remains, and simply material repurposed from an early 14th-century building nearby. The timbers do show signs of possible alteration, however, this may also be attributed to damage caused by decay or the phases of alteration of the roof of this wing (Pls 29-31).

Plate 29: Damage or rework to 14th-century timbers, northernmost edge of principal rafter

Plate 30: Damage or rework to 14th-century timbers, southernmost join of rafter and tiebeam

Plate 31: Damage or rework to 14th-century timbers, north eastern face of tiebeam

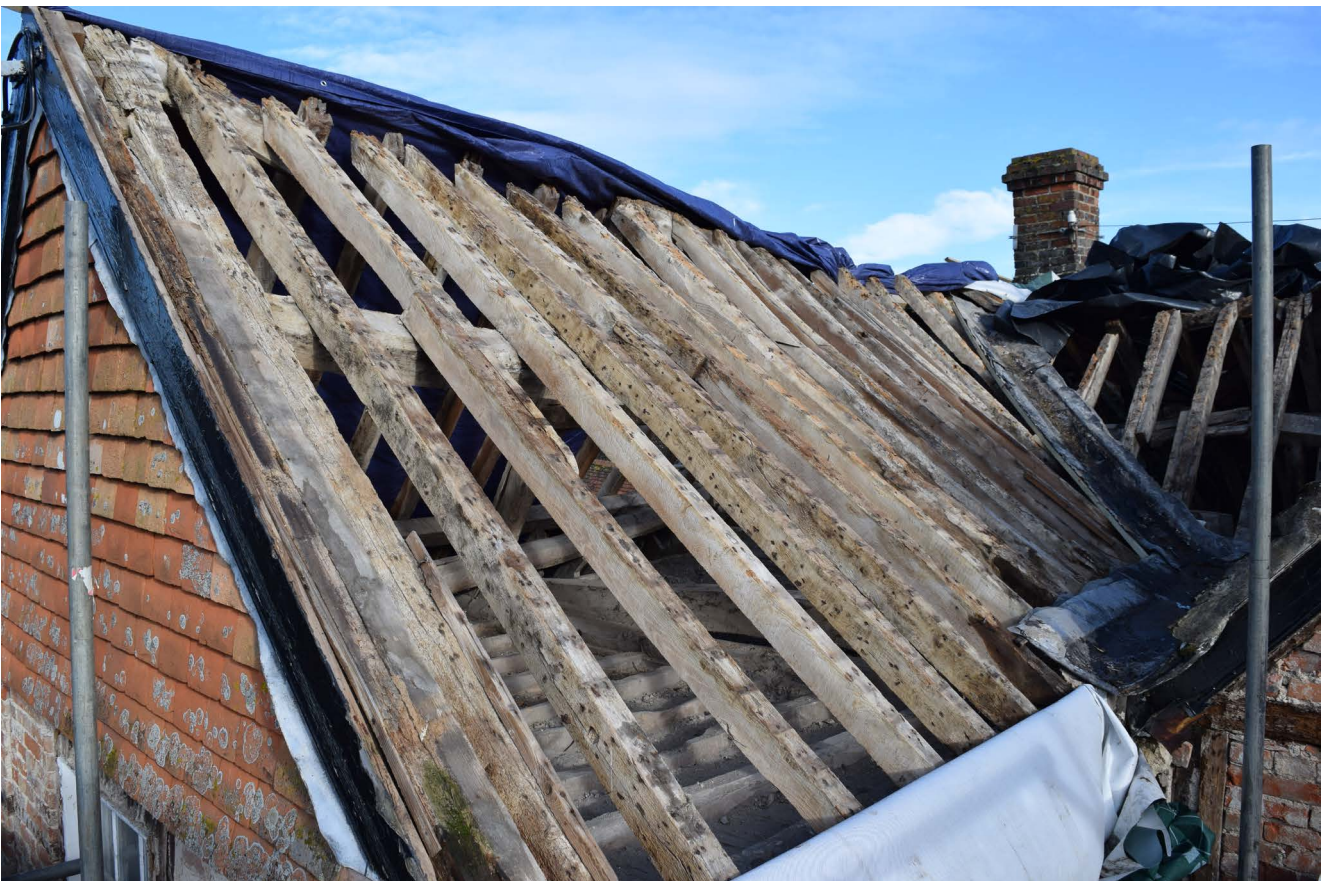
Plate 32: Southernmost rafters of the northernmost wing

- 4.2.8 The current roof structure has a ridge plank, albeit heavily decayed (PI 32). The common rafters of the northernmost slope have been replaced in one major repair, some of which have Baltic timber marks, indicating that they are imported from that area, a common source of softwood from the 17th century following the decline of available oak due to the demands of both house and ship building (PIs 33 & 34). The marks are scribed into timber before it is cut to size, hence the appearance of a series of random lines once in use.

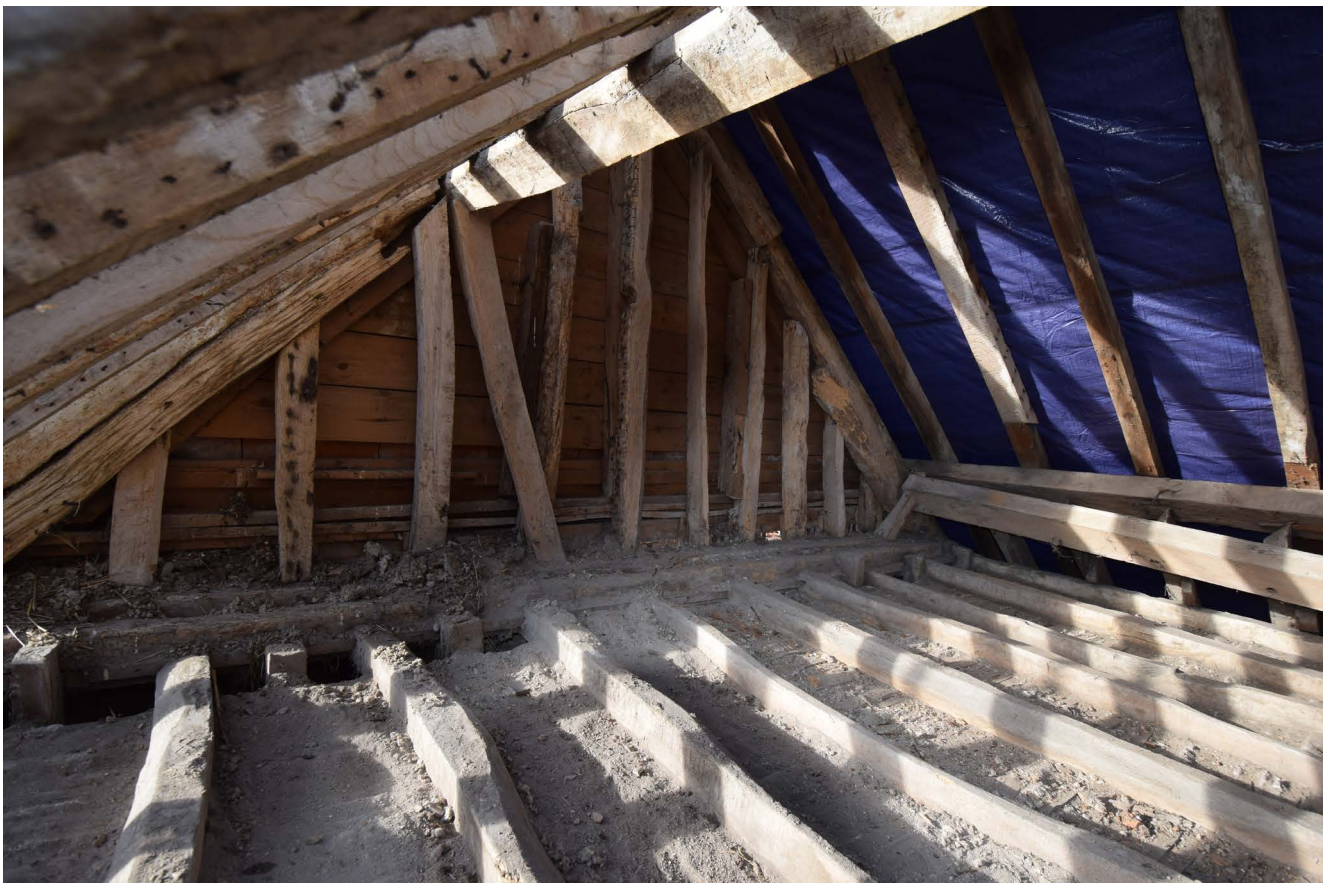
Plate 38: The timbers of the 17th-century northernmost wing extension

- 4.2.14 In the apex of the front gable, behind the hung tiles, is a simple arrangement of vertical timbers, some of which show signs of reuse, infilling the spaces in the end truss to support the battens for the tiles, which have since been replaced by modern horizontal boards. A brace between the purlin and beam has been added at some point (PI 38).
