The Old Rectory Letcombe Bassett

**Historic Buildings Recording and
Watching Brief**

southsouthsouth
January 2017

Client: Mr Nicholas Ashe

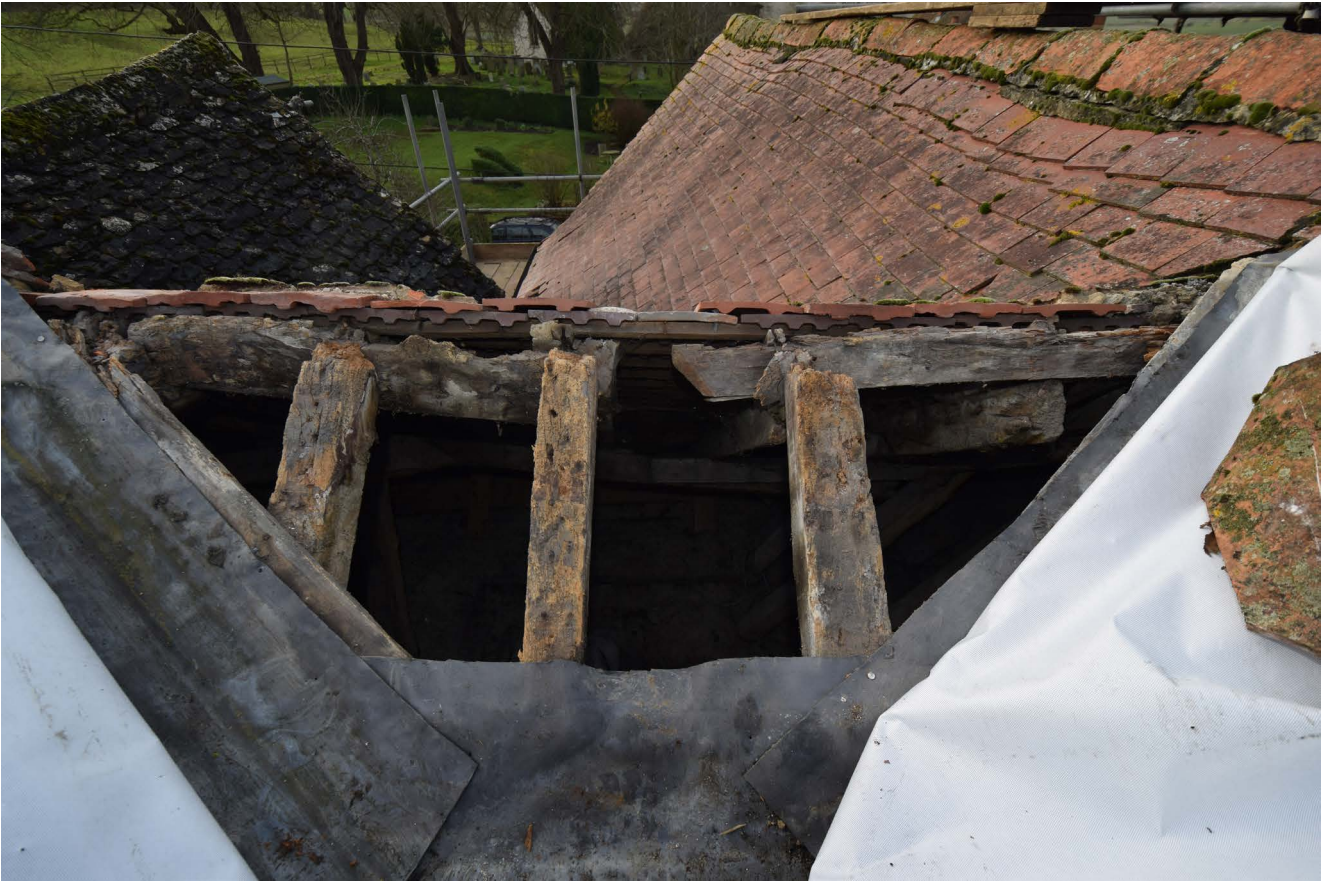
Plate 47: The roof structure linking northernmost wing and central bays, looking south west

- 4.2.21 The original rear roof of the central bays, which ran north west to south east, consists of a ridge plank, now very decayed, with common rafters nailed to it on either side which in turn are supported on a purlin (Pl 47). In some places, the purlin consists of several lengths of timber, braced in several places by posts supported on the beams or other members as necessary (Pl 48). Some of the bracing gives the appearance of raking struts, however, these are not part of a truss or directly associated with a principal or a truss (Pl 49). The limited visibility of the stone-covered roofs indicate that the structures of the two sides of the valley are the same. A combination of pegging and nailing has been used throughout, including to similar elements, and occasional reused timber is visible. These roofs display numerous repairs and additional timber bracing, as expected for structures of this age. There are a few surviving fragments of battens, but all traces of previous roof coverings have been removed.

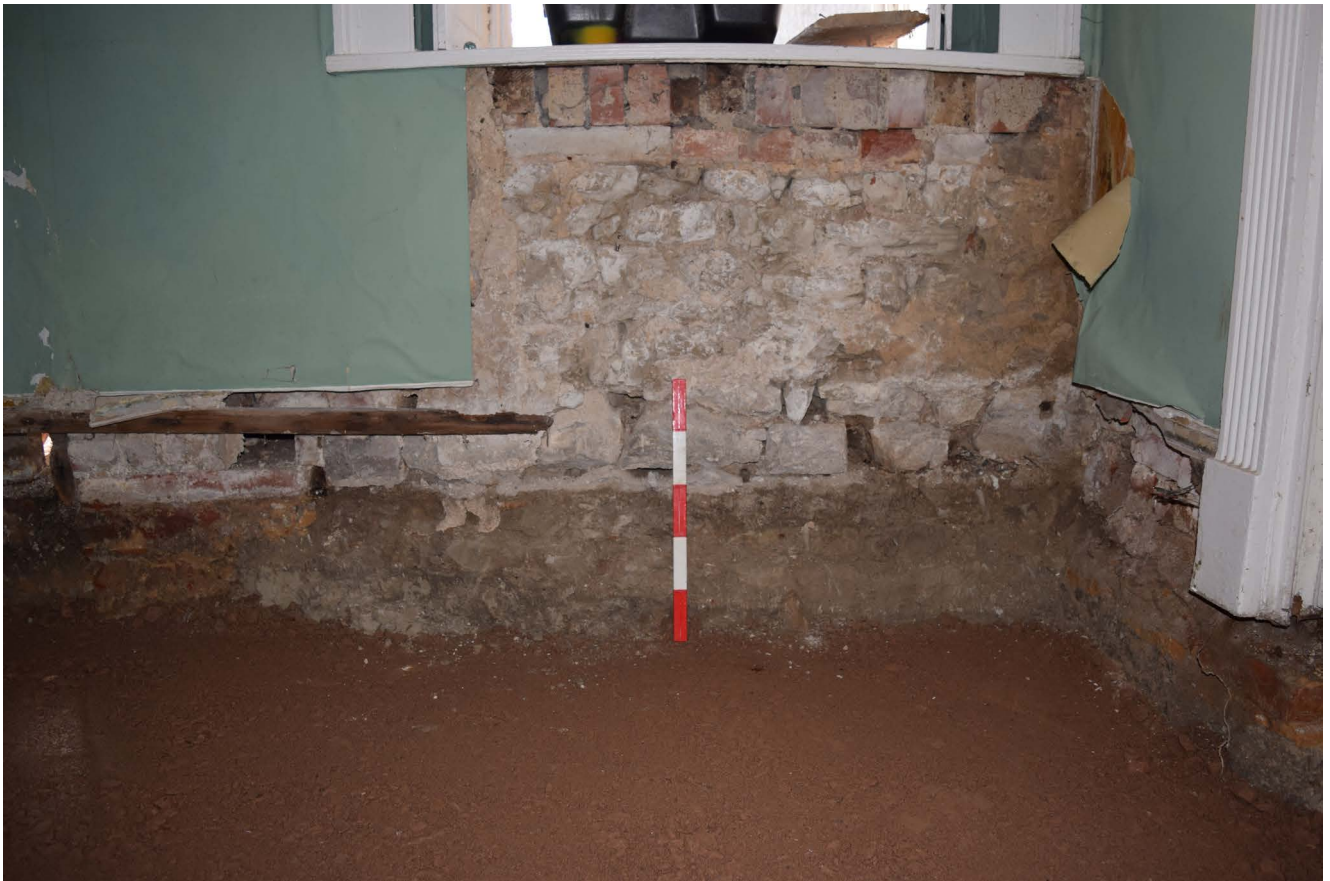
Plate 54: The base of the front wall of the Reception Hall

- 4.3.1 Due to considerable deflection, holes were cut into the plaster of the ceiling and the plaster covering the beams and their junctions to assess the condition of the timber. These confirmed that the decorative 'beams' consisted of laths and hair plaster over the structural timber beams (Pl 53).
- 4.3.2 The floor was excavated to allow damp-proofing and revealed shallow brick footings below the existing walls and some timber framing in the southernmost partition wall between the door to the rear hallway and the newly opened door to the downstairs study. Hardcore had been laid before the site visit, but no former features were observed by the builders (Pl 54).

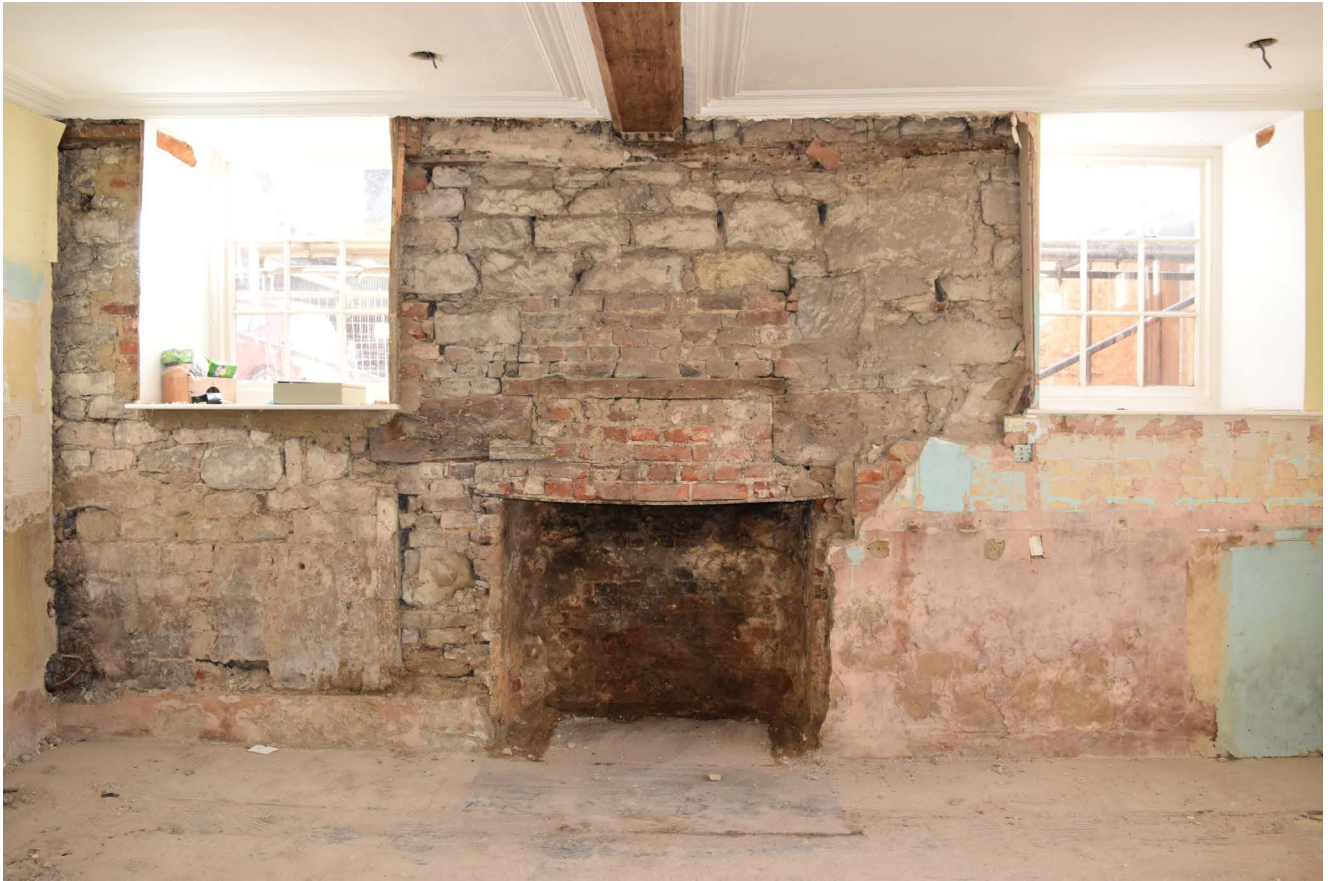
Plate 57: The south east wall and fireplace of the Kitchen after plaster stripping

- 4.3.9 Some of the modern plaster was removed from the southernmost wall where it had failed, revealing the stone internal face of the wall with at least three phases of alteration to the fireplace, indicated by the infill of two distinct phases of brickwork following the cutting of the timber lintel (Pl 57).

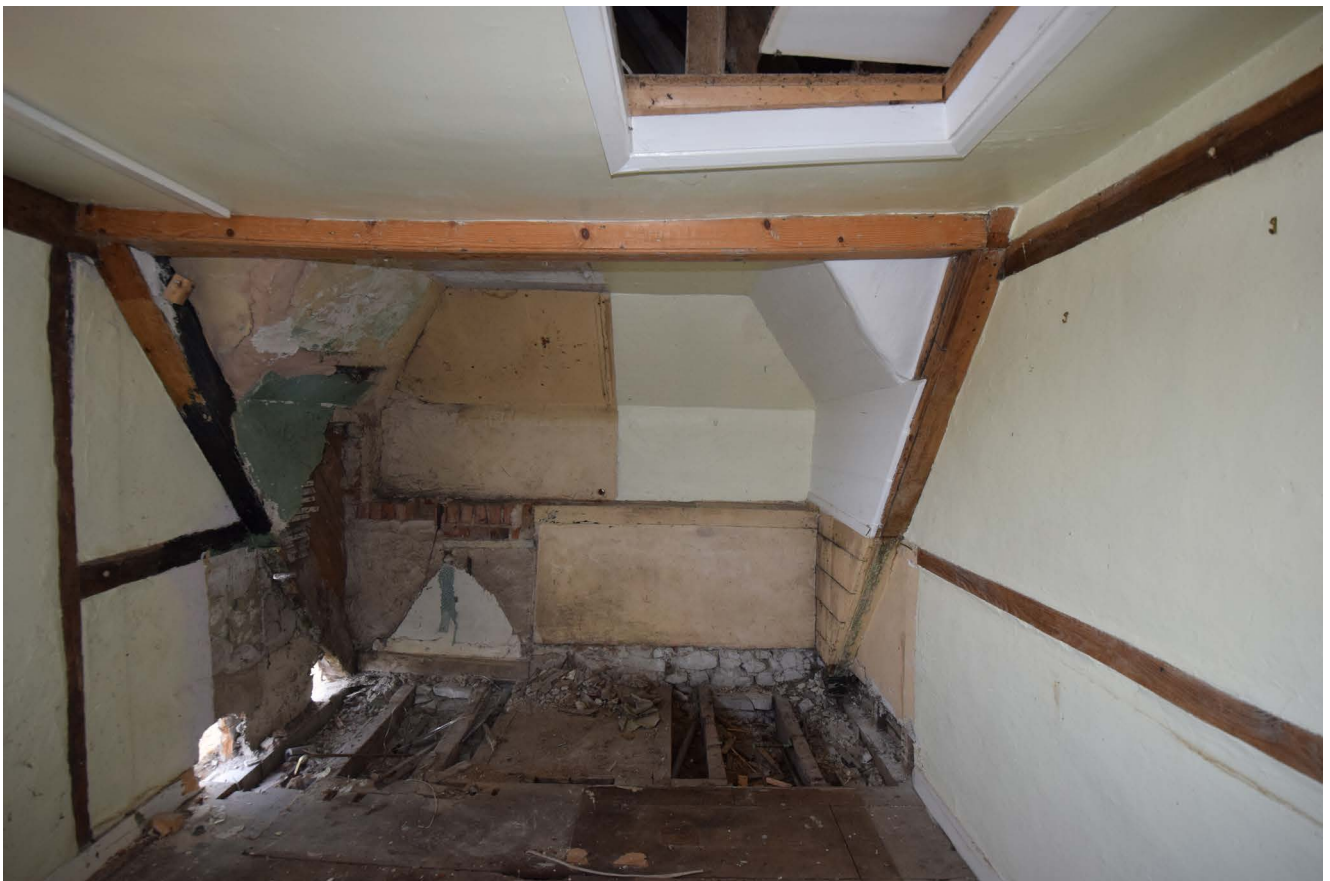
Plate 66: The visible brickwork and stonework in the south east wall of the second floor study

- 4.5.2 Late 20th-century cupboards were removed. Some of the plaster in the blind dormer had failed and exposed laths to the timber-framed gable and stone and brickwork to wallplate-height in the blind dormer (Pl 66).
- 4.5.3 The lath and plaster ceilings were taken down, exposing the roof structure as previously described. The carpenters' marks to the frame of the north eastern frame, detailed in the initial assessment, were confirmed as being unrelated to those on the rafters.
