The Old Rectory Letcombe Bassett

Historic Buildings Assessment and Heritage Impact Statement

Client Name: Mr Nicholas Ashe
Document Title: The Old Rectory, Letcombe Bassett
Document Type: Historic Building Assessment and Heritage Impact Statement
Issue Number: 2

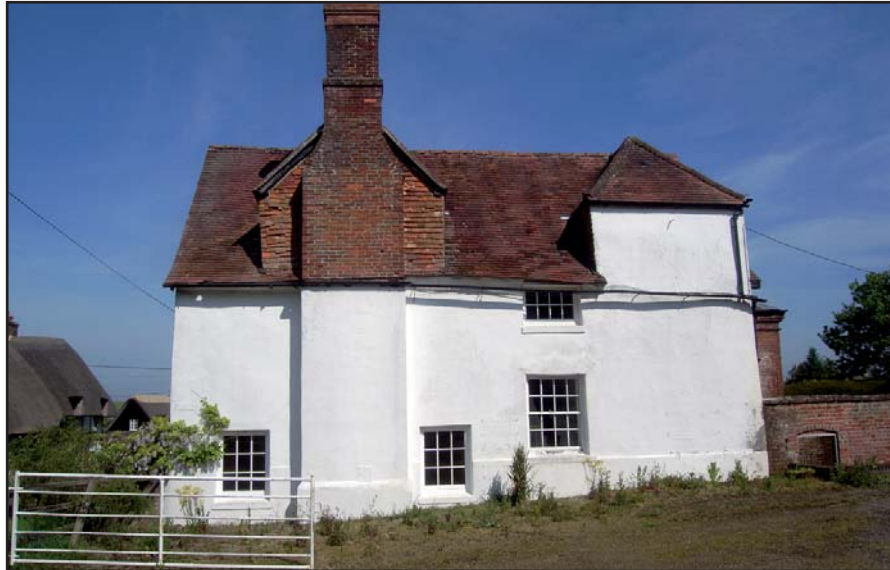
Plate 13 South-west elevation of the older building

- 3.1.17 The south-west elevation of the older building is painted render; one through-eaves hipped dormer and one gabled dormer which abuts the brick chimney stack, are present, both blind. The upper portion of the stack includes several vitrified headers which emphasises the beginnings and ends of three phases of repair or alteration (Pl. 13).

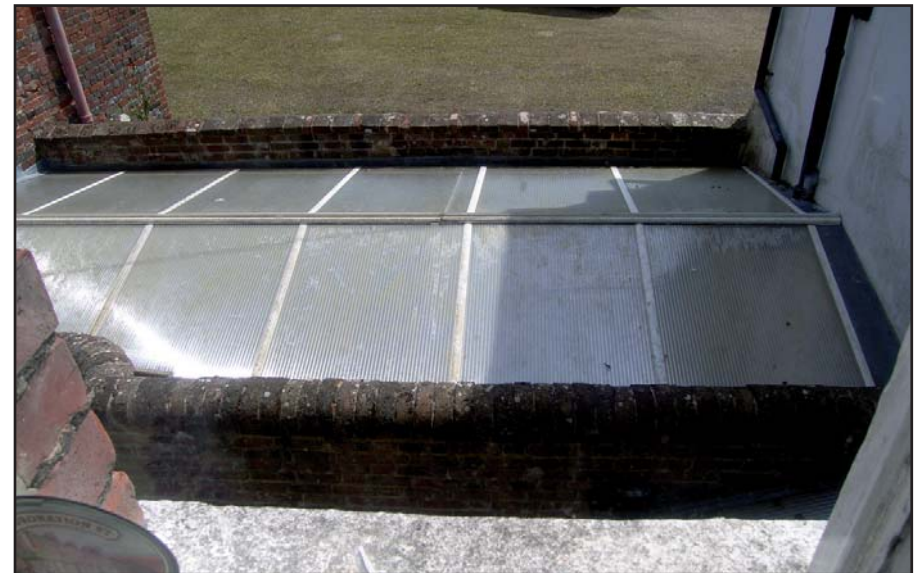
Plate 16 Roof of the conservatory

- 3.1.23 Extending from the rear of the house to the stable is a conservatory consisting of brick walls and a modern timber and plastic roof (Pl. 16). The walls, which abut the house and the stable to each end, are of reclaimed brick, likely to be repaired and/or rebuilt in the 1990s or early 2000s from the single-storey structure which formerly contained the outside WC and rainwater tank shown in the 1912 sanitary improvements plan. A short matching porch adjoins this and shelters the rear door to the house.

The demolition of the modern conservatory and replacement with a glass porch attached to the main house	<p>The existing conservatory was added in the late-twentieth century and, although designed in keeping with the appearance of the surrounding buildings, and on the approximate footprint of an earlier outbuilding, is having a detrimental effect of causing damp and efflorescence to the end wall of the coach house.</p> <p>The removal of the existing conservatory will have a positive impact on the heritage value of the house.</p> <p>The installation of a sympathetically designed new glass lean-to conservatory and porch will have minor detrimental impact on the heritage value of the house.</p>
The removal of the brick chimney stack to the north-west of the property. Victorian gothic cast iron fireplace in Bedroom 4 to be blocked, but grate and surround to be retained	<p>The brick stack to the north-west of the house serves only the fireplace in Bedroom 4. Contemporary with the Victorian Gothic cast iron fireplace, it has undergone several phases of repair and complete replacement of the dozen or so upper courses of brickwork.</p> <p>The stack does provide visual interest to the elevation and an indication of the history of the useage of the rooms within this wing. It's main interest lies within the installation of this fireplace and stack within what was the lower-status rooms and, soon after, specifically the servants' quarters of the house.</p>

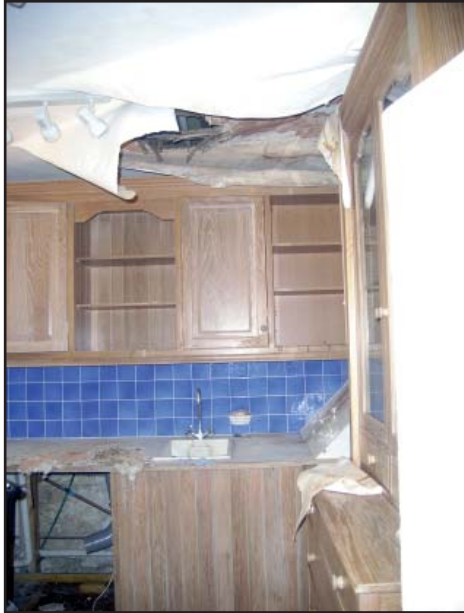
Plate 25 Utility room

- 3.1.33 Extensive damage to the lath and plaster ceiling was caused by a recent water leak (Pl. 25).
- 3.1.34 Obscured intersecting beams are present.
- 3.1.35 *The Conservatory*, as discussed in the exterior description, was rebuilt in the late 1990s or early 2000s, the tiled floor matching that of the Kitchen and Utility rooms (Pl. 26).

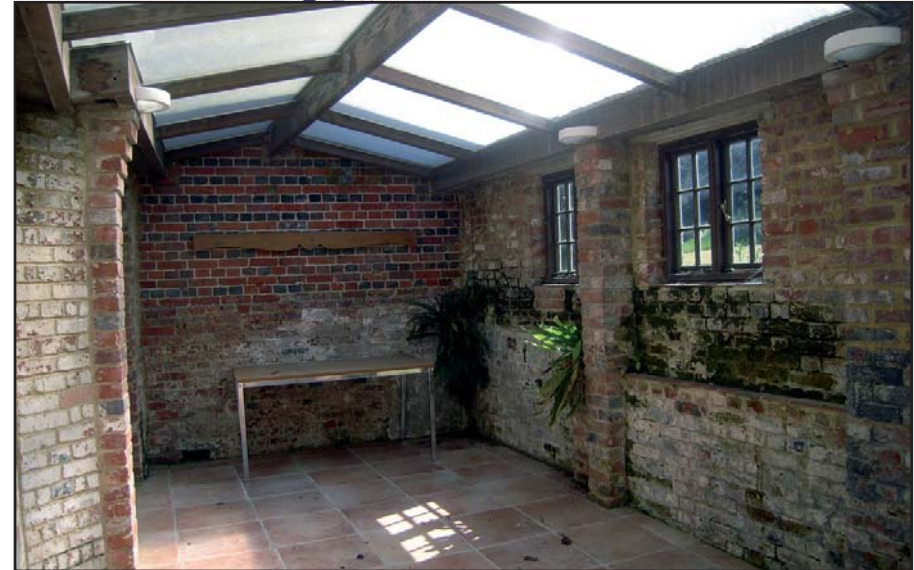
Plate 26 Conservatory showing efflorescence to the stable wall and ferns growing from walls

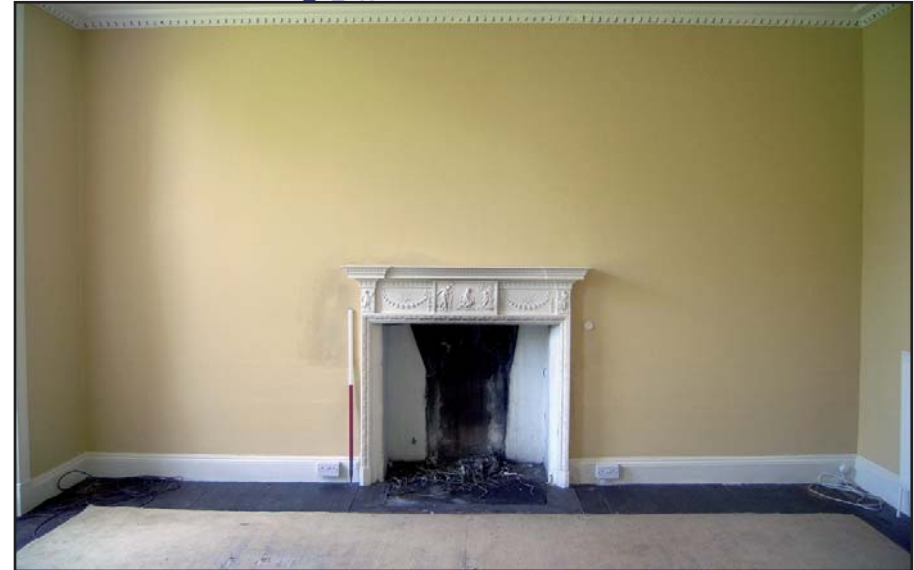
Plate 30 Sitting room fireplace

- 3.1.43 The grate is missing; the 1914 inventory lists a college grate with splay cheeks; the sale particulars show a modern fire, now removed (Pl. 30). The mantle is original, decorated

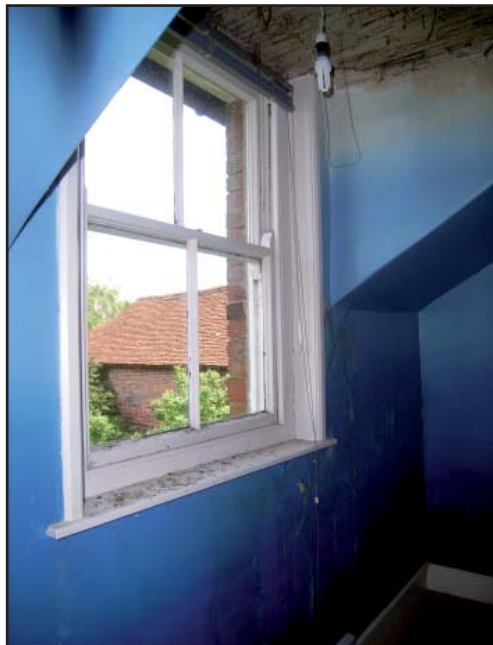
Plate 47 Bedroom 5

- 3.1.91 A horned sash window is to the right of the fireplace.
- 3.1.92 *Bedroom 5* contains the dormer window visible from the garden. A roof leak has exposed the lath and plaster ceiling above (Pl. 47).
