# **Plantation Mill, Peel Park, Accrington Lancashire**

## **Archaeological Survey**

May 2010

**Jacobs Engineering (UK) Ltd**

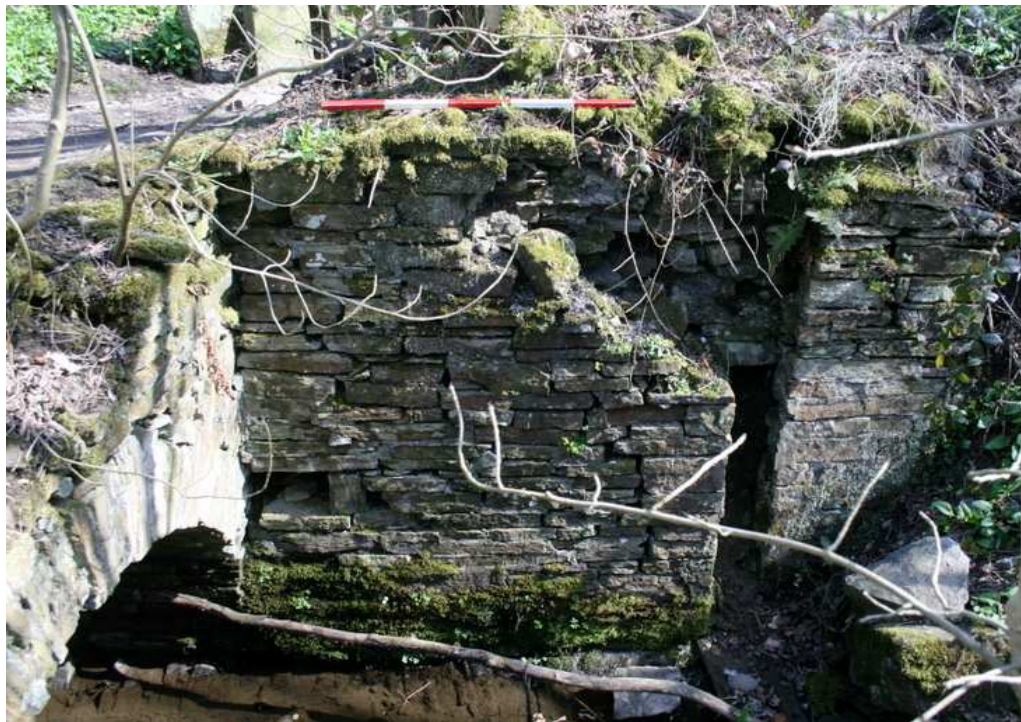
*Plate 11: North wall of sluice (A1\_1) with rebate for sluice gate*

- 4.2.3 Positioned approximately centrally within the extant fabric of the north wall is the housing of the sluice gate (Fig 8; Plate 11). This comprises a rebate in the wall, 0.22m wide, 0.31m deep, and 1.13m high, although where the wall facing survives on the eastern side of the aperture, this has a straight-edged return, suggesting the rebate for the sluice gate continued to the full height of the wall, at a reduced depth of 0.19m. At the base of the wall, a rectangular-section timber placed in the sluice channel (Plate 12) underlies the wall, and forms the bottom seal for the retractable sluice gate above. The north wall reduces in height by 0.65m at a distance of 0.72m to the east of the sluice (Fig 8). The extant higher section of the wall has a faced return into the hill slope, suggesting that the wall height was increased in the area of the sluice and the bridge, and was of a reduced height to the east.

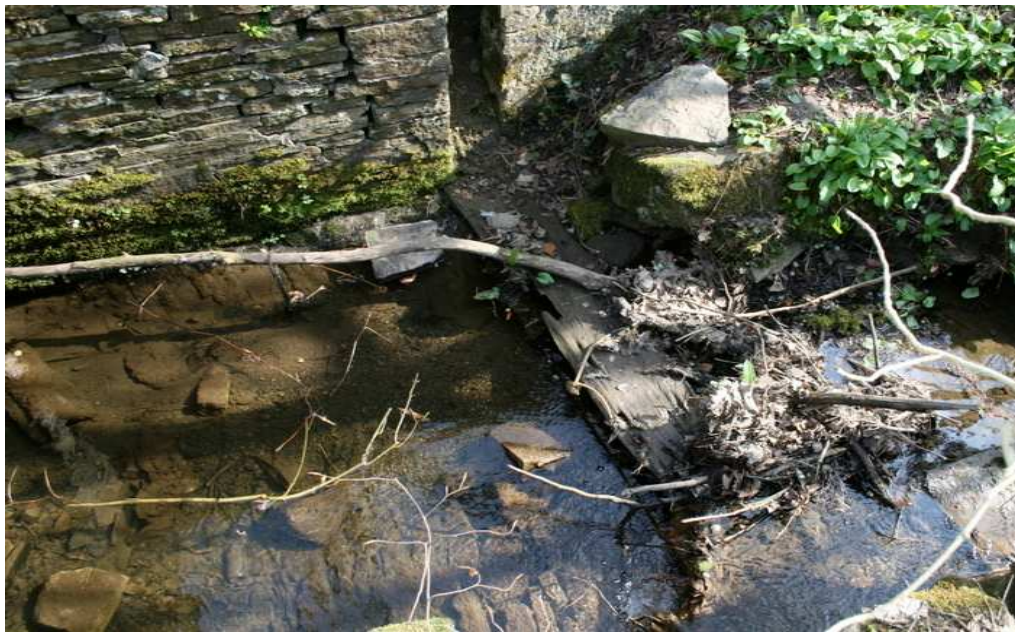
*Plate 12: Timber sluice board, with stone flooring to the left*

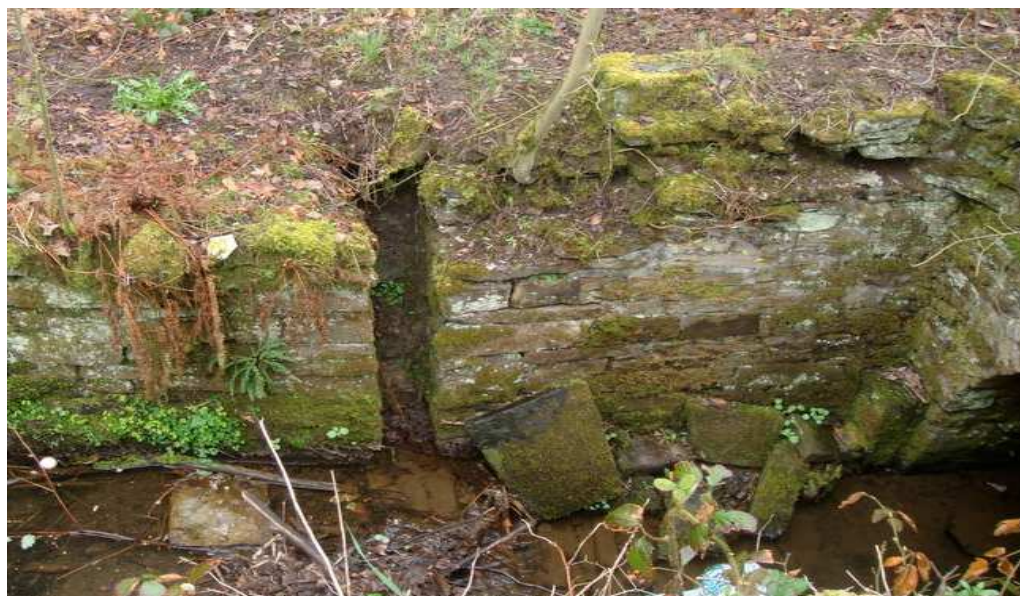
- 4.2.4 The south wall (Wall A1\_3; Fig 9) survives for a length of 8.13m, and curves sharply to the south-east from the position of the sluice gate, and becomes an earthfast bank below a well-established tree. The wall is of similar construction to the north wall, but is keyed into the bridge at its western end, with one of the upper stones being keyed across the joint between the two elements at an angle of approximately 45° (Plate 13). The aperture for the sluice gate is of similar dimensions to that in the north wall, although it survives to a much lower height (Fig 9; Plate 13). Again, it appears integral to the initial construction of the wall, and incorporates the timber sluice board within its base. The wall curves sharply to the east, through an angle of approximately 90°, presumably forming the western boundary wall of the reservoir. The wall was constructed to a greater height to the west of the sluice aperture, extending up to the level of the bridge to the west.

*Plate 13: South wall of sluice (A1\_3) with rebate for sluice gate*

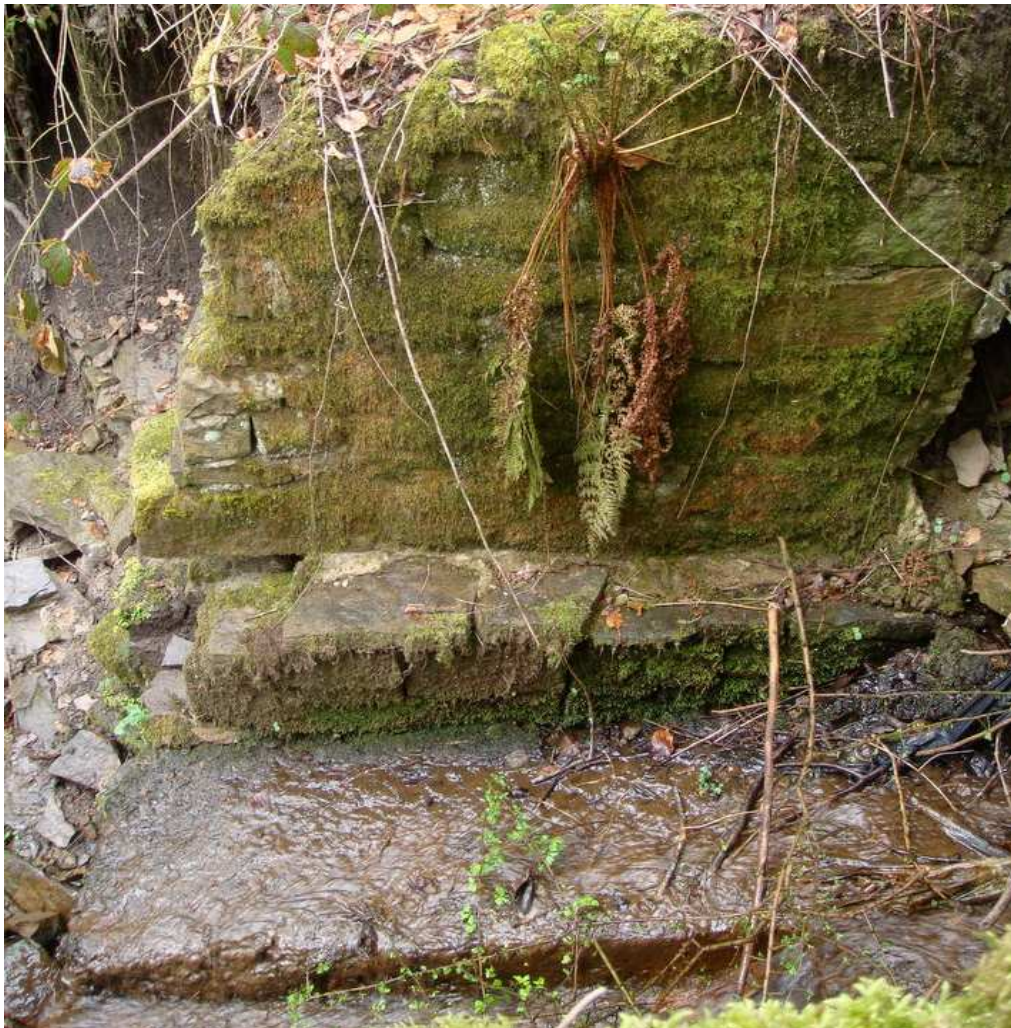
- 4.2.6 The sluice widens into the ravine of Pleck Brook to the west of the bridge, and has been remodelled heavily (Fig 7). This mainly involved the insertion of a concrete channel into the base of the sluice, which overlies the original edge-set sandstone floor at its eastern extent. This has sloping outer edges, with a vertical drop into a 0.61m wide, flat-bottomed central channel. It was presumably constructed to repair the base of the sluice, which terminates at the end of the concrete flooring (Plate 14).

Plate 14: North wall of sluice (AI\_4) with concrete sluice channel

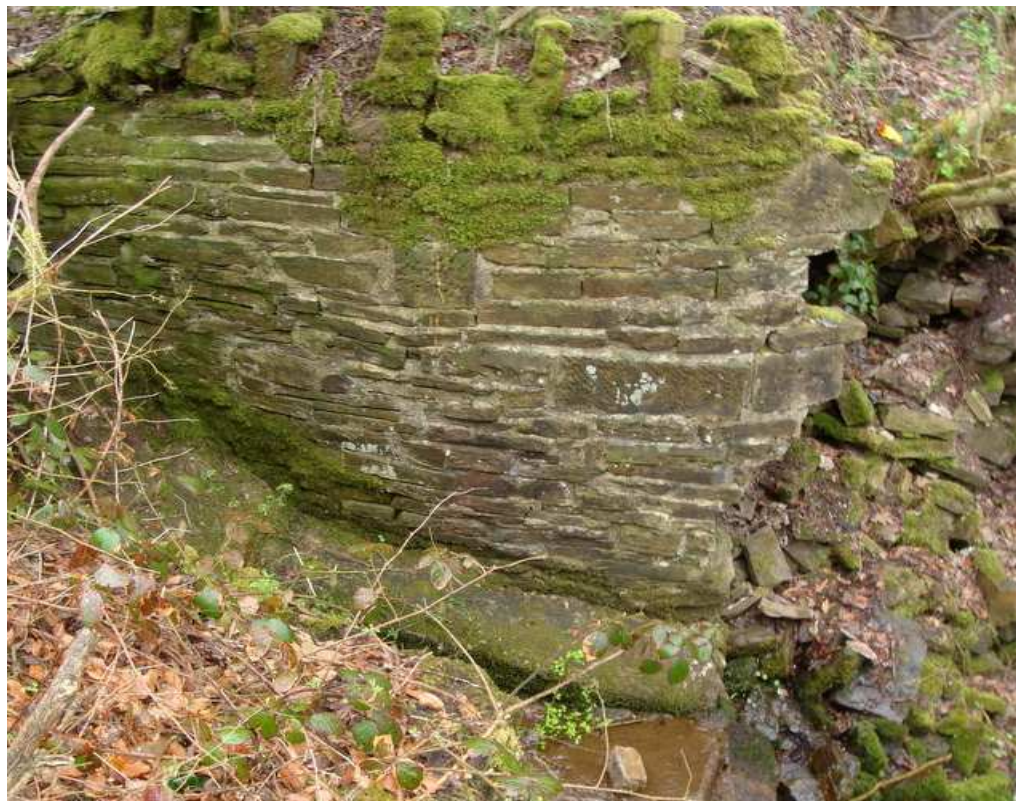
4.2.7 The majority of the north wall (Wall A1\_4) survives along this part of the sluice, although it has collapsed at its western end, and has lost several of the capping stones along its length (Fig 10). It has an offset plinth, 0.42m above its base (Plate 14), presumably for structural stability, and also allowing a greater flow of water through the channel when required. The southern wall (Wall A1\_6) survives to a greater height (a maximum of 2.59m), and retains several of its coping stones, laid in buck and doe style, comprising alternating raised and lower coping stones (Plate 15; Fig 11). At its western end, level with the end of the concrete channel within the sluice, the wall has a sharp curve to the south-west into the ravine of the Pleck Brook. However, the wall has collapsed almost immediately beyond this change of direction, surviving only as a loose rubble core (Plate 15). Both walls of the sluice abut the bridge to the east.

Plate 15: South wall of sluice (A1\_6) with concrete sluice channel

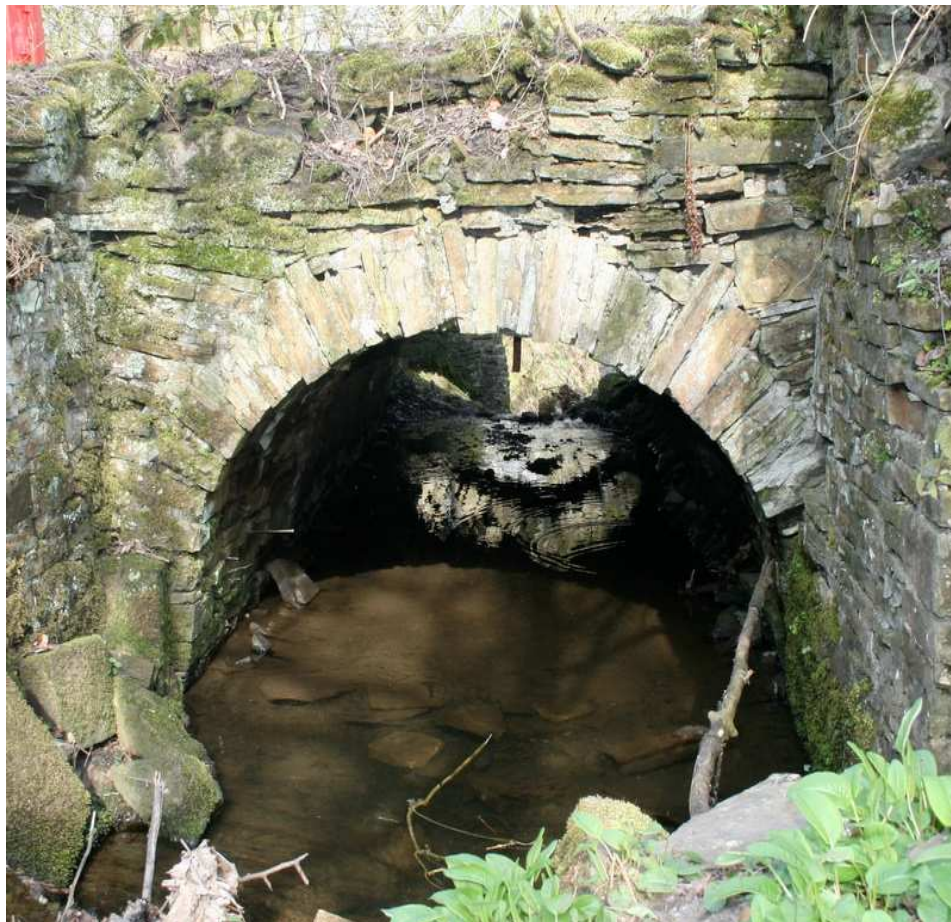
Plate 16: East face of bridge (A1\_2)

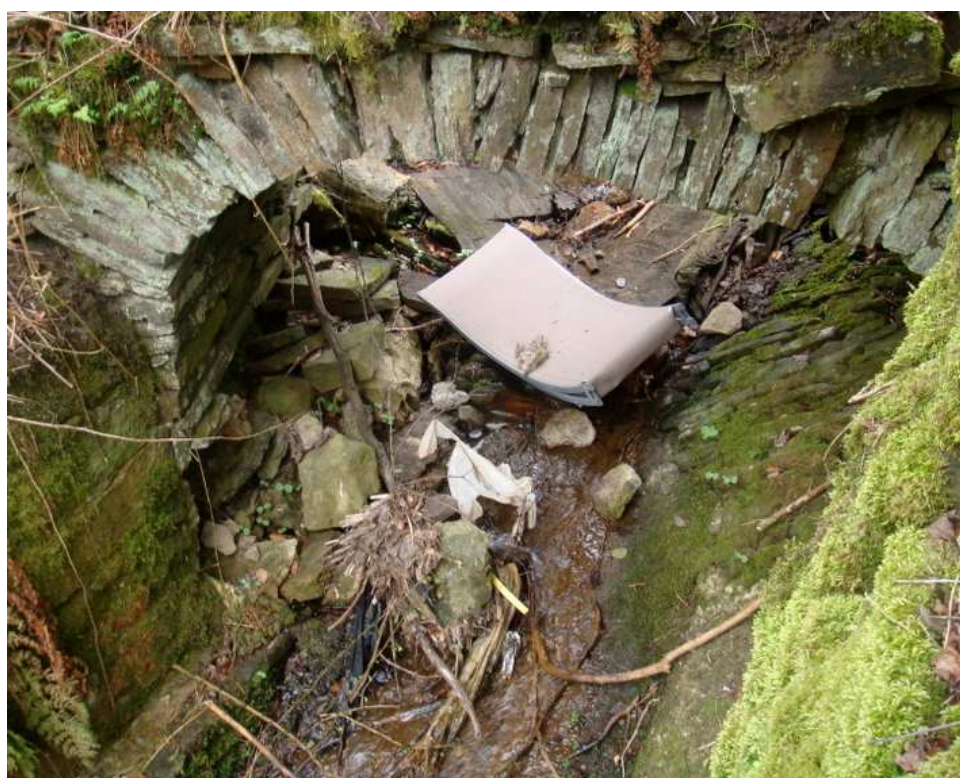
Plate 17: West face of bridge (A1\_2)

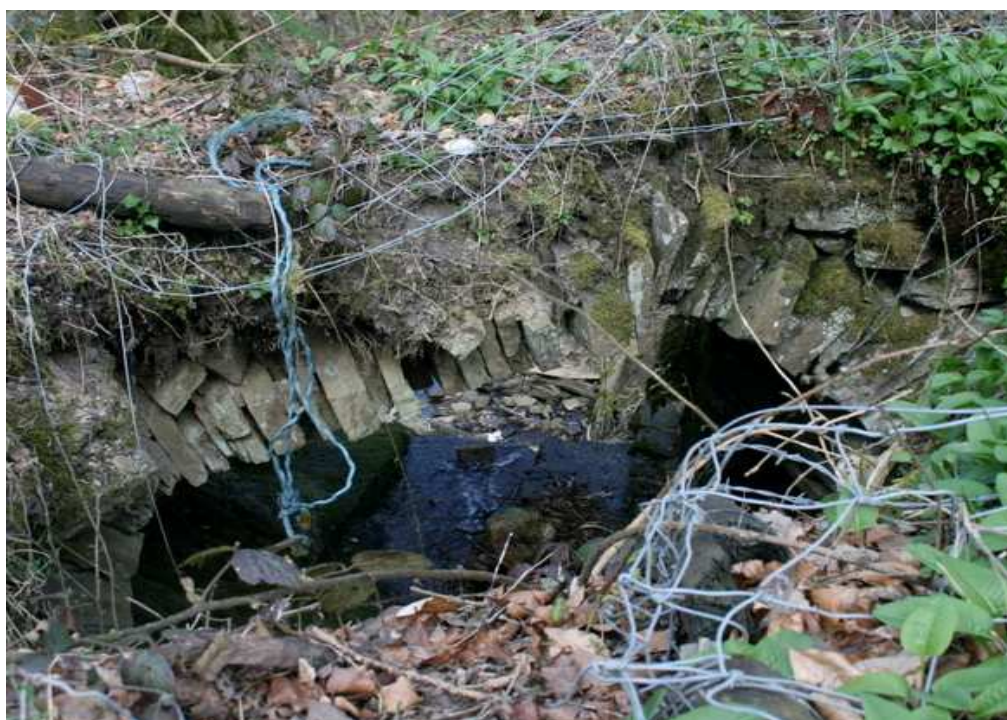
4.2.8 **Bridge:** a bridge appears to be depicted in this position in all the detailed historic mapping (*Section 3.5.5, above*), and carries a track over the Pleck Brook towards farms higher up the valley. It is still in use, and has a mud and rubble track bed, which appears to be very shallow, above the structural elements of the bridge. The bridge itself is of coursed, local sandstone rubble construction, with arches formed of edge-set, sandstone blocks, which have been roughly dressed (Figs 12 and 13; Plate 16). Whilst the two elevations of the bridge (Walls A1\_2 and A1\_5) survive in relatively good condition (although the western facade is heavily overgrown), the arch is in a very poor state of repair. At its western end it has been heavily compressed on its southern side (Fig 13; Plate 17), whilst in part of the central area of the bridge, it has collapsed completely, leaving a large void (Fig 7; Plate 18).

*Plate 18: collapsed section of bridge, showing instability of arch to west*

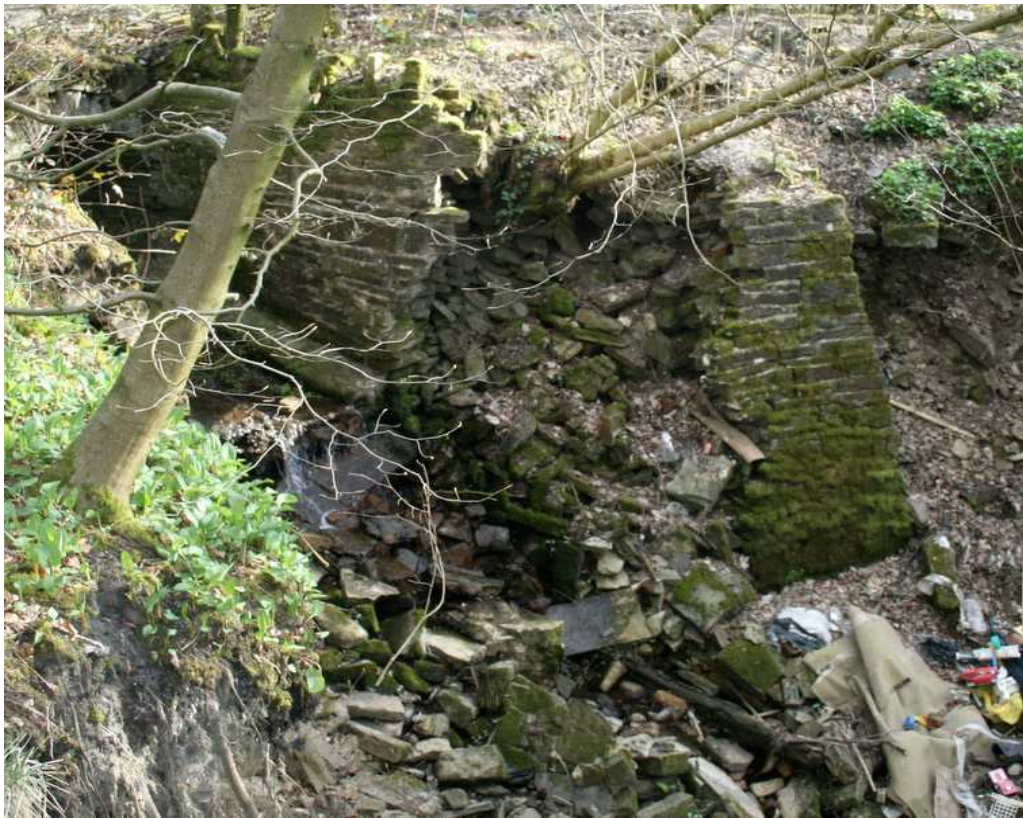
*Plate 19: Buttressed retaining wall on the south side of the ravine*

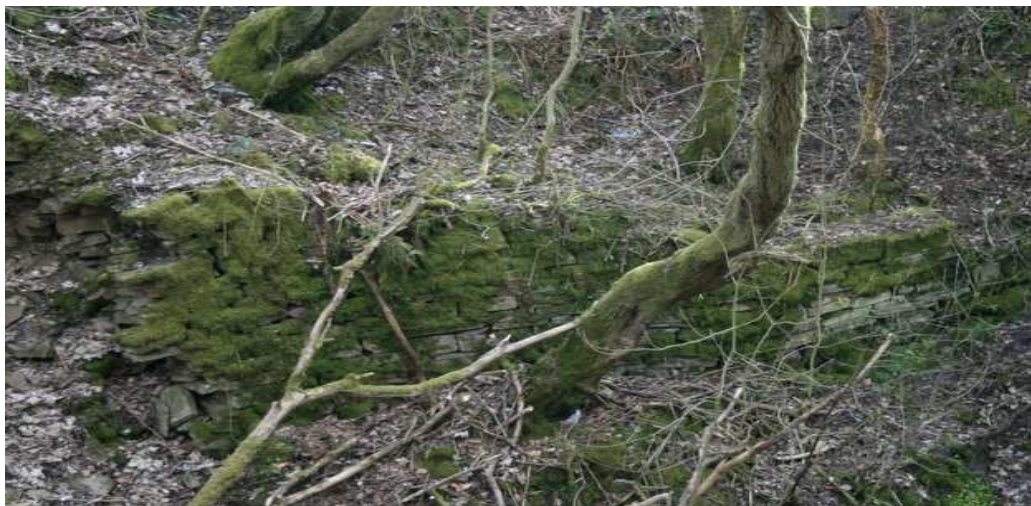
*Plate 20: Overgrown and partially collapsed retaining wall on the south side of the ravine*

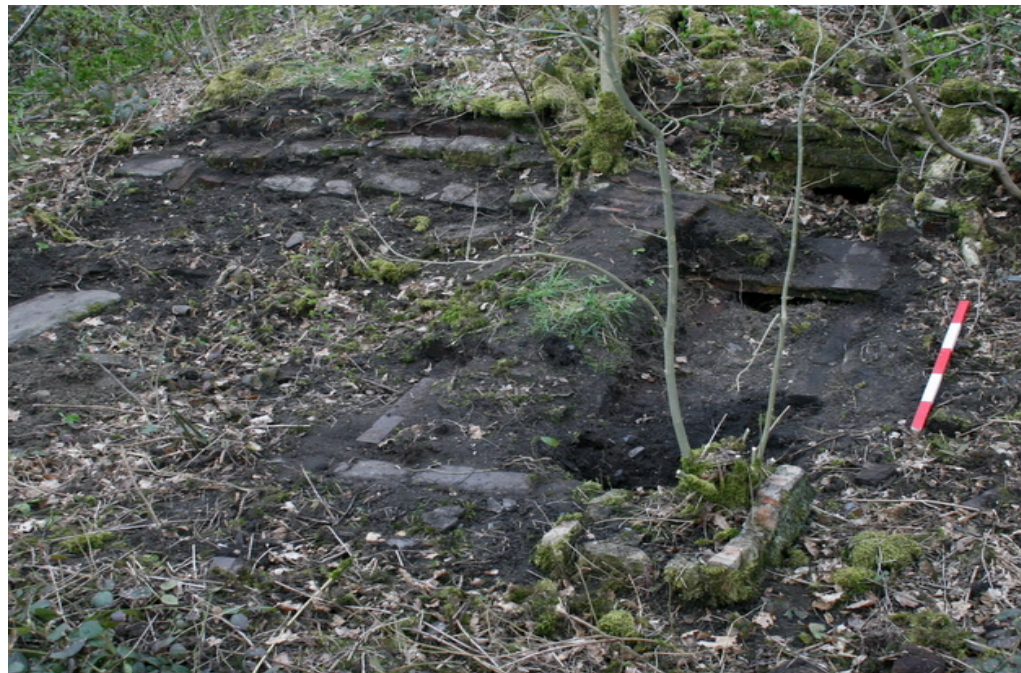
4.2.13 **Tank/culvert:** situated at a distance of approximately 6.5m to the west, a larger area of *in-situ* remains was revealed within the undergrowth (Fig 6; Plate 21). These remains included a wall of machine-made brick construction, which was 1½ bricks wide, and abutted a wall of sandstone rubble construction at its eastern end. The latter wall survived to three courses height, and had a 0.40m wide channel of brick and stone construction in its base. This ran 2.85m to the west, where it disappeared below another stone wall, which was capped with a small square structure, constructed of an edge-set refractory brick. Part of the channel, was also capped with refractory tile, suggesting that a possible tank overlying the culvert in this position may have been heated.

Plate 21: Culvert below probable tank, Area 1

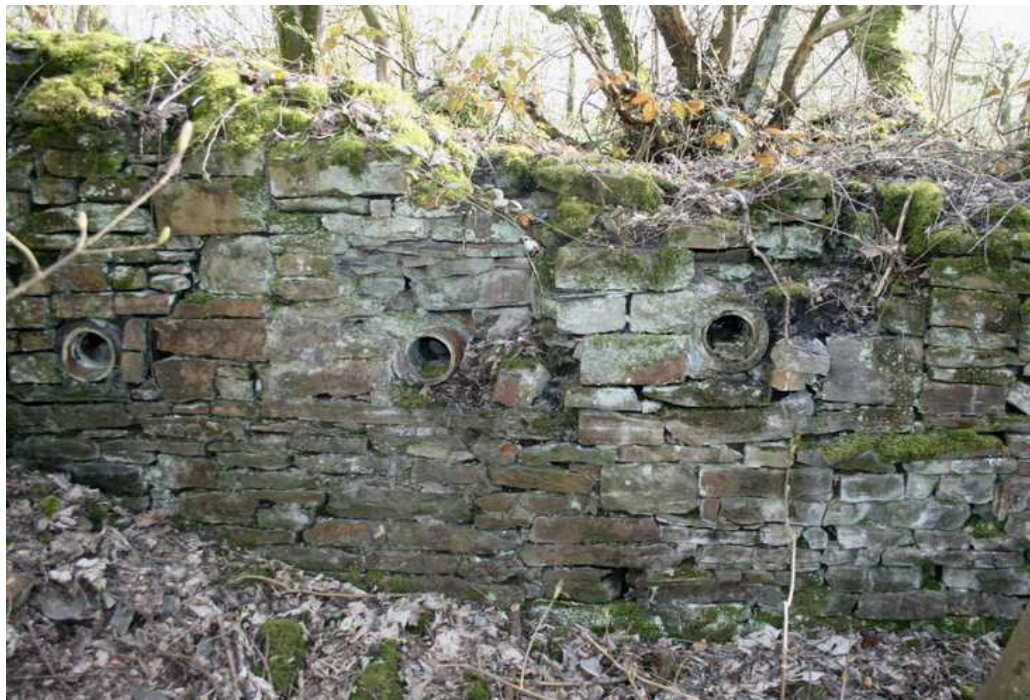
- 4.3.3 At the eastern end of the study area, an east/west-aligned sandstone wall (Wall A2\_1) survived for a length of 1.76m, and to a maximum height of 0.47m (Figs 15 and 16). At ground level at its eastern end, the vestiges of a possible northward return survived, whilst a damaged return to the south survived at its western end. This survived for a length of 2.57m, where it had an unclear junction with a more substantial east/west-aligned wall (Wall A2\_2), which survived to a maximum height of 1.73m, and for a length of 13.85m (Fig 15). This contained elements of phasing, demonstrating the development of the printworks over time. The initial phase comprised a wall of roughly dressed and coursed sandstone rubble, bonded in a lime mortar, although the majority of the wall face comprised hungry joints (Plate 22).

Plate 22: Wall A2\_2, with blocked window apertures and inserted ceramic pipes

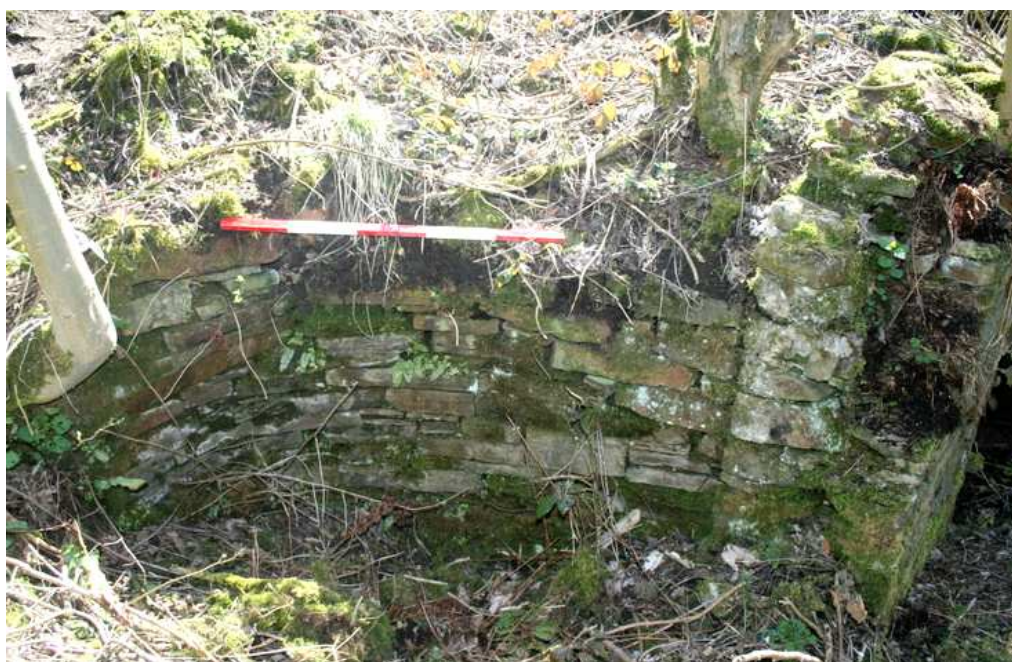
- 4.3.5 Immediately beyond the bank of the path the wall returns to the south (Wall A2\_3), emerging from the bank and surviving to a height of 1.00m. It curved sharply to the west through 90° (Figs 15 and 18; Plate 23), probably forming the rear of a storage bin, as these typically had curved walls to prevent the contents accumulating in corners. At its western end, the wall abuts a double-skinned stone wall (Wall A2\_4) with rubble core, which presently terminates at this point, but originally extended further to the north, the footings of which survive for a short distance at ground level (Fig 19). This wall is 0.5m thick and survives to a maximum height of 1.45m, bonded in its core with a pale lime mortar. At its southern end, where it is keyed into an east/west-aligned return, it has been partly remodelled subsequently to allow for the insertion of an overflow associated with a leat from the reservoir above (Figs 19 and 20).

*Plate 23: Curved Wall A2\_3, possibly forming a storage bin*

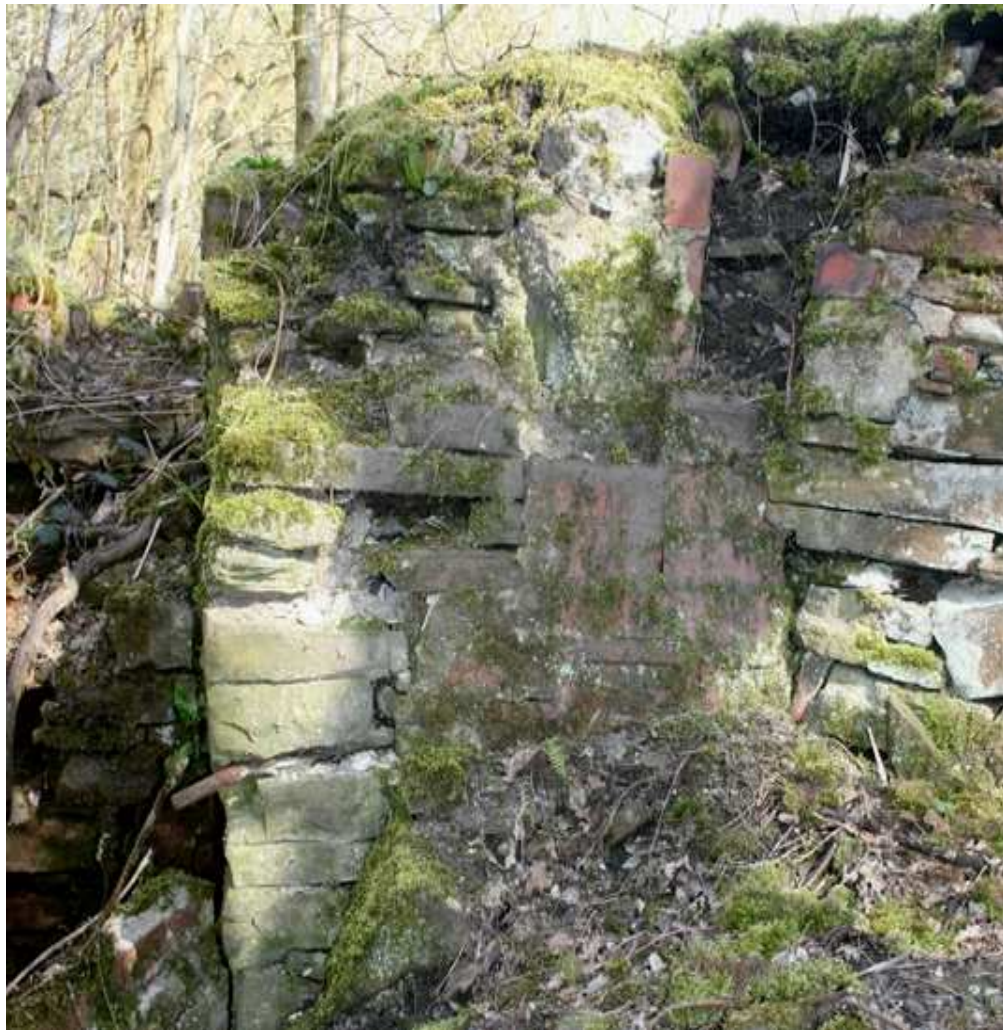
- 4.3.6 The leat from the reservoir was constructed of machine-made red bricks and concrete, and incorporated the remains of a sluice gate at its eastern end (Plate 24). It appears to have originally dog-legged slightly to the south, and entered what was probably a tank that was situated between the reservoir wall and the return wall of the building (Wall A2\_5; Figs 19 and 21). The aperture of the leat had been brick-blocked subsequently, and the area between the retaining wall of the reservoir and the rear wall of the building had been infilled with rubble, forming a gradual slope between the two structures. The wall face containing the leat aperture appeared to be part of a buttress, and whilst this could not be established with confidence, it may have been constructed as a return of the south wall of the building (Figs 19, 20, and 22; Plate 24).

Plate 24: Blocked aperture for leat in Wall A2\_4, and attachment bolt protruding from face

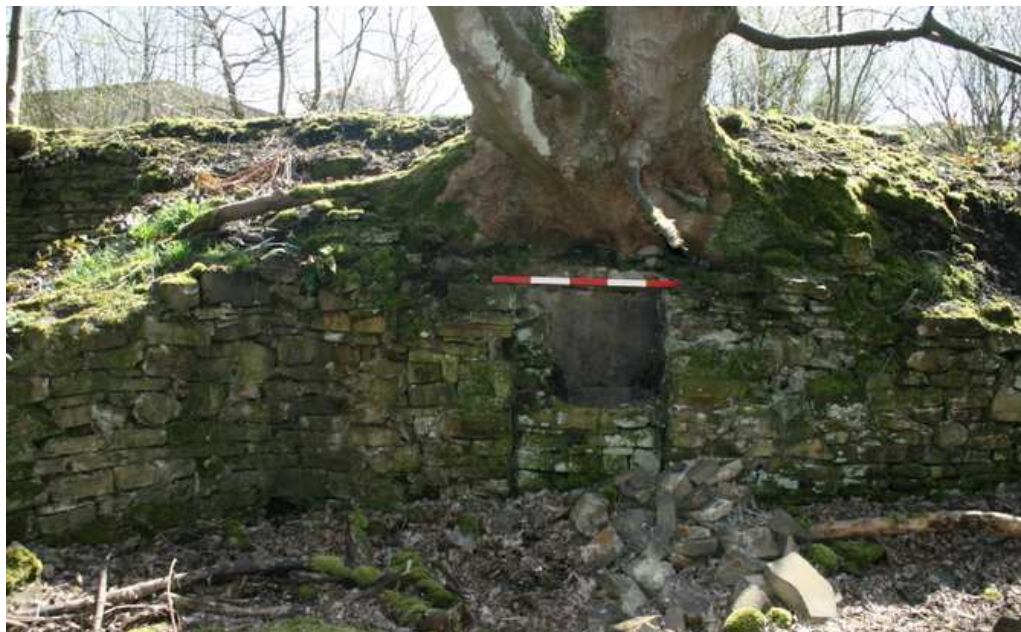
*Plate 25: Wall A2\_7, with partially blocked aperture, and invasive large tree*

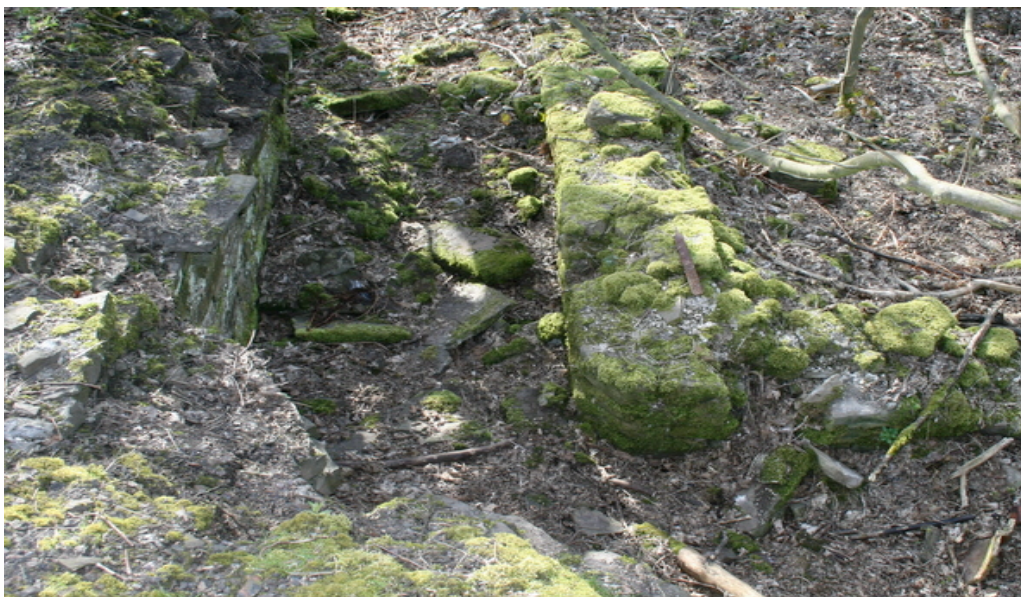
*Plate 26: Remains of earthfast walls forming an earlier external wall of the printworks*

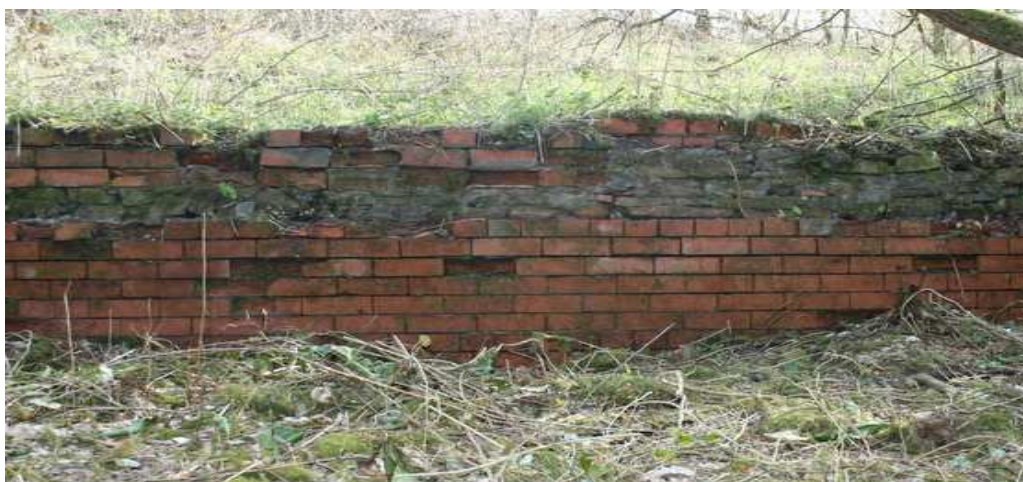
- 4.3.11 The wall is obscured completely to the west by vegetation for a distance of approximately 12m, reappearing as a stone wall lined with machine-made bricks (Wall A2\_13; Figs 27 and 28). This represents a remodelled or strengthening of the wall, and comprises locally-made 'Accrington' red bricks (Plate 27). At its western end, both the stone and brick elements of the wall return to the north, at a height of only 0.39m, before returning west as a shallow battered, stone retaining wall, for a distance of 13m (Fig 29; Plate 28). At the western end of the study area, this has a northward return as an earthfast wall, the vertical face of which is visible intermittently for approximately 12.7m. In the undergrowth between these two walls, the partial remains of a culvert are visible (Plate 29). This is of stone construction, measures 1.86m wide, and survives to a height of two courses on its northern side. It still retains water at its western end, and follows the alignment of the retaining walls. Its precise function remains, although it possibly represents a drain from the main processing areas from the structures adjacent to the reservoir to the east.

*Plate 26: Section of Wall A2\_13, with 'Accrington' brick refacing*

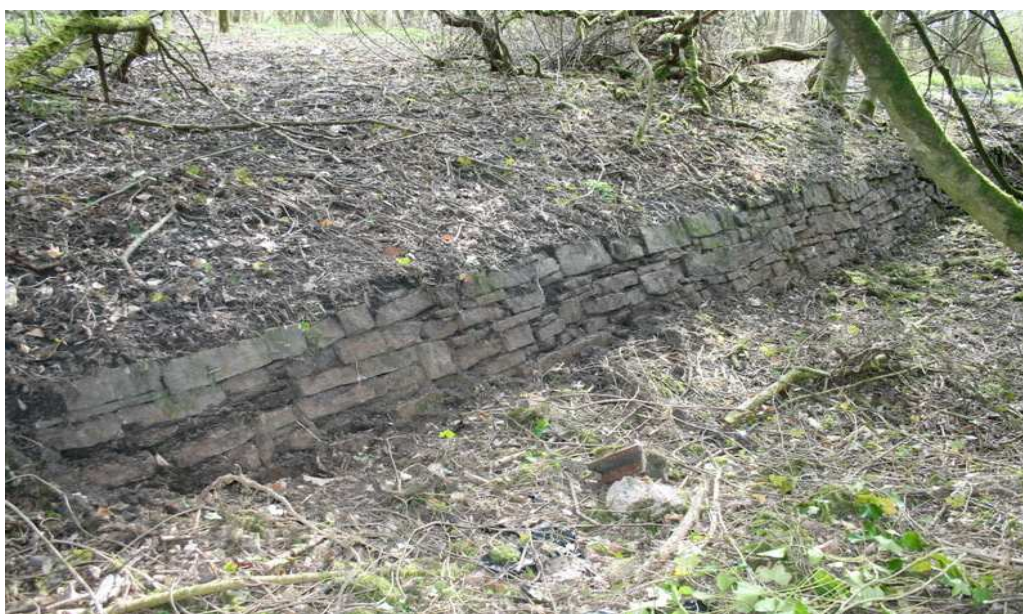
*Plate 27: Battered retaining wall at the western end of Area 2*

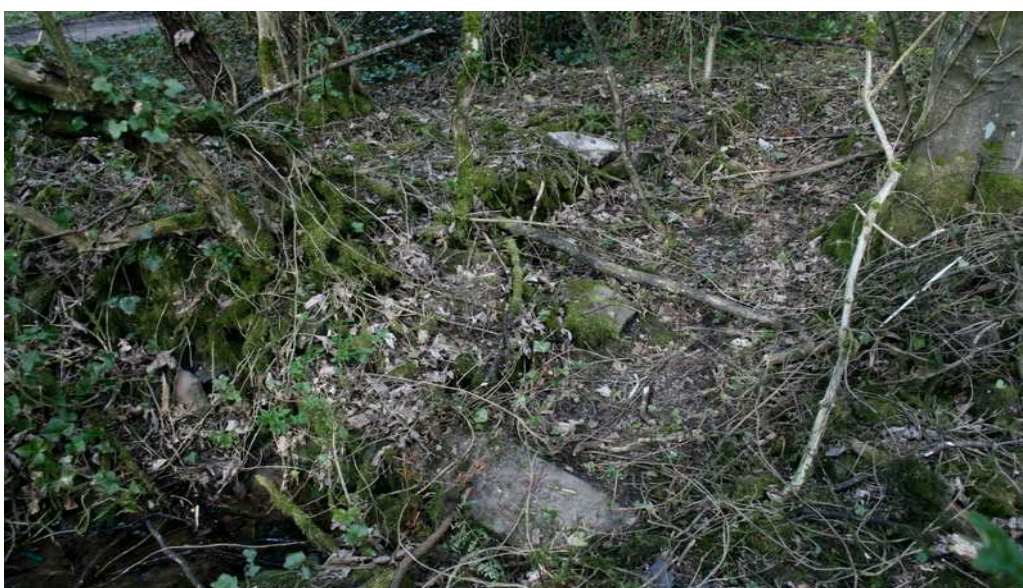
*Plate 29: Heavily overgrown culvert at western end of Area 2*

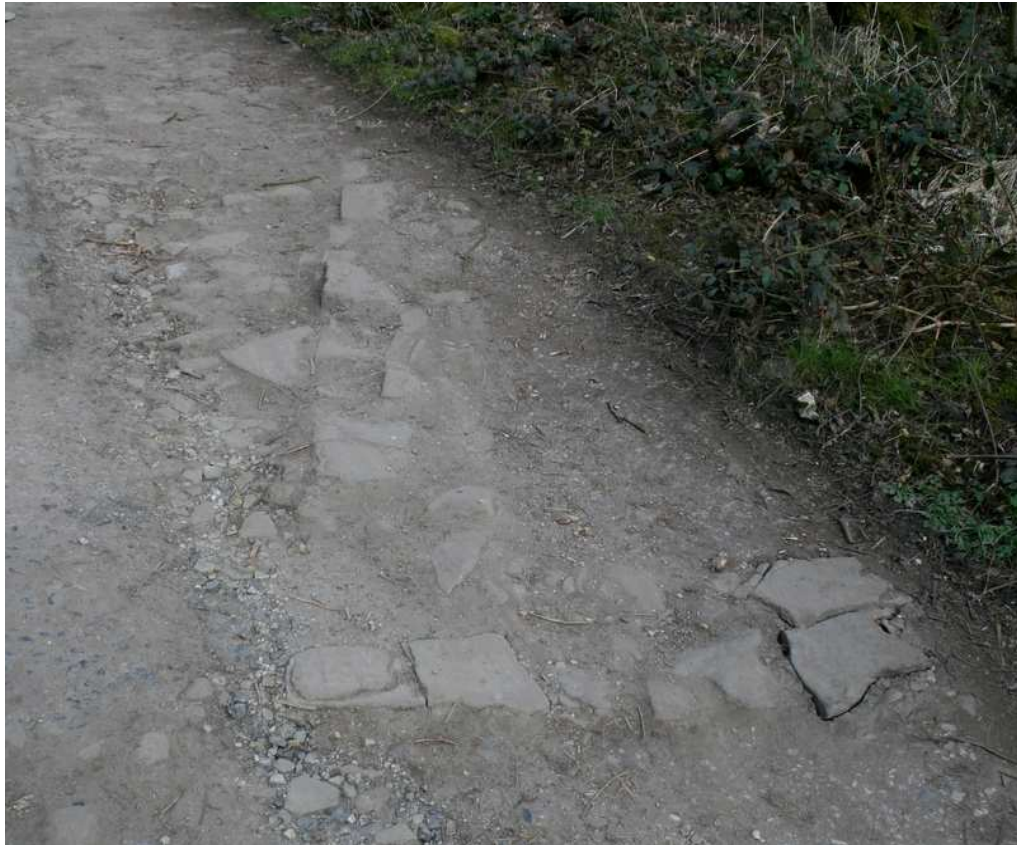
4.3.12 Two further features were observed within the surface of the rough earth trackway. The western of these represents the return of a building wall (Fig 19), possibly forming the western end of Elevation A2\_2 (Fig 14), and forming the north-western corner of a rectangular room of approximately 17 x 7.75m. It was of double-skinned construction, with a rubble core, and was 0.51m wide (Plate 30), similar to those walls where both faces were observed elsewhere.

*Plate 30: Exposed return of building wall within trackway in Area 2*

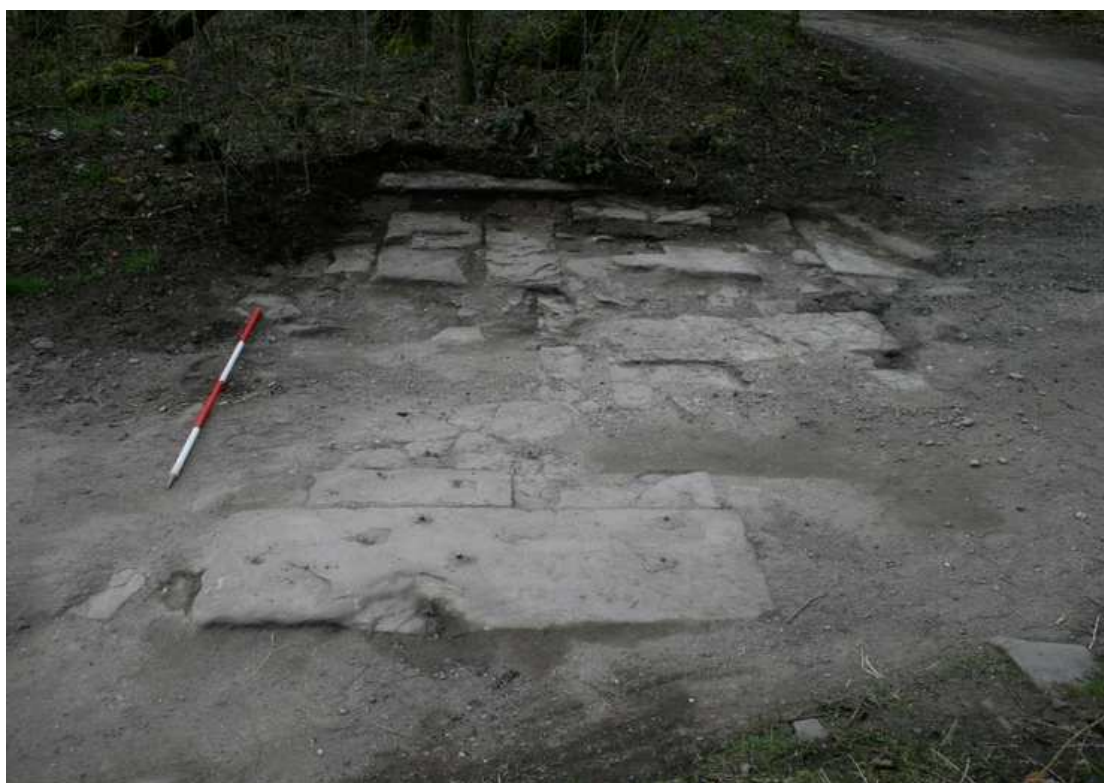
4.3.13 To the north-east, and spanning the whole width of the track, a series of sandstone blocks projecting from the road surface, represent part of the base of a large machine (Figs 7 and 30; Plate 31). The machine bed comprised several dressed sandstone blocks, situated on a similar orientation to the main structural walls. Each contained bolts of varying sizes and arrangements in their surfaces (Plate 32), with the areas of rubble between, almost certainly representing housings within the machine bed. The structure almost certainly survives to a significant depth, and continues beyond the exposed area to the north and east.

*Plate 31: Exposed machine base within trackway in Area 2*

- 5.4.6 The stone blocks exposed across the modern access track almost certainly represent foundation beds for large machinery within the mill. These foundation beds lie within the footprint of buildings shown on the Ordnance Survey first edition 6": 1 mile map of 1848, suggesting that they may represent elements of the mid-nineteenth-century calico-printing works. Subsequent editions of Ordnance Survey mapping, such as the second edition 25": 1 mile map of 1911, indicate that a large chimney had occupied this part of the site, which is also shown on historical photographs (*eg* Plate 9). It seems likely that this would have been placed adjacent to the boiler and engine houses that provided the steam power for the mill, and it would therefore be reasonable to suggest that the exposed foundation beds may have been intended to house a mid-nineteenth century steam engine.

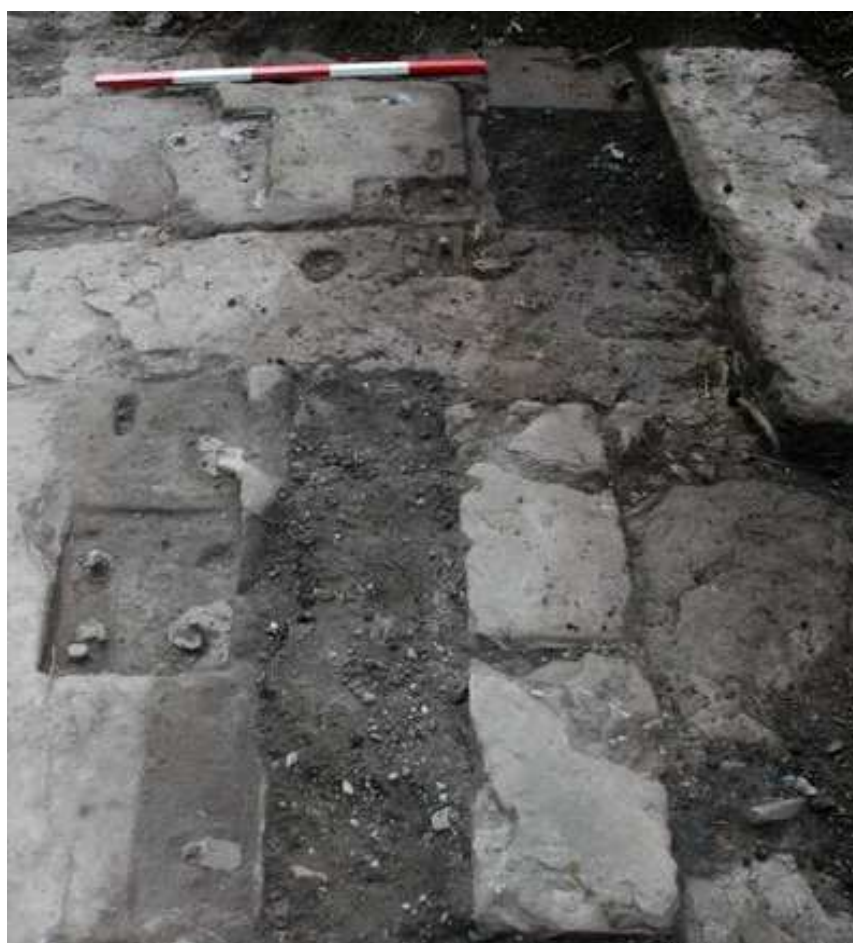
*Plate 32: Fixing bolts and housings within dressed blocks of machine base*
