Carr Mills, Meanwood Road, LEEDS, West Yorkshire

Archaeological Building Investigation

Oxford Archaeology North

May 2006

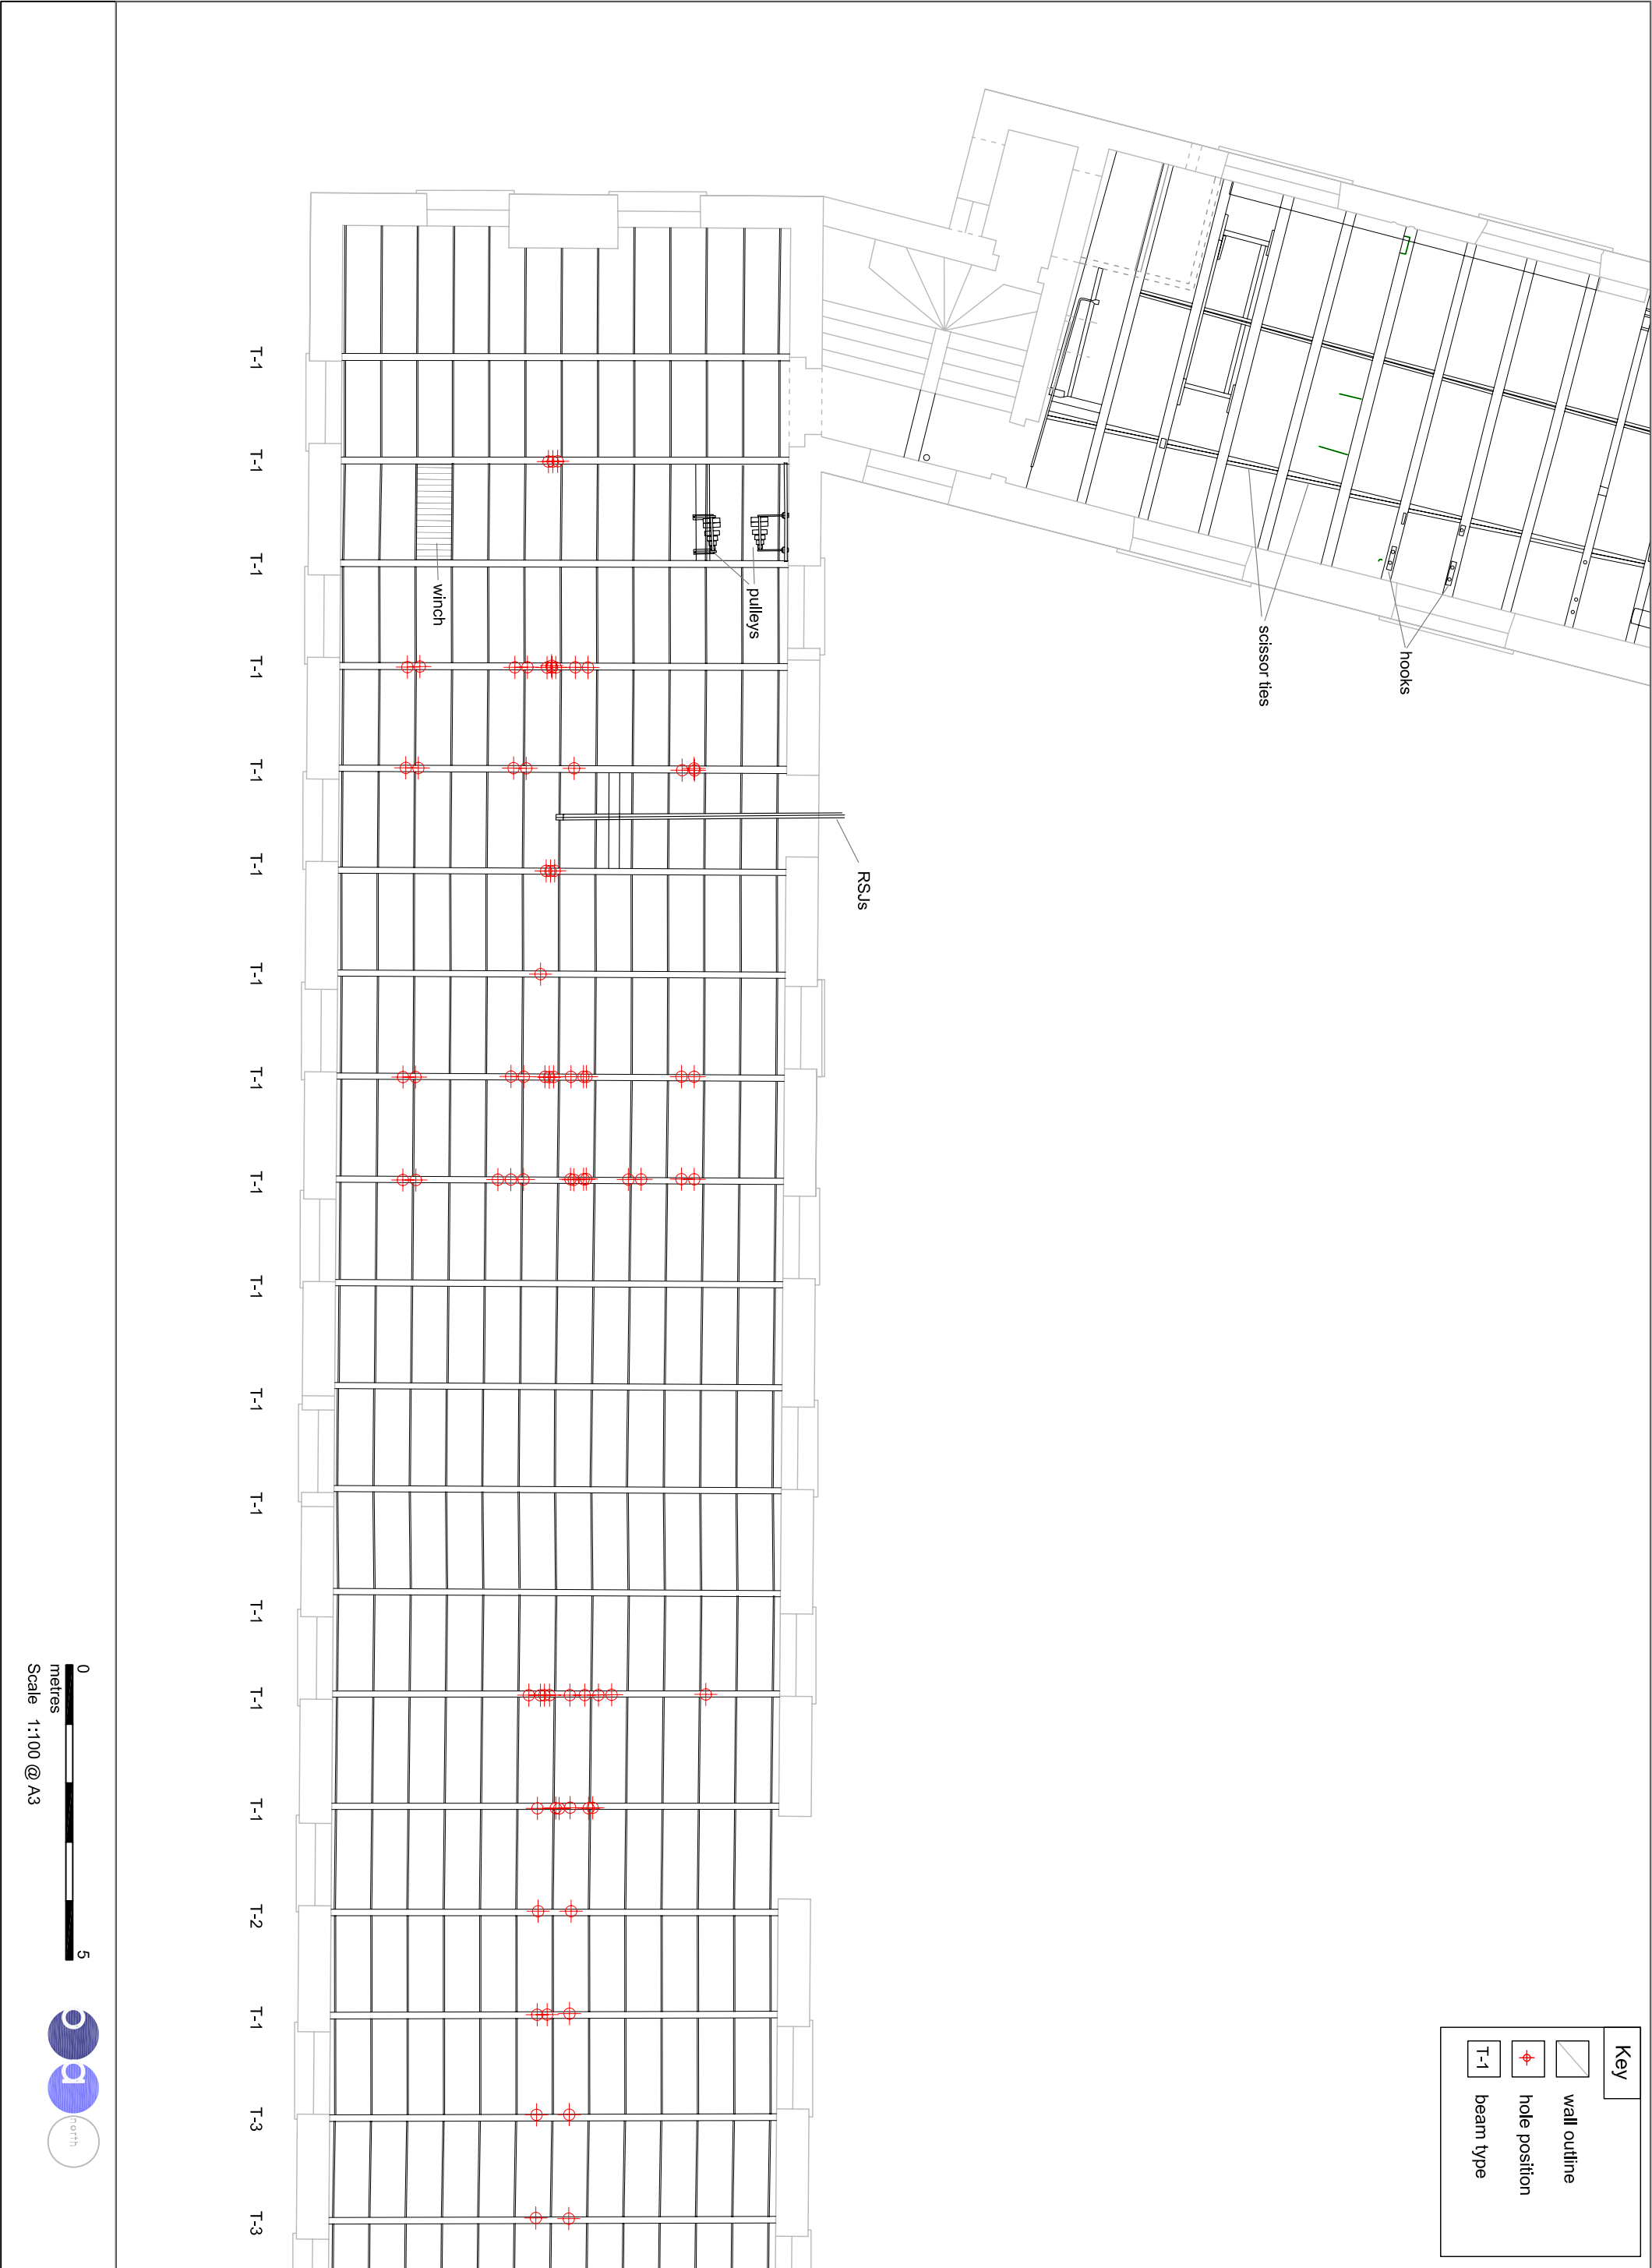
Figure 8: Second floor, reflected ceiling plan of Range A (west end)

- 3.5.14 The most notable feature of the second floor is the remaining cast iron framework which supports the floor above (Photos 4:4 – 4:7, Figs 8 and 9 and Figs 20 and 21), which is now concrete. This comprises 26 equally spaced parabolic cast iron inverted ‘T’ section north/south beams, creating 26 bays, each of which has 13 equally spaced upright ‘I’ section parabolic north/south joists. The eastern part of the framework beyond beam 26 is missing and was of differing design (see NAA 2003). This difference in style is also known to have existed on the ground, and first floors. Some of the joists are missing in bays four and five, within which the northernmost joist is missing; bay 14
