MIDDLE HOUSE FARM BARN, CHIPPING Lancashire

Archaeological Building Investigation

Oxford Archaeology North
October 2003

Issue No: 2003-4/168
OA North Job No: L9257
NGR: SD 5868 4304

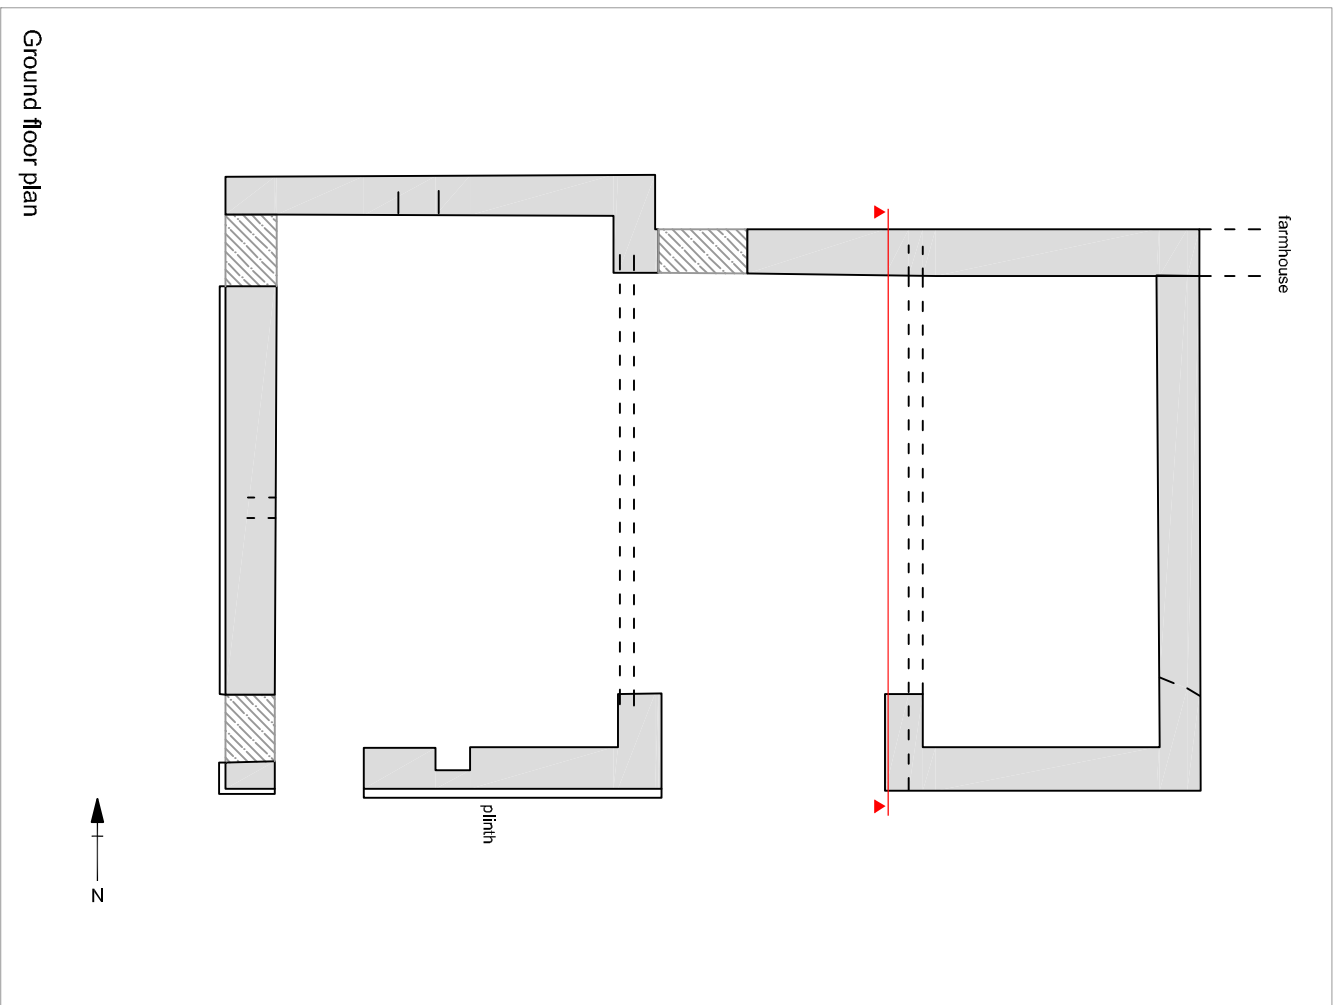
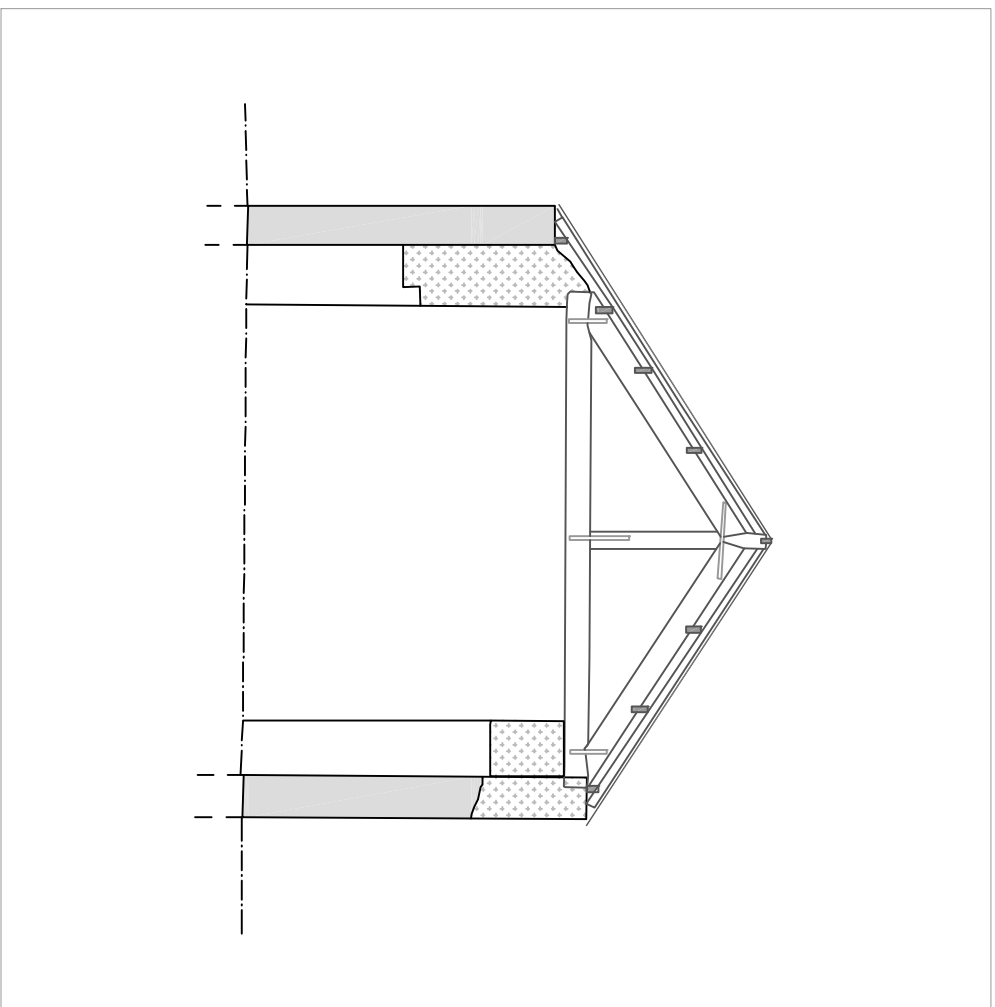
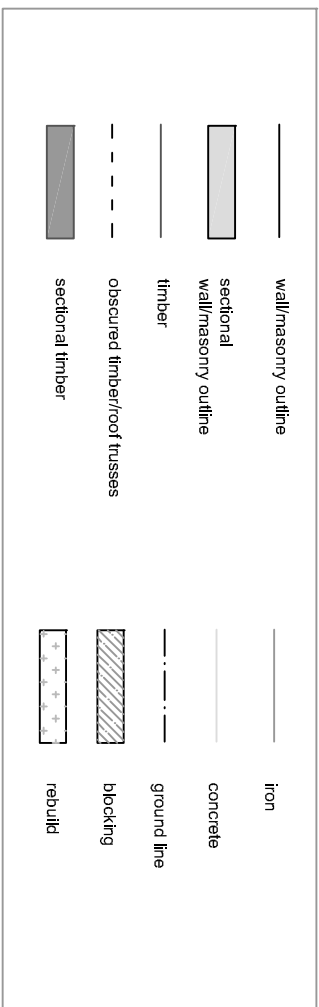
Figure 3 : Plan and west facing section of barn

- 3.2.2 The modern roof was of slate and had a skylight on the south side. The three trusses had been reclaimed and were of simple king post design (Fig 3). The floor was earthen and rather uneven.

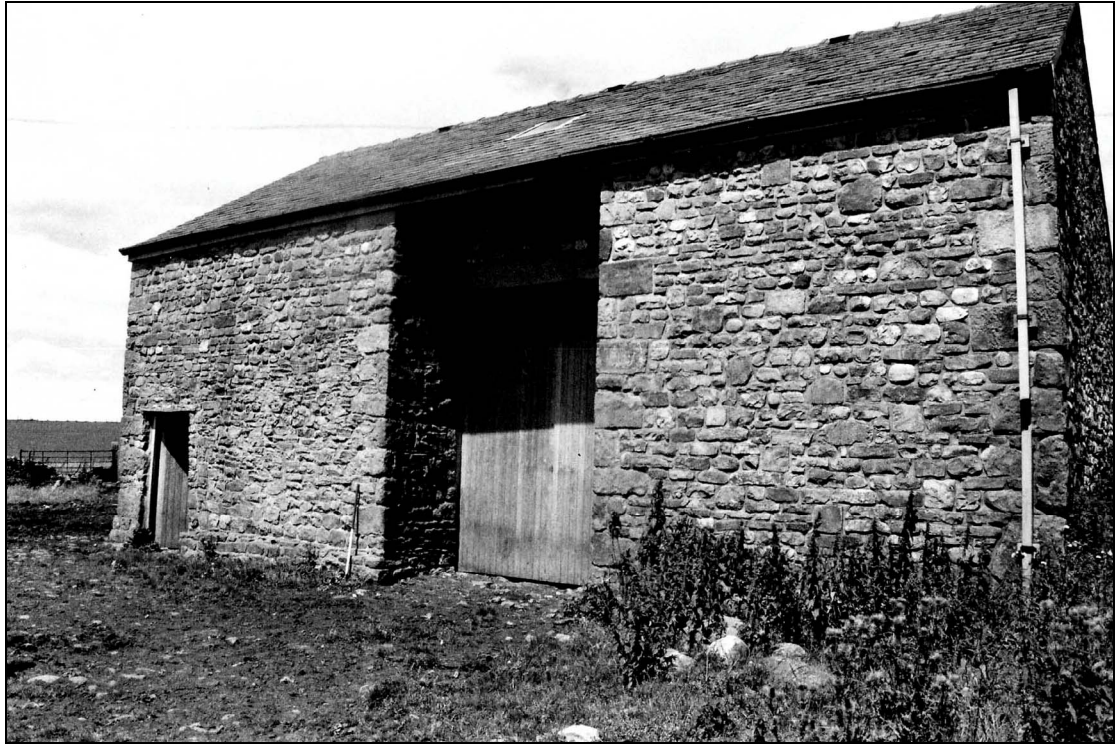
Plate 1: Front elevation of barn, looking north-east

- 3.2.11 The wagon doorway within the south elevation was recessed some 1.20m (Plate 1). The original iron door hinge bolt was fixed in a quoin on the east side. A possible blocked ventilation slit could be observed between the wagon and pedestrian doorways. 0.47m high, 0.09m wide, and located 0.96m from ground level. A plinth was located near the base of the building on the west

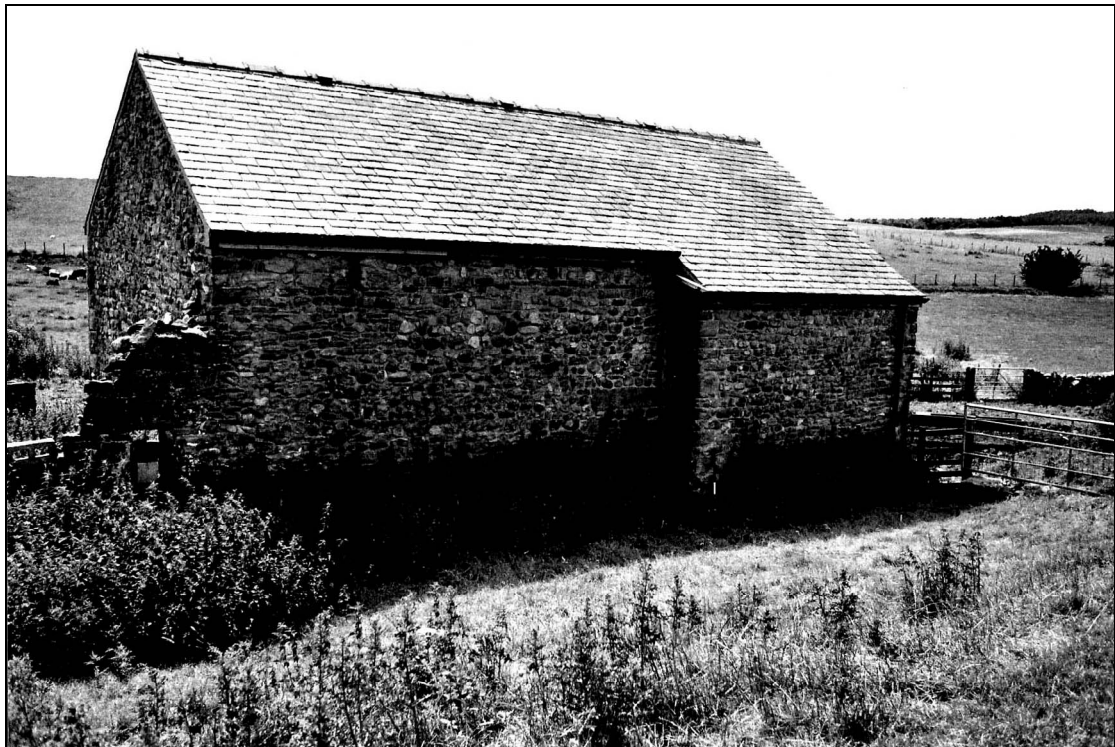
Plate 2: Rear elevation of barn, looking north-west

- 3.2.9 **External Detail:** all external elevations appear to have either been totally or partially rebuilt, or at least heavily repointed, and there is a skim of cement render across the top of all elevations. Quoins appear on all corners except at the east side of the north elevation where portions of the ruined farmhouse were still attached (Plate 2).

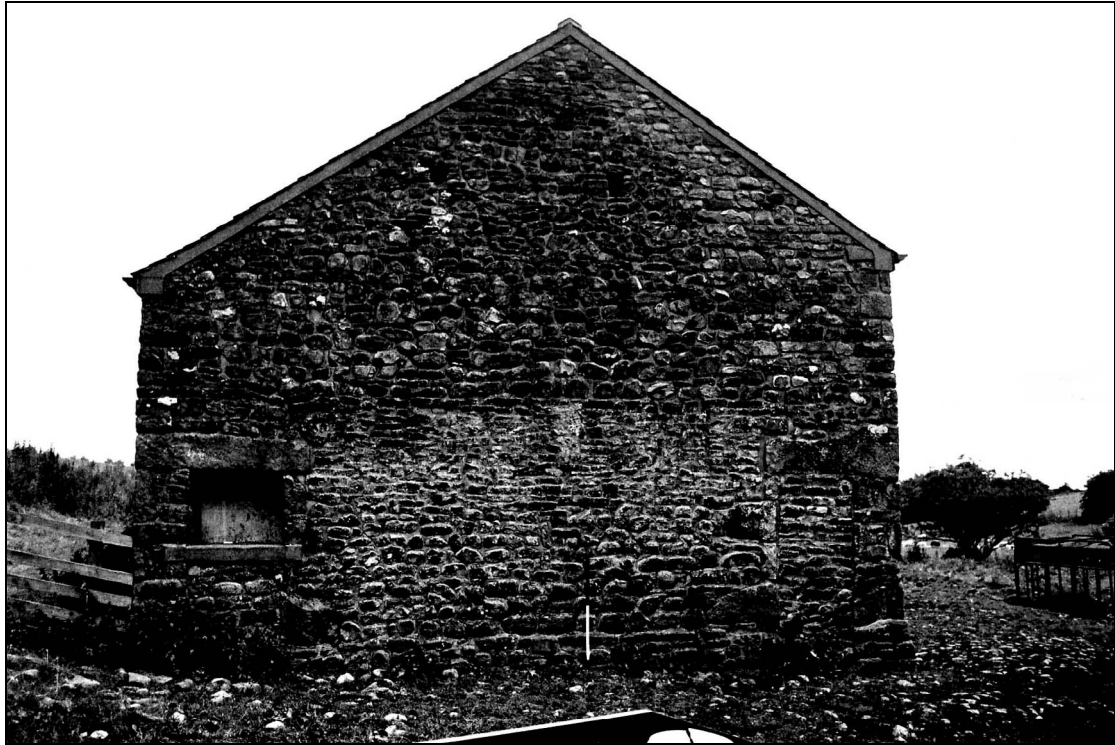
Plate 3: West gable of barn

- 3.2.12 A noticeable change in building materials was observed within the exterior of the western elevation above a height of approximately two metres (Plate 3), again indicating the extent of the ruinous state of the barn before recent renovation.

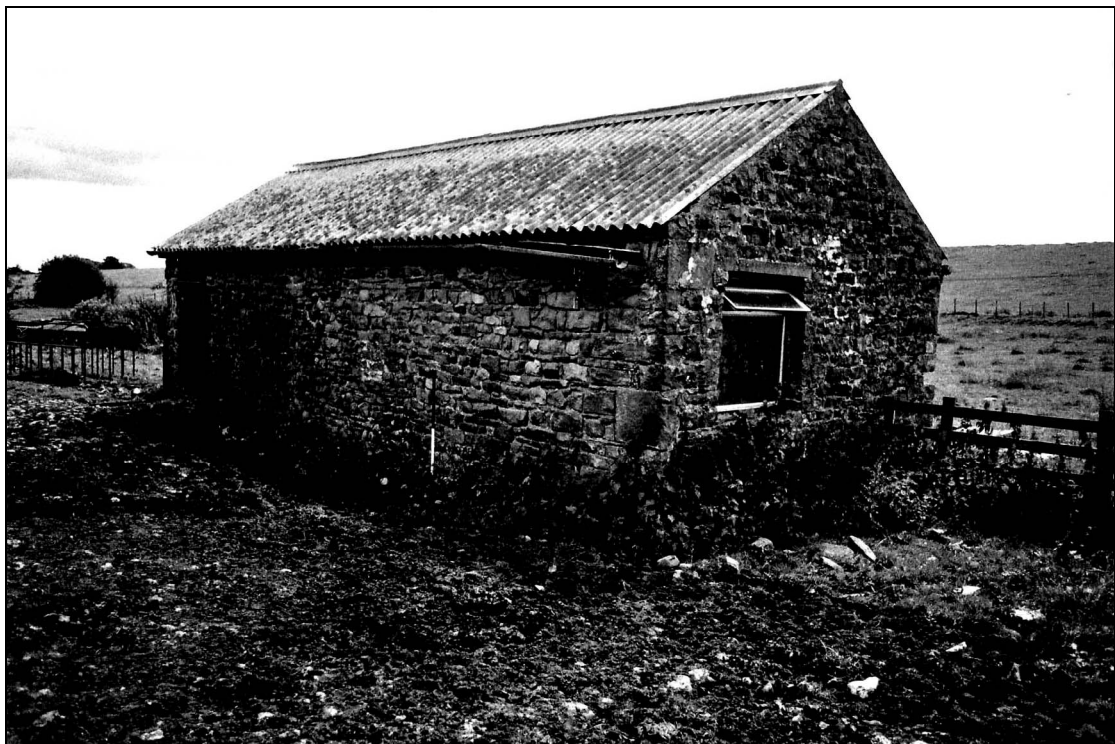
Plate 4: Shippon, looking south-west

- 3.3.1 *External Detail:* this single storey building was located approximately 4m south-west of the barn (Plate 4). The only existing doorway was located at the eastern end of the north elevation (Plate 8). The building was seen to have a distinctly different build from the east side to the west. The eastern half of the north elevation was composed of roughly coursed, rectangular sandstone, whereas the western extent incorporated much more rounded cobblestones. The other elevations were predominantly of squared sandstone. Quoins were utilised on all corners except the south-west. Three ceramic land drains had been used as vents, and were evident along the uppermost course of the west elevation. Above this was a modern gutter.

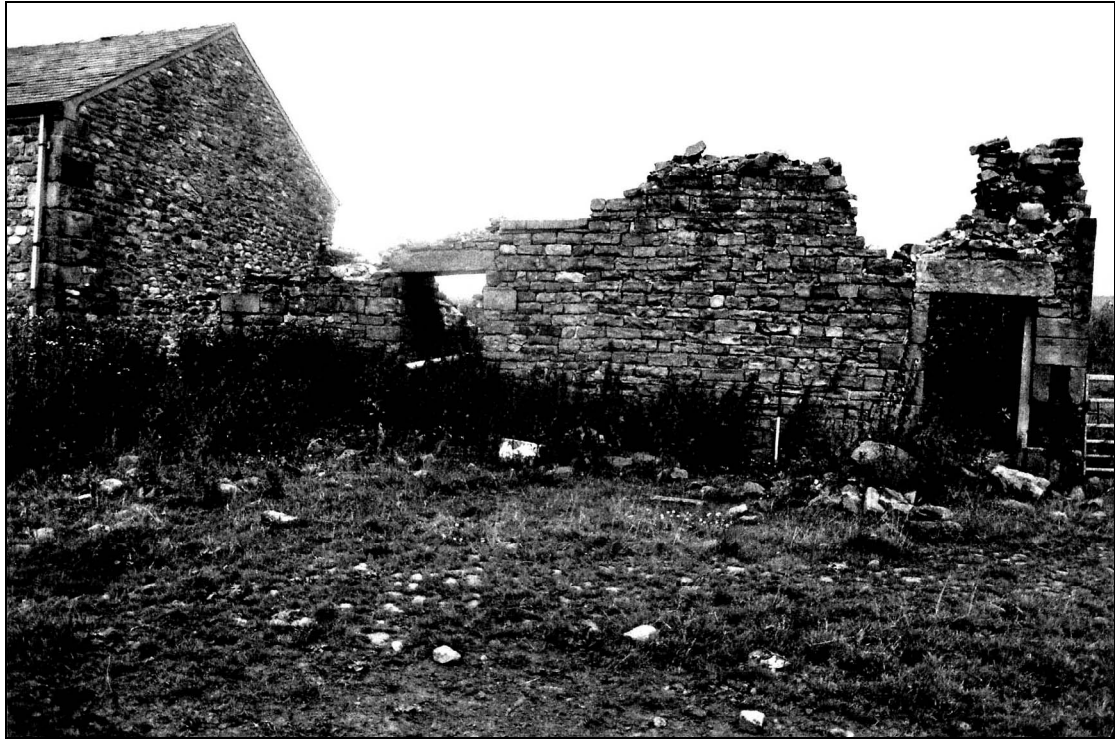
Plate 5: Front elevation of farmhouse remains, looking north

- 3.4.2 The south elevation contained a quoin edged doorway at the eastern end with large lintel. The remains of a dressed stone windowsill was observed in the centre on the first floor (Plate 5).
- 3.4.3 A pair of small, mullioned windows flanked a blocked door at the western end of the north elevation (Plate 6). All corners of the building incorporated large quoins. The remains of two fireplaces were observed, one each on the eastern side of the central and western rooms.
- 3.4.4 A further investigation of this building was beyond the remit of this project.
