Mission Church Paxford Gloucestershire

Historic Building Investigation and Recording

November 2020

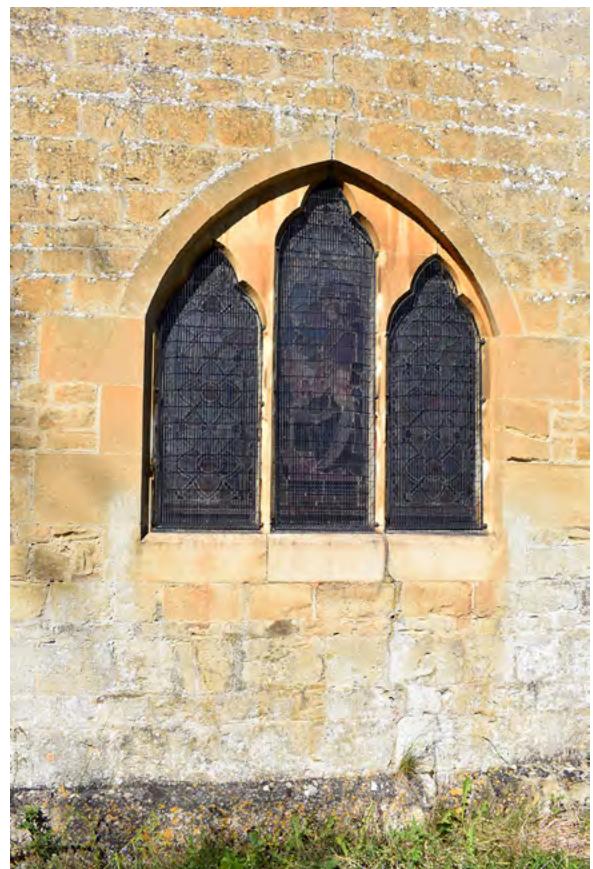
- 2.3.3 In c.1870 a stained glass by Holland and Holt of Warwick was added to the east window.

Plate 5: Stained glass window inserted in 1870 at east end

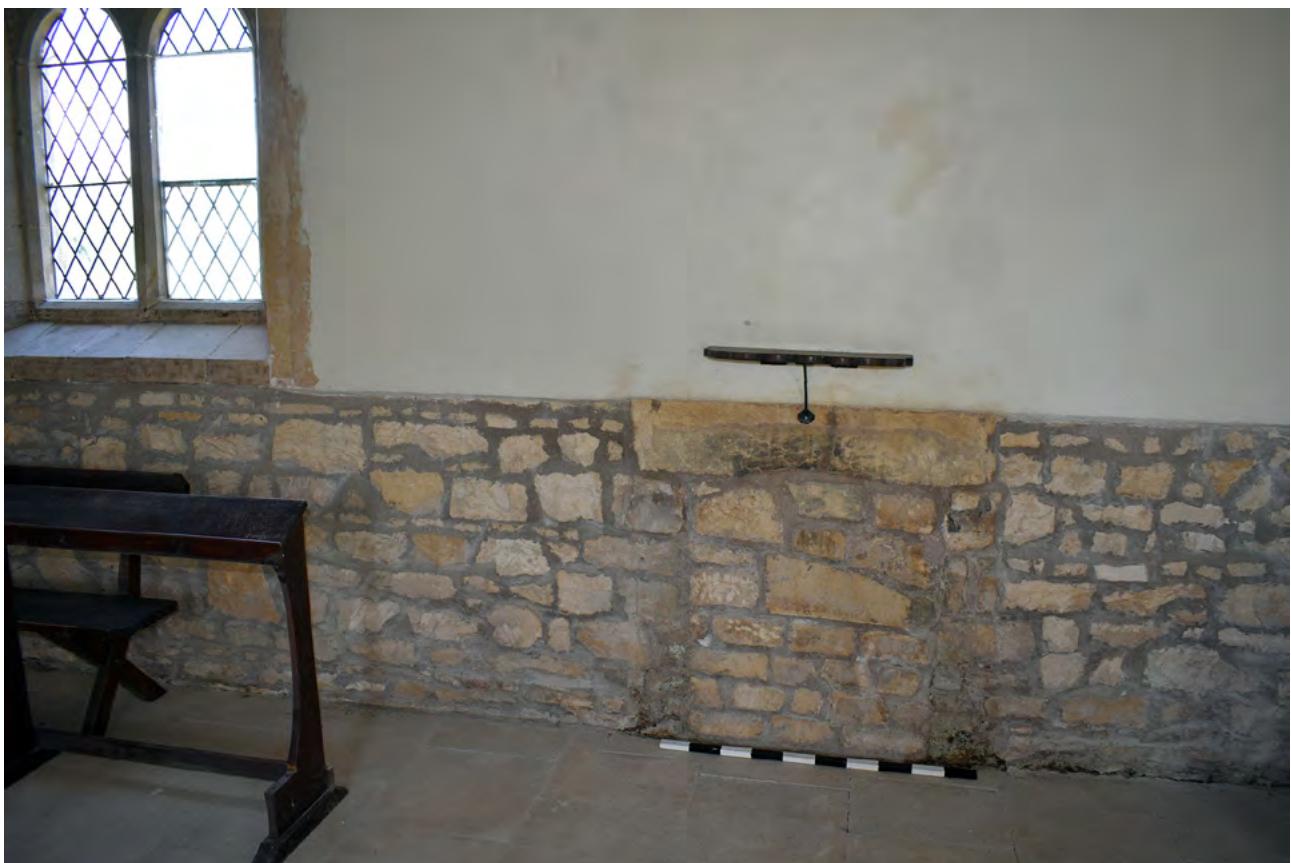
Plate 35: Outline of blocked fireplace in north wall of church

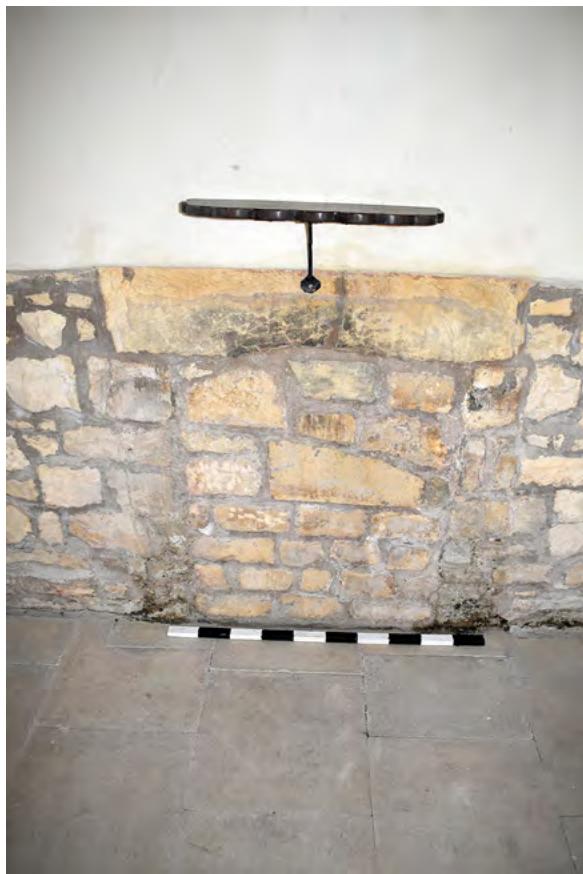
Plate 36: Former blocked fireplace in north wall
of church

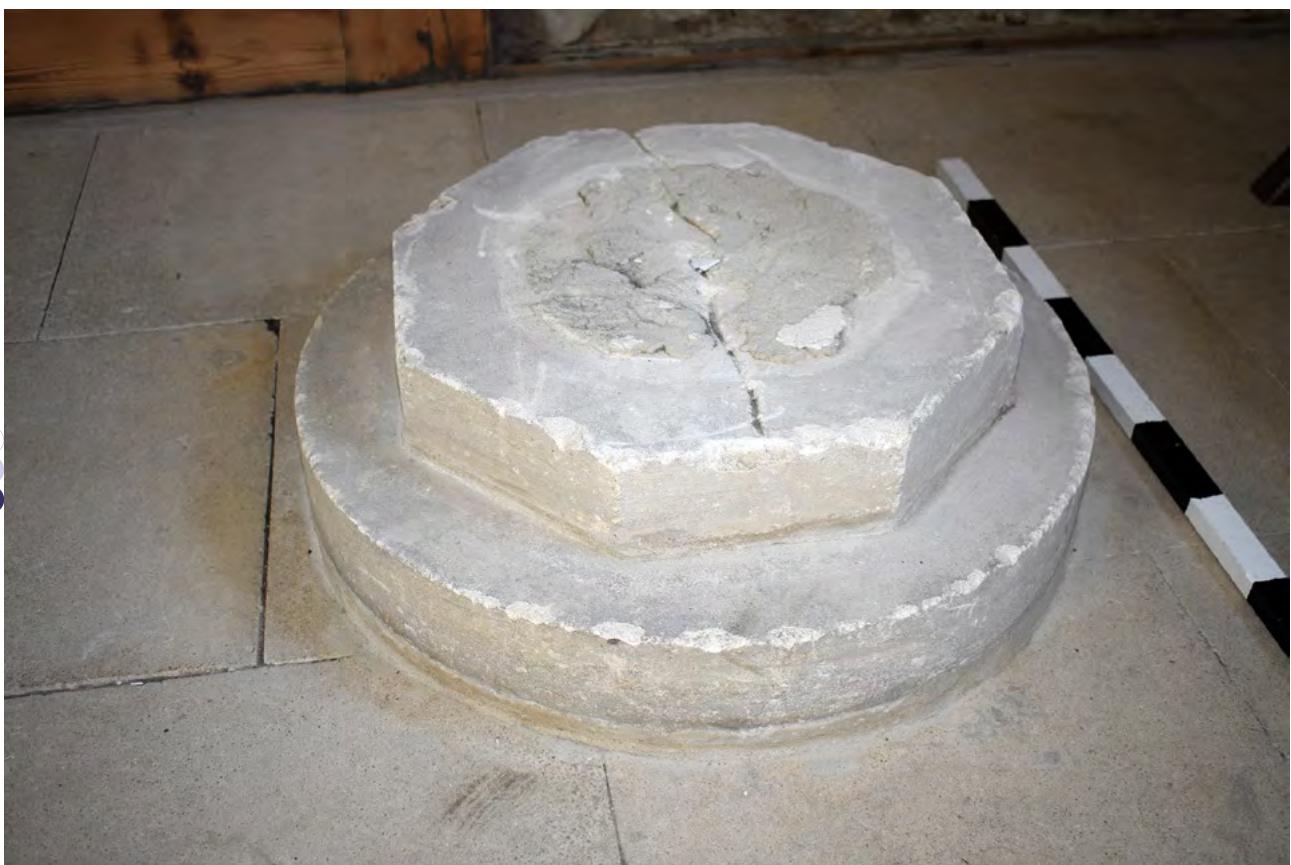
- 3.3.7 The font had been removed prior to the current recording under an ancient statute which the owner had been told dictated that when a church is deconsecrated the font must be removed and broken up (Pl. 38). The main pews had also been removed.

Plate 38: Base of font in church

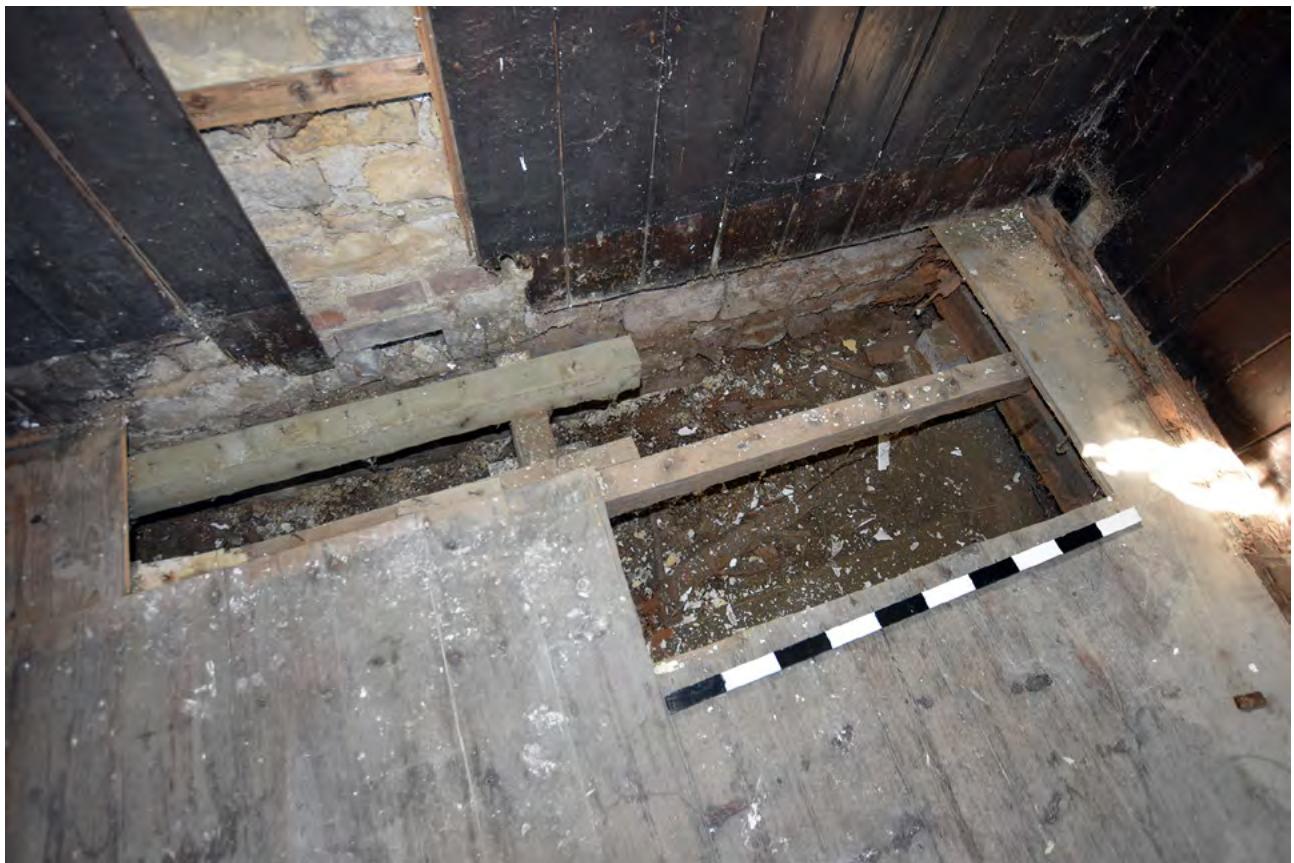
Plate 61: Exposed floor joists at south-west corner of school room
