Church View Barn Denchworth

Archaeological Watching Brief Report

Client: Vic Cox, V K Cox Developers

Issue No: 1
OA Job No: 6021
NGR: SU 38098 91739

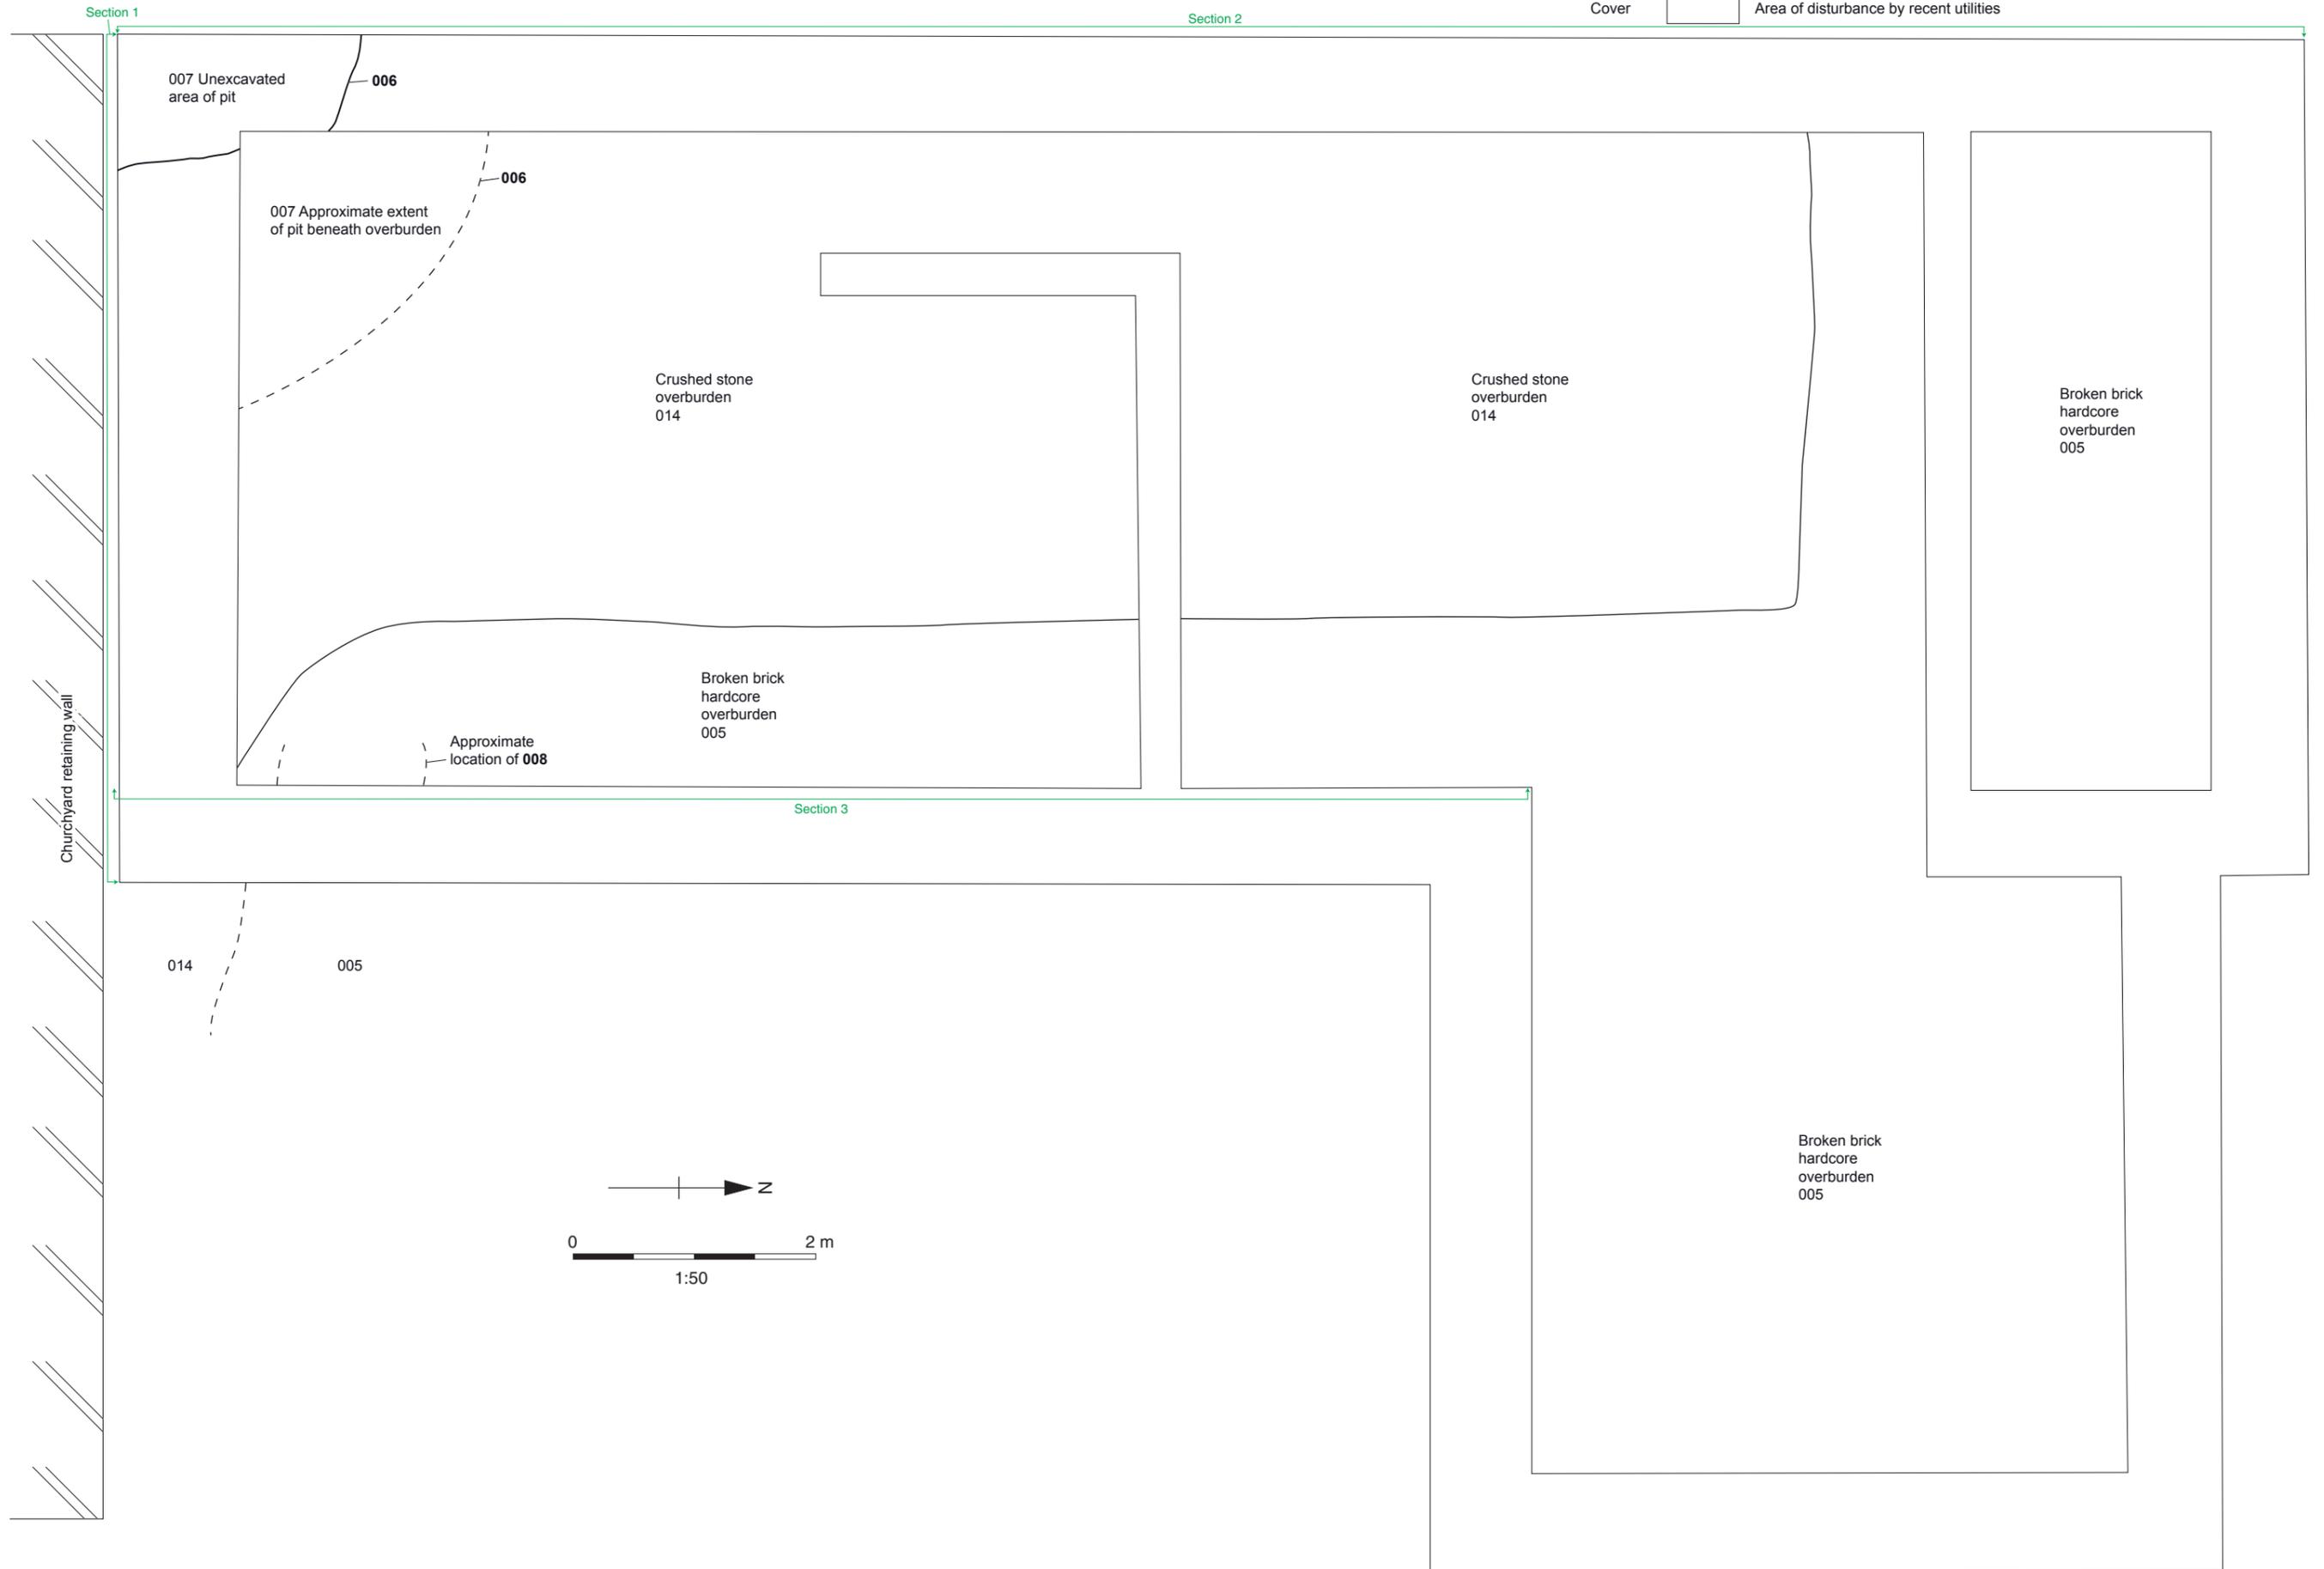
Figure 2: Site plan

2.2.7 For the *drawn record*, a site plan was drawn at 1:50; section drawings of sample sections of trenches with exposed features were drawn at scales of 1:20 and 1:50 accordingly (Figs 2 and 3).

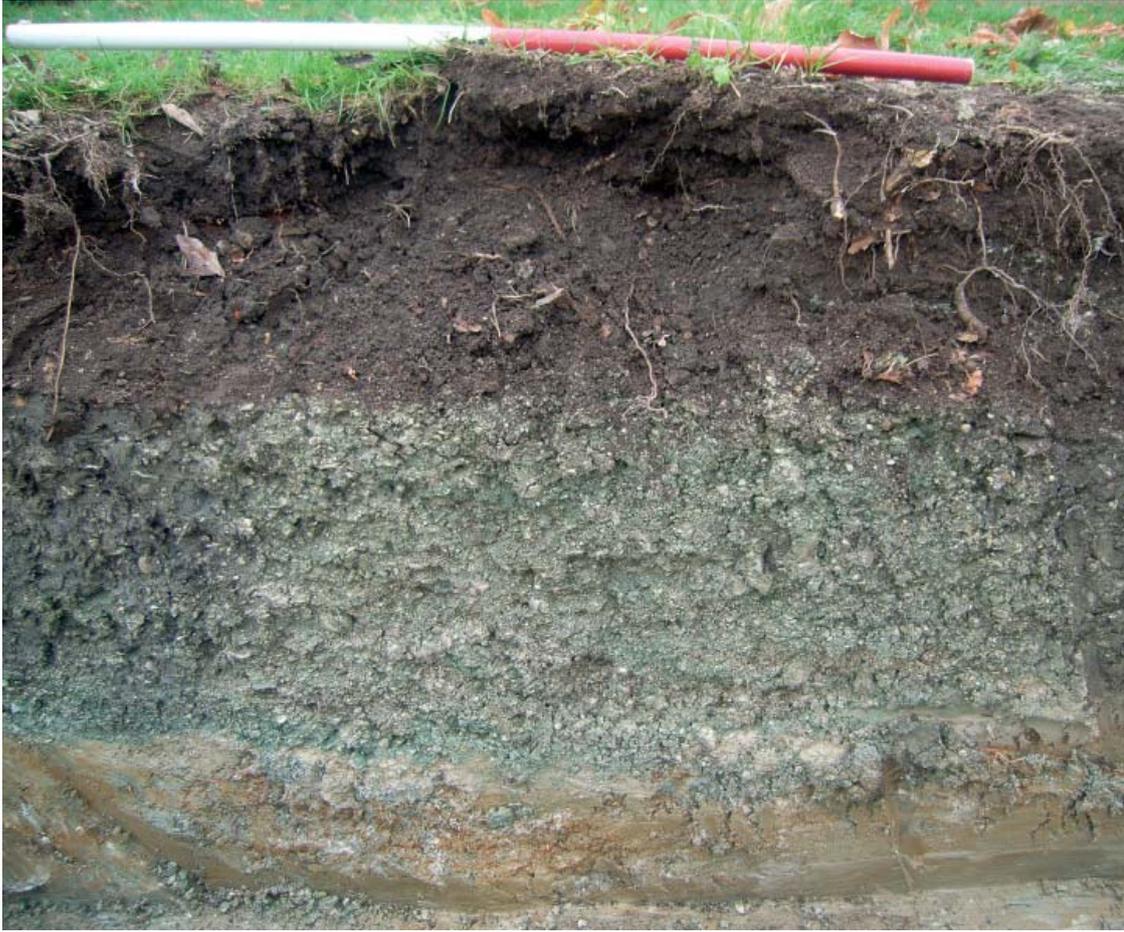
Plate 1: Typical section of topsoil to natural layers

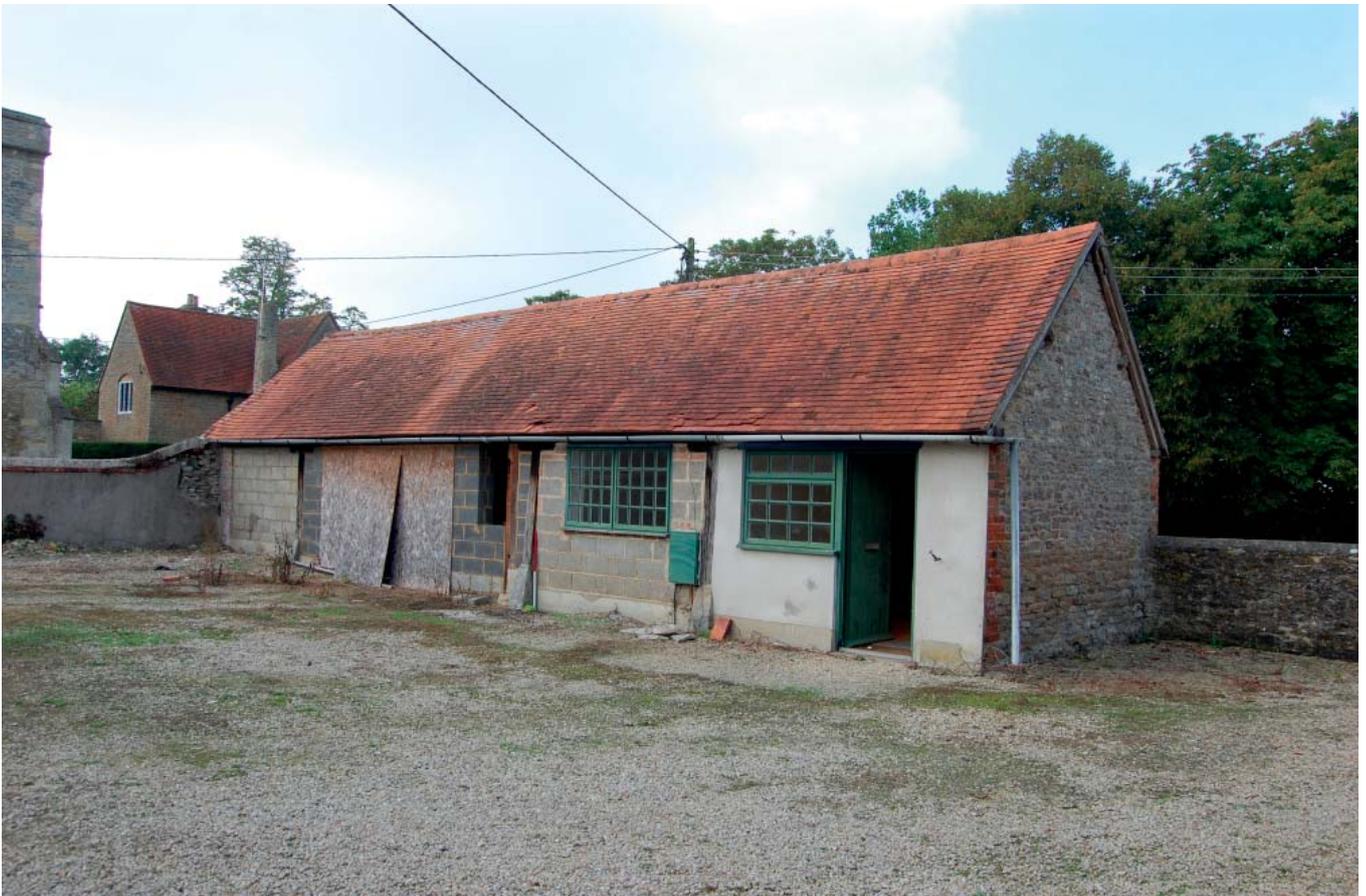
- 1.3.4 The barn had been heavily altered and portions rebuilt as necessary during its time in use. An open-fronted barn with a brick rear wall on a limestone footing and a limestone north gable (Pl. 2), the barn abutted the churchyard retaining wall (Pl. 3), utilising the retaining wall as its southern end with the projecting gable clad in timber (Pl. 4). The open-front was supported on timber posts which were set upon staddle stones. The barn had been converted in the late 1980s or early 1990s to office and storage use and the floor of the three southernmost bays concreted. The roof timbers and the timber posts had been renewed at around this time and a steel frame incorporated into the three southern bays; all that remained of the earlier structure was the western and northern walls and the re-used roof tiles.

Plate 2: East and north elevations of Church View Barn

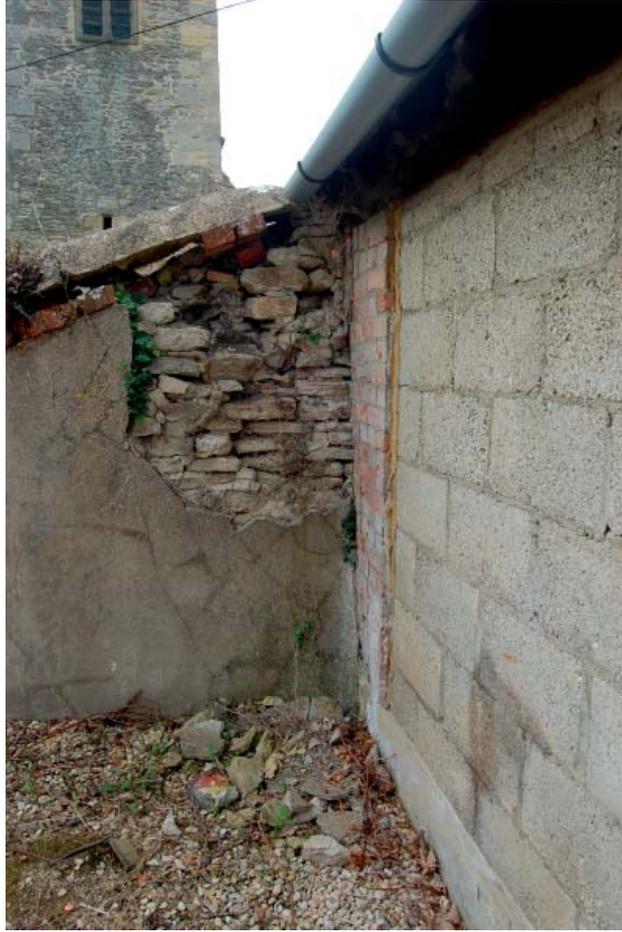
Plate 3: East wall of the barn abutting churchyard retaining wall

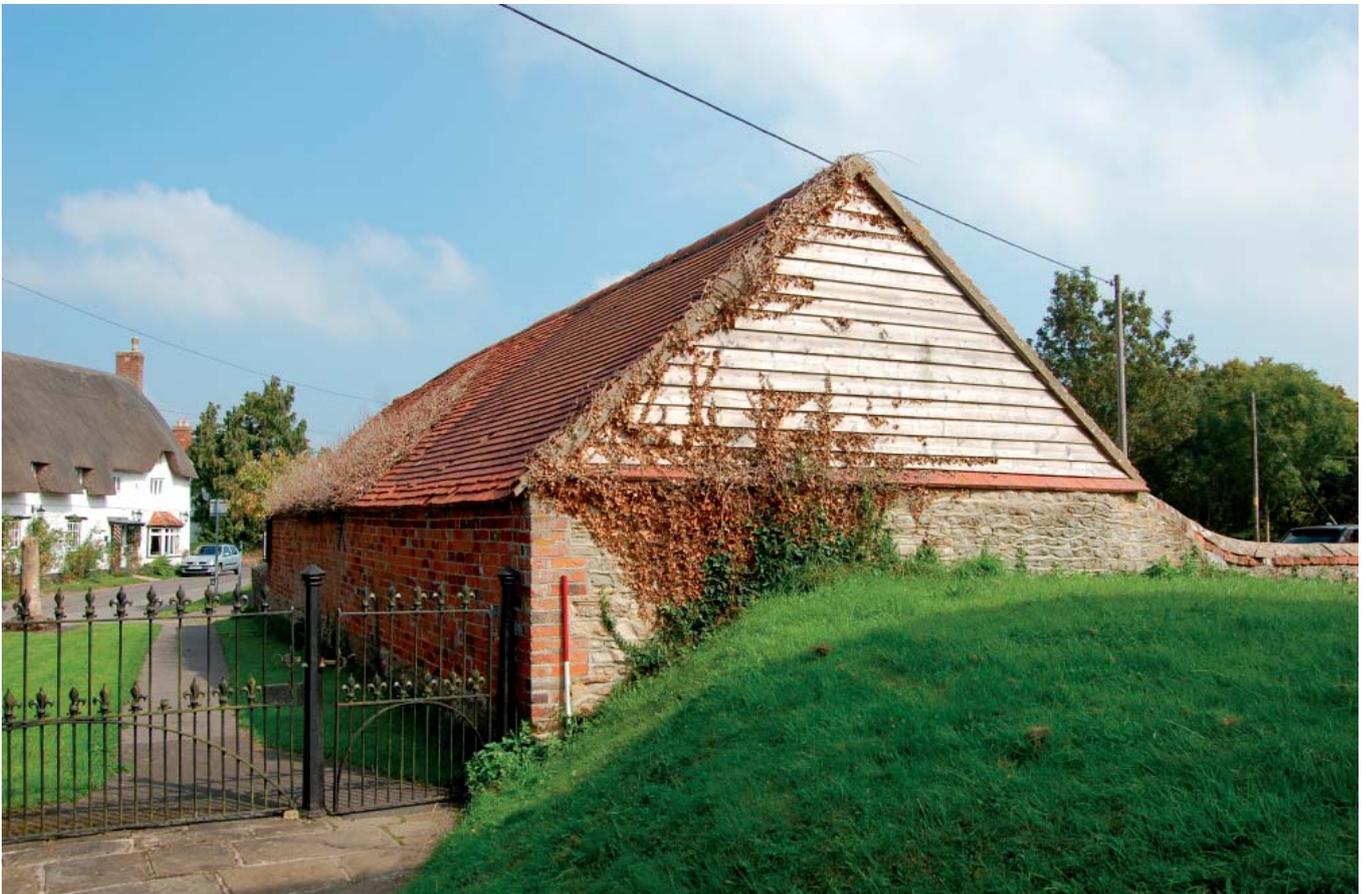
Plate 4: West and south elevations of Church View Barn

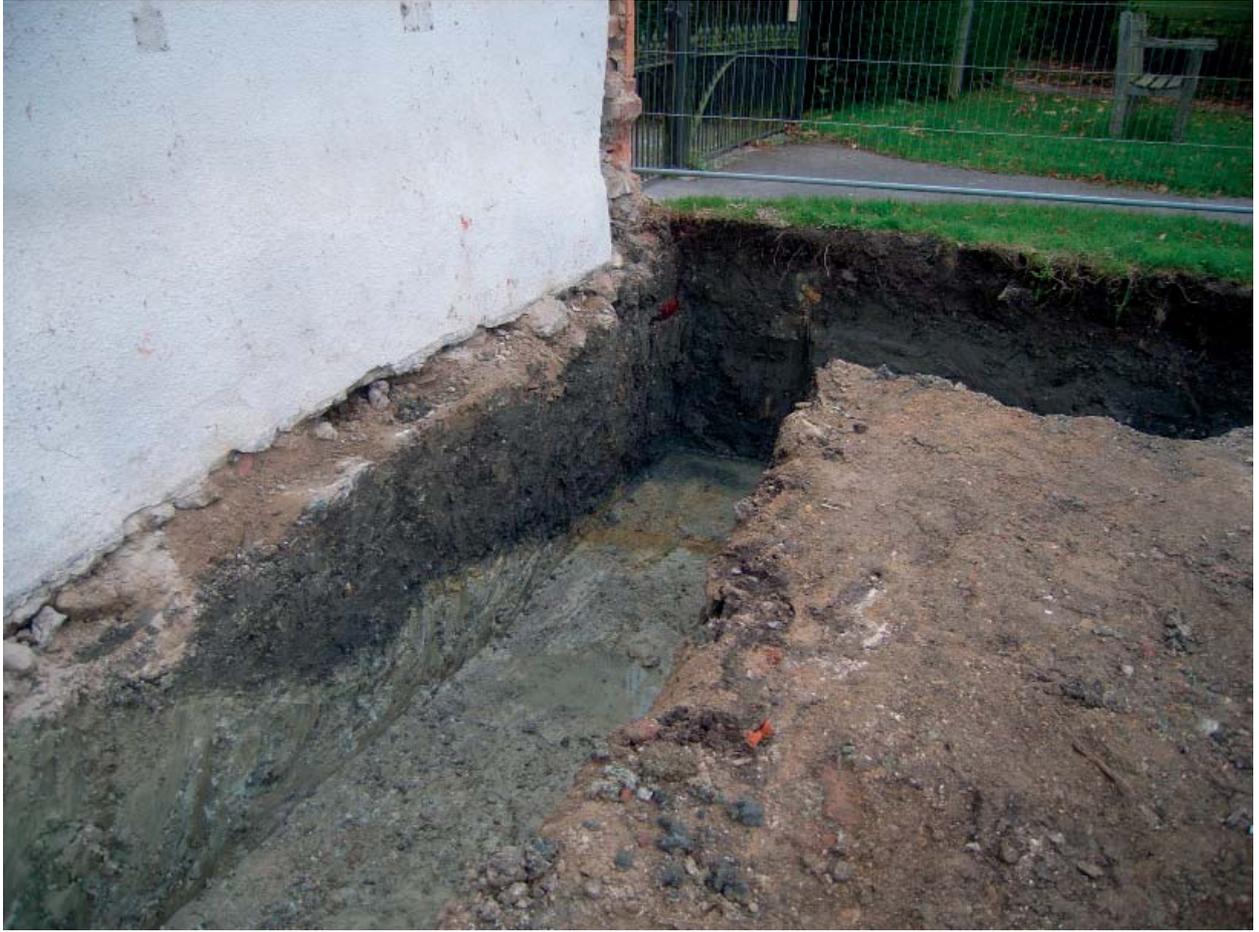
- 3.1.5 A large pit, [006], was located at the south west of the site, underlying the former barn, the churchyard retaining wall, footpath and the made-up ground of the churchyard. The fill, (007), consisted of a single-action of backfilling which contained no finds in the excavated material (Pl. 5). Repairs in the barn wall's stonework and brickwork were noted in this area during the building recording (Pl. 6).

Plate 5: Pit [006], looking west

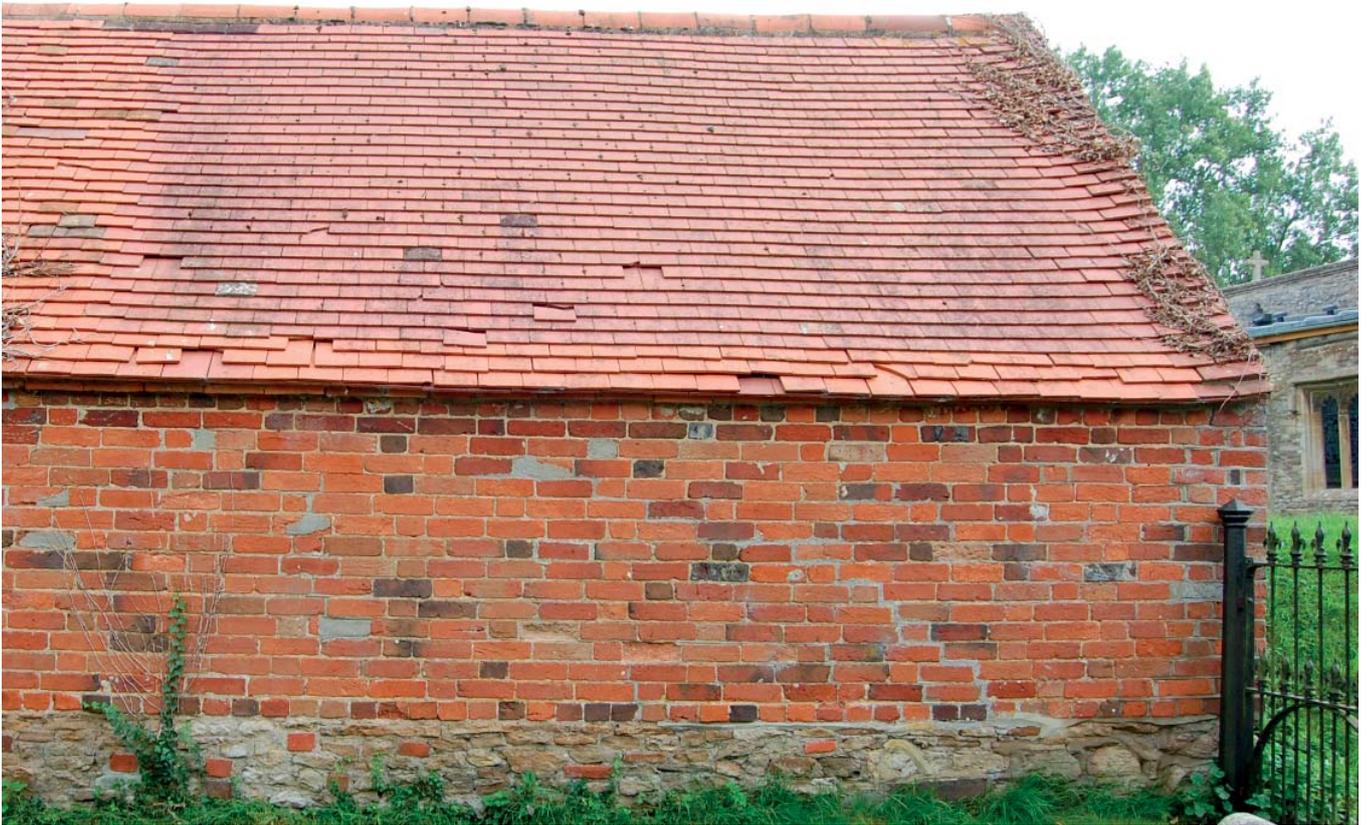
- 4.1.2 Following the demolition of Church View Barn, no evidence of foundations of previous buildings were encountered: traces were not visible on the surface of the site, during excavation or within the sections of the excavated areas (Pl. 9). The recently demolished barn was shown to have had little or no foundations and had been constructed directly onto the clay and gravel natural layers. The south western corner of the barn had been built over the pit [006] where structural repairs had been apparent in the brick and stone work.

Plate 6: Repairs evident in the wall above pit [006]

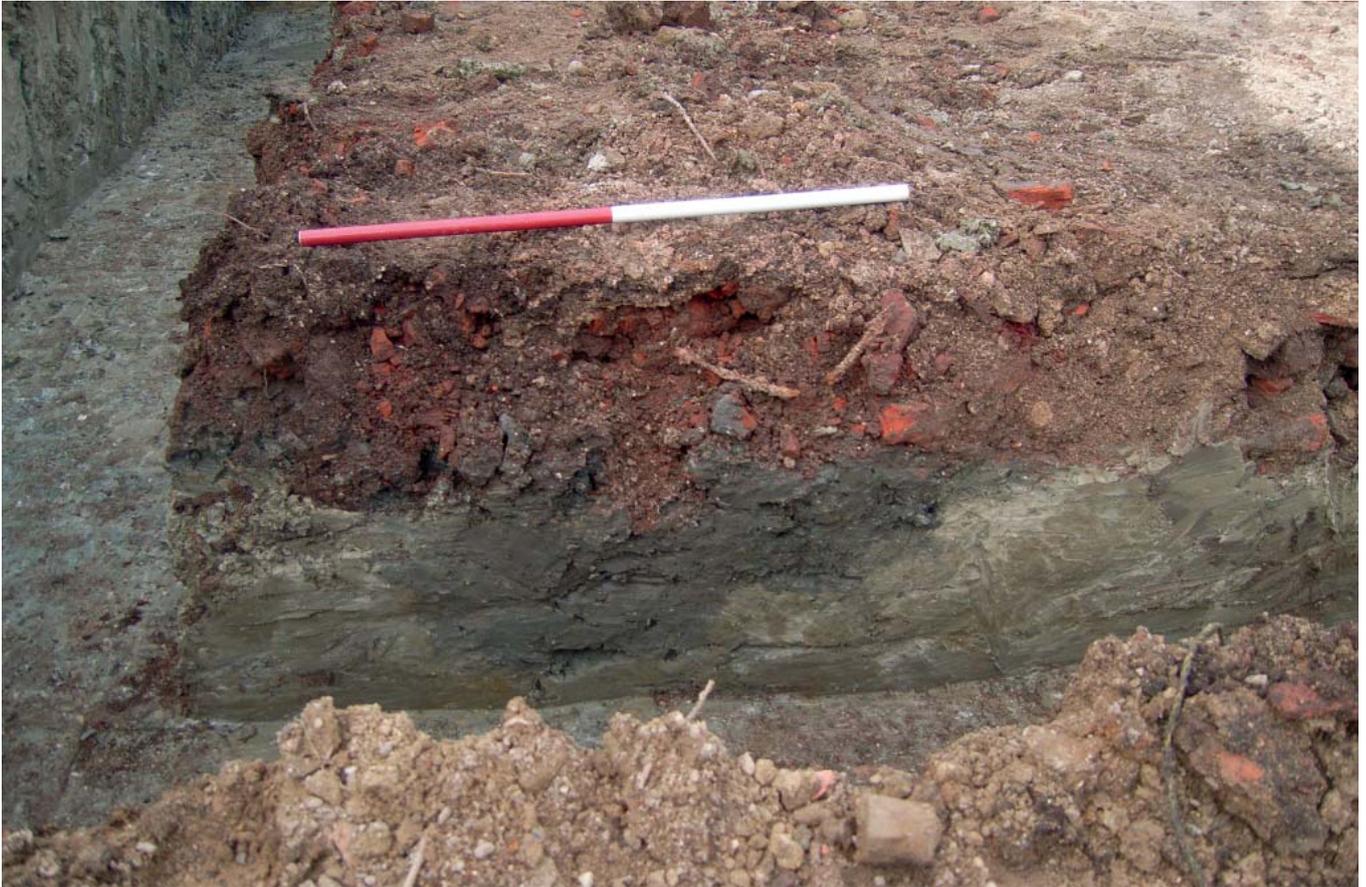
- 3.1.6 A small pit with some possible root disturbance, [008], was exposed in the east-facing section of the easternmost foundation cut, adjacent to the southernmost foundation cut (Pl. 7). The feature was overlain by the broken brick hardcore, [005], and so its extent was not uncovered in plan. The pit is located over a metre from the front of the former barn and so not associated with the construction. It may have been cut to extract a fairly small quantity of clay, and was backfilled with the associated subsoil immediately in a single event with no finds within the fill material (009).

Plate 7: Possible small pit [008]

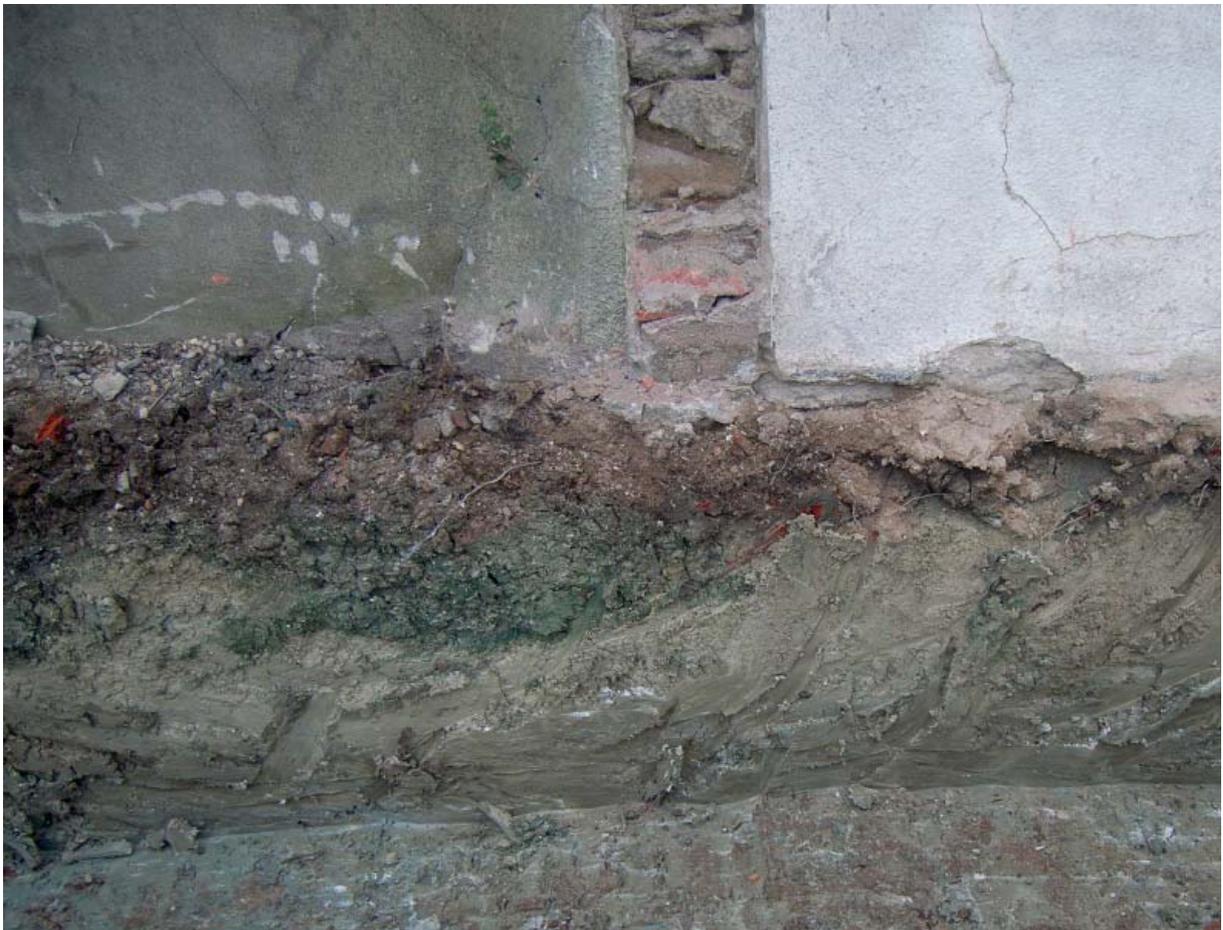
3.1.7 A feature, [012], was exposed by the cut for the southern foundation (Pl. 8). Backfilled with gravel, but appearing to contain some cess (013), this may be the remains of a drainage feature later obliterated by the addition of the broken brick hardcore layer (005). The feature is located to the immediate east of the location of the barn, to the front of the former open front of the barn. The surviving section may underlie the churchyard retaining wall, although structural concerns prevented undercutting the wall to verify this.

Plate 8: Possible drain [012]
