Church View Barn Denchworth Oxfordshire

Building Investigation and Recording

Church View Barn, Denchworth, Oxfordshire
Report on Historic Building Investigation

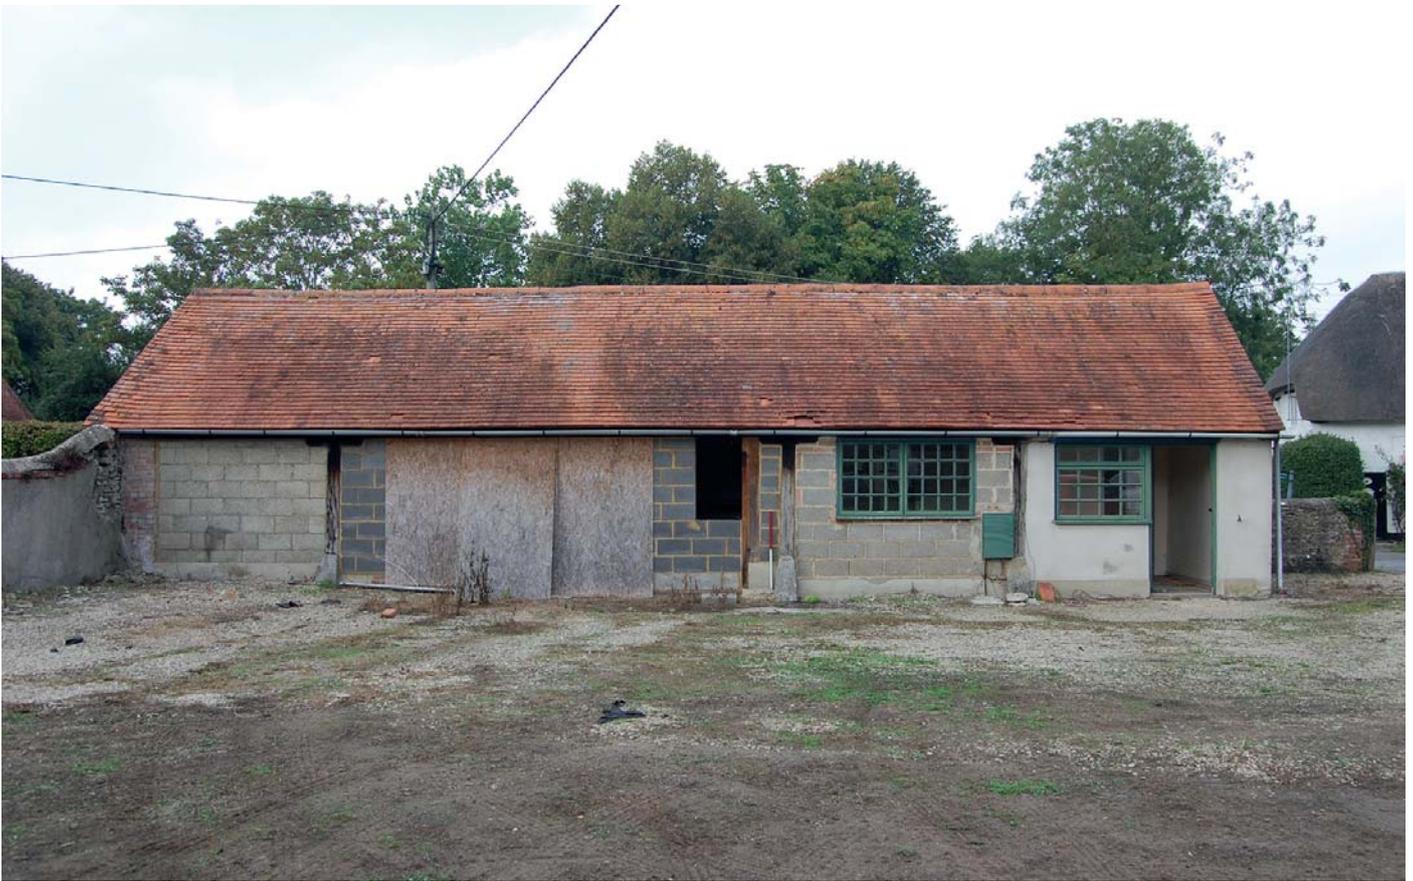
Plate 3 East elevation

- 3.1.2 The east elevation, the front elevation of the building, is much-altered (Pl. 3). The three surviving timber posts suggest that, prior to the modern blockwork enclosing the barn, the building was probably in use as an open fronted building, presumably a cart shed rather than for livestock due to the central village location.

- 3.1.4 The alteration to the front elevation is of three broad phases: following an apparently short-lived phase as an open fronted cart shed, the interior was divided into three spaces, as described in section 3.2, and the eastern openings to the two northernmost bays infilled with blockwork and associated door and windows. The northernmost bay was rendered externally, whilst the second bay received only a rendered plinth (Pl. 5). At roughly the same time, although utilising different aerated concrete blocks, the front of the southernmost bay was infilled. The remaining two bays have been infilled in recent years, although work has stopped before doors and windows were fitted.

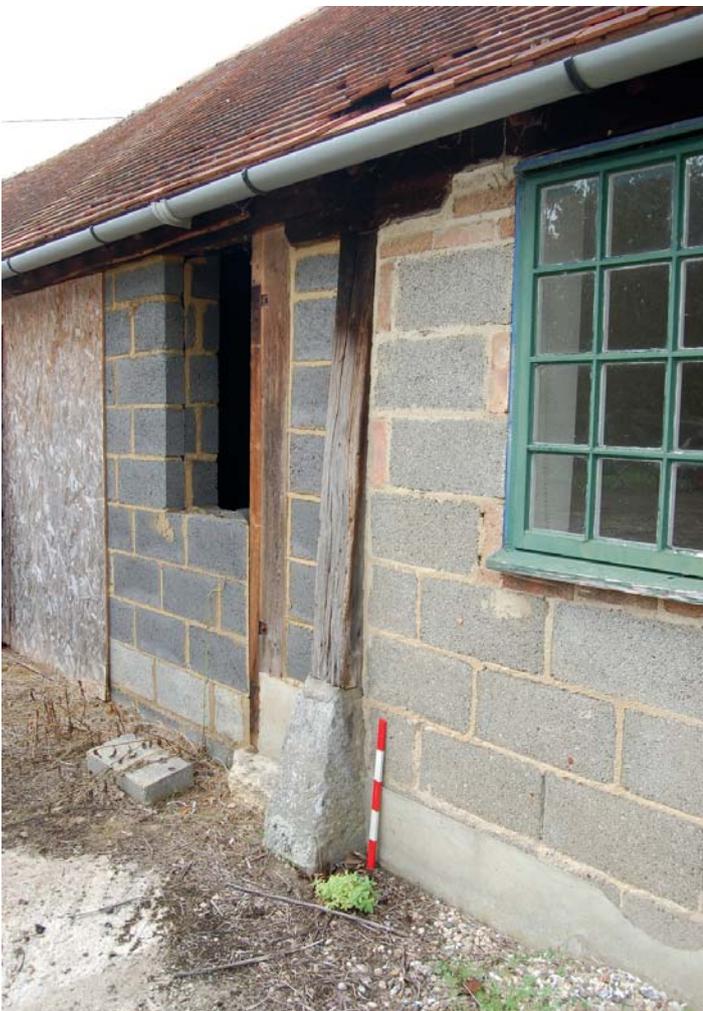
Plate 4 Post on staddle base

- 3.1.3 The aforementioned timber posts have been replaced, seemingly in the later part of the 20th century, and are currently standing on staddle bases (Pl. 4). These staddles are all of different sizes and so does not suggest that they came from a granary locally. The second post from the south has been replaced by an internal steel frame abutted by blockwork and boarded over externally.

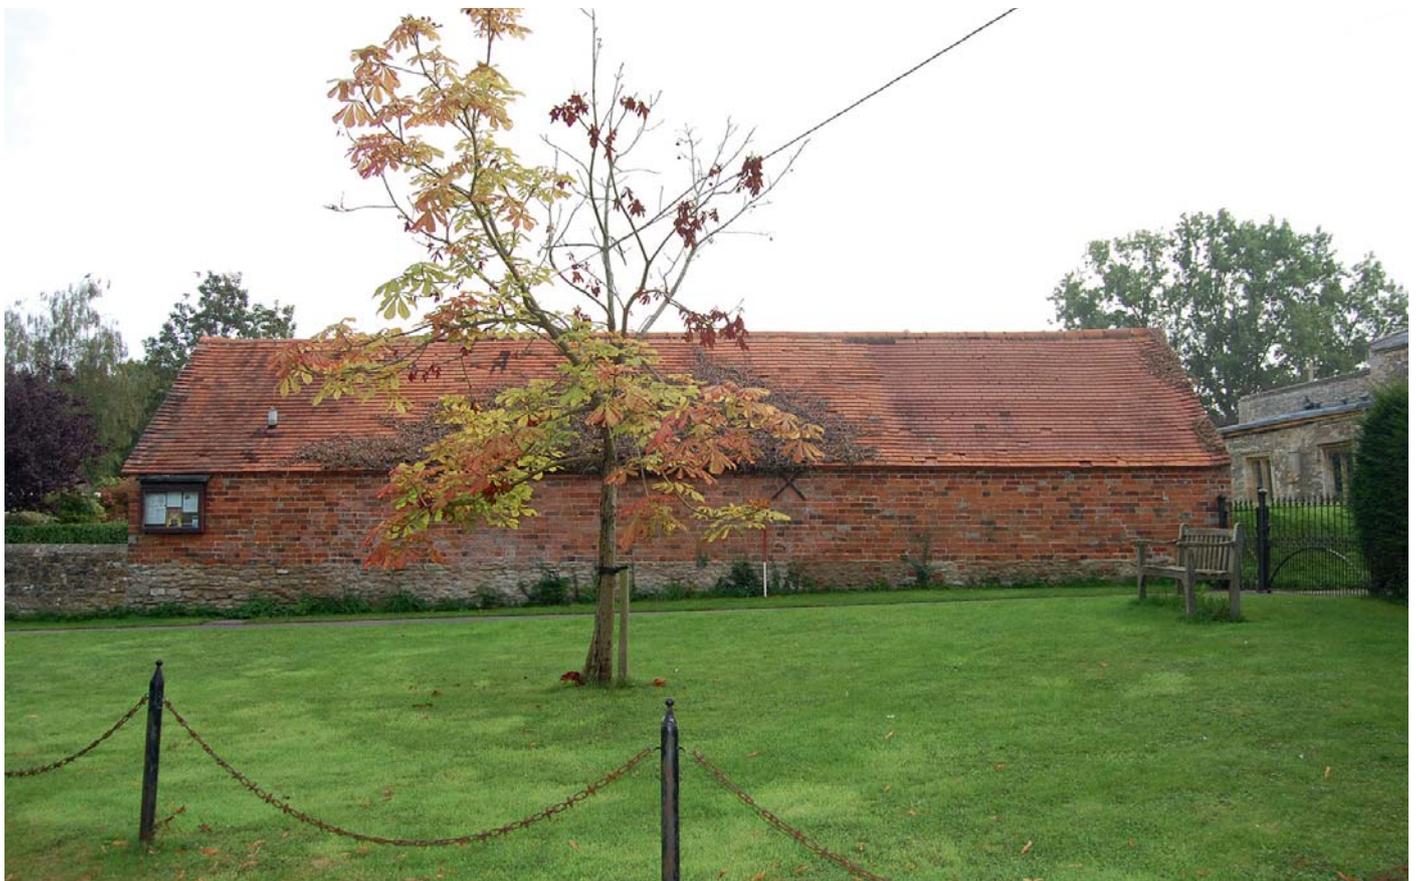
Plate 6 West elevation

- 3.1.5 The west elevation, the rear of the building, comprises a coursed limestone rubble plinth with Flemish garden wall bond brickwork above (Pl. 6). The handmade bricks are bonded with lime mortar with occasional cement mortar repairs; originally, the joints were probably flush pointed but are now fairly degraded, the repointing displays some attempts at rough double struck pointing. The bricks are of assorted colours and many have fairly large inclusions (Pl. 7).

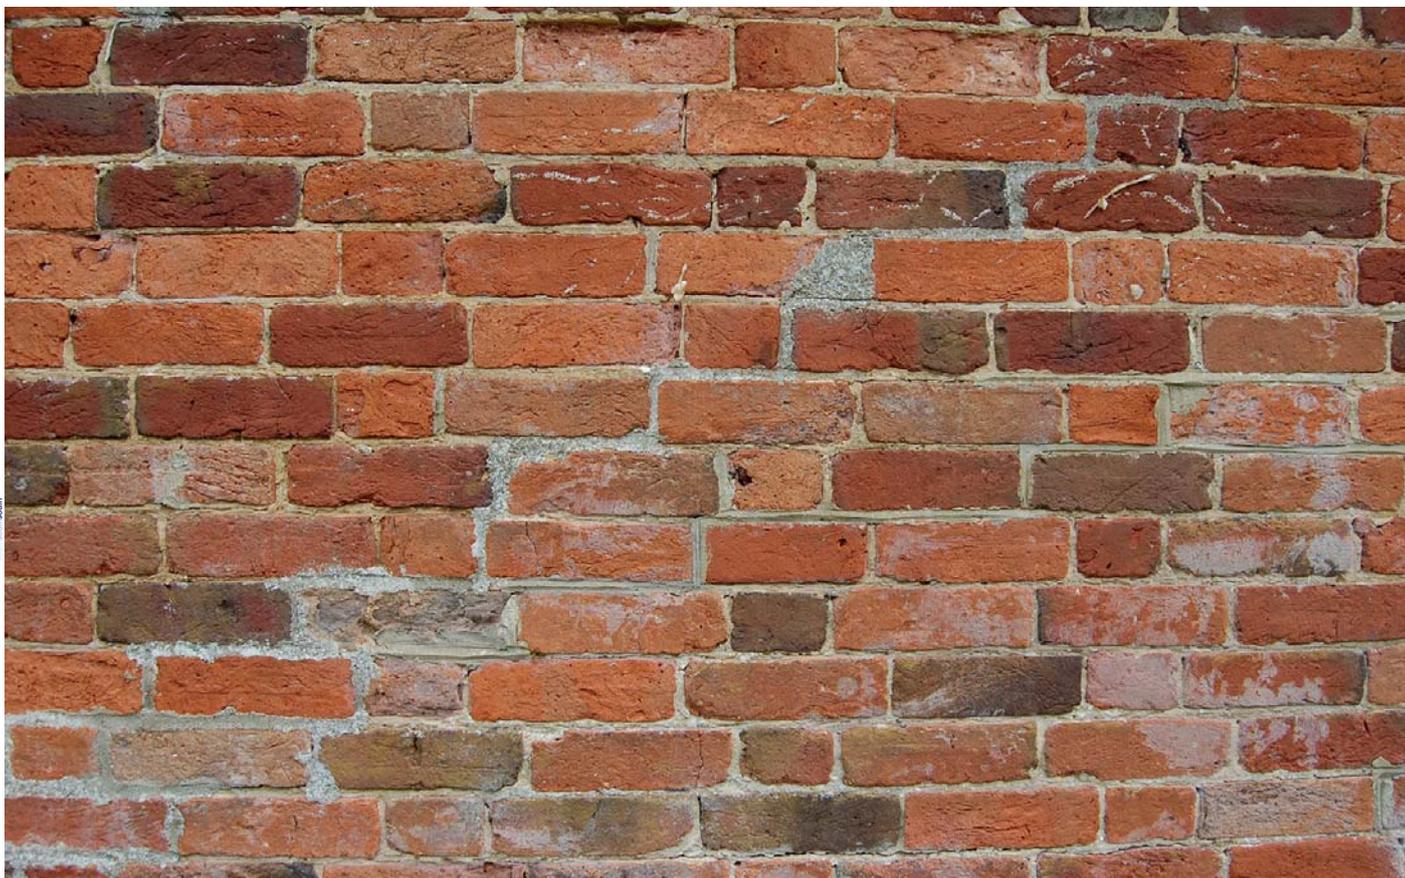
Plate 7 Brickwork of the west elevation including repointing

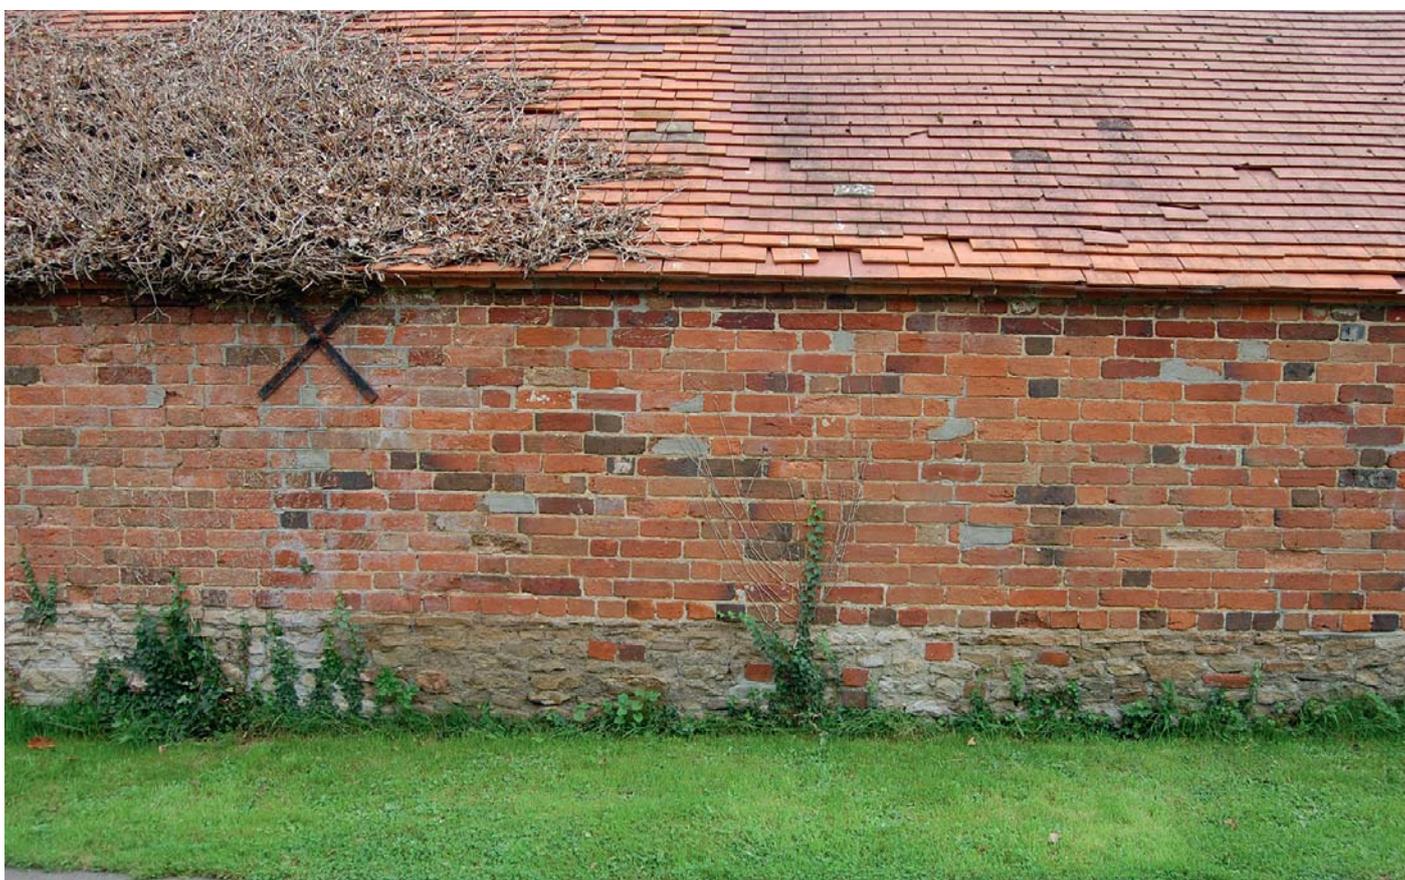
- 3.1.6 The limestone plinth shows some signs of repair, notably to the southernmost end where bricks have been used to substitute degraded stone. The occasional use of cement mortar to repoint the stonework in this area will have exacerbated the stone degradation (Pl. 8).

Plate 8 Signs of repair to the plinth of the west elevation

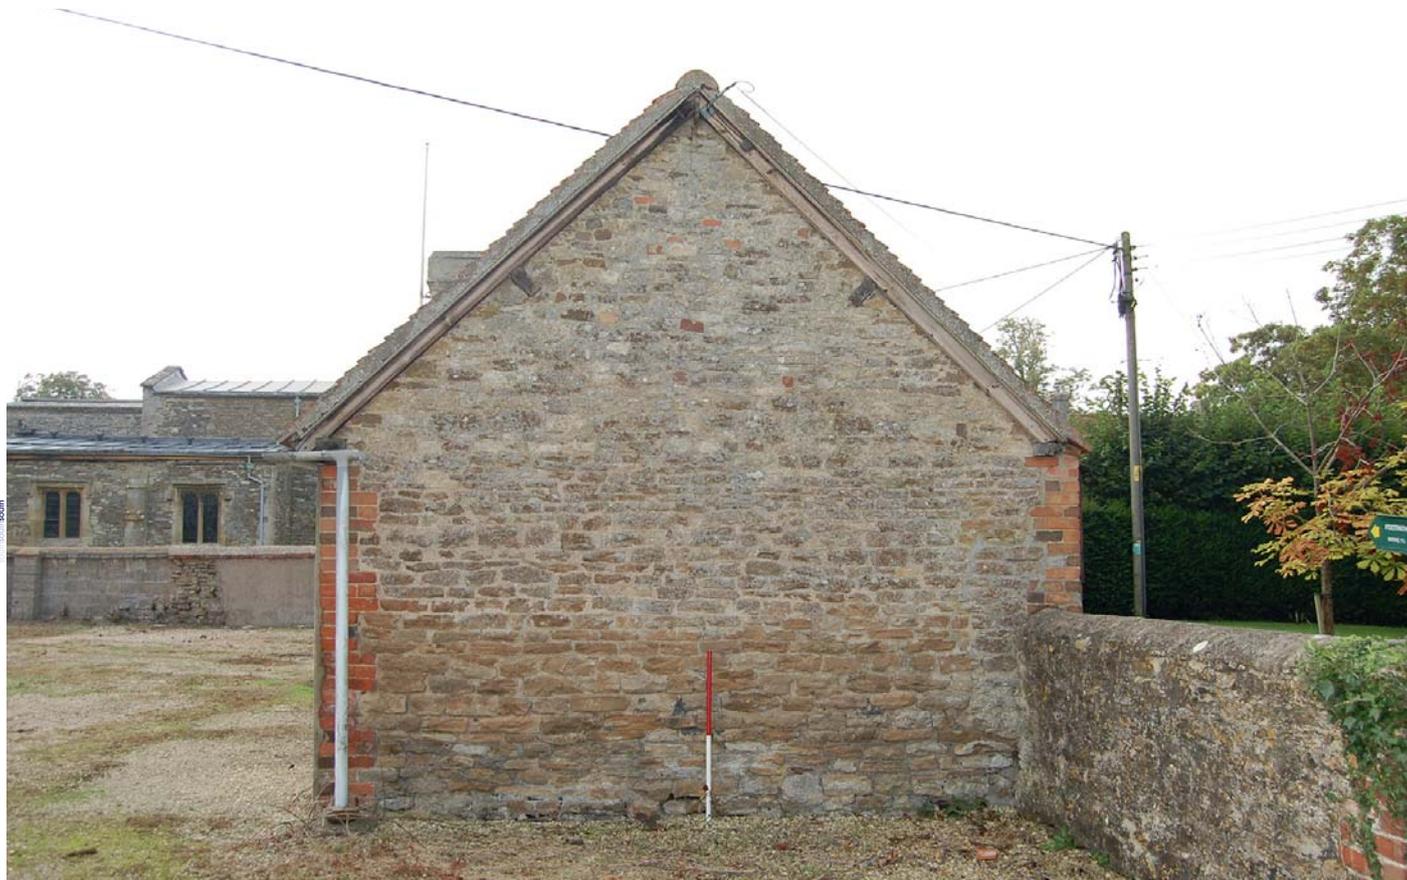
Plate 11 North elevation

- 3.1.9 The limestone boundary wall abuts the north western corner of the barn (Pl. 10).
- 3.1.10 The north elevation consists of coursed limestone rubble with short returns of the brickwork of the adjoining elevations to either edge (Pl. 11). Occasional bricks have been used for repairs. Heavy lichen growth obscures definition of the courses at high level.

- 3.1.11 The lower metre of the elevation lacks the heavy lichen growth of the remainder of the wall; repointing and degraded pointing prevent determination whether this is an area rebuilding or whether a lean-to structure has sheltered this area of the wall. The OS map of 1878 shows a projecting structure at this position which is likely to be the cause of the patching or sheltering of the stonework.

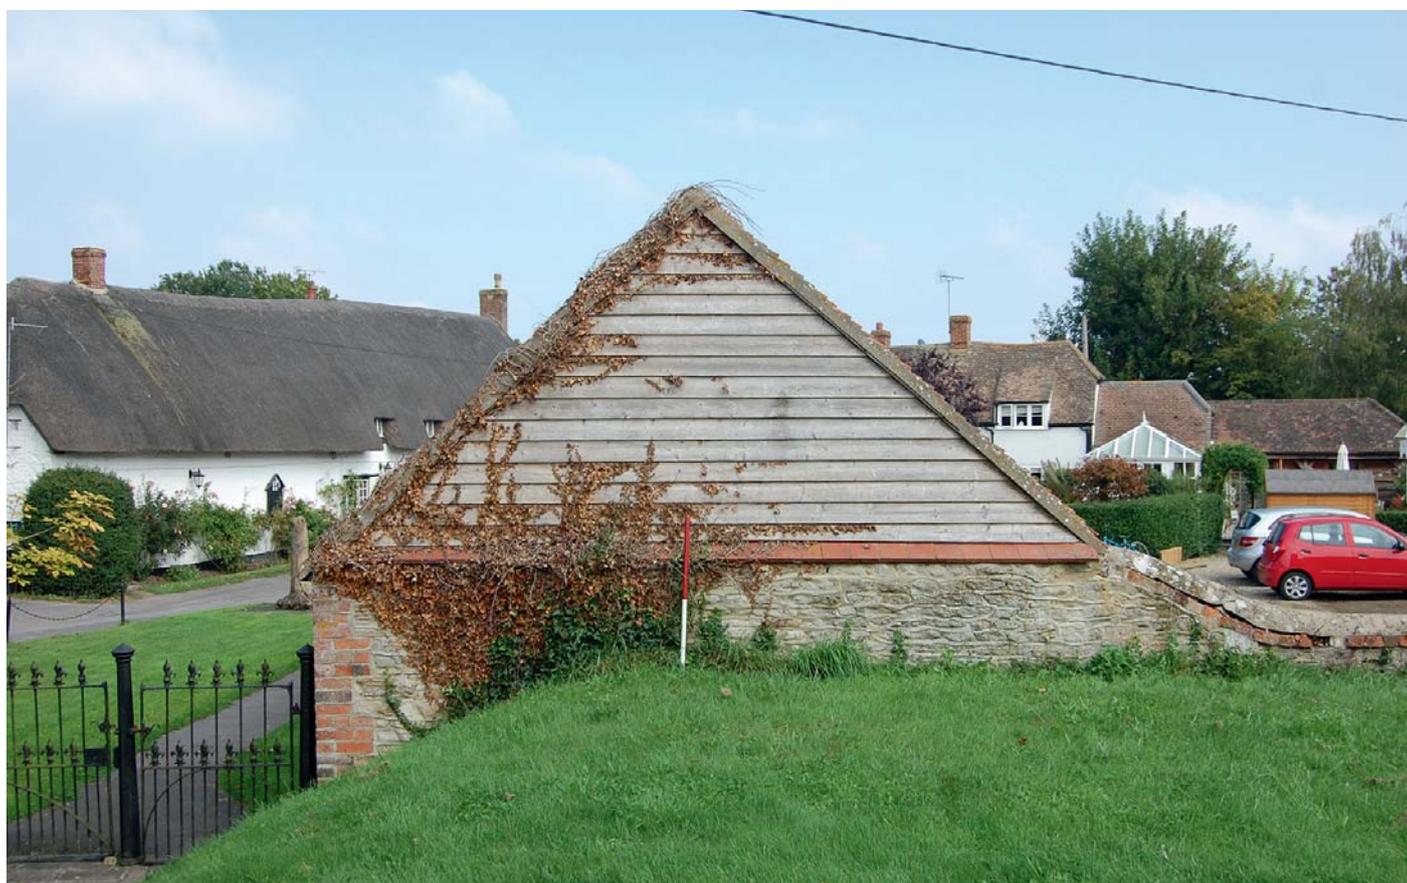
Plate 12 South elevation

- 3.1.12 The south elevation of the barn is comprised of the coursed limestone rubble churchyard wall (Pl. 12). It appears that the barn was originally built utilising this existing retaining wall as the southern end of the building. The majority of this elevation, therefore, is not visible. The limestone wall extends approximately 75cm above the current ground level of the churchyard, sloping to the south west corner of the barn, where a short return of the brickwork of the west elevation is visible.

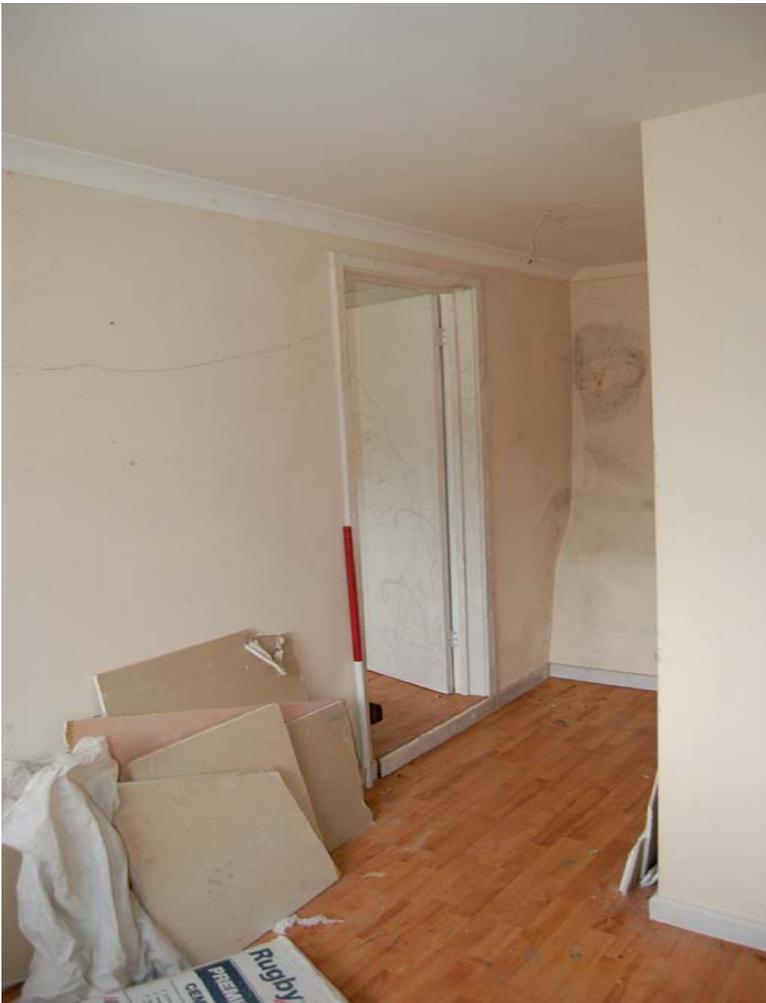
Plate 14 Entrance office including rear wall

- 3.2.3 The bottom of the rear, western, wall of the room slopes and widens, indicating that the stone plinth is over twice the thickness of the brickwork which is flush with the stone to the external face (Pl. 14).

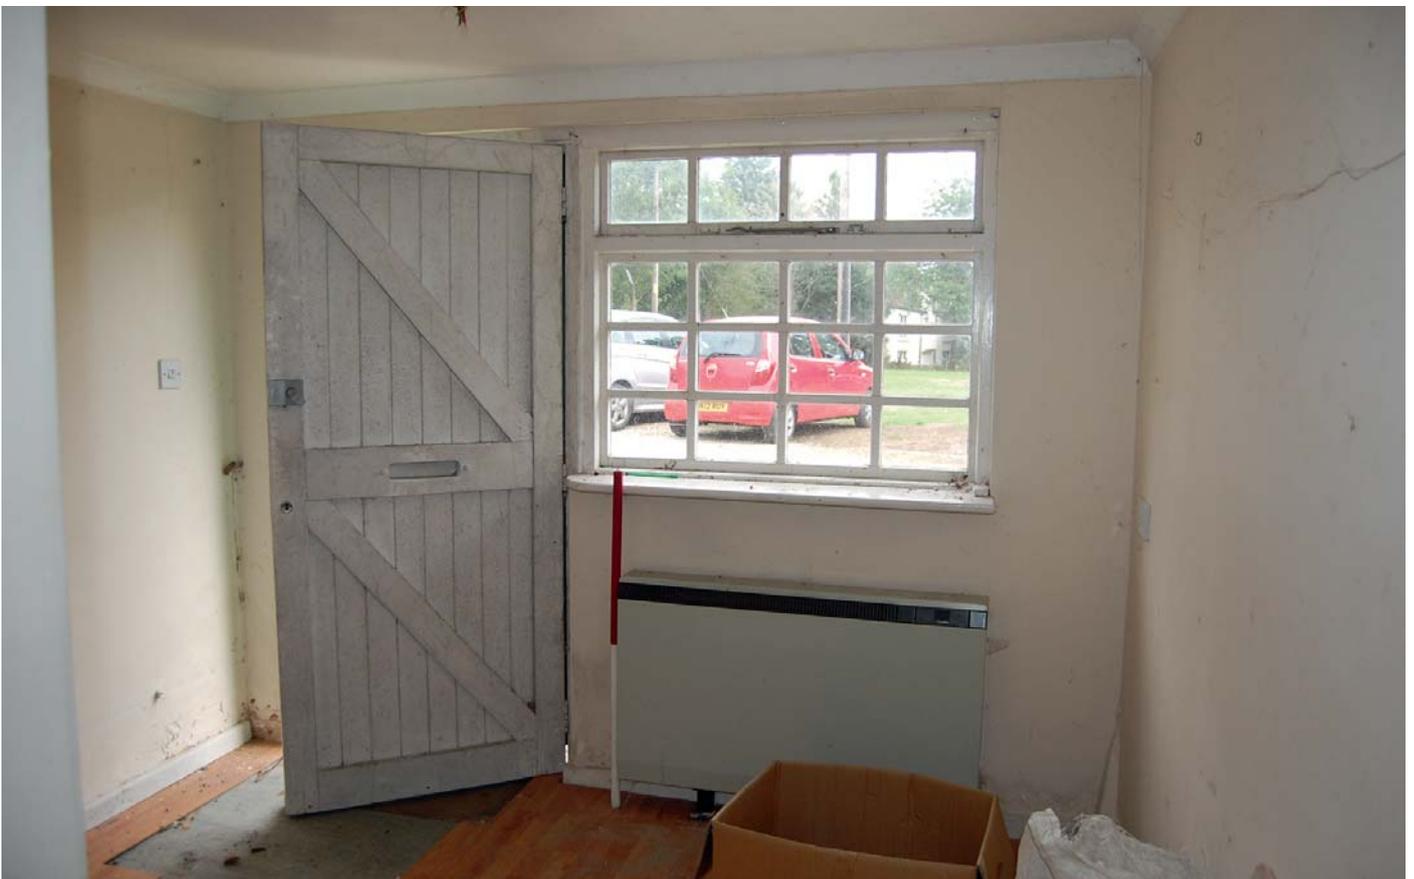
Plate 16 Entrance door and window

- 3.2.4 In the south eastern corner of the room, the corner of the staddle supporting the post projects from the walls (Pl. 15).
- 3.2.5 The door in the east elevation is a modern plank, ledge and braced door and the adjacent timber casement window is also modern. The storage heater and electrical fittings all date to the modern conversion, which appears to have taken place in the late 1980s or early 1990s. The laminate flooring is a recent addition, but has since failed due to damp (Pl. 16).

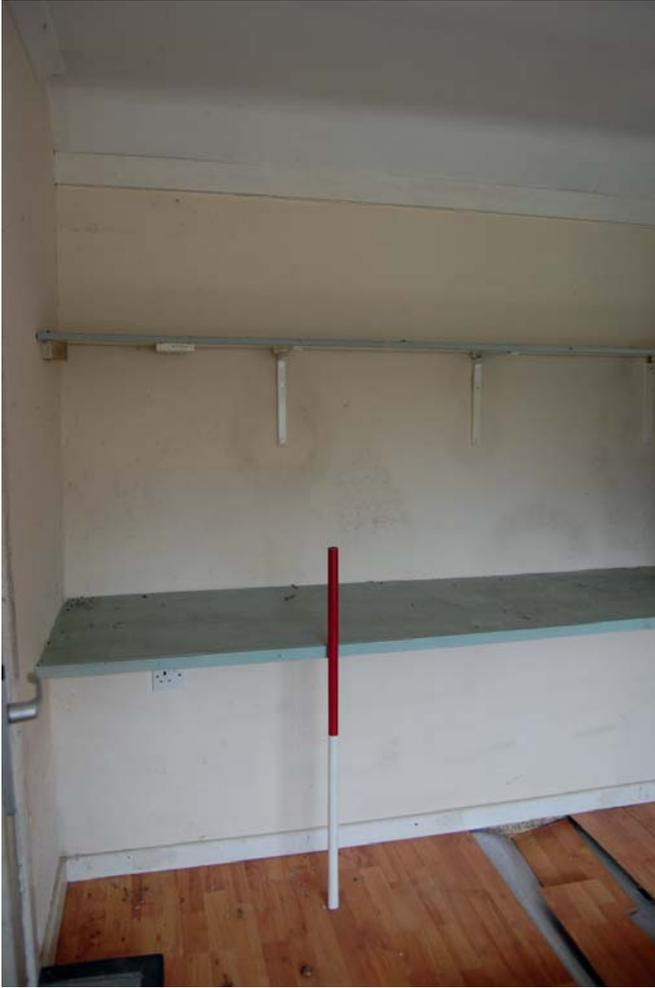
Plate 17 Rear wall of the middle office

- 3.2.8 The electrical fittings are identical to the adjacent office and shelves to the rear of the room create a workbench area which disguises the sloping stone plinth. The floor has failed due to rotting floor joists (Pl. 17).

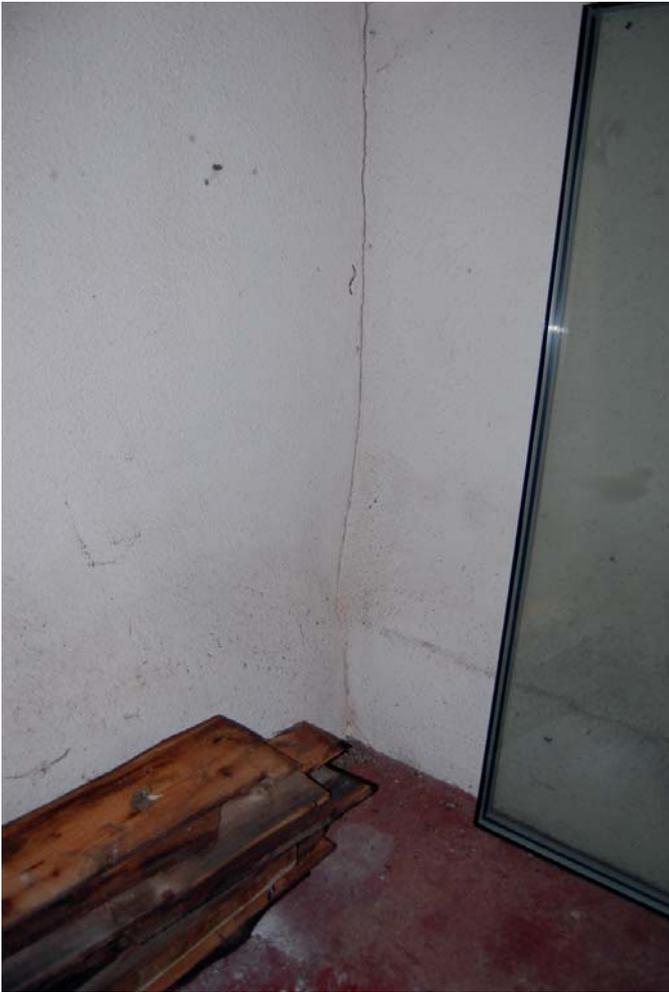
- 3.2.11 The rear wall demonstrates the wider stone plinth, as in the other rooms, and the southern end wall also indicates that the concealed retaining wall has been similarly reinforced (Pl. 19).

Plate 19 Rear and end wall of the store, demonstrating the thickness of the plinth

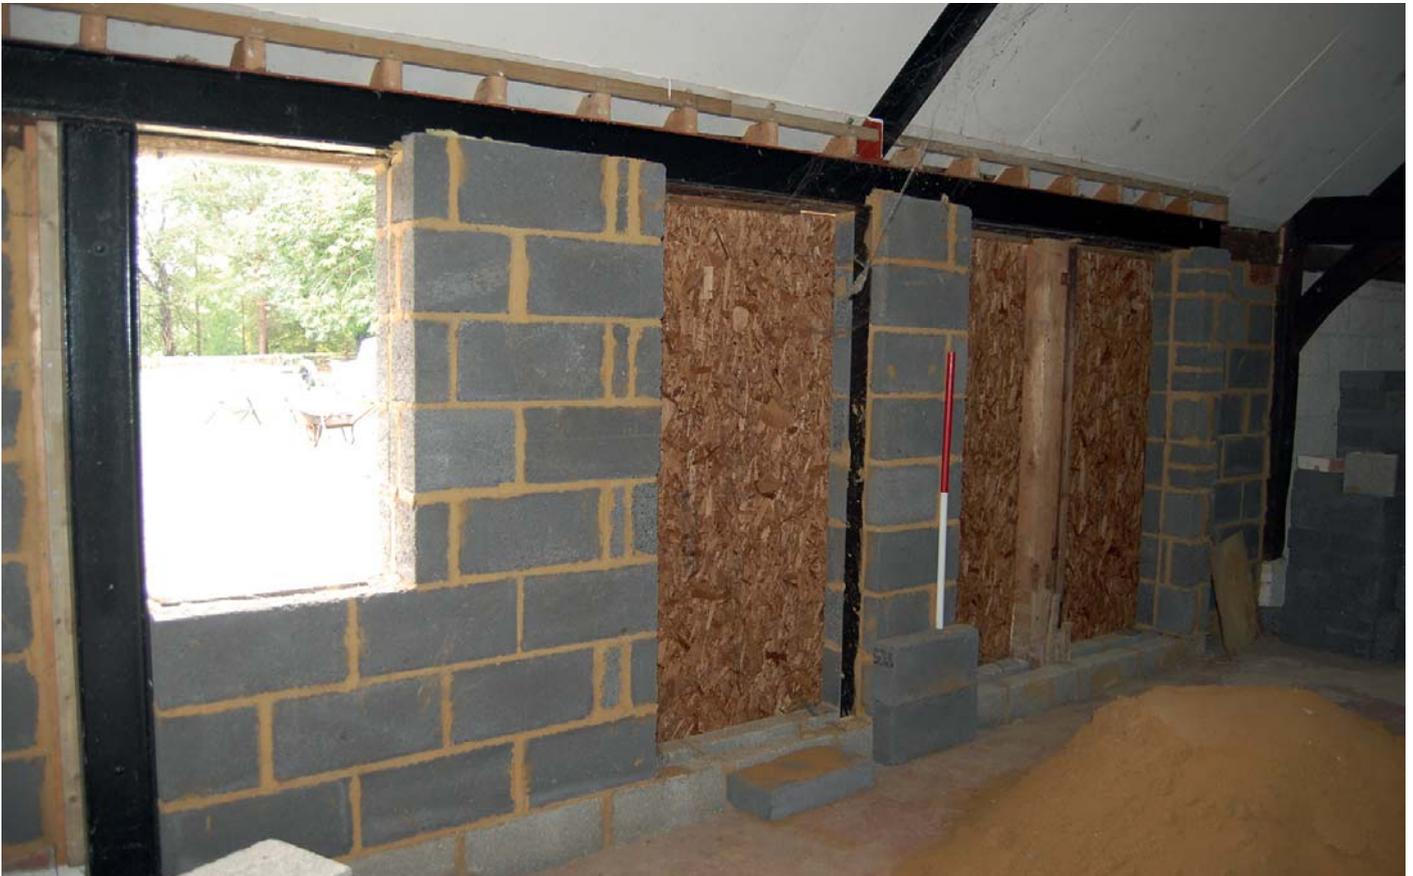
Plate 20 Blocking of the bays of the store room

- 3.2.12 The southernmost bay has been blocked to the front by aerated concrete blocks which have been painted; the two remaining bays have been blocked within the last few years, although the door and window openings have not been completed and instead have been boarded over (Pl. 20).

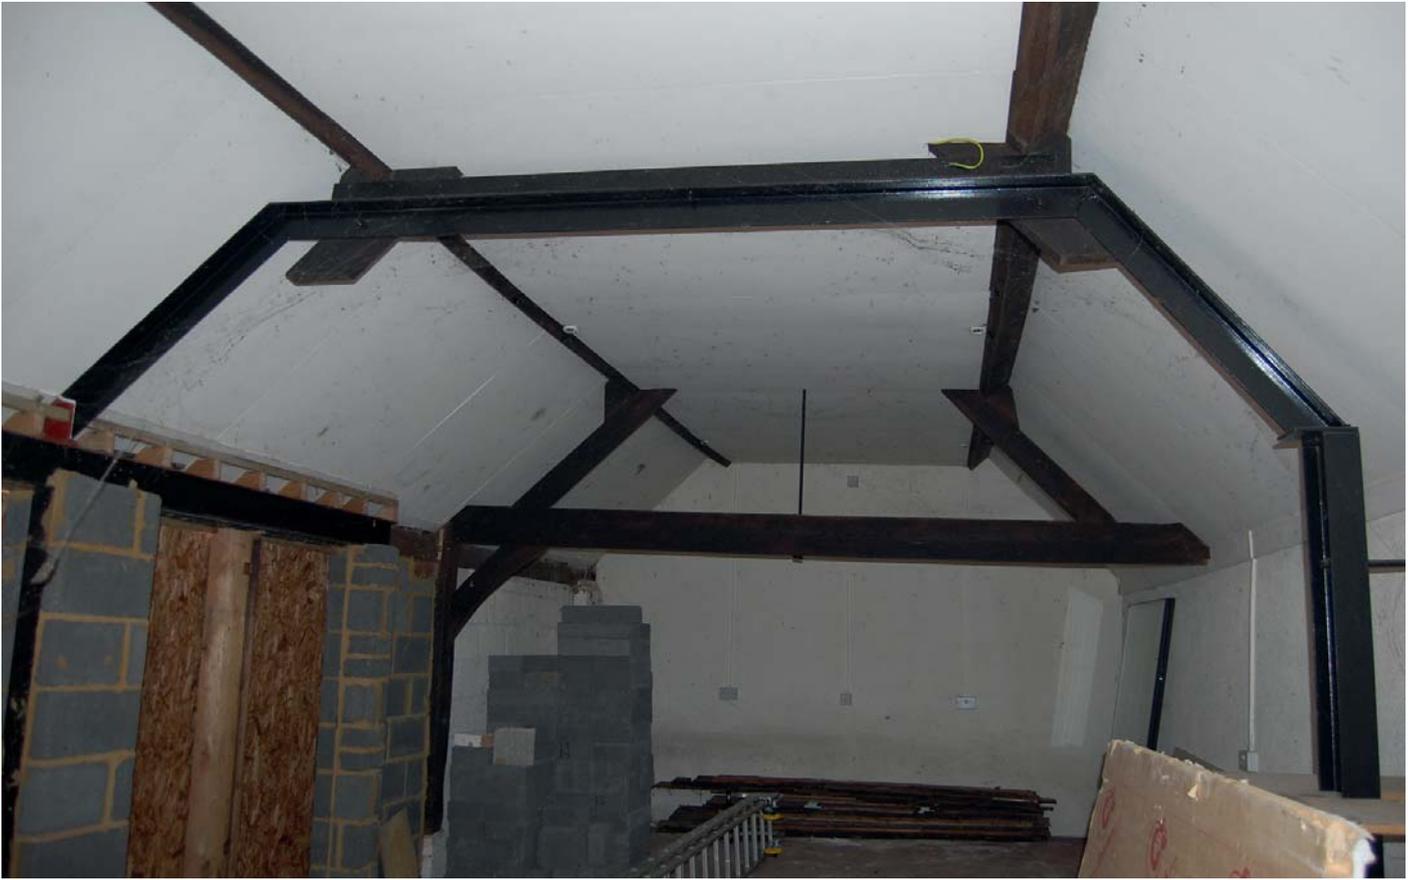
Plate 21 Structural steel frame in the store room

- 3.2.13 A modern steel frame has been added between the two newly-blocked bays and appears to replace the roof truss and timber post to the front elevation, however, the boarded ceiling and boarding to the front elevation obscure these elements. The tie rod attached to the cross-shaped anchor plate on the west elevation brickwork is tied into the steel column of this replacement frame (Pl. 21).

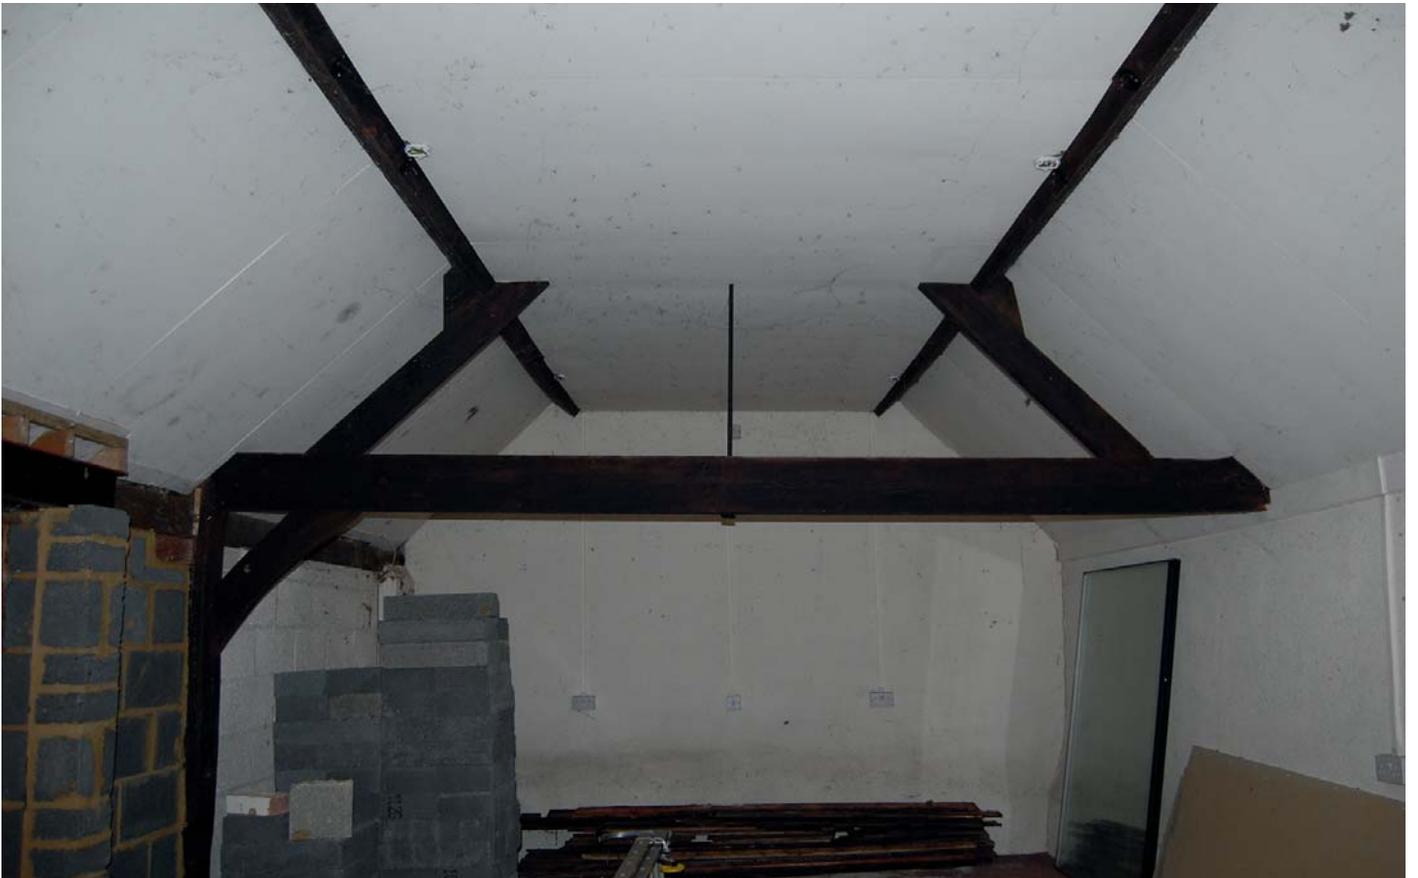
Plate 22 Partially visible truss in the store room

- 3.2.14 Much of the roof structure, where it survives, is obscured, however, the lower portion of the truss between the two southernmost bays is visible and shows the cross beam resting onto the wall plates to either end and the purlins being supported on cleats on the upper sides of the principal rafters. An iron bar acts as the post and is bolted to the cross beam, and to the couple above the ceiling (Pl. 22).
