# Ullenwood Court, Gloucestershire Former Second World War camp

## Historic Building Investigation and Recording

January 2021

**Client: Churcham Homes**

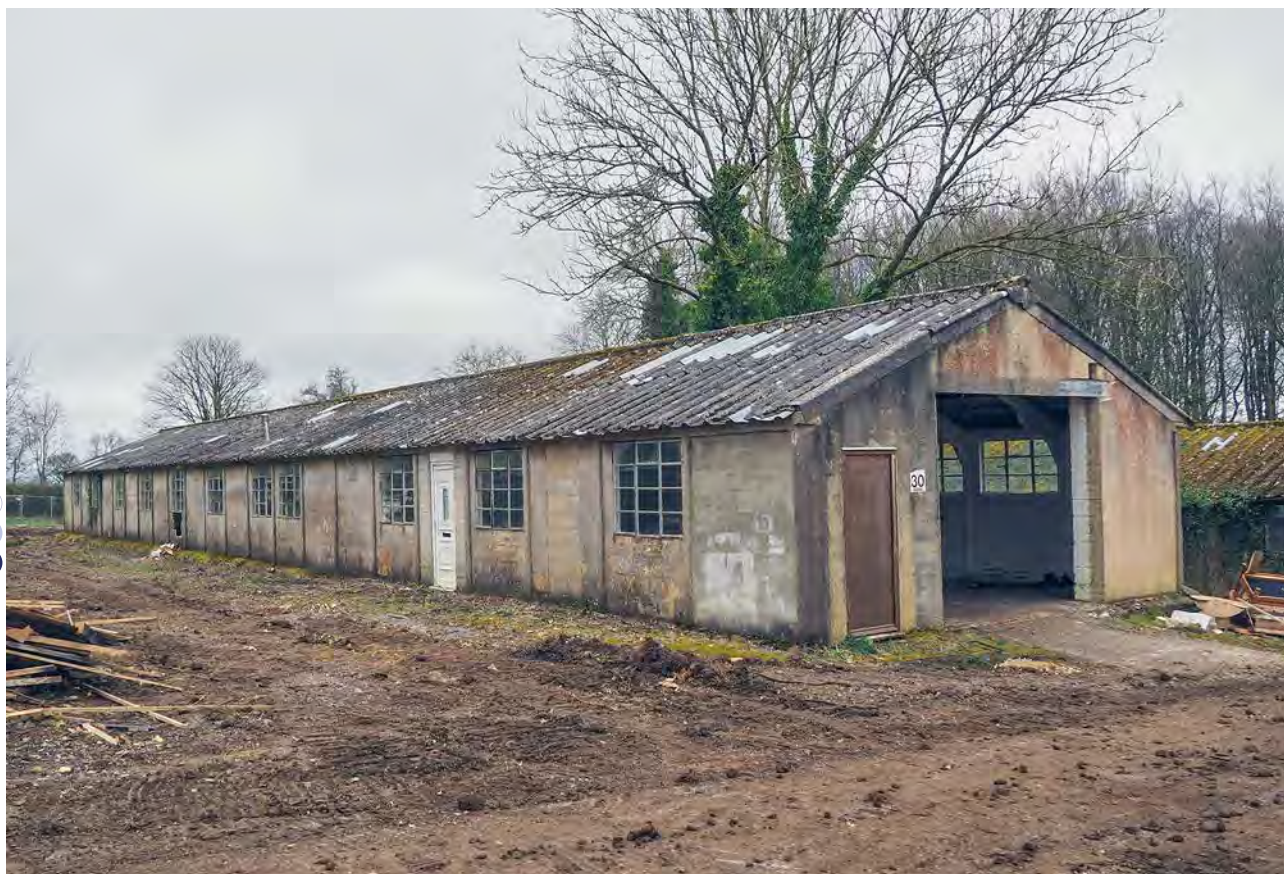
- 4.2.2 Most of the buildings are long linear structures (#2-6, 9-11, 16, 17, 19, 20 and 24-32) (Photo 1), although some are shorter but follow the same method of construction (#7, 8, 12-15, 21 and 23) (Photo 2). They use the same construction techniques, with the use of concrete portal frames, large hollow terracotta bricks to infill the panels and critical windows. A small number to the west use brick built covered walkways or passages connecting buildings. These types of covered passages are known to have been a common feature at military hospitals of this type. They are found in a number of surviving US military hospitals from the Second World War including Northwick Park, Blackmore Park, Nocton Hall, Wolverley and Ullenwood (Foot, 2005).

Plate 1: A typical wartime ward (Building 30)

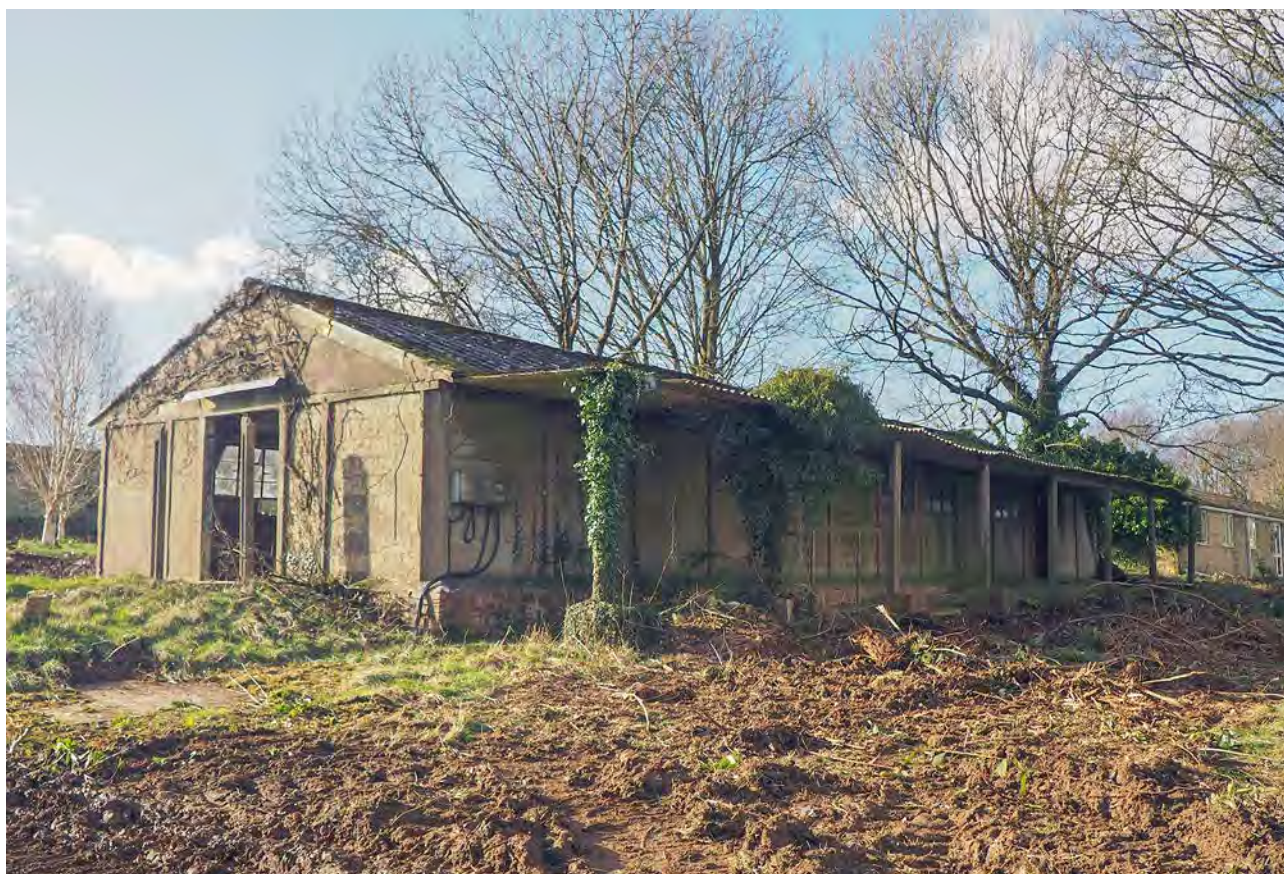
Plate 2: A typical (shorter) wartime ward (Building 12)

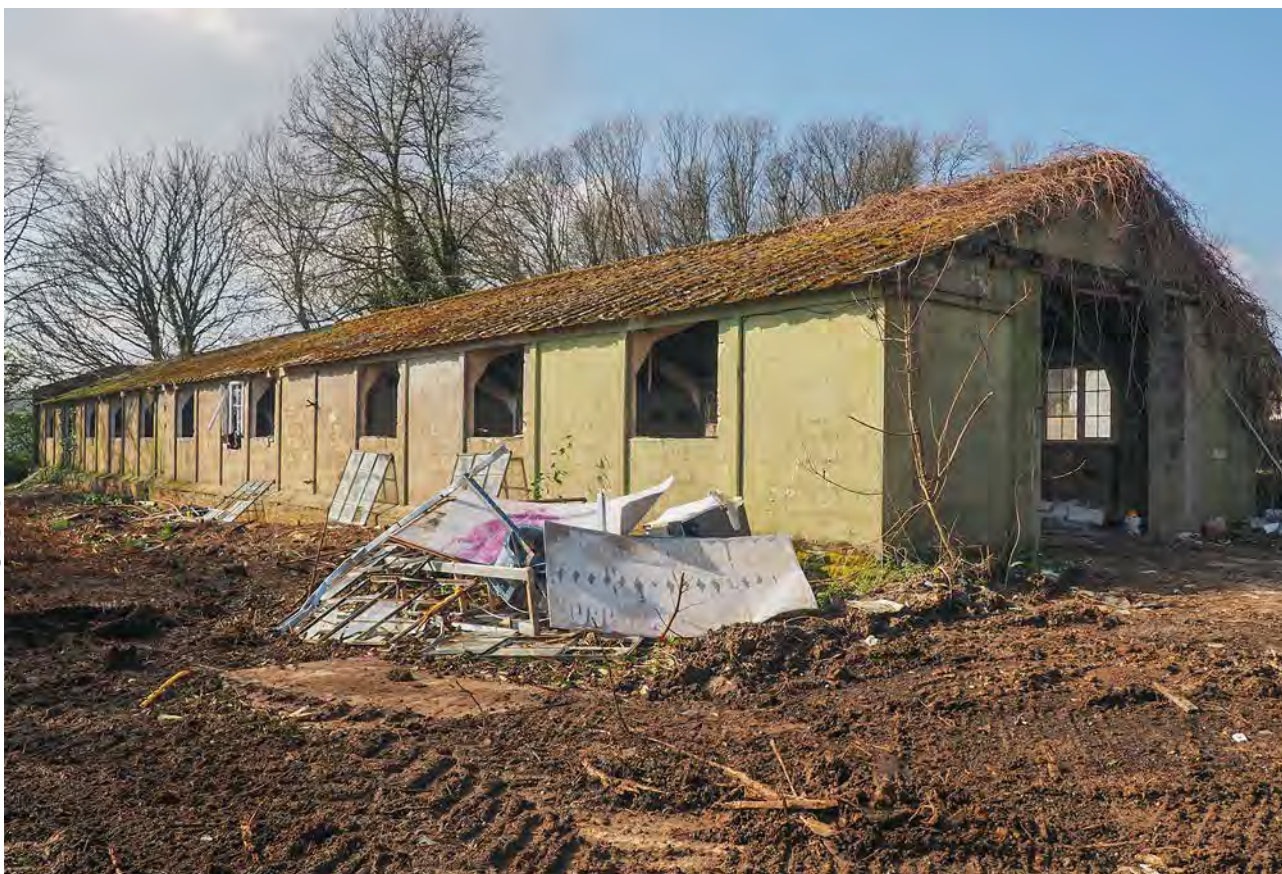
- 4.3.17 At the time of survey the windows had been removed from their frames in **building 3**, although the modern UPVC and crittal frames were visible on the floor showing that some windows had been replaced (Photo 17). The front elevation has the same modified opening although this is framed in breeze blocks with a timber lintel horizontally above the opening. This has mortices in it, suggesting it has been reused. To the north, attached to it, is a section of metal bar which is thought to have formerly held a sliding door which is no longer extant.

Plate 17: Building 3, front and east elevations

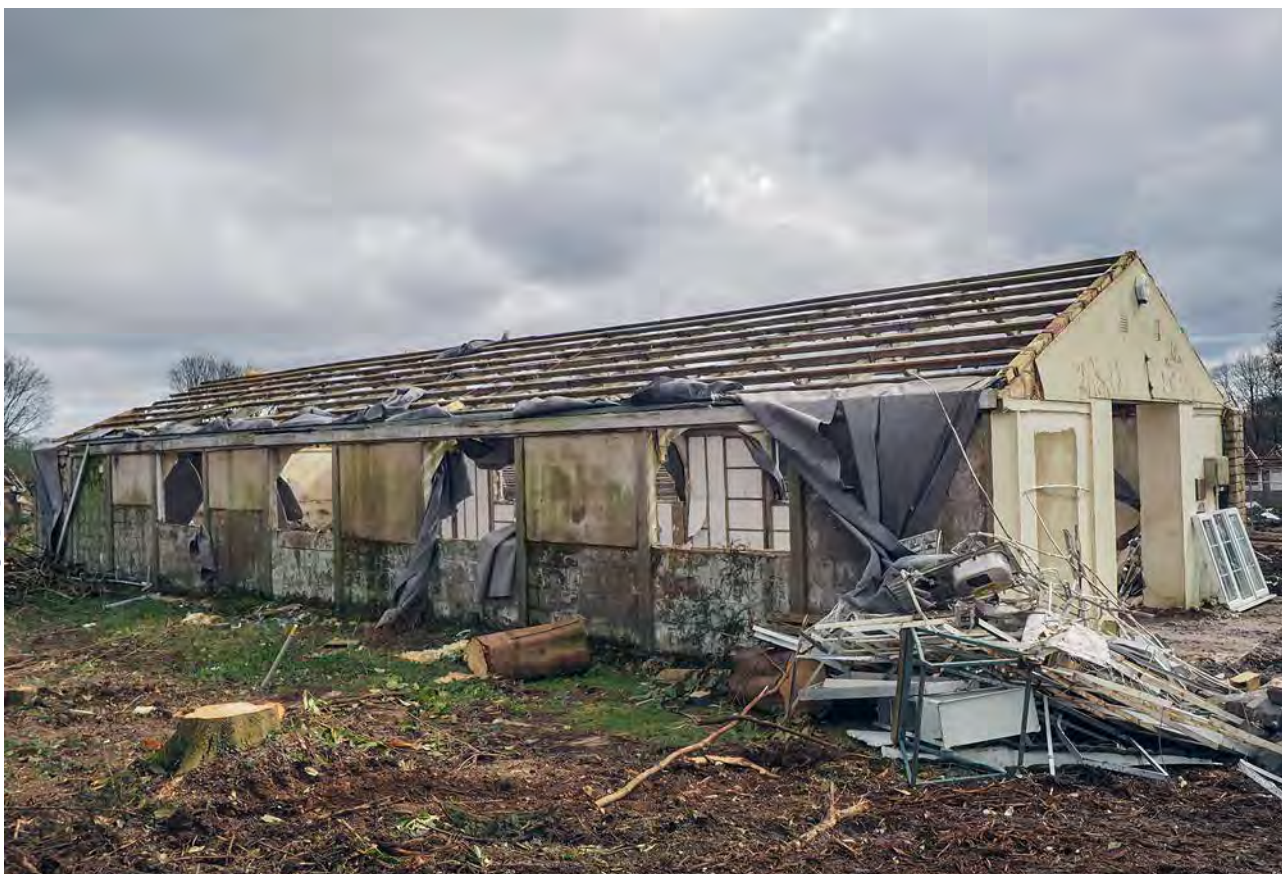
- 4.3.59 *Building 15*** is a small structure constructed on 10 portal frames, on an east/ west alignment, accessed from the same road as buildings 9-14 (Photo 37). It is a small structure, in a very poor condition at the time of survey as a considerable amount of the building's fabric had already

Plate 37: Building 15, south and east elevations

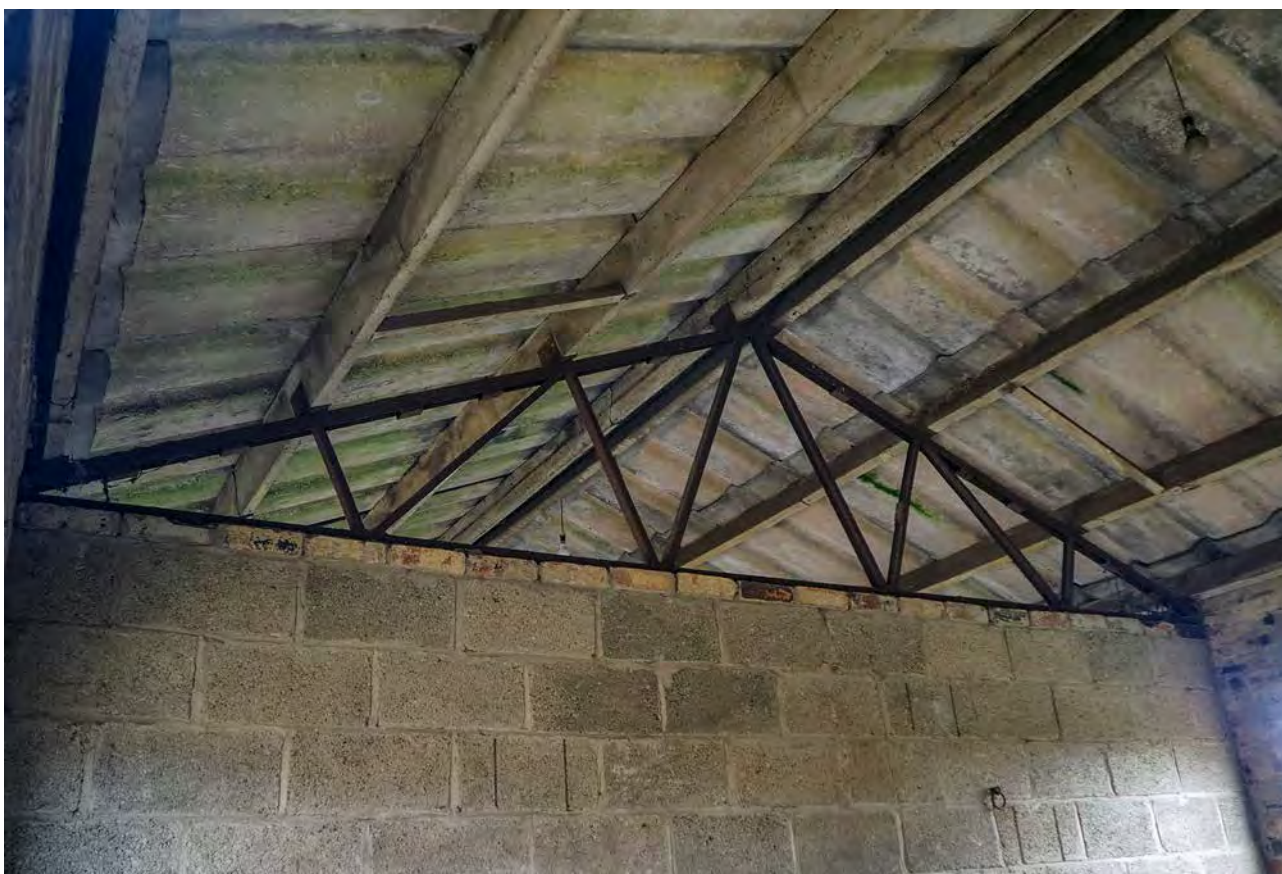
- 4.3.76 The building is divided now into nine sections, but an internal inspection show that it was originally only three sections which is evident by the internal brick walls (Photos 52 and 53). Further internal rooms were created through the construction of later breeze block walls. The doors (1.27m and 2.25m) to the nine sections are a later addition to facilitate its use for stables. Later brickwork is visible around some of the door frames especially along the top, and many have replacement brickwork around the sides.

Plate 52: Building 18, internal view of truss

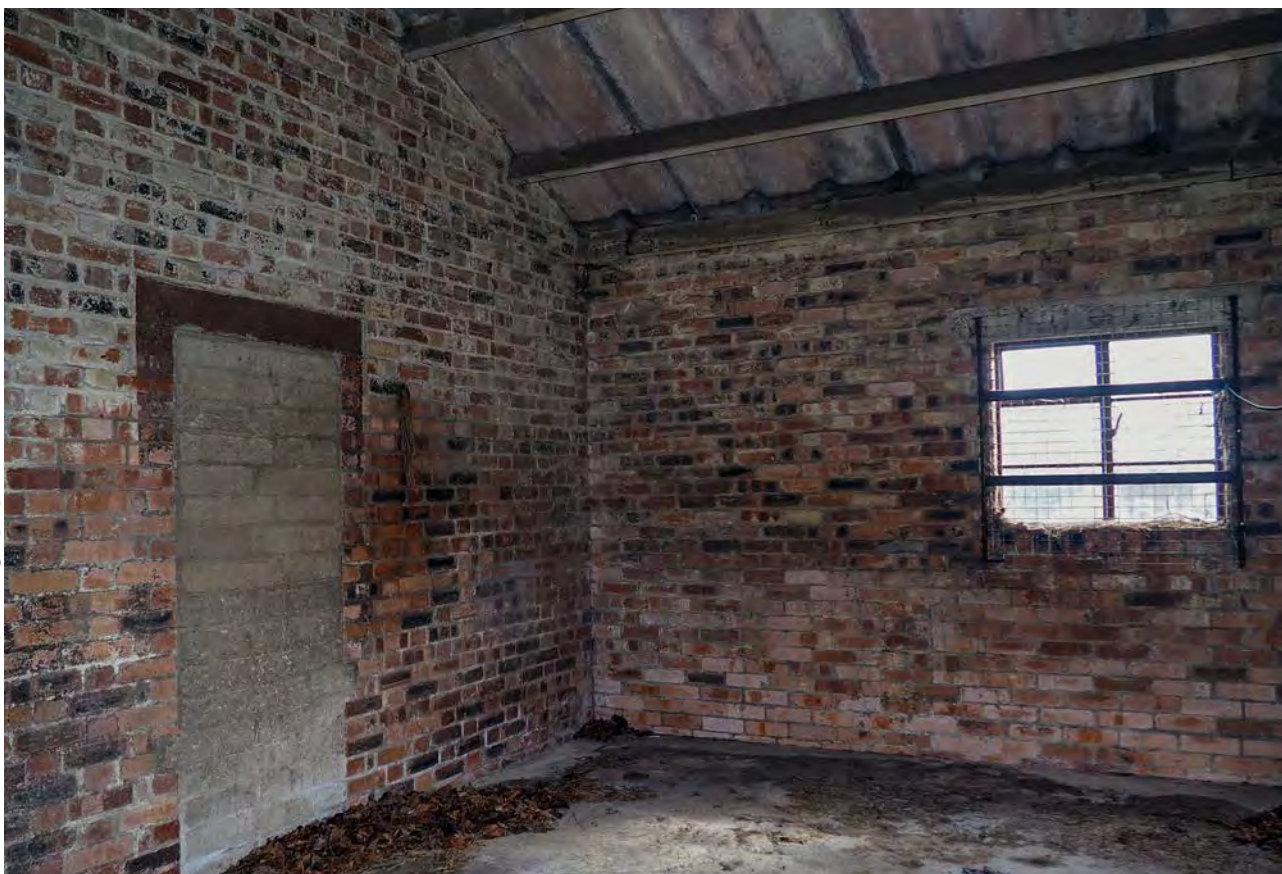
Plate 53: Building 18, internal view of blocked door

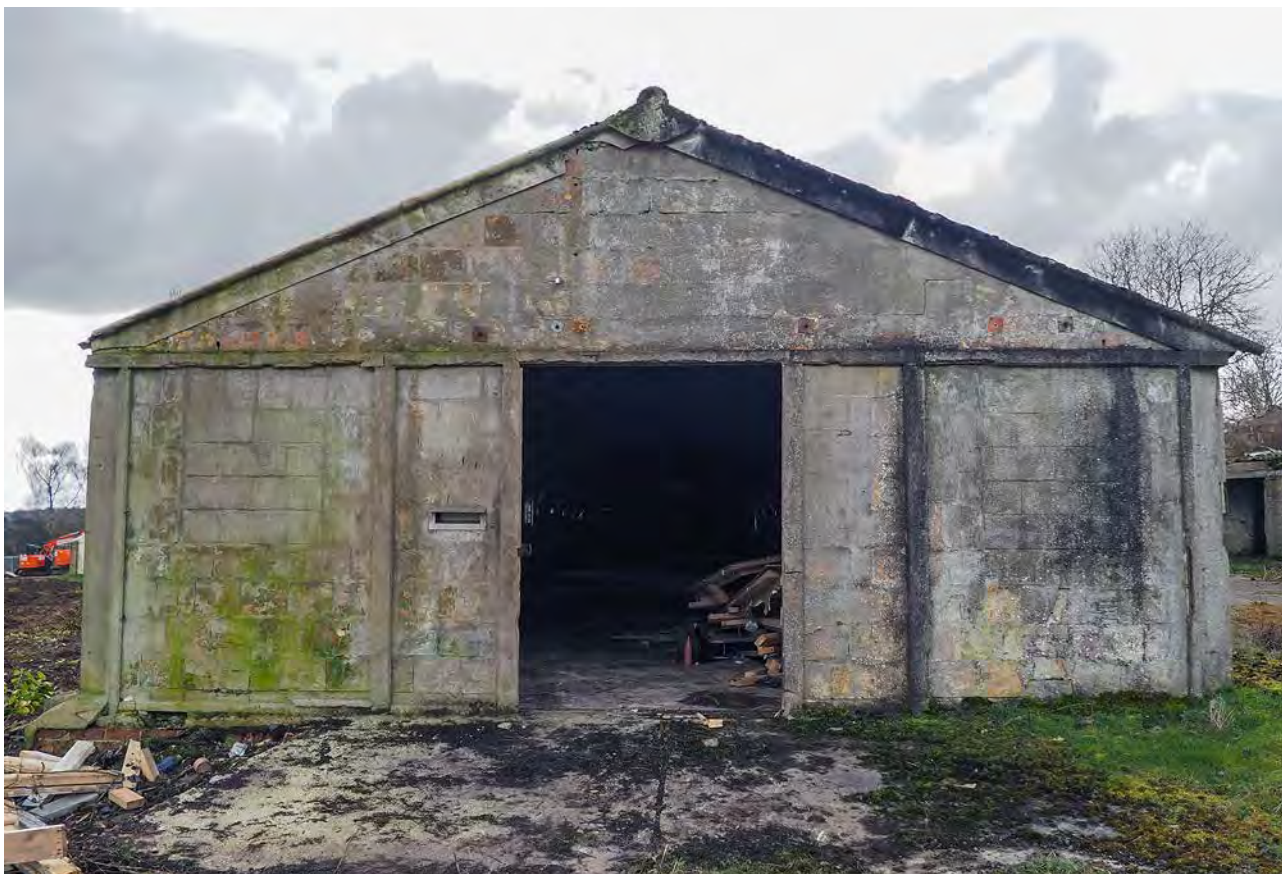
- 4.3.84 The south elevation is significant in reflecting the primary construction of the front elevation of these wartime structures (see Photo 56). This has the primary opening, which has not been widened to accommodate a larger door. The north elevation is covered in a considerable amount of vegetation, but it is possible to see that the two primary windows have been partially infilled and replaced with smaller timber windows of the same type as previously described. Otherwise, this elevation is of the same build as the standard wartime structures.

Plate 56: Building 20, front elevation

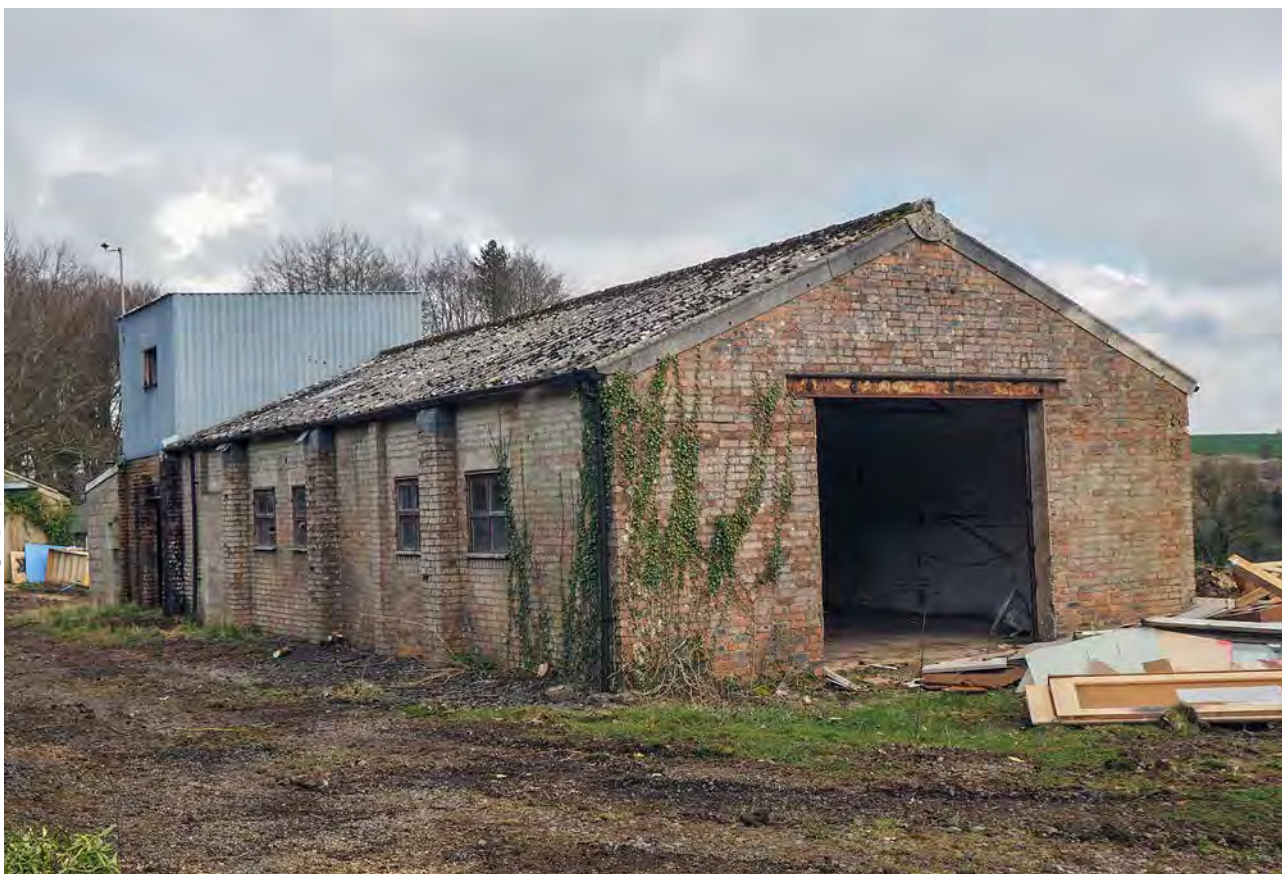
- 4.3.86 **Building 21** is not a standard wartime structure and is thought to have formerly functioned as a plant building or similar (Photos 59-62). It has thin single-skin brick walls which incorporate irregularly sized and spaced structural piers. The roof is gabled with primary corrugated asbestos cladding. The windows are timber replacements. The building has been extended at the north end with concrete breeze blocks and a gently sloping corrugated asbestos roof. This single storey extension includes a blocked door in the west elevation.

Plate 59: Building 21, south and west elevations

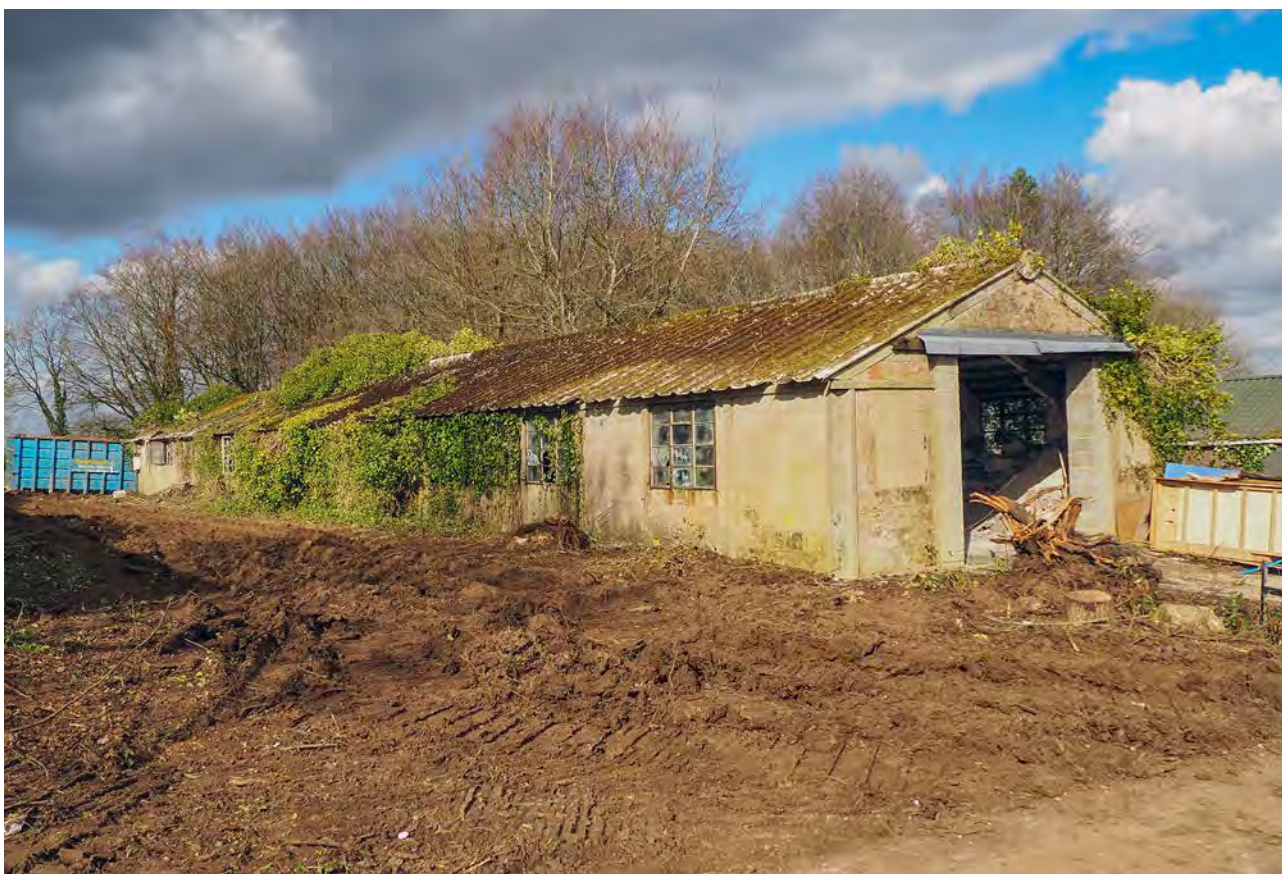
- 4.3.97 **Building 24** is a standard wartime ward, that survives in good condition (Photo 66). The entrance to the front (south) elevation has been widened, and breeze blocks pillars added to the sides of the entrance. There was evidently formerly a metal roller door here, which is no longer extant. There are two infilled windows to each side of the entrance. The east and west elevations are covered in ivy but the primary crittal windows appear to remain *in situ*. The rear elevation also retains its primary build, although the central door is blocked with concrete breeze blocks. The two windows situated to each side of the former entrance are thought to have been infilled relatively soon after the building was constructed as these are infilled with terracotta blocks.

Plate 66: Building 24, south and west elevations

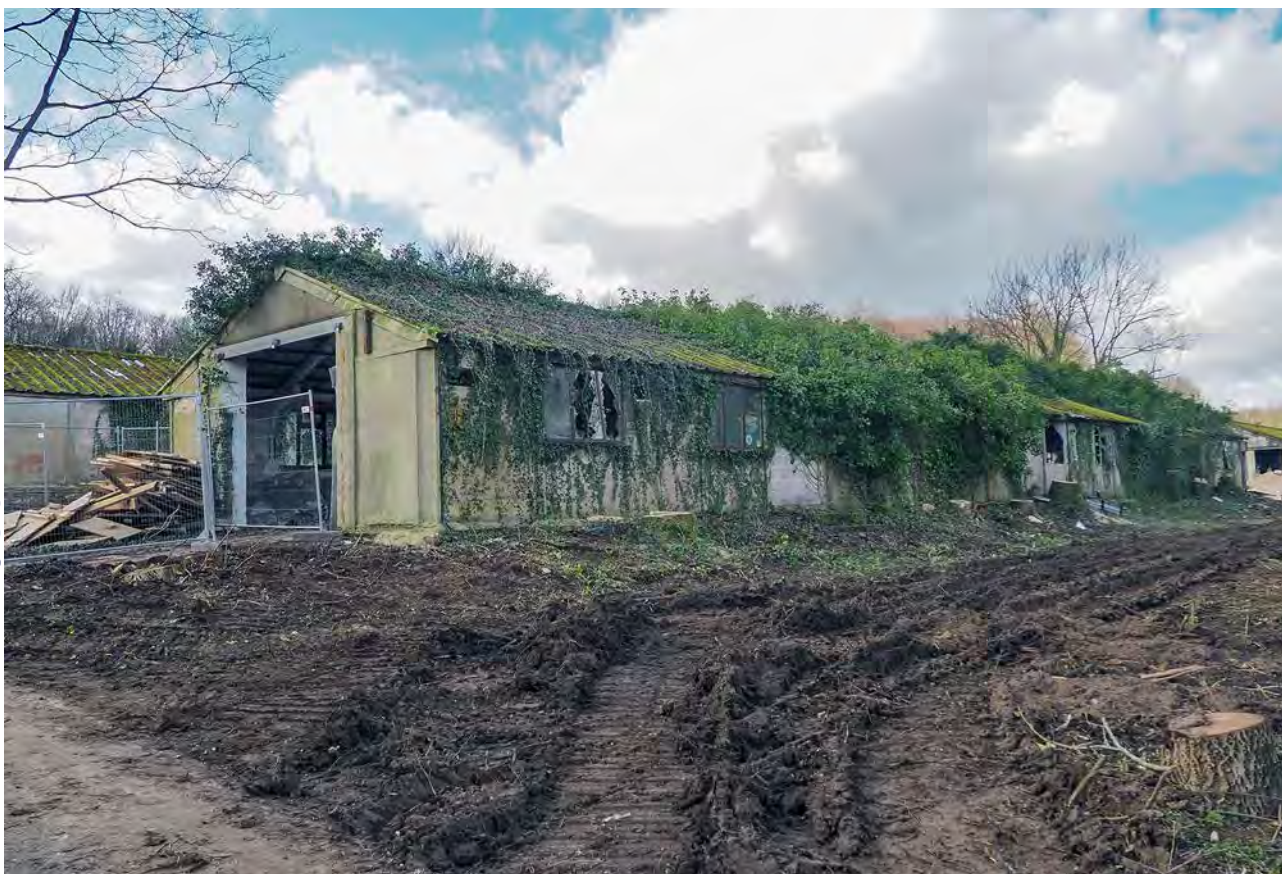
- 4.3.99 **Building 25** is a standard wartime structure at Ullenwood, with a modified front elevation to accommodate a wide access door (Photo 67). Internally it is possible to see that the front elevation has been entirely rebuilt with breeze blocks and a door added to the east. The windows to the east and west elevations are largely primary crittal windows, but some are later timber replacements. Internally, there are markings on the floor for a spinal corridor and for some smaller rooms. In alignment with building 24, there is a single infilled door at the north end of the east elevation. The rear elevation is covered in ivy, but it is possible to see that the door has been infilled with breeze blocks.

Plate 67: Building 25, south and east elevations
