**LAWKLAND HALL**  
**SETTLE**  
**NORTH YORKSHIRE**

**Archaeological Watching Brief Report**

Report no 1997-98/7768/AUA7778

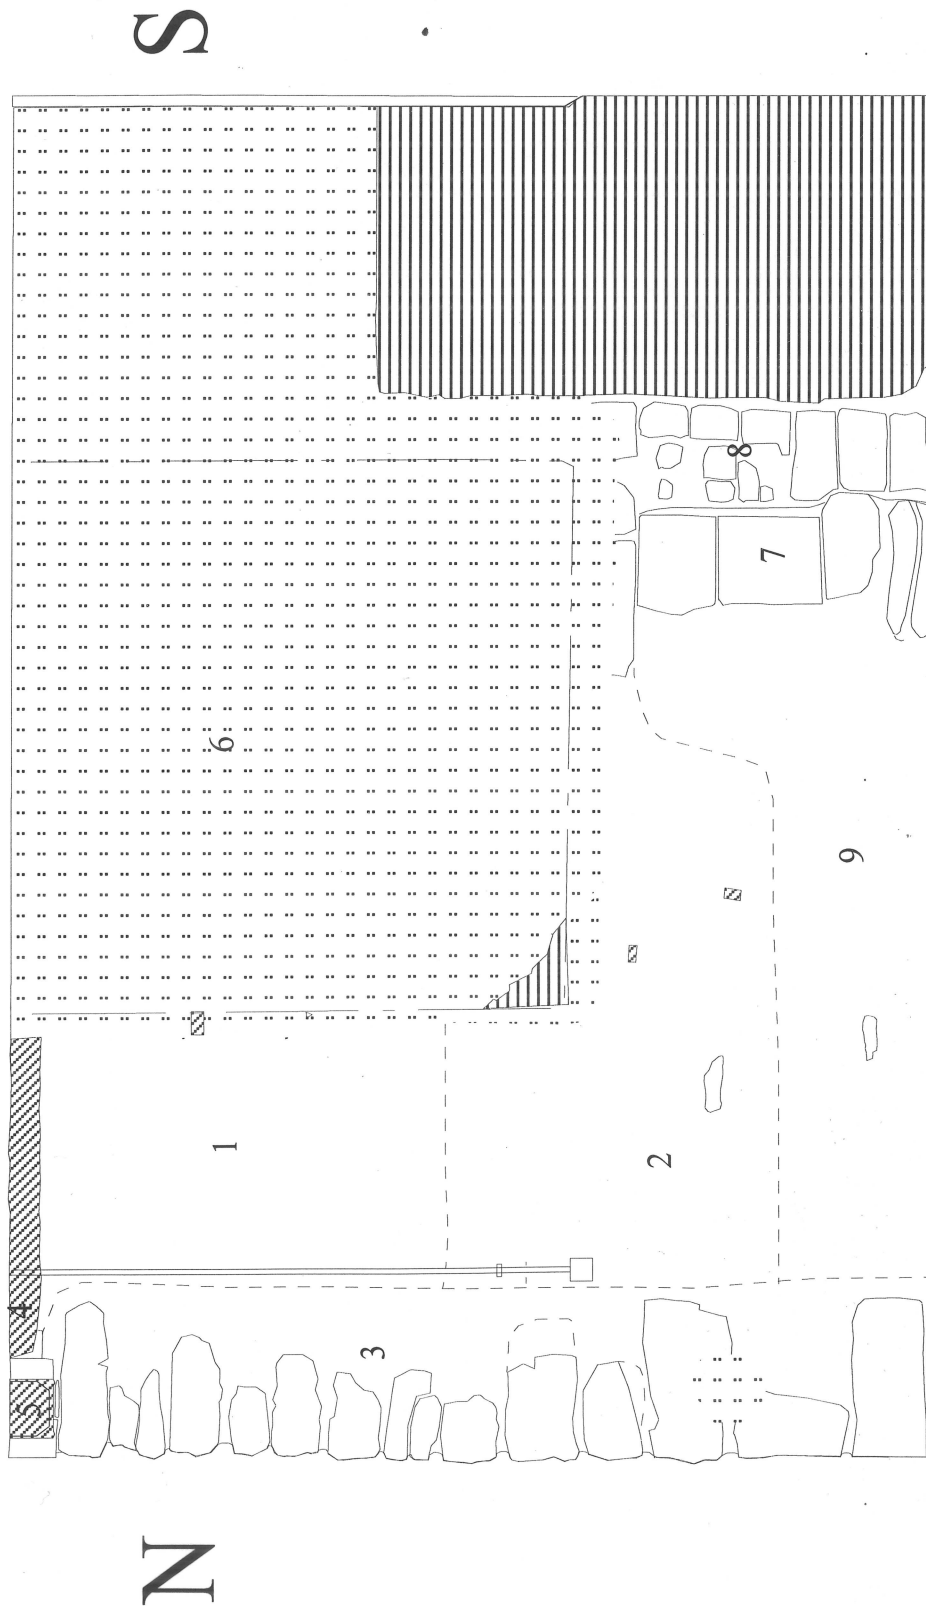
Fig 4 West Elevation of Passage Way Wall

- 3.5 The wall to the south of the rebuilt section would appear to be of greater antiquity, and a product of more than one phase of construction (1, 2 and 9). Examination of the eastern face of the wall revealed that it has at least two distinct constructional forms; the upper half of the wall (1) incorporated considerable amounts of limestone slabs/slates, mixed in with the sandstone blocks, but by contrast the lower half of the wall was predominantly constructed of small and medium coarsely dressed sandstone blocks. Although there is an obvious distinctive character between the two builds, the interface between them was not precisely defined, but occurred at an approximate height of c1.5m up from the floor. This constructional form is not as evident on the western face of the wall, but is nevertheless definable, albeit with difficulty.

- 3.8 At the southern end of the wall is the remnant of a door jamb (7), which survives to a height of 1.1m although there is no surviving fragment of an equivalent jamb on the southern side of this doorway. The moulding of the door jamb (7) is identical to that of the adjacent door to the outshut, and this contemporaneity can be assumed. The base of the door jamb in the passageway wall is slightly higher (c 0.25m) than that of the outshut door, but this could reflect the existence of a former step and is not necessarily an indication that the blocks are *ex situ*. These stones are closely married together, as would be appropriate for their use as a door jamb, and there is no evidence that the jamb stones had been reused as quoins or building material. Although it is not possible to be totally confident, the evidence would appear to suggest that these door jambs are *in situ* and therefore provide an indication of an early doorway.

- 3.9 This early doorway had been modified by the construction of another doorway (8) inside it, of roughly dressed sandstone quoins, which had been subsequently faced with a timber door jamb. There are therefore surviving elements of three successive doors in this location.

- 5.1 The passageway wall has been the subject of considerable structural change since its original construction and there is relatively little remaining of the original fabric. The upper part of the original wall has been lost as has the northern terminal of the wall. One of the few surviving elements of the original build would appear to be the fragment of early door jamb (7) and this provides invaluable evidence of the development of the hall. It is recommended, therefore, that any proposed development of the hallway and passage wall should incorporate the preservation of this structural element.

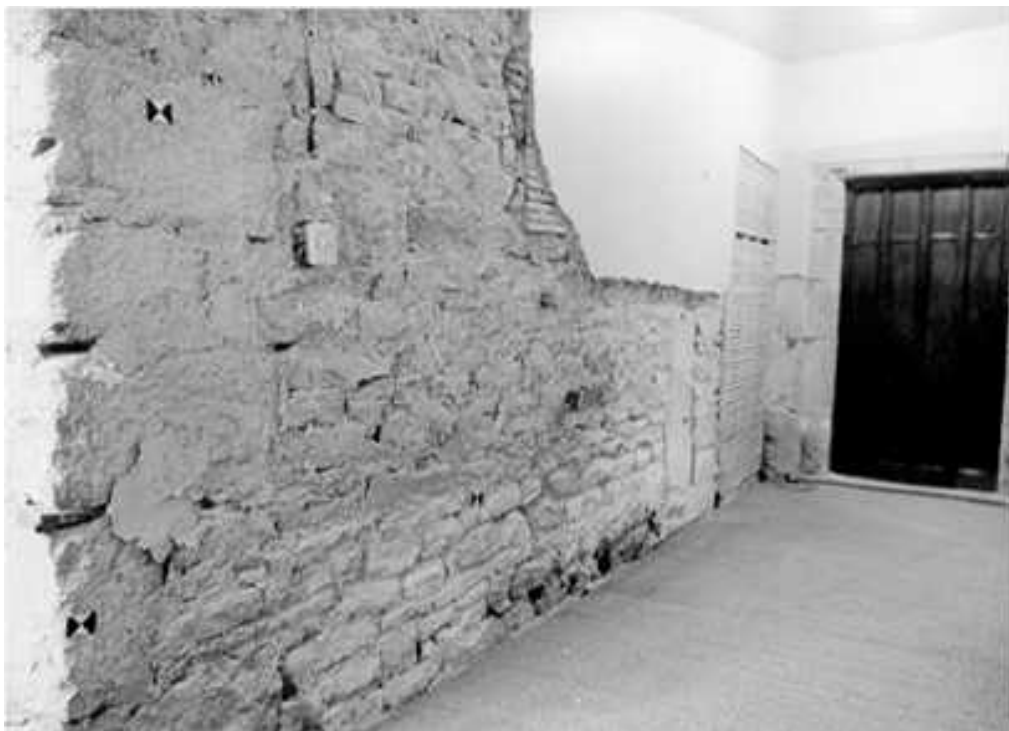
- 3.1 The development involved first the removal of wall finishes and then the dismantling of the northern end of the wall (1.5m of this wall was removed). The removal of wall finishes from the passageway wall, in the stairway hall, revealed that the northernmost part of the wall survived to ceiling height, but the southernmost had been removed and was now a void faced by panelling (6). The character of this panelling and its condition suggests that it was of relatively recent construction.

Plate 2 West Face of Passageway Wall – oblique view

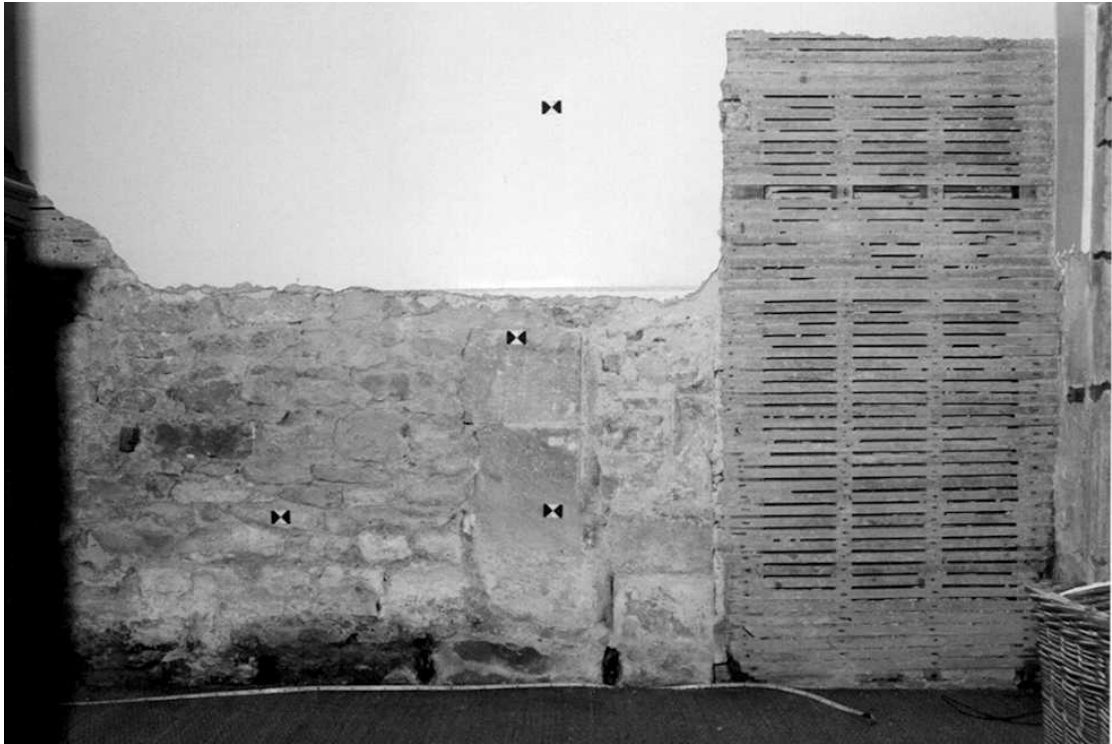
Plate 3 West Face of Passageway Wall showing truncated door jamb

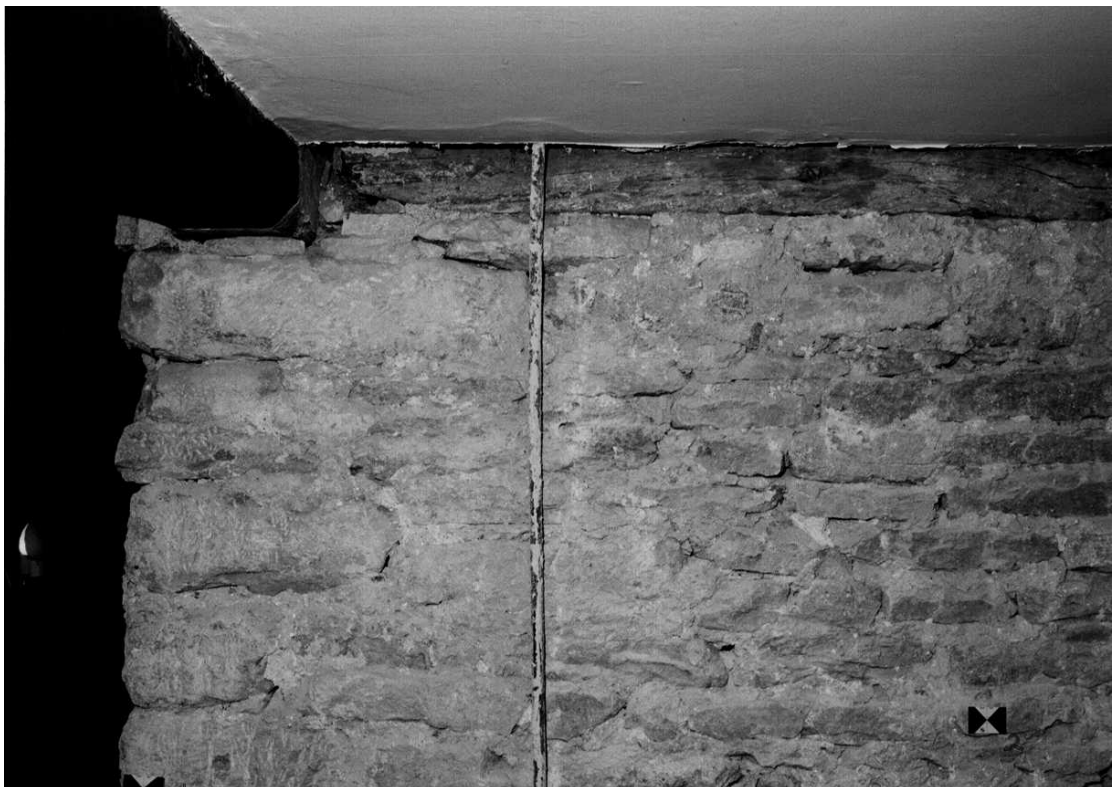
- 3.2 Examination revealed that the northern end of the wall was rebuilt within the last hundred years in order to support a major ceiling beam set on its terminus. The extent of the rebuild was demonstrated by the presence of a distinctive pale lime/cement mortar (3) which extended c300mm from the northern end of the wall and had been uniformly applied from the top to the bottom. This was particularly noticeable on the eastern face of the wall (Plate 5). The end of the wall had large, irregular long and short quoins at the base, extending up to a height of c 1.5m; above this height roughly dressed stones were used as quoins. Despite the different character of the quoining between the top and bottom of the wall this does not appear to reflect different phases of construction, particularly given that the uniform mortar has been applied across the whole height of the wall here. It is probable that the dressed quoins were utilised until this source of the stone was exhausted and then the builders continued with a much cruder and smaller quoin stone. The source of the dressed quoin stones is not known but it is possible that they were part of the original wall prior to the rebuild.

- 3.4 The ceiling beam (5) (orientated west/east), supported by the southern terminus of the wall, is machine cut and in good condition, and is probably of twentieth or perhaps late nineteenth century date.

Plate 4 West Face of Passageway Wall – ceiling timbers at the north end of the wall

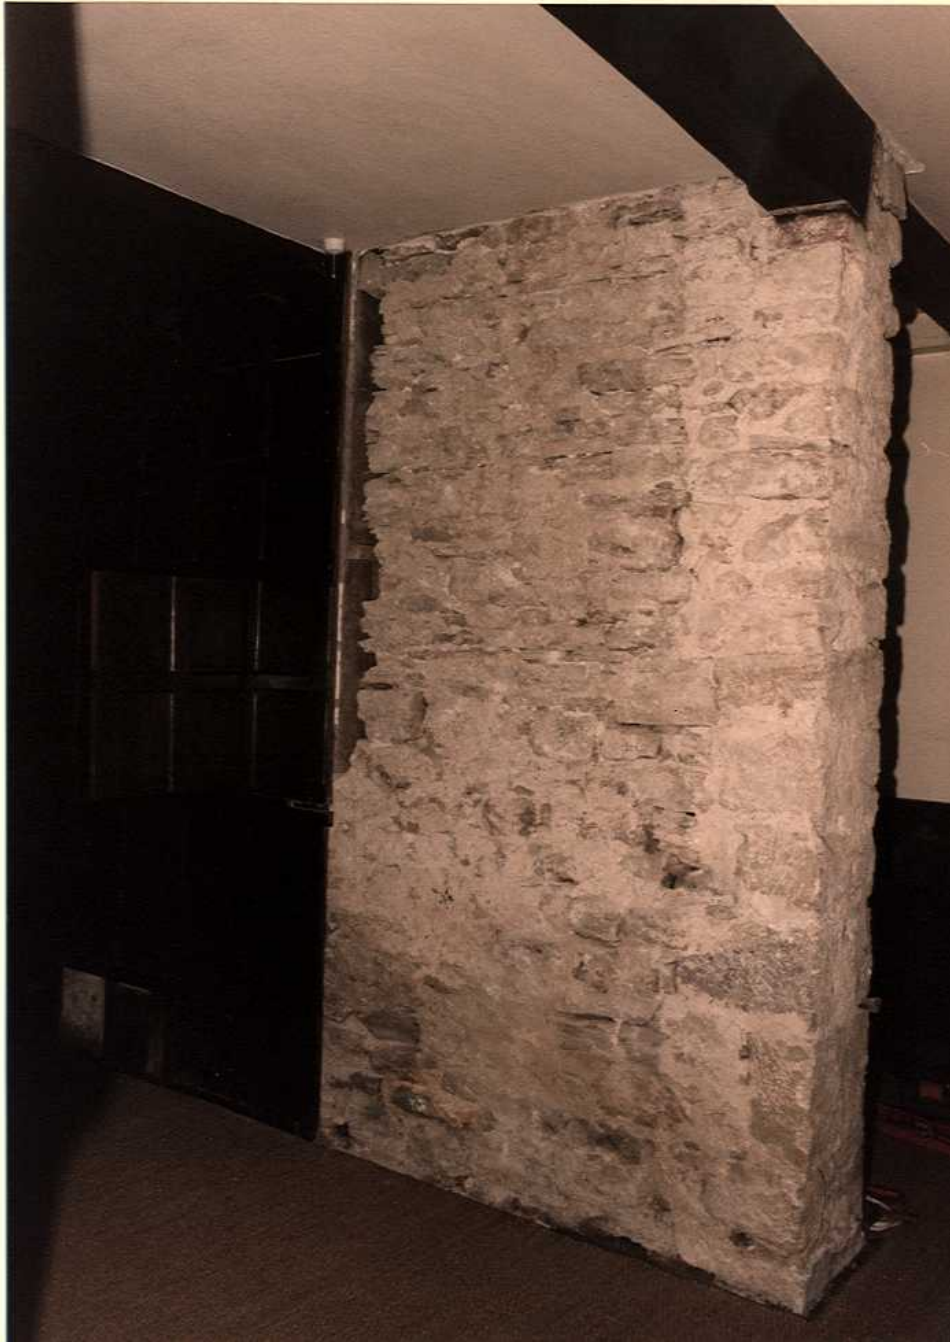
inserted into the masonry wall fabric; it was set within a lime mortar that is distinct from that used elsewhere in the wall. It is evident, therefore, that this was an insertion, possibly to block a putlog hole or similar aperture, and consequently has no significant implications for the chronology of the wall. The lime mortar and hand-made character of the brick, however, would suggest that it was not a recent insertion.

Plate 5 East Face of Passageway Wall Following Removal of Wall Finishes
