The Black Barn, Warren Farm Horton-cum-Studley

Building record prior to repairs and alterations

NMR DATA	
Site Name	The Black Barn
Address	Warren Farm
Town	Horton-cum-Studley
Parish	Horton-cum-Studley
County	Oxon
NGR	SP 6055 1245
Listed Status	Grade II
Visit/Survey Date	May 1995
OAU Site Code	HOSWF 95

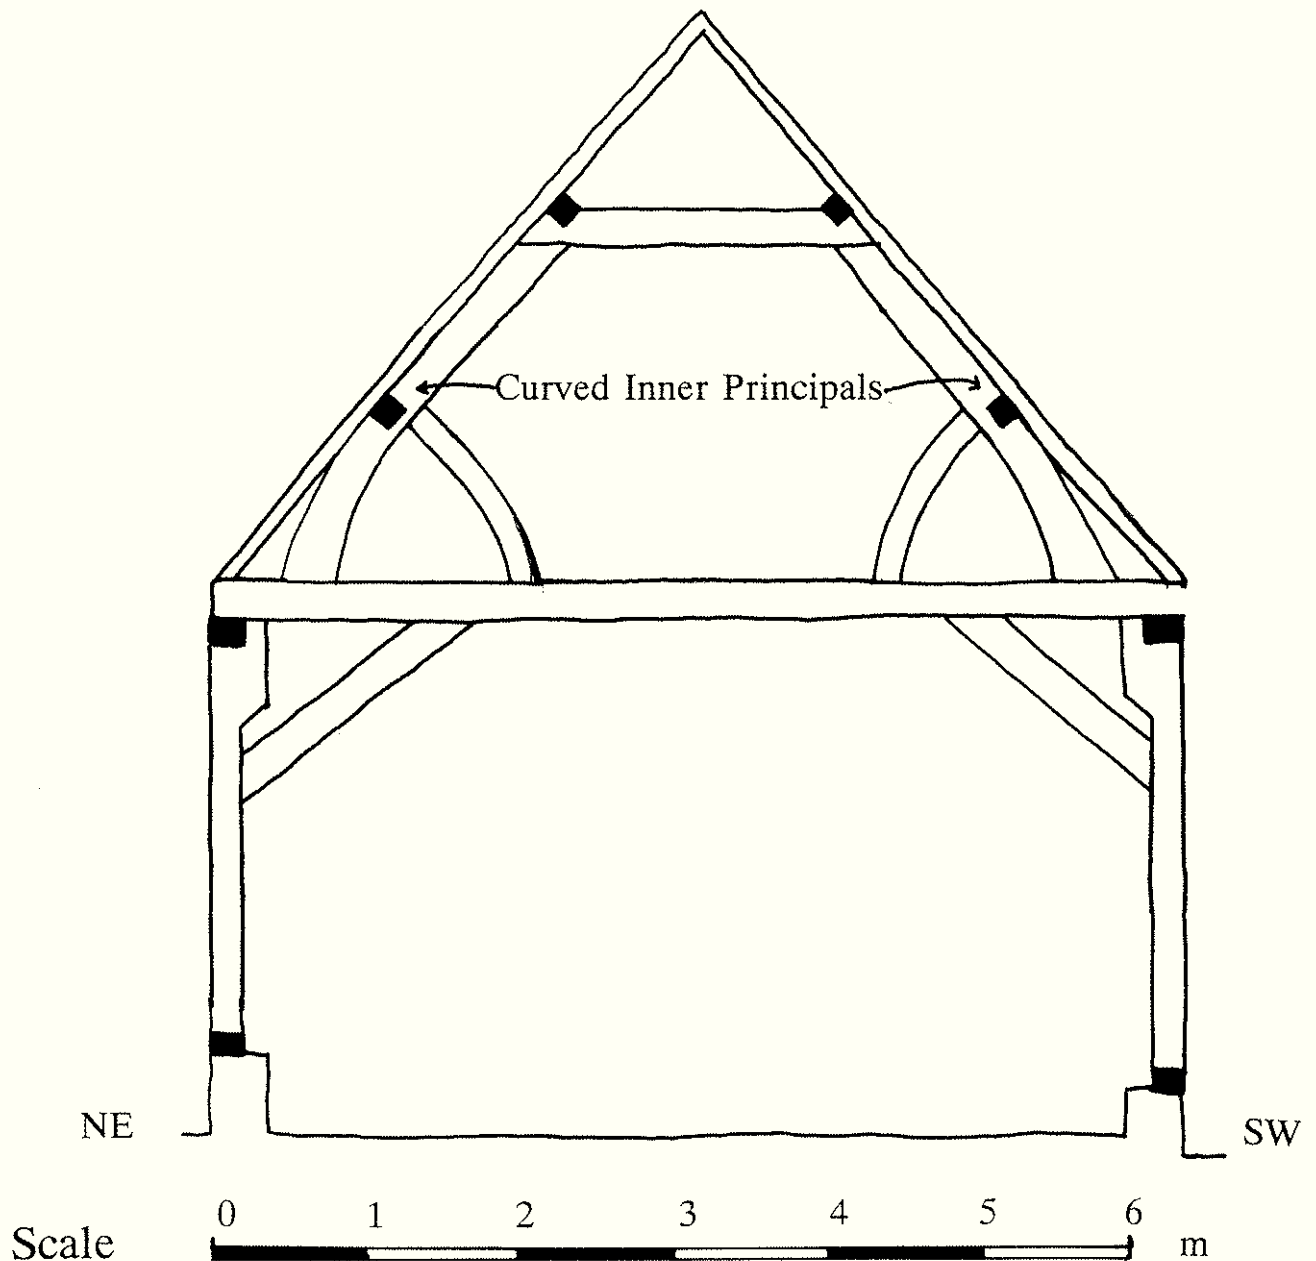
Cross Section Showing the Curved Inner Principals

The barn is fairly unremarkable for its type and construction, but nevertheless important to record as these buildings come increasingly under threat. It is of some interest for its roof construction, having curved inner principals (i.e. secondary rafters or braces) that carry the purlin in the mid-height between the tiebeam and collar. Alternative forms would have the purlin clasped by the collar-beam (as in the east gable end), or supported by a raking (i.e. an outward leaning) strut; the curved principal performs the same task but occupies less space in the centre of the roof. A preliminary impression gained by asking those with knowledge of vernacular buildings in the region is that these roofs are not uncommon in the 18th and 19th centuries, but that they have a distinct and possibly quite localised distribution. This is reported as follows:

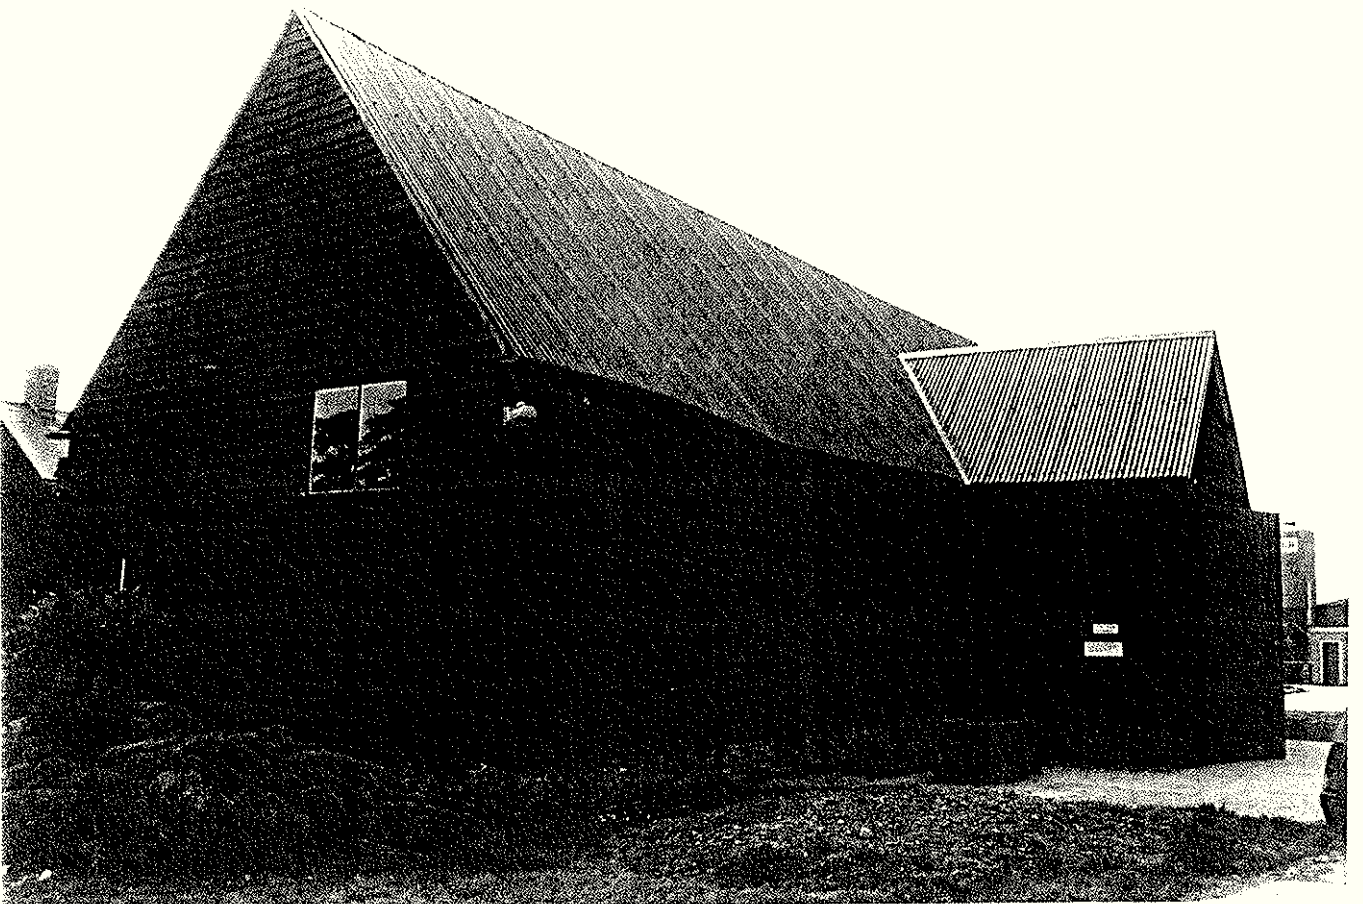
2. Exterior: N side, E end (5/32)

The barn is weatherboarded with elm and sits on a rubble plinth (5/32 & 4/1) which has been exposed in a test pit showing it descending for at least 1 metre. The walls are built of timber studding with downward bracing. The roof trusses have two clasped purlins and curved inner principals, and the end trusses have queenposts and interrupted collars. The stable extension was originally timber-framed but it is now brick on a stone plinth with a queenpost truss with two butt purlins on free tenons.

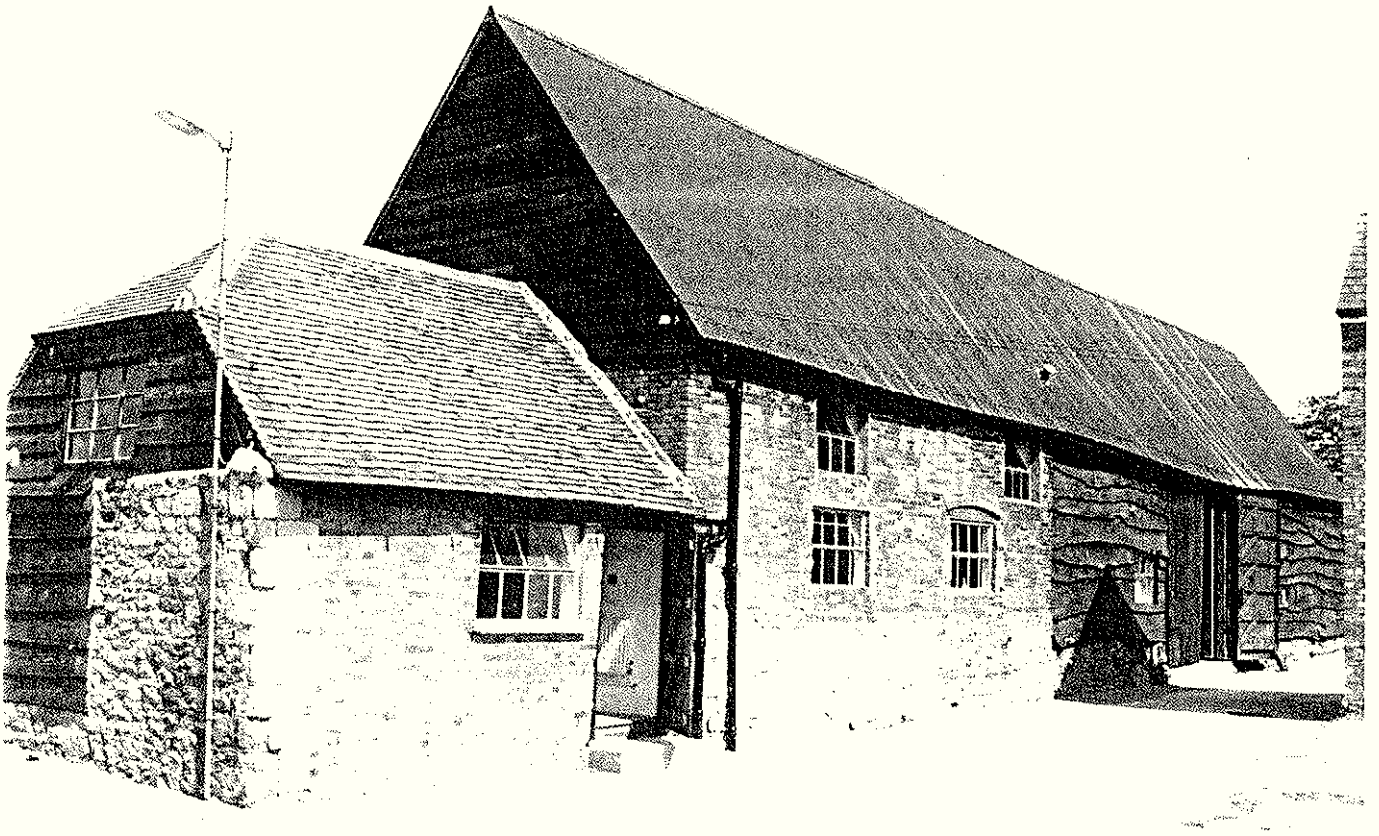
3. Exterior: S side W end (4/20)

From the exterior it can be seen that there is a blocked doorway in the north wall of Bay VI, raised about 0.75m from the ground (general 4/29 & 4/30 and specifically 4/31, 4/32 & 4/33). Windows have been inserted into the north wall of Bay IV (5/26) and into the easternmost wall (5/30). Windows also occur in the west and south walls of the western extension (4/20). On the

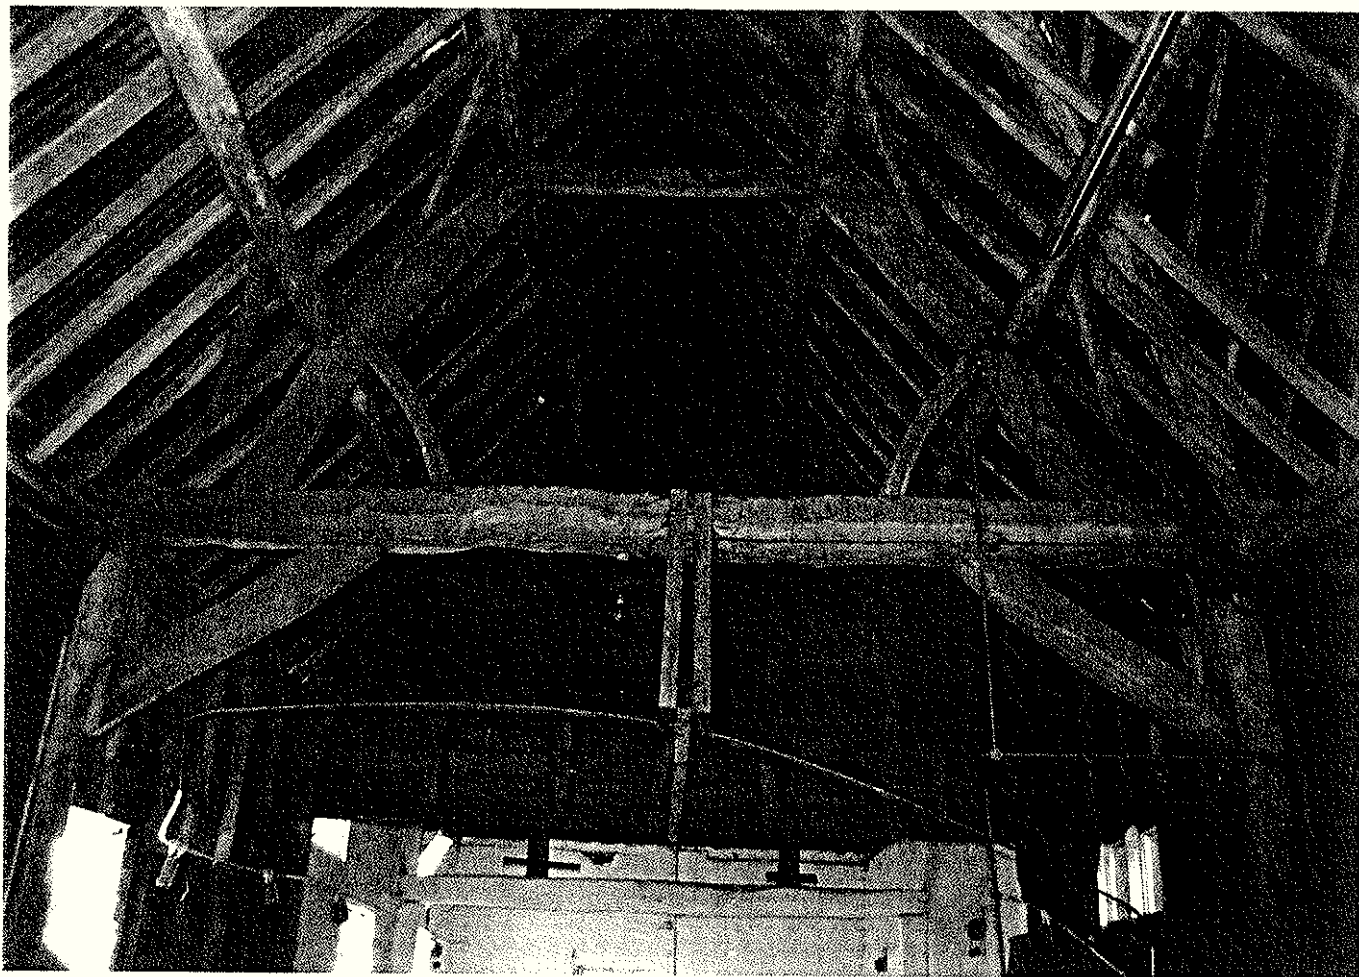
7. Roof truss 4, from E (3/6)

4.3.5 Truss IV (3/6, 3/9, 3/7, 3/8) is similar to Truss III.

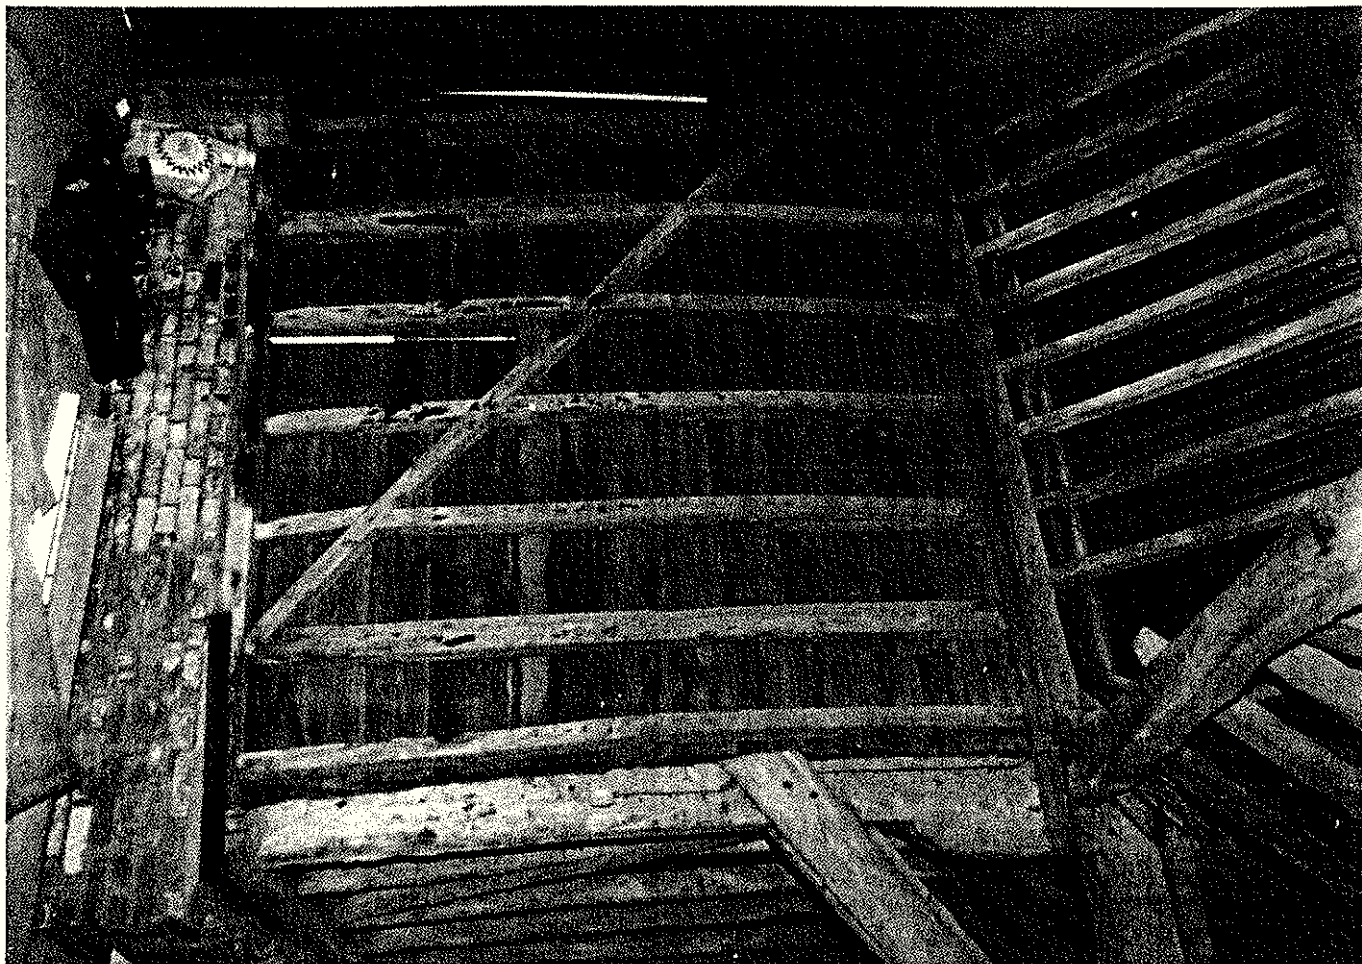
9. N porch framing and truss 4 (1/24)

- 4.3.4 The north porch has a brick plinth and plain framing of square-sawn elm. The roof has two purlins and a kingpost in the gable wall (1/11, 1/13, 1/14). The porch doors are new (1/12). The east (1/24, 1/25, 1/26) and west (1/18, 1/19, 1/20, 1/22) facing walls of the porch have 5 studs with a diagonal downward brace to a sill beam sitting on the brick plinth. The roof has 9

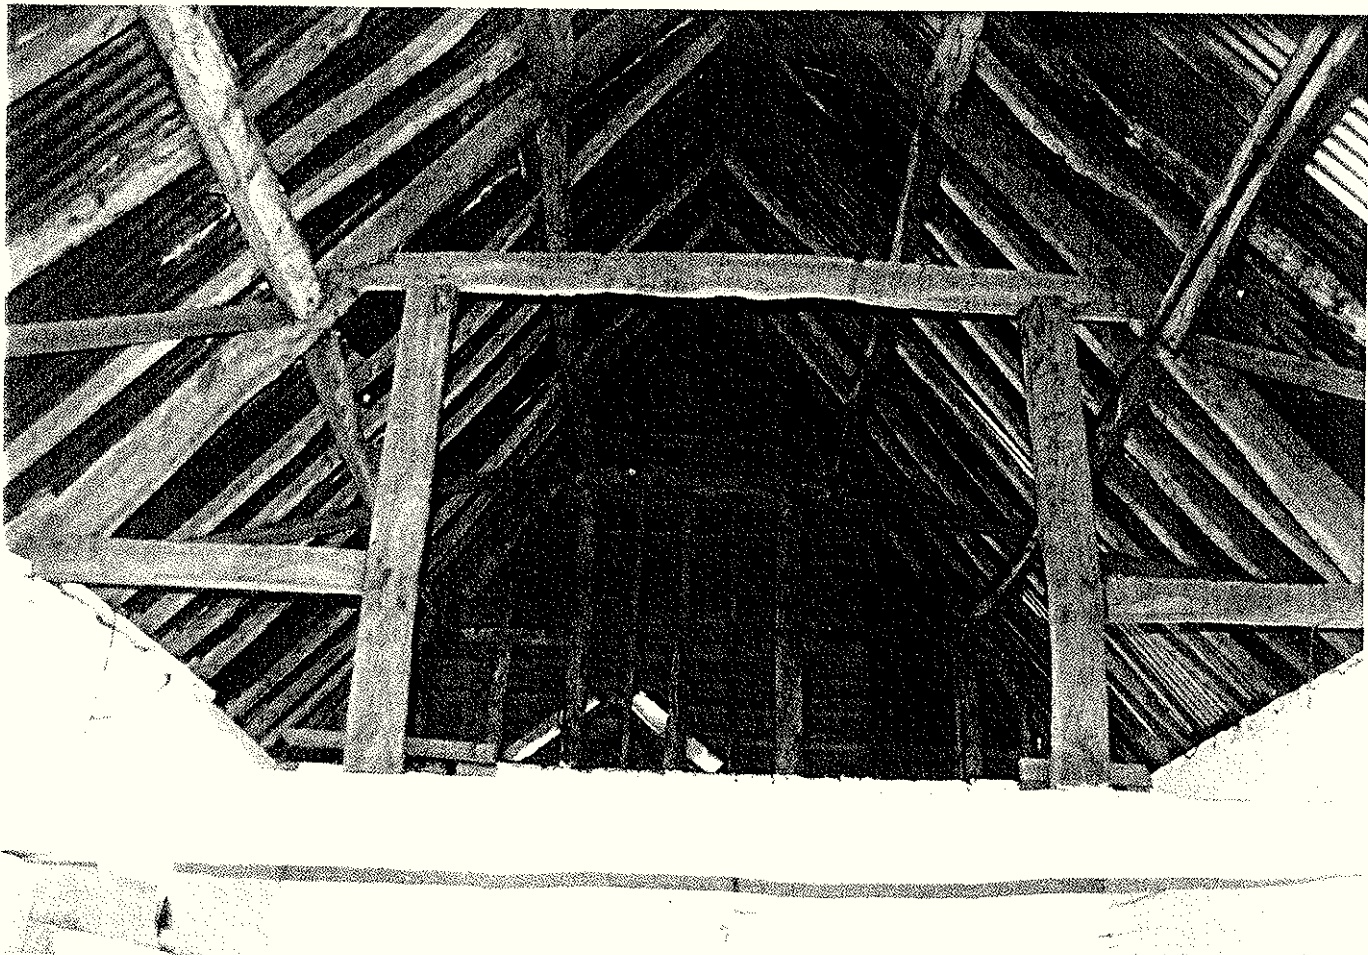
13. Roof truss 6 looking W (3/13)

4.4.2 Truss VI (3/13, 3/11, 3/14) has queenposts with an interrupted lower collar and butt purlins. The truss is well faced on the east side (3/13), but on the west the top of the queenpost is lapped over the waney edge of the upper collar (3/14).
