Berry Hill Ice-house, Maidenhead, Buckinghamshire
ARCHAEOLOGICAL RECORDING IN ADVANCE OF DEMOLITION

OXFORD ARCHAEOLOGICAL UNIT
OCTOBER 1998

NGR: SU 9070 8132

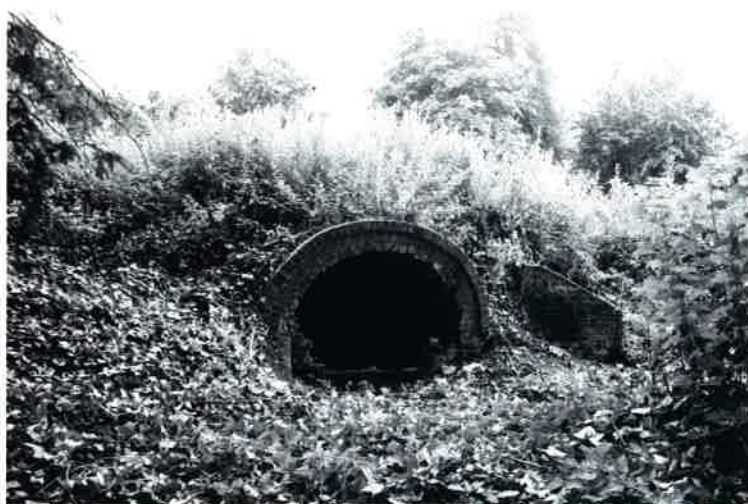
Plate 1: General view of ice house and mound

- 4.3 It is not an ostentatious ice-house, consisting of a simple brick arched entrance with projecting rim (cement render on top) and an earth mound with vegetation obscuring the main body. The first 0.3 m of the top of the brick tunnel entering the mound is visible. Along the inner rim of the entrance evidence can be seen of the former doorway sealing the ice-house. Towards the springing points of the arch there is a rough pattern of every other brick being slightly recessed, while towards the top there is a more constant indentation where every brick appears to have been slightly knocked off to allow a frame member to be wedged in. It is possible that the doorway would have been roughly bricked up each year and each corner of the base of the opening retains a few bricks from what would have been a larger sealing structure.

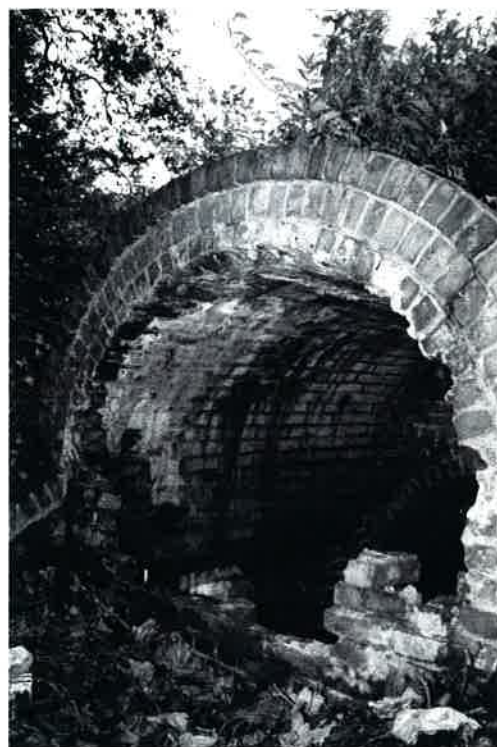
Plate 2: Entrance to ice house

- 4.4 It is also possible that there were twin parallel doors to the entrance, possibly with an insulating layer in between. There is no clear archaeological evidence for this although it could be that this was an ephemeral structure leaving no trace.

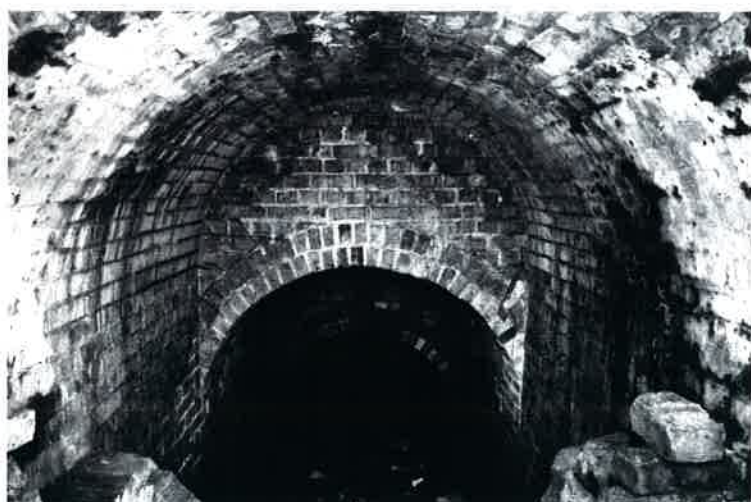
Plate 3: Interior of ice house from upper chamber

- 4.2 The structure is notably intact, retaining its entire shell and with no substantial cracks in the structure, although the highest chamber is subsiding slightly away from the lower sections. Several steps appear to have been lost between the first and second chambers and some repointing has been undertaken, particularly in the vault of the first chamber, the cross face between the first and second chambers and in the curved rear wall of the third chamber. The original mortar is soft, contrasting with the later hard texture.

- 4.6 The ice-house is entered *via* a platform, 0.86 m deep, *c* 0.3 m below external ground level and 0.55 m above the floor height of the rest of the first chamber. The eastern half of the north edge of the platform curves slightly outwards. As existing the platform is hollow, containing a trench now full of debris, which was partially excavated as part of the project. There was presumably a surface over this trench. This was probably a set of steps, suggested by a small set of stepped bricks towards the front, which may once have formed part of a larger structure. The vault of the first chamber has a white residue, more pronounced than in the rest of the ice-house, with a green algae coating.

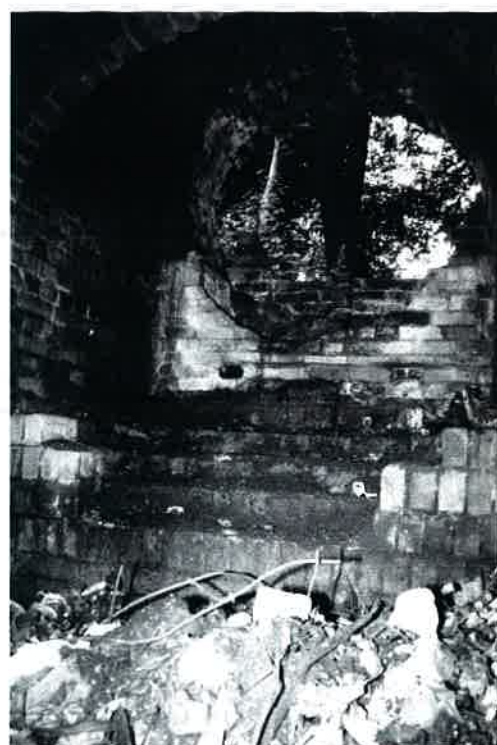
Plate 4: Steps between upper and middle chamber

- 4.9 The second chamber (2.3 m long) is reached from the first via a set of four brick steps which were completely obscured by general debris within the ice-house before the start of the recording work. The final step has a fall of *c* 0.85 m above the probable original floor surface, suggesting that several more steps no longer exist. It was impossible to remove all the debris from the floor of the second chamber and thus it is not known for certain whether the floor is completely flat or (as is probable) has a slight gradient to allow melted ice to drain into the lowest chamber.

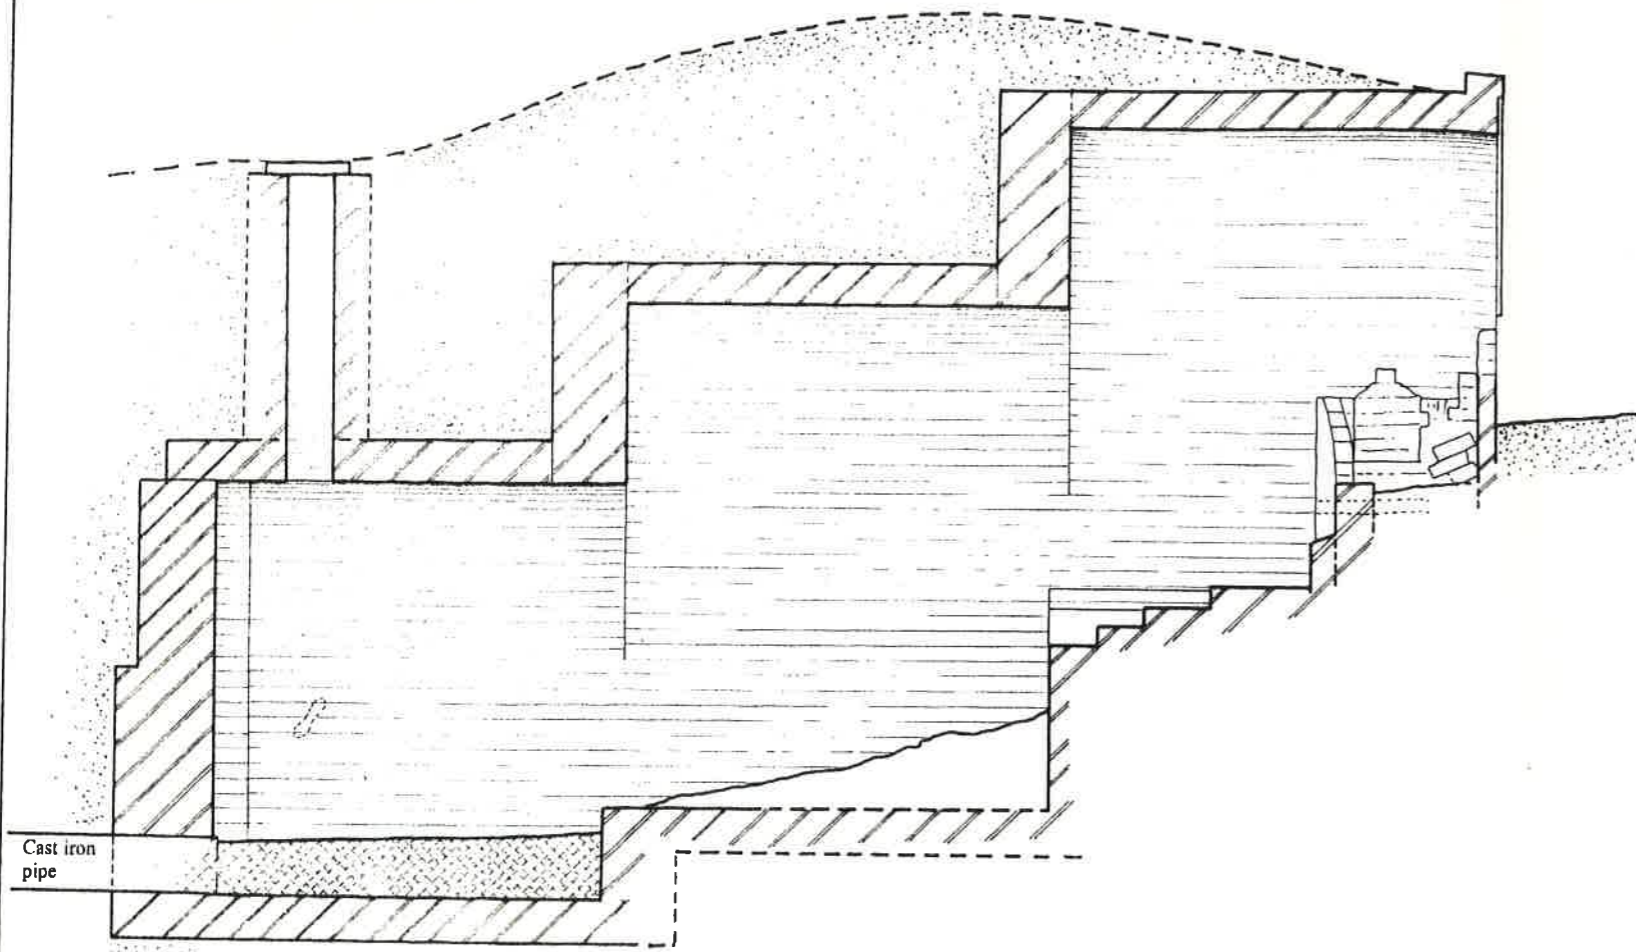
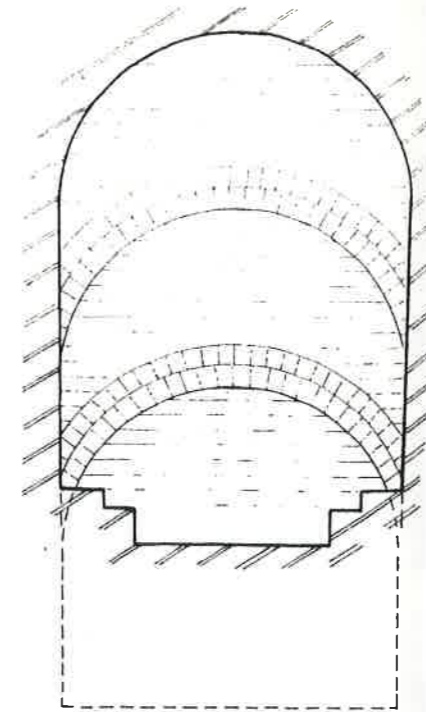
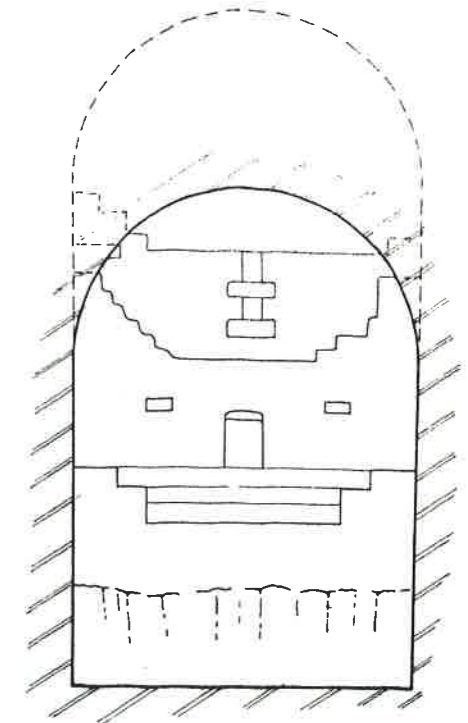
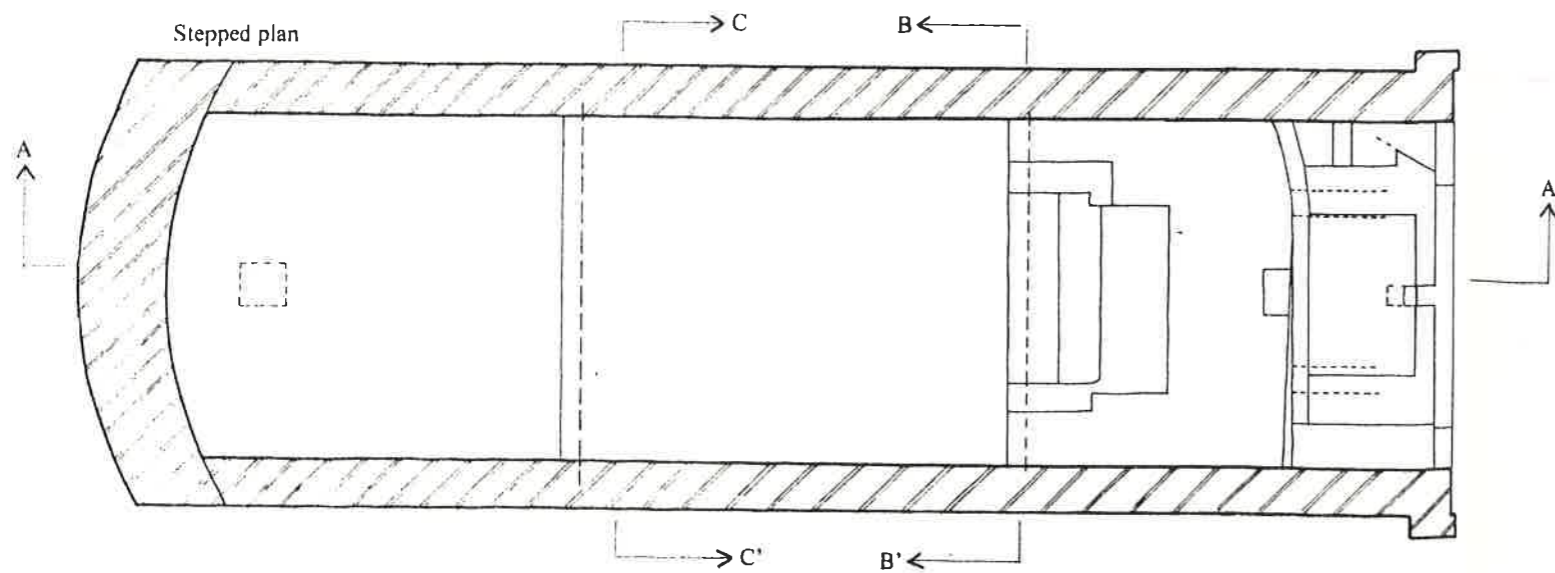
Berry Hill ice-house
Figure 2: Plan and sections

- 4.1 Berry Hill ice-house consists of three barrel vaulted, brick walled chambers, each one at a lower level than the previous. The full length is 6.45 m and the width is *c* 1.81 m. The bricks used are generally yellow; many are frogged, and are of a rough, imperfect nature, with wide jointing. It appears from the brick bonding and from the section of vault visible from above that cavity wall construction has not been used in the structure. Each chamber is roughly square in plan, the highest principally being a porch and the lowest being where the ice was packed. The central chamber may possibly also have stored ice or may have been used to allow ease of access to the ice below.

- 4.12 A drainage problem affecting the ice-house was also initially suggested by the thick water/sludge raising the floor level of the lowest chamber. This sludge prevented a comprehensive survey of the full depth of this chamber during the initial field work and it was expected that this chamber descended a significant distance, possibly with a grill at the existing mud level to support the ice and allow water to drip away through a small drain at the bottom of the chamber.

- 4.13 However, a solid brick floor (3 courses deep) was revealed during the watching brief, 6 courses (*c* 0.48 m) below the floor level of the middle chamber with no evidence of a former grill to support the ice. There also did not appear to be a small drain at the base of the chamber, although the floor was well below ground level and due to health and safety reasons it was not possible to closely examine it. A cast iron pipe (diameter *c* 0.30 m) was revealed entering the chamber, immediately above floor level, at the central point of the curved end wall and continuing west towards the lake. Significantly, the pipe appears to gently slope down towards the ice-house and thus could not have been a drain to remove melted ice. When broken the pipe emptied a modest amount of stagnant water. The sludge within the chamber was clearly deposited via the pipe, rather than seeping in through the walls or rising from below, and was retained by the apparently well sealed walls of the ice-house. The watching brief also demonstrated that the ground surrounding the icehouse is relatively well drained (the local geology is gravel), despite the structure being towards the bottom of a slope and at the same height as the adjacent lake. A layer of puddling clay is sometimes added to the outer face of below ground ice-houses to improve the structure's water resistance but no such layer was revealed on this ice-house.
