KNOWLES AND SON  
HERTFORD COLLEGE

LOCK HOUSE, SALTER'S BOATYARD, OXFORD  
HISTORIC BUILDING INVESTIGATION

OXFORD ARCHAEOLOGICAL UNIT  
JUNE 1997

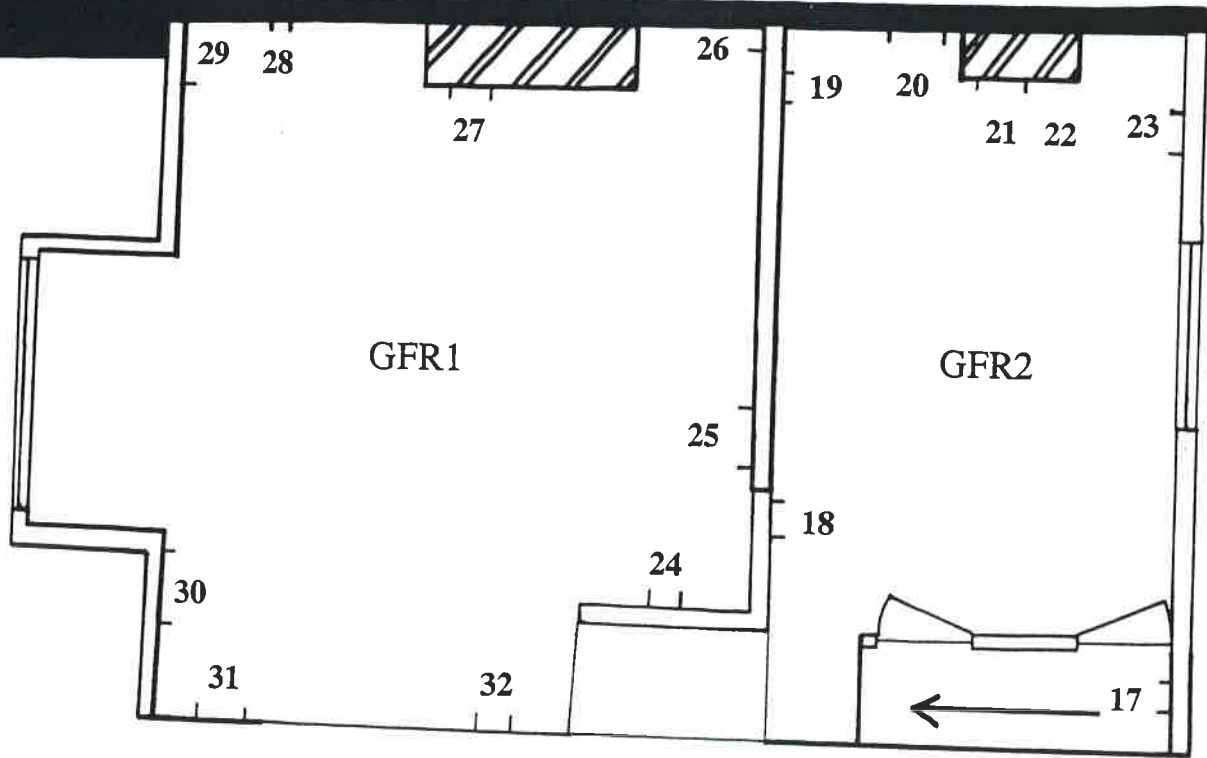
Figure 1: Ground Floor Sketch Plan. Showing location of investigative openings.

2.2.1 The ground floor has two rooms. GFR1 (Openings 24 - 32) has recently been in use as a living room. The west wall is the coursed limestone rubble wall, as seen from the exterior. Its eastern surface viewed via openings 20 and 28 is weathered demonstrating the previous function as an exterior boundary wall. The wall has been refaced twice with grey plaster board and subsequently modern sterling board. The current fireplace is a modern replacement presumably built in the original location of the hearth. The red brick chimney stack has been disguised by modern boxing and coving. Dimensions of the bricks were investigated in every room in the building (Openings 8, 11, 21 and 27) and are of a consistent type throughout measuring 22.5 x 7 x 11 cm. The lime mortar binding the bricks was also similar throughout being light beige in colour with inclusions of grit.

2.2.2 The southern wall of GFR1 (Openings 29 & 30) is of lath and plaster with an inserted bay window / french door. All the laths exposed in the building are riven and fixed to studs by means of handmade nails. The lime plaster mix is also of one type throughout the building; it is light grey in colour with a hair binder and is 2cm in thickness. Information about the timber frame of the building was seen in several of the openings; the normal size of stud is 7 x 10 cm. However in opening 29 a corner post was exposed measuring 12 x

9cm. In opening 30 evidence for bracing was found.

- 2.2.3 The eastern wall of GFR1 was of lath and plaster to the southern end (opening 31) with modern pink plaster board to the north (opening 32); this disturbance probably being due to the modern breeze block built extension to the building.

- 2.2.4 The northern wall of GFR1, also the southern wall of GFR2, was found to be of lath and plaster construction (openings 19, 25 & 26) with an area extending 90 cm to the west of the connecting doorway of pink modern plaster board (opening 18). Two studs of this internal dividing wall were observed, opening 25 had a stud of 6 x 10 cm however the stud in opening 19 was 6 x 5 cm.

- 2.2.5 A modern entrance hall has been constructed using grey plaster board and is built into GFR1 (opening 24).
- 2.2.6 The wooden floor boards making up the softwood floor in GFR1 are suspended 57 cm above a ground surface covered in rubble and debris. The boards are laid E - W and are 17 cm in width, 2 cm thick and of various lengths. The bay window area is framed separately. The boards sit on joists running N - S with centres of 42 cm, measuring 7.5 x 10 cm and of various lengths.

- 2.3.1 Room GFR2 has been recently used as a kitchen and this was no doubt its original function. All walls of this room have an additional covering of modern rendered pink cement. The west wall is the rubble wall described above, it has been refaced using grey plaster board (opening 20). The brick built chimney stack presumably served as the flue for a range, no evidence of this could be found as the area had been covered in hard cement. The stack projects 41 cm from the rubble wall surface.
- 2.3.2 The northern wall of GFR2 is of modern grey plaster board (opening 23). The southern wall has been described above 2.4.4. The eastern wall is of modern plaster board partitioning forming an under the stairs storage space.

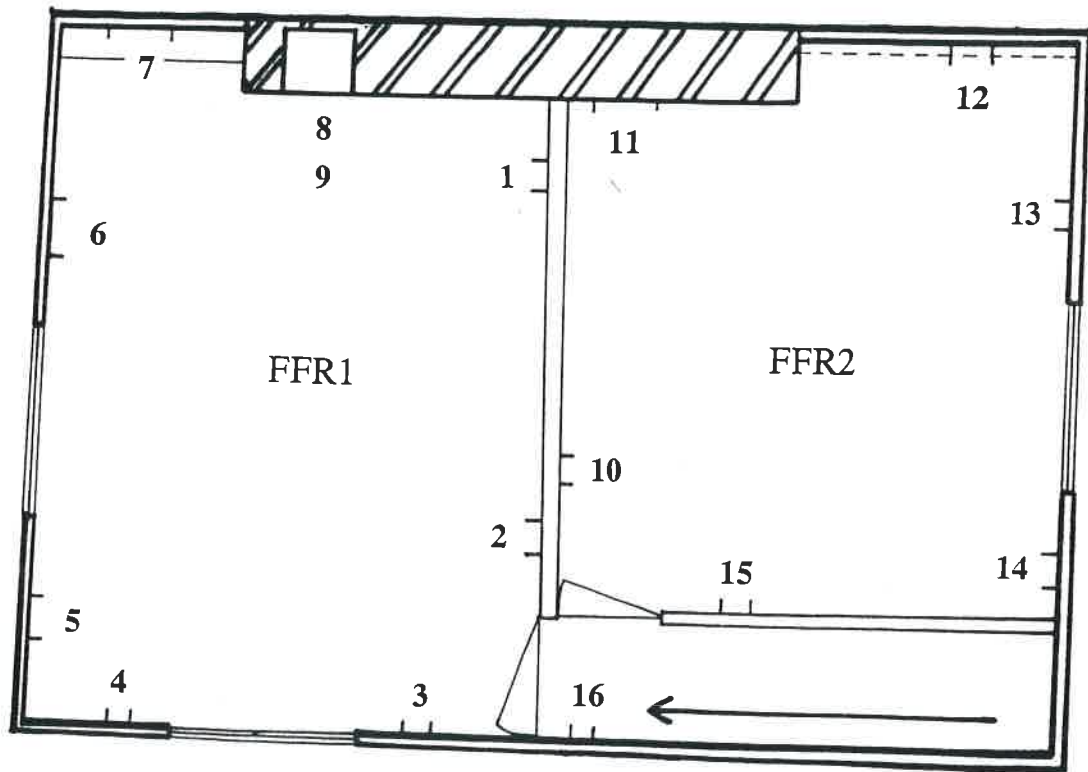
Figure 2: First Floor Plan Sketch Plan. Showing location of investigative openings.

- 2.5.1 The first floor of Lock House is currently split into two rooms; however it appears from the investigative openings made that there was originally only one room. The west wall of the upper floor exposed by the investigative openings is not the rubble wall seen in the ground floor openings but lath and plaster construction on the timber framing of the upper section of the west elevation. The brick stack takes up the majority of the wall surface and projects 44 cm into the room; openings 8 & 9 uncovered the central fireplace. No original fittings were revealed beneath the plaster board blocking. The fireplace was 45 cm in width with a vertical height of 98 cm above the floor boards; it has a depth of 20 cm. The flue slopes diagonally up the stack.

- 2.5.2 The southern wall of FFR1 is of lath and plaster construction on the buildings timber frame (openings 5 & 6). The eastern wall is also of lath and plaster work on the timber frame although the window is a replacement and has a surrounding of modern pink plaster board. The northern wall of FFR1, also the southern wall of FFR2, is a modern construction of pink plaster board.

- 2.5.3 The floor of FFR1 is of softwood. The boards run E - W and measure 22.5 cm in width and 2.5 cm in thickness with various lengths. The joists have dimensions 5 x 13 cm and are spaced at 38 cm centres. The floor in front of the fireplace has a stone support measuring 89 x 46 cm. The floor of FFR2 is of the same construction as FFR1.

- 2.6.1 The west and north walls of FFR2 are of lath and plaster construction fixed to the timber frame of the building, and have been covered with various layers of modern wooden board (openings 12, 13 & 14). The brick chimney stack takes up the southern half of the wall and stands 32 cm proud of the wall surface (opening 11). No evidence for a blocked fireplace was found, adding to the evidence that the upper floor was originally only one room.
- 2.6.2 The southern and eastern walls of FFR2 are of modern pink plaster board (openings 10 & 15). The door from the stairs in the eastern wall is modern as are the skirting boards of the room unlike those of room FFR1.
