# Homewell Parchment Works Havant Hampshire

## Archaeological Watching Brief Report

September 2004

**Document Type:** Building Recording and Watching Brief

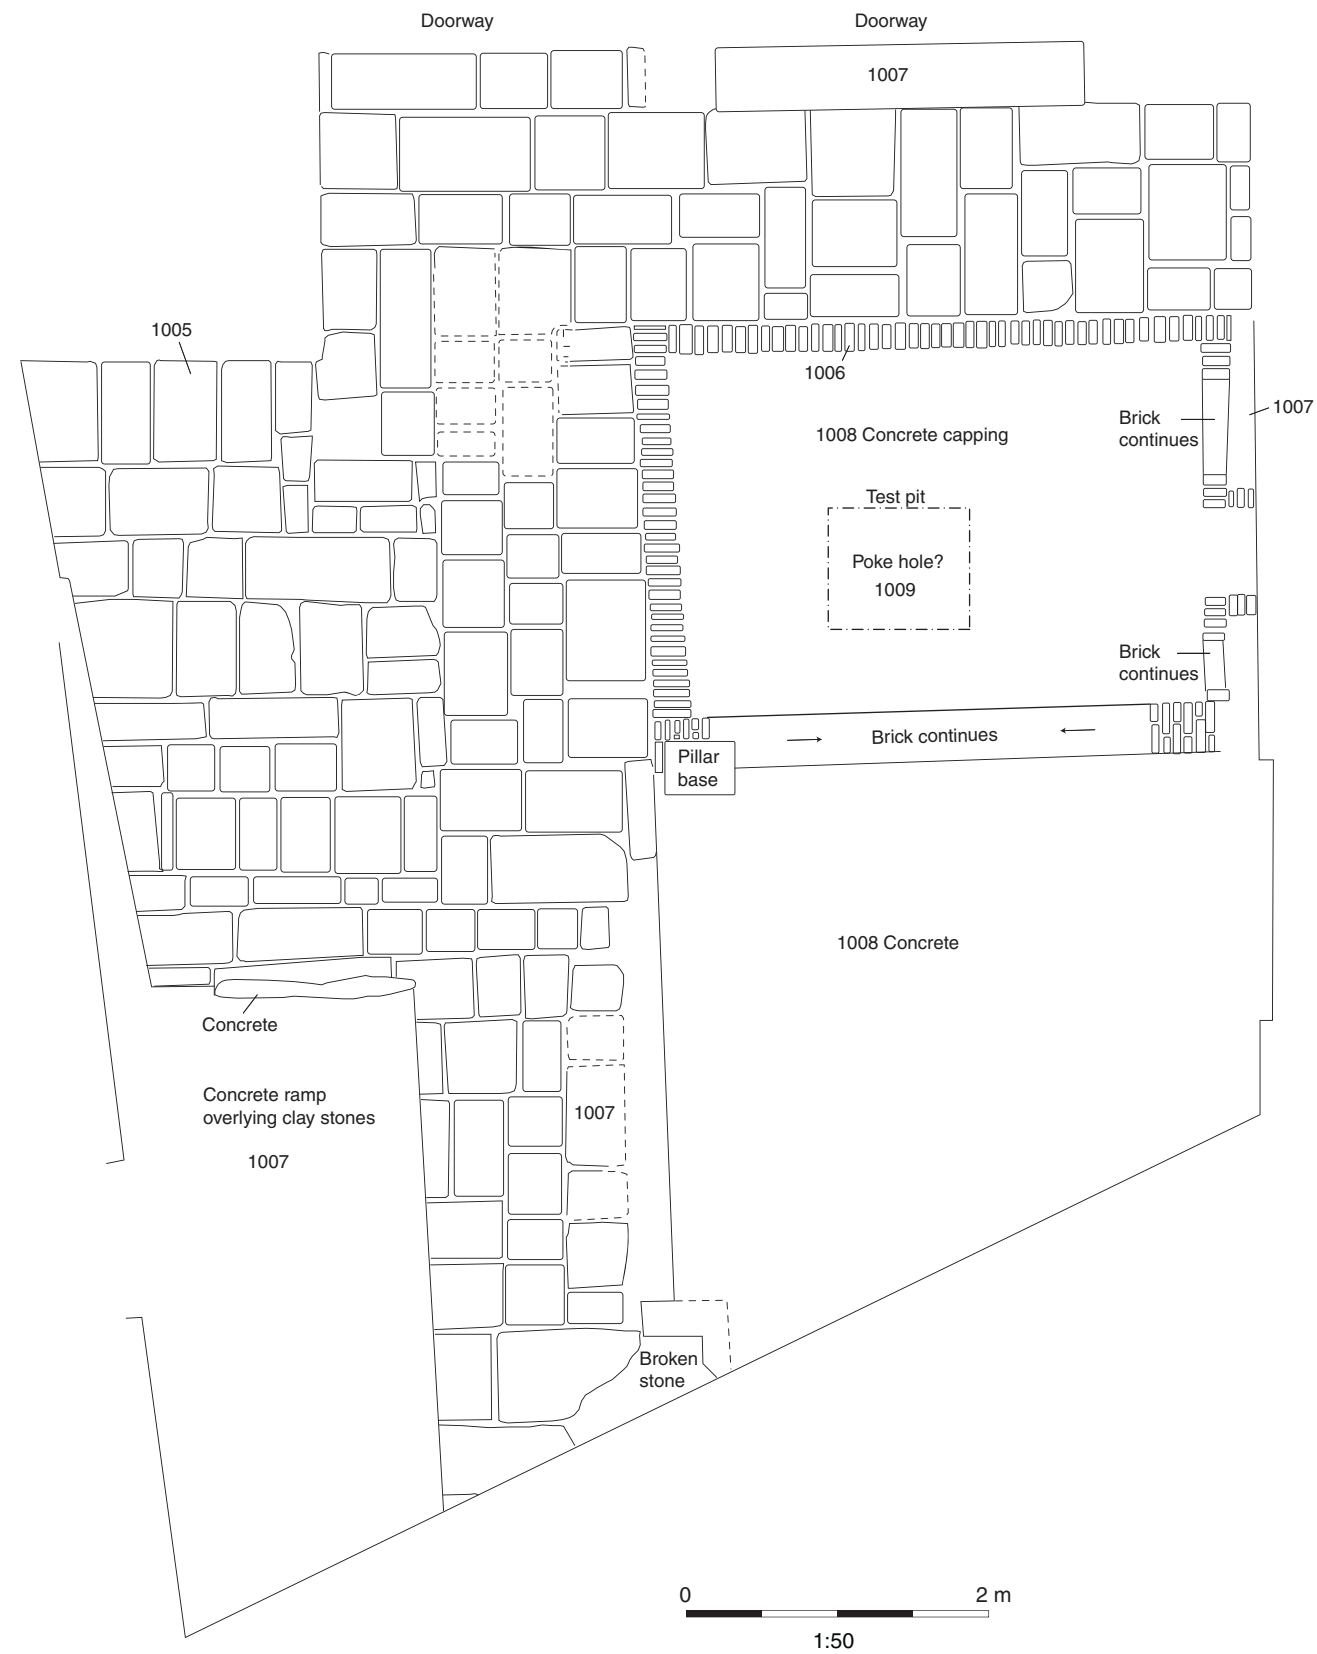
Figure 3: Plan of Room 1A

- 3.1.2 A large, irregularly shaped room measuring 10.4 m by 8.1 m across its longest dimensions. The floor is almost entirely paved with limestone flags (1005). Centrepiece of the room is a brick rectangular structure (1006), set flush with the floor, measuring 3.8 m by 2.9 m. This is the brick lining to a *Poke* or soaking tank. A channel leads from this out through the west wall of the room possibly leading to the spring to the north of the building. Both the poke and the channel had been backfilled with a coarse gravel (1009) and capped by a concrete slab (1008) probably when the buildings were used as a builders store in the late 20th century. The concrete ramp (1007) laid over the flags and running up to the doorway was probably also laid at this time.

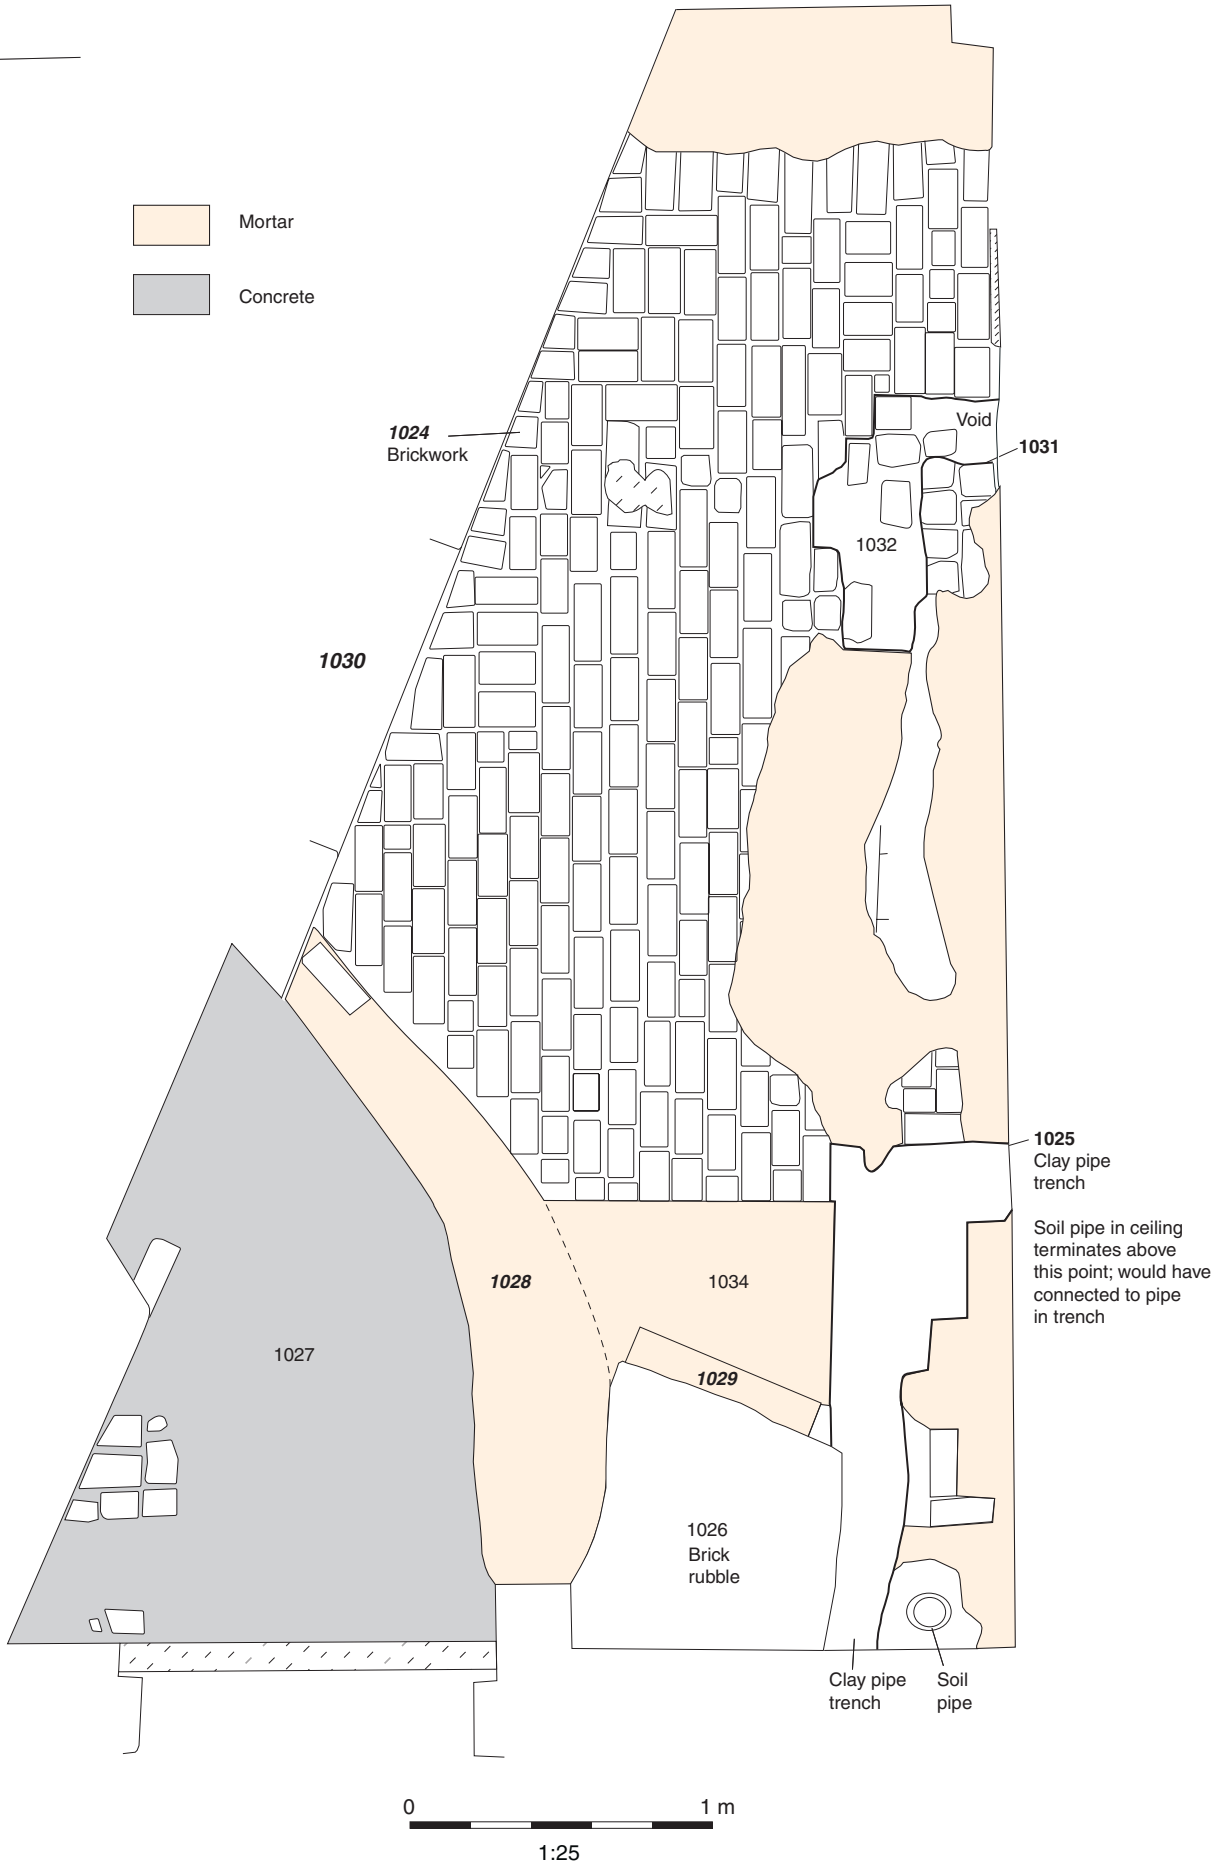
Figure 4: Plan of Room 1B

- 3.1.3 An almost triangular shaped room measuring 5.5 m by 3.7 m. The centre and eastern extent of the room was floored using bricks (1024) with evidence of 19th century repairs (1032). A (demolished) dividing wall (1028) would have created a passageway from the doorway in the north-east wall into room 1A. This surface of this passage way is a mortar floor (1027) and is probably contemporary with the construction of the wall. The south-west corner of this room has been heavily disturbed by the insertion of a sewer pipe trench (1033). The presence of a mortar floor (1034) and a truncated stub of brick wall (1029), (a possible toilet cubicle wall ?) suggests that possibly a toilet and associated fittings had been inserted in this corner during the early 20th century. It is probable that walls 1028 and 1029 were demolished to ease access to the room during its use as builders stores.

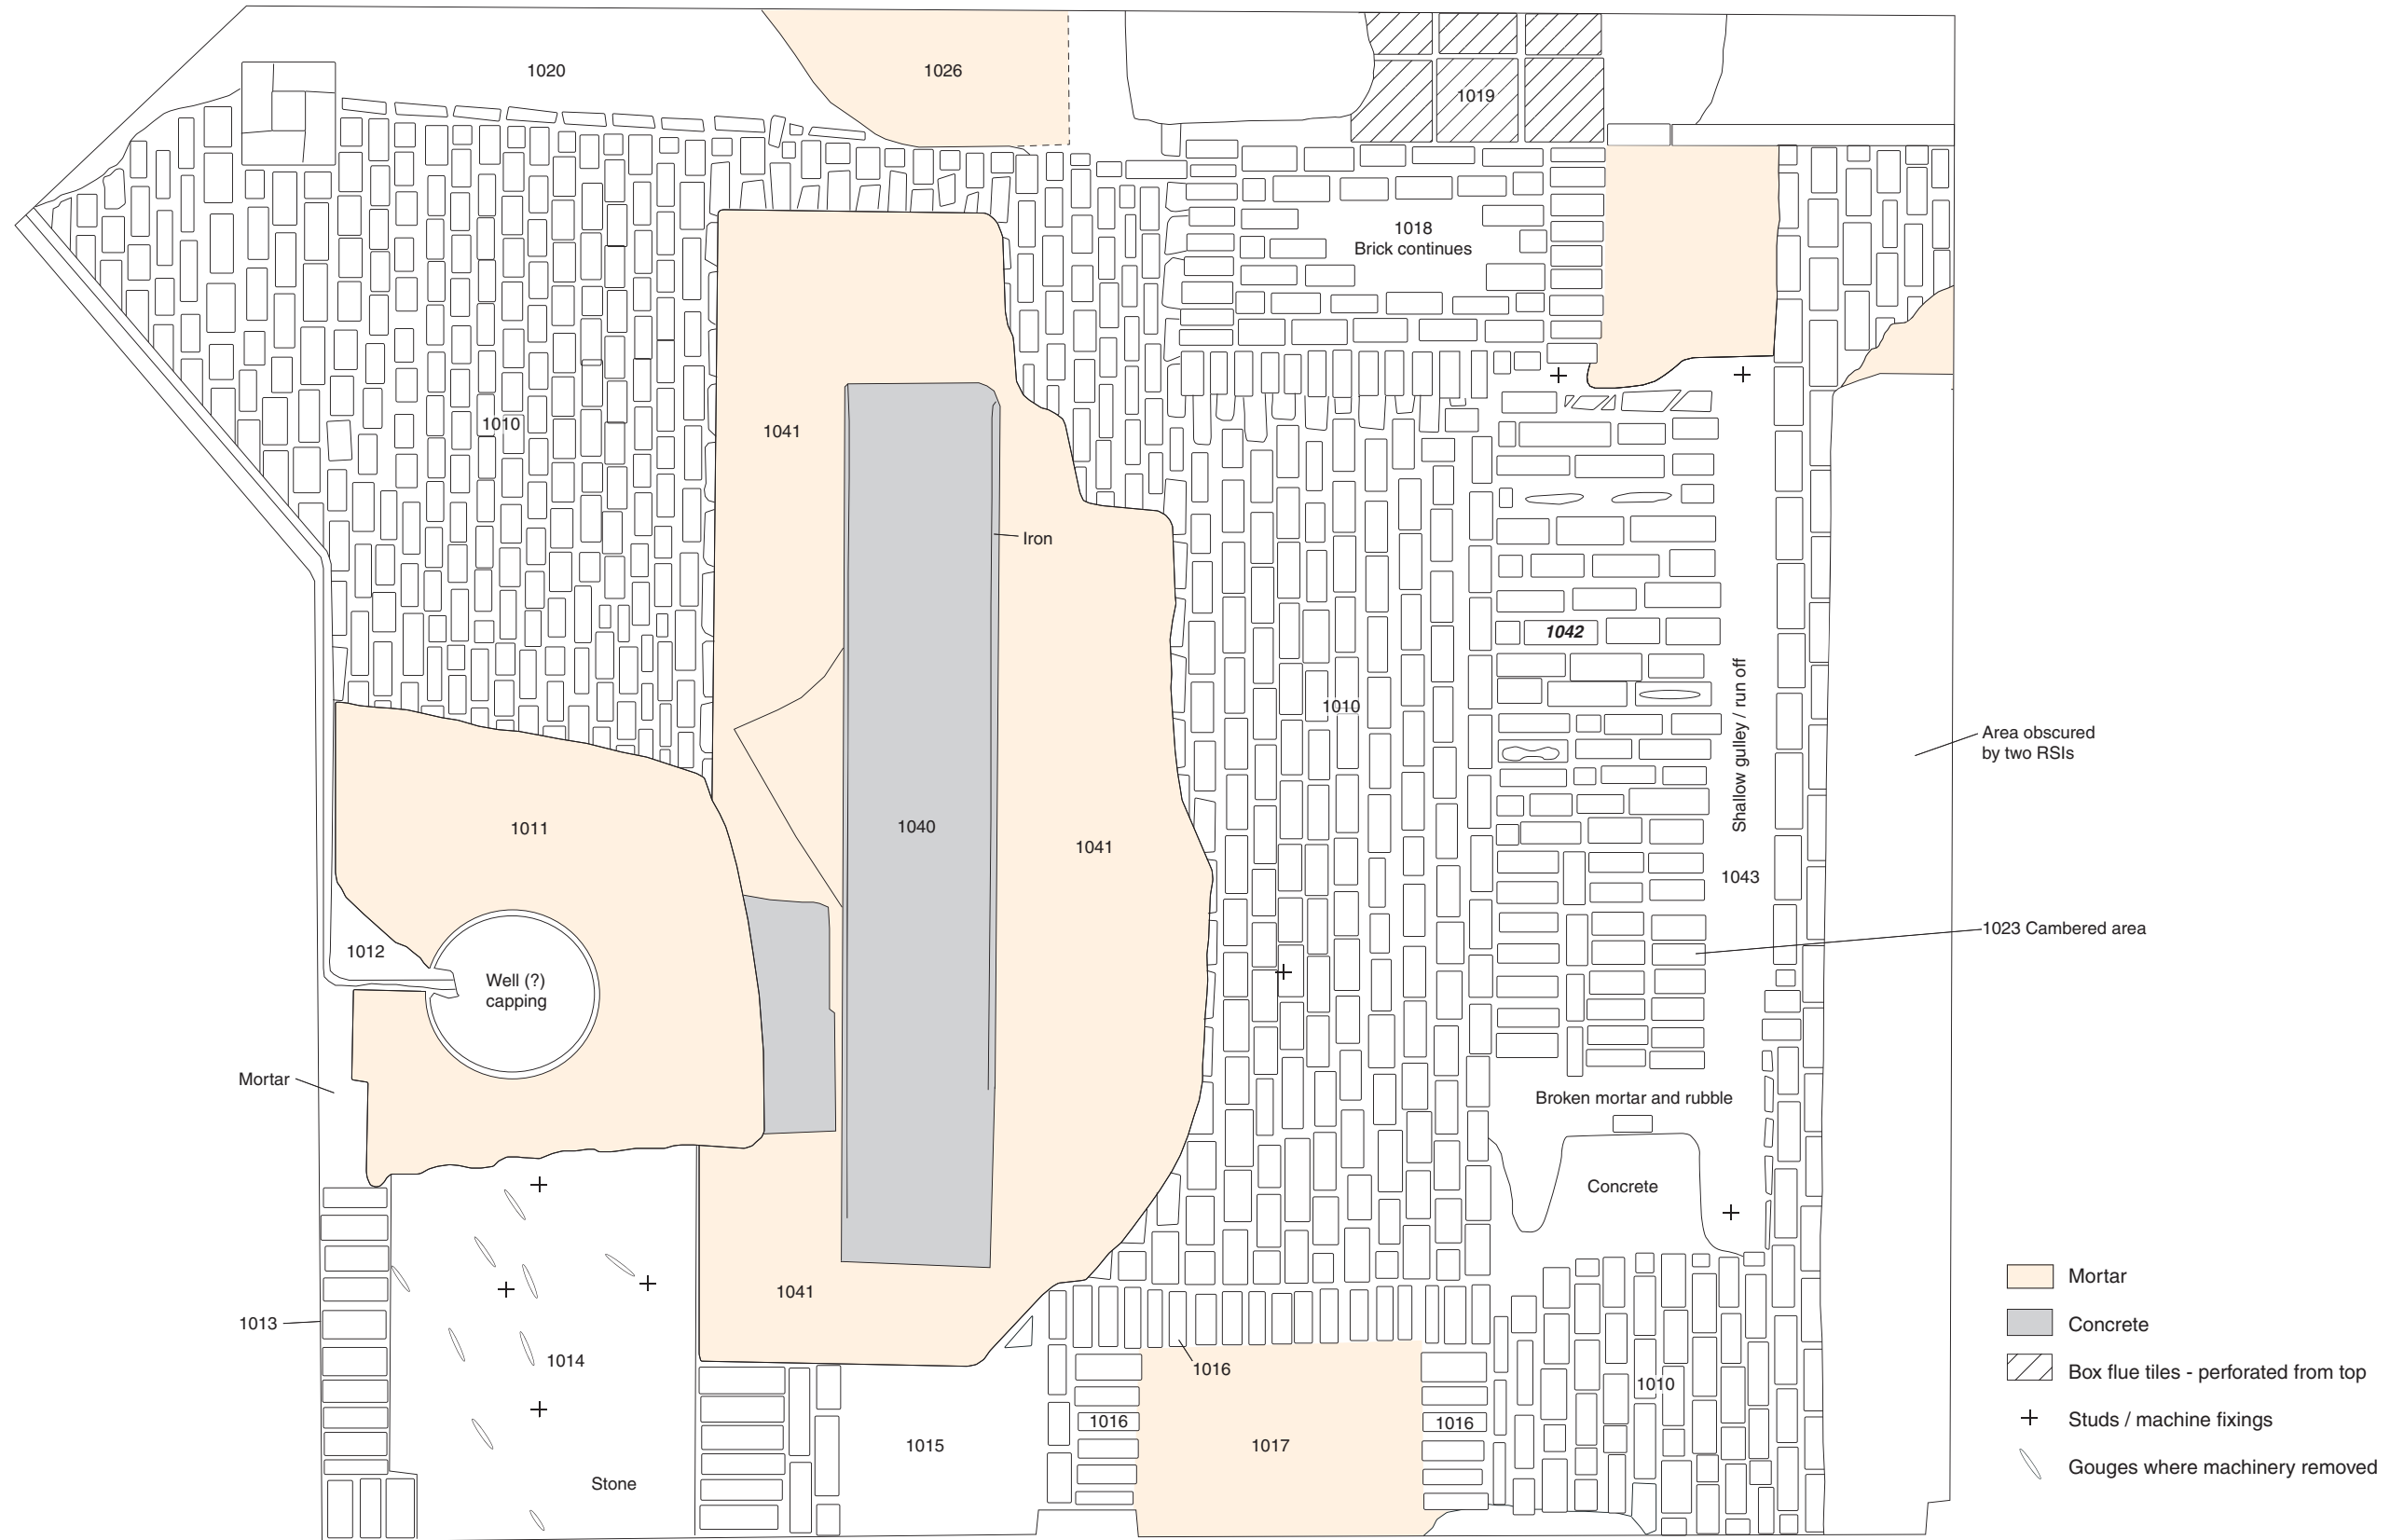
Figure 5: Plan of Room 1C

- 3.1.4 A roughly rectangular room measuring 6.8 m by 5.6 m. The room would have originally had a brick floor (1010) throughout, with the exception of a small amount of limestone flags (1019) against the west wall. Along the north wall of the room a shallow gully, a probable drainage channel, (1043) is built into the surface of 1010. On the east side of the room 1010 runs up to the brick lining (1016), of a probable poke. This has been backfilled and sealed by the mortar spread (1017).

- 3.1.5 Several later additions and structures have been built directly upon the brick floor. In the south-east corner of the room a sandstone plinth (1014), edged with a brick surround (1013) has been installed. A series of holes where machinery, possibly a pump has been removed are visible within the upper surface of 1014. This machinery may have been associated with a possible cement well cap (1011), immediately to the west, into which pipe (1012) also runs. Butting up to the stone flags (1019) is a brick plinth (1018), a possible machinery base. Located roughly centrally in the room is a mortar spread (1041) upon which a concrete machine base (1040) had been built. This may be a later (early 20th century ?) continuation of the 19th century brick plinth (1015) built up against the east wall.

- 4.1.9 The machine mounts 1014 and 1040 in room 1C appear to have been installed in the early to mid 20th century, possibly during partial mechanisation of the processes or as part of later reuse of the buildings. As in building 5 the differences in floor surfaces are probably during to continuous use and repair rather than by design.

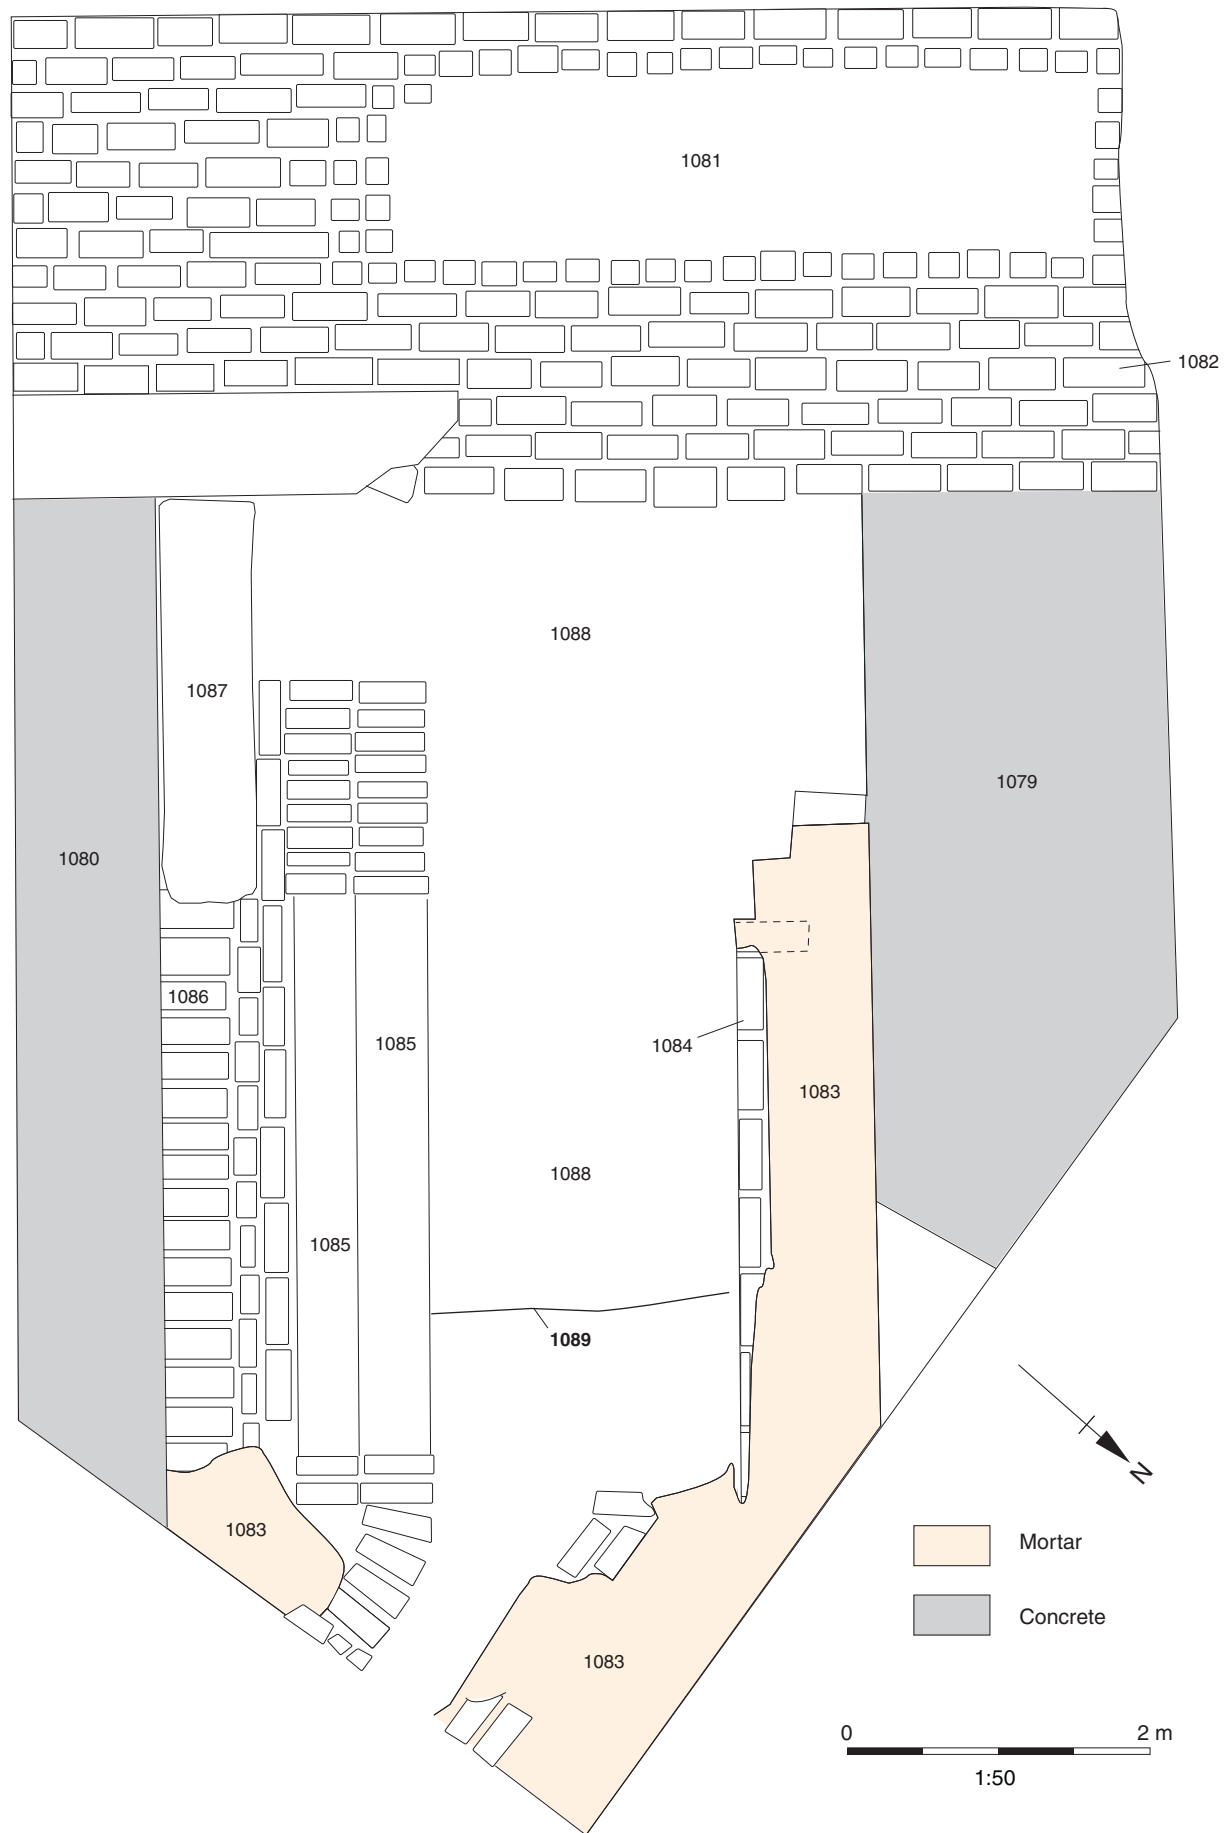
Figure 6: Plan of Room 1D

- 3.1.6 A five sided room measuring 6.0 m by 3.6 m across it's longest dimensions. The original brick floor (1082) runs across the south-east end of the room. This contains a large concrete patch (1081), embossed with a square cobble like pattern in it's centre. While this may be a 20th century repair, this may also be the backfill of a possible poke. In the northern end of the room the parallel pair of brick structures (1084) and (1085), 1.0 m apart, (Structure No. 1089), run towards the north-east corner, before necking down to a 0.3 m wide channel which turns to run out of the eastern wall into room 1A. A mortar spread (1083), covers the top of (1084) while a similar mortar spread (1087) covers the top of (1085). These spreads may represent capping of the brickwork or alternatively the mortar bed for now demolished brickwork, such as an arched vault between the two. The backfill (1088) between these walls contains a high percentage of charcoal suggesting this may have been a firebox or hearth. A brick floor (1086), possibly a continuation of (1082), butts up to the south-east side of (1089). Two concrete surfaces (1079) and (1080) have been laid either side of this feature, possibly in the early 20th century.

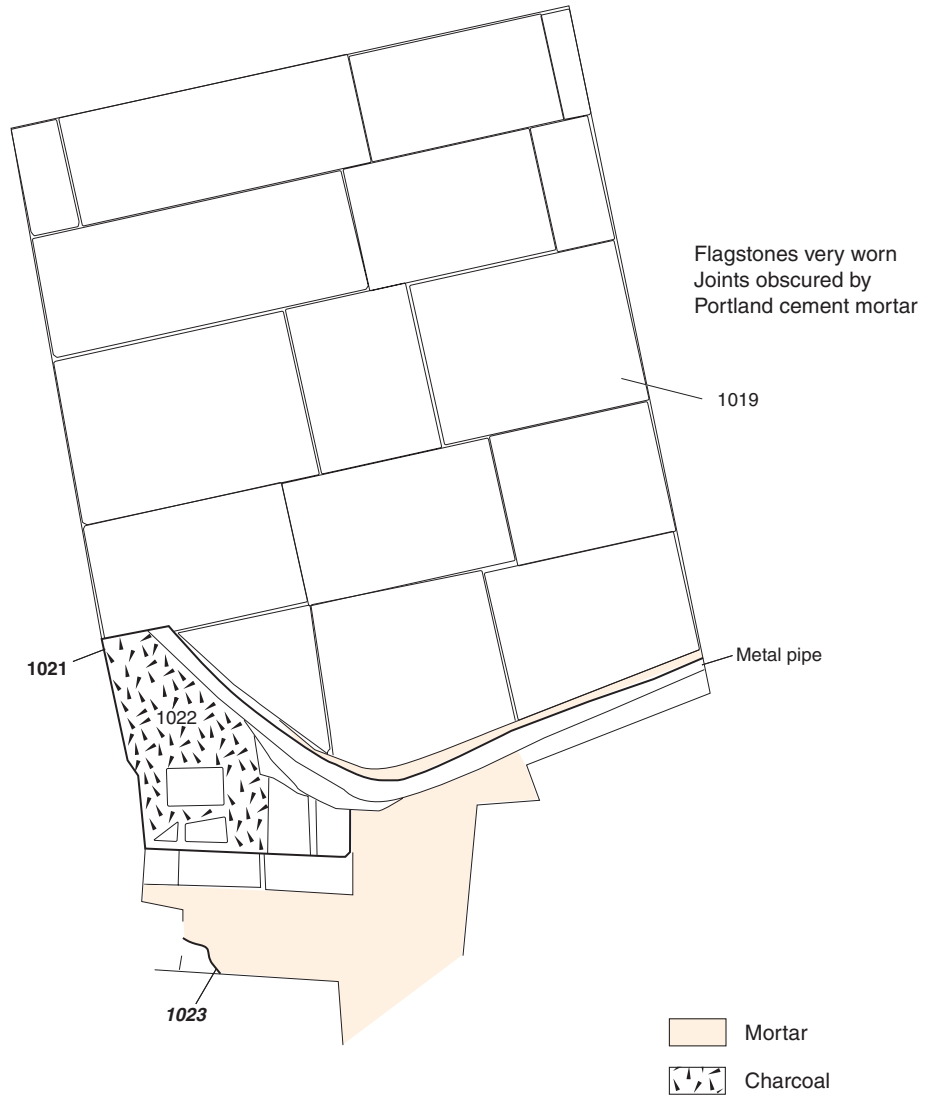
Figure 7: Plan of Room 1D

- 3.1.7 A small room measuring only 2.5 m by 1.5 m. The majority of the floor consists of a limestone flag floor (1019). This has been cut along it's western extent by a small channel (1021) containing a 75 mm diameter metal pipe. The flag floor had been disturbed in the north-western corner of the room (probably during the cutting of the channel) exposing a charcoal rich soil (1022), possibly the bed for the flags and an isolated stub of a demolished brick wall (1023).

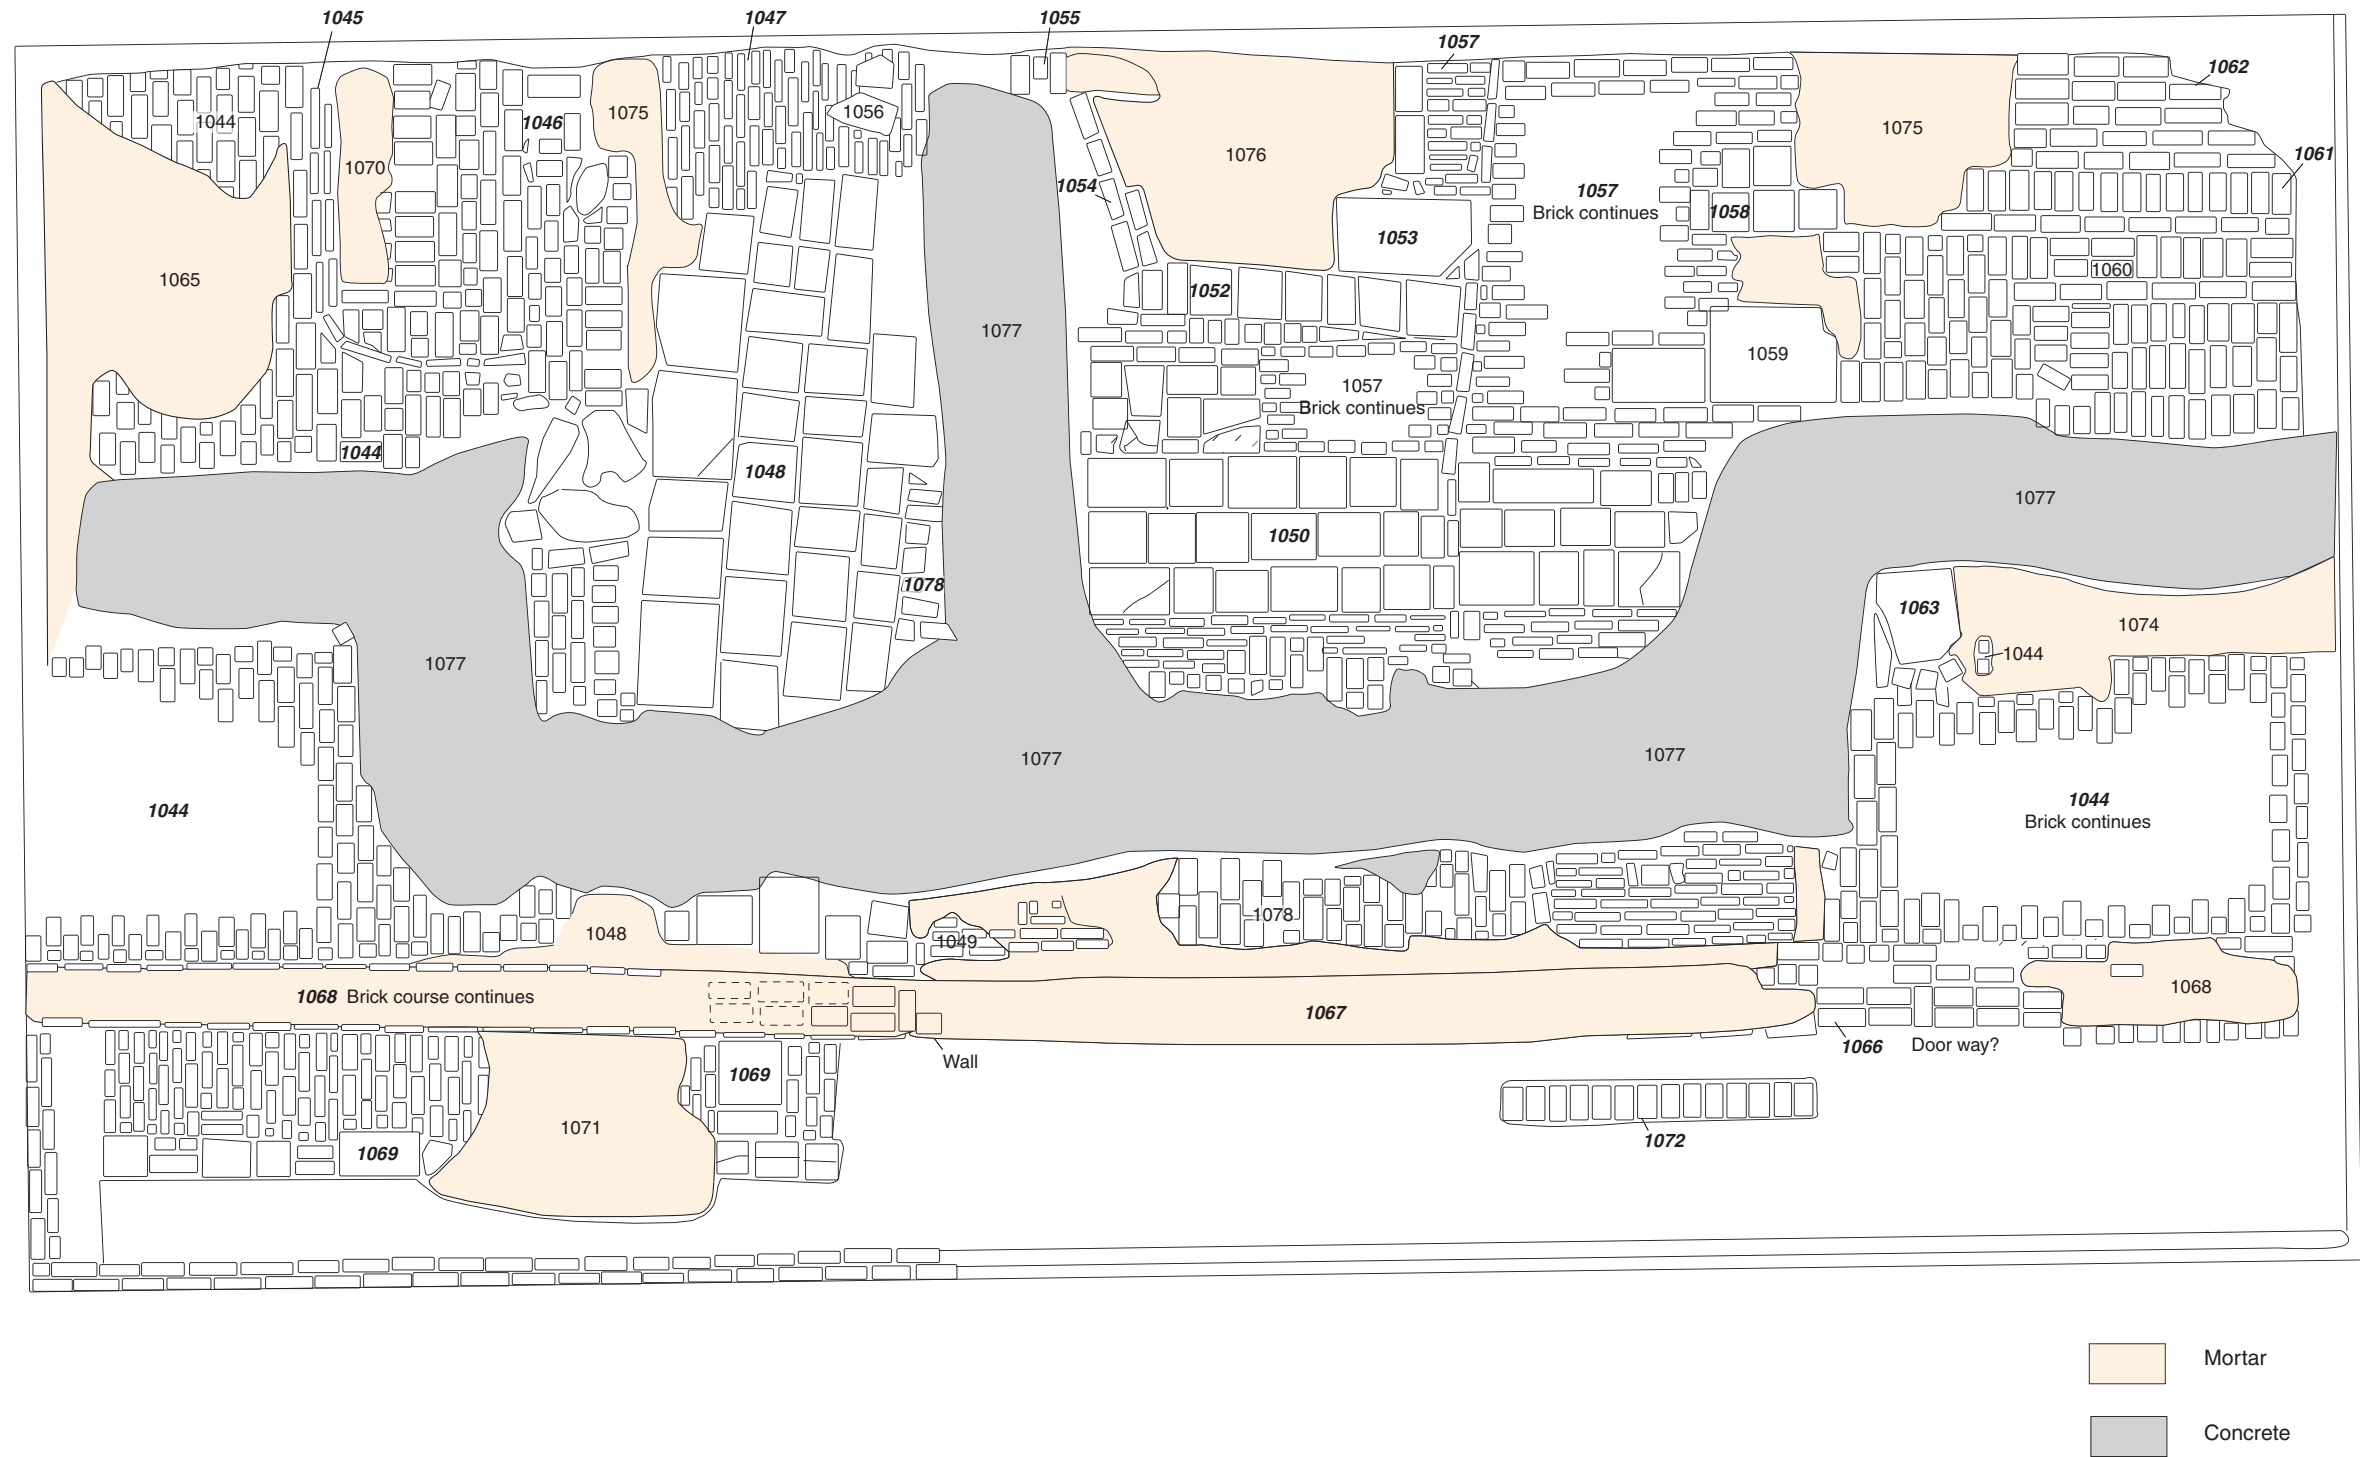
Figure 8: Plan of Room 5A

- 3.1.8 A large, rectangular room measuring 12.6 m by 6.6 m. It's floor was composed of a medley of brick and stone flag flooring. The bottom courses of a truncated wall (1068) run lengthways across the room approximately 1.2 m in from the southern wall defining what was a possible corridor. The brick surface (1069) forms the floor at the western end of this corridor, being sealed by the mortar spread (1071) towards the centre. An isolated length of wall (1072) stands in the eastern end of this corridor, with a double course of bricks (1064) running around the south and west sides of this corridor.

- 3.1.9 An alternative explanation is that this area might represent a possible long tank or process area rather than a corridor. At what date wall (1068) was taken down to floor level is unknown.

- 3.1.10 In the main part of the room the stone flag floor (1048) and it's probable brick repair (1047) splits the room. An area of brick flooring (1044) runs between these flags and the western wall of building 5, sealed in places by the later mortar spread (1065). A small area of a brick floored surface (1046), defined by the brick edging (1045) has been inset into the north-west limit of (1044), butting up to the western edge of the stone flags (1048) and may represent a repair.

- 3.1.11 In the eastern half of the main area a 0.8 m wide pathway of stone flags (1050) runs east to west approaching 1048 at roughly right-angles. The space between these flags and wall (1067) is filled by the brick surface (1078). In the south-east corner of the room a probable continuation of the brick surface (1044), along with later repairs (1063) and (1074) is exposed. In the north-east corner an irregular series of brick surfaces (1057), (1060), (1061) and (1062) together with repairs (1058) and (1059) form the floor. An area of stone flags (1052) and (1053), edged by the line of bricks (1054), possibly a separate working area is sited against the centre of the north wall of the building.

- 3.1.12 A band of concrete approximately 1.0 m wide, (1077) runs erratically through the building. This may be a 20th century repair to worn areas in the floor or might represent the backfilling of a service trench that was cut through the floor level.

- 3.1.13 While the exact function of this building is unclear, the lines of stone flags (1048) and (1050) may indicate possible walkways across the room and the brick surfaces possible working areas.

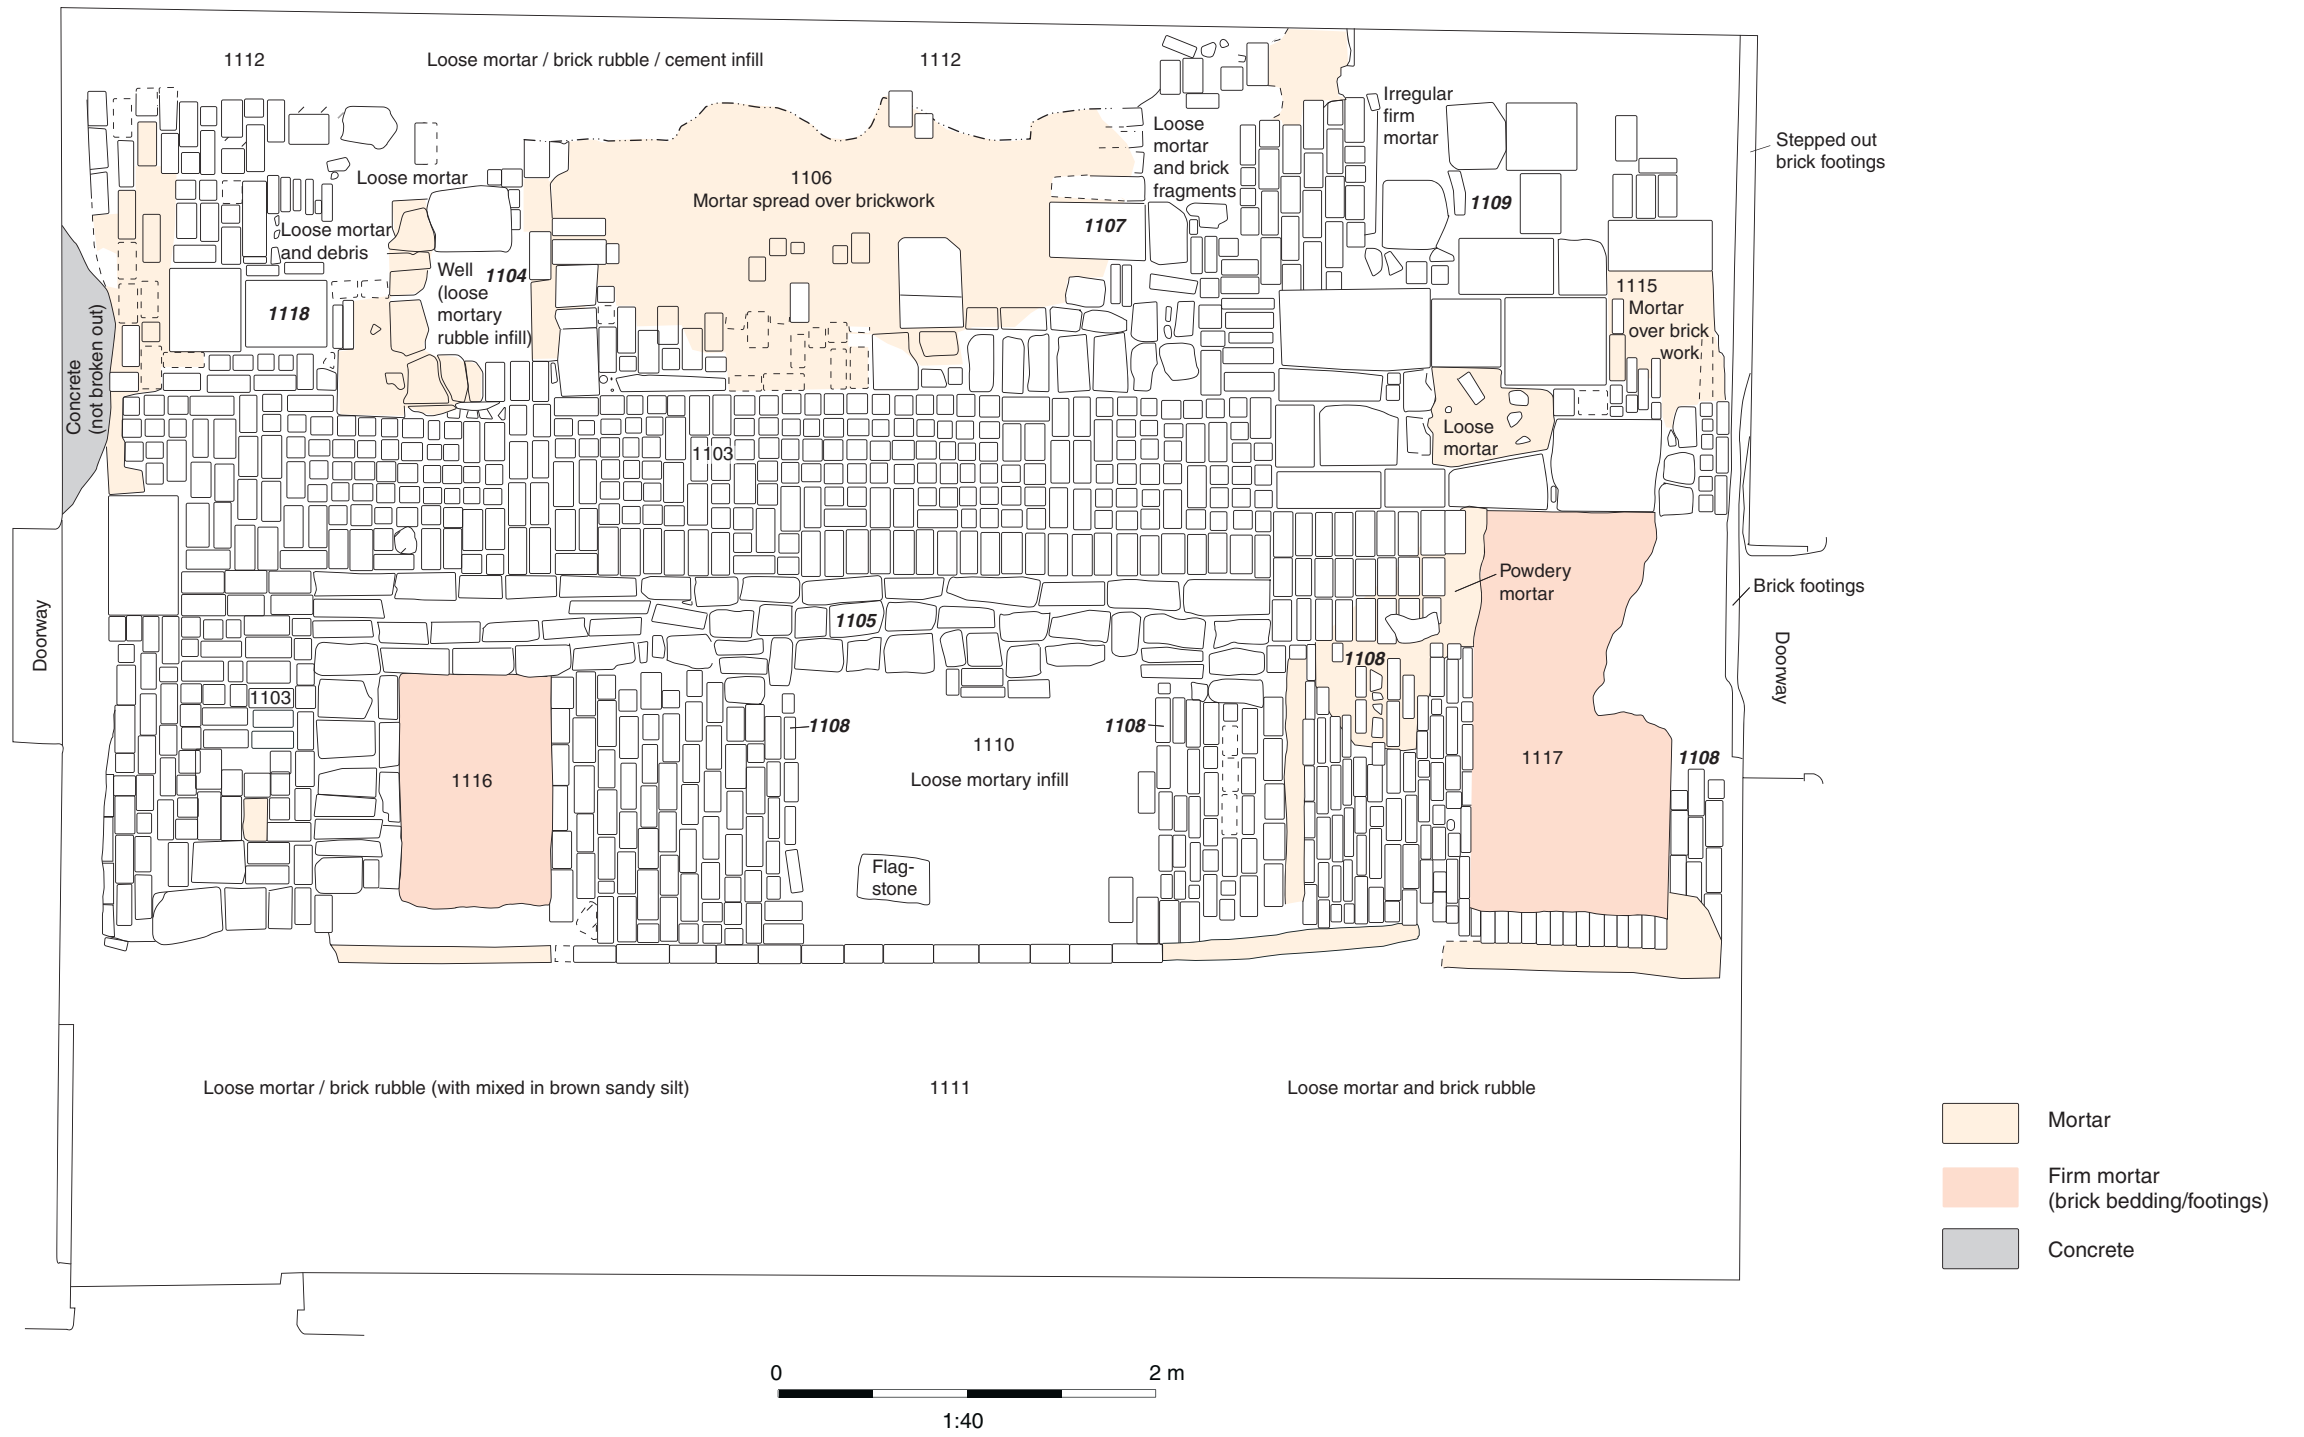
Figure 9: Plan of Room 1B

- 3.1.14 A large rectangular room measuring 9.0 m by 6.6 m. A 1.6 m wide band of loose mortar and rubble (1111) runs down the north wall of this room and probably represents the bed for an area of robbed out flagstones. No doorways are apparent at either end of this feature suggesting it is just an area of workshop floor rather than a corridor. Butting up to the centre of this area are two lengths of brick floor (1108) which together with an area of stone flags (1105) encloses a 1.5 m by 1.2 m feature (1110), filled with a loose mortar and ash mix, probably representing a backfilled process pit. On either side of the brick surface 1108 are the mortar beds of robbed out brick plinths (1116) and (1117), possibly machine bases. These may have been reduced to floor level either during reorganisation of the parchment works or possibly during later use in order to provide the biggest area of clear floor space. Running along the centre of the room is a 1.0 m wide band of brick flooring (1103) which butts up to an area of stone flags (1109) in the south-east corner of the room, while in the north-east corner it is butted by an irregular area of brick flooring (1118). In the corner formed by 1103 and 1118 is a 1.2 m square feature (1104), consisting of stone and brick edging around a central 0.6 m square opening which is filled with a loose mixture of mortar and rubble, and may be a backfilled well or poke.

- 3.1.15 An area of brick flooring sealed by an orange mortar spread (1106), a similar area of brick flooring (1114) and an area of stone flags (1109) run along the eastern side of (1103). A line of loose mortar 0.6 m wide (1112), identical to (1111) runs along the east wall of the room and again may be an area of robbed out flagstones.
